Article

On the Corrosion Fatigue of Magnesium Alloys Aimed at Biomedical Applications: New Insights from the Influence of Testing Frequency and Surface Modification of the Alloy ZK60

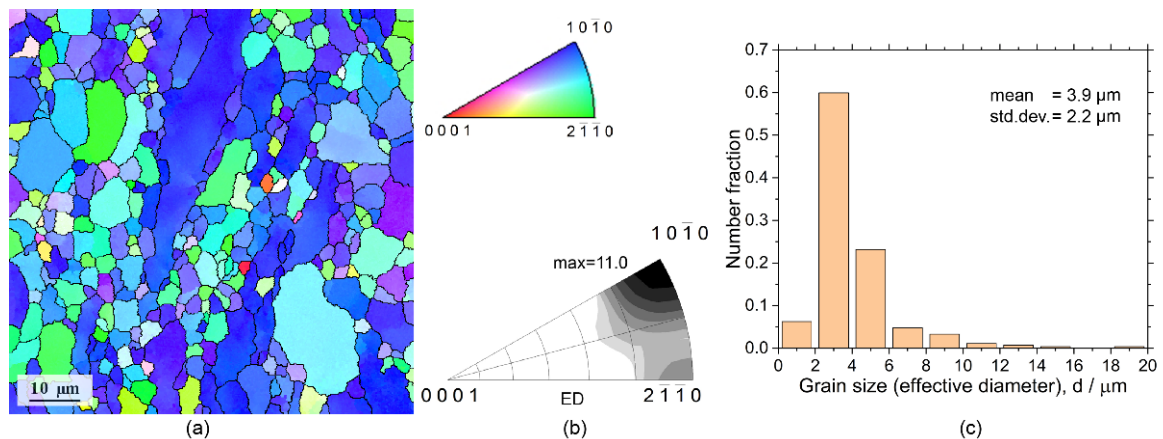
Figure 1. SEM-EBSD grain map (a) representing the typical microstructure of ZK60 alloy in the extrusion direction (ED), a crystallographic triangle with the inverse pole figure (IPF) colour codes applied to the grain map in (a) and the IPF (b), and the corresponding grain size distribution (c).

As it is commonly seen in the transverse sections of the ex-extruded ZK60 alloys (Figure 1), the microstructure is not uniform due to incomplete dynamic recrystallisation

occurring during hot extrusion. Some coarse unrecrystallised grains are surrounded by fine equiaxed recrystallised grains, representing a typical extrusion microstructure. From the EBSD grain map and the corresponding distribution of grain sizes shown in Figure 1a,c, respectively, the mean grain size (edge grains exclusive) is about 3.9 μm , and the standard deviation is 2.2 μm .

Wrought Mg alloys usually generate a strong fibre texture during hot extrusion, depending on the alloy composition and extrusion parameters [69–72]. Figure 1b shows the inverse pole figures (IPFs) in the extrusion direction, exhibiting the commonly observed $\langle 10\bar{1}0 \rangle$ fibre texture with the maximum texture index of 11 and the basal plane and $\langle 10\bar{1}0 \rangle$ direction being preferably parallel to the extrusion direction (ED).

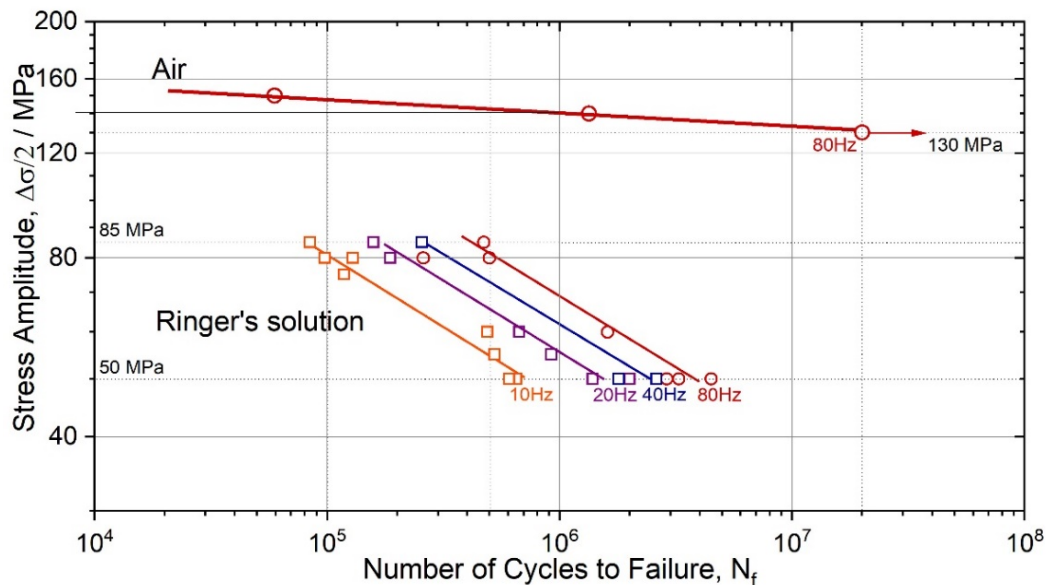
Figure 2. Wöhler plot for the ZK60 specimens with the ground surface tested at different frequencies—10, 20, 40 and 80 Hz in air and Ringer’s solution.

The bending fatigue strength (at 10^7 cycles to failure and $R = -1$) of the wrought alloy ZK60 is typically ranged between 110–140 MPa [67], depending on the microstructure attained during processing (note that the axial fatigue limit can reach up to 150 MPa after grain refinement by severe plastic deformation [25]). The present results in air, Figure 2, fall nicely in the typical range: the endurance limit in uniaxial symmetrical push-pull testing is at 130 MPa (ground surface) in the high-cycle regime at $N_f = 2 \times 10^7$ cycles to failure. After immersion in SBF, the fatigue strength dropped sharply from 140 MPa at 5×10^5 loading cycles in air to 80 MPa in the solution at the same 80 Hz frequency. Such a significant degradation in mechanical performance is not unusual for Mg alloys. For instance, for the alloy AZ80 in 3.5% NaCl solution, the fatigue strength reduced by a factor of 1.4 and 2.6 at 10^6 and 10^7 cycles, respectively [73] (this is comparable to the present results although Al-containing AZ80 is nominally more corrosion-resistant than ZK60; moreover, the cross-section of the samples tested in [73] was five times larger than that in the present study, which provided higher mechanical stability of the specimen during the corrosion-induced surface degradation). With the reduction of frequency from 80 to 40, 20 and 10 Hz, i.e., with the proportionally increasing holding time in the corrosive solution, the deterioration of fatigue strength is even more pronounced, reducing further to 70, 65 and 55 MPa, respectively. Recently Han et al. [74] reported interesting results showing that

low-frequency cyclic tension–compression alternating loads significantly accelerate the corrosion process in magnesium alloys, and the higher the applied frequency, the faster the corrosion. The trends observed in the present work are, however, different in that the lower the frequency and the longer the material is exposed to the aggressive solution, the greater the corrosion damage and the shorter the fatigue life.

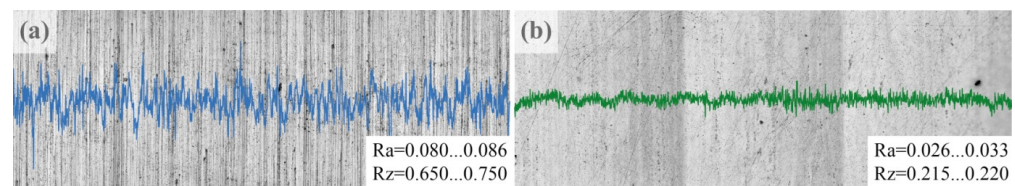
Figure 3. The surface appearance and the corresponding profiles after grinding (a) and polishing (b); roughness parameters are shown in the insets.

The surface roughness significantly affects the fatigue life. The fatigue testing standards ASTM E466 [62] and E606 [75] require final specimen polishing to impart a maximum surface roughness R_a of $0.2 \mu\text{m}$. The typical profile of the samples prepared with two grinding options is shown in Figure 3. Measured surface roughness R_a and R_z values are shown in the insets. For both samples with different surface treatments, the R_a values are well below the acceptance threshold, albeit they differ by a factor of 3 or 4.

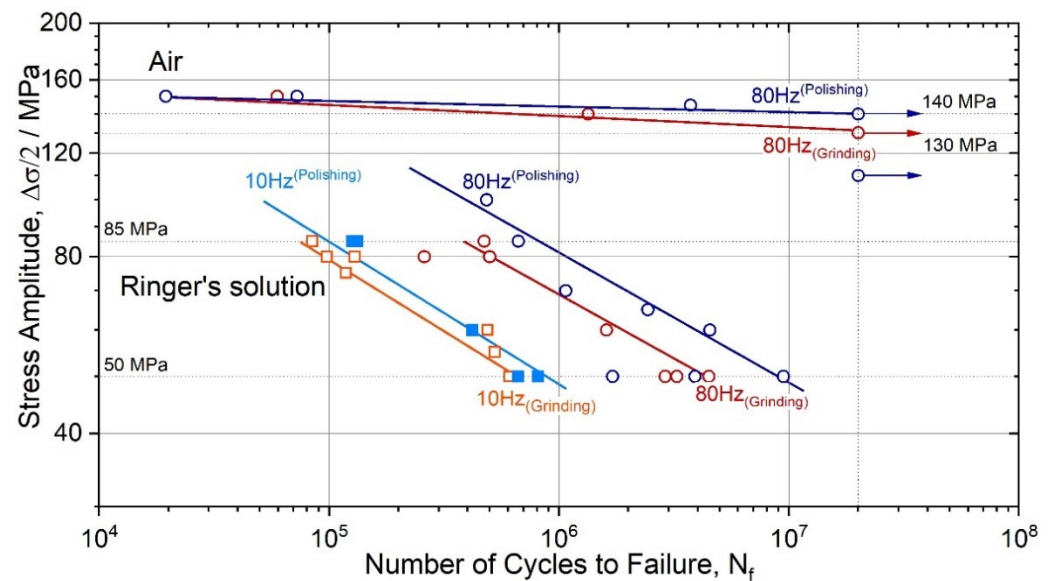
Figure 4. Wöhler diagrams for the ZK60 specimens with the ground and polished surfaces tested at 10 and 80 Hz in air and Ringer's solution.

Compared to the ground specimens, the polished specimens tested in air at 80 Hz showed longer fatigue life. The endurance limit, corresponding to 2×10^7 cycles to failure N_f of polished specimens, was $140 \pm 3 \text{ MPa}$, while their ground counterparts failed at the stresses by 10 MPa lower (Figure 4). The same trend is observed for the specimens tested in Ringer’s solution: polished samples had a consistently longer fatigue life at the same stress amplitude than their ground counterparts. Furthermore, one can notice that the difference in the tolerable stress amplitude for the polished and ground specimens increases with the test frequency in the corrosive solution.

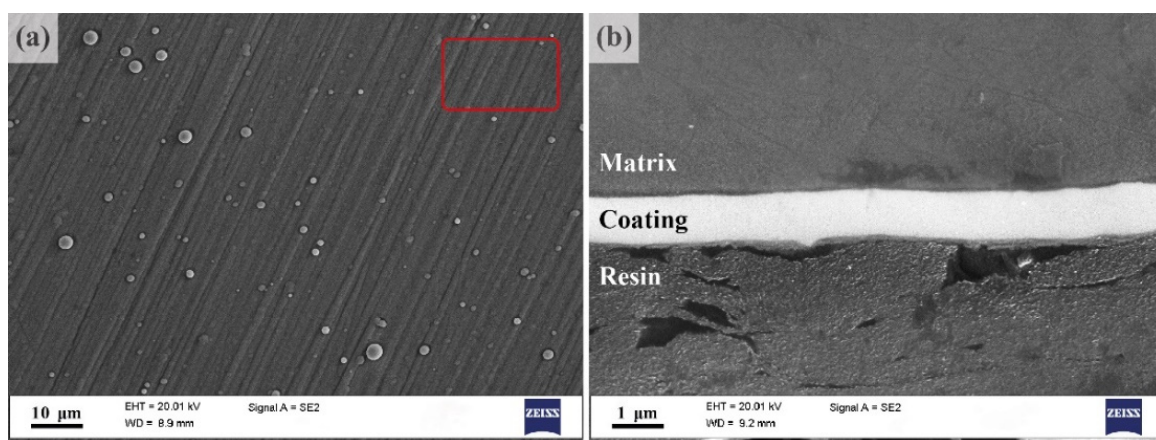
Figure 5. SEM images illustrating the Zr coating appearance of the specimen surface (a), and a view of the cross-section of the coating deposited on the ZK60 substrate (b); the area for the EDS spectroscopy analysis is indicated by a red rectangle (shown for the coating only).

The typical appearance of the surface of the coating applied to the fatigued sample is shown in Figure 5a, and the view of its cross-section is represented in Figure 5b. The coating is thin, of $0.8 \pm 0.2 \mu\text{m}$, dense, i.e., without visible voids, and it follows the surface waviness. Individual droplets of Zr of 1 μm diameter can be seen on the surface. The diffusion layer can hardly be formed under sputtering conditions, where the surface temperature did not exceed 200 °C, to preclude any microstructural modification of the substrate.

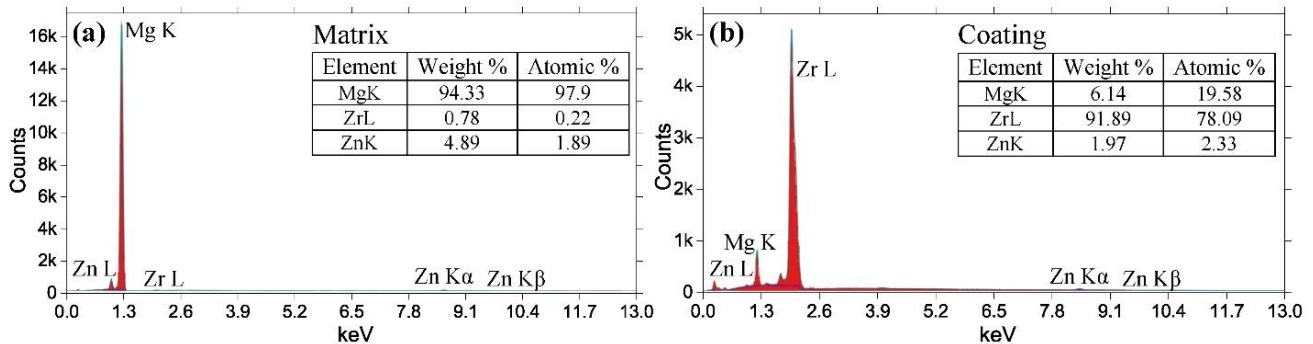
Figure 6. Energy dispersive X-ray (EDX) spectra obtained from the α -Mg matrix (a) and the zirconium coating (b) (the area for the analysis is indicated in Figure 5).

Results of the energy dispersive X-ray analysis carried out on the cross-section of the specimen (Figure 6) confirm that in line with the purpose of the present work, a reasonably pure Zr coating has been formed on the surface without oxidation.

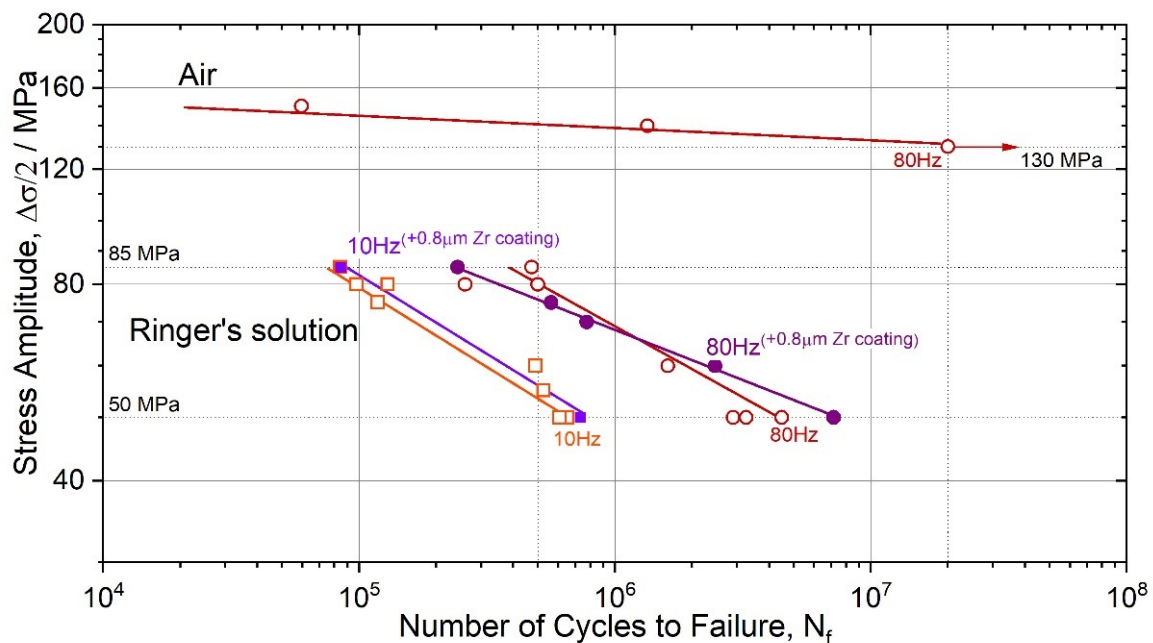
Figure 7. S-N plot for the ZK60 specimens—bare and coated by a 0.8 μm thick pure Zr coating—tested at 10 and 80 Hz in air and Ringer's solution.

The endurance limit for the Zr-coated specimens was found to be 47 ± 3 MPa at $N_f = 10^6$ and 27 ± 3 at 10^7 10 Hz, and 68 ± 3 MPa and 48 ± 3 MPa at 80 Hz (Figure 7). Although the Zr coating of the same thickness helped to reduce the corrosion rate by at least a factor of 1.6 as assessed by hydrogen evolution after 110 h submersion in Ringer's solution, the increase in the cyclic resistance was practically negligible.

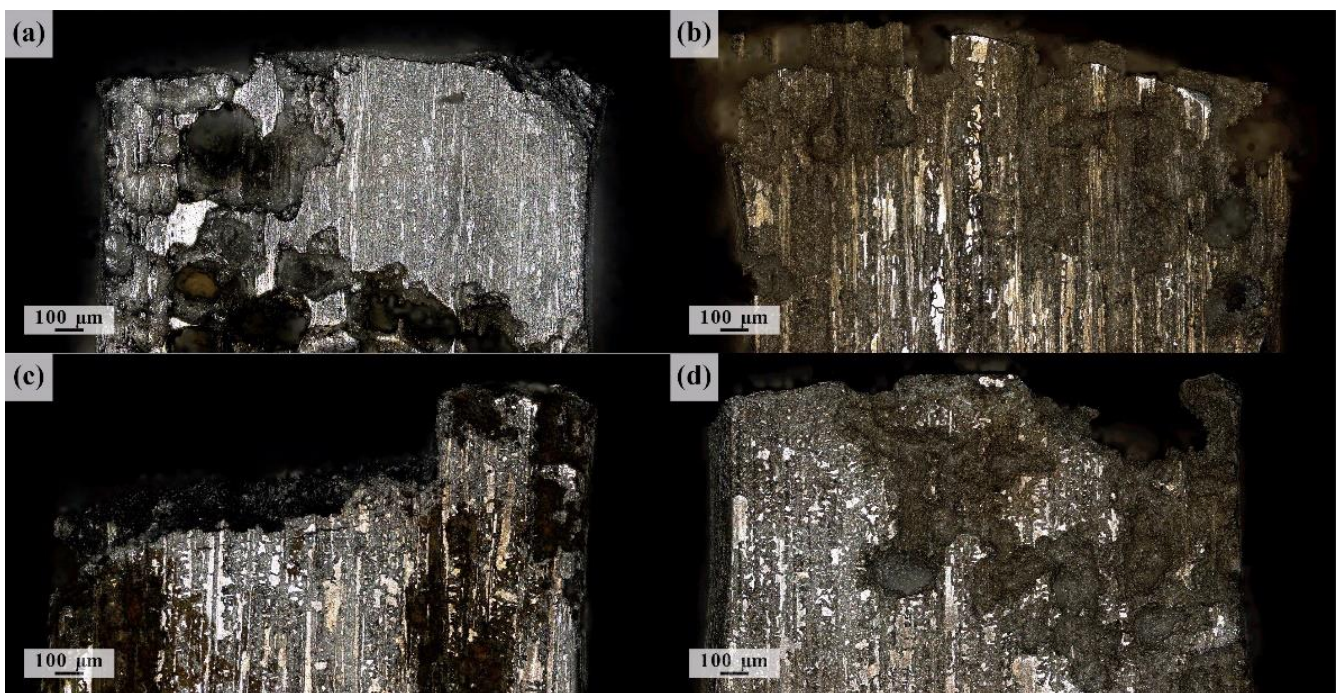
Figure 8. CLSM images of the side fracture surface of ZK60 specimens tested at 50 MPa stress amplitude after surface preparation by grinding (a,c) and polishing (b,d); (a,b) refer to the 10 Hz test frequency, (c,d) correspond to the 80 Hz frequency.

The typical appearance of the lateral surface of the specimens after fatigue fracture in SBF, followed by immediate removal of corrosion products, is shown in Figure 8. All specimens immersed in the corrosive solution suffered from multiple pits chaotically distributed over the surface. It is unclear whether the locations of individual pits are completely random or are pre-determined by the microstructural/chemical inhomogeneity. However, the results of Li et al. [87] show, quite unambiguously, that in line with the discussion given in the introduction, the micro-galvanic corrosion in the alloy ZK60 initiates primarily in the areas around the second-phase particles at the grain boundaries. Figure 8 indicates that once initiated, the corrosive pits tend to grow and deepen under the action of cyclic loads. This process, in turn, significantly accelerates the localised corrosion damage propagation by breaking the unstable layer of continuously forming corrosion products. No significant difference was found in the appearance of corrosion damage (in terms of geometry, depth and distribution of corrosion pits) on the ground and polished surfaces.

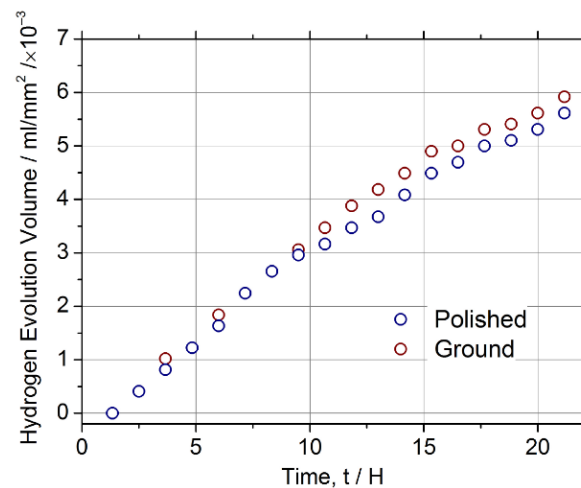
Figure 9. Hydrogen evolution curves for ZK60 specimens, with the ground and polished surfaces tested in Ringers’s SBF at 37 °C.

Similar conclusions are drawn from the measurements of hydrogen evolution in the same SBF carried out, as described in [88] according to the guidelines outlined in [89]. Figure 9 reveals no appreciable difference in the corrosion rate estimated during 20 h of testing of the polished and ground specimens.

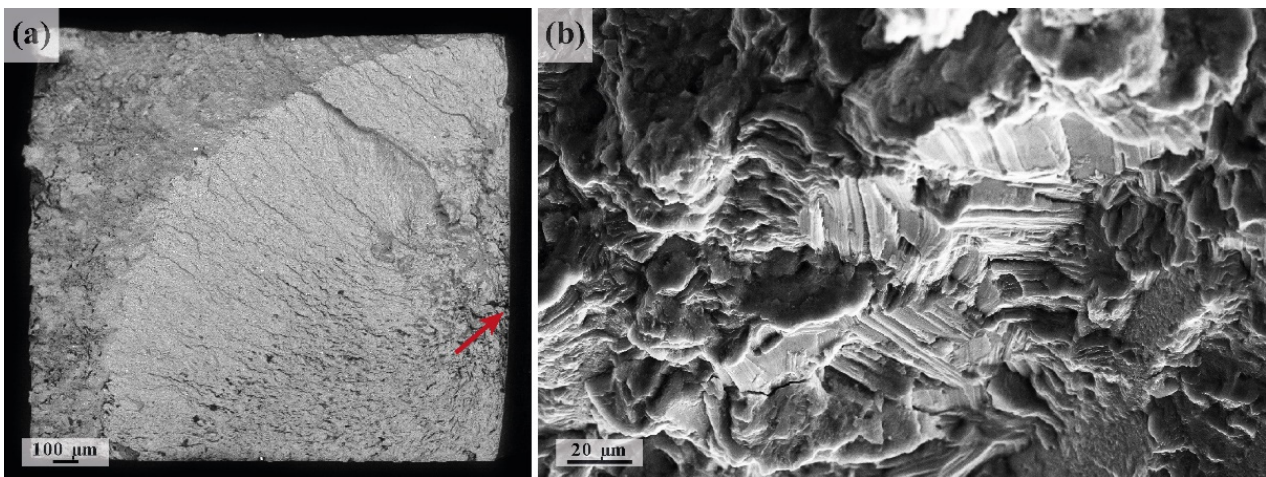
Figure 10. SEM fractography images of the alloy ZK60 specimen fatigued to fracture in air: (a) overview of the fracture surface (a) and a magnified view of the crack initiation site (b), pointed to by a red arrow in (a).

Characteristic regions corresponding to the different stages of a fatigue fracture in air are usually well-defined on the fracture surface, reflecting the crack initiation stage, followed by the area of steady crack propagation and the final rupture [25] (c.f., Figure 10). The river pattern, which is typical of fatigue, visible in Figure 10a, points to the region of crack initiation. The initiation stage I of the fatigue crack growth is known to be strongly microstructurally dependent [93,94]. It is controlled by the interplay between the dislocation slip along the basal planes and twinning in Mg alloys [26,82,95–98]. The traces of the slip planes, such as those visible in Figure 10b, are often seen in the fatigue fracture surfaces of Mg alloys at this stage (see, e.g., [99]).

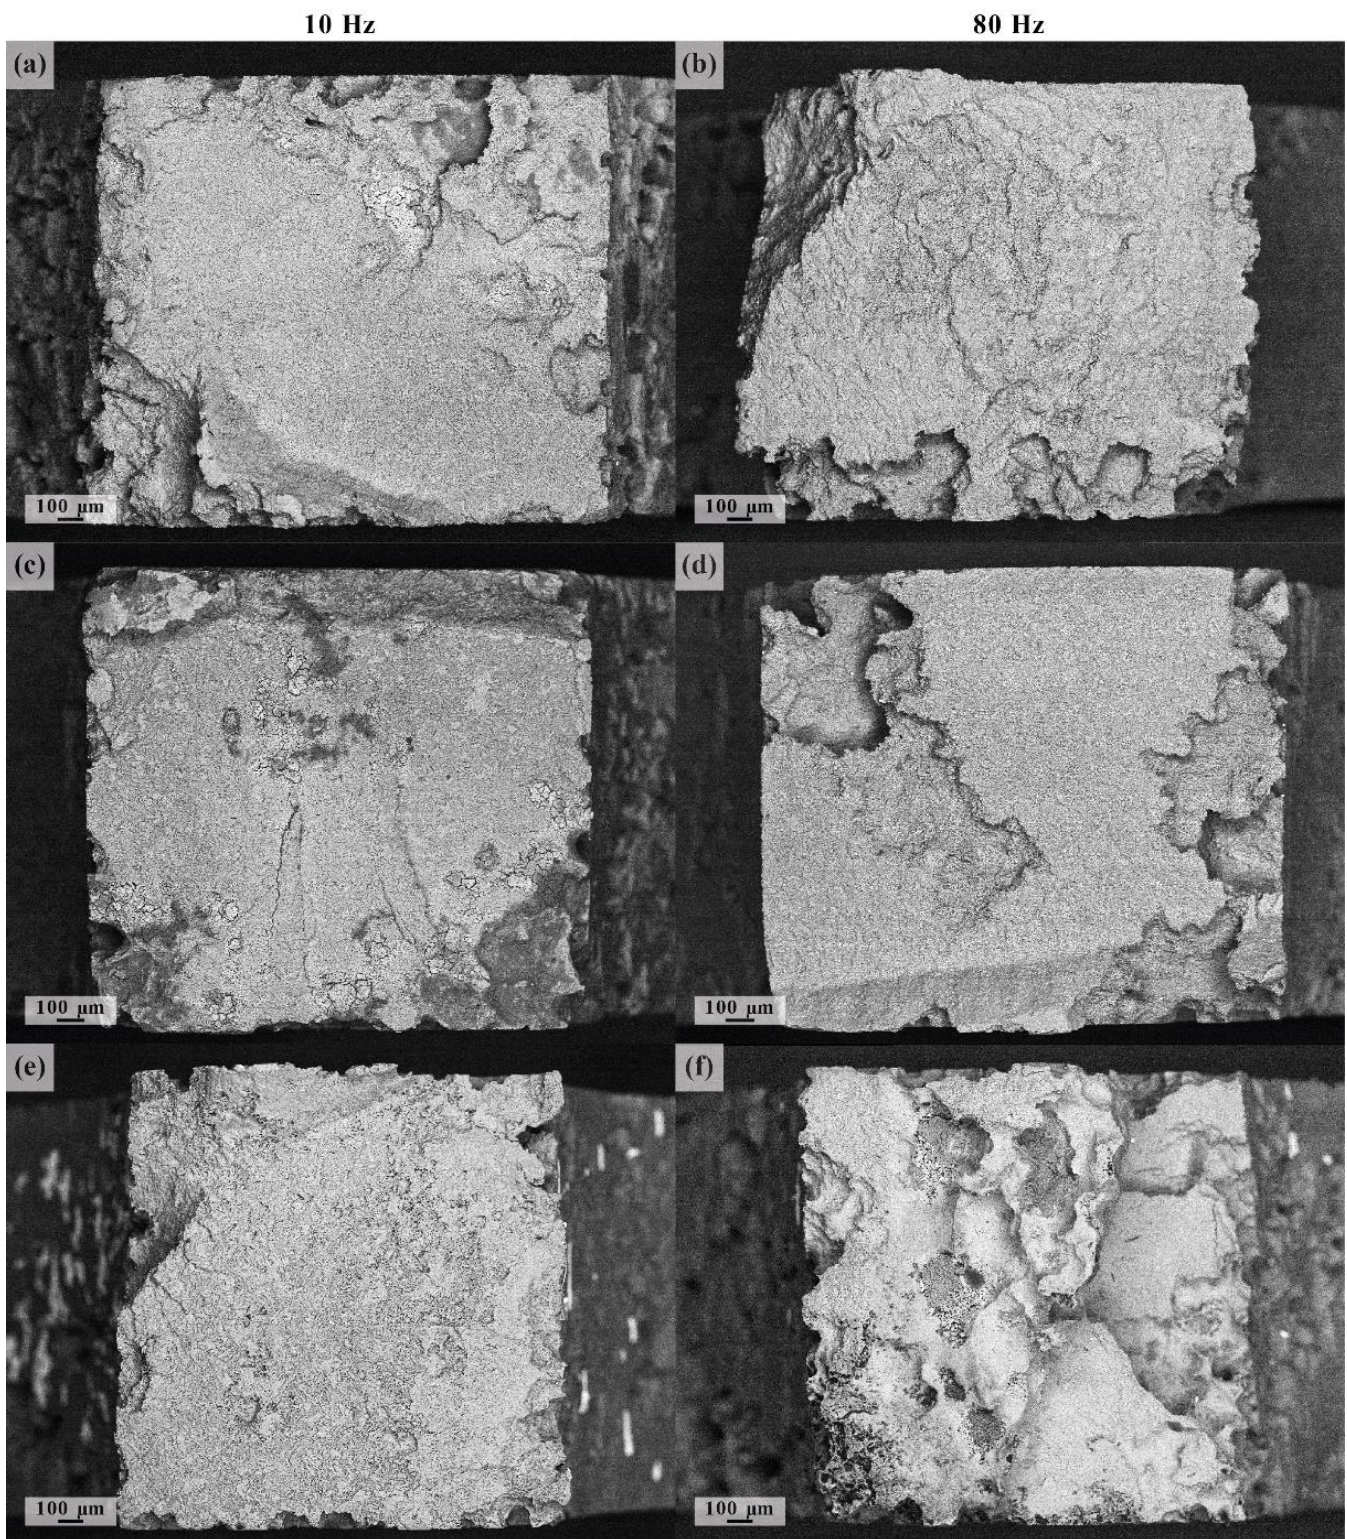
Figure 11. SEM images of the fracture surface after testing in Ringer's solution with 50 MPa at 10 (a,c,e) and 80 Hz (b,d,f); initially ground surface (a,b), polished surface (c,d), and Zr-coated surface (e,f).

On the contrary, the fractographic images of the investigated ZK60 specimens tested in SBF reveal (after removal of corrosion products) two notably different zones: one highlights severe corrosion-induced pitting along the perimeter of the fracture surface and the other the central flat matte areas with fine fibrous fracture morphology. Identifying the site (either single or multiple) of fatigue crack initiation is impossible for fracture reliefs of this kind. Neither it is possible to recognise the direction of the crack growth as there are no radial marks or visible roughness change due to crack propagation. Moreover, no regular striations are found on the fracture surface of the ZK60 specimens tested in the corrosive solution (Figure 11). Striations are characteristic of fatigue fracture morphology; they indicate successive positions of the advancing fatigue crack front in many structural materials [100], including Mg alloy fatigue tested under corrosion [91]). The presence of striations on the fracture surface is often regarded as a fingerprint of fatigue [101]. Striations form due to crack tip plasticity, the significance of which is characterised by the cyclic plastic zone forming at the crack tip as a result of unloading from the far-field load. If the size of the reversed plastic zone is too small, the striations may not form, and the fracture mechanism is a brittle one. On the one hand, the smaller the cyclic plastic zone, the lower the stress intensity ahead of the crack, and the slower the crack growth rate. On the other hand, the small plastic zone absorbs a smaller amount of mechanical energy needed for the crack advance, i.e., the crack propagation requires less energy. The small plasticity and the small, reversed plastic zone are reasonably anticipated when the stress amplitudes are small (e.g., 50 MPa or so, as in the present case) in corrosion fatigue testing. Therefore, it is not surprising that the conventional striations do not form, and the fine fibrous relief prevails. Even though the absence of striations does not exclude fatigue as a cause of failure [102], it strongly suggests that other factors play an important, if not decisive, role in the cyclic stress–corrosion damage evolution. Admittedly, the fractographic observations indicate that it is corrosion that takes the lead in mechano-chemical interactions and, finally, in the integrity degradation of small-size Mg alloy specimens under cyclic loads. However, if one assumes that the failure in SBF is governed chiefly by the adverse effect of corrosion, then the damage-controlling factor would be the holding time in the solution. In that case, the experimental data obtained for different test frequencies and plotted as a function of time to failure must converge to the same line. Corresponding plots are shown in Figure 12. The straight lines for different test frequencies converge to some extent; however, they do coincide only for 10 and 20 Hz frequencies. Consequently, corrosion damage, although having a crucial impact on durability, is not the sole factor controlling the failure process during fatigue testing of the Mg alloy in SBF.

The reduction of the cross-section area caused by the corrosion attack from the specimen periphery is noticeable in Figure 11. With the ultimate tensile strength in excess of 300 MPa for the alloy ZK60, it is, however, not large enough to cause an ordinary quasi-static failure under tensile stresses as small as 50 MPa, corresponding to the lowest stress amplitude in the cyclic test. Neither does the fracture surface bear any similarity with the dimpled surface commonly observed after ductile fracture in tension [24]. Nevertheless, one can notice that the flat, fibrous fracture surface topology bears a lot of similarity to that reported for magnesium alloys fractured in physiological solutions under stress corrosion cracking (SCC) conditions (e.g., AZ91D [103,104] or AZ31 and ZK60, as shown by some of the present authors in dedicated investigations [28,105,106]). Figure 13 illustrates some of the observed features, which are typical of SCC in many Mg alloys (including the same ZK60 [28,105–108]) and are not seen in the specimens conventionally fatigued in air—there are visible signatures of intergranular brittle fracture (marked by red arrows) and multiple secondary cracks—and the characteristic fluted relief (marked by white arrows), which is indicative of SCC-induced plasticity ahead of the crack tip (flutes represent specific elongated dimples formed when voids are nucleated along slip-band intersections [109]). Of course, these features, which are sporadically observed on the fracture surface of the specimens fatigued in corrosive media, do not represent the predominant fracture mechanism, but rather, they indicate the plurality of the mechanisms involved in the fracture processes. The relatively simple picture of a fatigue fracture in air, represented in Figure 10, is exacerbated by both corrosion and SCC phenomena. The interaction of corrosion fatigue and stress corrosion cracking is a complex process that has not been understood to date and requires further investigation.

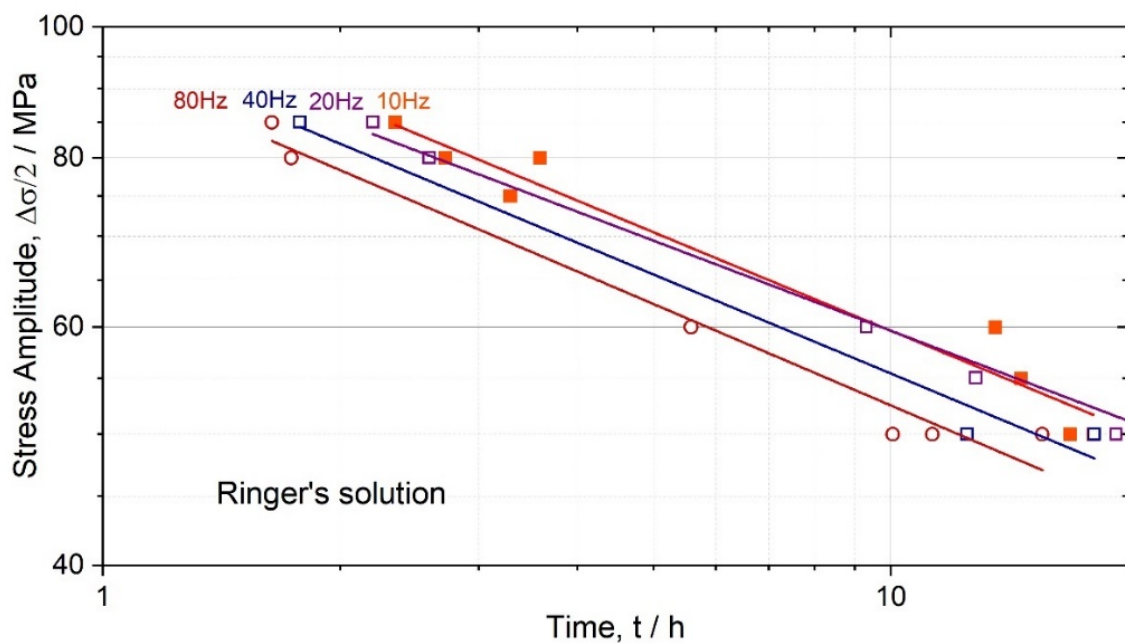
Figure 12. Fatigue diagrams for the ZK60 specimens plotted as the stress amplitudes vs. fatigue time, corresponding to different testing frequencies in Ringer's solution.

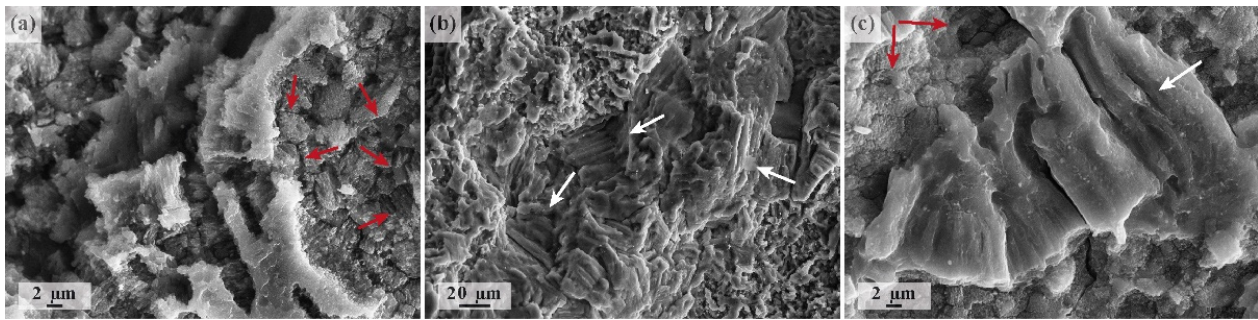
Figure 13. Enlarged fragments of the fracture surface after corrosion fatigue testing of ZK60 samples to failure at 50 MPa nominal stress amplitude and 10 Hz frequency, showing sporadically observed features that are typical of SCCs in many Mg alloys (including the same ZK60 [105]); red arrows point to the features characteristic of intergranular brittle fracture, and white arrows point to the fragments with a fluted fracture surface.

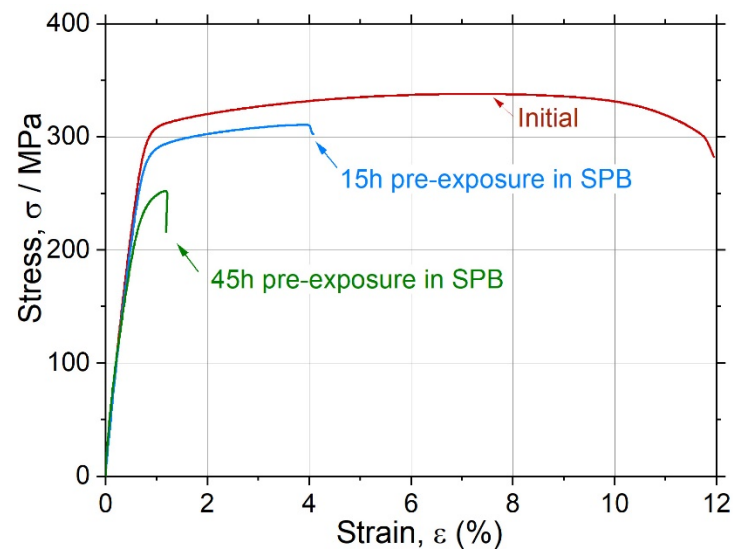
Figure 14. Engineering tensile stress–strain curves the ZK60 specimens tested in air in the initial condition and after pre-exposure in Ringer’s solution for 15 and 45 h.

To get a deeper understanding of the impact of conventional corrosion on the mechanical response, additional quasi-static tensile tests were performed on the miniaturised specimens ($20 \times 2 \times 2 \text{ mm}^3$) with the same cross-section area used for the fatigue testing campaign. The specimens were pre-immersed to Ringer's solution for 15 and 45 h, which correspond to the average and longest time to fatigue failure, respectively, at the stress amplitude of 50 MPa in the same environment. After pre-exposure, the specimens were cleaned with isopropanol, dried by compressed air and immediately mounted in the grips of the tensile machine. The time lag between the end of pre-exposure in SBF and testing was about 15 min. These tests were performed in air at the strain rate of $4.2 \times 10^{-3} \text{ s}^{-1}$ with the 5 kN load cell. Results are shown in Figure 14. Although the ultimate tensile strength reduced from 338 MPa to 310 and 252 MPa after 15 and 45 h pre-immersion times, respectively, it still remained high—much higher than the fatigue fracture stress observed at the same testing time under cyclic loading. However, the ductility loss was notably more severe—from 12% to 4% and 1%, respectively, which is indicative of the embrittlement associated with SCC.

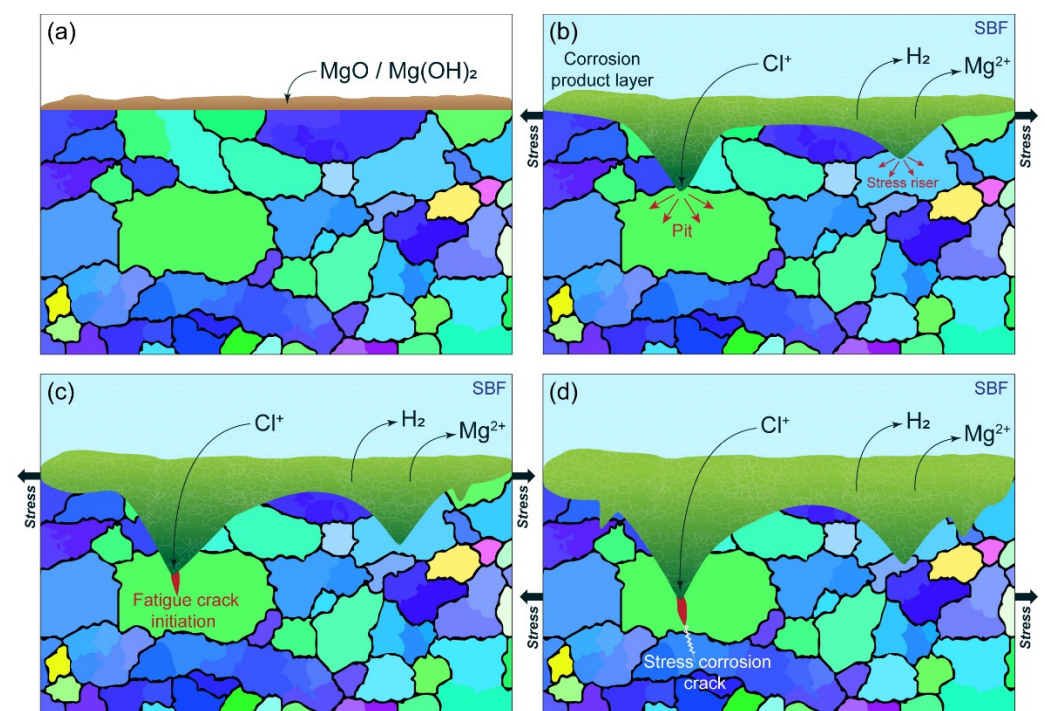
Figure 15. A simplified schematic illustration of the corrosion-fatigue-induced damage propagation. (a) Initial state with the $\text{MgO}/\text{Mg}(\text{OH})_2$ protective film formed on the surface; (b) advanced stage of the stress-stimulated corrosion process with the protective film broken, resulting in the formation of corrosion pits and the corrosion product layer; (c) initiation of the fatigue crack at the stress concentrator created by the notch-like root of the corrosion pit; (d) stress corrosion cracking initiated in the vicinity of the sharp fatigue crack.

The scenario of the stress-corrosion fatigue-induced multistep fracture process envisioned from the results of the present study is schematically outlined in Figure 15. The MgO/Mg(OH)₂ protective film (a) forming on the surface of the Mg alloys in a neutral solution containing Cl[−] ions breaks locally under the action of cyclic stresses, providing the aggressive environment access to the bare metal surface. The corrosion pits nucleate and grow both laterally and in depth throughout the duration of the test, providing significant stress concentration at the roots of multiple pits (b). The fatigue cracks initiate in the vicinity of the pits (c) at nominal stresses, which are remarkably smaller than those required for fatigue crack initiation in smooth bodies in the air of the inter environment. Corrosive products forming at the bare surface facilitate the occurrence of stress-corrosion cracking (d), which can become either a prevailing fracture mode or develop concurrently with fatigue processes. It would be naïve, of course, to believe that the proposed picture matches reality comprehensively and that the scenario illustrated by Figure 15 is the only viable one. As has been mentioned above, the details of the fatigue and SCC interactions are

not clear from either a microstructural or mechanistic viewpoint. It, however, simply and consistently explains why it is practically impossible to find the unique site of fatigue crack initiation, why the fatigue striations are not observed, and why the SCC features can be recognised on the fracture surface.
