ARTICLE

Corrosion-induced damages and failures of posttensioned bridges: A literature review

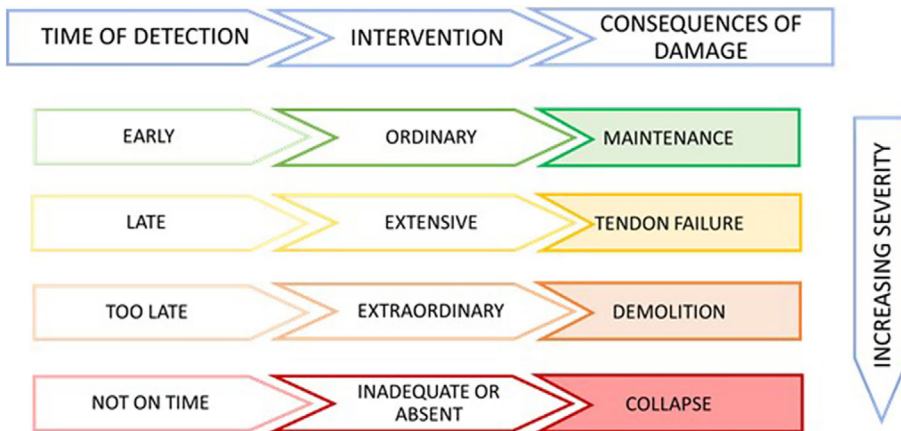
FIGURE 2 Illustration of typical relationships between how early the damage was detected, the typology and suitability of the interventions carried out, and the structural consequences in terms of increasing severity

The reported cases were classified according to the increasing severity of the observed damage and consequent interventions (Figure 2).

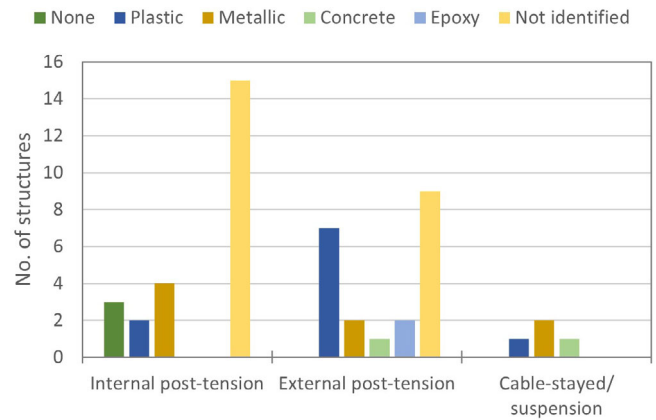
FIGURE 10 Type of ducts in the studied structures divided by type of prestressing system. Pretensioned structures are not included in the figure

The type of ducts and duct fillings are related to the type of prestressing system in Figure 10 and Figure 11, respectively. Excluding the “not identified” cases, the figures show that:

- most of the external tendons were enclosed in plastic ducts filled with cementitious grout;
- internally posttensioned tendons were equally enclosed in metallic and plastic ducts filled with grout or were not provided with ducts using alternative solutions (e.g., inflatable ducts removed after grouting²⁸).

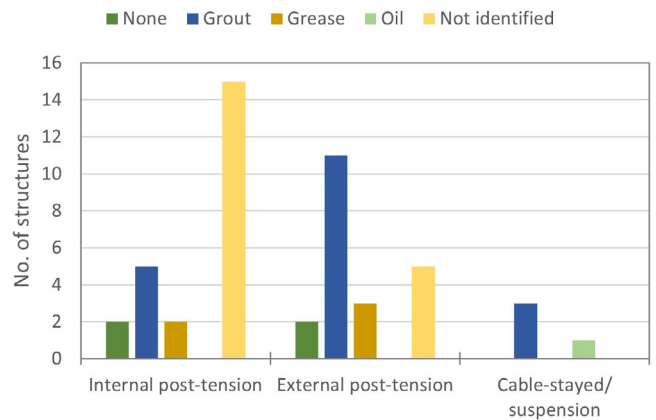
FIGURE 11 Type of duct filling in the studied structures divided by type of prestressing system. Pretensioned structures are not included in the figure.

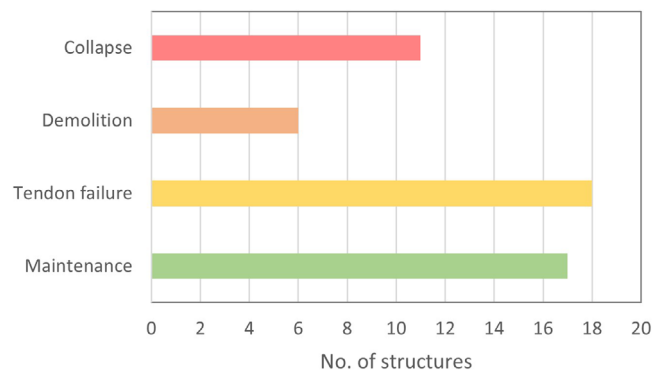
FIGURE 12 Level of damage of the studied structures

The damage was mostly detected late, yielding to extensive and extraordinary operations like tendon substitution and demolition of the structure. Figure 12 highlights that the number of cases in which the structure could be brought back to safety was also significant. Still

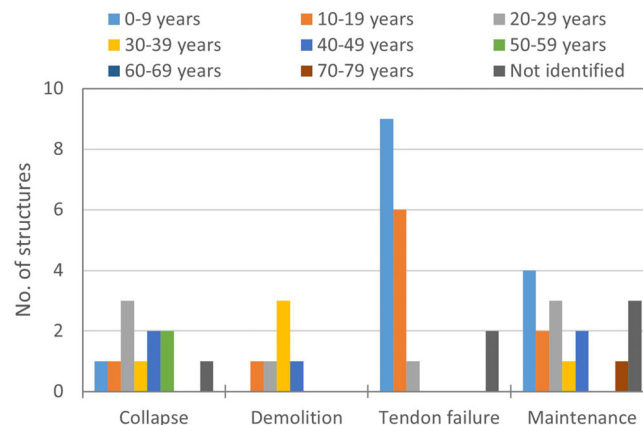
FIGURE 15 Age at damage detection of the studied structures divided by level of damage

When it comes to the age at damage detection of the structures, Figure 15 highlights that:

- tendon failures tended to occur during the first years from construction;
- collapses and demolitions occurred mainly 20 years after construction;
- damage needing ordinary maintenance was present during the entire life span of the structures.

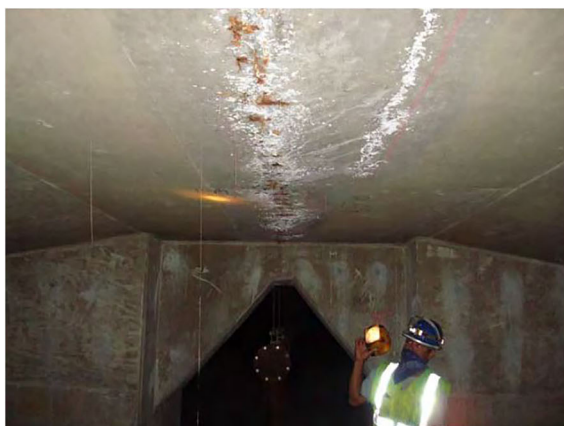
FIGURE 14 Warning signs detected in a posttensioned bridge in the Midwest of the USA.²⁹ Presence of efflorescence, delamination, and spall observed on a posttensioned box girder (left side). Voids and rust at different sections of the tendon (right side)

Warning signs such as small and large longitudinal cracks, corrosion staining, concrete cover spalling, were detected in half of the case studies (example of warning signs in Figure 14). For the other half, they were partly not detected or no information about them was reported in the literature. The analyses conducted by the authors²³ indicate that detection of warning signs can help limit and reduce the damage, provided some conditions are fulfilled:

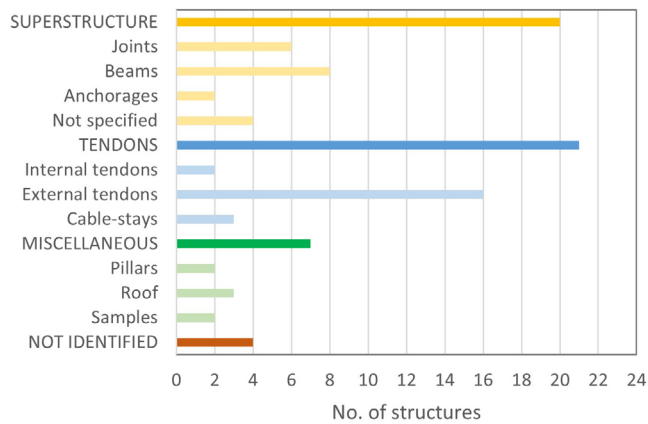
FIGURE 16 Damage location in the studied structures. The locations have been collected in the macrocategories “superstructure,” “tendons,” “miscellaneous,” and “not identified,” reported in yellow, blue, green, and brown, respectively. The entries included in the macro-categories, are reported in lighter shades of the color corresponding to the appurtenant macro-category

The locations where the damage associated to the failures was observed are listed in Figure 16. The damage was mainly observed along the tendons and in the bridge superstructure at joints or anchorages, where water could penetrate.

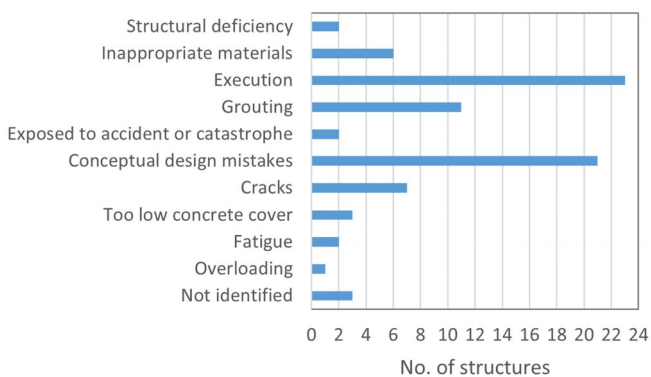
FIGURE 17 Major damage and failure causes of the studied structures

Figure 17 presents a list of the major damage and failure causes which created the conditions for corrosion to

occur, and their frequency for the case studies. Contrary to previous analyses (concerning, e.g., type of structures, type of ducts, presence of warning signs), this figure includes up to three entries for each structure. This is because past investigations (e.g.,³¹) highlighted how it is unlikely that damage, but especially failure can be caused by one of the insufficiencies alone. In fact, failures are usually the result of a combination of factors that arise over time.

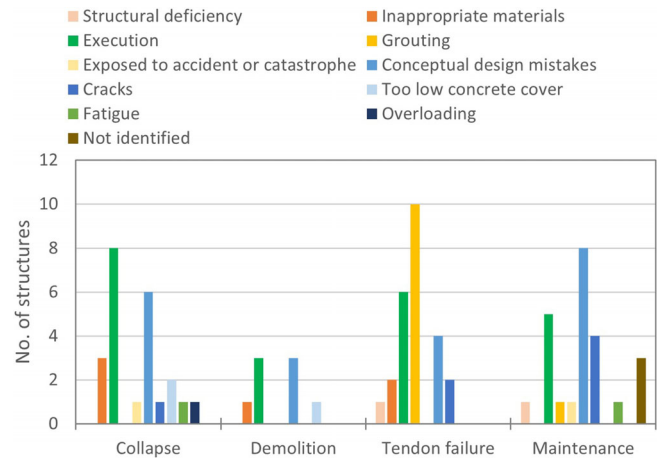
FIGURE 18 Major damage and failure causes of the studied structures divided by level of damage

To better understand how the causes produced the observed damage and failure, they are reported in Figure 18, classified according to the level of damage. This figure demonstrates the importance of accurate design and careful execution in preventing failure (Figure 19). It also highlights that tendon failures were caused mostly by grouting problems. This information is valuable because, as previously discussed (Figure 13), tendon failure occurred in almost all the externally post-tensioned bridges included in the survey. This means that those bridges were extremely sensitive to corrosion due to grouting problems, more than to execution or design mistakes.

In addition, Figure 18 shows that cracks have some importance in cases where monitoring and ordinary maintenance could be performed. Cracks can be considered as a result of corrosion (due to the stress generated by the presence of corrosion products with increased volume compared to uncorroded steel). Taking this into account, some studies have also started to use cracks as an indicator for the degradation of bond and load-bearing resistance due to corrosion of reinforcement.^{33–35} However, cracks are also a cause of corrosion. This can be considered when cracks are produced not only by design and execution mistakes, but also by various other factors

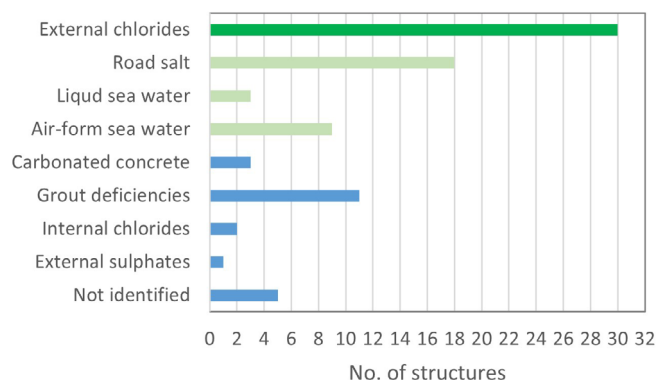
FIGURE 20 Major corrosion causes of the studied structures. The entry “external chlorides” (in green) is the sum of the sub-entries “road salt,” “liquid sea water,” and “air-form sea water” (in a lighter shade of green). The sub-entries specify the origin of the external chlorides

Figure 20 lists the major corrosion causes detected in the survey. Only one corrosion cause (i.e., the one that seemed to be the most relevant in enabling corrosion) is associated to each structure. External chlorides, mainly coming from de-icing salts, were the main corrosion cause in the analyzed structures. Other origins of external chlorides were liquid and air-form sea water.

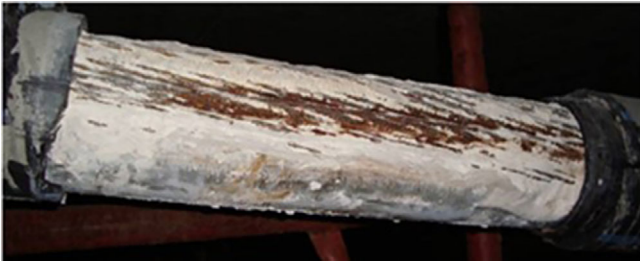
FIGURE 21 Example of whitish segregated grout embedding corroding strands in an Italian bridge³⁷

The current study showed that in structures that exhibited failure of tendons, corrosion was mostly enabled by problems in the grout. In all these cases, the grout remained unhardened, with a whitish and soft appearance (Figure 21). High pH, low levels of chlorides, and high levels of sulfates were detected inside the chalky grout, while corrosion would manifest as “deep and localized attacks that resembled the form of pitting attacks.”³⁷
