Learning from the catastrophic 1979-flood in Jostedal in Norway

Bridging past and future across Jostedalsbreen with high-resolution hydrological modelling

Master's thesis in Natural Resources Management

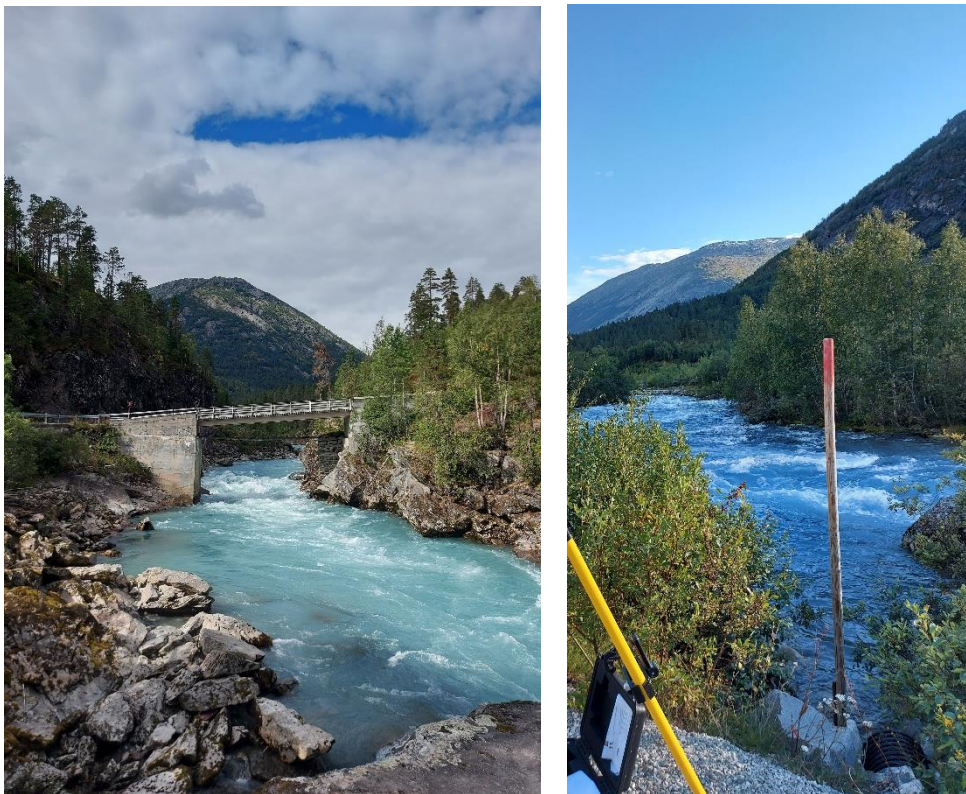
Figure 6: Jostedøla river and the valley (Photo: Afrida Iqbal)

Jostedalen valley runs through the town of Gaupne, population of 1233 (SSB, 2022), in Luster municipality into the Lusterfjorden. The river Jostedøla and several of its tributaries from the Jostedalsbreen glacier flows through the valley making it an ideal settlement for farming and tourism (Figure 6). The valley highly impacted by the Jostedalsbreen glacier on its west, therefore, the river has been monitored since 1949 by several gauging stations located throughout the river and the Nigardsbreen lake (Roald, 2021). The two active gauging stations in the river are currently located in the Nigardsbreen lake outlet and Myklemyr. The inactive gauging stations data are however still accessible.

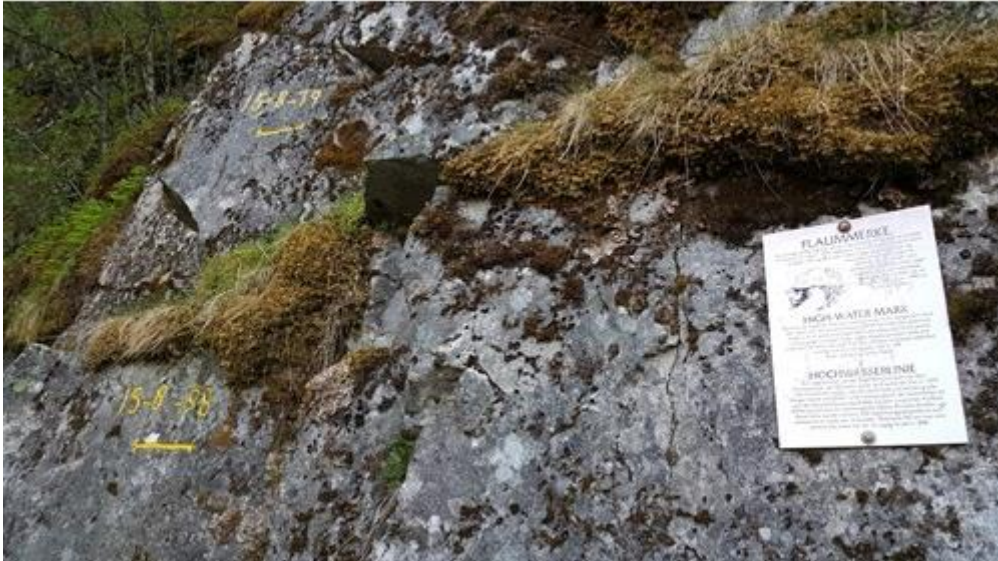
Figure 7: Flood Markers from 1898 and 1979 (Photo: Rasmus Benestad)

The largest one-day flood observed in river was in Myklemyr on 15 August 1979 with a discharge of 409.1 m³/s corresponding to 711 l/s/km² or to a runoff of 61.4 mm/day. This was the most devastating flood in the region since 1898. Both the major flood occurred on 15 August 1898 and 1979 respectively. The flood in 1979 was 1.35 meters higher than the one in 1898. Flood markers for both the major floods can be found in the valley (Figure 7).

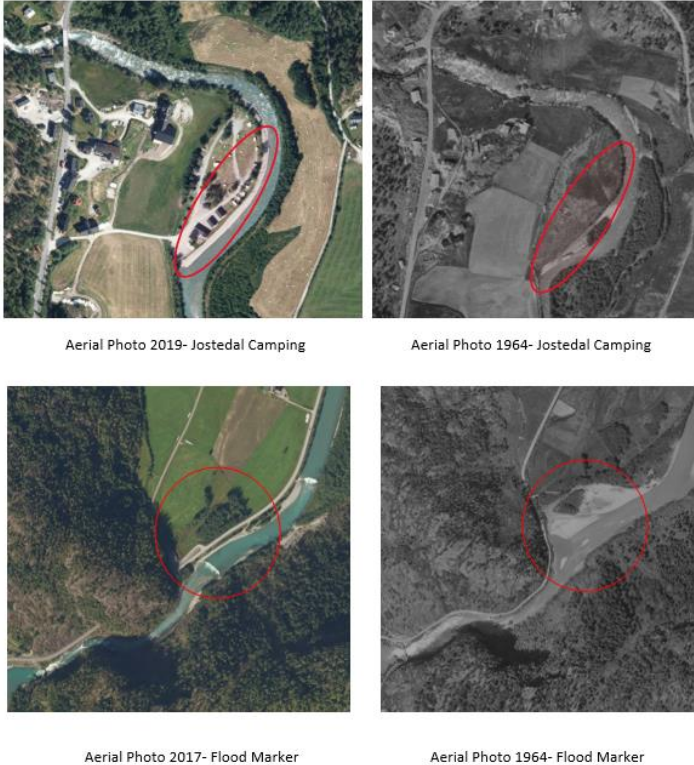
Figure 12: Change in terrain and land use from 1964 to recent years (Photos: Norge I Bilder)

In order to recreate the flood of 1979, some parts of the terrain had to be modified to match the terrain of the region 50 years ago. The DTM used was from 2020 (Table 2) and there has been several installations and modification made along the river over the years. Based on interviews, markers of flood in the valley and aerial photos from 1964, several locations along the river were went through terrain alteration for flood mitigation measures. Figure 12 shows the difference in topography of two areas GOTHECA team visited and interviewed that has changed since the flood in 1979. Therefore, to match the real scenario of the flood, protections were removed in these locations and the terrain was modified (Figure 13) using the terrain modification tool in HEC-RAS 6.3.1 (Gibson, 2022). The terrain modification tool is the latest update added to the HEC-RAS modelling system. The line modification option allows specific elevation along a line drawn over the terrain, it creates an interpolated 3D line with a shape of template wither a channel or a high ground. Depending on the length of the shape and the elevation of the surrounding the model interpolates along the profile to create a surface and merges it with the terrain. The tool also allows the users to edit the height and width of the newly added shape which can be used for both terrain elevation and reduction.

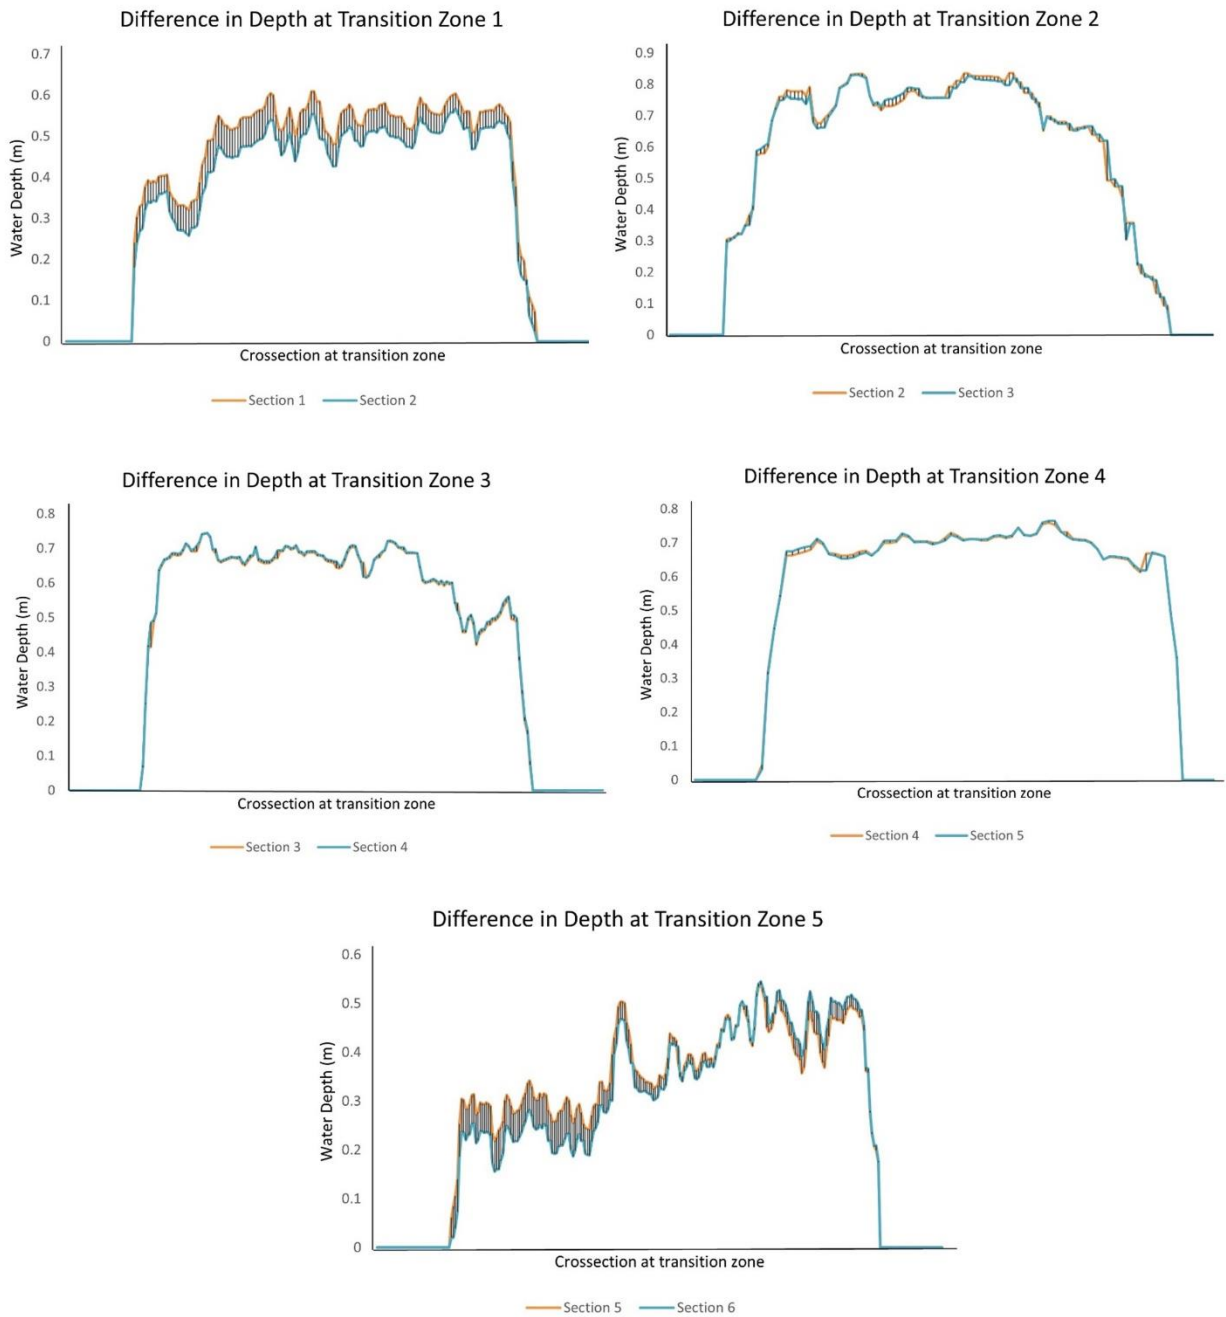
Figure 19: Water depth of profiles across each of the transition zones

Figure 19 shows the water depth at the transition zone of two consecutive river sections. In transition zone 3,4 and 5, the profiles overlap almost perfectly. Transition zone 1 and 6 however, have some difference, but the maximum difference observed was only 6cm. Therefore, these transition zones were used for the rest of the simulations.

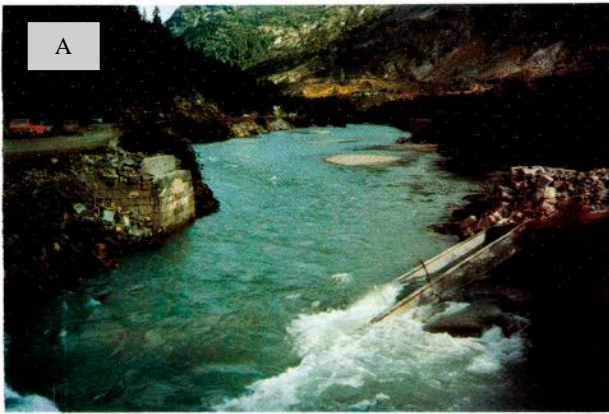
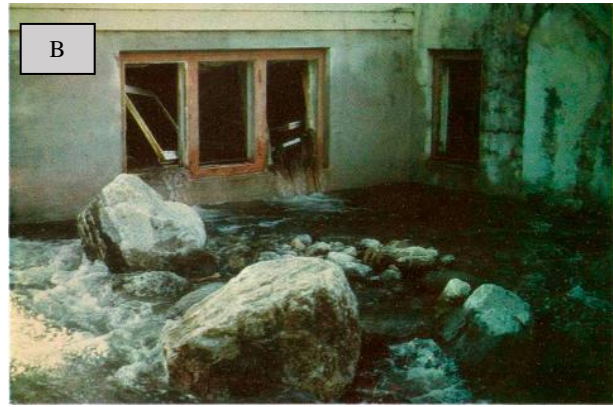
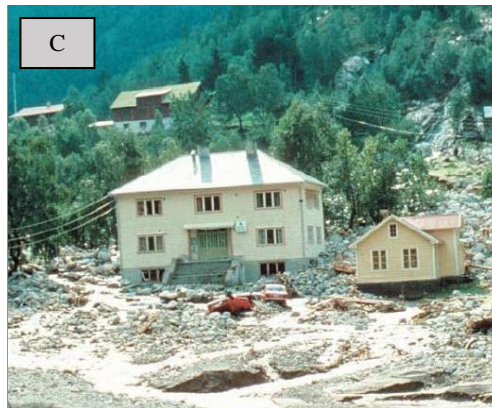
Figure 52: Damage left behind by 1979 flood at Sagrøy: A) Remains of Høgebru bridge (Photo: NVE, 1981), B) Sagrøyelva flowing through building basement (Photo: NVE, 1981), C) Damage left behind by Sagrøyelva (Photo: Hoel, 2013)

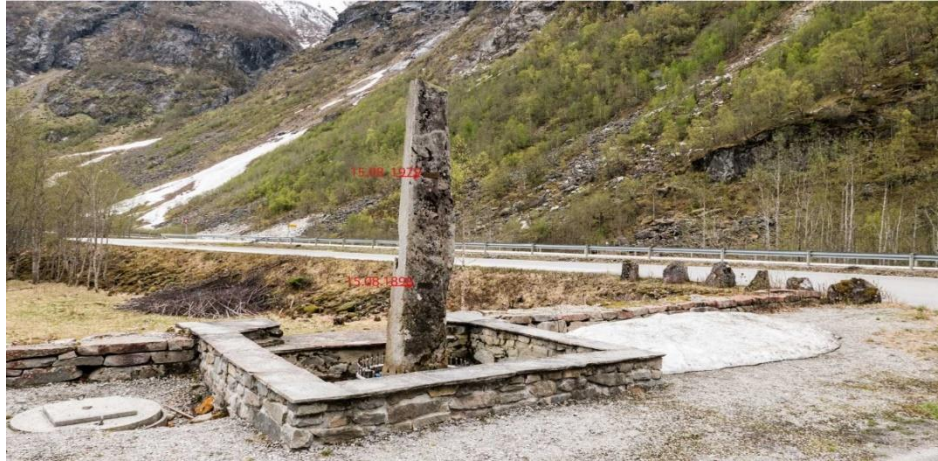
Figure 56: Flood marker of Jostedalen at Fossøy, (Photo: Barnhaugen Media)

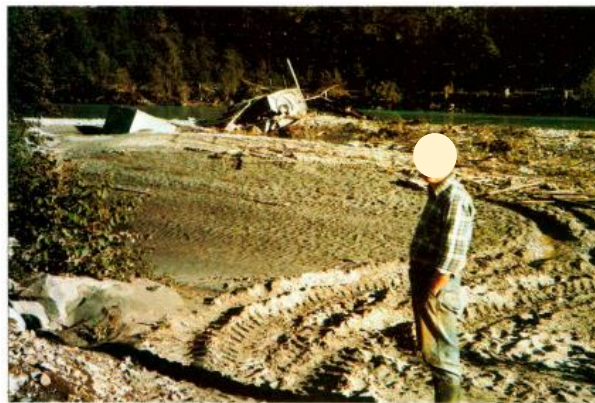
Figure 58: Photo of a farmer standing by his destroyed land (NVE, 2018)

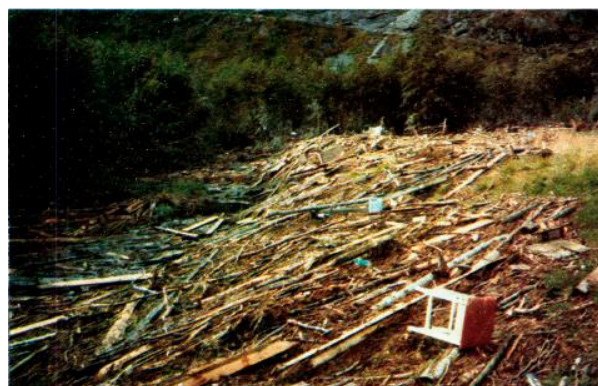
Figure 60: Damaged land near Myklemyr after 1979 flood (Photo: NVE, 1981)

Affected Area 8, Section 4: The next affected area on the validation map is at Myklemyr (Figure 59). This area had gone through flood mitigation modification due to the damage left behind by the 1979 flood. The simulations for reconstruction show that majority of the area was flooded with water level 0.45- 1.30 m. The photo in Figure 60, shows the ruins left behind by the flood at Myklemyr, this could be one of the two marked area on the map, Figure 59. The post flood brief from NVE (1981) mentions that one of the households could not evacuate in time, therefore by the time they were leaving, the water levels around the house were already too high and they had to stay inside overnight and could not leave.

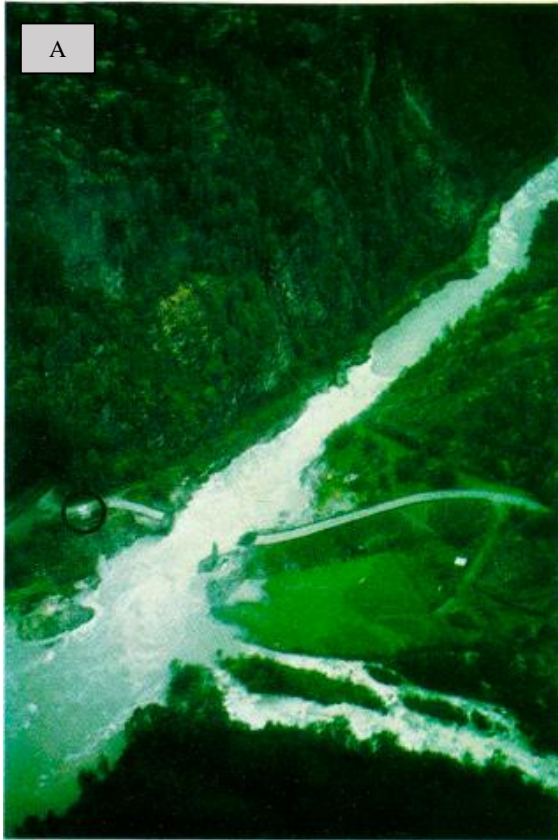
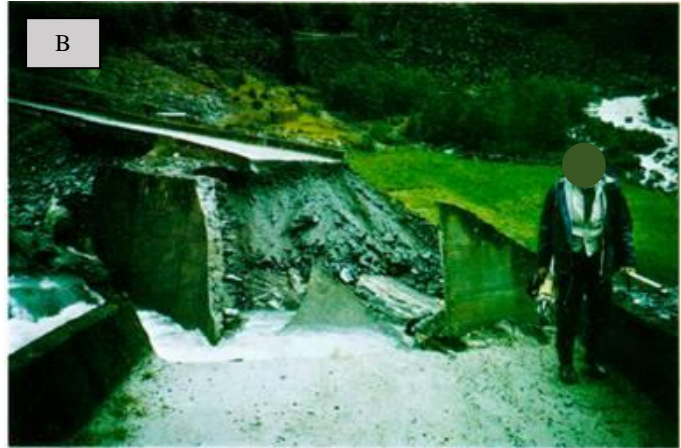
Figure 62: A) Aerial image of broken Bridge at Husøy B) Close-up of remains of the bridge (Photo: NVE, 1981)

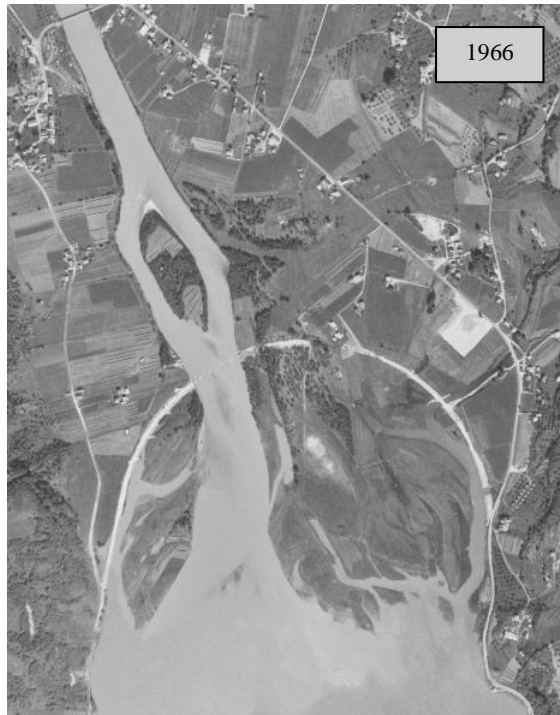
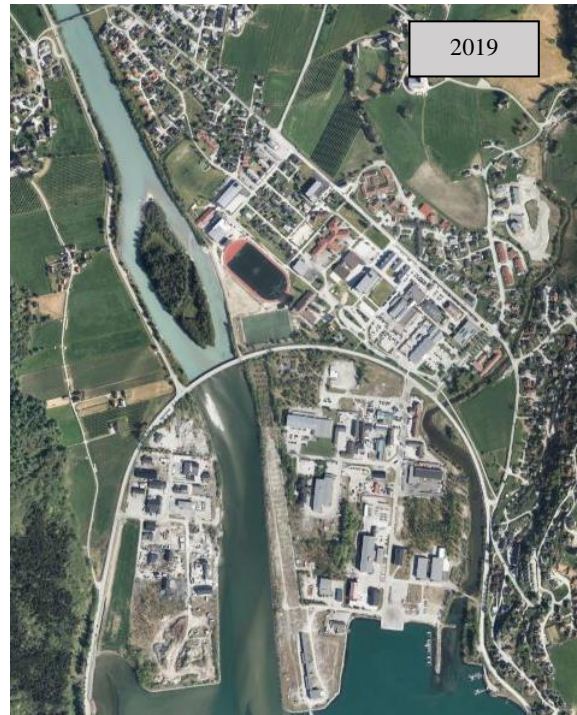
Figure 66: Aerial photos of Gaupne from 1966 and 2019 showing land use change (Photo: Norge i Bilder)

Affected Area 11, Section 6: The affected Area 10, is the end of the river Jostedøla in the town of Gaupne. As per the flood report by NVE, this area suffered the least amount of damage during the 1979 flood. Figure 65 shows the reconstruction of the past flood; however, most parts of this area did not exist 43 years ago. Figure 66 is an image showing the aerial photos of Gaupne from 1966 and 2019, the settlements were not as dense as it is in the present and most of the area was still part of the fjord. Therefore, the simulation in the southernmost part of the map, do not represent the past scenario. However, the eastern part of the did exist in 1979, and the flood simulations for both 50- and 100- year floods, show water infiltrating the parts of town, which in the past were farmlands (Figure 66). The water levels go up to 1 m in some places but remain below 50 cm throughout.

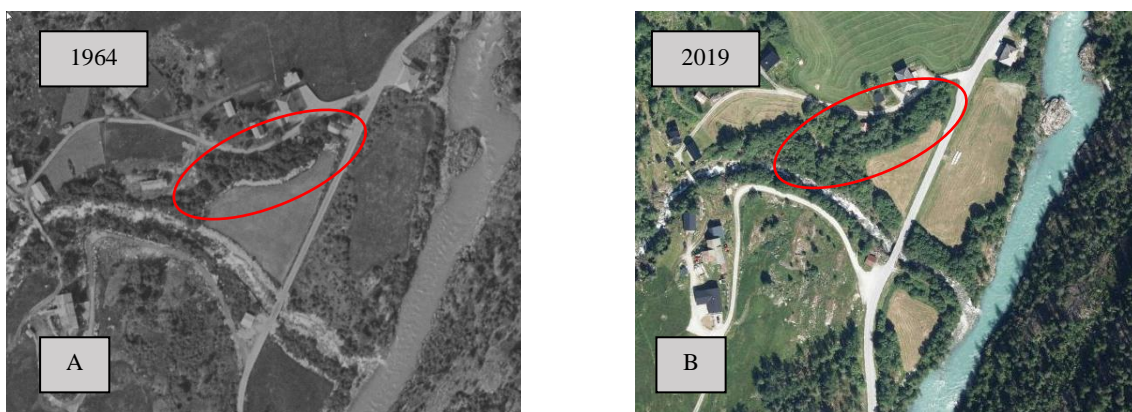
The location of old Sparebank building next to Sagrøyelva tributary is the most terrain modified location along the river. Figure 67A shows the aerial image from 1964 of a small stream (Marked in red) flowing from Sagrøyelva into the private property. Given the destruction caused due to this stream (Figure 52B and 52C) in 1979, it was blocked off completely and covered with vegetation to mitigate any future flood being initiated through this stream. In the reconstruction, In the past reconstruction, Figure 51, it was very prominent how much this stream contributed to the flooding. However, in the present-day simulation without the stream (Figure 37), there was no impact in the same location from the high intensity floods. Therefore, blocking off the stream for flood mitigation works really well.

Figure 67: Aerial images of modified stream from Sagrøyelva
