**Fatigue Crack Growth behavior of Additively
Manufactured 17-4 PH Stainless Steel: Effects
of thickness and surface condition**

Norwegian University of Science and Technology

Master Course in Mechanical Engineering

Advisor: Prof. Seyed Mohammed Javad Razavi Author: Davide Agiollo

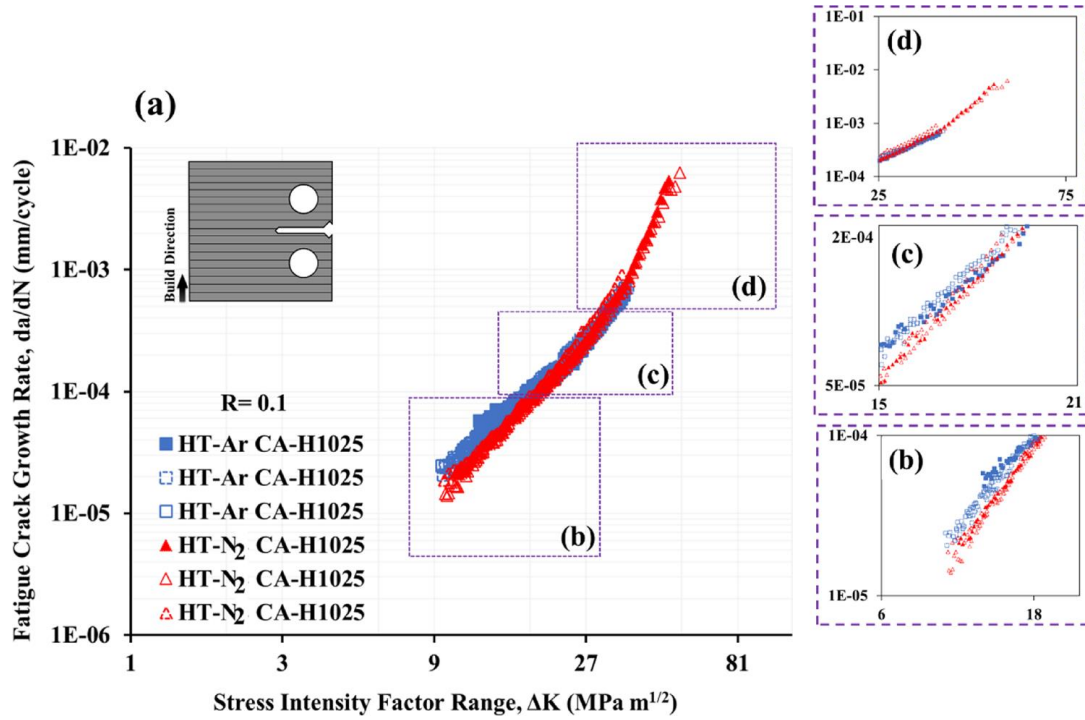
Figure 1: Fatigue crack growth rates of AM 17-4 PH SS built under N_2 and Ar atmosphere, heat treated with CA-H1025 (a), in the 3 different regions: near-threshold (b), Paris Regime (c) and unstable (d). Figure taken from [8].

under N₂ considerably increases in high cycle life (for a stress amplitude of 500 MPa, the reversals to failure can be 10 times greater, from 10⁶ for Ar, to 10⁷ for N₂). Regarding the fatigue crack growth tests, for the same reasons related to a micro-/defect-structure, in the near threshold zone, Argon specimens have less FCG resistance, while in the Paris regime the behavior is approximately the same. In regime III, specimens built under N₂ atmosphere exhibit higher fracture toughness, and this has to be attributed to the lower amount of defects. The quantitative results are reported in Figure 1, and the Paris Law parameters in Table 2.

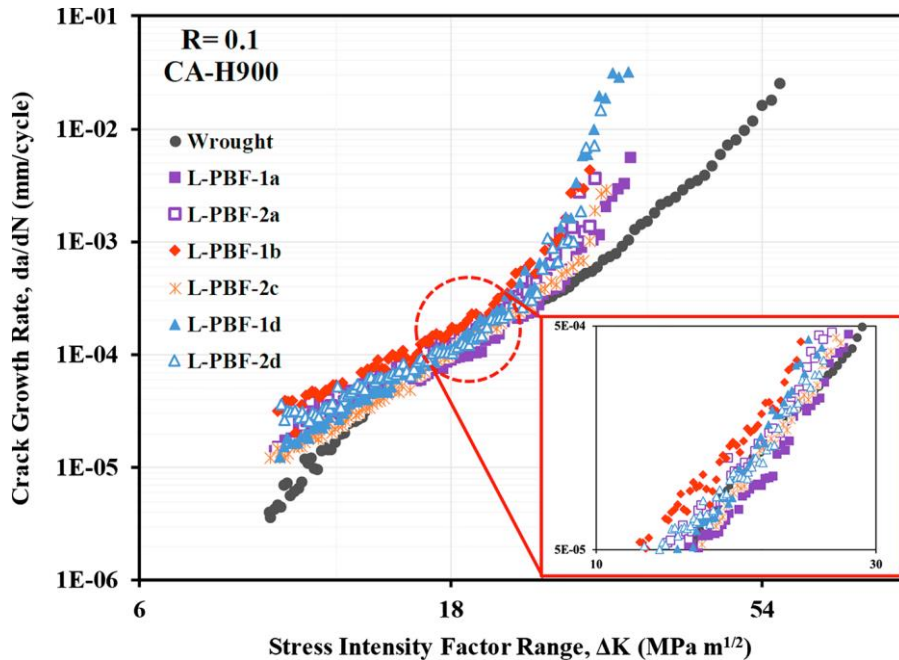
Figure 4: Fatigue crack growth rate experimental data of LB-PBF and wrought 17-4 PH SS subjected to CA-H900 heat treatment. Figure taken from [10].

Due to these features described in the above, the only valid FCG tests were conducted on the CA-H900 heat treated specimens. The reason has to be ascribed to the primary solution heat treatment step (CA), in which fine austenite grains, in the cooling step, transform to fine martensite, resulting in a higher material strength. The results are reported in Figure 4:

higher crack growth resistance if compared to the LB-PBF one. The Paris Region is characterized by similar behaviors, and it is important to underline that there is insignificant difference between set 1 and set 2. This is due to the CA-H900 heat treatment, that permits to obtain a homogenous fine microstructure and to remove any residual stresses induced from the process. Finally, in region III, the wrought material shows a higher cyclic fracture toughness. An analysis of the experimental results suggests that region I and region III are critical for the LB-PBF material due to the higher sensitivity of the material to microstructural features in those regions.

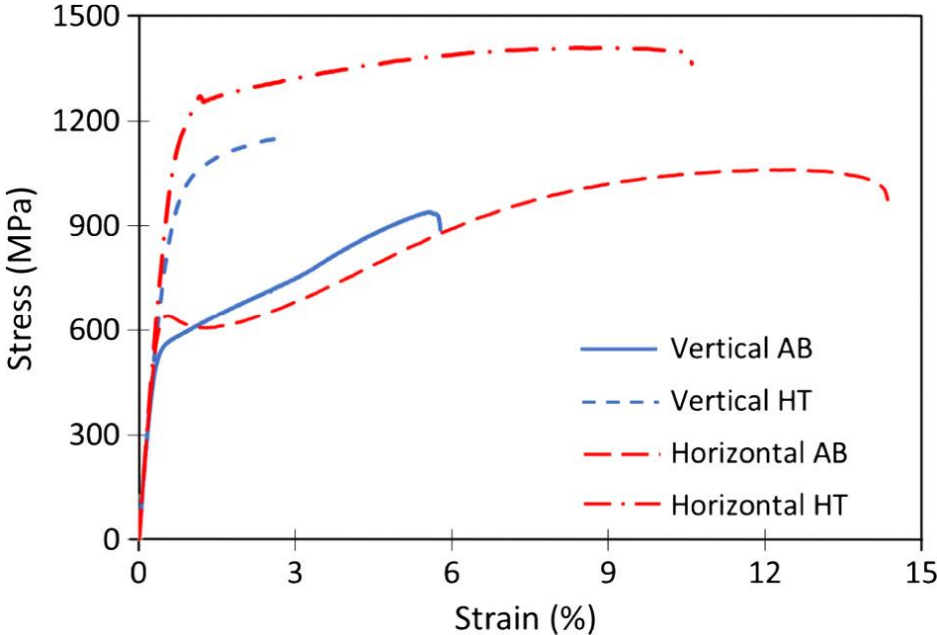
Figure 5: Engineering stress versus strain curves of LB-PBF PH 17-4 SS, horizontally and vertically built and subjected to CA-H900 heat treatment. Figure taken from [13].

The modulus of elasticity measured is 187 GPa, while the yield strength for the vertical built specimens is 580 MPa for the as built and 1020 MPa for the heat treated, while, for the horizontally built, it is 650 MPa for the as built and 1250 MPa for the heat treated, with an improvement of the static properties of about 75% and 90% respectively. In both cases the static properties are significantly lower if compared to the wrought material, but for the horizontally-built heat treated one the value is comparable. Regarding the fatigue properties, the results are reported in Figure 6, with the plot of the reversals to failure versus stress amplitude:

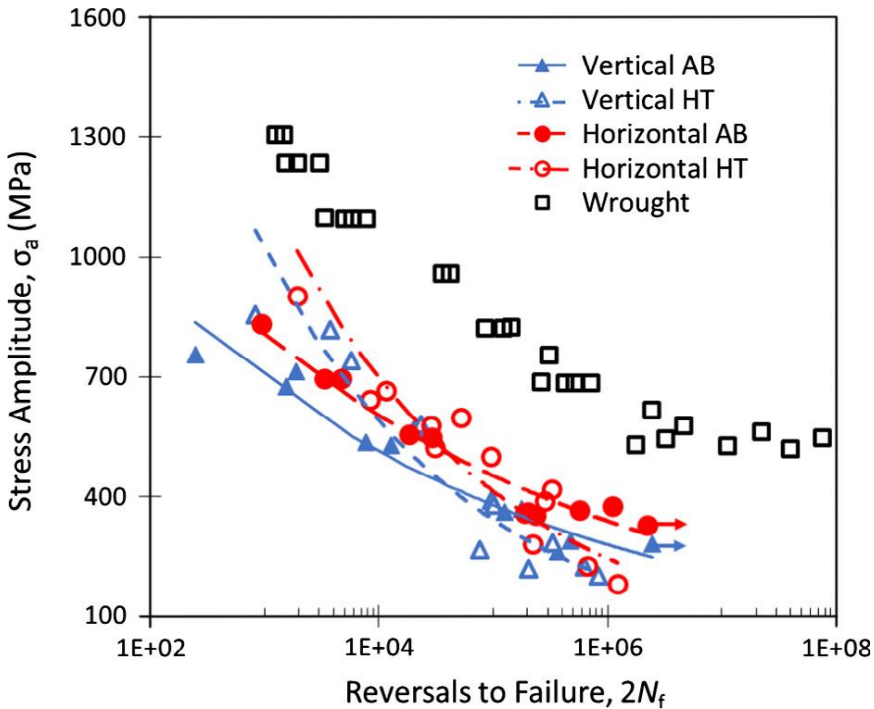
Figure 6: Fatigue stress life data of LB-PBF 17-4 PH SS horizontally and vertically built subjected to CA-H900 heat treatment, compared to wrought 17-4 PH SS subjected to H1050 heat treatment. Figure taken from [13].

In this case the comparison with the ‘wrought’ material comes from literature data[14], and it corresponds to values of polished flat specimens, heat treated according to H1050 condition. Despite of this, it is shown a significantly shorter fatigue life for AM specimens, and this can be attributed to the higher size and amount of defects.

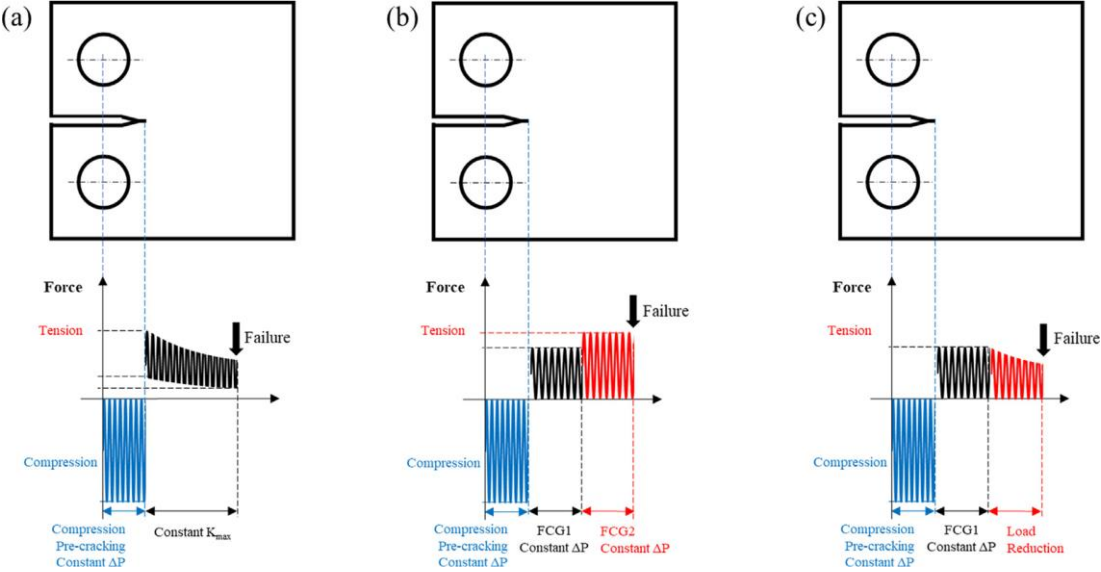
Figure 7: Load history of the different fatigue crack growth tests: a) compression pre-cracking and constant K_{max} testing, b) compression pre-cracking and constant

amplitude loading ($R=0$), and c) compression pre-cracking and load reduction loading ($R=0$). Figure taken from [16].

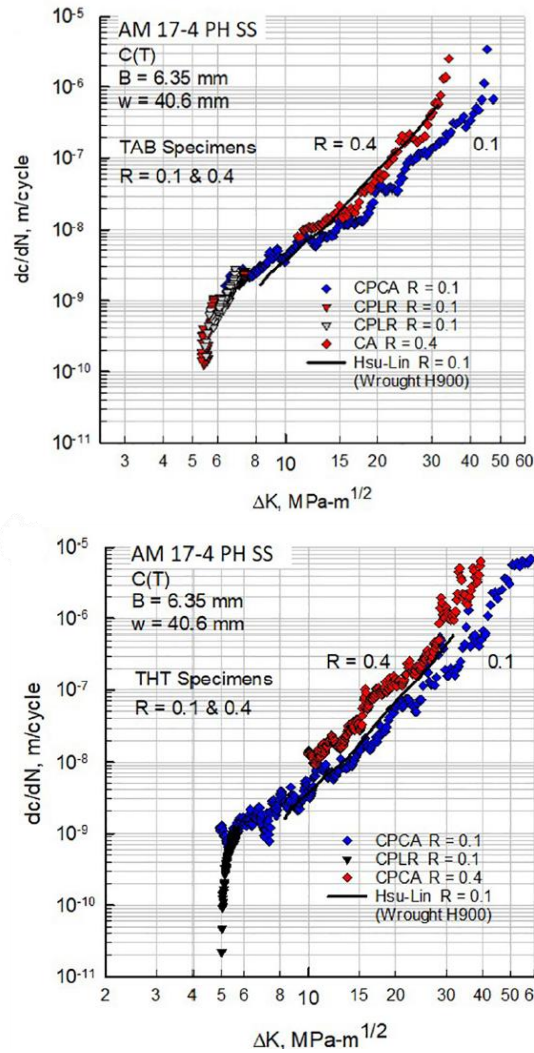
Figure 8: Fatigue crack growth rate experimental data of LB-PBF 17-4 PH SS with transverse notch as-built (left) and CA-H1050 heat-treated (right), compared to wrought 17-4 PH SS subjected to H900 heat treatment. Figure taken from [16].

The results show more scatter if compared to wrought alloys, and this can be attributed to the presence of lack of fusion defects and residual stresses. It is important to underline, however, that among the main purposes of the work there was to validate new methods to produce data for the threshold region because of the difficulty in investigating it. The different testing strategies resulted in obtained data, is a threshold of about $5.5 \text{ MPa}\sqrt{\text{m}}$, and an estimated fracture toughness of $70 \text{ MPa}\sqrt{\text{m}}$, for the transverse crack heat treated specimens according to the ASTM E-647 (ΔK decreasing). Moreover, analyzing the Paris region, a comparison between heat treated specimens and non heat-treated ones, reveals that the heat treatment doesn't affect significantly the long crack behavior, that shows comparable values with those of wrought counterparts. This means that process induced defects don't influence the FCG behavior as they do for fatigue life. The results in term of crack growth rate against stress intensity factor range are reported in Figure 8.

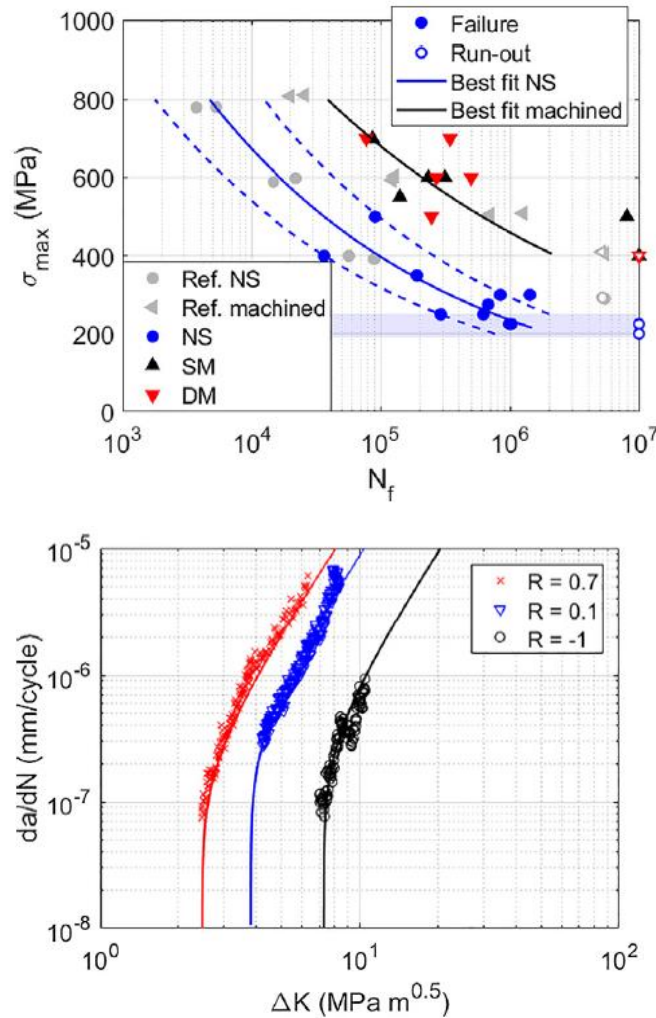
Figure 10: Experimental data and best-fitting curves of 17-4 PH SS, for uniaxial fatigue tests and fatigue crack growth tests. Figure taken from [18].

fatigue life, and according to this paper, the optimal depth for the machining is 200 μm . The fatigue crack growth behavior was studied with ΔK decreasing tests and then analyzed by fitting the experimental data with the NASGRO equation. The obtained threshold is 4.06 $\text{MPa}\sqrt{\text{m}}$. Both fatigue and fracture data are reported in Figure 10:

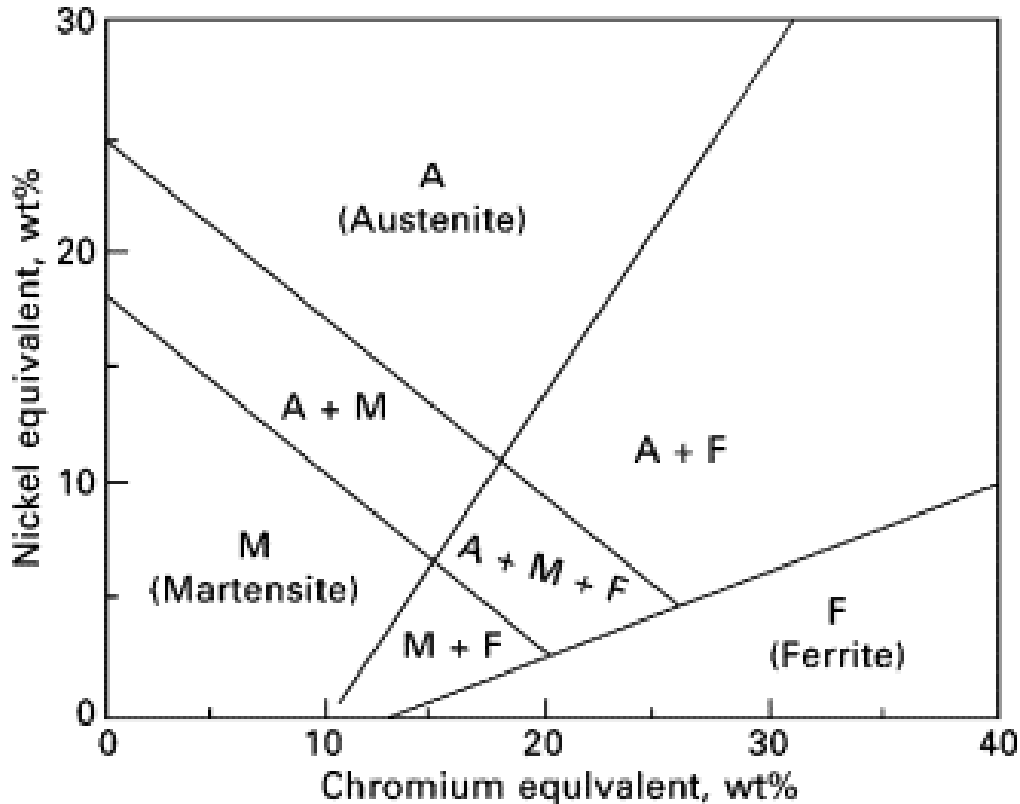
Figure 12: Shaeffler-Delong diagram used to characterize Stainless Steel microstructure as a function of equivalent Chromium and Nickel. Figure taken from [19].

With the obtained values, the material can be characterized using the Shaeffler-Delong diagram (Figure 12: Shaeffler-Delong diagram used to characterize Stainless Steel microstructure as a function of equivalent Chromium and Nickel) and a prevalent martensitic phase is expected, with a minimum part of ferritic and austenitic phases present, that will be further reduced after the heat treatment.

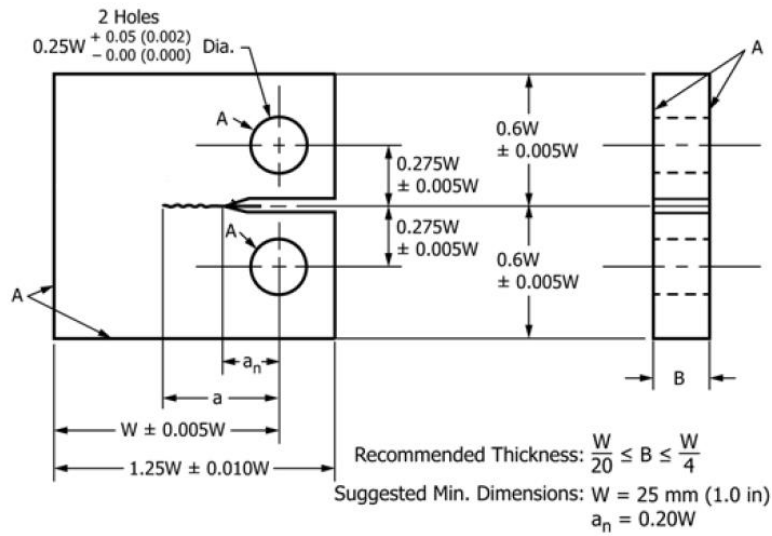
Figure 14: CT specimen geometry for fatigue crack growth testing, according to the ASTM E-647. Figure taken from [11].

Finally, the blocks were machined, with respect of the ASTM E-647, into the final configuration of CT specimen. The geometry of the entire experimental apparatus is defined in the method as a function of thickness (B) and width (W). It is also recommended for the thickness to be in the range of $W/20 \leq B \leq W/4$. It is important to underline that all the limits are based on specimen buckling and through-thickness crack-curvature considerations, mostly from empirical data. The geometry suggested by the method is reported in Figure 14:

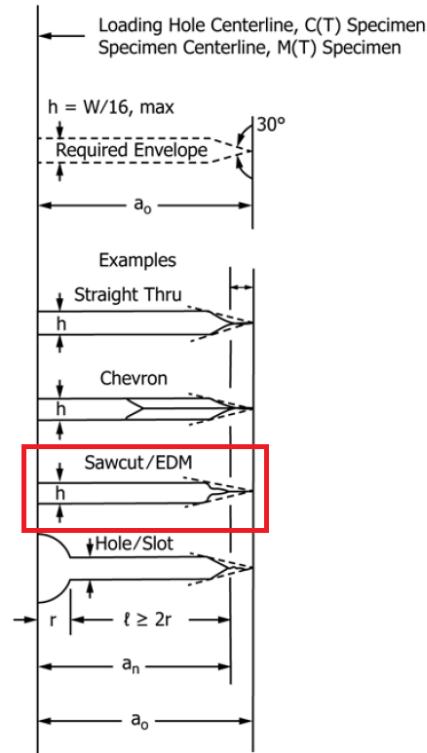
Figure 15: Notches suggested by ASTM E647, as a function of material and machining technique. Figure taken from [11].

Regarding the notch, the method doesn't suggest a unique solution (Figure 15), but it depends on the tested material. In the case of high-strength steel, the notch has to be obtained with electro-discharge machining (EDM) with a notch root radius $\rho < 0.25$ mm to facilitate the pre-cracking phase.

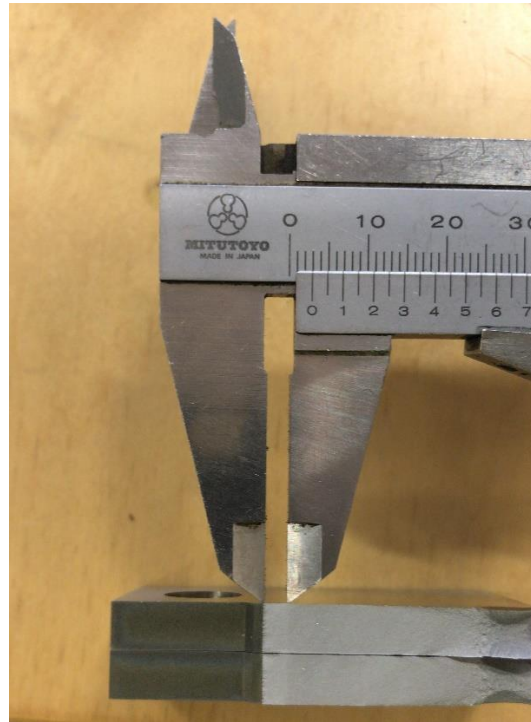
Figure 21: Crack size symmetry validation for an LIMC specimen.

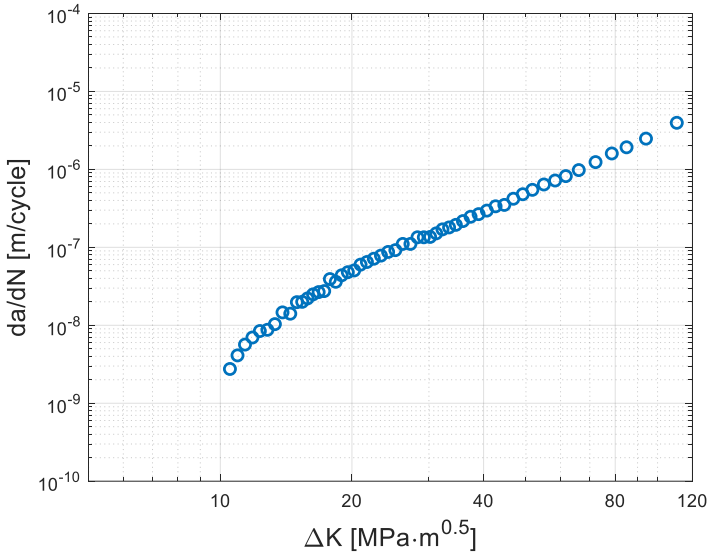
Figure 24: Crack growth rate data points as a function of the stress intensity factor range in log-log coordinates, resulting from the test data processing.

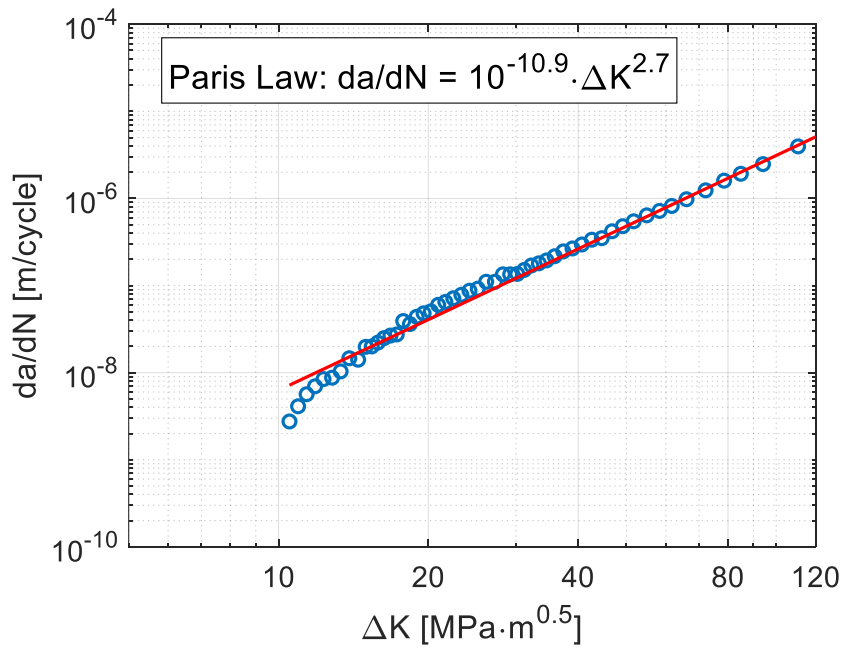
Figure 25: Non-linear regression of the processed test data points, resulting in the determination of Paris Law coefficients C and m .

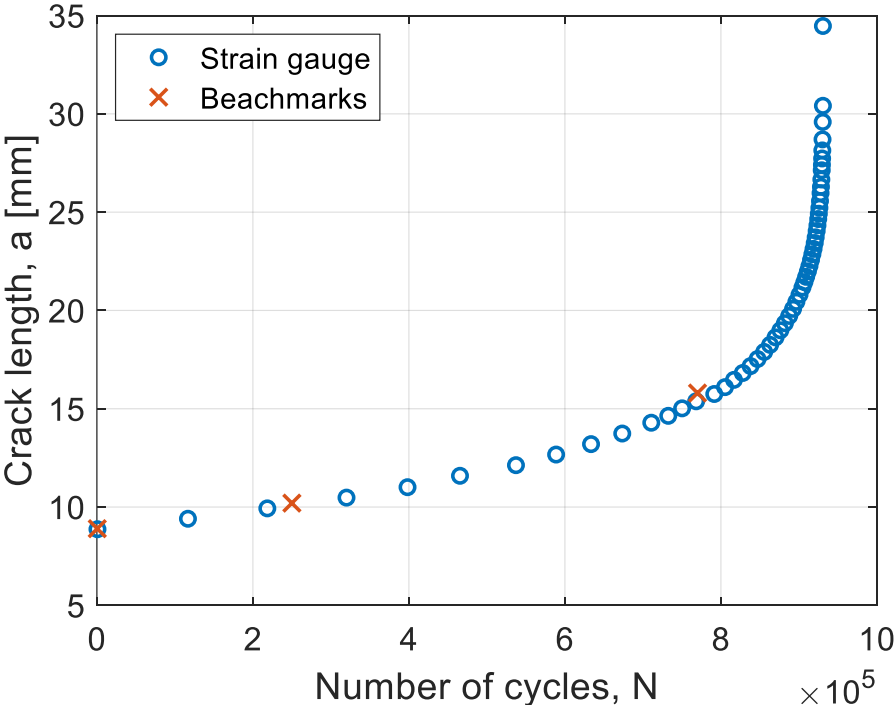
Figure 32: LIAB crack length versus number of cycles plot obtained with back-face strain gauge technique and validation through beachmarks measurement.

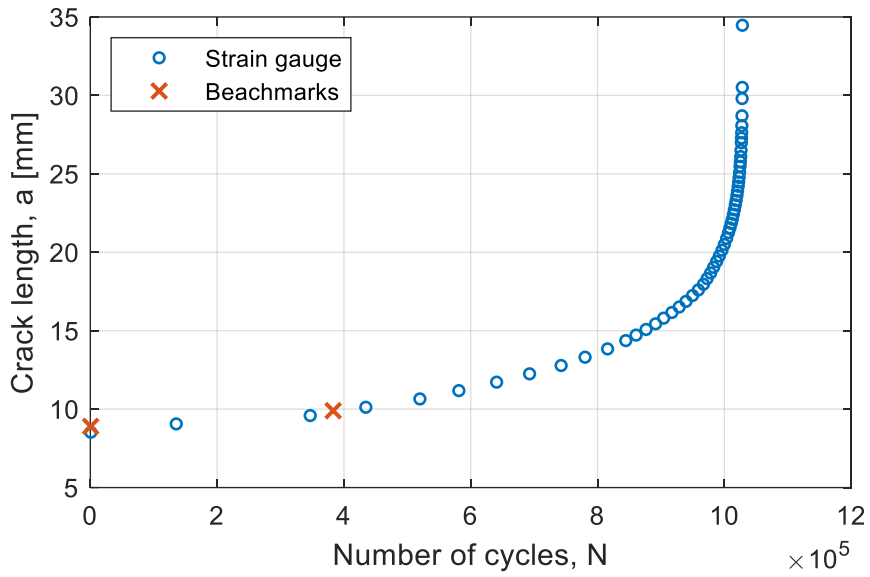
Figure 33: Crack size versus number of cycles plot for the LIMC-2 specimen.

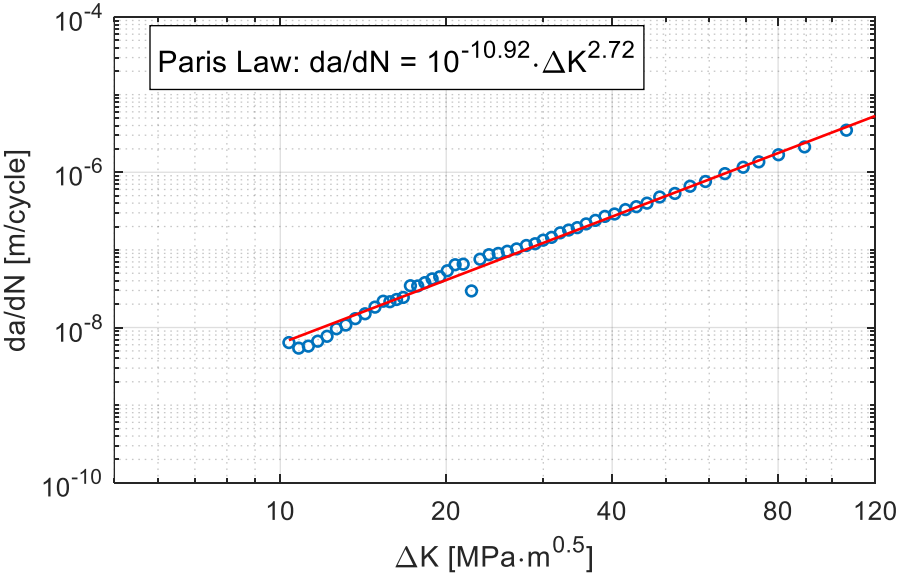
Figure 42: Crack growth rate versus stress intensity factor range for the LIAB-4 specimen.

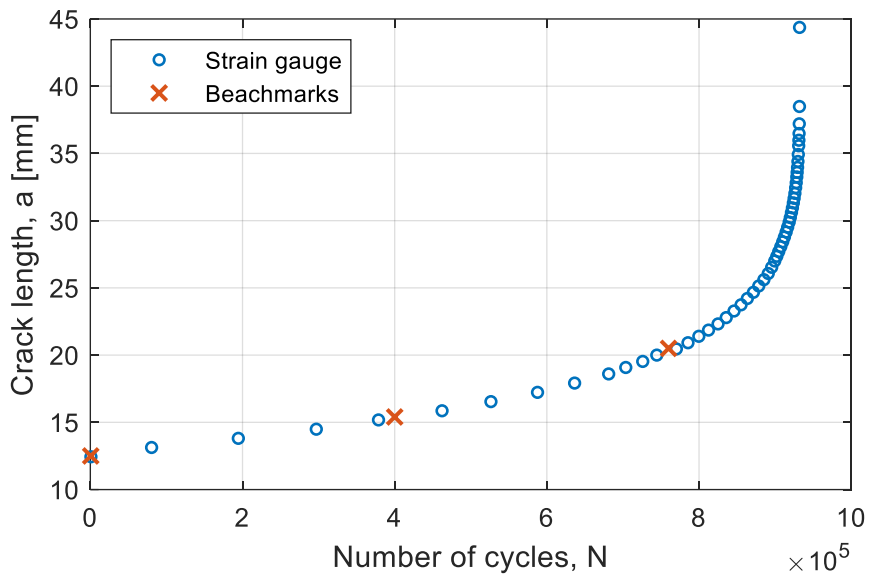
Figure 43: Crack size versus number of cycles plot for the L3MC-1 specimen.

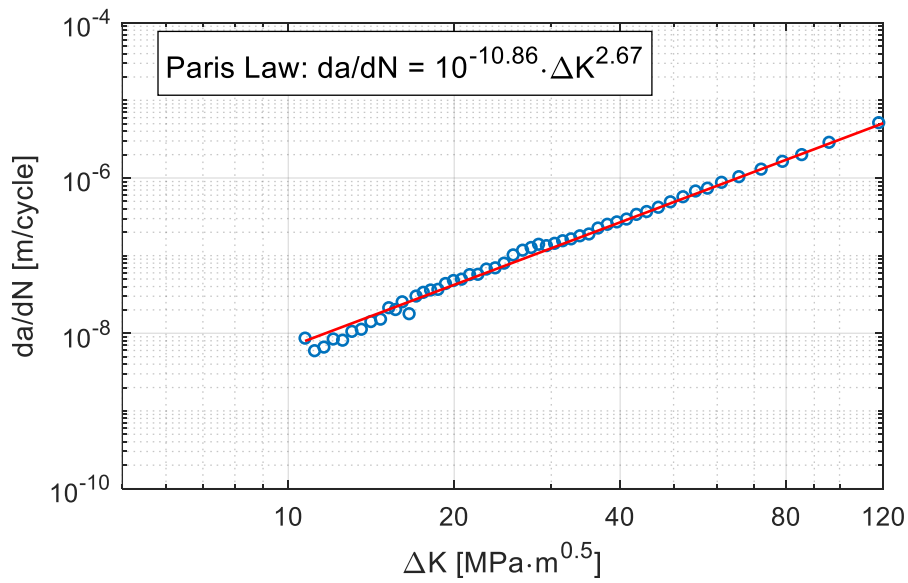
Figure 44: Crack growth rate versus stress intensity factor range for the L3MC-1 specimen.

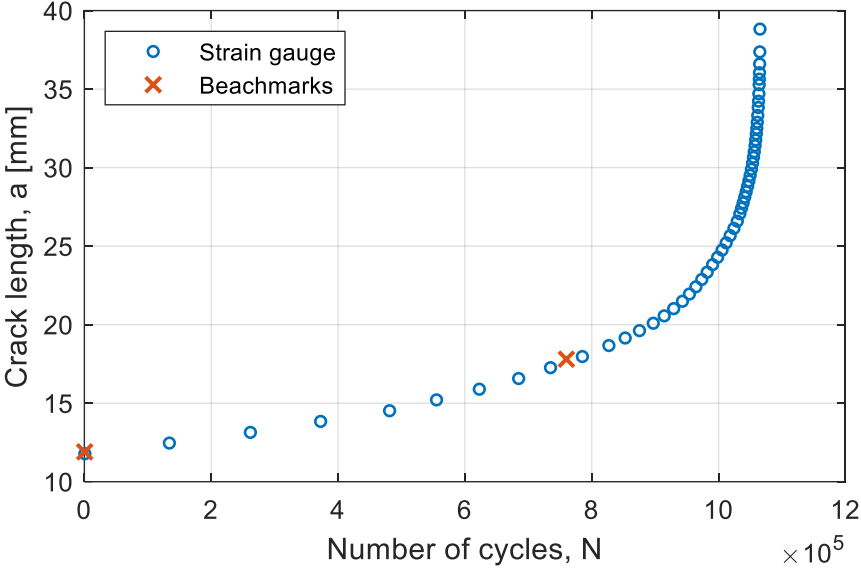
Figure 45: Crack size versus number of cycles plot for the L3MC-2 specimen.

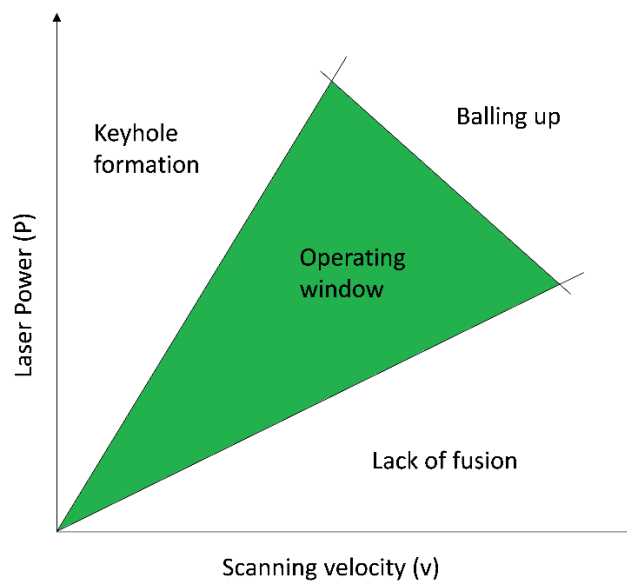
Figure 52: Qualitative representation of defects present in AM components as a function of laser power and scan velocity.

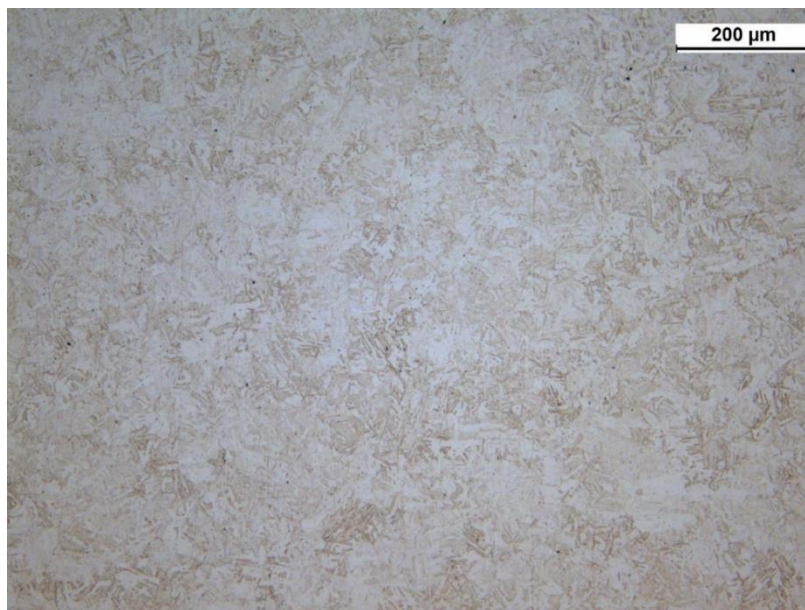
Figure 56: *Microstructure of the L3MC-2 front sample at the optical microscope after chemical etching.*

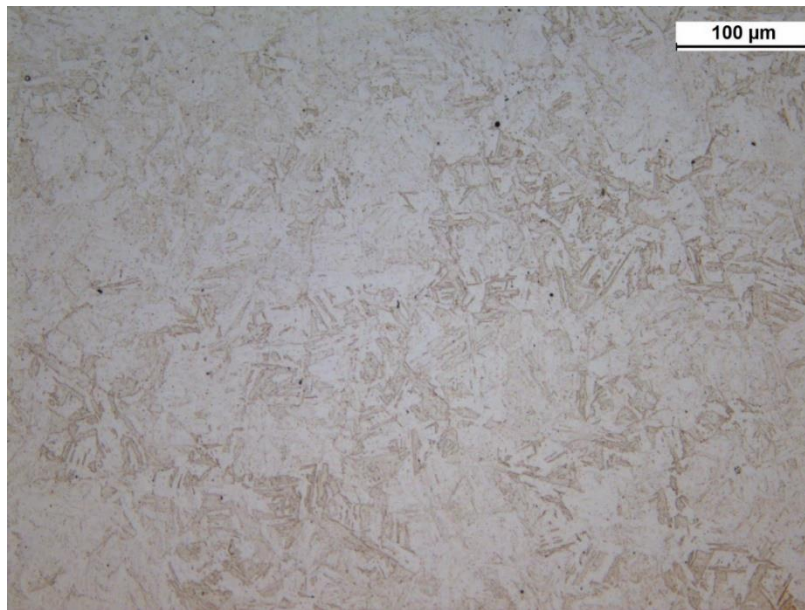
Figure 57: *Detail of the L3MC-2 front sample microstructure.*

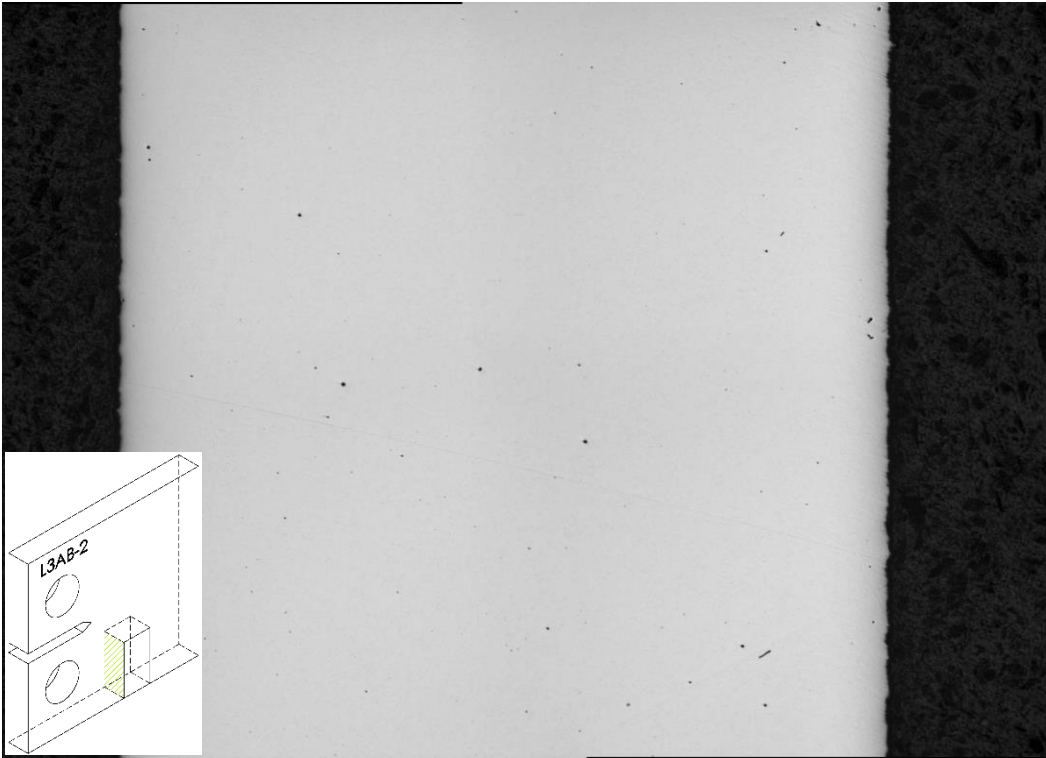
Figure 63: Overview of the incidence of defects in through-thickness sample of L3AB-2 specimen.

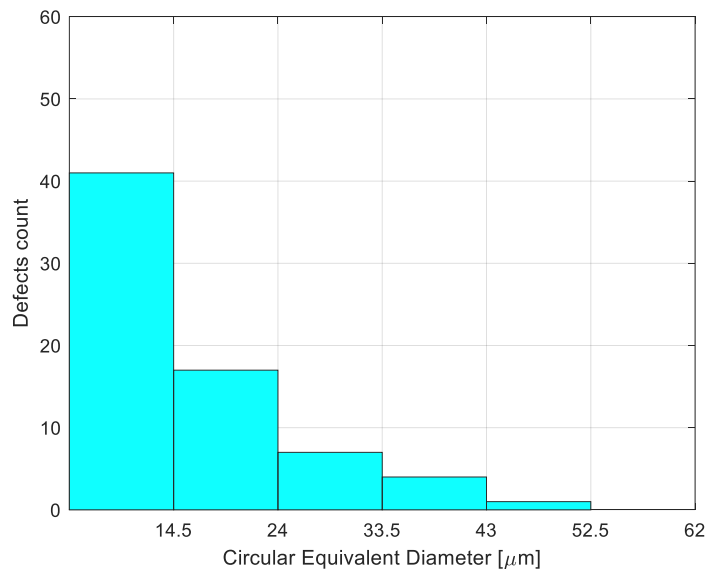
Figure 65: Number of defects versus circular equivalent diameter of the L3AB-2 through-thickness sample.

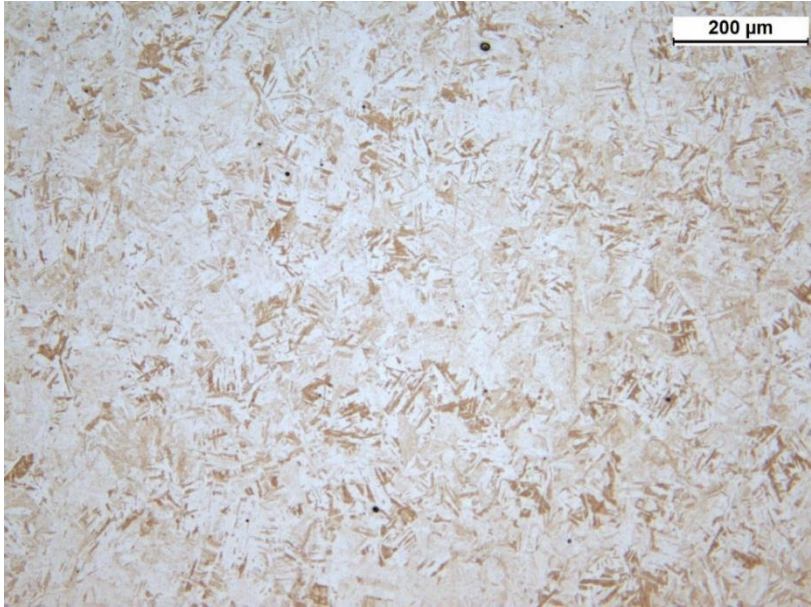
Figure 66: Microstructure of the L3AB-2 through-thickness sample at the optical microscope after chemical etching.

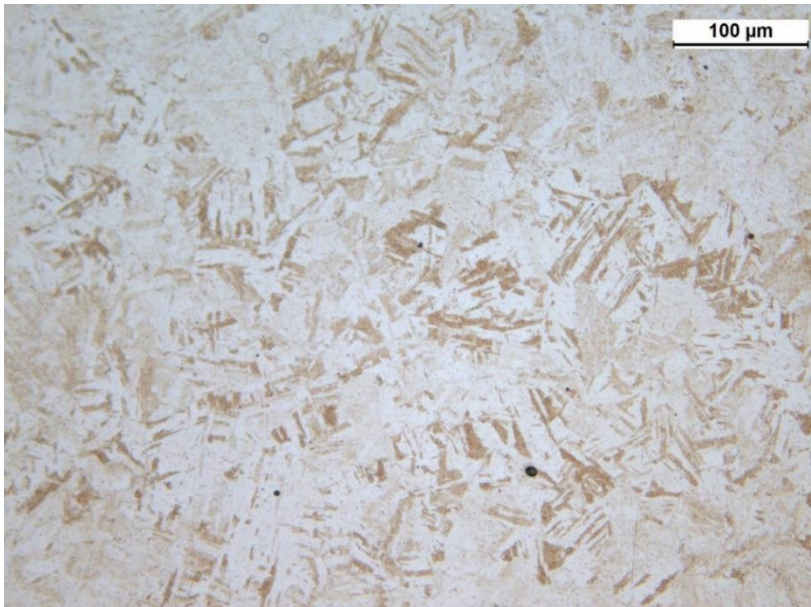
Figure 67: Detail of the L3AB-2 through-thickness sample microstructure.
