DC Breakdown Strength of HVDC XLPE Cable Insulation

Short-term testing of cable peelings

Master's thesis in Energy and Environmental Engineering

Norwegian University of Science and Technology
Faculty of Information Technology and Electrical Engineering
Department of Electric Power Engineering

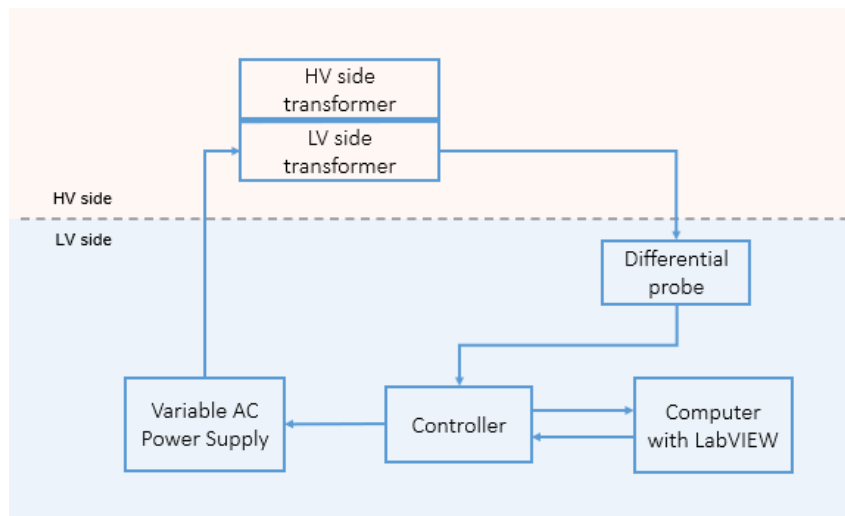
Figure 3.2: Setup for automatic adjustment of applied voltage.

In the figure, only the transformer from the HV side is presented. On the LV side, the setup consisted of a Variable AC Power Supply (variac), a controller, a differential probe and a computer with LabVIEW. The code in LabVIEW was set based on the given requirements for this project. The differential probe, giving voltage measurements to the controller, measured the voltage directly on the LV side of the transformer. Therefore, the automatic adjustment of the voltage was based on the transformer's primary AC voltage. Based on the settings in LabVIEW and the voltage measurements from the probe, the controller adjusted the voltage on the exit of the variac. The exit of the variac set the voltage on the primary side of the transformer. In the LabVIEW program, the following parameters were set:

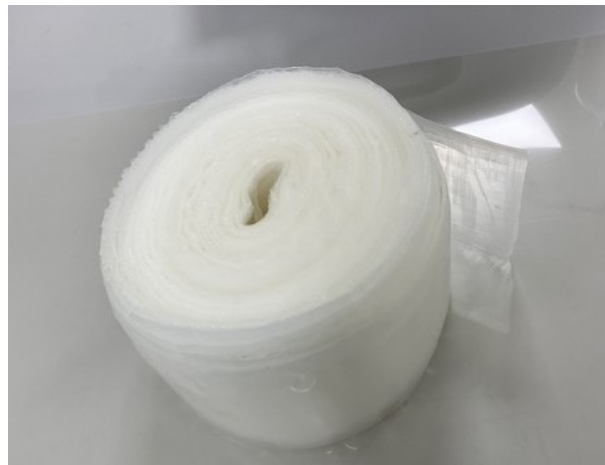
Figure 3.5: A test sample of cable peeling.

To collect data on the DC breakdown strength of XLPE cable insulation, the test objects were made of such insulation taken from an HVDC cable. As breakdown testing on solid dielectric implies irreversible destruction, a high amount of test specimens being as identical as possible is required. To obtain specimens satisfying such criterion, the test objects were in the form of cable peeling. Figure 3.5 shows an example of an unused test sample of cable peeling.

The cable peeling was cut from a full-scale cable end of a 525 kV HVDC cable, where the test samples were obtained from fresh and aged cable insulation. For this study, all the test samples were cut from the same cable with the same production run:

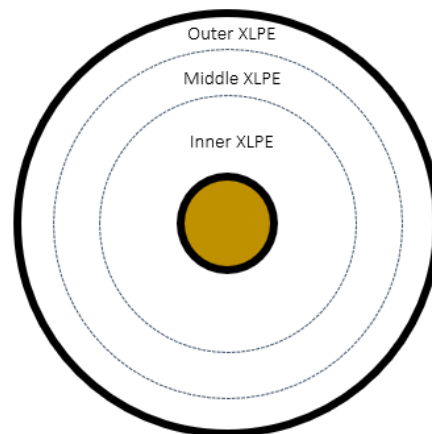
(b) Classification of orientation in the cable peeling samples. The classification is inspired by the work in reference [39].

Unfortunately, the slot was not made on the peeling samples from the aged specimen. Therefore the orientation in the cable peeling will be referred to as "inner XLPE", "middle XLPE" and "outer XLPE". The classification can be seen in Figure 3.6b.

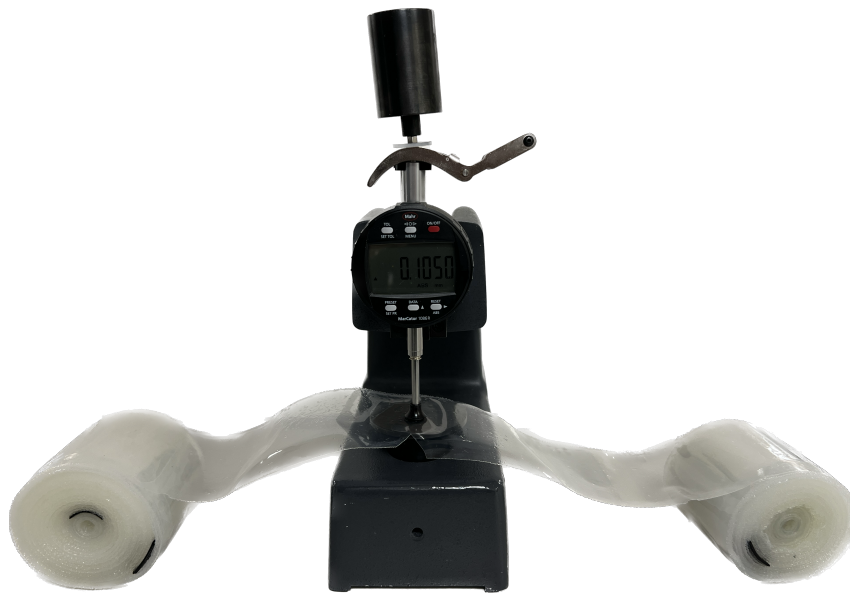
Figure 3.9: Micrometer used for thickness measurements.

Throughout the testing, a marking was cut in the edge of the cable peeling, where the breakdown channel could be found. After all 60 test on one cable peeling was performed, the thickness measurements of the breakdown channels were done. The purpose of this was to ensure a correct determination of the electrical field required to result in a breakdown. The thickness was measured after the breakdown tests to prevent damaging the peeling and possibly affecting the resulting breakdown voltage. Before the thickness measurements, the cable peeling was taken out of the test cell, and the oil was roughly wiped off. The used micrometer can be seen in Figure 3.9.

The micrometer gave measurements with four decimals. Only three decimals were considered when determining the electrical field strength. The values were rounded off, but the fourth decimal was experienced to vary, meaning there will be some margin of error related to the obtained values. For some of the breakdown channels, three additional measurements were done to assess the thickness variation in a turn. In addition, it was used a digital microscope to inspect some of the breakdown channels. The used microscope was a Keyence VHX-600 with a Keyence VH-Z100R lens. The zoom range was of 100 – 1000 times magnification.

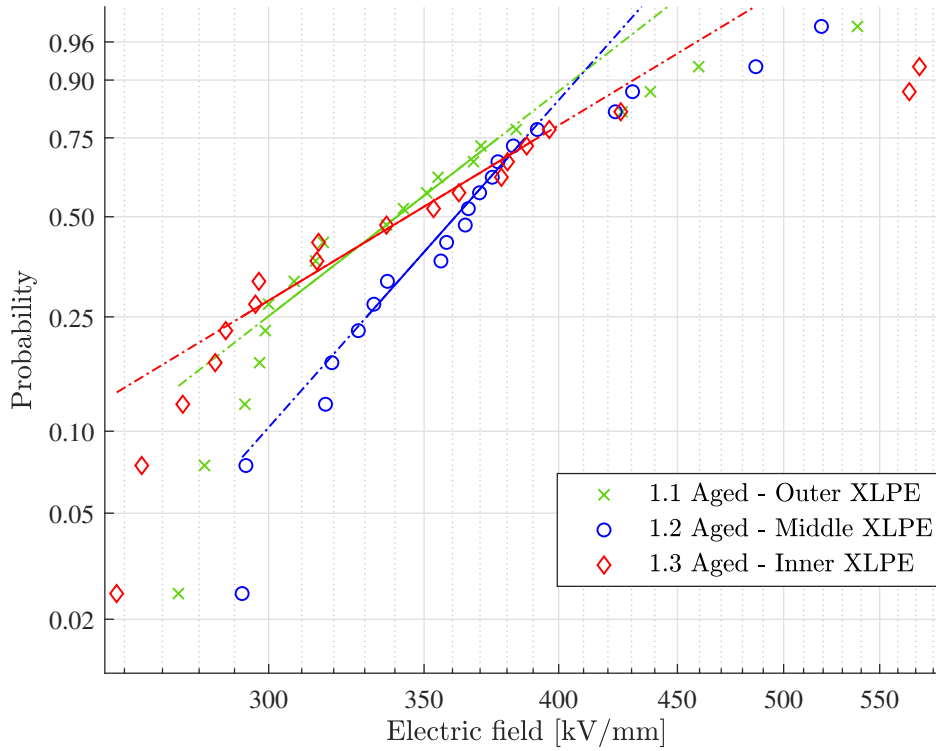
Figure 4.1: Weibull probability plot of the DC breakdown strength of the aged XLPE insulation. Each color and type of marking indicate one region of the insulation.

In Figure 4.1, the obtained data on the DC breakdown strength of aged cable peeling is gathered in a Weibull probability plot. In addition, the resulting scale parameters ($\hat{\alpha}$), or 63.2% characteristic breakdown strength, and the shape parameters ($\hat{\beta}$) for the distribution of the three regions are presented in Table 4.1. Each color and type of marking indicate one region of the insulation.

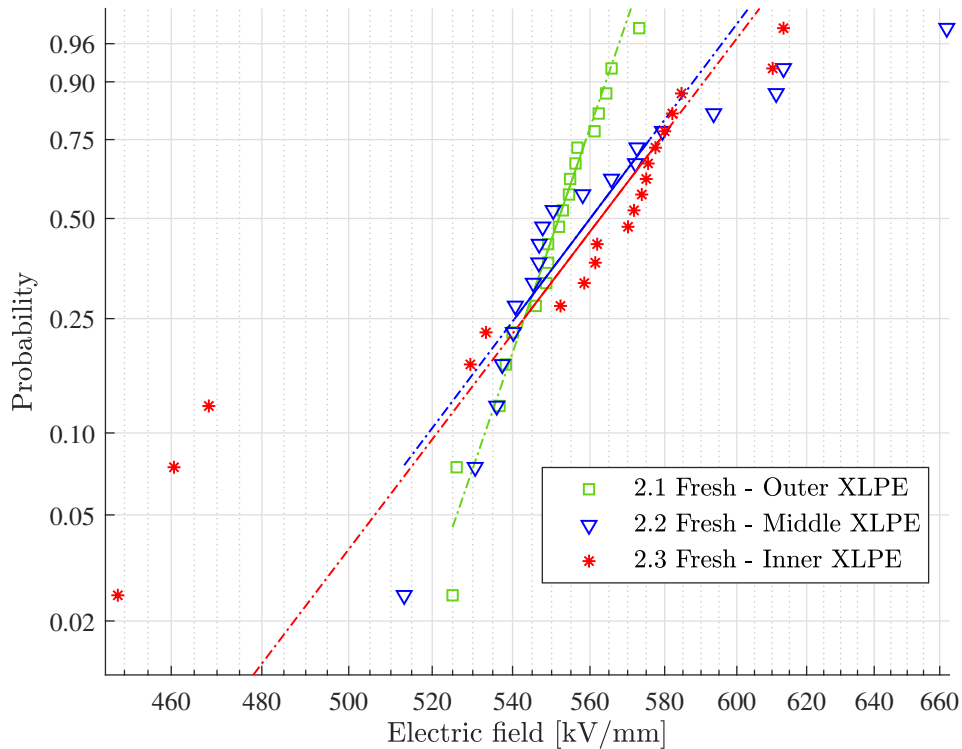
Figure 4.2: Weibull probability plot of the DC breakdown strength of the fresh XLPE insulation. Each color and type of marking indicate one region of the insulation.

In Figure 4.2 the Weibull probability plot for the DC breakdowns tests performed on the fresh cable peeling is given. Furthermore, the scale and shape parameters of the Weibull distribution for each of the DC breakdown strengths of the different regions are presented in Table 4.2. The data on the different regions follow the same indications of colors as for the plots on the aged cable peeling, but there are new markings.

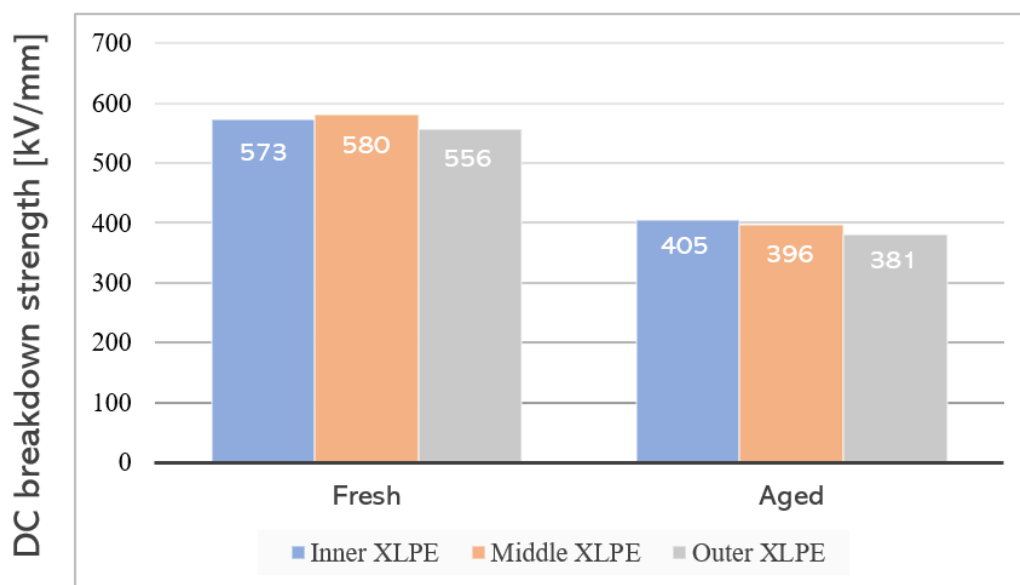
Figure 4.4: A bar chart comparing the 63.2% characteristic breakdown strength (scale parameter) of the fresh and aged XLPE cable peeling.

Figure 4.4 shows a bar chart of the 63.2% characteristic breakdown strength of the different regions of fresh and aged cable peeling. The three bars to the left and right belong to the fresh and aged insulation specimens, respectively.

The bar chart in Figure 4.4 shows an evident difference in the DC breakdown strength of the regions of the fresh and aged insulation. The scale parameters of the aged specimens are more than 100 kV/mm lower than those of the fresh specimen. It is observed that for both the fresh and aged insulation, the lowest scale parameter is given for the outer XLPE. Lowest found breakdown strength for the outer XLPE could be due to the manual cutting of the cable peeling. Possible uneven cutting could lead to minor damages in the peeling; hence it could be a reason for an enhancement of a local field at even low electrical field strengths. Nevertheless, since the 95% CIs did not show a statistically significant difference in the breakdown strength of the different regions, it is reasonable that this resemblance is a coincidence.
