Creation of a GIS based Case Study Collection for Marine Accidents and Exercises in the Arctic

Master's thesis in Master Thesis in Cold Climate Engineering
Supervisor: Dr Nataly Marchenko (UNIS), Dr Knut Vilhelm Høyland (NTNU), Per Knudsen (DTU)

June 2022

Norwegian University of Science and Technology
Faculty of Engineering
Department of Civil and Environmental Engineering

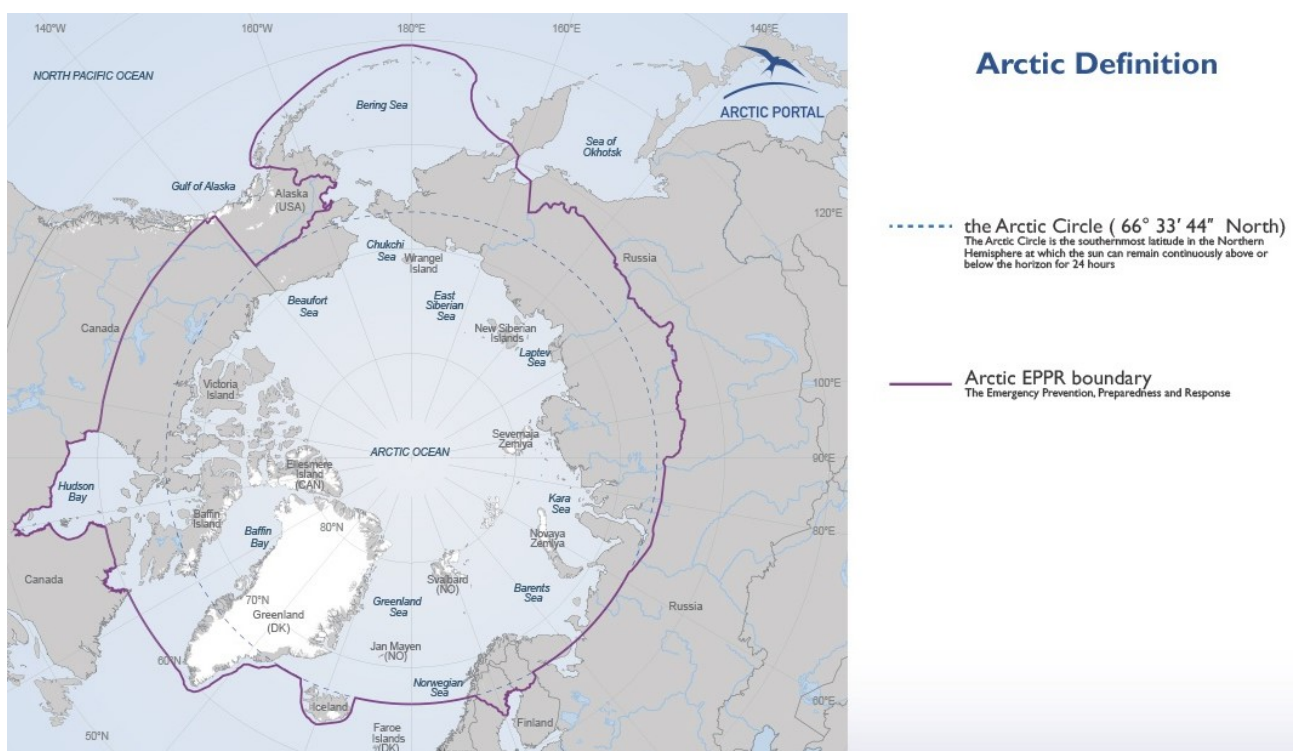
Figure 11: The Arctic area under the Emergency, Prevention, Preparedness and Response[10]

The Emergency Preparedness, Prevention, and Response (EPPR) Working Group is one of the six working groups operating under the Arctic Council[10]. The EPPR Working Group focuses on enhancing emergency preparedness, prevention, and response capabilities in the Arctic. It collaborates with the IMO and other organisations to address preparedness and response in the polar regions. This includes the implementation and enforcement of the Polar Code. The EPPR geographical extent aligns with the Polar Code's coverage, although it goes further South of the Polar Code line in areas such as Iceland. In keeping with the EPPR and Polar code, this is what will define the project extent.

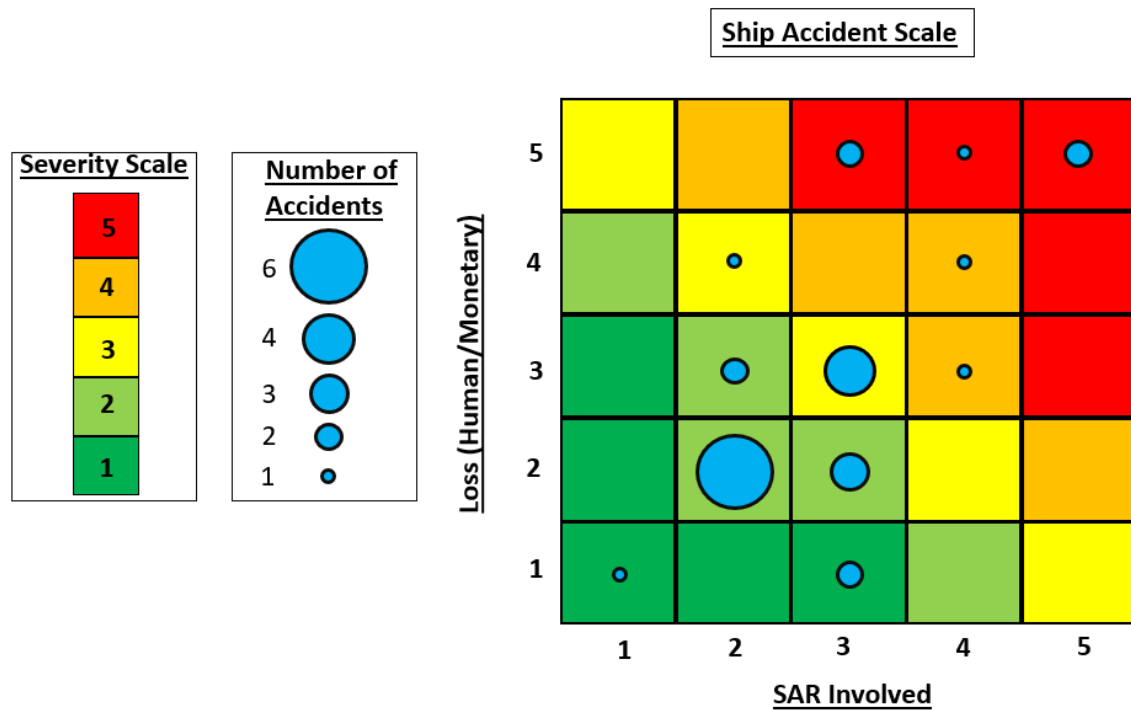
Figure 14: Marine Accident Scale Classification Summary

In order to better sort through and quickly show the severity of an accident or size of an exercise, classifying the scale of each was deemed an effective tool to both show visually and link the scale of the accident to the size of the icon on the dashboard. A rating scale of 1-5 was used to classify the severity of an accident as well as the size of each exercise. Taking the format from similar classification scales of risk analysis as discussed in the literature review in Section 2.11, a structure to rate the collection was formulated.

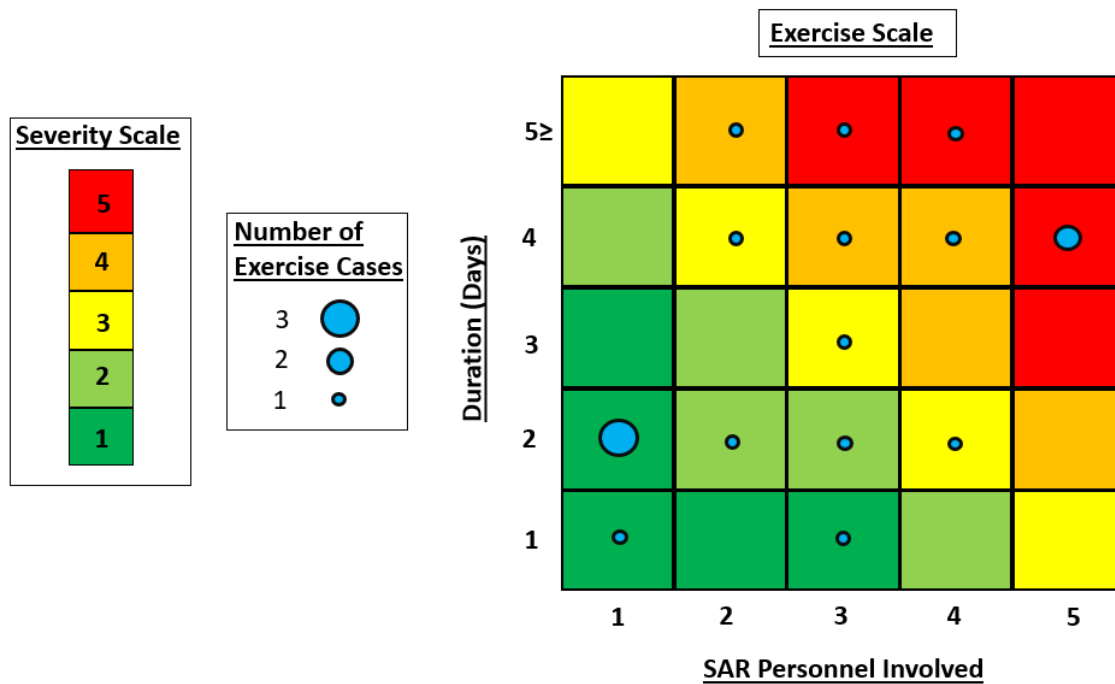
Figure 15: Created Exercise Collection Scale Classification Summary

the duration of the exercise in days. For the x-axis with personnel different number bands of persons involved were defined to separate each value. The ranges in the number of personnel were adjusted based on the specific data obtained in the data collection phase. With maximum and minimum values, the exact number ranges are seen in Table 4. The y-axis was outlined in a similar process where the collected days for all exercises was taken into account and then divided into five distinct brackets. With ratings 1-4 they corresponded to 1-4 days, while the fifth was anything five days or more in duration. The created scale matrix is then seen in Figure 15 with a summary of where the collection exercise fall within the table also displayed.

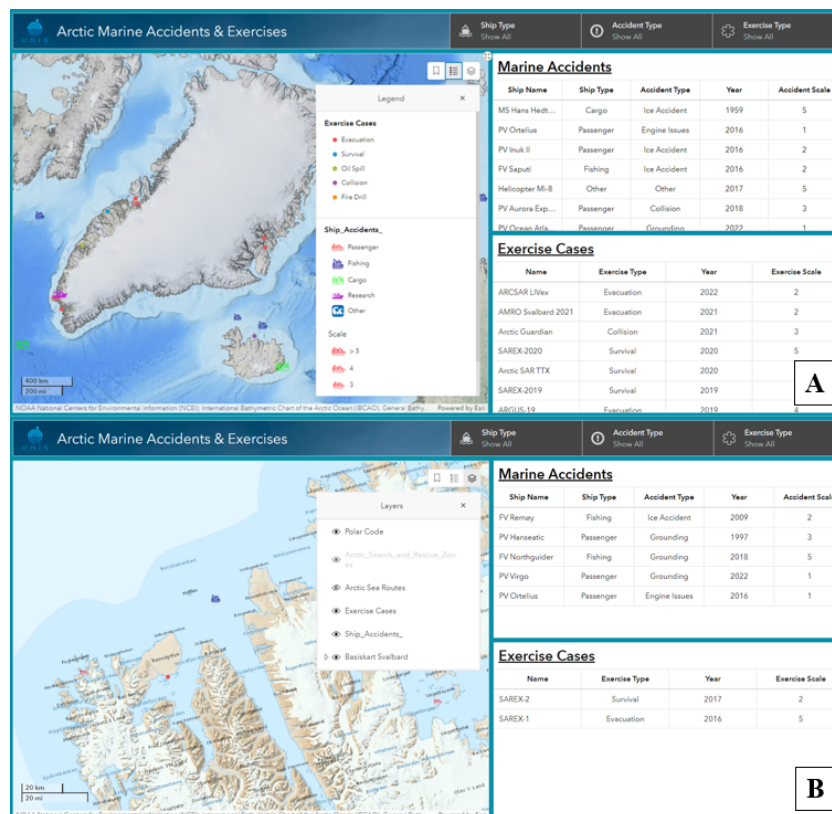
- Figure A(24): The centre icon in the map plugin represents the Legend. Clicking on this icon displays the legend for all the layers on the map.
- Figure B(24): Clicking the right icon in the map plugin allows users to turn on and off other layers. This includes layers such as the local TopoSvalbard map and the Search and Rescue zones with country jurisdiction.

Figure 24: Layer Control

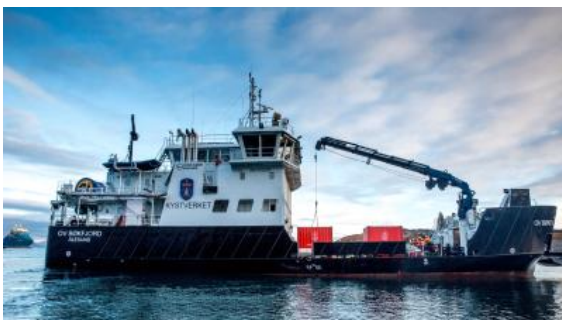
The OV Bøkfjord before the exercise began in Adventfjorden

The vessel used as the cruise ship in distress for the exercise was the OV Bøkfjord. It is a pollution control vessel owned by the Norwegian coastguard. Its length is 44 metres with a large open space on deck and at the bow where passengers could gather in the open air to await the airlift.

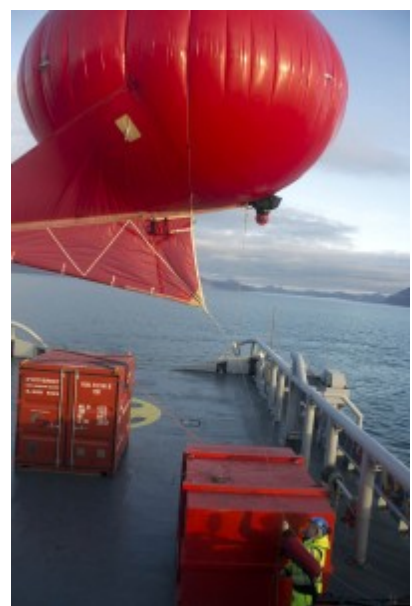
Helium balloon fitted with a specialized video camera.

such as containment as best as possible until further reinforcements come. A plane conducted an ariel survey shortly after the ships reached the “spill” site, but much of the overhead observation was done using a large helium balloon fitted with a specialised camera. The Norwegian Coastal Administration who co-led the simulated cleanup at sea aboard the NCA’s Barentshav during the main part of the exercise. The OV Bøkfjord has the ability to recover over cubic litres of oil and its use was a significant area of interest to all parties involved.

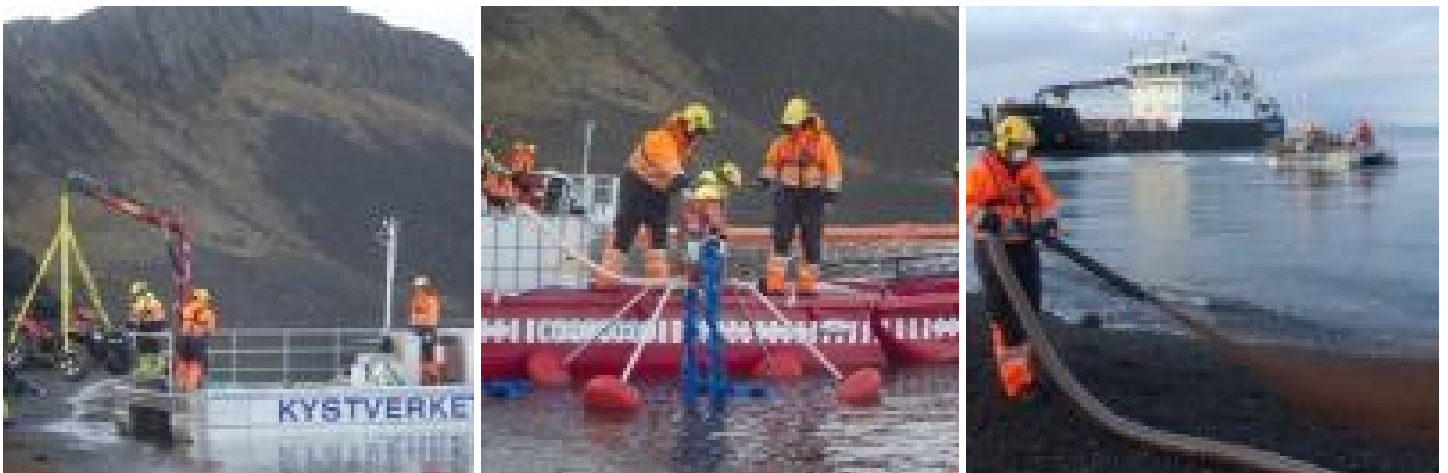
Photos from the second day of the exercise.

The first picture above shows workers bringing an ATV ashore using one of the Norwegian Coastal Administration's auxiliary boats. The second shows crew using a skimmer to suck foam representing spilled oil from the water near shore area. The third shows a crew member spraying specially treated bark chips designed to soak up oil over a shoreline as equipment is unloaded from the Bøkfjord.

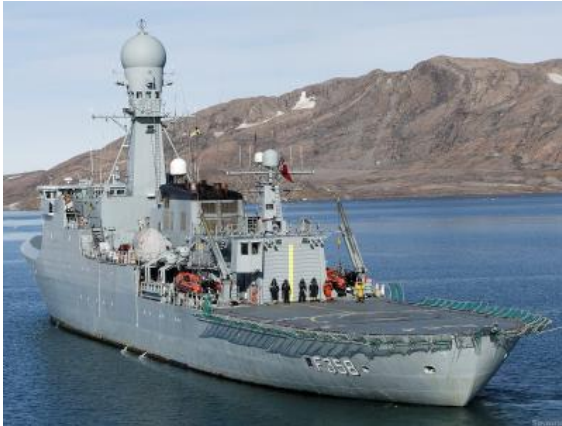
The HDMS Triton on patrol in Greenland.

The vessel that was used as the cruise ship in distress for the entirety of the exercise was the HDMS Triton. For the full exercise she was called the Arctic Victory. She is a Danish Navy ocean patrol vessel that operates in the waters around the Faroe Islands and Greenland. The ship is 113 metres with a large stern deck that has a helicopter landing spot on it as well as room for

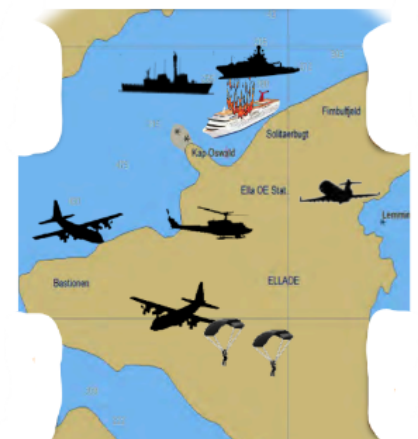
The second part of the exercise was the simulated cruise ship catching fire and running aground in the area just North of Ella island at Kap Oswald. The icons in the image show approximately how rescue craft were located for the exercise.

Illustration of where different SAR services were situated.

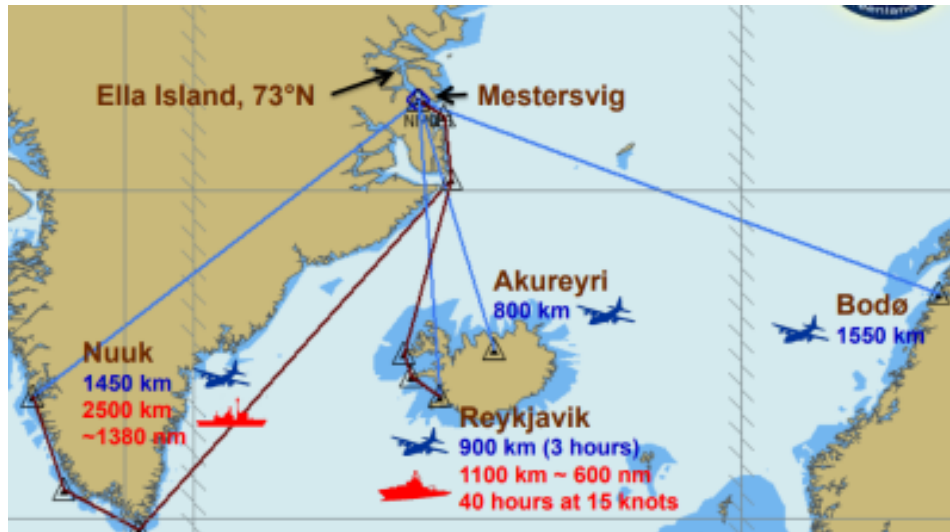
Distances and times to reach the area.

The distance to reach and rescue a ship in the exercise situation is huge and its remoteness was fully realised. Arctic nations have to be ready for this type of event if it did occur and understand that the approach to it is different than in other regions.

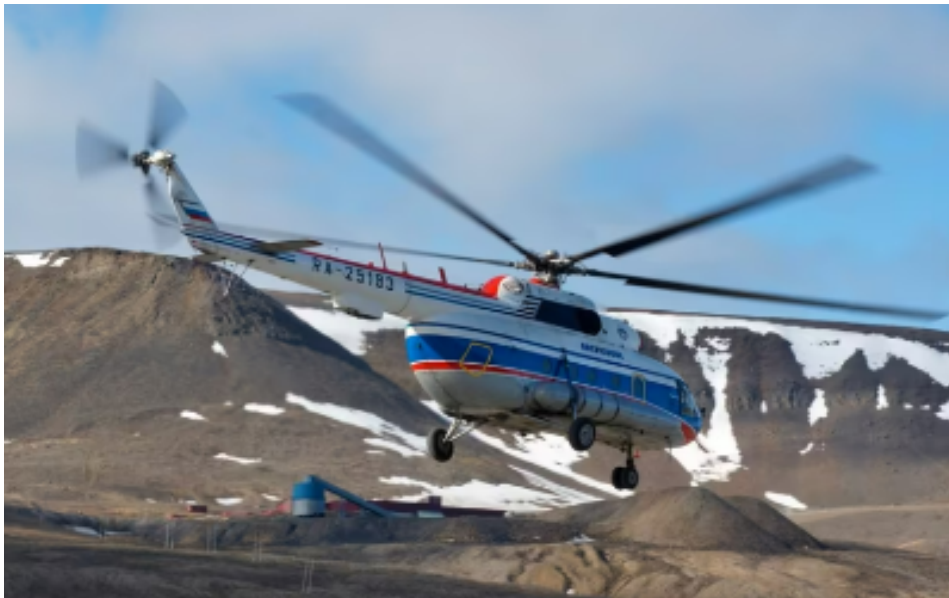
The Mi-8 helicopter that crashed seen at Barentsburg the previous year.

The Accident Investigation Board Norway (AIBN's) investigations and interviews with persons involved did not give any indication of technical failure of the helicopter or any of its systems prior to the accident. On the other hand, there were circumstantial factors indicating that safety problems related to operational conditions in a challenging weather

situation contributing to the accident. Based on available information, the AIBN concluded that the helicopter hit the water surface with the tail portion of the fuselage first at low or no speed forward. This indicated a loss of visual references in poor visibility with subsequent loss of control over the helicopter. Therefore, in the analysis, focus was on general operational conditions, weather conditions and the change in visibility conditions during the approach, which probably led to the loss of visual references.

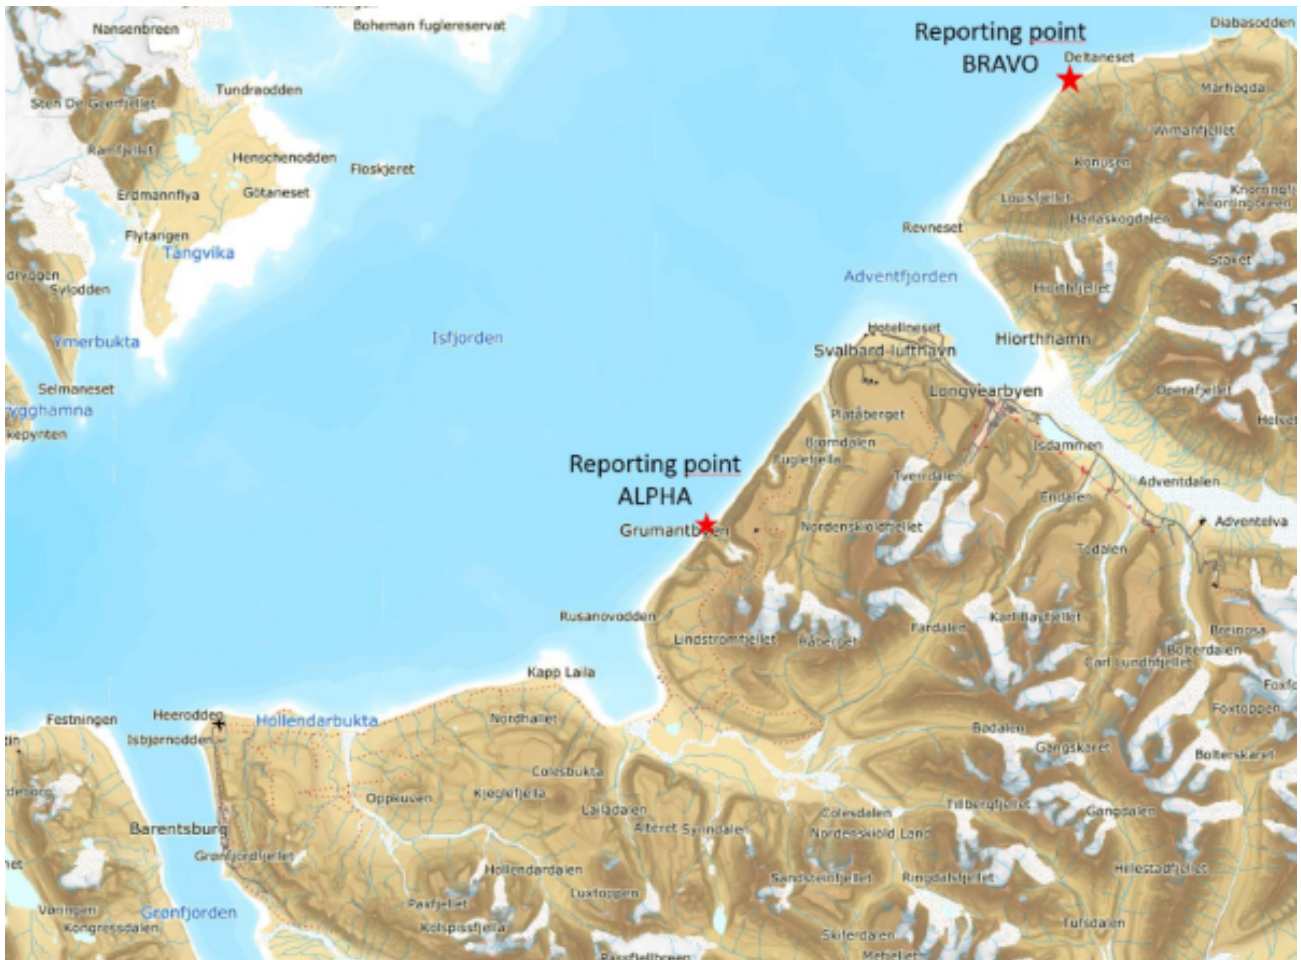
Pyramiden, and that they were continuing on to Barentsburg at a height 600 ft with 8 persons on board, and that they would call back when passing “reporting point Bravo inbound”. See picture below for points Bravo and Alpha.

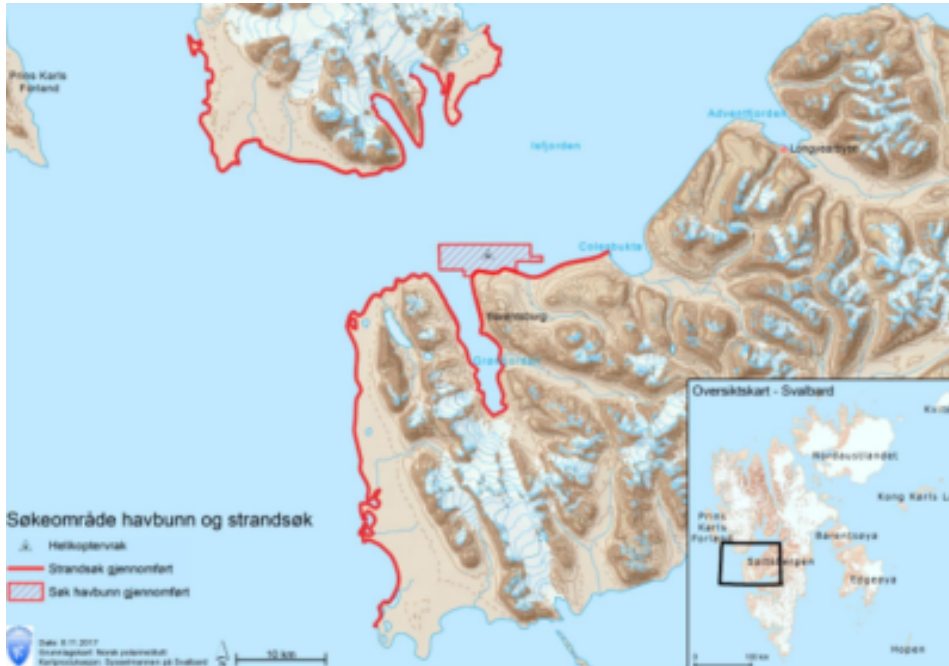
Overview of shorelines searched in red with crash area searching shaded.

Several local boats came to the accident area the same evening to take part in the search. The smell of jet fuel was detected in the accident area. A Norwegian Air Force P-3 Orion and the Coast Guard vessels KV Barentshav and KV Senja arrived early the next morning to the area to take part in the search. The G.O. Sars, started searching in the area using an ROTV24 in the afternoon of October 28. At 06:20 on October 29 G.O. Sars reported a possible find. This was later confirmed by KV Barentshav. The deceased was later found and taken on board G.O. Sars at 09:13 on 31 October.

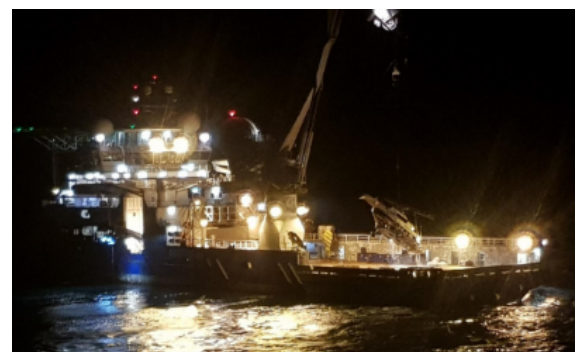
Maersk Forza hauling the wreckage onboard.

some search operations on the sea bottom. The main part of the helicopter wreck was salvaged in the morning on November 4 and was hoisted aboard the Maersk Forza.

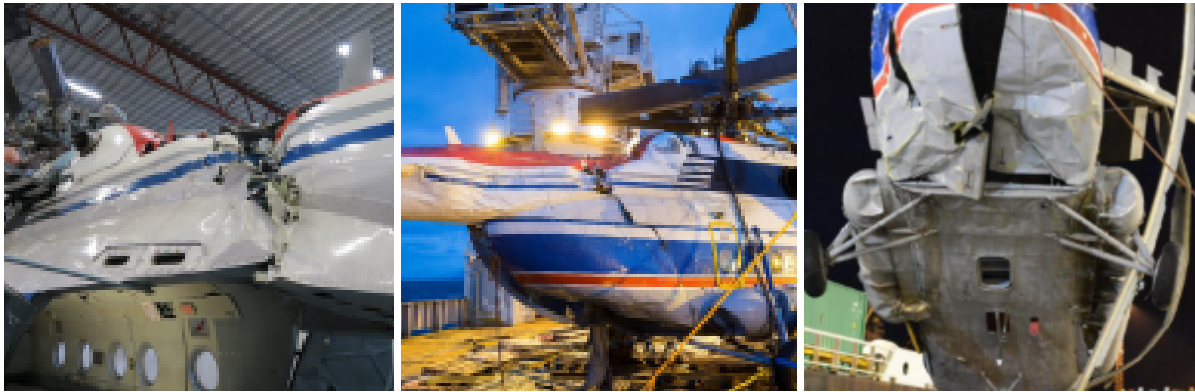
Pictures of the Mi-8 wreckage.

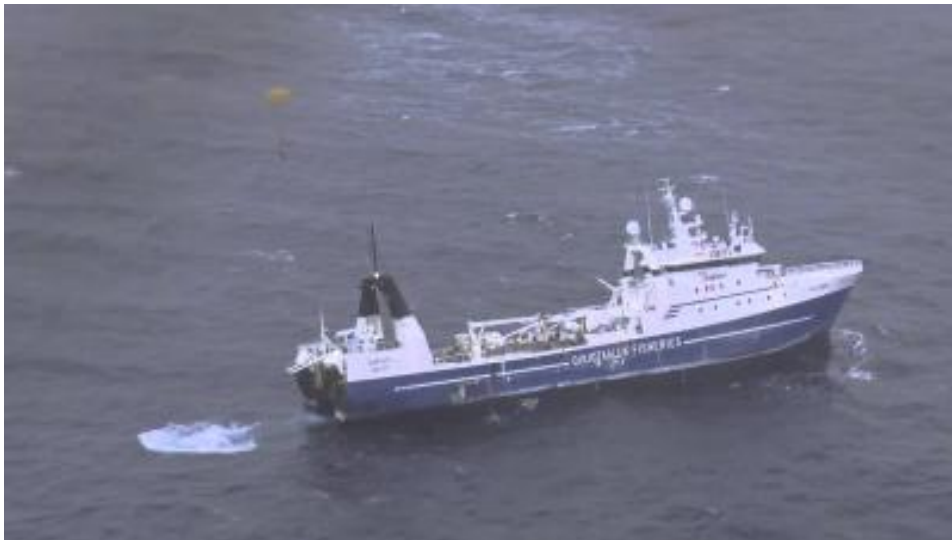
The trawler pictured listed heavily after striking sea ice in the Davis Strait.

The ship's shell plating was sampled to test its specifications and several results showed impact energy needed to fracture the steel was lower than others at the same temperature, but these are not indicative of a fault or defect. The master had significant experience in ice and the vessel made its required specifications.

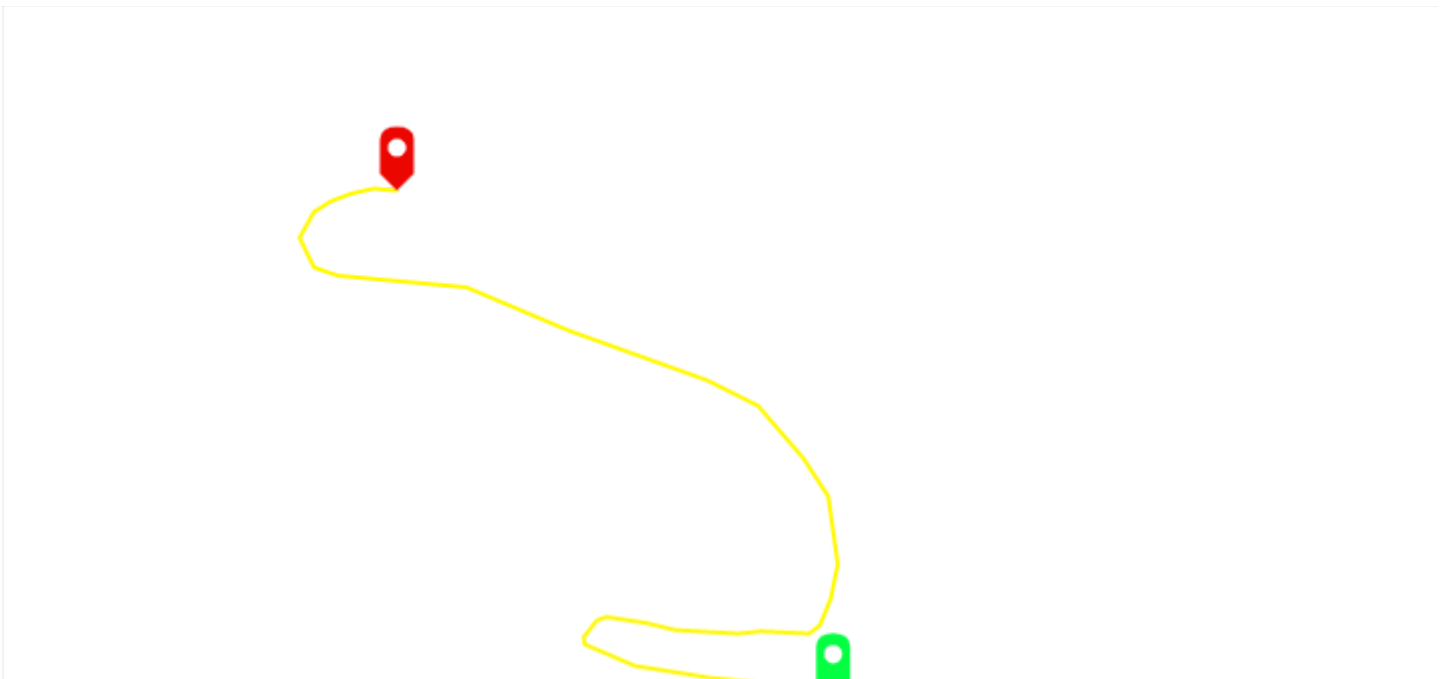
This map shows the location in green of the ship itself with regards to the glacier area and the accident itself. Passengers got into two rubber dinghies of 7 persons each and proceeded to be guided nearer the glacier itself. The yellow line indicates the route taken by the group before coming to the main glacier front itself where the accident occurred.

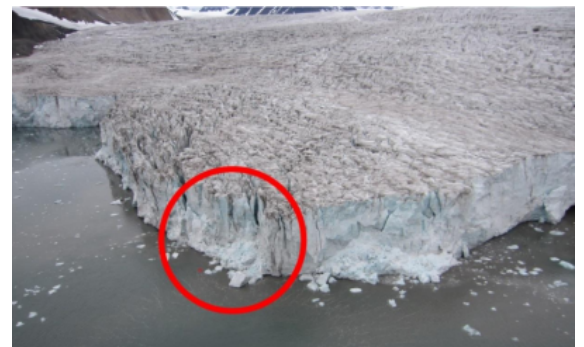
The location on the glacier where the accident occurred

Passengers as well as guides on the dinghies estimated the distance at this stage from the glacier to be greater than the minimum distance of 200 metres. It was then that the large glacier calving occurred. A large bang was heard followed by the glacier front coming loose and falling forward. The image shows the location of where the calving came from. Ice blocks fell from approximately 33 metres onto dry land causing them to shatter and be projected into the fjord. Pieces of the ice hit the first dinghy at high velocities. It was then the injury and fatality occurred when a piece of ice hit one of the passengers in the head causing near instant death. Another passenger received minor injuries.

- Before the accident, both the guides and the passengers had been made aware that the glacier front might calve and that the ice could land on dry land, but they did probably not anticipate such violent calving.
- There is a lot of uncertainty in the distance the dinghies were to the glacier at the time of the accident. The AIBN estimated that the distance was between 100 - 130 metres but this is not certain. Regardless, they were close enough that a piece of calving ice caused a fatality.
- The minimum distance of 200 metres away from glaciers is hard to perceive as there are no objects of reference. The
