# Journal of Rock Mechanics and Geotechnical Engineering

## Full-scale pullout tests of rock anchors in a limestone quarry focusing on bond failure at the anchor-grout and grout-rock interfaces

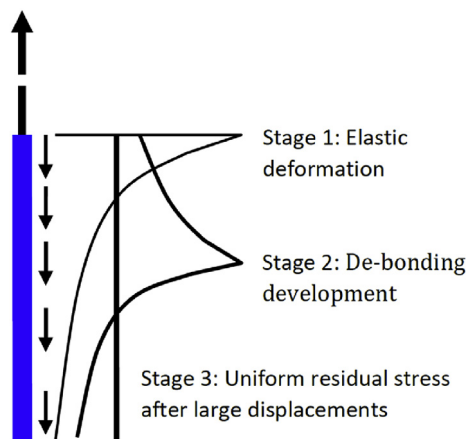
Fig. 1. Three stages of stress transfer from anchor to rock: (1) Elastic deformation, (2) Debonding development, and (3) Uniform residual stress after large displacements.

The measurement data from the tests in this study agree in principle with the models for the shear stress distributions in Stage 1 and 3 in Fig. 1, but not in Stage 2. A short section of the bond length at the top might be debonded at a certain load level, but it was not observed that the debonding section extended toward the distal end with increasing of the applied load in the tests.

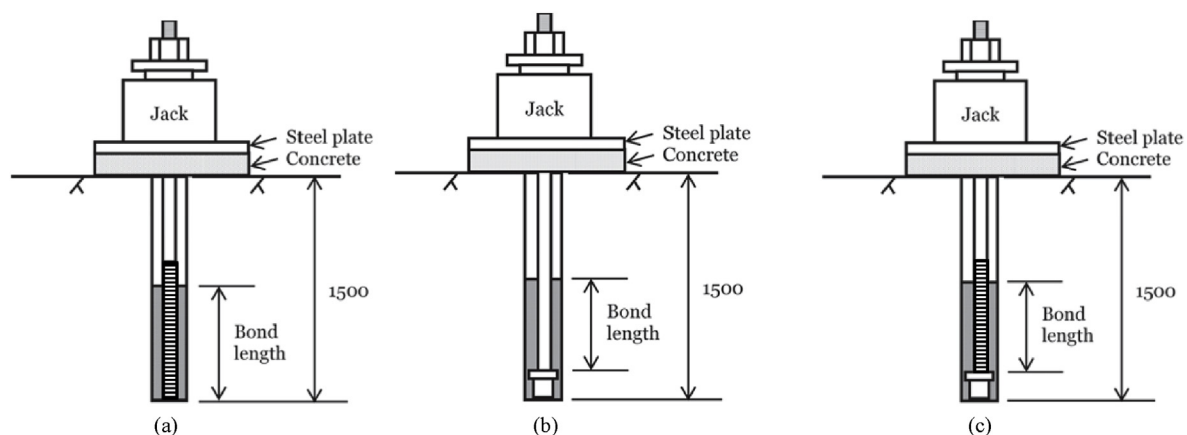
Fig. 2. Three configurations used for the tests: (a) Solid threaded bar, (b) Solid bar with endplate (the thread was debonded from the grout by a sleeve), and (c) Solid threaded bar with endplate.

The field tests aimed to investigate the failure along the anchor-grout and grout-rock bond interfaces. A testing plan with three test setups was developed to investigate the bond failures through pullout, as shown in Fig. 2. All the tests, 14 in total, were carried out with 64-mm diameter bar anchors in 140-mm boreholes drilled to a depth of 1.5 m. The rock anchor in test setup A, as shown in Fig. 2a, is a type of threaded bar anchor that is currently used for rock anchoring in various rock engineering projects. The anchor could fail along either the anchor-grout or grout-rock interface. A critical embedment depth exists for this type of rock anchor. The anchor would be pulled out of the borehole when the bond length is shorter than the critical embedment length. An endplate was attached to the distal end of the bar in test setups B and C, as shown in Fig. 2b and c, aiming to force the failure to occur along the grout-rock interface to investigate the bond strength of that interface. For test B, the anchor stem was debonded by a polymer sleeve so that the applied load was entirely transferred to the endplate, while for test C, the applied load was partially carried by the bonded thread section so that the effect of the thread on the load transfer to the endplate was investigated. The bond length for tests B and C was defined as the grouted length above the endplate.

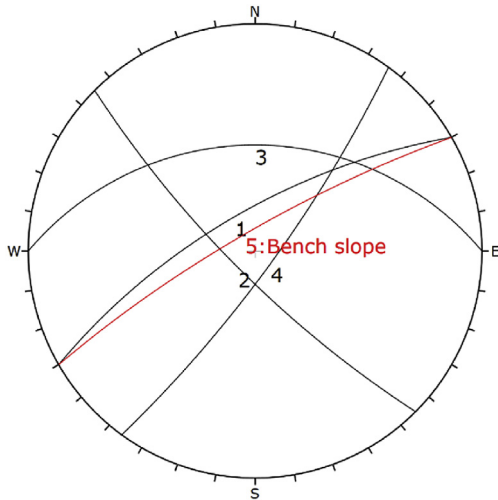
Fig. 3. Stereogram showing the strike and dip of the four joint sets in the rock mass at the test site and the bench slope.

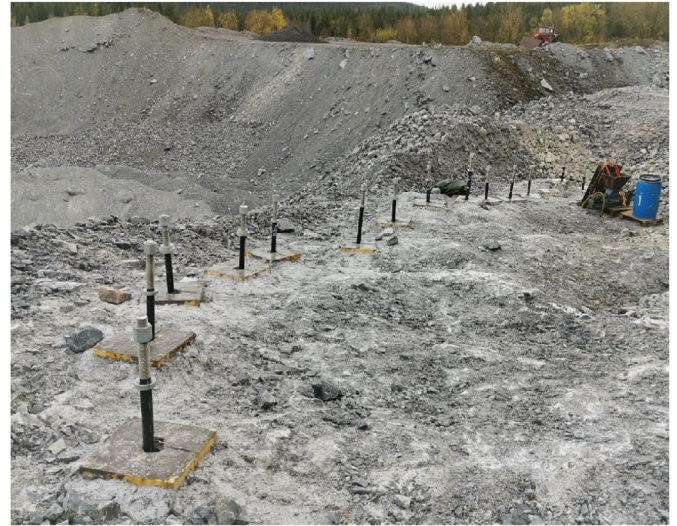
Fig. 6. Hole layout in the field.

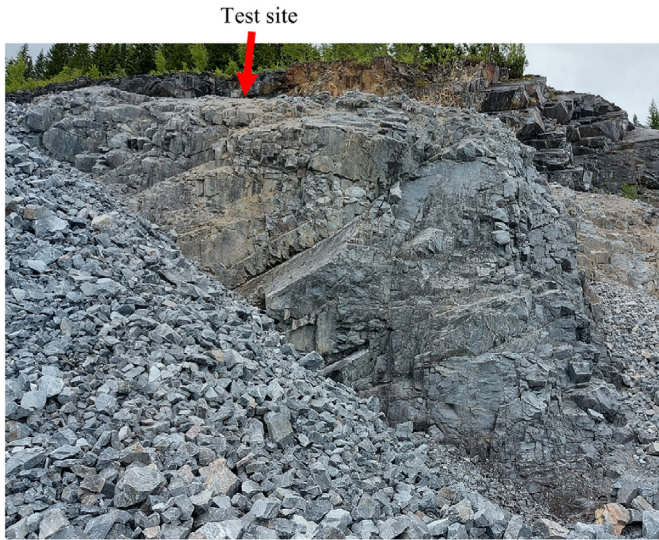
Fig. 4. Rock mass in the test site seen from the bench below, with clear signs of blast damage at the top of the bench closest to the test site.

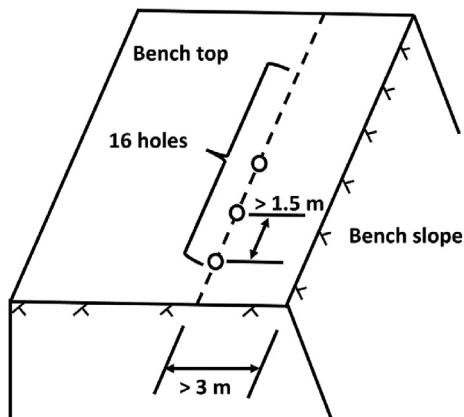
Fig. 5. Sketch of hole layout.

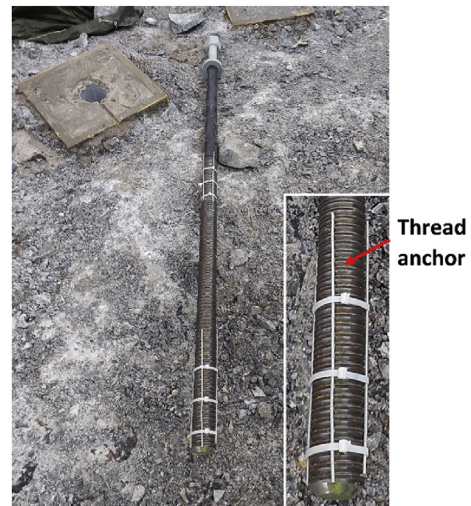
Fig. 7. Example anchor used for test setup A (A-anchor).

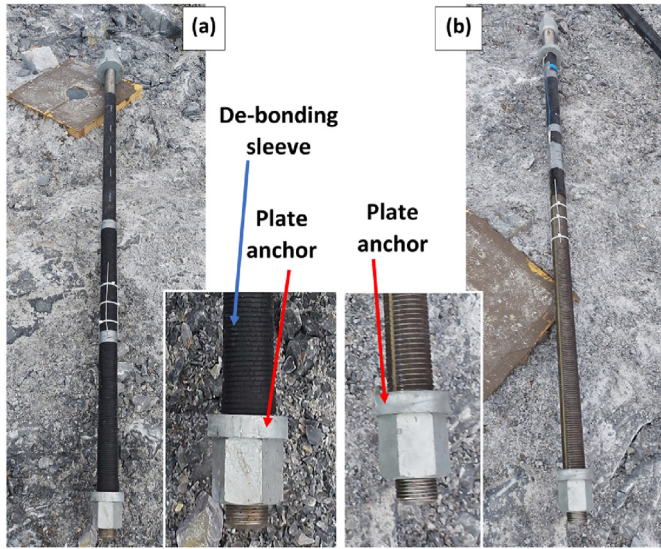
**Fig. 8.** Examples of anchors used for tests B and C, (a) with plastic debonding sleeve (B-anchor) and (b) with a longitudinal groove instrumented with an FBG cable (C-anchor).

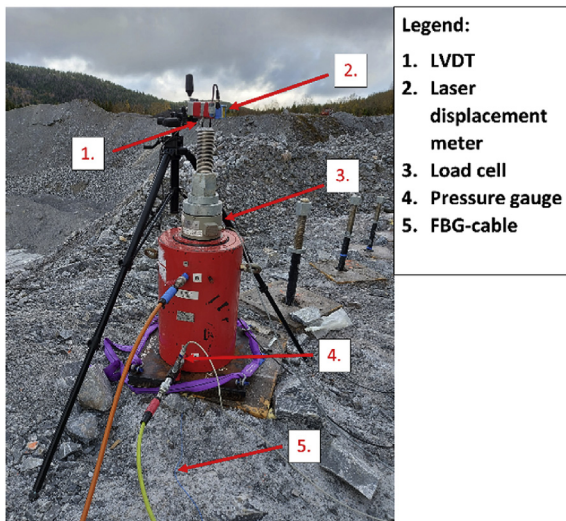
**Fig. 9.** Test setup with instrumentation for an anchor.

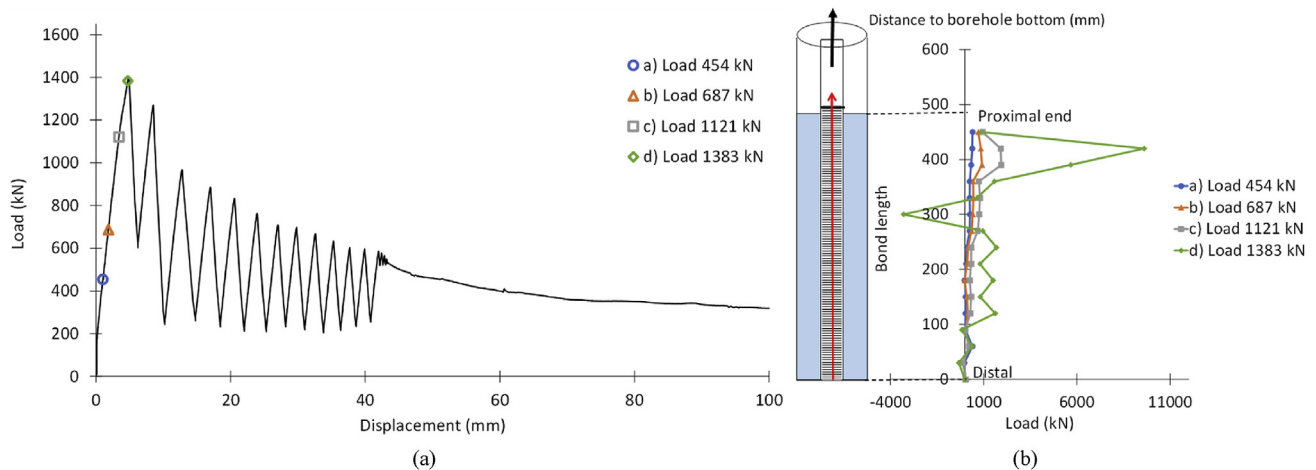
**Fig. 10.** Pullout test results for anchor 1A: bond length 485 mm and  $W/C = 0.42$ : (a) Load vs. displacement plot, and (b) Load distribution along the anchor. Ultimate pullout load  $P_{ult} = 1404$  kN.

The pattern of the load-displacement curve is similar for all A-anchors. The pull load reached its maximum after a very small displacement, around 5 mm. The load oscillated in five of the seven anchors in the post-peak stage, as shown in Fig. 10. The load oscillation was periodic, with a displacement of around 4 mm for every load drop, which is equal to the pitch (the tooth spacing) of the anchor thread (see Fig. 7). This behaviour was particularly clear for anchors 1A (Figs. 10a) and 4A (Fig. 13a). In this case, the load oscillation appears to be caused by the slip of the anchor thread in the grout; in other words, the failure was at the anchor-grout interface. The oscillation disappeared, and smooth slip continued when the anchor-grout interface was flattened.

elastic stage of the anchor test with some measurement uncertainty. At the plastic stage, the measurements started to vary more (see green curves in Figs. 10b and 11b), and after bond failure and crushing of the grout, the measurements had large fluctuations and were unreliable. Some of the fibres failed during the tests. These large variations in the measurements could be associated with dilation in the grout as the anchor was pulled out. In the soil anchor tests by Smet et al. (2019) and Fabris et al. (2021), likely, the grout was not crushed, and the fibres were therefore not exposed to dilation, which may be the reason why fibre optic cables work well in soil applications.

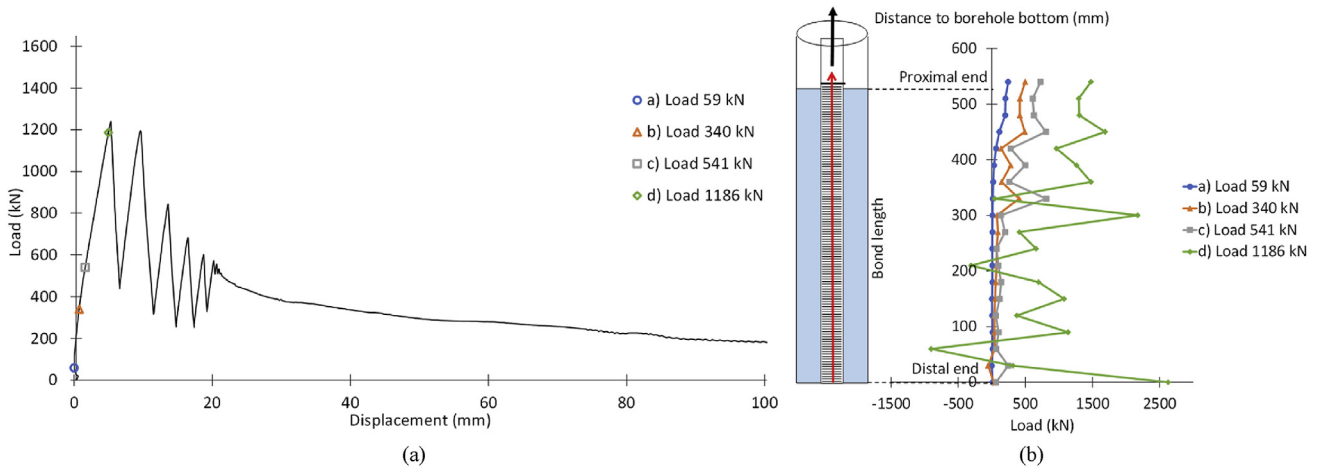
**Fig. 11.** Pullout test results for anchor 2A: bond length 523 mm and  $W/C = 0.42$ : (a) Load vs. displacement plot, and (b) Load distribution along the anchor. Ultimate pullout load  $P_{ult} = 1240$  kN.

The intensity of the load oscillation of anchor 2A (Fig. 11a) is in between the anchors subjected to strong oscillations (1A and 4A) and the anchors to weak oscillations (3A and 5A). Both the anchor-grout and grout-rock interfaces might fail, but the failure might dominate at the anchor-grout interface because of its high ultimate load per metre of bond length.

Fig. 11b shows the load distribution of anchor 2A at four levels of applied load. The distribution was similar to that in anchor 1, except at 1186 kN, close to the ultimate load. The load-mobilised section was the top 220 mm from the proximal end to approximately 300 mm from the distal end. It is hard to interpret the load distribution at the load level of 1186 kN because of the fluctuation of the measured load. The FBGs are either damaged or disturbed at that load level. It appears that the entire 523-mm long bond length of the anchor was mobilised at that level.

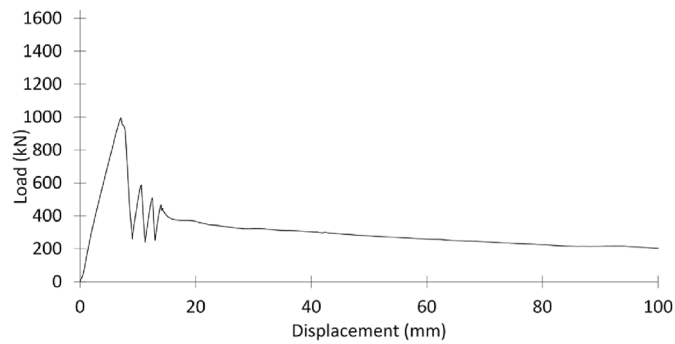
**Fig. 12.** Pullout load vs. displacement plot for anchor 3A: bond length 625 mm and  $W/C = 0.42$ . Ultimate pullout load  $P_{ult} = 995$  kN.

The oscillations of anchors 3A (Figs. 12) and 5A (Fig. 14) were very weak and lasted for only a short displacement. The load oscillation implies that slip first occurred at the rough anchor-grout interface. These anchors had 1–2 mm larger displacement at peak load than the other A-anchors with oscillation, which also implies

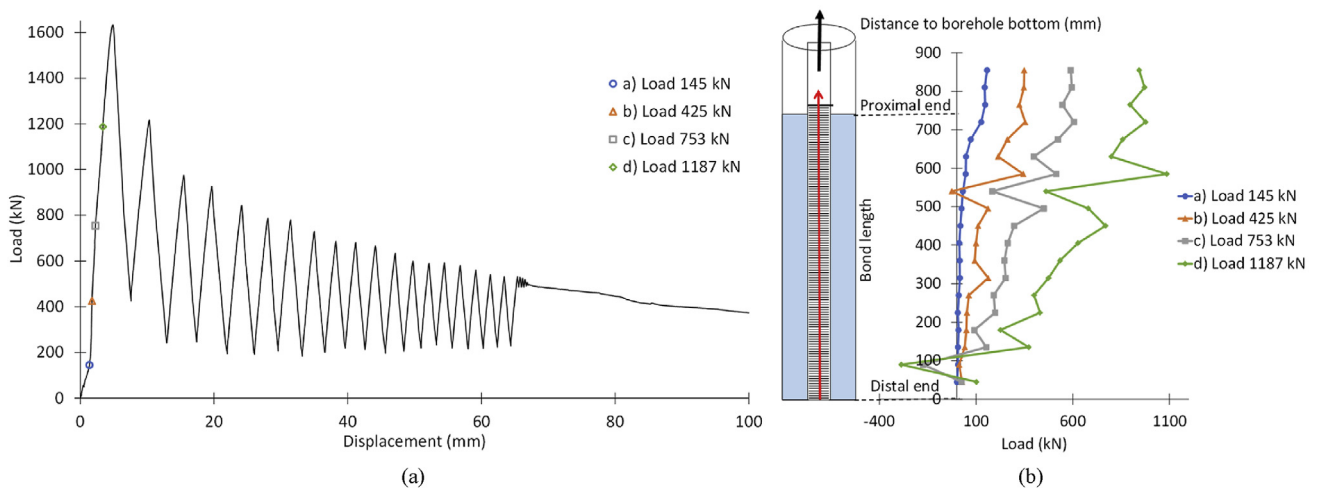
**Fig. 13.** Pullout test results for anchor 4A: bond length 730 mm and  $W/C = 0.42$ : (a) Load vs. displacement plot, and (b) Load distribution along the anchor. Ultimate pullout load  $P_{ult} = 1634$  kN.

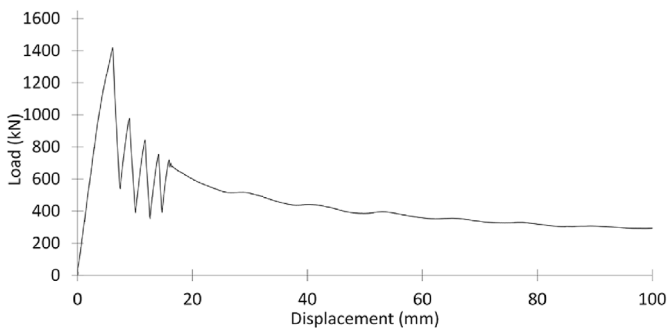
Fig. 14. Pullout load vs. displacement plot for anchor 5A: bond length 1080 mm and  $W/C = 0.42$ . Ultimate pullout load  $P_{ult} = 1418$  kN.

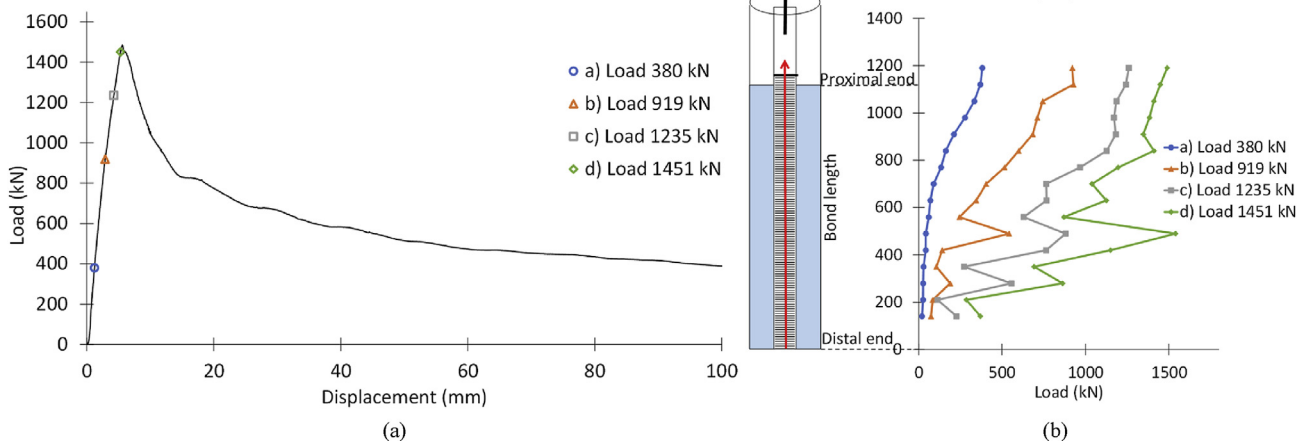
Fig. 15. Pullout test results for anchor 6A: bond length 1100 mm and  $W/C = 0.42$ : (a) Load vs. displacement plot, and (b) Load distribution along the anchor. Ultimate pullout load  $P_{ult} = 1484$  kN.

No oscillations at all were observed for anchors 6A (Figs. 15a) and 7A (Fig. 16). No oscillation implies no slip at the thread, anchor-grout interface, so that the shear failure might occur at the grout-rock interface.

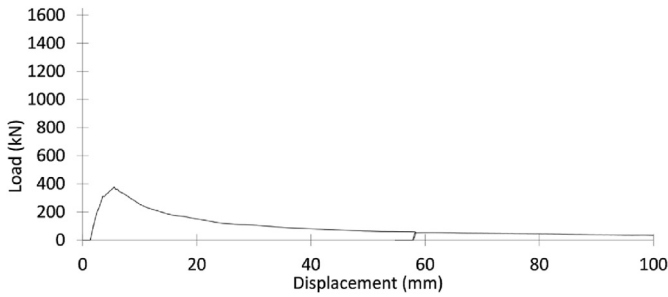
**Fig. 16.** Pullout load vs. displacement plot for anchor 7A: bond length 415 mm and  $W/C = 0.55$ . Ultimate pullout load  $P_{ult} = 377$  kN.

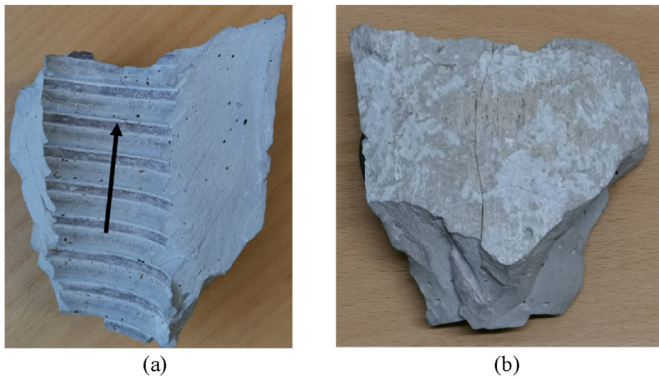
**Fig. 17.** A hardened grout fragment from anchor 7A that was pulled out of the borehole: (a) The side facing the anchor, and (b) The side facing the borehole wall. The arrow indicates the direction the anchor moved during the pull test.

Fig. 17 shows a hardened grout fragment after anchor 7A was pulled out of the borehole. The anchor thread was entirely cast in the mortar, as shown in Fig. 17a, indicating that the anchor-grout interface did not experience shear failure until the end of the test. Fig. 17b shows slick friction traces on the outer cylindrical surface of

the grout, implying that the grout column slid along the borehole wall. Therefore, the shear failure was on the grout-rock interface. It is inferred that the shear failure was mainly in the grout because the slick powder was dominated by grout cement, although limestone particles were also present. Hence, the shear strength of the grout-rock interface was decided by the strength of the grout.

Several parallel tiny fractures are visible on the rupture surface of the grout, as shown in Fig. 17a. The fractures started at the bottom of the anchor thread and propagated upward in the grout at an angle of around  $35^\circ$  to the anchor axis.

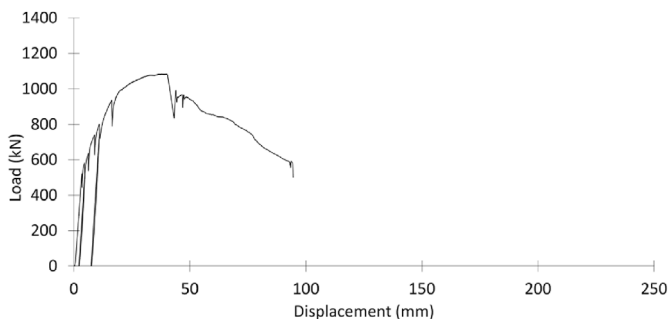
**Fig. 18.** Pullout load vs. displacement plot for anchor 1B: bond length 315 mm with debonding sleeve and  $W/C = 0.42$ . Ultimate pullout load  $P_{ult} = 1084$  kN.

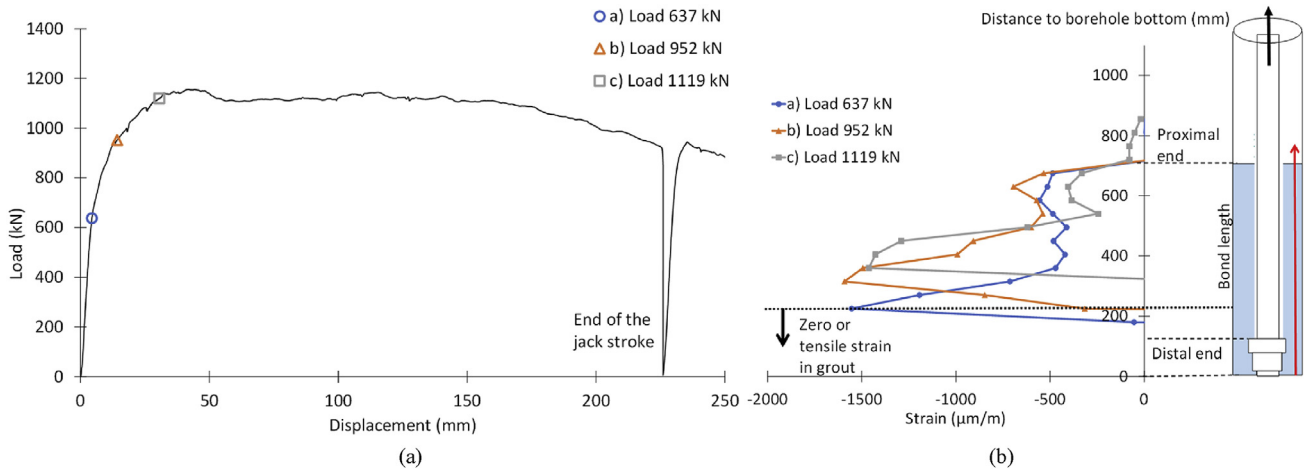
**Fig. 19.** Pullout test results for anchor 2B: bond length 560 mm with debonding sleeve and  $W/C = 0.42$ : (a) Load vs. displacement plot, and (b) Strain distribution in the grout column. The load drop at around 230 mm marks the end of the stroke of the jack. Ultimate pullout load  $P_{ult} = 1156$  kN.

from short to long bond lengths. The load drops in some of the B- and C-anchors at displacements around 220 mm, such as in Fig. 19a, were due to unloading at the end of the stroke of the jack. The anchor was reloaded after stroke adjustments. The load displacement in the second loading cycle is only partially shown in the figure.

The bond lengths of the other four B- and C-anchors, 2B, 3B, 2C and 3C, varied from 560 mm to 840 mm. These anchors behaved similarly in the post-peak stage, as shown in Fig. 19a, 20a and 23a and 24a. The load remained slightly smaller than the ultimate load for a long displacement after passing the ultimate load. In other words, these anchors were tough. All the B- and C-anchors failed at the grout-rock interface along the borehole wall. It was observed in the field that the grout columns were pulled and slid along the borehole during the tests. When anchors 1B and 1C were excluded, the mean grout-rock bond shear strengths of the remaining four B- and C-anchors for the grout with  $W/C = 0.42$  were similar, varying from 3.71 MPa to 4.69 MPa with a mean value of 3.97 MPa, as shown in Tables 5 and 6. The mean grout-rock bond strengths in Tables 5 and 6 are not based upon pure shear between the grout and rock, and they also include some crushing of the grout. The mean bond strength was 6.56% of the UCS of the grout (60.5 MPa).

The strains in the grout columns of anchors 2B and 3B were measured by FBGs. The load was transferred directly to the endplate because the anchoring thread was debonded by the sleeve. The pull load in the anchor stem was converted to compressive load in the grout column via the plate at the distal end of the anchor, and the grout column was pushed upward. The load was then transferred to the rock mass at the grout-rock interface. The variation of the compressive load in the grout column represents the distribution of the shear stress to the grout-rock interface along the borehole length and manifests where the anchor load is transferred to the rock mass. Theoretically, the measured strains can be converted to stress or load by Hooke's law, but bias could be generated when the grout fractured and was no longer a linear elastic medium and there are some uncertainties in the measurements related to FBG fibres. The grout in the borehole was fractured, at least in the proximity of the endplate. Because of that consideration, the measured strains are directly presented in Fig. 19b and 20b for

Strains in the grout column were measured for the debonded B-anchors 2B and 3B. The negative strains presented in Figs. 19b and 20b meant that the grout columns were subjected to compression. The axial compressive stress in the grout could be estimated from the measured strains according to the Hooke's law. It is seen in Fig. 20b that the curves of the strain are zigzag along the grout column possibly because of the sensitivity of the optical fibres which will be discussed in Section 4.5. In general, the compressive strain in the grout was the largest in a location slightly above the endplate. It then trended to attenuate toward the top of the grout

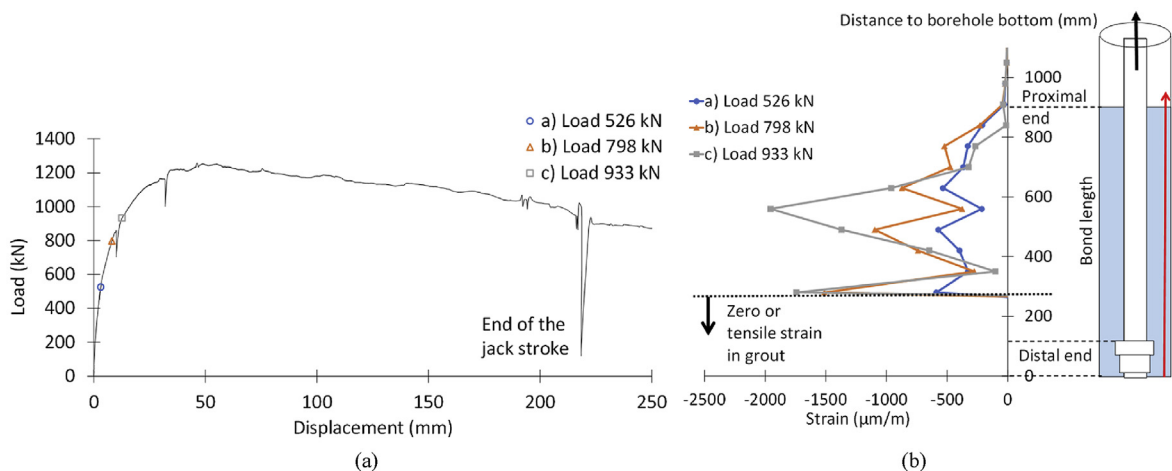
**Fig. 20.** Pullout test results for anchor 3B: bond length 770 mm with debonding sleeve and  $W/C = 0.42$ : (a) Load vs. displacement plot, and (b) Strain distribution in the grout column. The load drop at around 220 mm marks the end of the stroke of the jack. Ultimate pullout load  $P_{ult} = 1257$  kN.

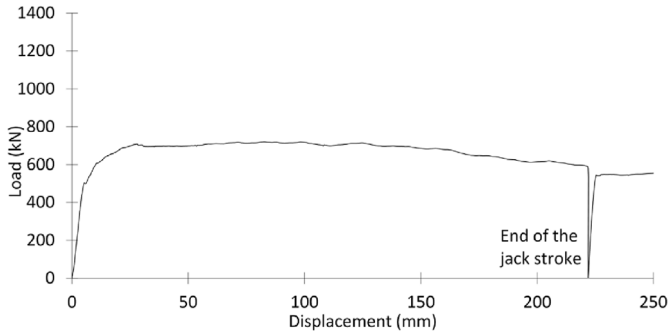
**Fig. 21.** Pullout load vs. displacement plot for anchor 4B: bond length 435 mm with debonding sleeve and  $W/C = 0.55$ . The load drop at around 220 mm marks the end of the stroke of the jack. Ultimate pullout load  $P_{ult} = 720$  kN.

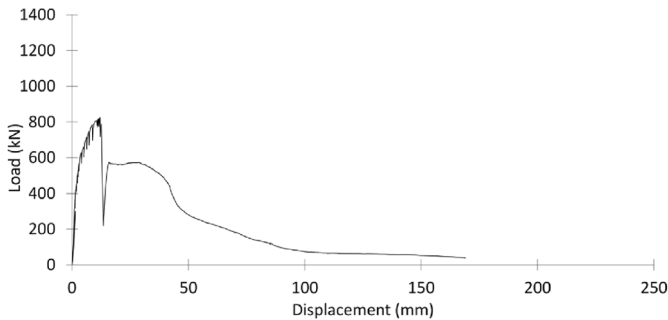
**Fig. 22.** Pullout load vs. displacement plot for anchor 1C: bond length 280 mm without debonding sleeve and  $W/C = 0.42$ . Ultimate pullout load  $P_{ult} = 826$  kN.

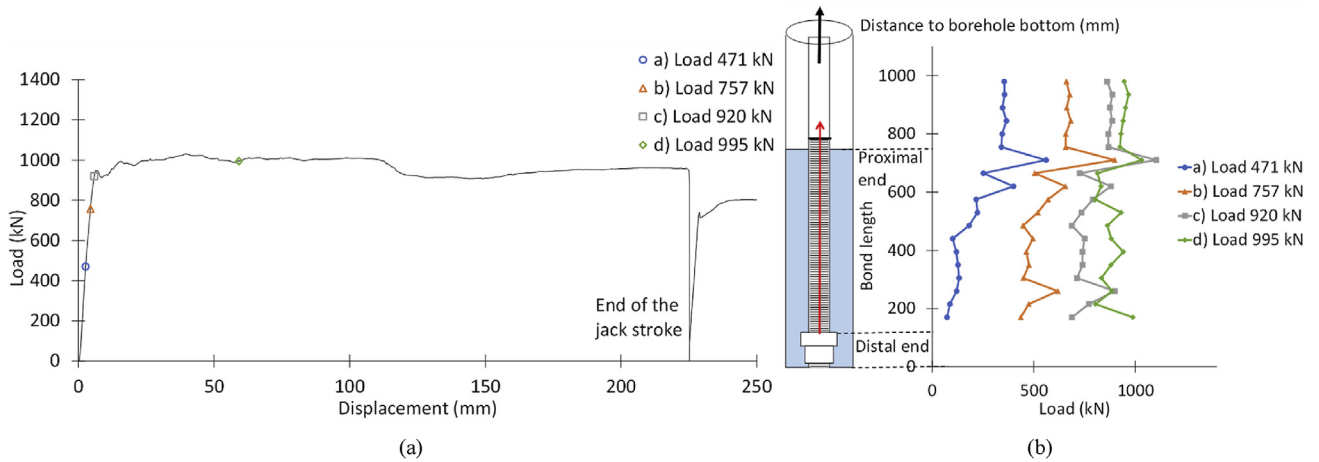
**Fig. 23.** Pullout test results for anchor 2C: bond length 625 mm without debonding sleeve and  $W/C = 0.42$ : (a) Load vs. displacement plot, and (b) Load distribution along the anchor. The load drop at around 220 mm marks the end of the stroke of the jack. Ultimate pullout load  $P_{ult} = 1031$  kN.

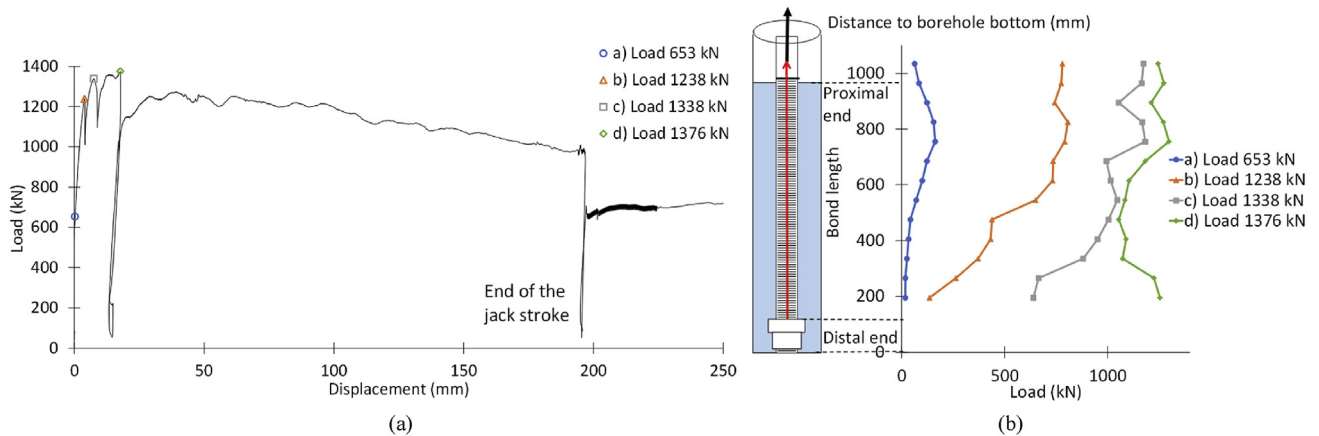
**Fig. 24.** Pullout test results for anchor 3C: bond length 840 mm without debonding sleeve and  $W/C = 0.42$ : (a) Load vs. displacement plot, and (b) Load distribution along the anchor. The load drop at around 200 mm marks the end of the stroke of the jack. Ultimate pullout load  $P_{ult} = 1376$  kN.

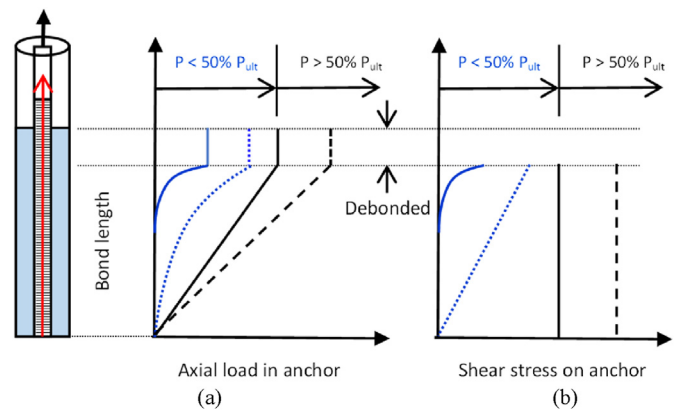
**Fig. 26.** Models for the axial load in the anchor (a) and for the shear stress on the anchor surface (b) (i.e. the anchor-grout interface) for A-anchors.

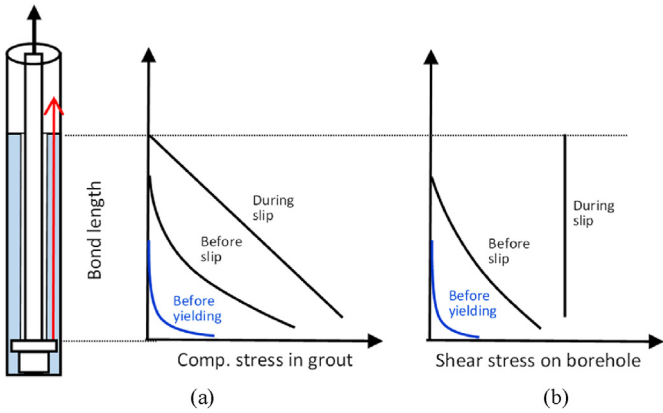
Fig. 27. Models for the compressive stress in the grout (a) and for the shear stress on the borehole wall (b) (i.e. the grout-rock interface) for the B-anchors.

stress on the borehole wall are schematically sketched in Fig. 27. The axial stress is the largest close to the endplate and decreases toward the top of the grout column. The variation of the compressive stress is nonlinear at the elastic deformation stage, but it becomes linear when the column starts to slip along the borehole wall (Fig. 27a). The shear stress on the borehole wall, or on the grout-rock interface, is then constant during slippage (Fig. 27b). The absolute value of the constant shear stress during slippage

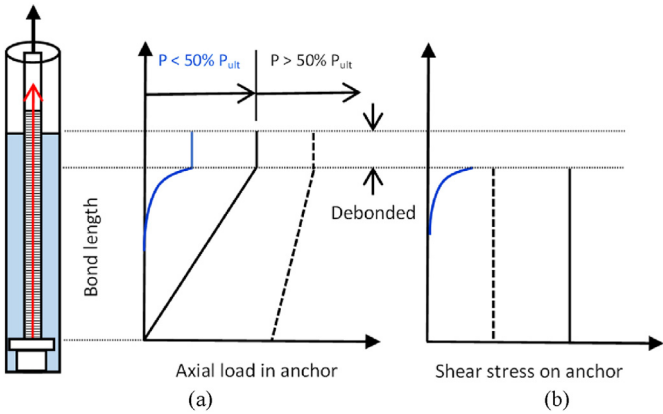
Fig. 28. Models for the axial load in the anchor (a) and the shear stress on the anchor surface (b) (i.e. the anchor-grout interface) for the non-debonded C-anchors.

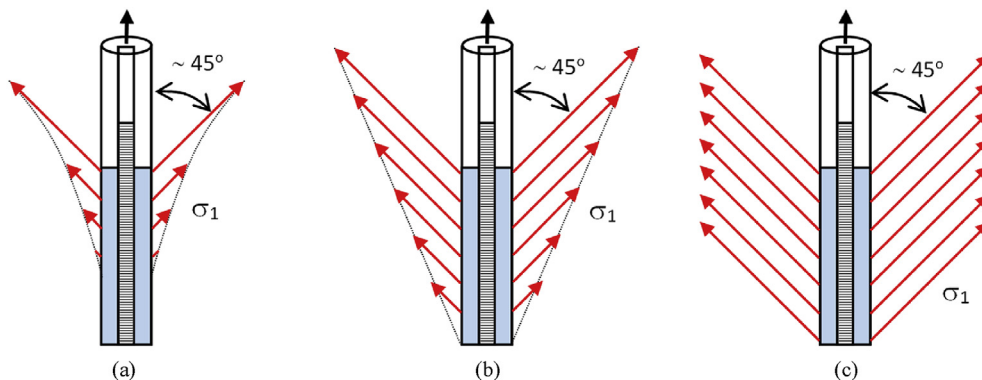
Fig. 29. Load-transfer patterns when the applied load is (a)  $P \ll 50\% P_{ult}$ , (b)  $P \approx 50\% P_{ult}$ , and (c)  $P = P_{ult}$  and at the post-peak stage for A-anchors.

Ultimately, the anchor load transferred to the rock mass. The load-transfer patterns of the two types of anchors are illustrated in this section based on the test results from this study. Fig. 29 shows the models for the load transfer in the A-anchors in three loading stages. The load transferred to the rock mass at the grout-rock interface was the largest at the top of the bond length and attenuated approximately exponentially toward the distal end of the anchor when the applied load was very low, as shown in Fig. 29a. The entire bond length was mobilised to carry the load, and the load distribution decreased linearly when the applied load was approximately 50% of the ultimate load. The load distribution became uniform along the grout-rock interface when the grout column started to slip along the borehole wall (Fig. 29c). Under the axial pull load of the anchor, the stress state on the borehole wall is dominated by shear stress because the grout dilation is little and the dilation-induced normal stress is very low. With such a stress state, the major principal stress  $\sigma_1$  transferred to the rock mass orients in an upward direction of approximately  $45^\circ$  to the borehole axis.

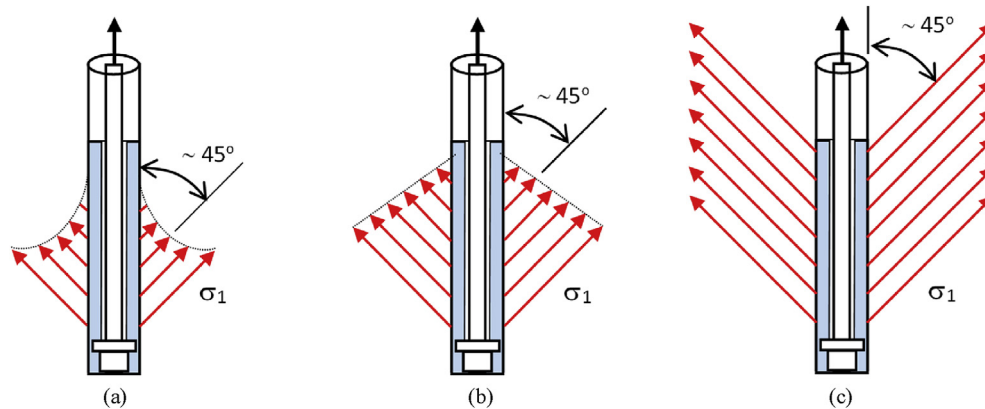
Fig. 30. Load-transfer patterns when the applied load is (a)  $P \ll 50\% P_{ult}$ , (b)  $P \approx 50\% P_{ult}$ , and (c)  $P = P_{ult}$  and during slippage of the grout column for B- and C-anchors.

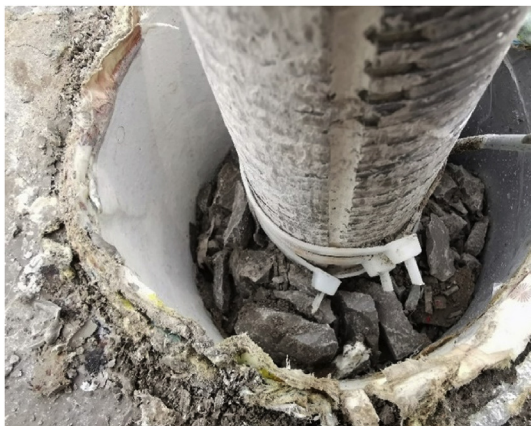
Fig. 31. Crushed grout in the borehole of anchor 3C after the endplate slid approximately 580 mm.

Fig. 31 shows the crushed grout in the borehole of anchor 3C after the endplate anchor was displaced upward by 580 mm. The grout was heavily fragmented, but the anchor was still carrying around 400 kN in this damaged state, which must be attributed to the normal stress on the borehole wall, which was induced by the dilation of the grout.

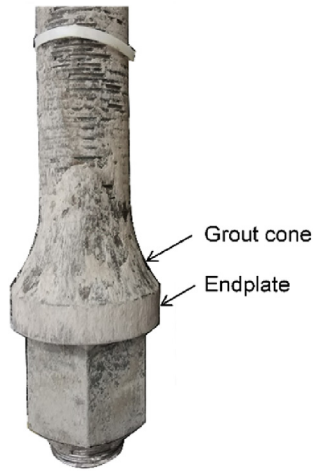
Fig. 32. The grout cone formed above the endplate of a C-anchor after pullout of the anchor.

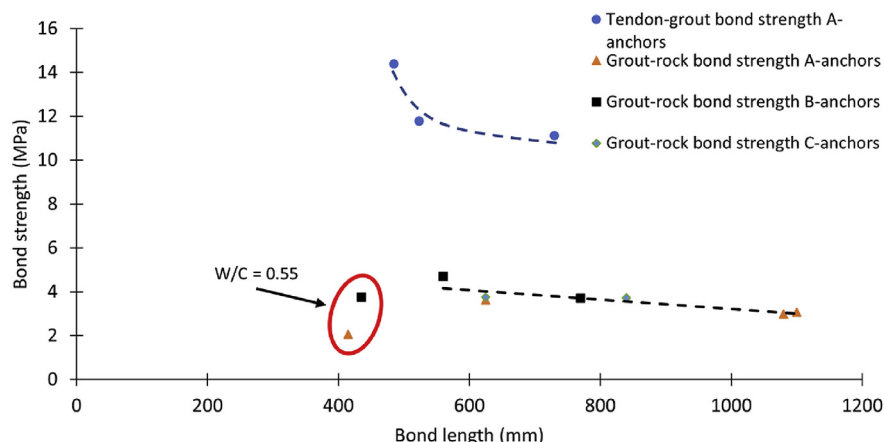
Fig. 33. Bond strength plotted against bond length for the valid tests.

anchors and 6.56% for the four B- and C-anchors. The bond strengths obtained for the B- and C-anchors were slightly larger than those for the A-anchors (Fig. 33), possibly because of the greater dilation normal pressure induced by the grout cone in the B- and C-anchor tests. The bond shear strength on the grout-rock interface was also scale-dependent, but the scale effect was very weak, as shown by the black dashed line in Fig. 33. The current rock anchor design uses 10% of the UCS of the rock for the bond strength of the grout-rock interface (Littlejohn, 1992). The failure in this study was not necessarily in the rock but could have occurred in the grout, as appeared in the tests of our study. It is not always appropriate to estimate the bond strength from the UCS of the rock, as suggested by Littlejohn (1992). Based on the test results in our study, a reasonable bond shear strength is approximately 5% of the UCS of the grout or rock, whichever is weaker.
