# A Journey in Architecture.

Resource exploitation in Cuba and Norway

Faculty of Architecture and Design  
At the Norwegian University of Science and Technology  
Department of Architecture and Planning  
Master in Architecture  
Submitted: 27.05.2020

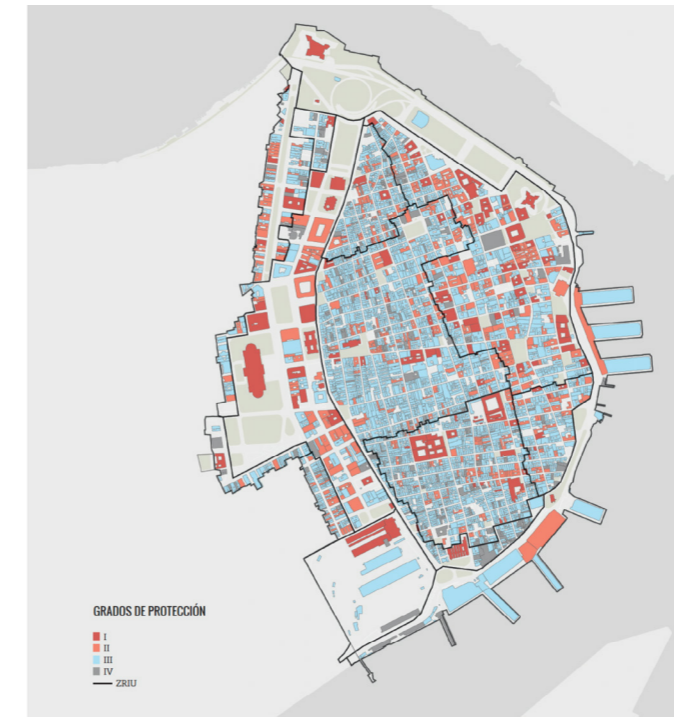
Figure 4: Old Havana and its building distribution of protection degrees

palities, has an area of 2,14 km<sup>2</sup> with 3.500 buildings from different periods. Just over 500 buildings are classified with a degree of protection I and II, associated with the highest patrimonial value, while another 2.500 are classified with degree of protection III, and define the harmonic landscape of the urban complex. Only one third of this heritage is considered to be in good technical condition, and in recent decades the number of buildings in poor and critical condition has increased, which constitutes a challenge for their conservation.

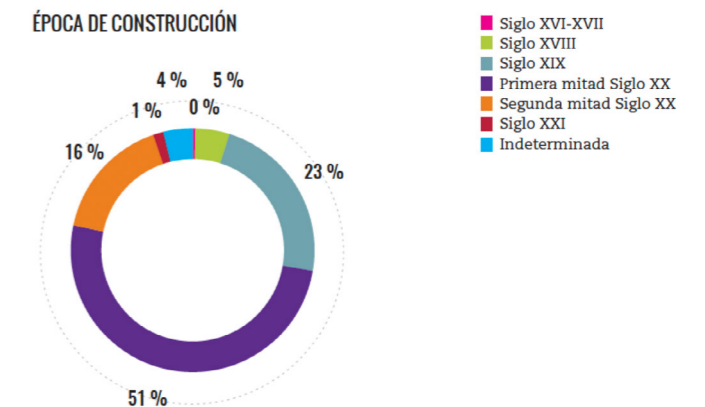
Figure 5: Percentage of buildings within different eras

The 3.500 properties that make up the historic center belong to different eras and styles. Domestic architecture constitutes the bulk of the building stock – more than 80% of the buildings – and reflect the stylistic influences of various periods. Buildings between one and three levels with high ceilings predominate, with some exceptions. This also applies to the high compactness of the urban fabric, conditioned in the past, and to the presence of the inner courtyard, which is very distinctive of Cuban colonial architecture in the different architectural typologies among which the domestic and mixed typologies stand out. The building typology we refer to as “mixed” is divided between a domestic upper part and commercial or service premises on the ground floor, is typical for corners and the historically commercial streets.

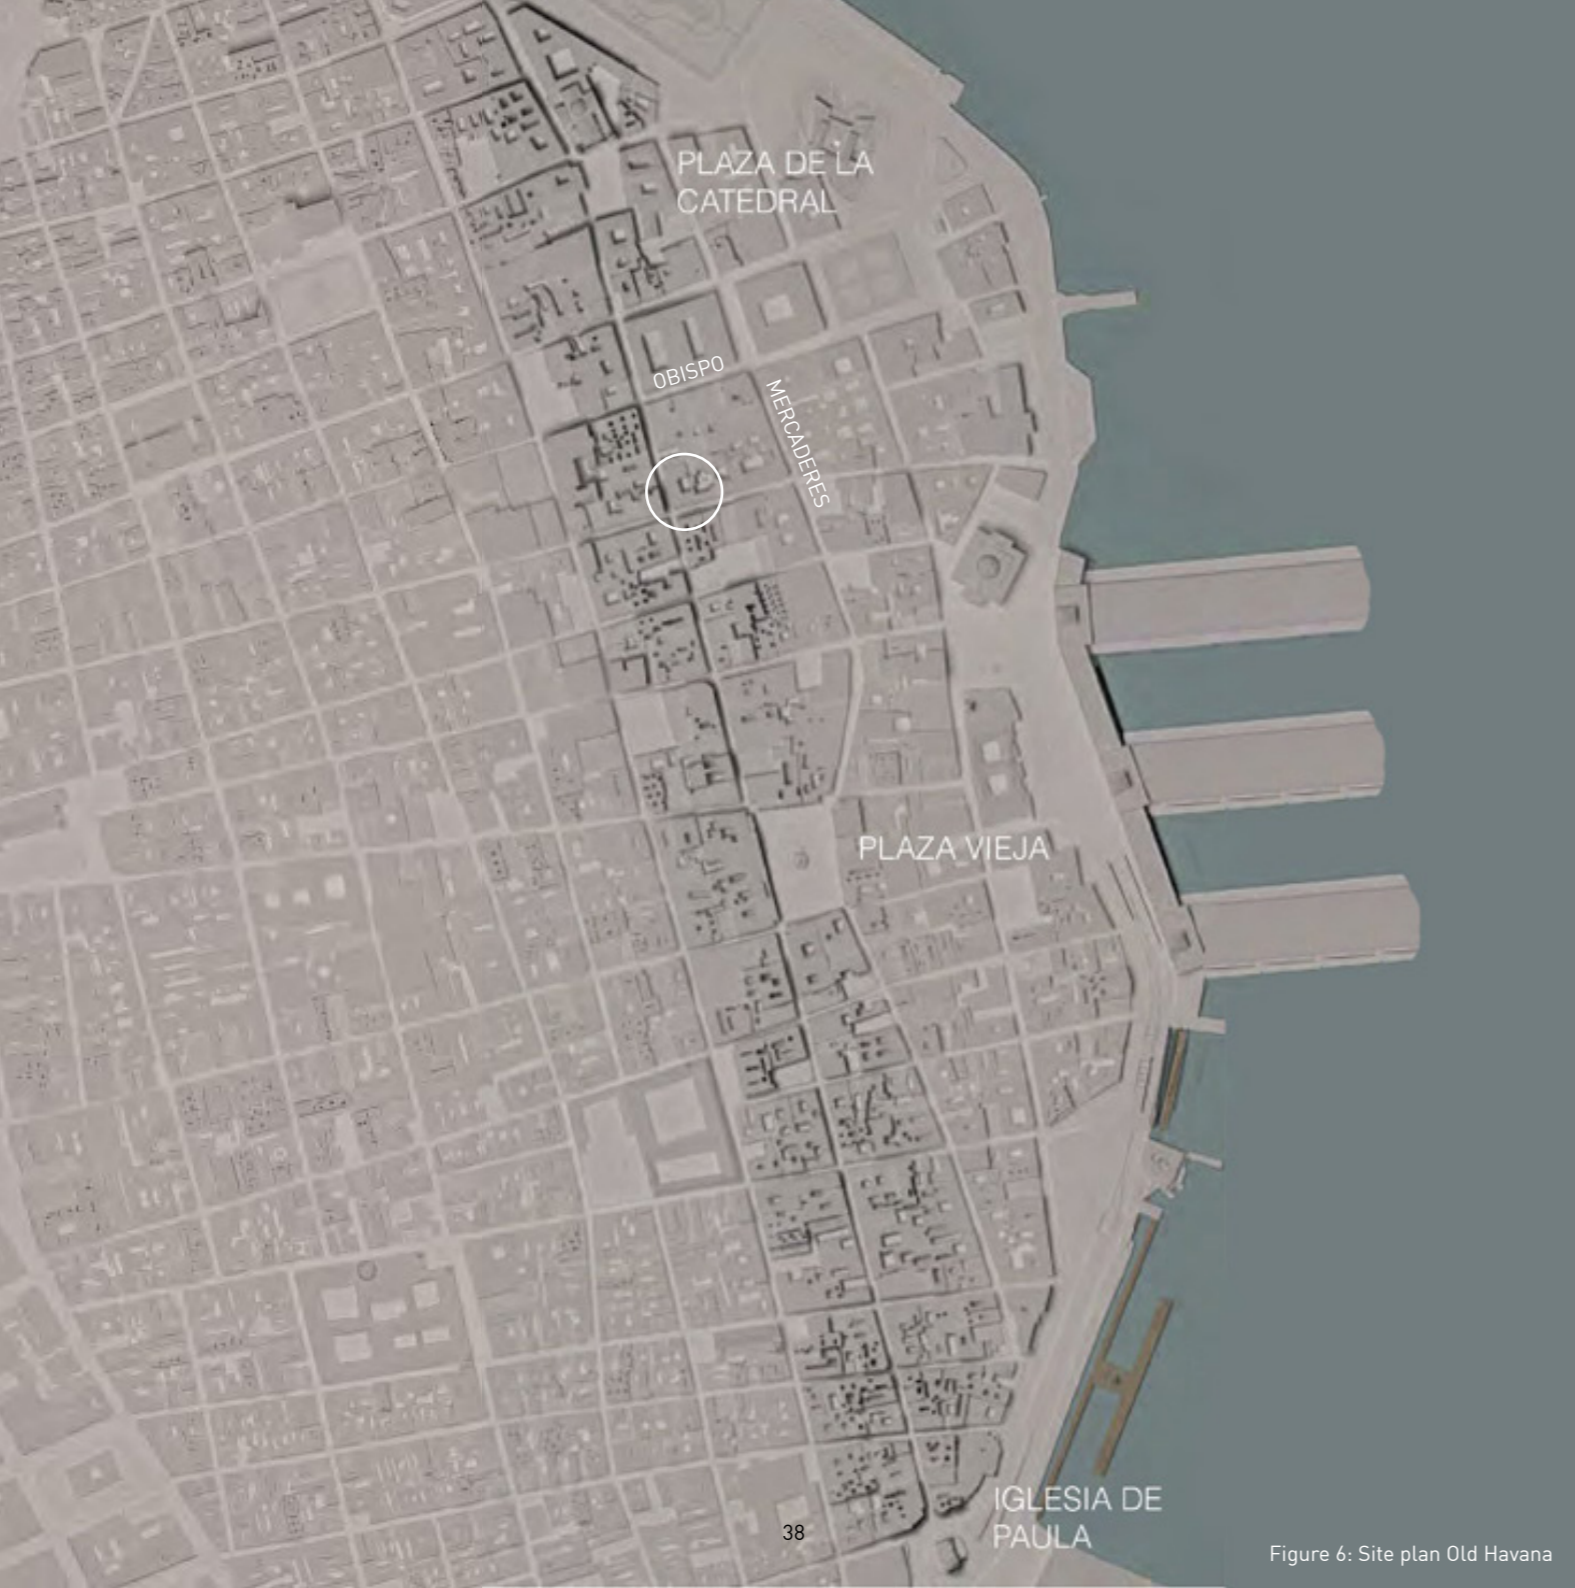
Figure 6: Site plan Old Havana

Casa Don Gaspar Riveros de Vasconcelos is situated on the corner of Obrapia and Calle San Ignacio. This building is the site of our project, where we have collaborated with a Cuban architectural office, RESTAURA, under Oficina del Historiador. Following their method we have gathered information through archives for historic documents regarding the building, and performed inspections: to understand its history, context, constructive and technological state as well as its patrimonial heritage, before designing a conceptual project based on these premises, to demonstrate and highlight how their processes contribute to a project design.

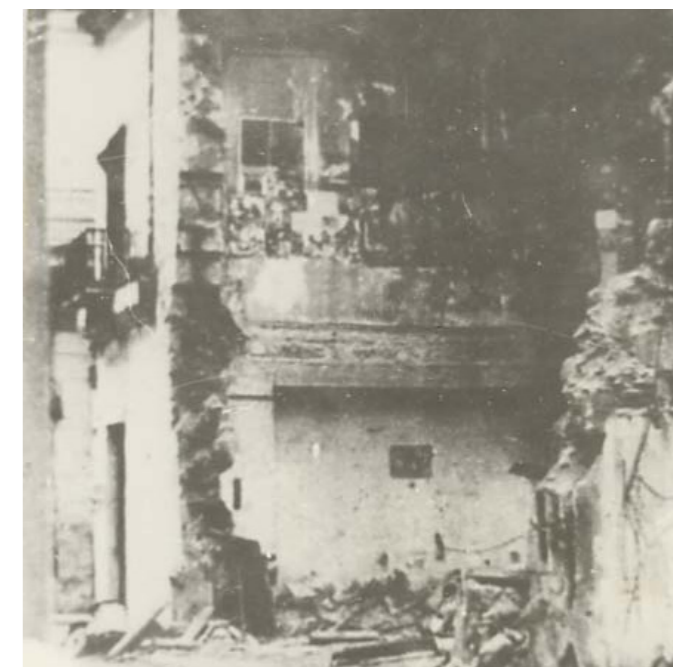
Picture 4: After the Hurricane Frederick

The building as a whole did not undergo substantial interventions until 1979, when, as a result of the torrential rains caused by Hurricane Frederick, parts of its bays were damaged, and would be rebuilt and restored years later.

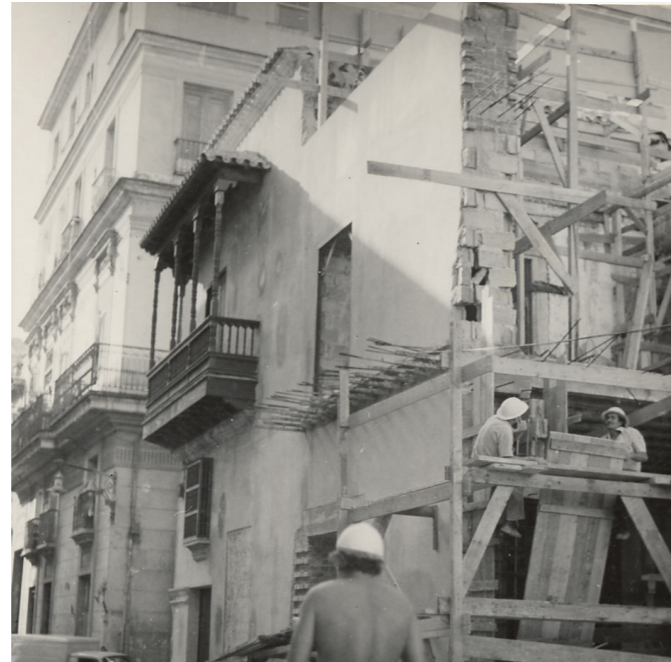
Picture 5: Restoration in the 1980s, facade

Between 1982 and 1986 a restoration process began aiming to reconstruct the old house as it looked in colonial times, based on a thorough historical and documentary study, directed by the Architect Jaime Rodríguez. This restoration covered the building in its entirety, including the reconstruction of elements such as the facade helped by old pictures. The same happened with the balconies and the entrance (with the participation of the sculptor René Palenzuela). The first floor of the building was proposed to function as accommodation for FMC members from other provinces visiting to participate in activities related to the organization.

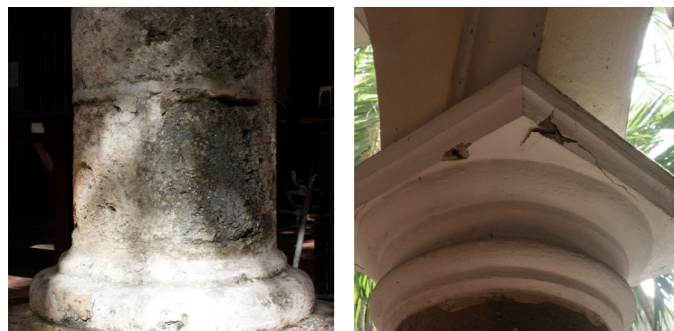
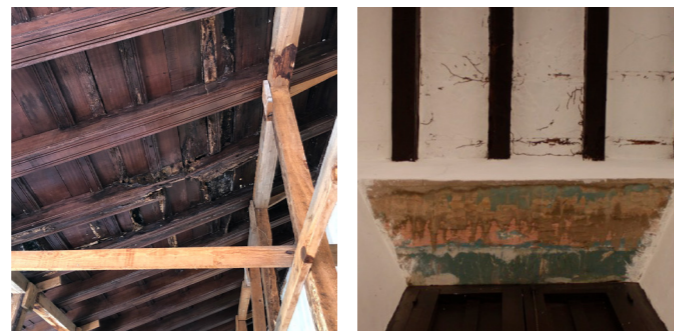
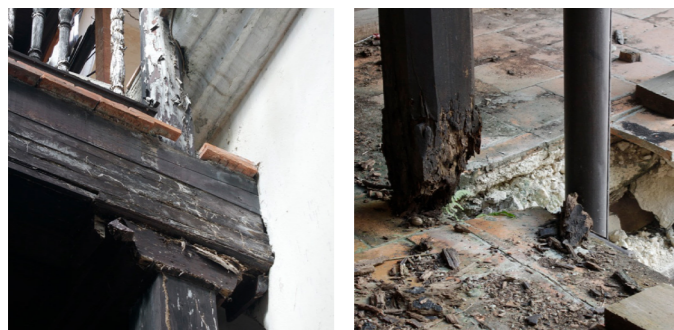
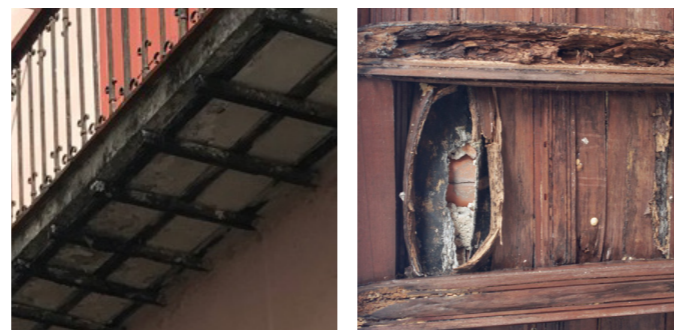
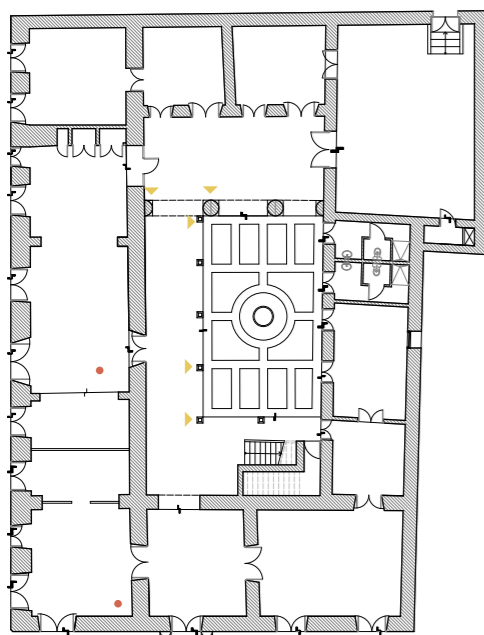
Ground floor

Damage: Breakage cracking in the concrete slab, often leaving the internal structure or filling exposed.

Possible causes: poor quality of material, structural overload, impact and lack of maintenance

Damage: Irregular spots in white, presence of basidiomycete funghi.

Possible causes: inadequate selection of the wood, lack of preventive treatment of the wood, lack of adequate ventilation and sunlight, presence of humidity, exposure to water and lack of maintenance.

Damage: attack by xylophagous agents. Defibrations, holes, loss of profile and presence of underground termite tunnels in the wooden elements are observed.

Possible causes: exposure to moisture over prolonged periods due to leaks, inadequate selection of the wood used for structural elements, lack of preventive treatment of the wood, lack of adequate ventilation and lack of maintenance.

Damage: rot at the base or at the capital of the columns. Segregation of the constituent components of the wood, softening, or rot is observed, which causes the element to lose its structural properties.

Possible causes: high levels of concentrated humidity, a product of leaks from the roof, or leaks from the facilities, poor ventilation, sun exposure, weathering, poor selection of wood, insects and fungi, and lack of maintenance.

Damage: Disintegration and chipping, A deformation or detachment of the mortar or coating is observed. In some cases, cracks appear in several directions.

Possible causes are: shrinkage of the mortar that generally has a greater modulus of elasticity than the material of the wall, presence of excessive moisture, lack of adhesion between support and cladding, poor execution of the cladding, poor dosing of the cladding, aggression of atmospheric agents and lack of maintenance.

Repair: structural

Repair: structural.

Repair: non-structural.

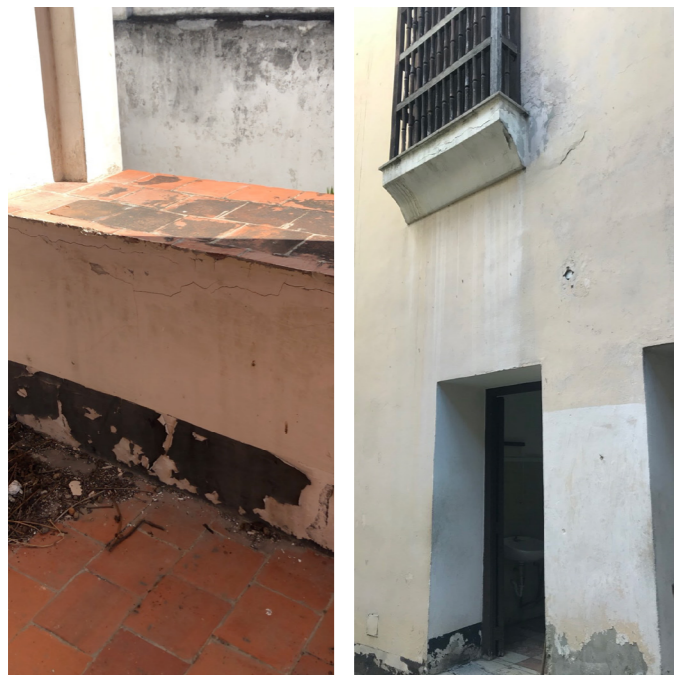
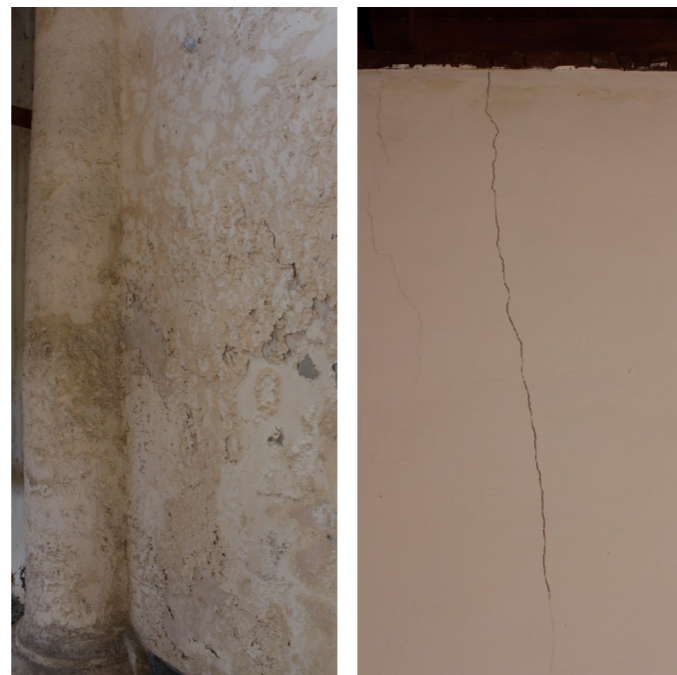
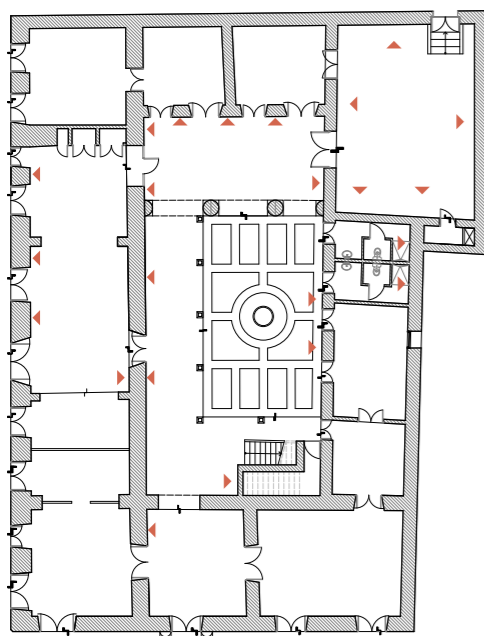
Ground floor

Damage: Disintegration and chipping, A deformation or detachment of the mortar or coating is observed. In some cases, cracks appear in several directions.

Possible causes: shrinkage of the mortar that generally has a greater modulus of elasticity than the material of the wall, presence of excessive moisture, lack of adhesion between support and cladding, poor execution of the cladding, poor dosing of the cladding, aggression of atmospheric agents and lack of maintenance.

Damage: horizontal cracks. Horizontal cracks are visible in the structure. They were found in load-bearing walls close to the floor slab or ceiling, especially under windows.

Possible causes: error in the design or execution of transition elements between elements of different natures i.e. wall to steel elements, eccentric loads and flexion compression of floor slabs or roofs, lateral thrusts, absence of an enclosure element, poor design or execution thereof.

Damage: inclined cracks. Inclined cracks are seen in the elements that in some cases follow the path of the joints of the elements that make up the wall, forming stairlike patterns.

Possible causes: differential settlement of the foundation, lateral forces from arches, vaults, frame-support roof structures: the materials that make up the wall have low resistance, concentrated loads greater than the resistance capacity of the wall, presence of higher floors.

Damage: vertical cracks. Vertical cracks are seen in the lower or upper center of the wall, with the largest opening in one direction or the other. They are usually accompanied by inclined cracks normal to the direction of traction. They also usually appear at the junction between two walls or other construction elements.

Possible causes: roots, incorrect mechanical union, presence of metallic elements affected by corrosion, thermal movement, forces from the ground

Repair: non-structural.

Repair: structural

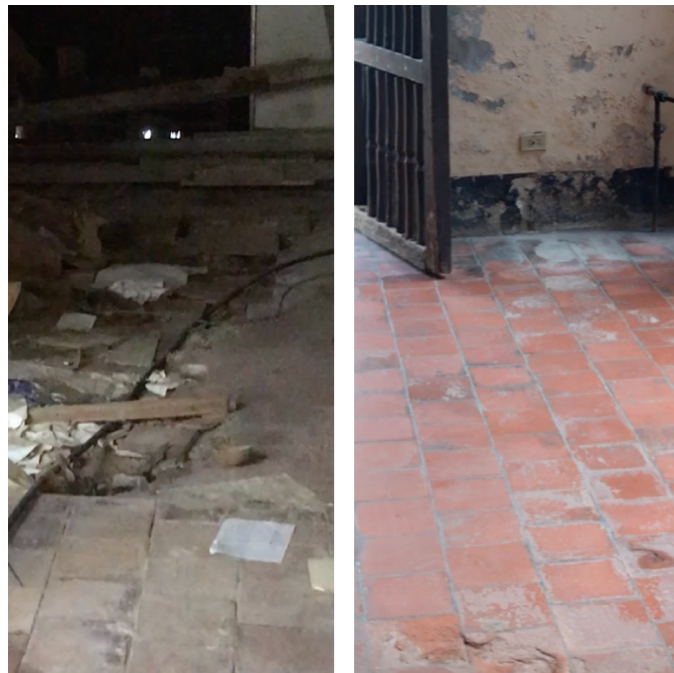
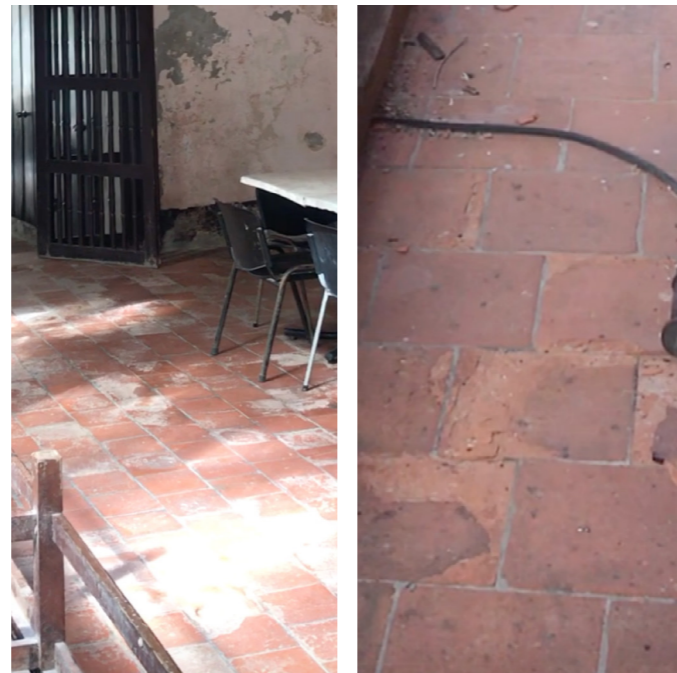
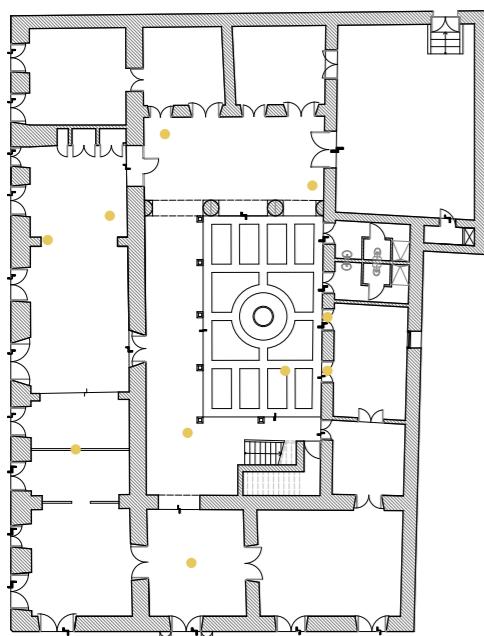
Ground floor

Damage: Wear on the edges of the pavement and flooring or the loss of them due to cracking. In the center of the Zaguán flooring is missing.

In a building the floors are one of the most important elements when it comes to the finished look and image as it provides both hygienic aspects as well as beauty. Floors supports its own weight, the weight of interior and of the people moving around using the building space.

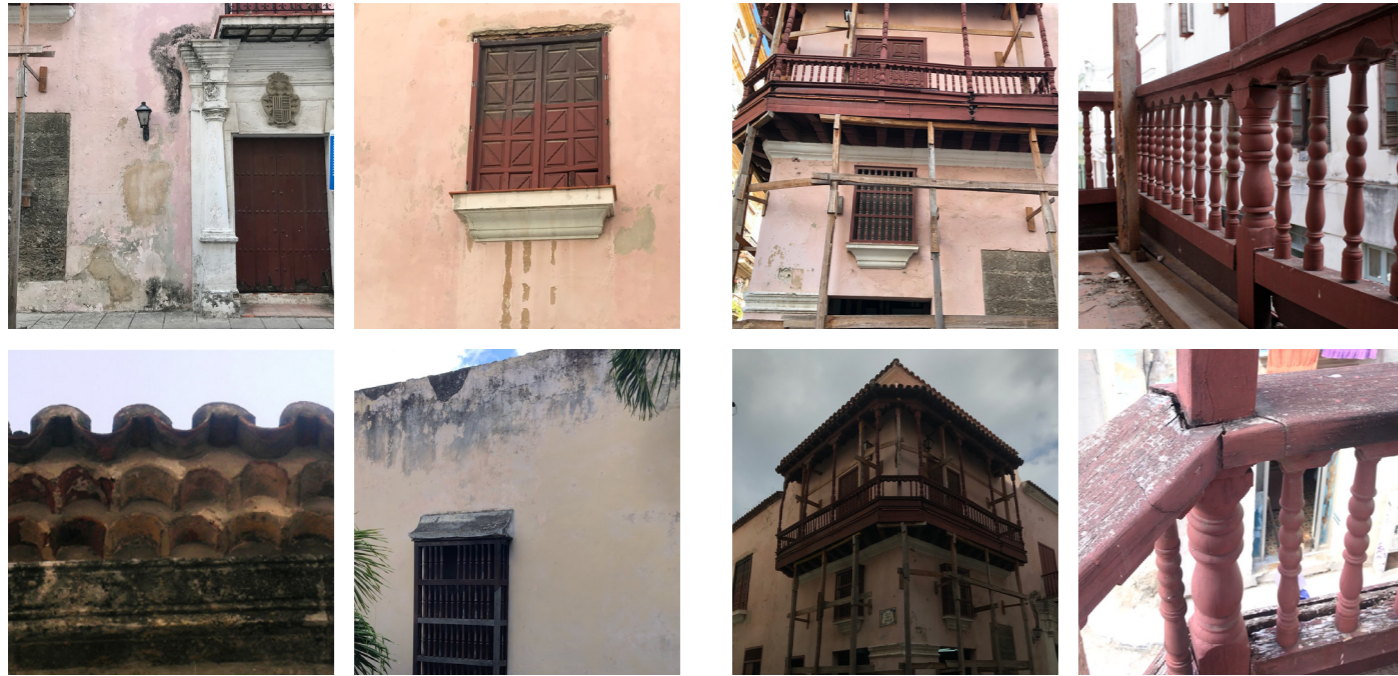
## Balconies

### Wood rot

Possible causes: humidity, poor quality of materials, errors in execution and lack of maintenance.

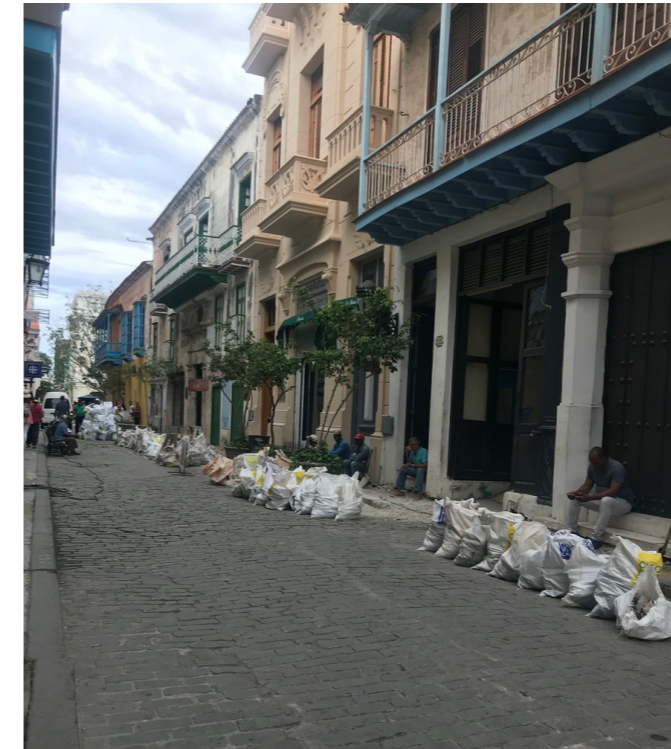
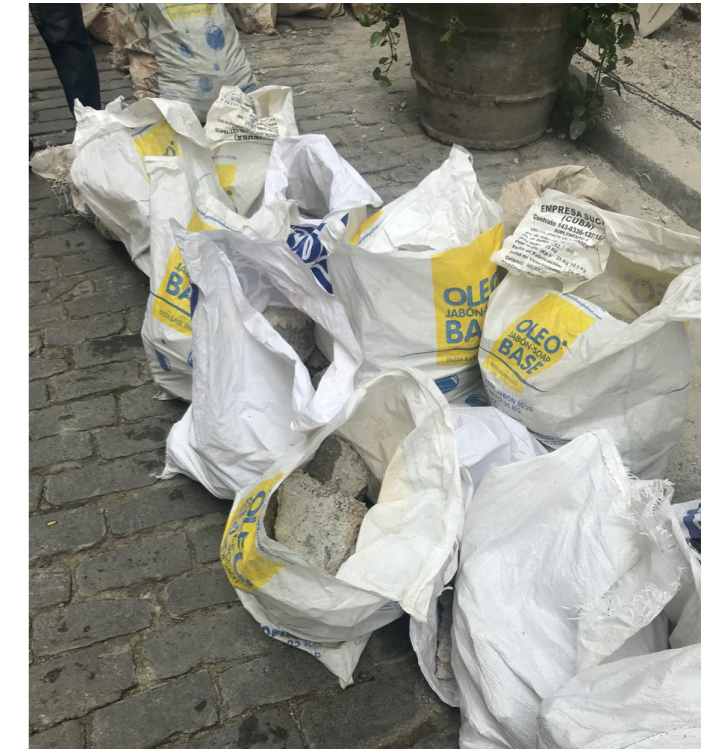
In an interview with the Investment directorate we learned that they try to reuse every material that has patrimonial value, including all ironwork, carpentry, wooden beams, and stones used in staircases. The careful extraction of materials does not only apply to patrimonial valued elements, they also extract any other materials they come by in good condition, everything from tiles and bricks to the frames around and on windows.

When the process of disassembling the building starts, they have specialized people come in to do the job, having knowledge on what can, and what cannot be reused or recycled. This ensures that the building is disassembled in the best possible way so that as much as possible is reusable (Appendix B). The technical checks of the materials take place during this phase and are done by experts (Appendix C). This reuse or recycling normally happens directly on the building site, but sometimes parts from another house can be found - already having been reused. If this is the case, and the other building is also under restorations they will, if possible, bring it back to its original location (Appendix B).

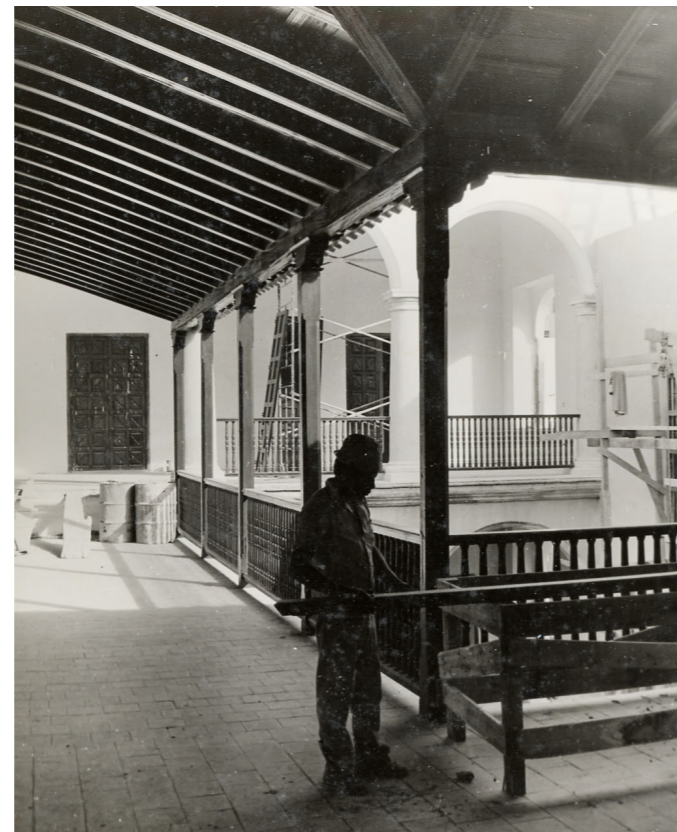
Picture 7: Restoration in the 1980s, gallery

by important community families, and the fact that the restorations performed in the 1980s after the cyclone were based on previous drawings and pictures of the property contributes to the building possessing the "Degree of protection II".

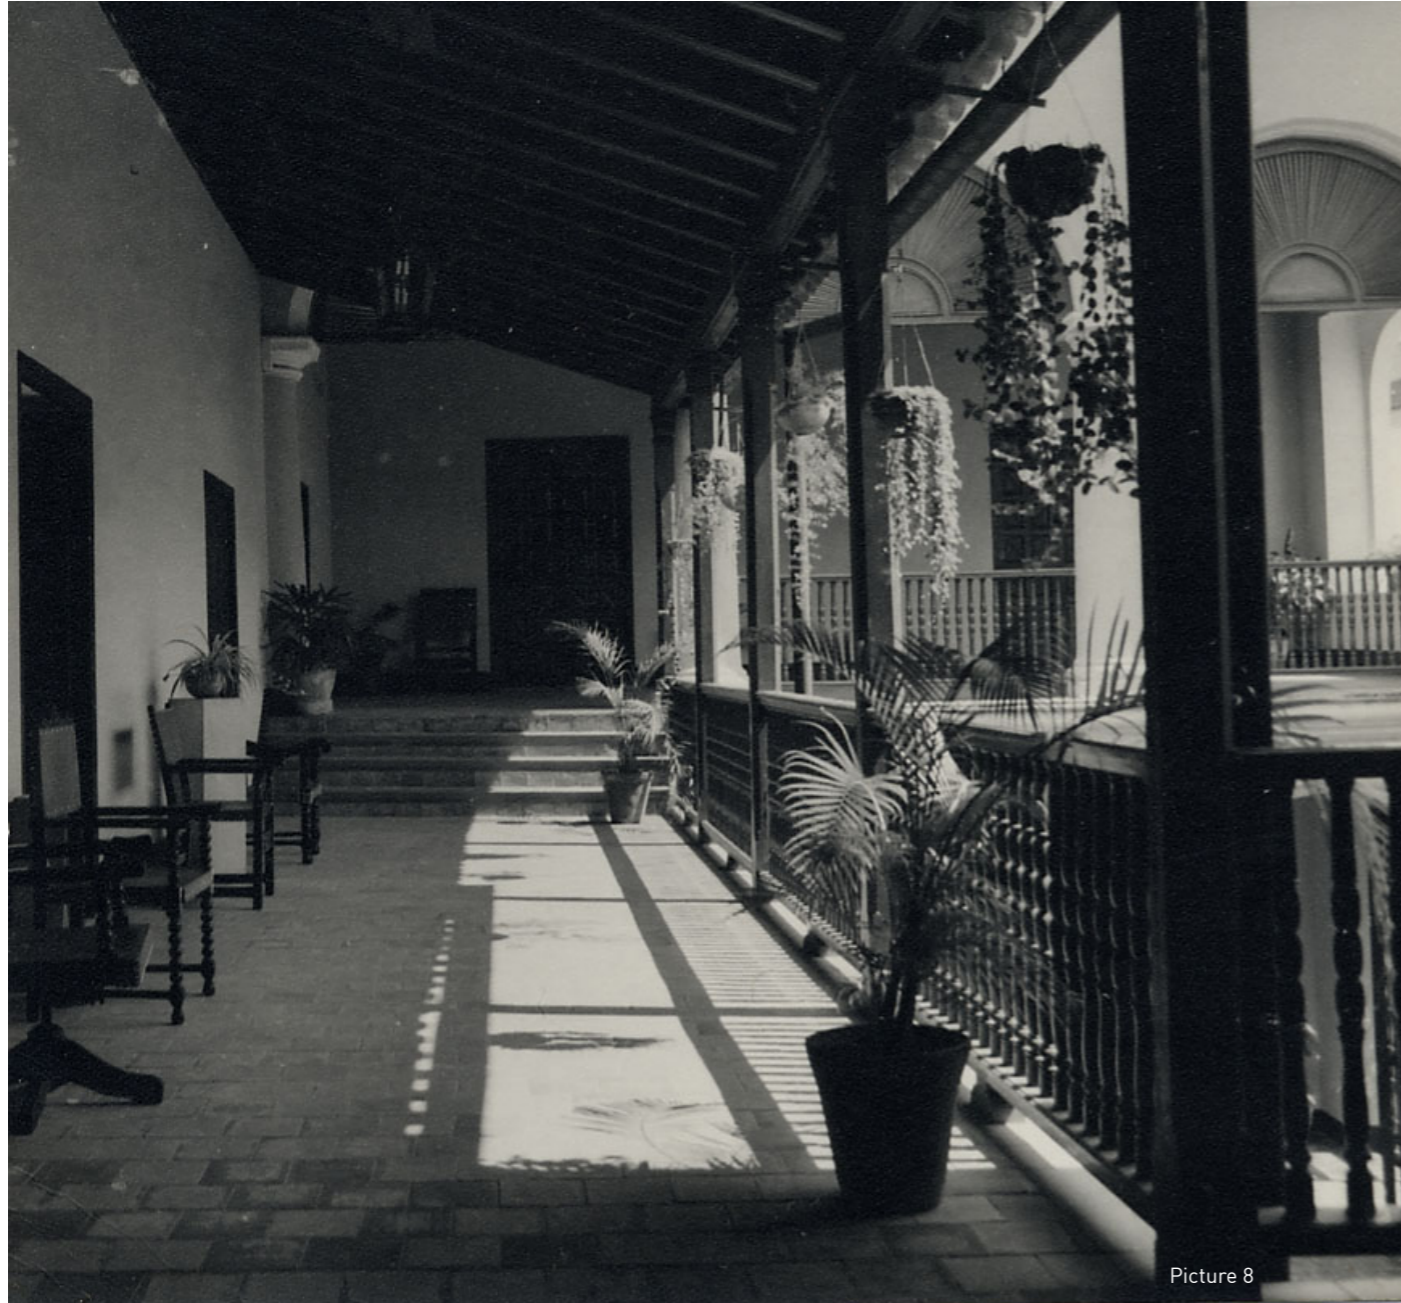
Picture 8

These are the current floor plans of Casa Don Gaspar Riveros de Vasconcelos. The historical main entrance of the building, called a Zaguán (a roofed entryway, especially one leading to the patio or courtyard of a house) lies in Obrapia Street, next to the corner unit. Today both this entrance and its adjacent room along Obrapia is completely closed from the outside. They are not in use due to decay and have become disposal areas. Today they use the multiple entrances along Calle San Ignacio to access the building. The room located farthest north in Calle San Ignacio is currently a small shop. The next rooms are used for meetings and workshops by the Quitrin organization, and the corner is a hair and nail salon only separated from the rest by partition walls. It is apparent that this part of the building has earlier been divided by thick walls into various smaller sections. The room in the corner volume, having doors opening to both streets, was historically intended, and used as a store.

The courtyard in the center of the building can be seen through the complex and had a direct link through the Zaguán that today is lost. This courtyard is, as mentioned in Chapter III, typical for Cuban Colonial architecture. It has a gallery supported by octangular wooden posts crowned by capitals. It is evident from their character that these galleries are among the oldest parts of the building. Unfortunately, as a result of the high degree of deterioration of the wooden construction, the wooden galleries are currently held up by scaffolding. The back gallery (the northern volume), formed by three arches supported by thick Tuscan columns, is more modern. Historically the ground floor of this volume was most likely used for stable purposes accommodating horses and carriages that could enter

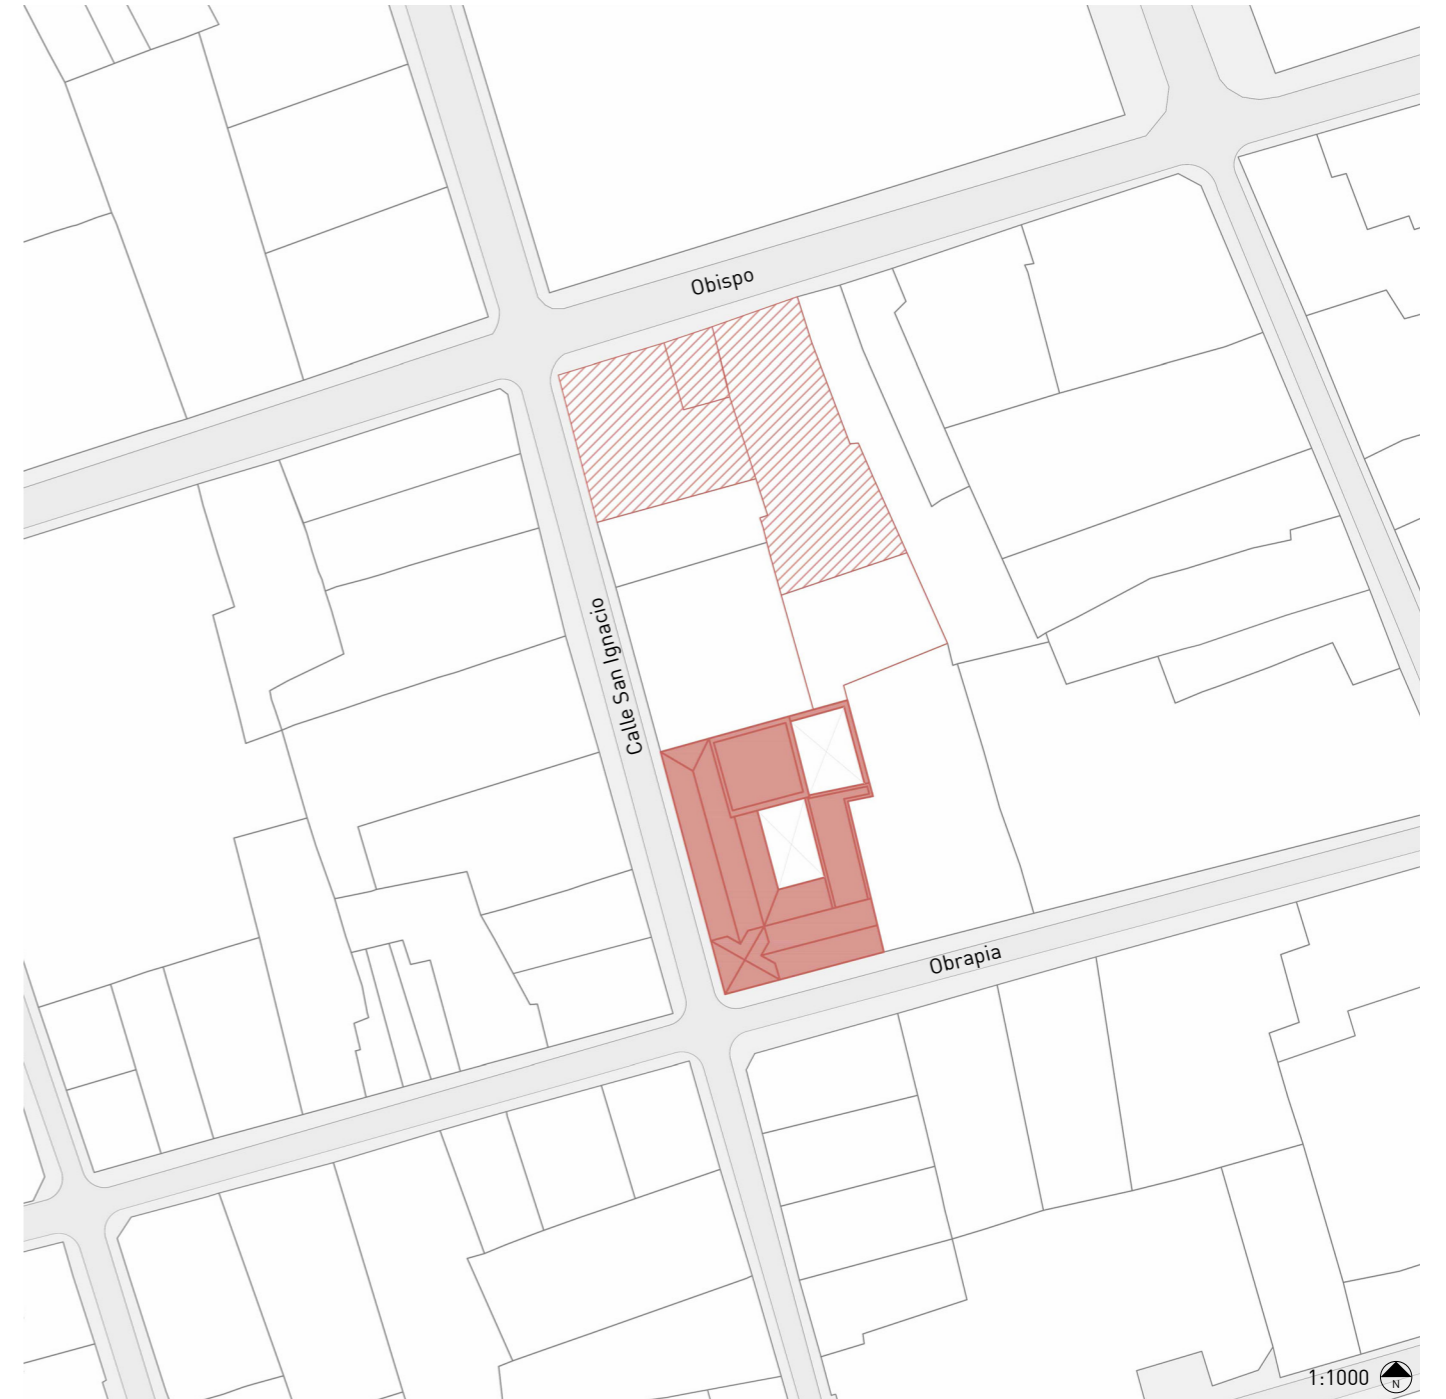
## Current situation

through the Zaguán. Today the rooms in this volume are used for storage and the archway as a passageway since it connects to Quitrin's other building through a backyard. The eastern volume is vacant but contains bathrooms.

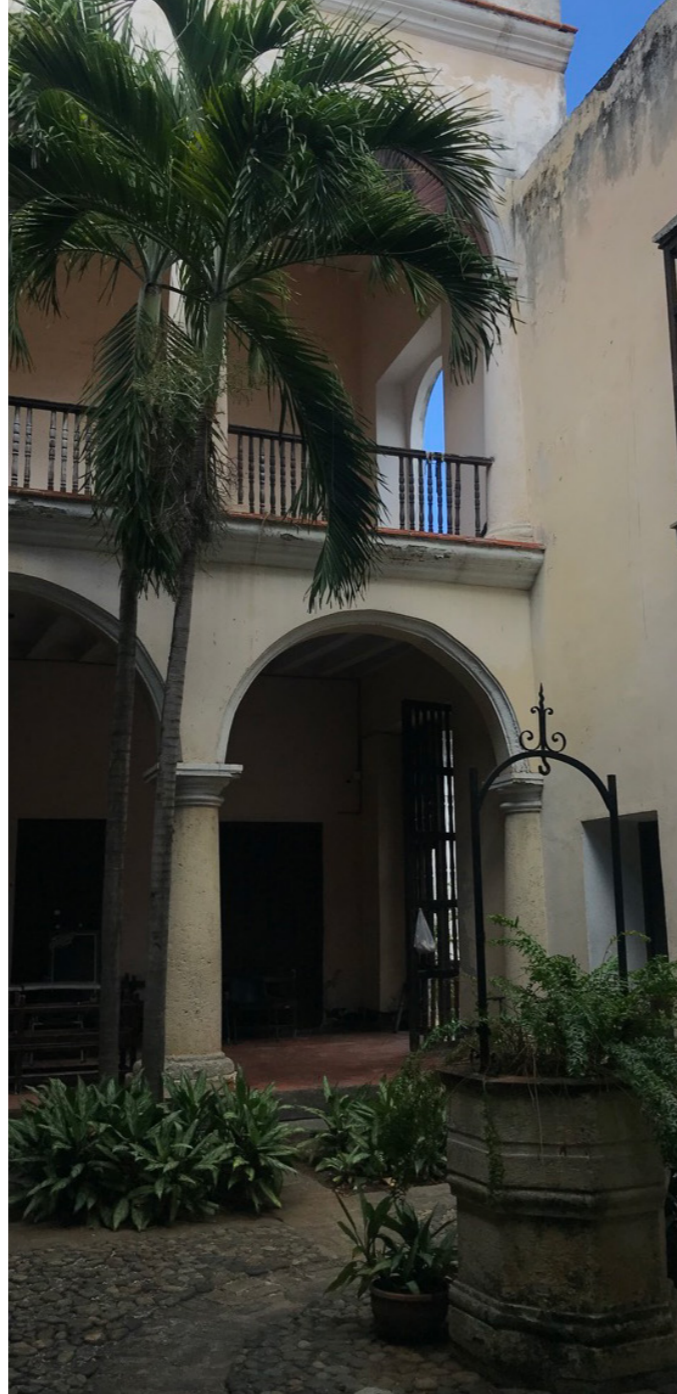
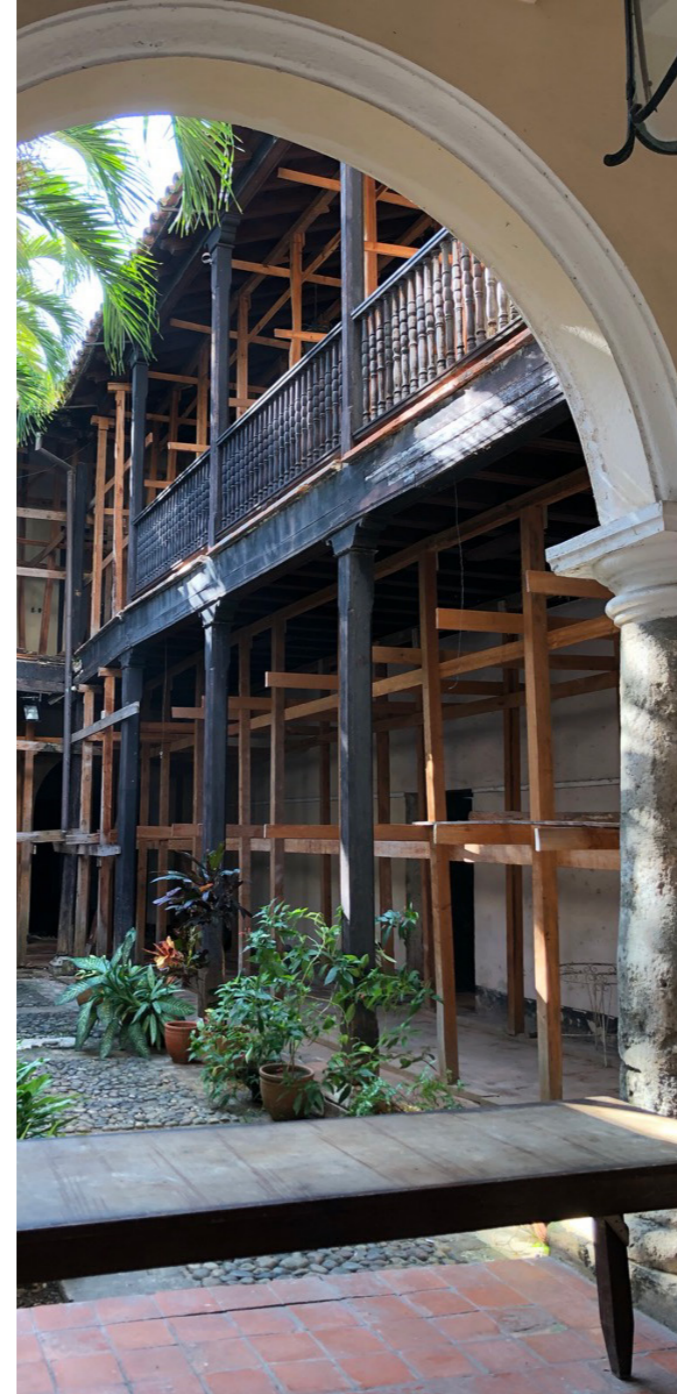
Ground floor

In the following illustrations we will demonstrate the interventions we are doing, and how most of what we are touching is not leaving the building. This includes; walls, tiles, doors, wooden parts, stairs and sanitary equipment. The reuse will not only be to alter the floor plans to the new program, but also to fix some of the damages discovered during the inspection of the building as presented under chapter xx, and to recycle into missing parts.

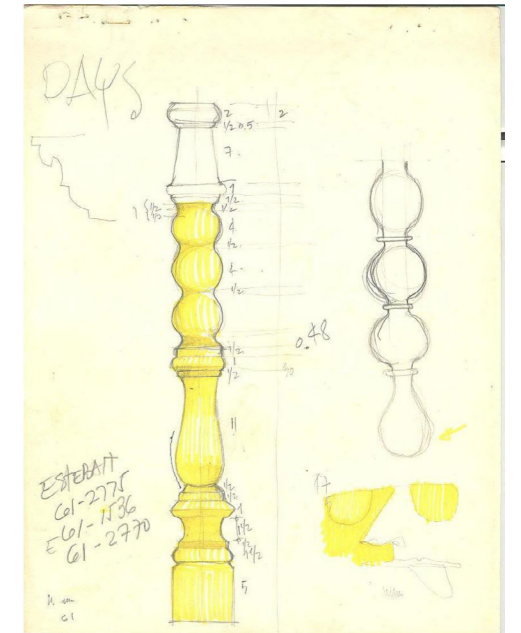
Picture 9: Carpentry details

As seen in the section 'Technical state', a selection of the roof's beams, both in the main building and the gallery are damaged. This also goes for some of the columns of the gallery. These massive wooden elements have damages on their ends, but the middle parts can still be used. Unless they can be reused as shorter beams in different projects, we postulate that much of the decorative carpentry will be possible to make from these spare parts. The only needed new woodwork might thus be the big constructive pieces marked in the illustration of the roof, two pieces for the balcony, and two columns on both floors in the gallery.

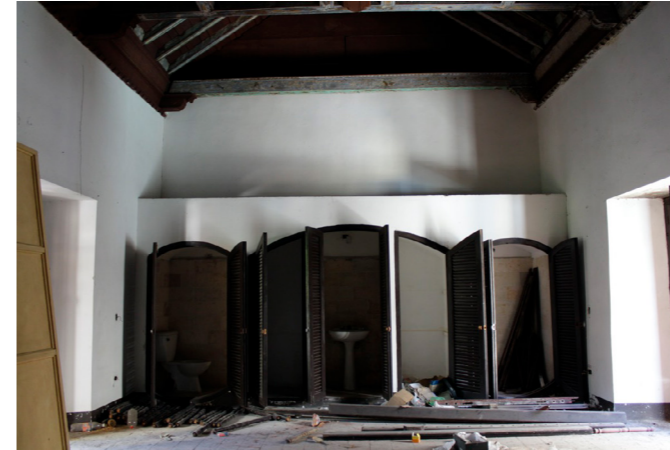
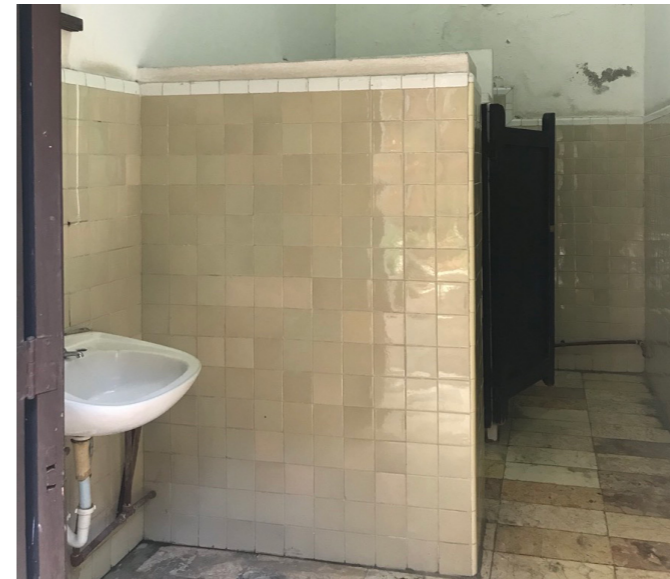
Assuming they are in good state, we have planned on reusing all the sanitary equipment, and will only need to further acquire five toilets and two bathroom sinks. There will also be an extra shower, that can be donated to another project, or used in a different way in one of the laundry areas.

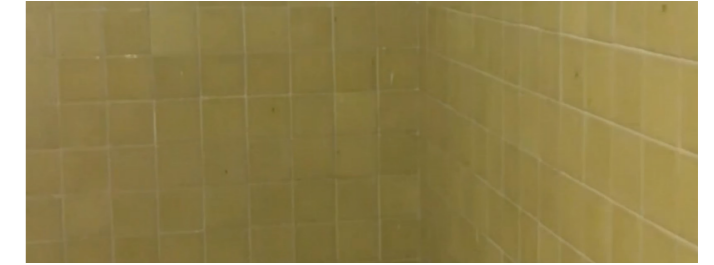
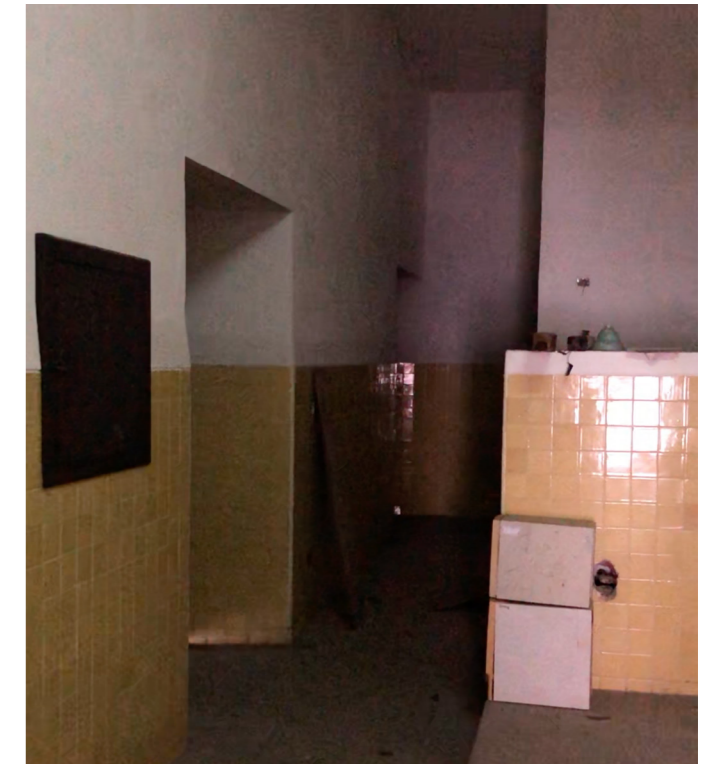
When removing the bathrooms in the rooms along Calle san Ignacio it should be taken great care as to remove them in such a way that the stone tiles on both the walls and the floors can be reused in the new bathrooms. This also applies to the eastern part as this whole room is covered in yellow glazed tiles.

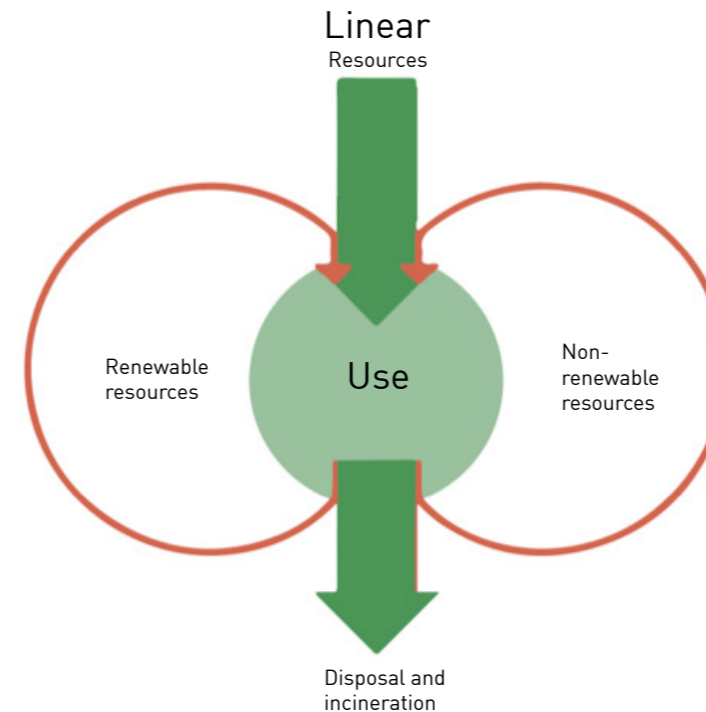
Figure 8: Circular and linear approach

It is rare to start a project on an empty site in Old Havana, usually they deal with an already existing
