# A Journey in Architecture.

Resource exploitation in Cuba and Norway

Faculty of Architecture and Design  
At the Norwegian University of Science and Technology  
Department of Architecture and Planning  
Master in Architecture  
Submitted: 27.05.2020

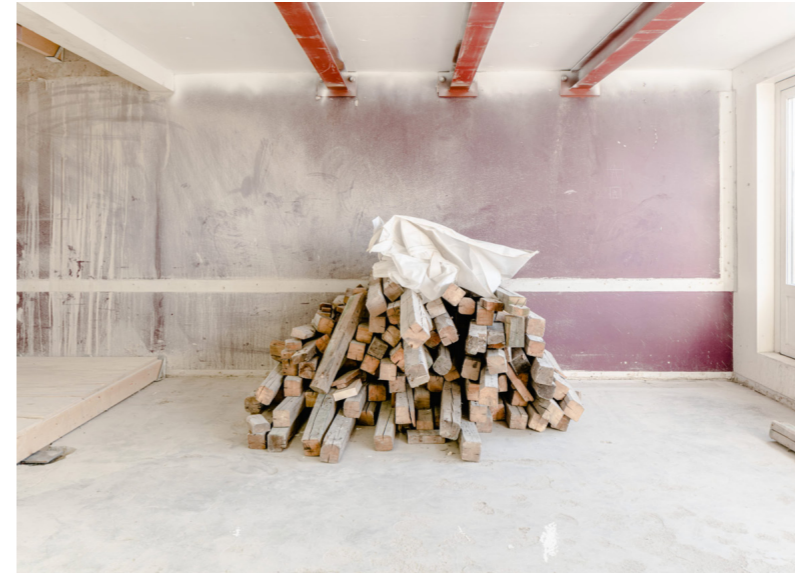
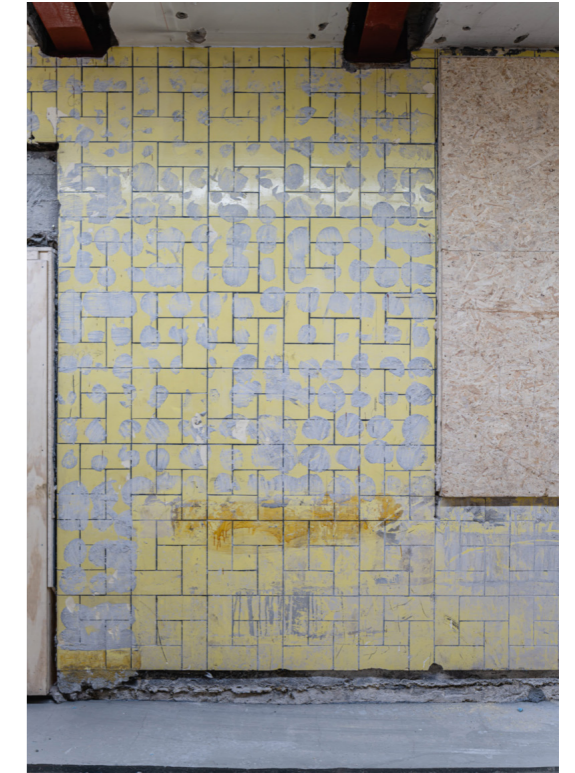
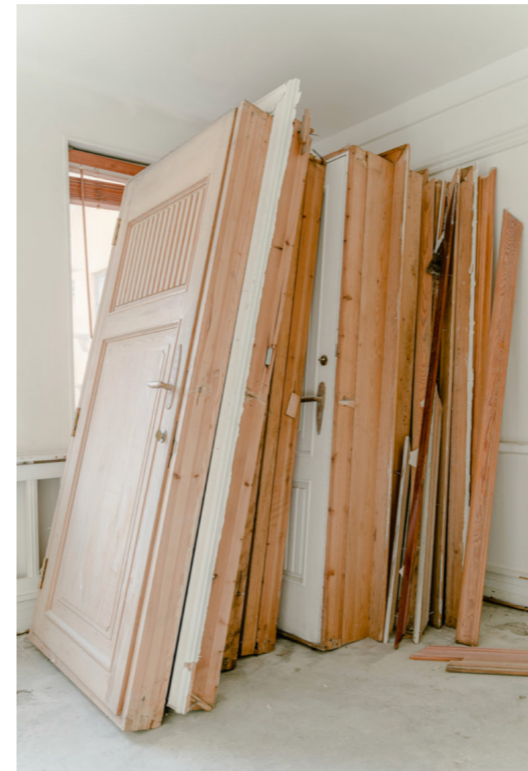
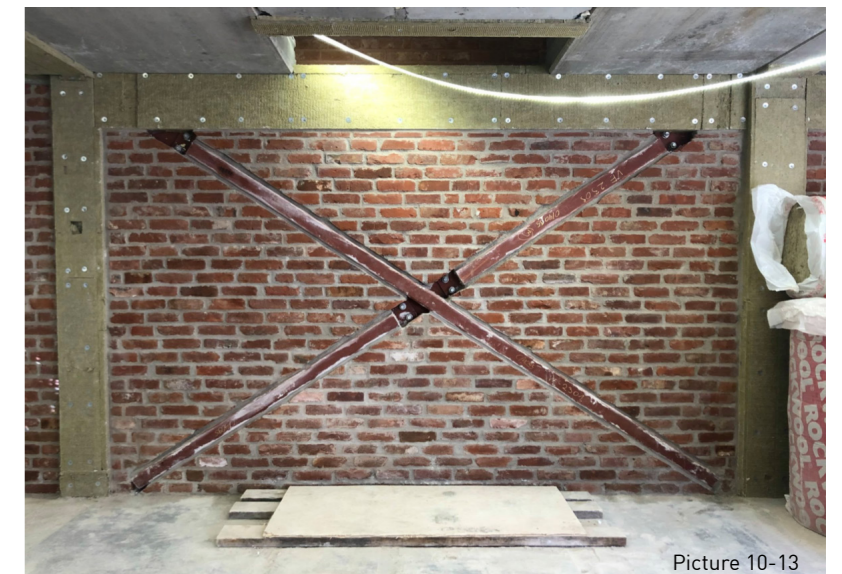
Picture 10-13

Reuse of materials in KA13

When dealing with technical requirements for the steel parts, they have tried to put down a system for how to do these processes in any other project in the future that wishes to reuse steel. They have also focused on using methods for assembling them for easier disassembly in the future when and if the building is taken down.<sup>49</sup>

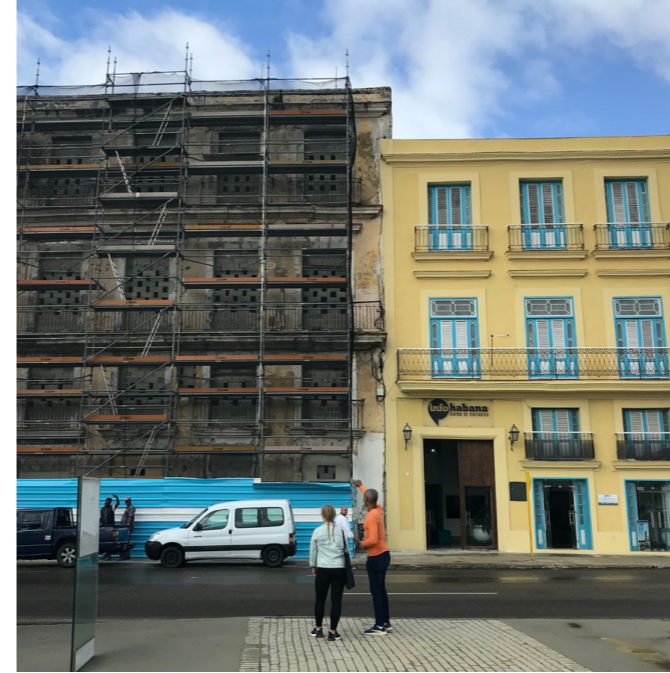
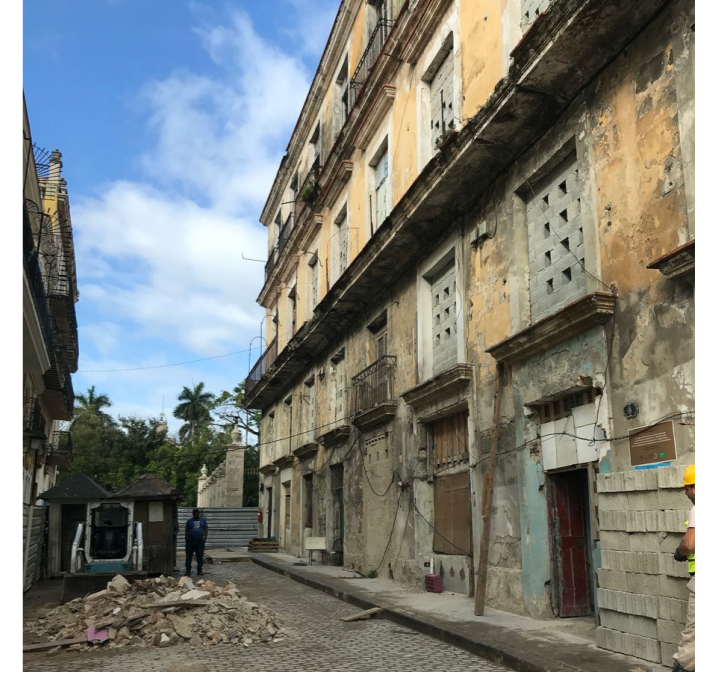
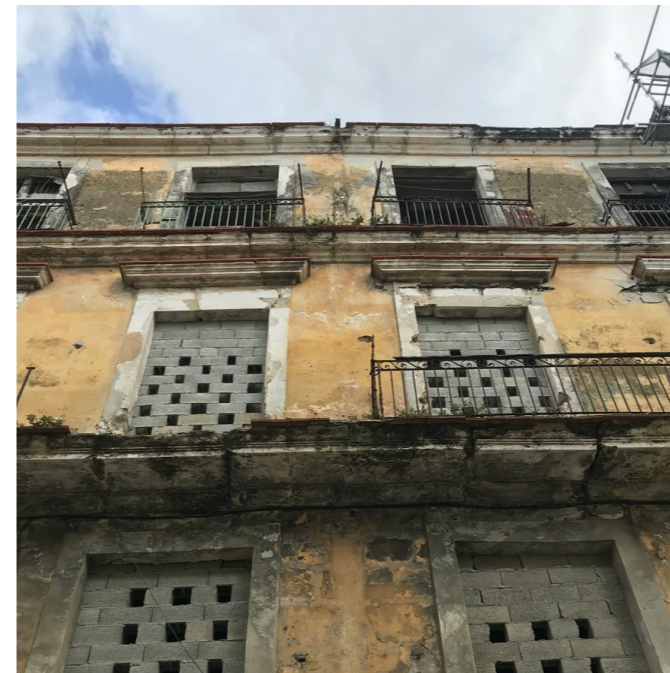
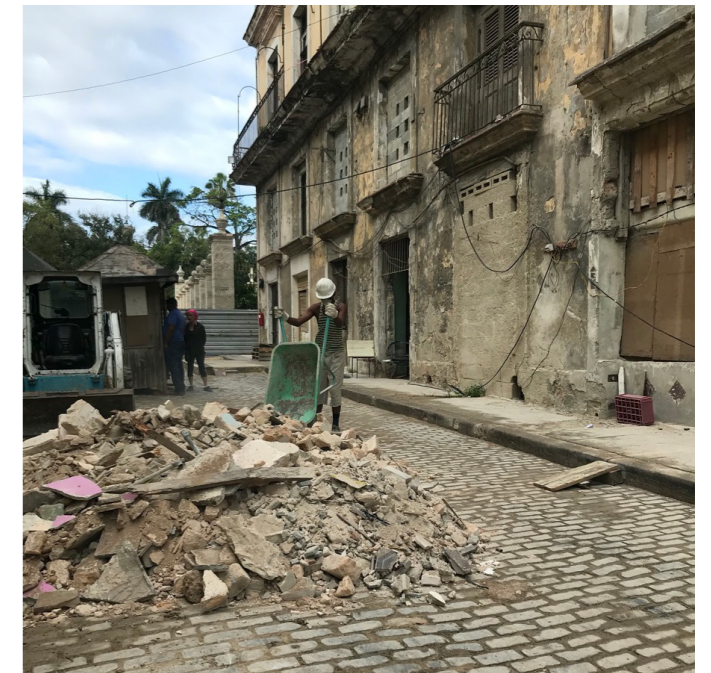
The ironwork missing from the facade in these pictures is being reused in a school that they are renovation in a different location. That school was missing some ironwork, they have taken iron from the balconies at this building and used there to complete the work.

They are also waiting for some experts to come by the building site to proof-check some iron columns in the interior for further use where they are.

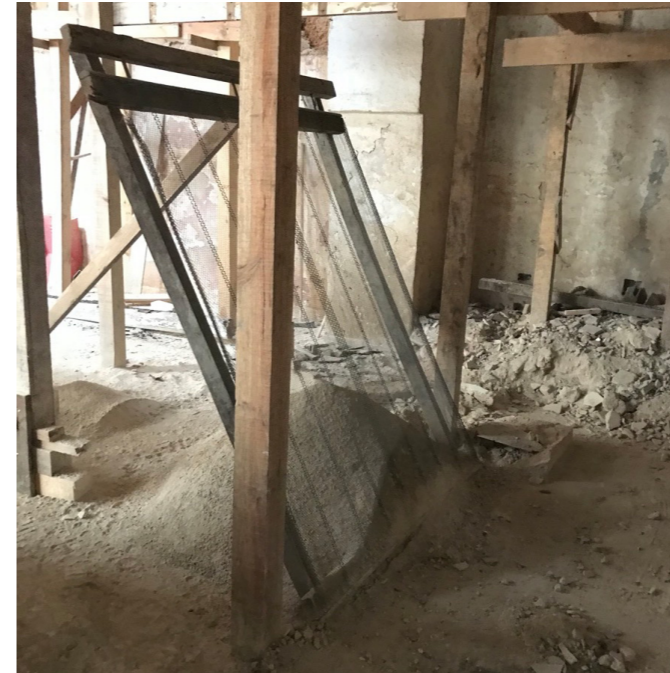
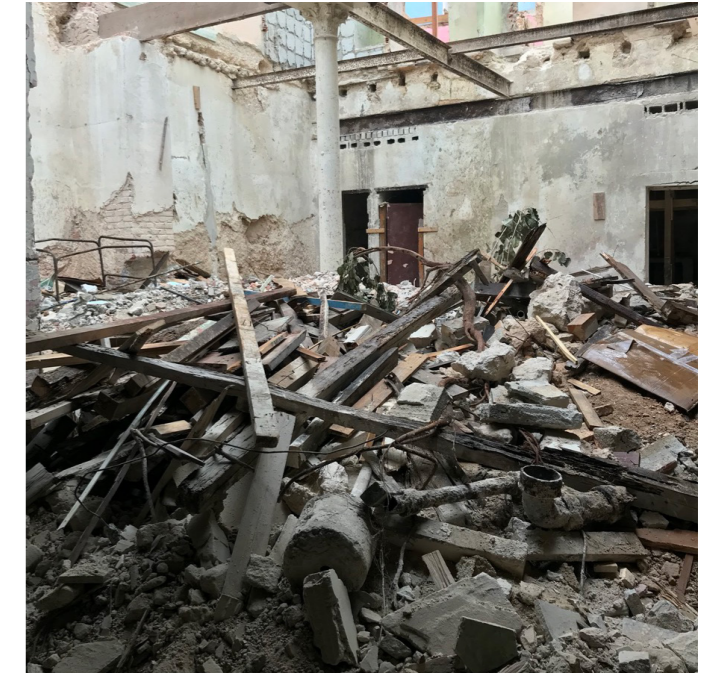
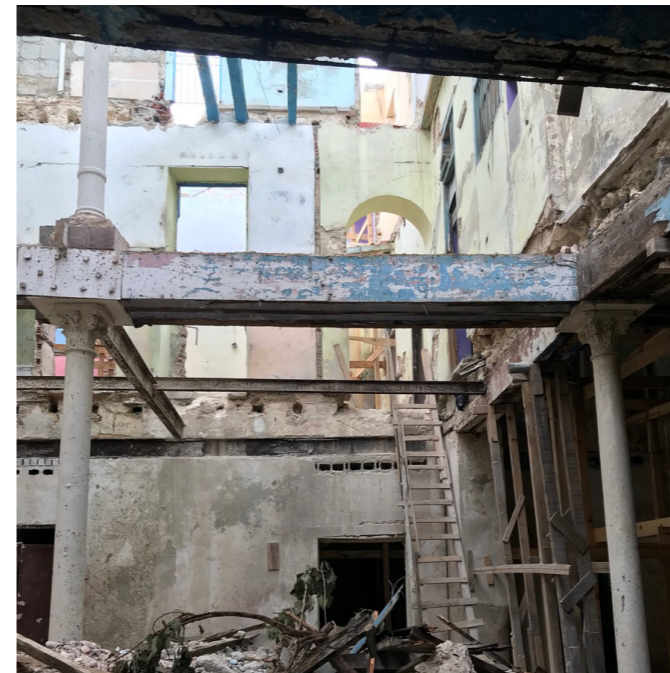
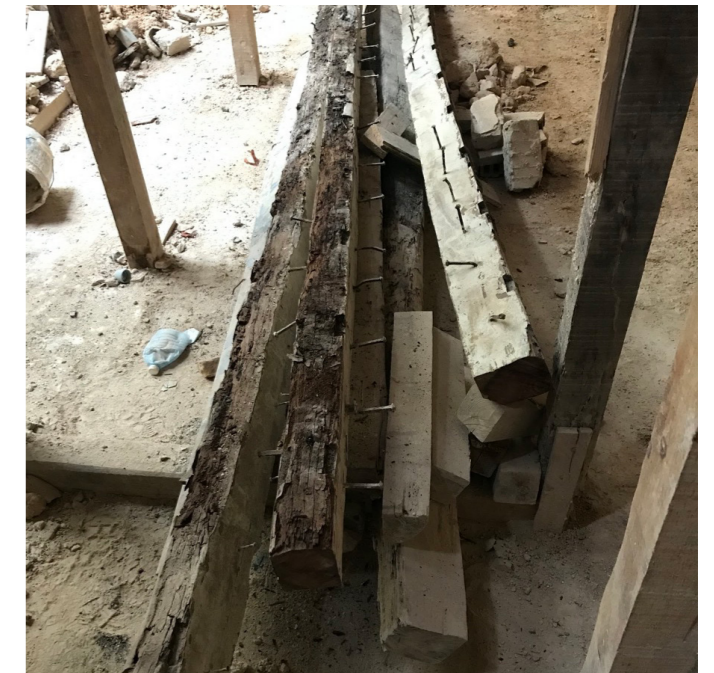
## Mercaderes e/ Amargura y Teniente Rey

This building site is at the dismantling stage, they have already gotten quite far at taking out almost everything inside. The state of the building was critical, and the only thing remaining after the dismantling is going to be the facade, and some building elements from the interior like tiles, story separators and staircase stones. Beside that they are also recycling as much they can of the wooden beams. They are quite rotten from termites and humidity, but some of it can still be used and those are saved at the spot for the future.

What we also encountered was a big standing filter, where they would throw through any plaster or stone that would be possible to reuse in a mixture for cement.

We also noticed that the main skeleton/structure in steel of the building was left as it were, to be renovated and (re)used where it is.

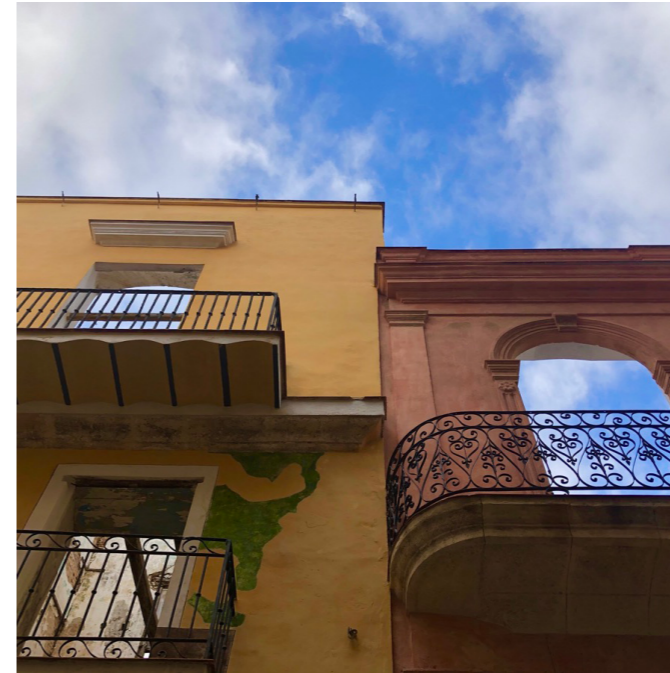
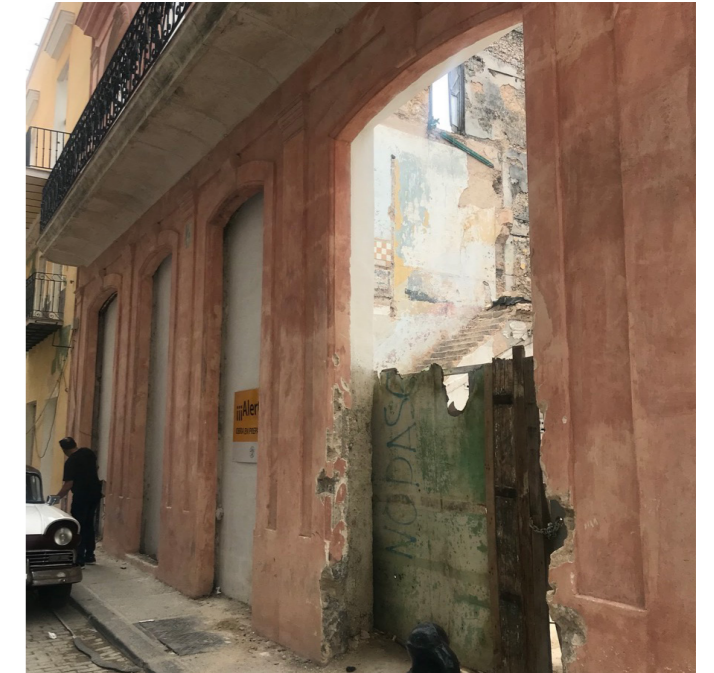
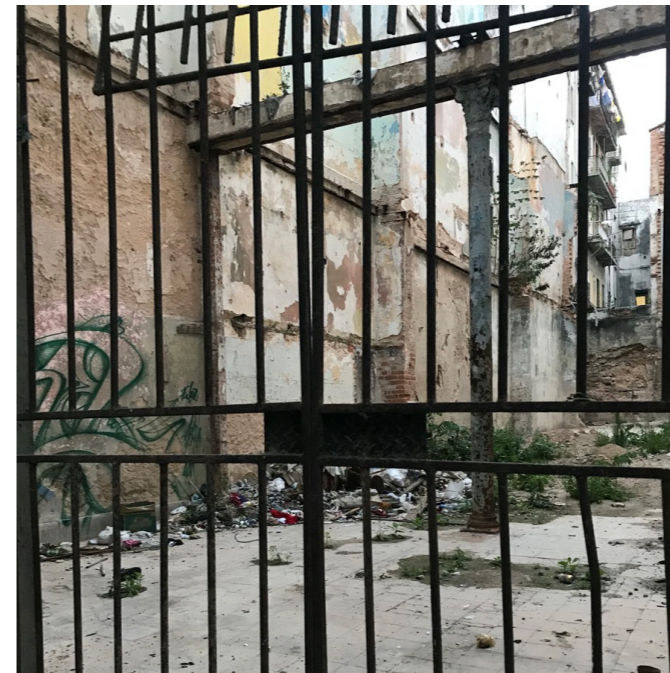
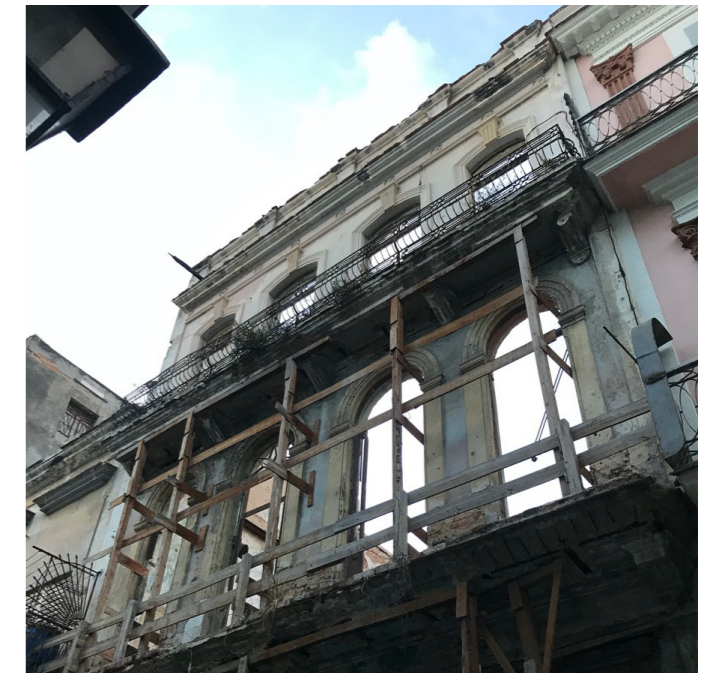
## Mercaderes e/ Muralla y Sol

At this site we were not going in, but had a talk about what keeping the facade looks like. Because at this place there were two buildings under renovation where only the facade was left and some iron columns on the inside, otherwise everything was gone. This because of the deterioration of the building. As for the facade, a lot of the building components had been dismantled to be restored, and then put back. As a part of the UNESCO listing, this is obligatory, but not possible for them to do on the whole building based on deterioration and cost, therefore it is only done on the facade. Here we were also demonstrated the search for the original color, if you have a look at the picture with a pink and a yellow building, you can see that the yellow also had green spots, that is the oldest color they can find. But since this color is hard to find at the moment, it will be left like this until further work on the building. They are still waiting for materials to come in from abroad before starting, something happened with the company that were supposed to deliver them in regards to some taxes to the United States, so for the moment work is put on hold. We asked about what our guide thought about keeping the facades, and then he sort of joked back that in the case of La Habana it was a good thing, as to being able to keep the street although the building was not really there, at least it looked like it.

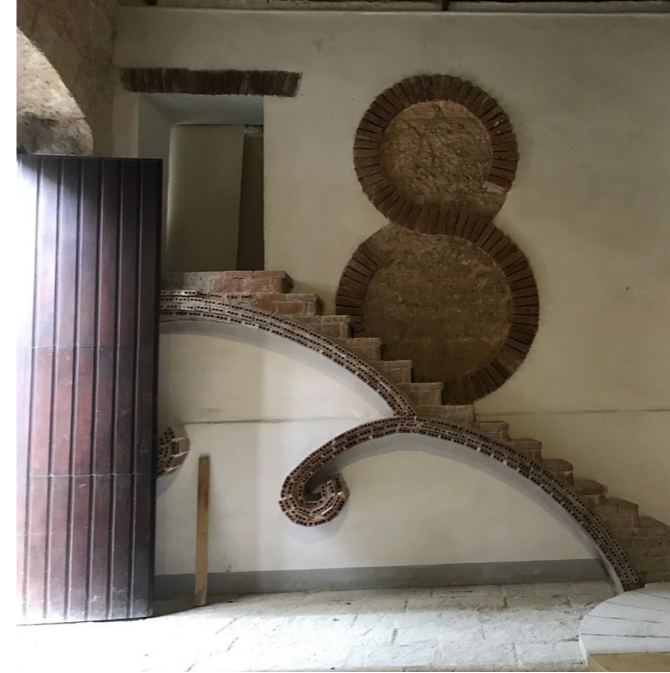
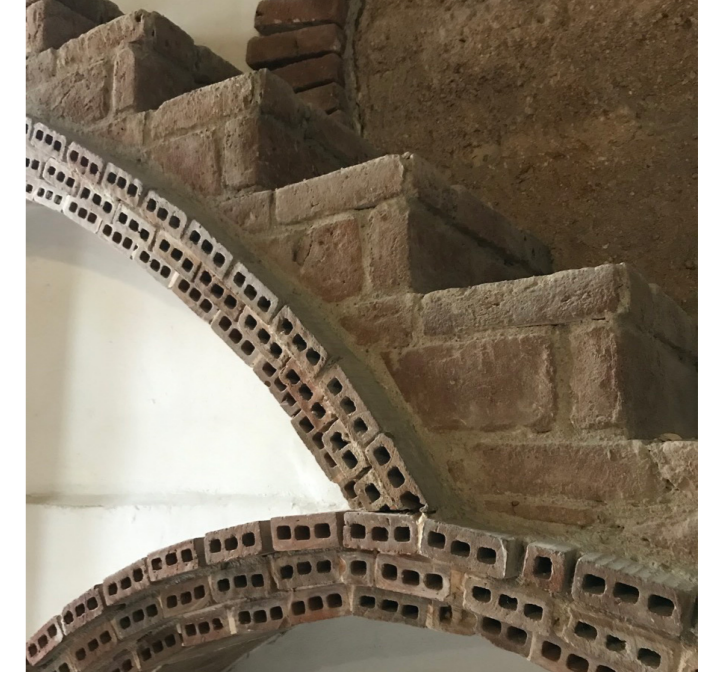
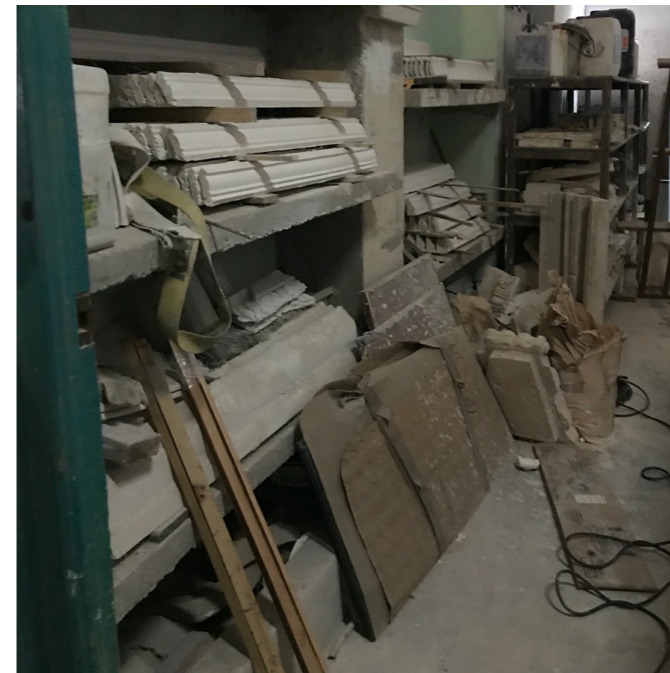
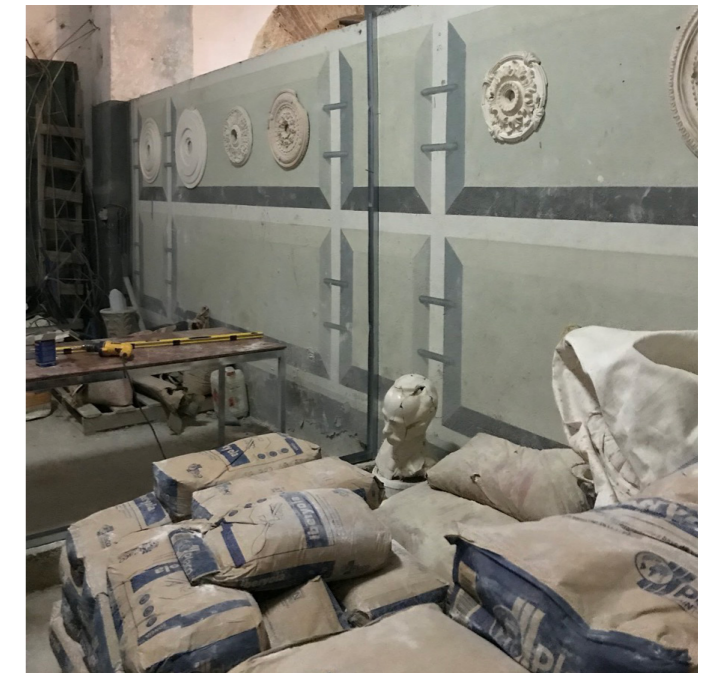
## Teniente Rey e/ Mercaderes y Oficinos

This building is being used as a storage and educational space while under renovation. The renovations and building are being performed by the student as part of their courses. They also store woodwork, cement etc. here. And as part of an educational scheme, students are also being encouraged to experiment with what the materials can do, as seen in the picture with the staircase made out of slim bricks.
