Experimental investigations on
fire
performance of the engineered
wood
products cross-laminated
timber and
I-joists

Doctoral thesis

NTNU
Norwegian University of Science and Technology
Thesis for the Degree of
Philosophiae Doctor
Faculty of Engineering
Department of Civil and Environmental
Engineering

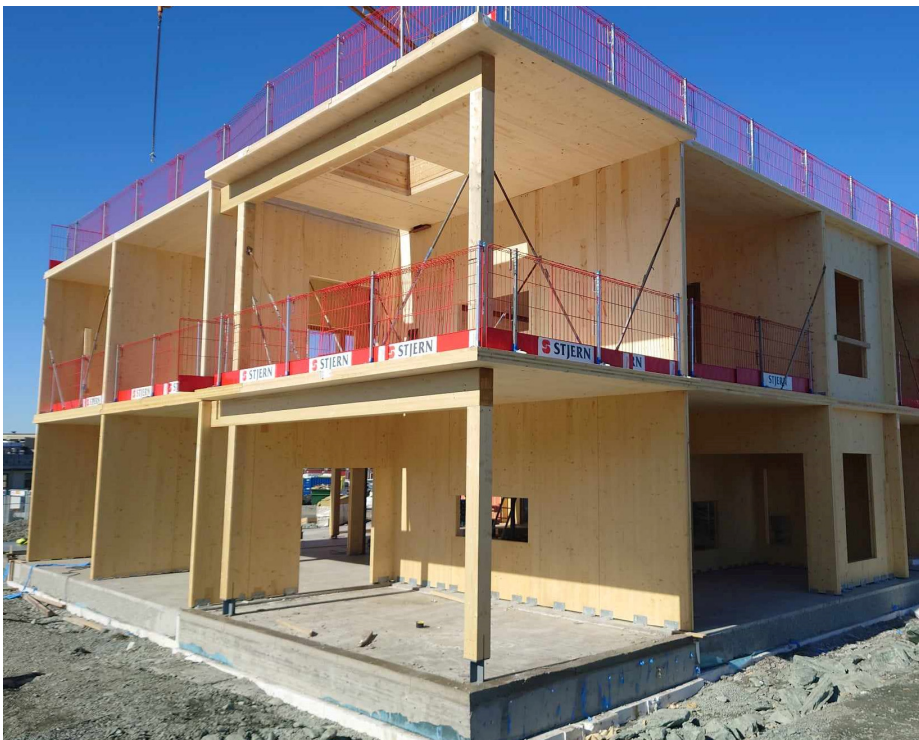
Fig. 1 Building under construction where load bearing CLT elements are used in walls and floors. Openings for windows and doors have been cut out during production.

CLT, or cross-laminated timber elements, are prefabricated engineered wood products used as load-bearing elements in walls and floors, see Fig. 1. A CLT element comprises an odd number of layers, typically 3, 5 or 7, where adjacent layers have a 90° orientation to each other and are held together by an adhesive. There are several different adhesive types, including phenol resorcinol formaldehyde (PRF), polyurethane (PUR), melamine urea formaldehyde (MUF), and emulsion polymer isocyanate (EPI). The choice of adhesive strongly depends on the wood species [10]. The two most common ones used for CLT are PUR and MUF [11].

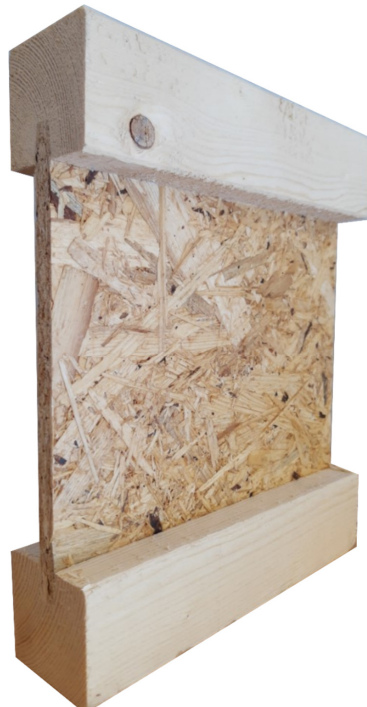
Fig. 2 An I-joist comprises two flanges and a web in between. Here, the flanges are made of solid wood and the web of oriented strand board (OSB). The length of the I-joists is normally much longer than in the image.

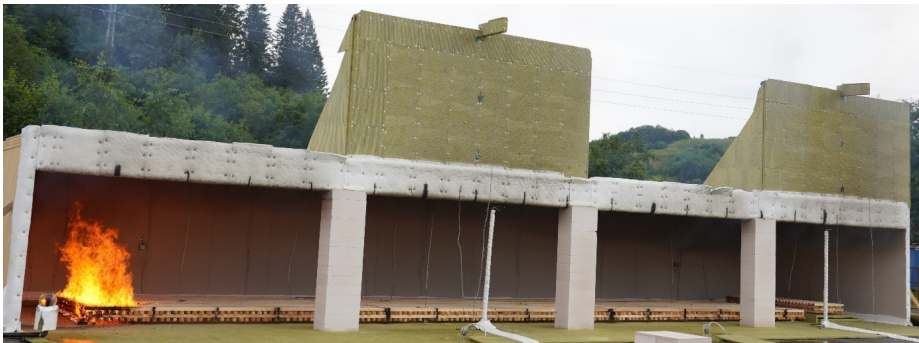
Fig. 3 Photo of the CLT compartment with exposed CLT ceiling. This is of the #FRIC-01 experiment with only the ceiling (not shown) exposed.

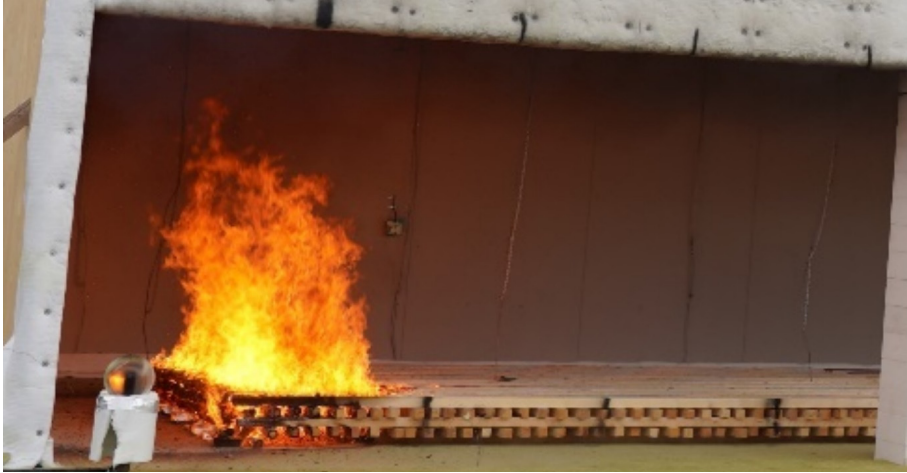
Fig. 5 It took 32.5 minutes before the ceiling was ignited. This image is taken from ca. 20 minutes. This fire spread to 1.5 m before the ceiling was ignited but did not grow larger in size as the first part of the crib was starting to burn out from this point.

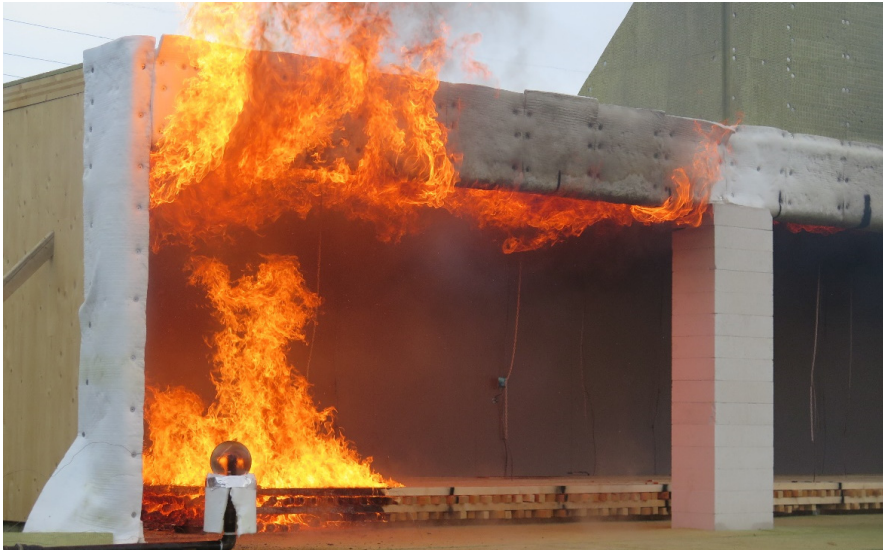
Fig. 6 Flame spread under the ceiling shortly after ignition of the CLT ceiling in #FRIC-01. The image was taken at 33 minutes.

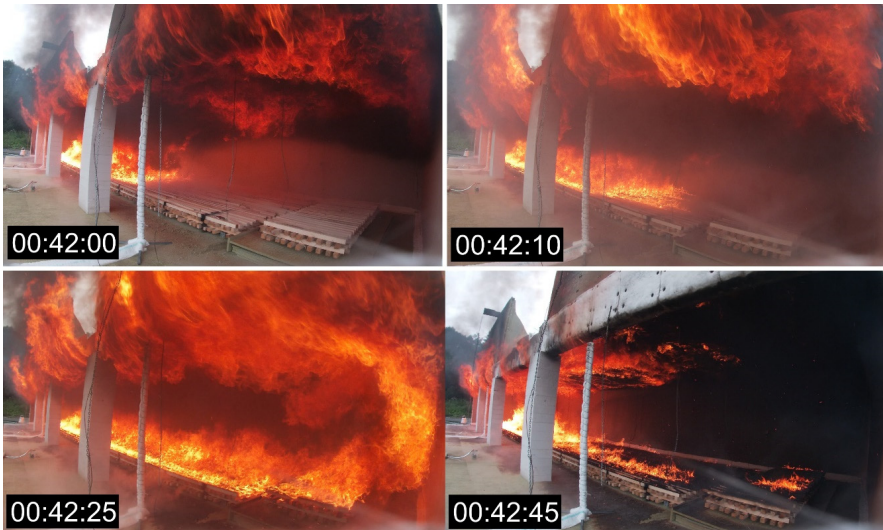
Fig. 7 In the third flashing wave, the fire spread to cover the entire wood crib and ceiling before it retracted shortly after. Time (hh:mm:ss).

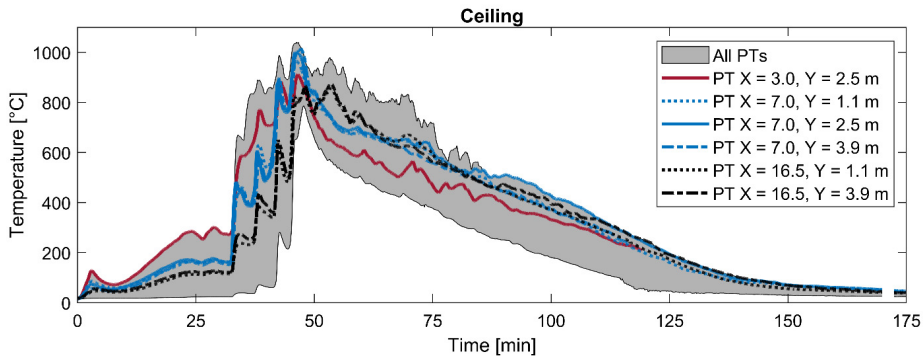
Fig. 9 Temperatures measured by plate thermometers (PT). The grey area represents the range of temperatures measured at all the installed PTs at the wood crib (facing upwards), at the wall (facing outwards) and in the ceiling (facing downwards).

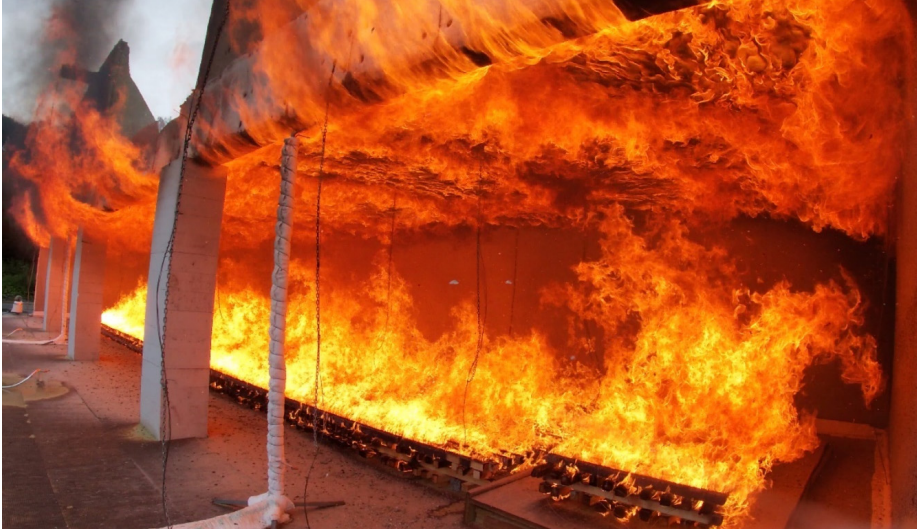
Fig. 10 Image of the fully developed fire in #FRIC-01. Image from 47 minutes.

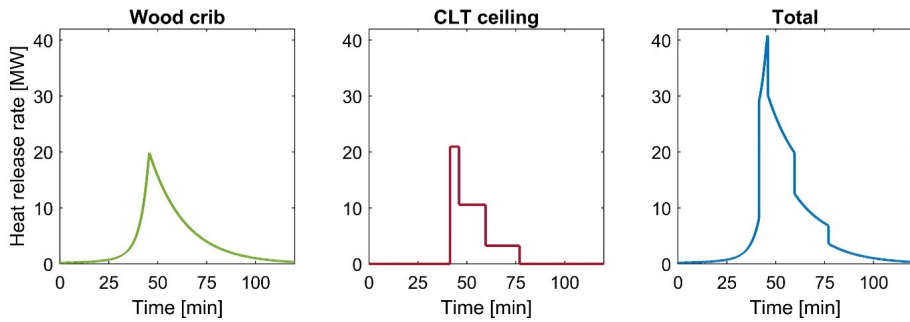
Fig. 11 Heat release rate for the wood crib, CLT ceiling, and total (wood crib + CLT).

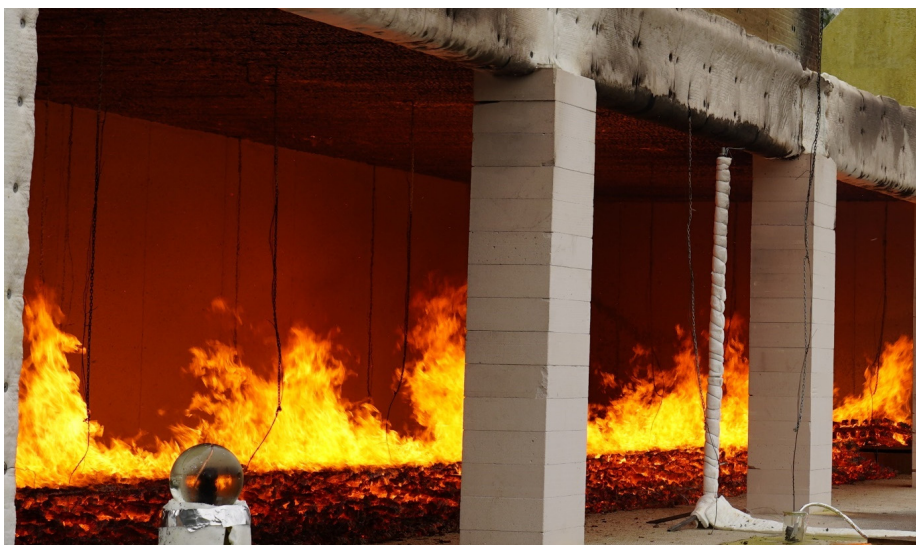
Fig. 14 Self-extinguishment of the flames in the CLT ceiling when the wood crib was still burning.

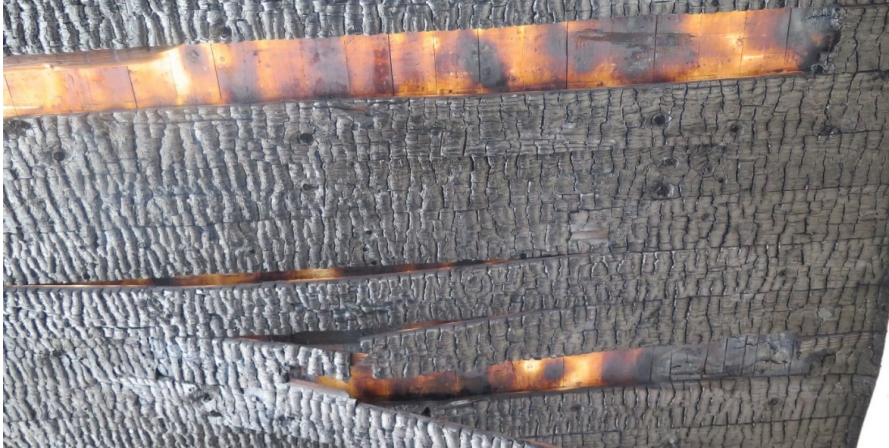
Fig. 15 The image shows partial delamination where several lamellas are partly loose, and some are hanging down. The second layer was mostly discoloured, not charred, which indicates that the temperature at delamination was around 200 °C or lower.

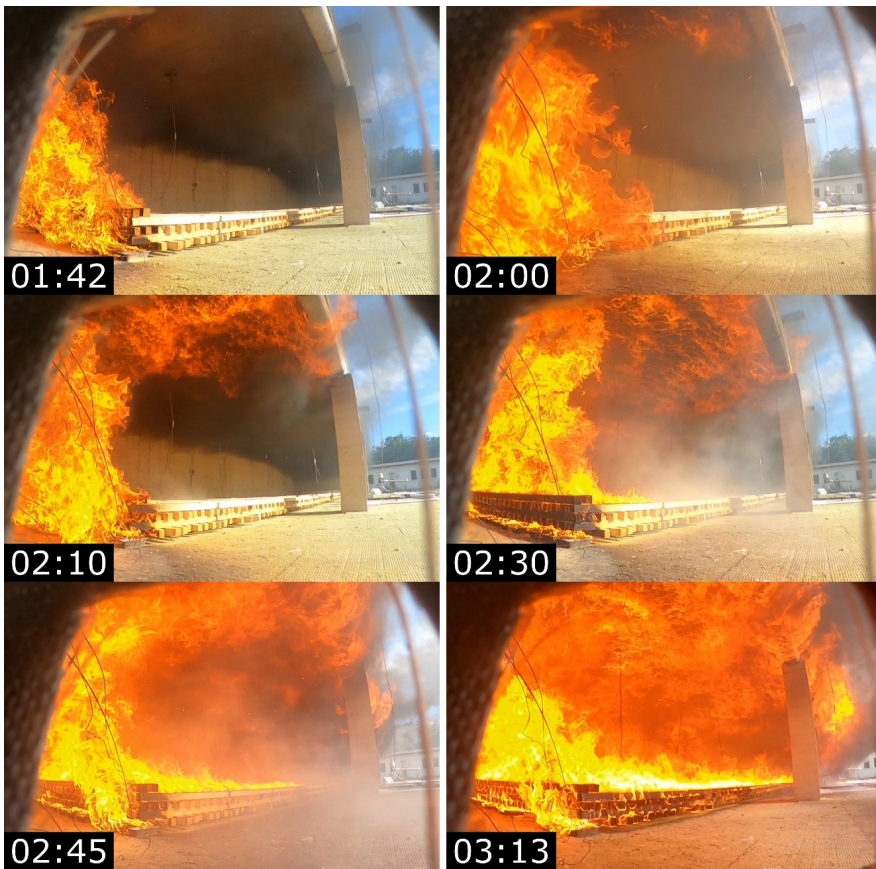
Fig. 17 From ignition of the ceiling, the fire spread across the room in just 91 seconds. Time (mm:ss) after the start of the experiment.

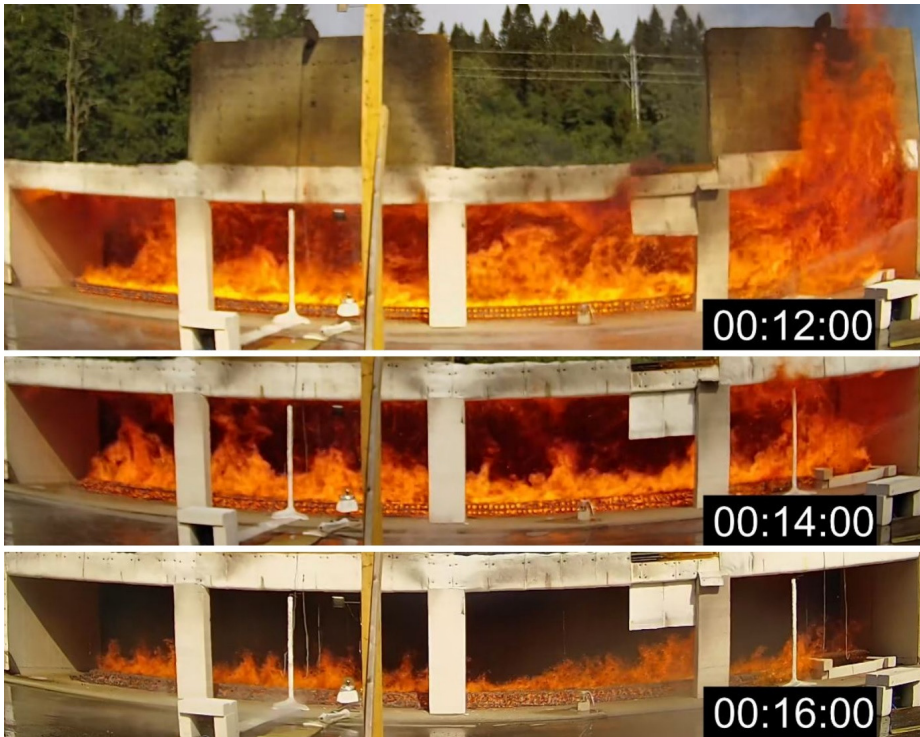
Fig. 19 Self-extinguishment of the flaming combustion of the CLT. Time (hh:mm:ss) after the experiment started.

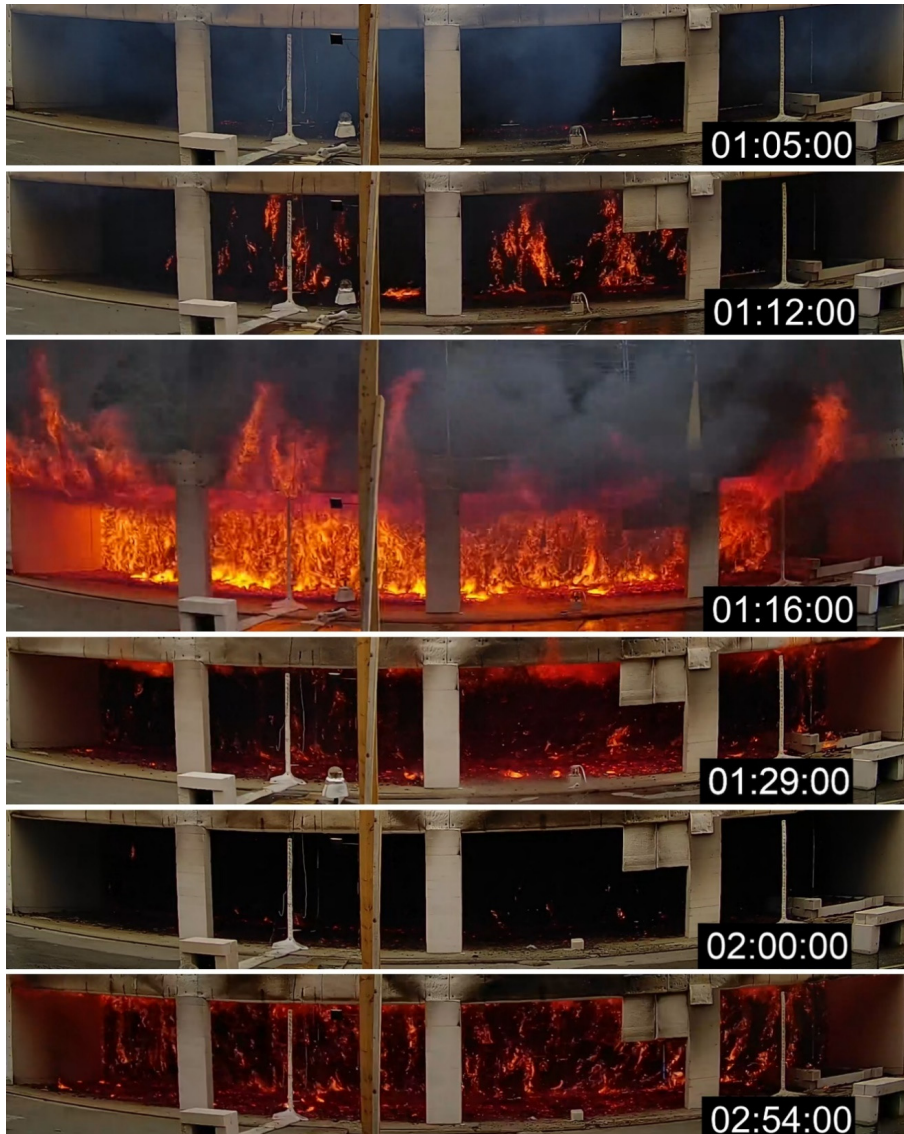
Fig. 20 Development of the second flashover. Time as hh:mm:ss.

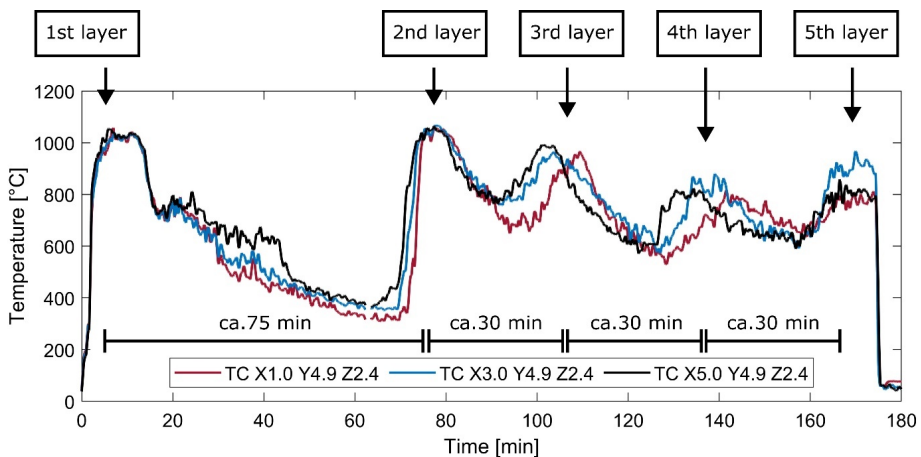
Fig. 21 Gas temperatures 100 mm from the back wall at three different locations. The peaks correspond to the burning of the different layers in the CLT wall.

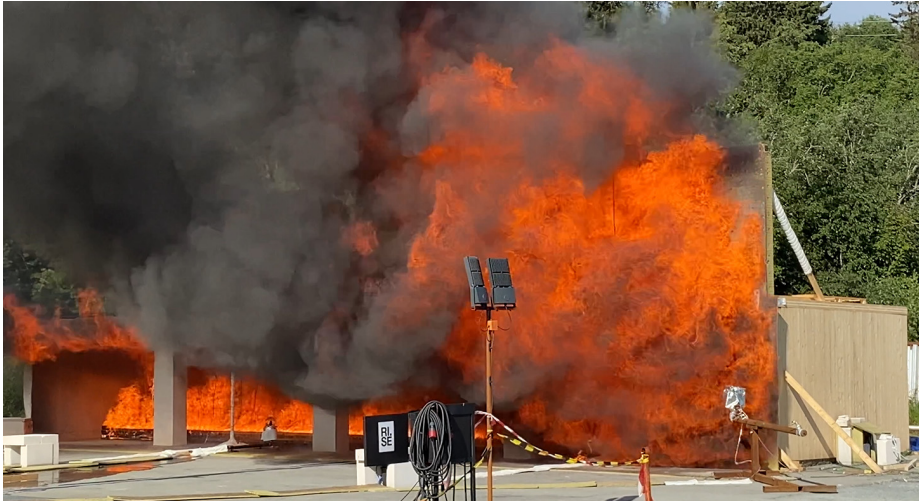
Fig. 22 Image of #FRIC-02 after 3.5 minutes. The external flame covered almost the entire opening of Window 4 directly after flashover, whereas the external flames from the other windows were relatively small.

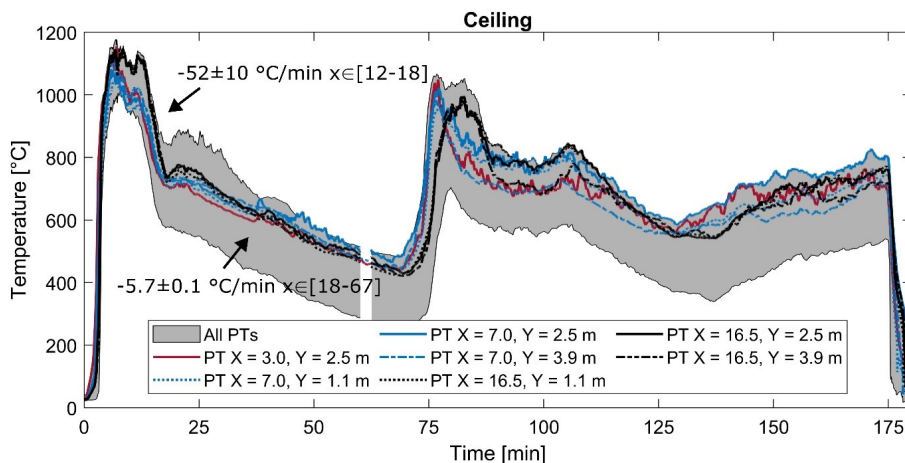
Fig. 25 Temperatures measured by plate thermometers (PT). The grey area represents the range of temperatures measured at all the installed PTs at the wood crib (facing upwards), at the wall (facing outwards) and in the ceiling (facing downwards).

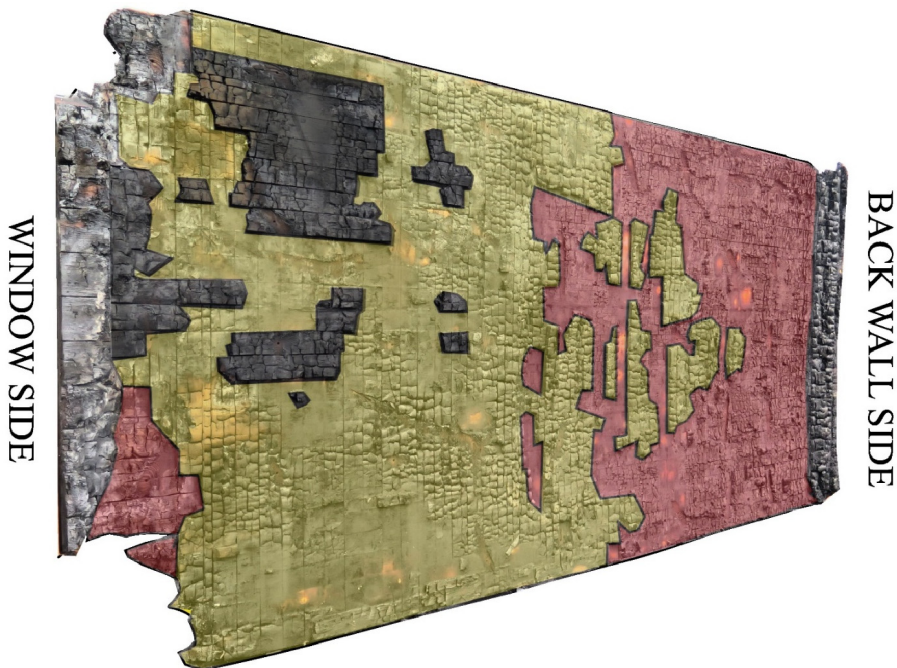
Fig. 28 Visualisation of non-uniform charring for one CLT ceiling element based on a photo. A colour filter is added to better separate the layers. Black is the 3rd layer, yellow is the 4th, and red is the 5th layer. The holes at the right and left lower corners of the window side were caused by smouldering and reignition after the end of the experiment, as this part was hard to reach with water due to safety precautions.

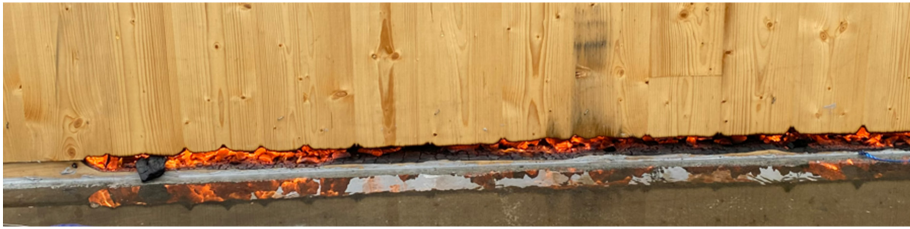
Fig. 29 The fire burned through the intersection between the back wall and the bottom plank at approximately 60 min. The image is taken at a later point when the gap had become larger. The lack of a fire sealant between the bottom plank and the CLT wall enabled this and highlights that connection details are crucial to fire safety.

In the joint between the CLT wall and the bottom plank, increased charring was observed, as seen in Fig. 29. The hole was visible from 60 minutes, and is believed to be due to the lack of any sealant between the wall and the bottom plank. Hence, the hole likely formed due to a tiny gap in the joint.

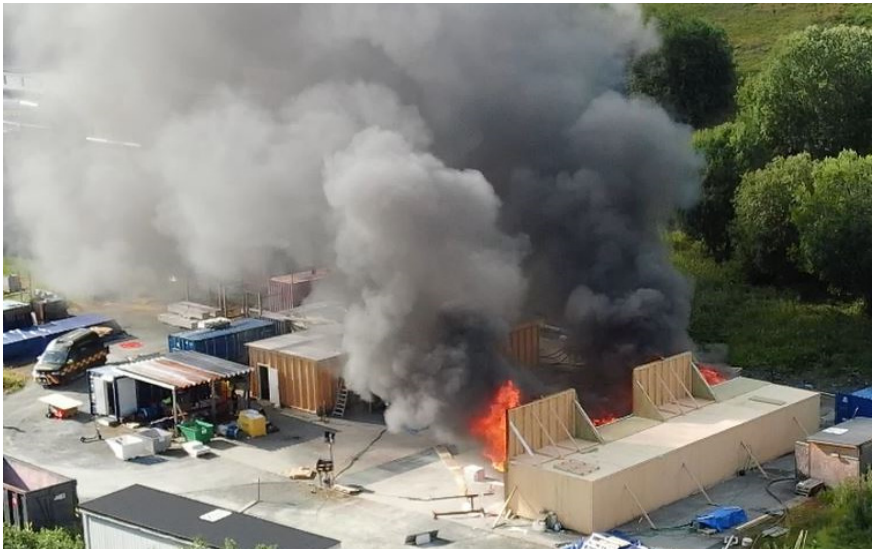
Fig. 30 The wind was coming diagonally from behind the compartment, as seen by the direction of the smoke. The image was taken by a drone.

A reference simulation was conducted with no wind added, and compared against a simulation with a constant wind of 2 m/s coming diagonally from behind the compartment, as in the real experiment, see Fig. 30.

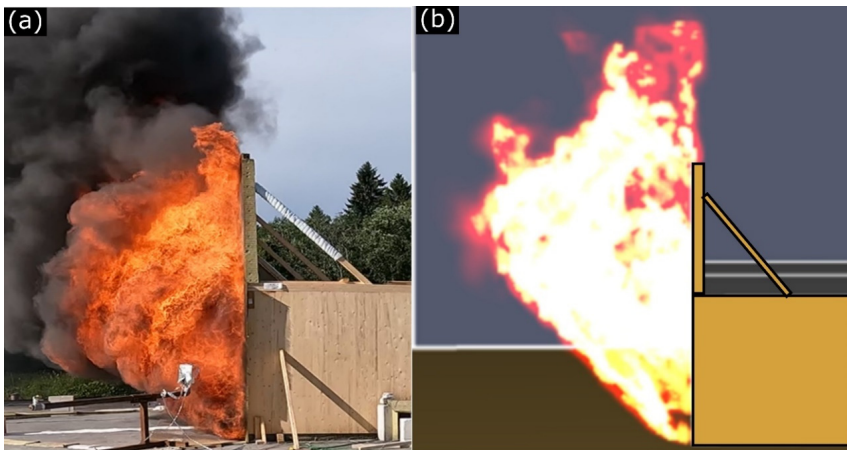
Fig. 31 The external flame covered the entire window height in both #FRIC-02 (a) and the simulation (b). The images are taken shortly after flashover.

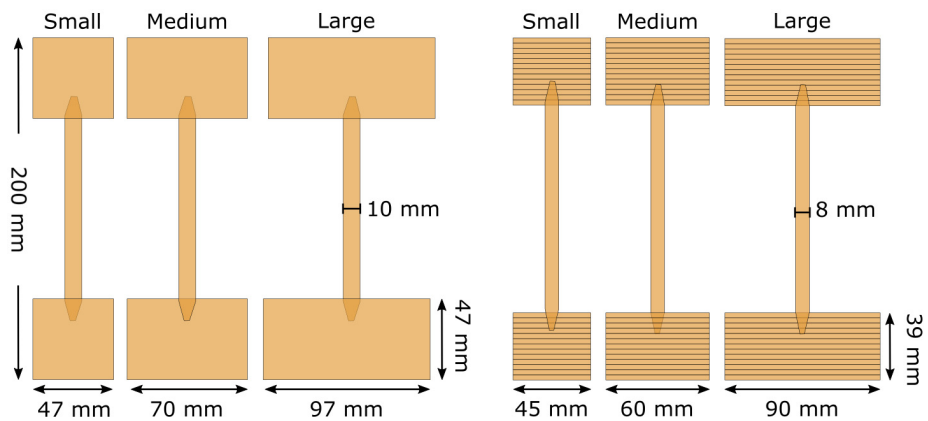
Fig. 33 Overview of the two flange types: solid wood and LVL, with three different flange sizes.

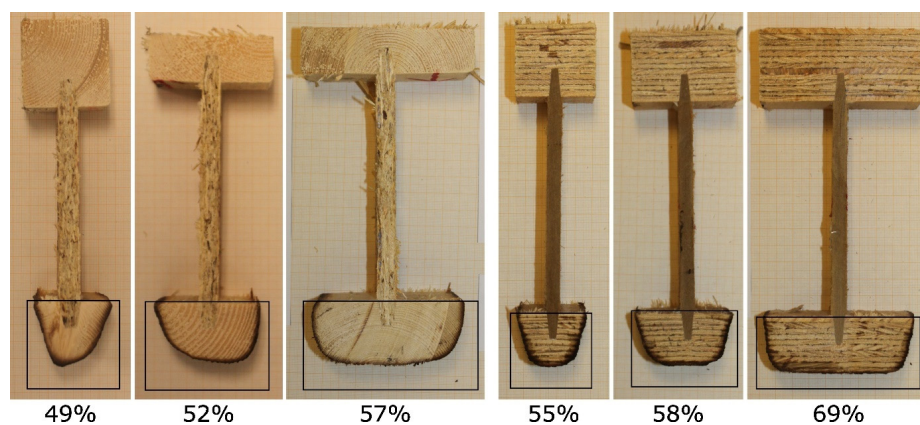
Fig. 35 Example of remaining cross-sections for I-joists with different flange sizes and types. The black rectangles show the size of the flanges before exposure to fire, while the numbers represent the remaining cross-section area. The I-joists to the left have a solid wood flange, while the ones to the right have flanges of LVL. The I-joists are from Test no. 4 and were protected with wood fibre insulation.

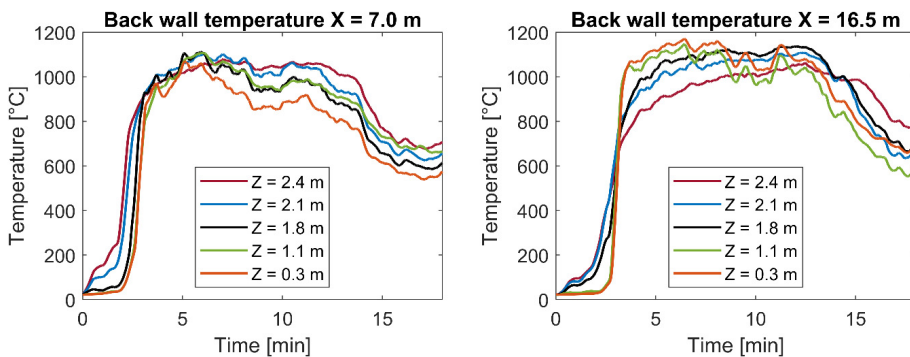
Fig. 36 Temperatures at different heights (Z) 0.1 m from the back wall in #FRIC-02. At $X = 7.0$ m, the temperatures increase with increasing height, while for $X = 16.5$ m, the temperatures decrease with increasing height between 3 and 8 minutes. The temperatures are averaged over 30 seconds.

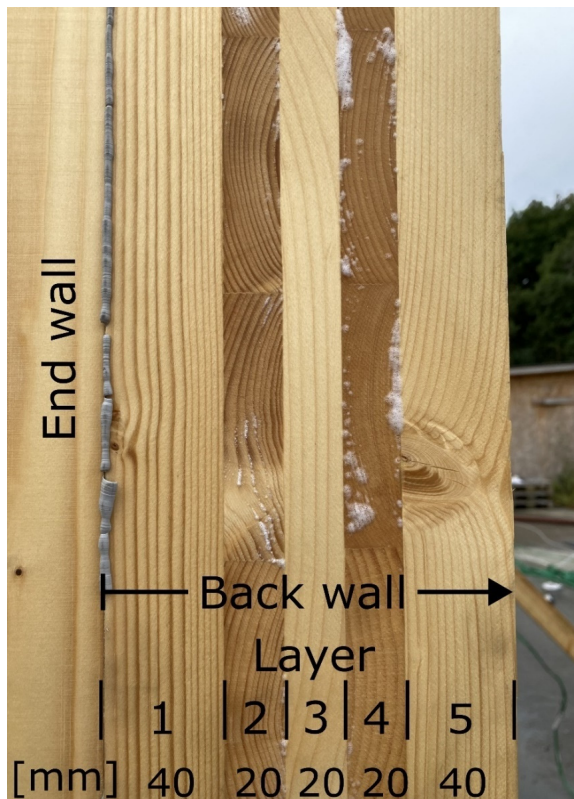
Fig. 40 Water migration towards the CLT edges of the back wall was observed after the experiment was terminated. This is recognised by the apparently wet surface of layers 2 and 4 and foam appearing out between the yearlings. The grey stuff on the left is fire sealant between the back wall and the end wall.

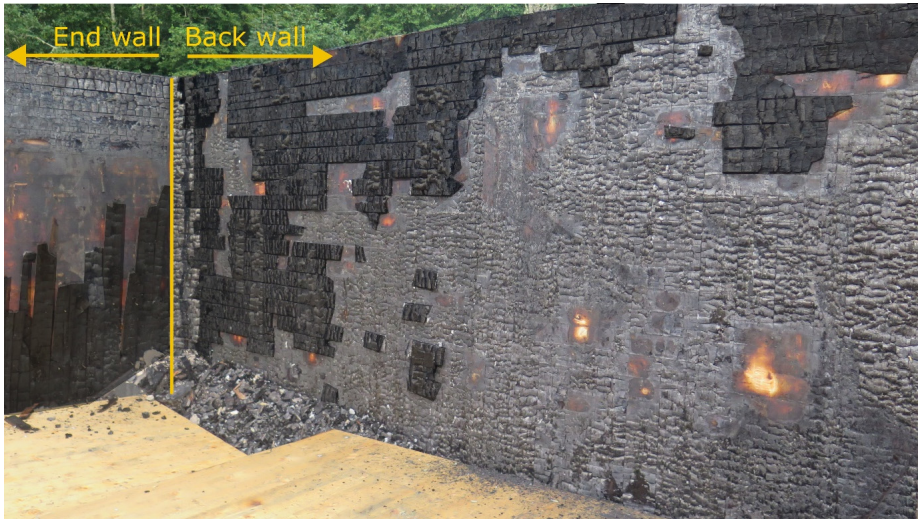
Fig. 42 Charring of the back wall close to the left end wall of #FRIC-02. The back wall is less charred closer to the end wall. The bright spots are fresh wood and show areas that recently have been exposed due to the fall-off of the layer above. A black colour filter has been added to the image to separate the remaining layers better.

Fig. 42 shows less charring of the back wall close to the end wall. This is recognised by more of the 4th layer remaining at the leftmost part of the wall compared to the rightmost part of the image.

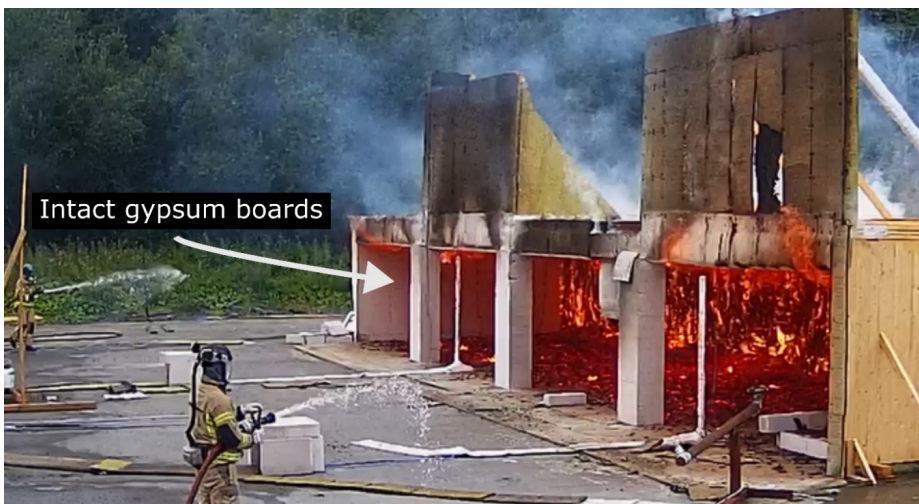
Fig. 44 The gypsum boards at the end walls were intact until the extinguishment of #FRIC-02. The image also shows that the fire was far from being close to self-extinguishing when manually extinguished. Image from 175 minutes

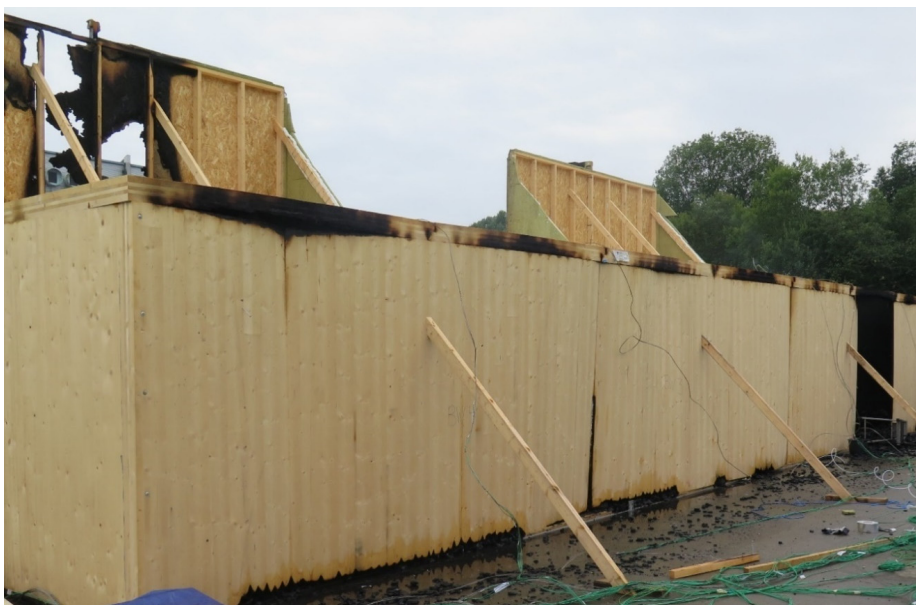
Fig. 45 Damages seen from the back side of the compartment of #FRIC-02 after the end of the experiment.

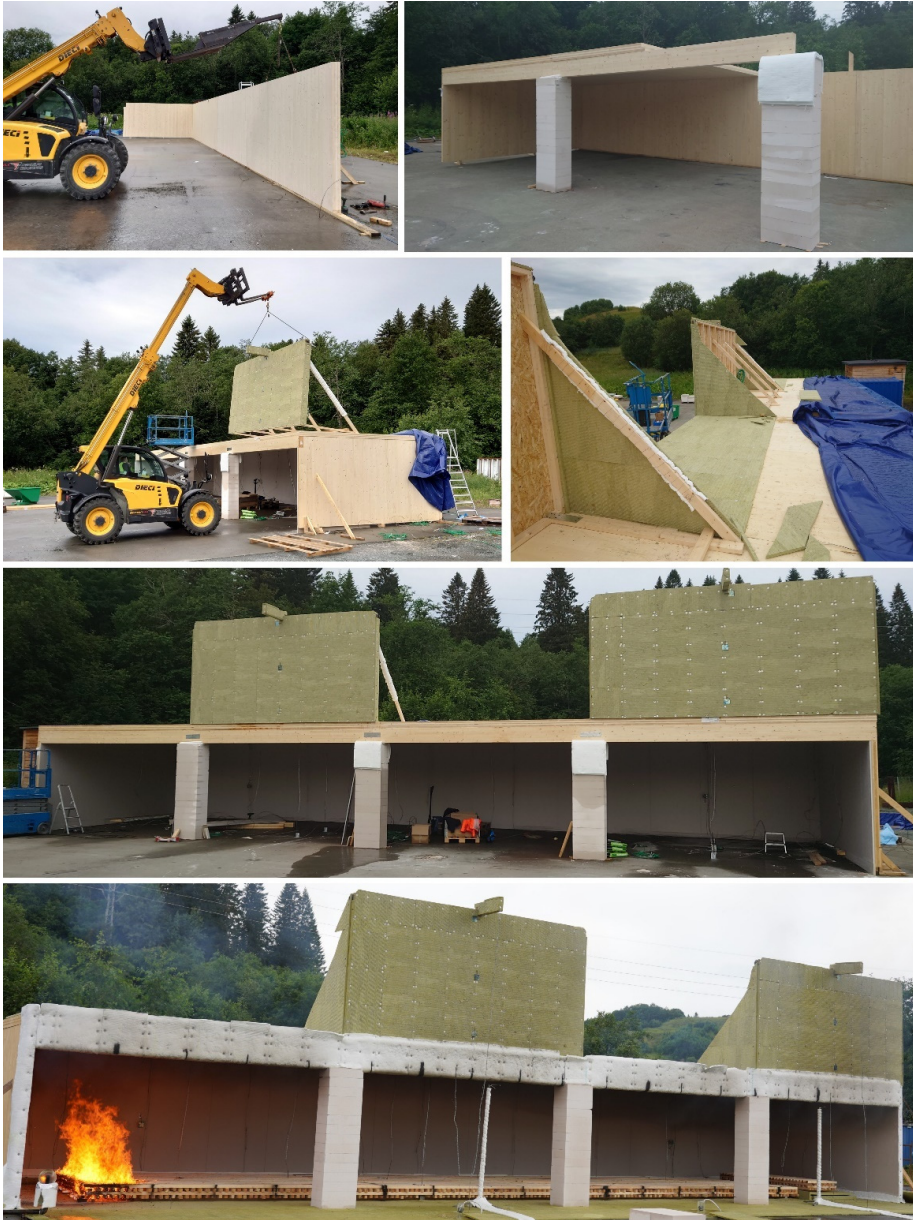
Fig. 46 Images from the rigging of the compartment and the final experimental setup. The image at the bottom is from #FRIC-01.

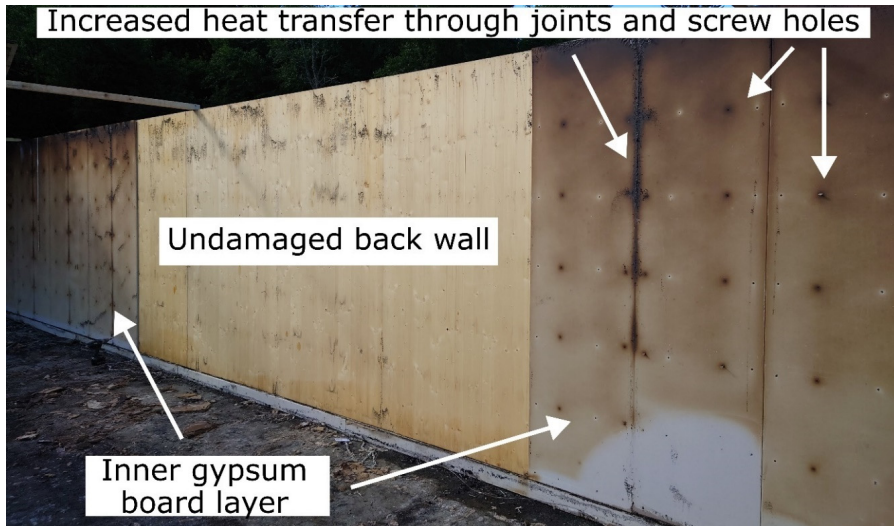
Fig. 48 The CLT back wall appeared undamaged after #FRIC-01 when the two gypsum board layers protecting it were removed. The gypsum boards shown belonged to the innermost layer. Increased heat transfer was seen at the joints between gypsum boards at the outermost layer and through the screws at which the outermost layer was fixed to the CLT.

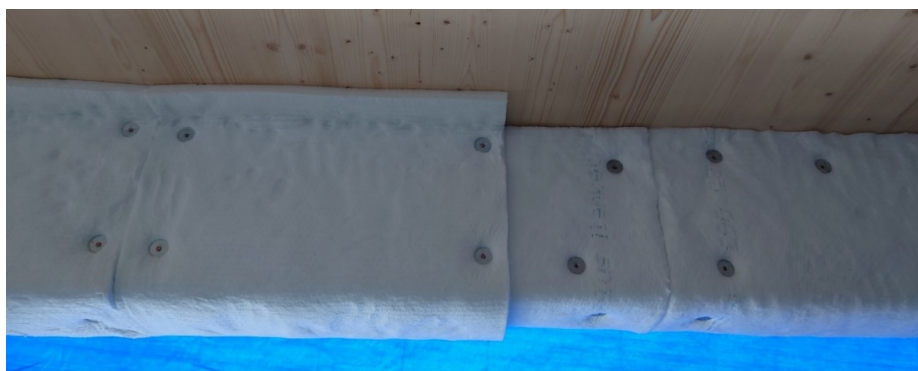
Fig. 49 The glulam beam was protected with two overlapping layers of 25 mm ceramic fibre insulation. This was sufficient to protect the beam in #FRIC-01.

A glulam beam was located above the window openings to support the ceiling elements and distribute the load to four columns of aerated concrete. The glulam beam was protected with two overlapping layers of ceramic fibre insulation to avoid joints leading directly to the wood, see Fig. 49. This setup protected the glulam beam well after the first experiment, and the beam was reused in the second experiment, but with new insulation. In #FRIC-01, several hot spots were detected by an infrared camera in the corner between the exposed ceiling and the protected beam before extinguishment. After extinguishment in #FRIC-02, smouldering burned a hole through the ceiling at two locations and transitioned to flaming combustion. Thus, it seems likely that the insulation facilitated ideal conditions for those hot spots to occur.

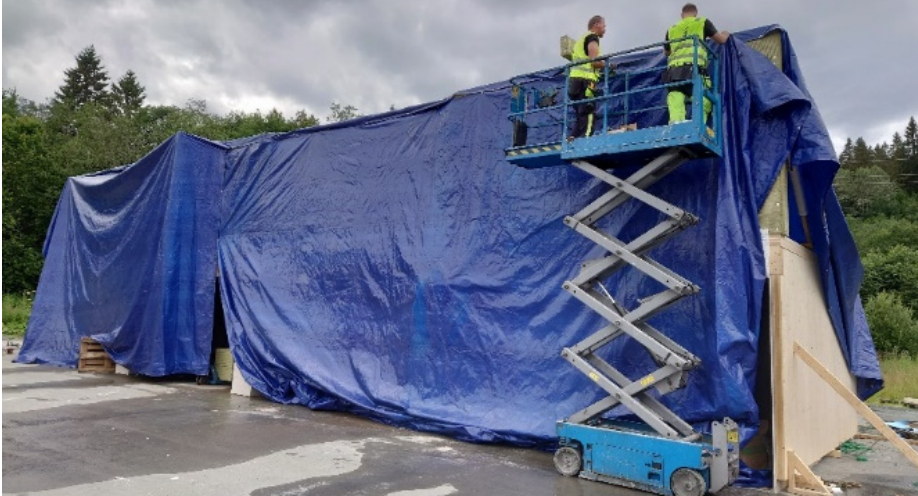
Fig. 50 The compartment was protected against rain with several large tarps.

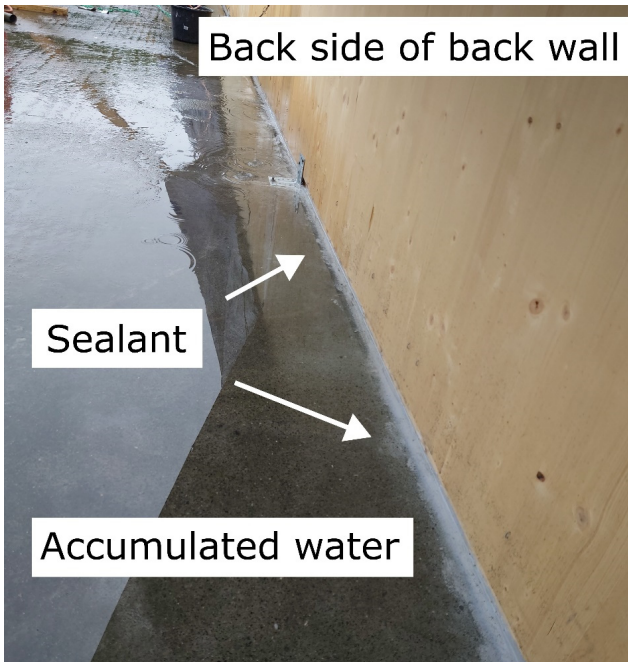
Fig. 51 Accumulated water on the back side of the compartment after a rain shower.

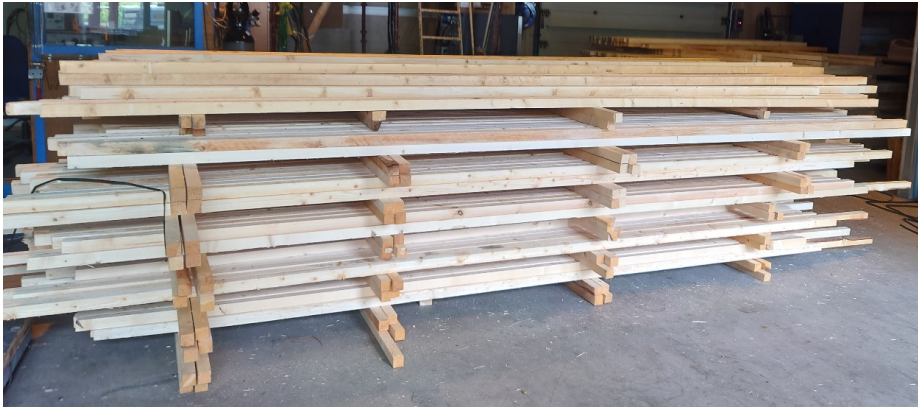
Fig. 52 The wood sticks for the cribs were dried indoors for several months before the experiments.

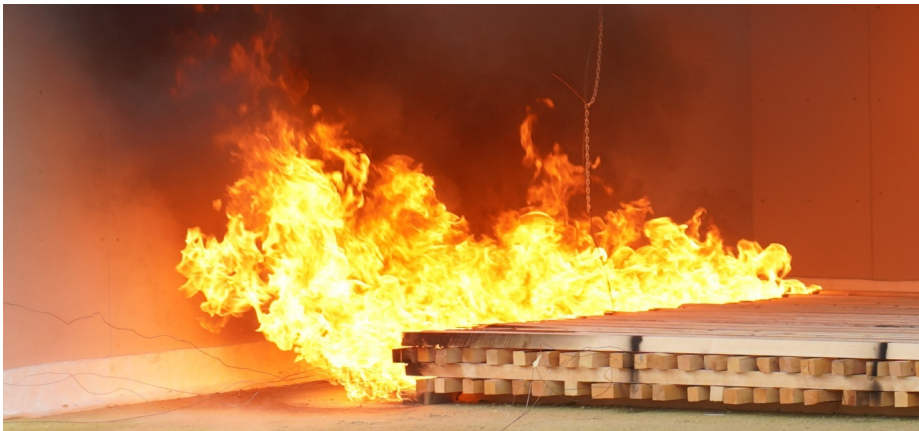
Fig. 53 The heptane fire in #FRIC-01 was tilted away from the wood crib due to local draft conditions, and very little of the wood crib was burning when the heptane fire burned out.

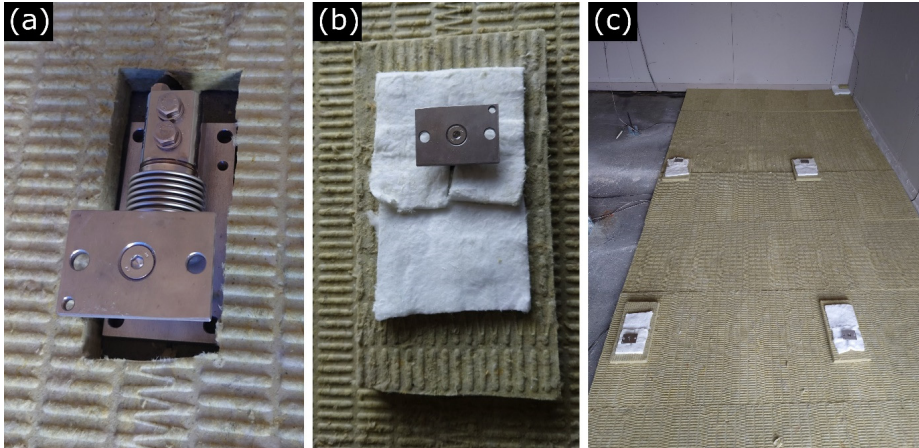
Fig. 54 Thermal protection of the load cells. (a) Load cell positioned on the floor with a stone wool batt around. (b) Load cell further protected with ceramic fibre insulation. (c) Arrangement of the four load cells before the steel plate was added. A layer of ceramic fibre insulation was also added between the top of the load cell and the metal plate (not shown here).

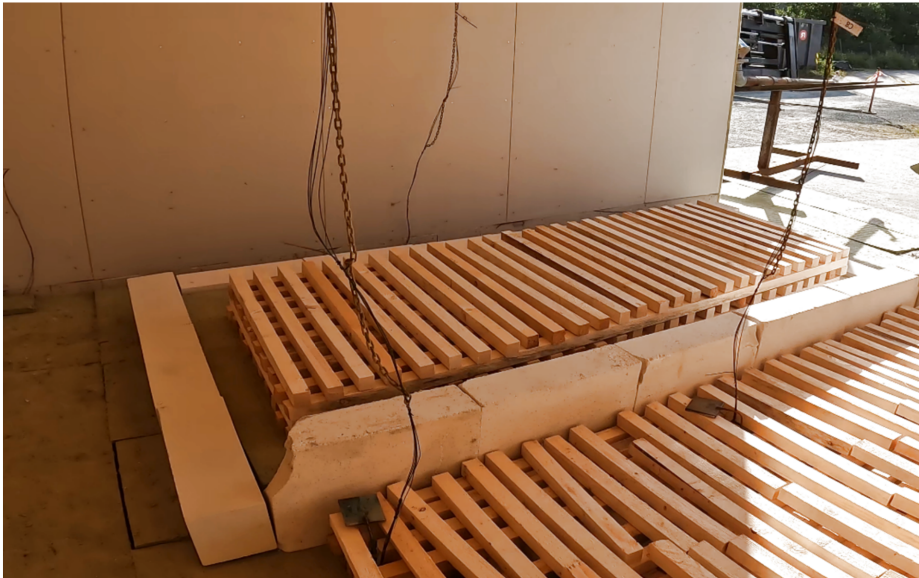
Fig. 55 Image of the small wood crib on the scale. In #FRIC-02, aerated concrete blocks were added to the sides of the scale for better thermal protection.

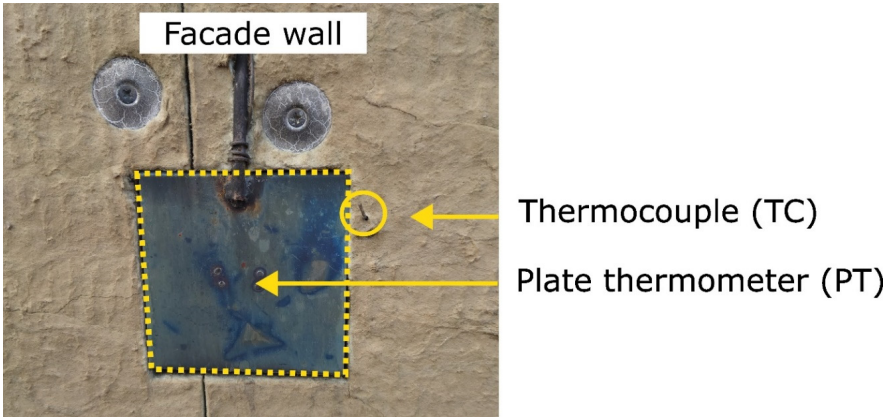
Fig. 59 PT flushed with the facade wall and the TC beside it.

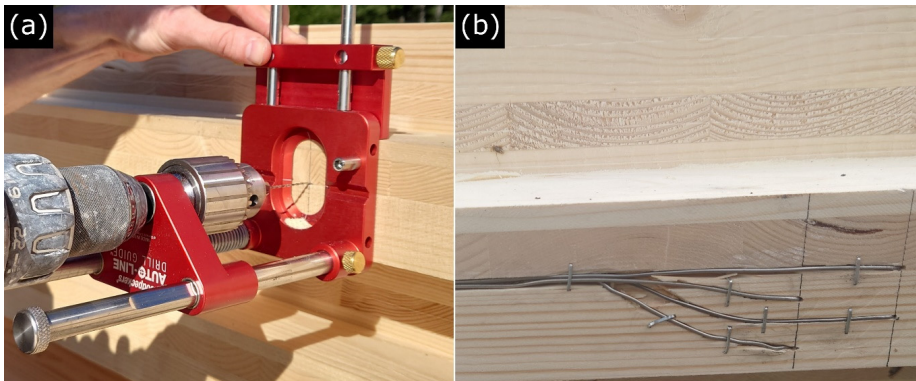
Fig. 60 (a) TCs were embedded from the rebate joint, and the use of a drill guide ensured straightly drilled holes. (b) The TC wires were hidden and protected in precut slits.

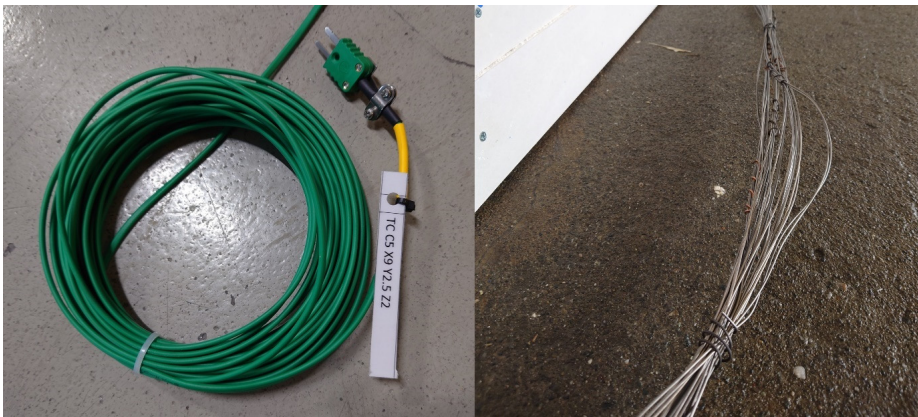
Fig. 61 All sensors were named adequately by a unique ID and organised in bundles.

When conducting experiments with many sensors, in this case around 150, it is crucial to have full control over them. Thus, each single sensor was adequately labelled with a unique name, which also served to identify its exact location in the compartment. Also, to avoid a mess with all the running TC wires, they were bundled, as shown in Fig. 61.

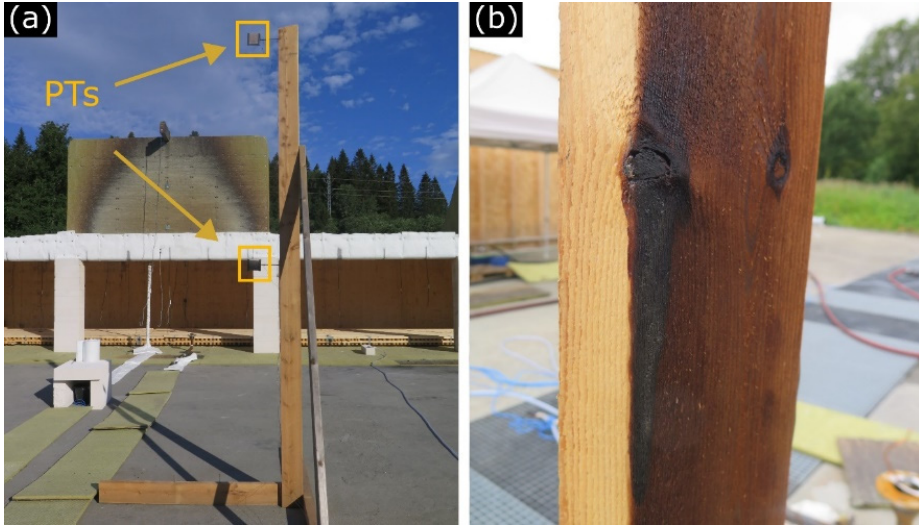
Fig. 63 (a) Plate thermometers (PTs) 8 m away from the centre of the compartment. (b) Clear signs of charring and discolouring of the wooden board at the front side.

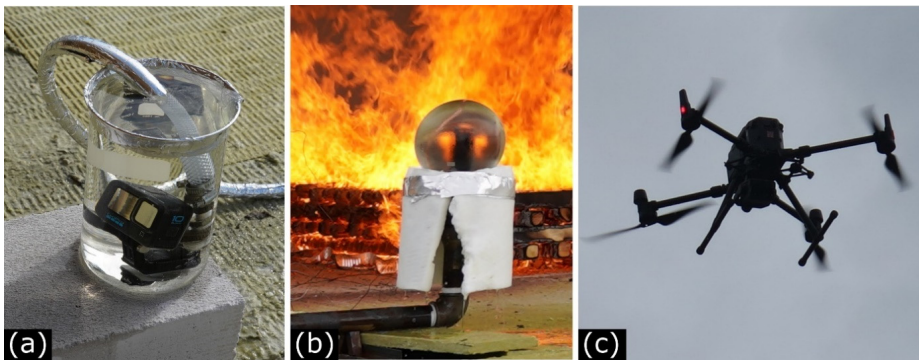
Fig. 64 Examples of cameras used. (a) A GoPro camera inside a Pyrex column with recirculating water. (b) A water-cooled 360 camera inspired by Hoehler [90]. (c) A drone.

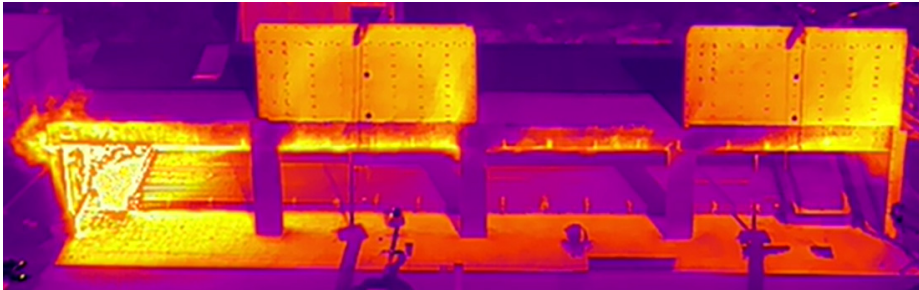
Fig. 65 Infrared image of the compartment before ignition of the ceiling in #FRIC-02. The colour differences at the wood crib gives an indication of how much of the crib that is affected by the initial fire.
