Experimental investigations on
fire
performance of the engineered
wood
products cross-laminated
timber and
I-joists

Doctoral thesis

NTNU
Norwegian University of Science and Technology
Thesis for the Degree of
Philosophiae Doctor
Faculty of Engineering
Department of Civil and Environmental
Engineering

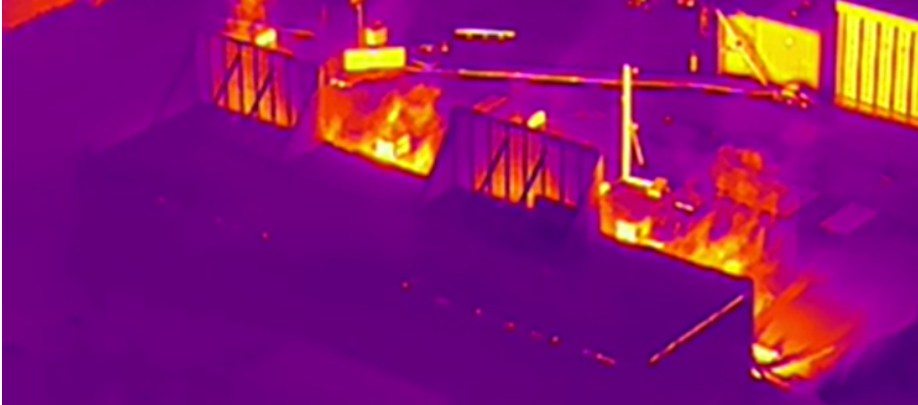
Fig. 67 The infrared camera revealed leakage points at several locations between the wall and the ceiling intersection in #FRIC-01. Here, the temperatures at the back side of the facade walls appear more even between the two facade walls.

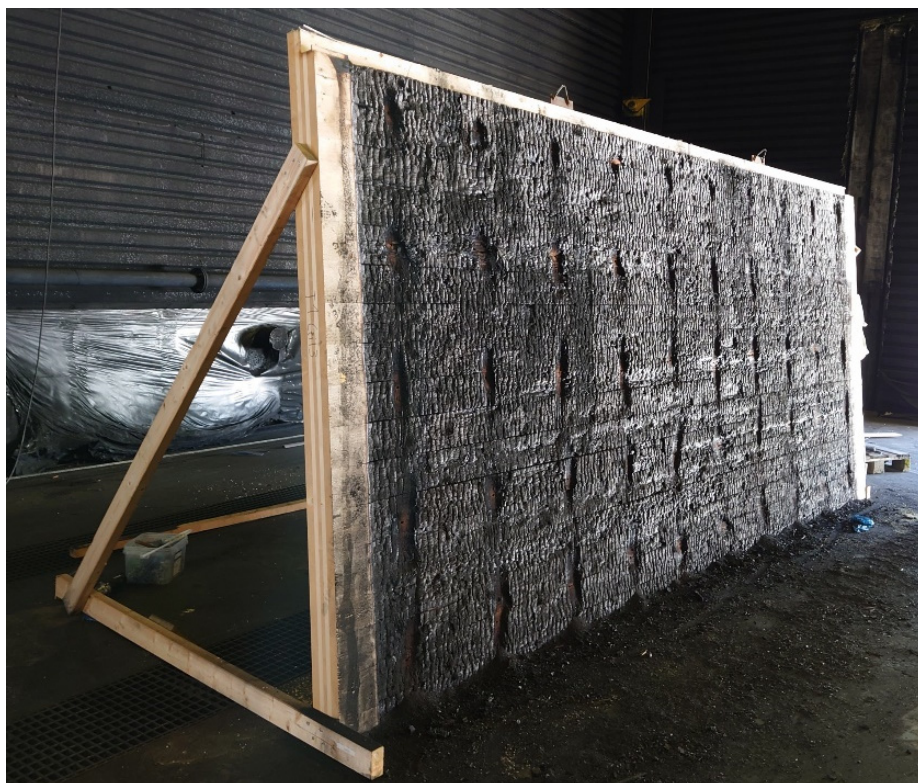
Fig. 68 The elements were raised for easy access from both sides. The vertical stripes are signs of the physically removed char layer around the drilled holes. The element at the picture is one of the ceiling elements from #FRIC-01.

The drilling and the measurements were mainly performed when the elements were standing, see Fig. 68, as the elements in this way could be reached from both sides.

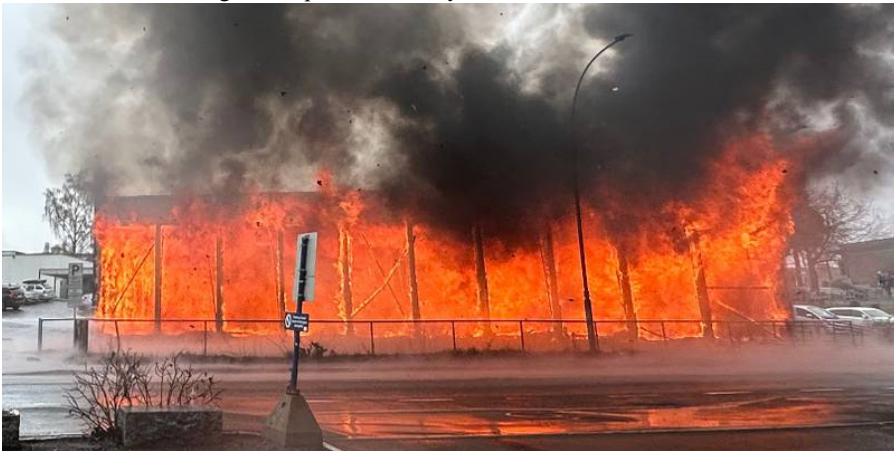
Fig. 69 Massive fire at Lambertseter school gym. Here, all windows have been broken. The image was taken approx. 16 minutes after ignition. Photo: Glenn Berggren, used with permission.

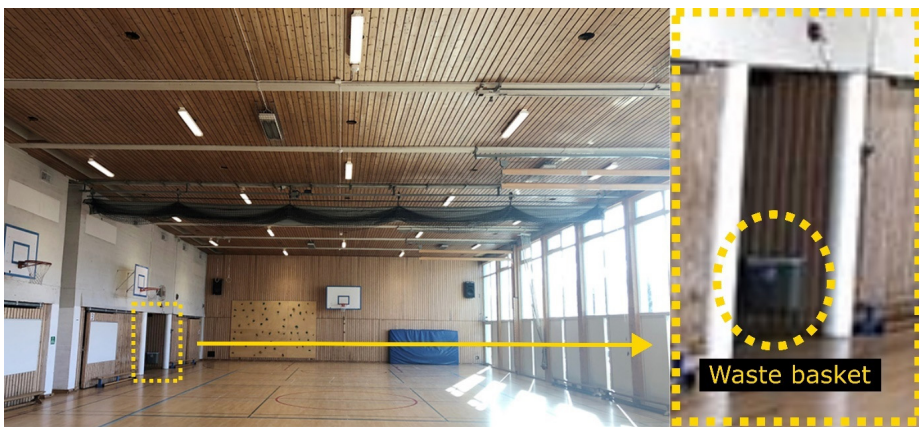
Fig. 70 Image of Lambertseter school gym before the fire. The fire started in a waste basket similar to the one highlighted. The location was in another entrance corridor more to the left of the image perspective. The image is edited with permission by SG AS [109].

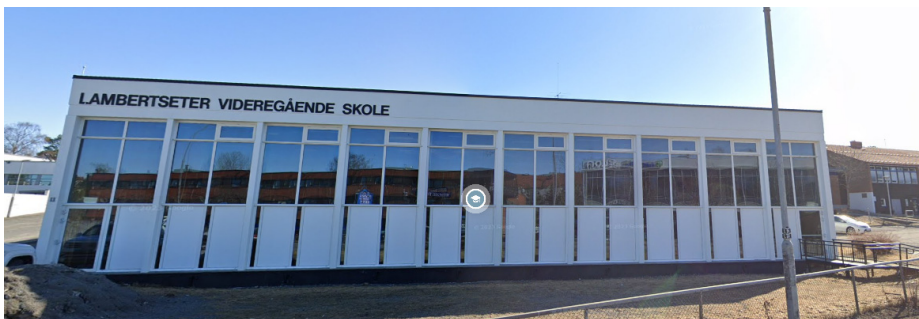
Fig. 71 The window wall of the school gym before the fire. The door to the left was blown open by the pressure. Photo: Google Maps/Google Street View.

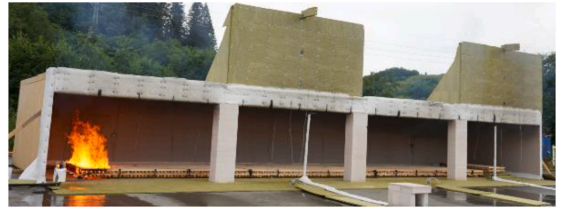
Fig. 2. The compartment with the burning wood crib fire before the ceiling was ignited. The small crib is at the right end of the compartment. The fire shows at which end the wood crib was ignited.

The wood crib was ignited, as described in Section 2.2.3. The heptane flames had a height of 1.0–1.5 m in the beginning and tilted towards the left end wall, away from the wood crib. This behaviour of the flames is believed to be due to local draft conditions. The heptane fire caused the formation of a thick black smoke layer below the ceiling across the entire compartment, and a slight discolouring was observed in the CLT ceiling closest to the left end wall. However, the ceiling did not ignite. The fire gradually decreased in size from around 2.5 min after ignition of the heptane, and the smoke layer was diluted. At 3.5 min, the heptane fire burned out, and the wood crib fire almost died out, with only 5 cm high flames over the first 5 cm length of the crib. During the next 30 min, the fire spread slowly and grew in size to cover about 1.5 m length of the crib, covering an area of approx. 3 m² and the crib fire base area stabilised at this size after 22 min, see Fig. 8. The base area of the fire was here defined as the length of the burning crib (i.e., the position of leading-trailing edge) multiplied by the width of the crib. The base area stabilised at approx. 3 m² because the fuel in the first part of the crib was burning out. The flame height during this period varied from 0.5 to 2.2 m, and flames were not impinging the ceiling, see Figs. 2 and 8.

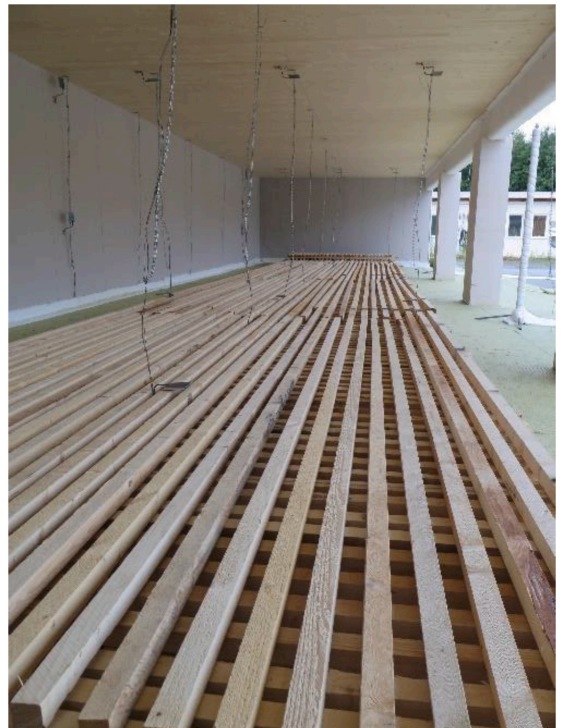
Fig. 3. View from inside the compartment, showing the large wood crib, the exposed CLT ceiling and the protected walls. The glulam beam (above window openings) is covered with ceramic fibre insulation, creating a reservoir height of 0.36 m.

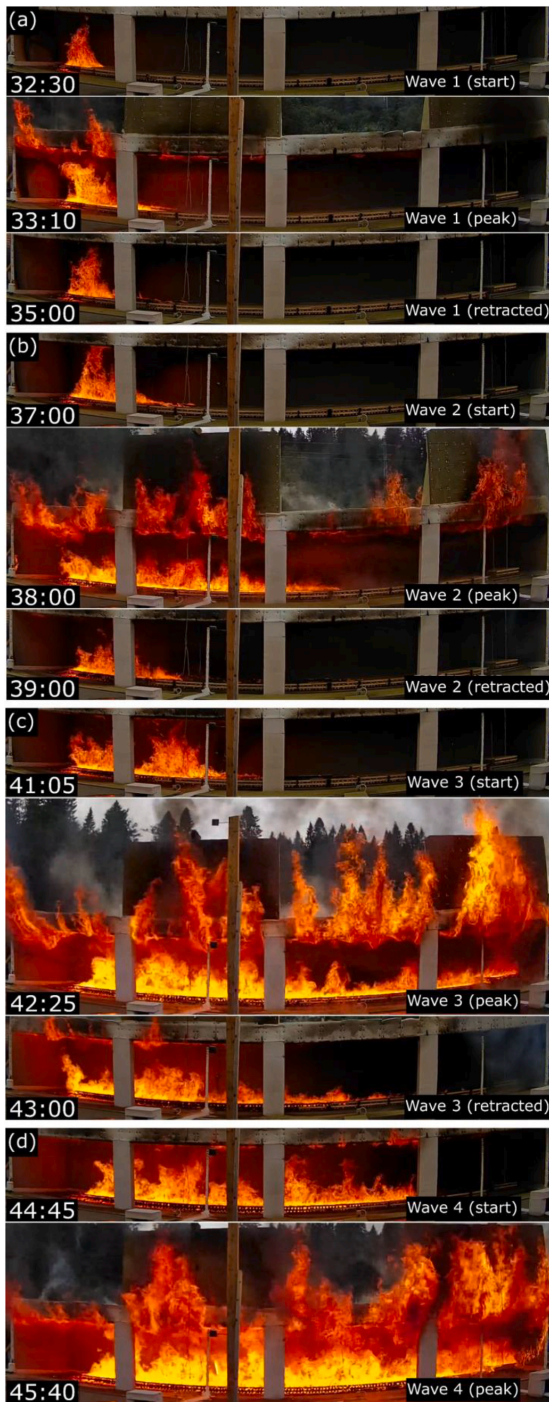
Fig. 9. (a), (b), (c) and (d) represent the 1st, 2nd, 3rd and 4th flashing waves, respectively. Time is given as (mm:ss) after ignition.

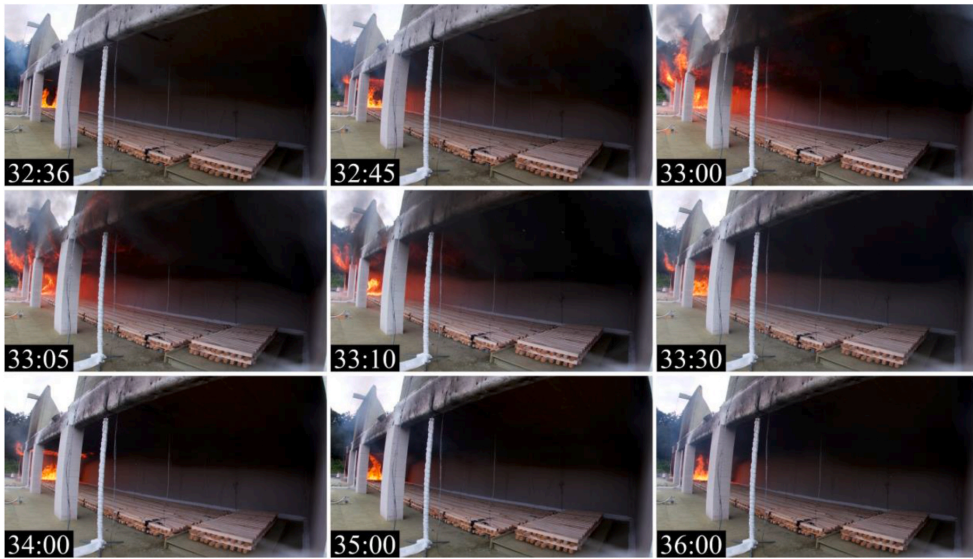
Fig. 10. Development of the 1st flashing wave. The ceiling ignites at 32:36, and within 30 seconds, flames reach almost to the end of the compartment. Flames retract after a short period. Time is given as (mm:ss) after ignition.

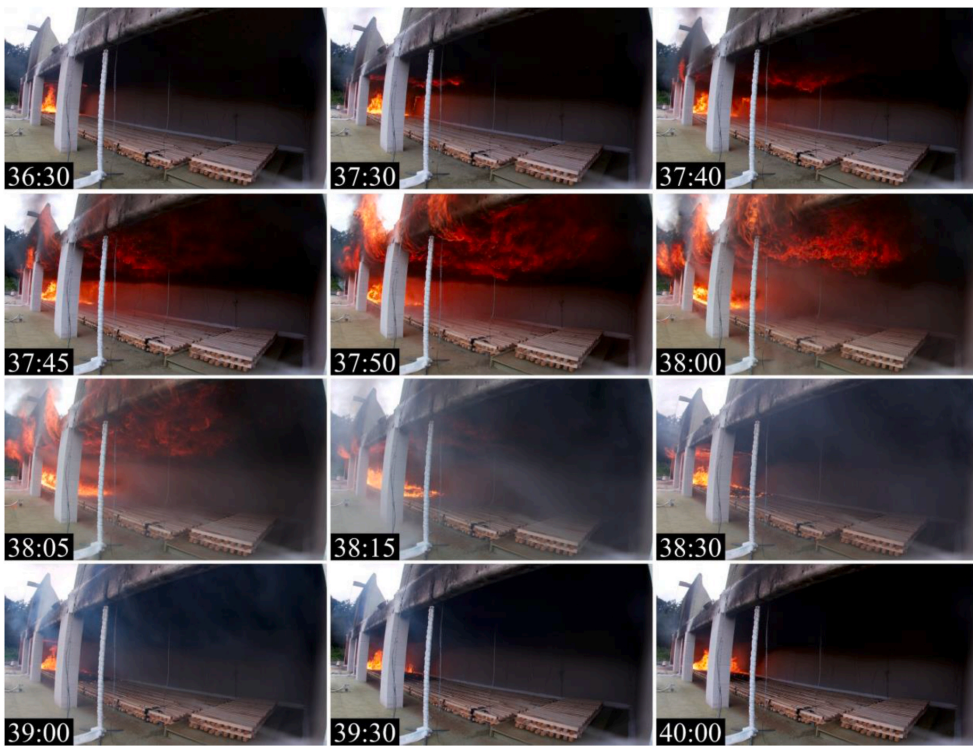
Fig. 11. Development of the 2nd flashing wave. At ~36:30, the ceiling reignites, and the flames spread below the ceiling by burning the combustible gases of the smoke layer. After a short, intense burning, the flames in the ceiling and top of the wood crib retract. Time is given as (mm:ss) after ignition.

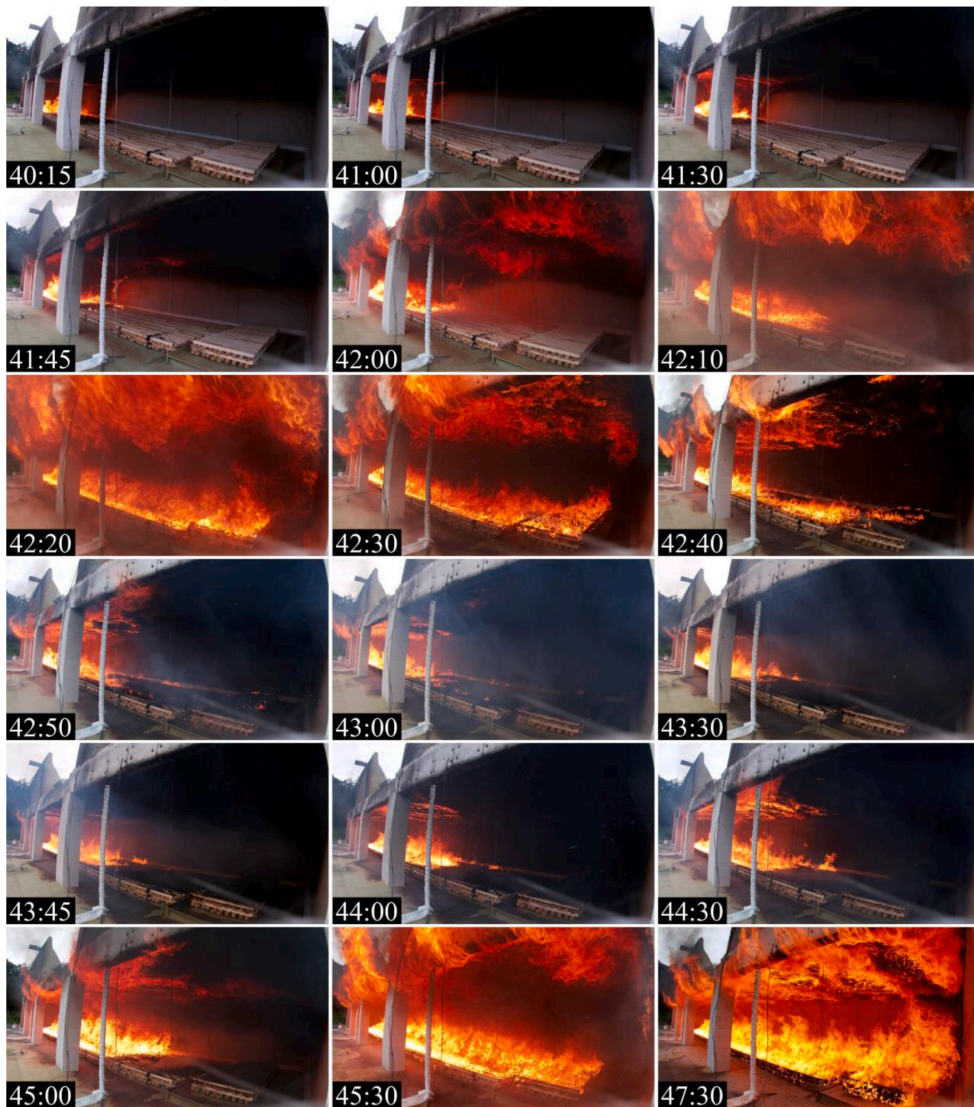
Fig. 12. Development of the 3rd and 4th flashing wave. Initiation of the 3rd wave occurs with reignition of the ceiling at ~40:15. Within 2 minutes, the flames have spread to cover the entire ceiling and crib. After a few seconds of the entire compartment burning, the flames below the ceiling and on top of the crib retract. The 4th wave occurs shortly after the retraction of the 3rd and leads to a stable flashover. Time is given as (mm:ss) after ignition.

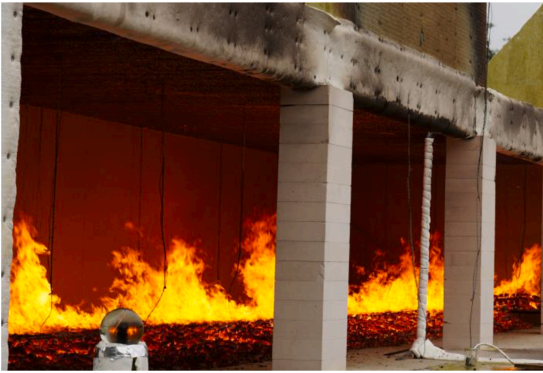
Fig. 13. Cessation of flaming combustion in the ceiling occurred while the wood crib was still burning. Photo from 62 min.

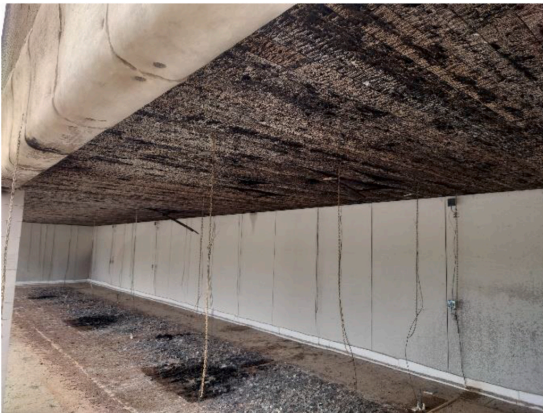
Fig. 14. Compartment after burn-out of the wood crib. No gypsum boards had fallen down, and the wood crib was completely consumed.

95–240	Decaying temperatures, no visible flames, and no re-ignition.	Fig. 14

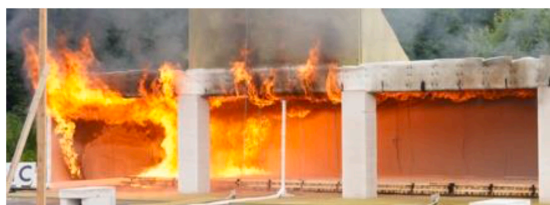
Fig. 18. During the first flashing wave, the heat exposure to the walls was sufficient to ignite the paper of the gypsum boards on the walls close by.

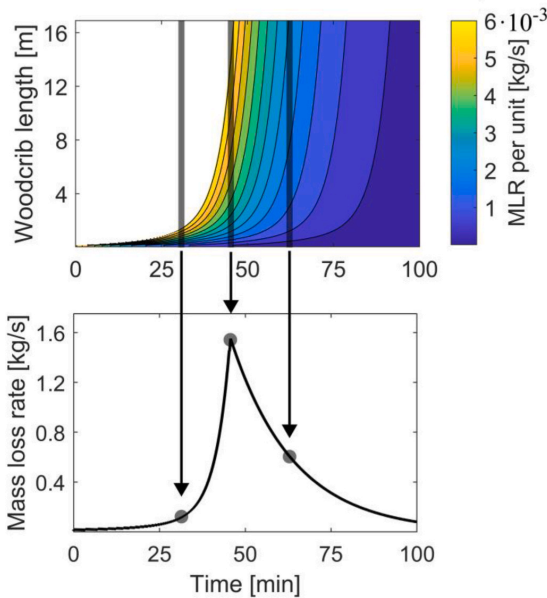
Fig. 29. Illustration of how the mass loss rate for the whole wood crib was determined. At the top, the MLR per unit length is represented by contour lines as a function of time and wood crib length. The curve is a combination between Figs. 24 and 28. By summation over the MLR per unit length for all wood crib units at one time point (illustrated by grey lines), the MLR for the given time point is generated (grey dots).

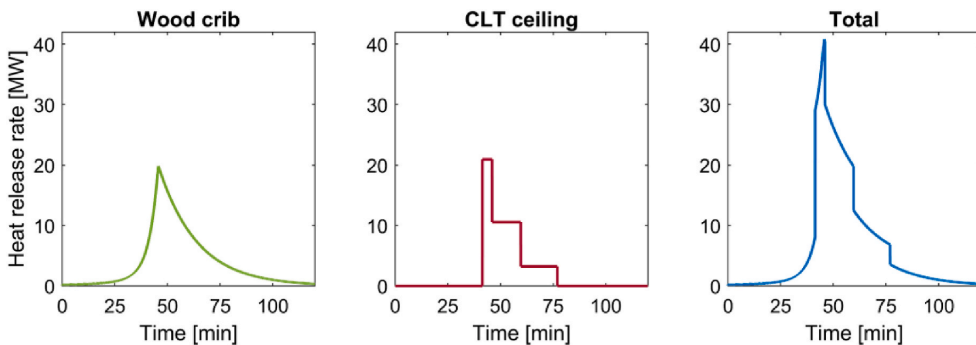
Fig. 30. Estimated heat release rates of the wood crib and the CLT ceiling.

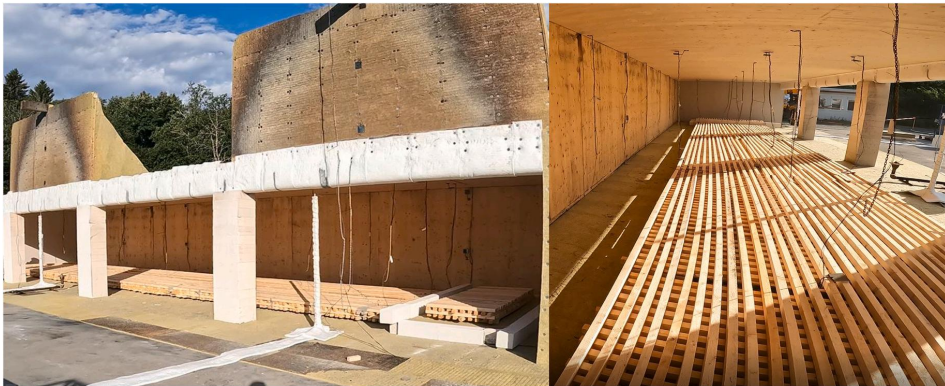
Fig. 1. Experimental setup from the outside and inside of the compartment. The small wood crib on the scale is on the right side of the left image.

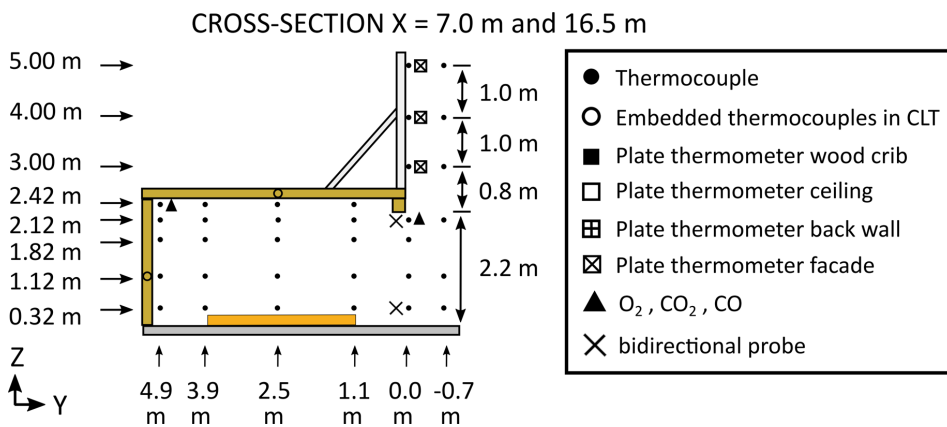
Fig. 3. Instrumentation in the YZ-plane (cross-section) at X = 7.0 m and 16.5 m. For X = 16.5 m, only gas measurements in the window opening. Figure from #FRIC-01.

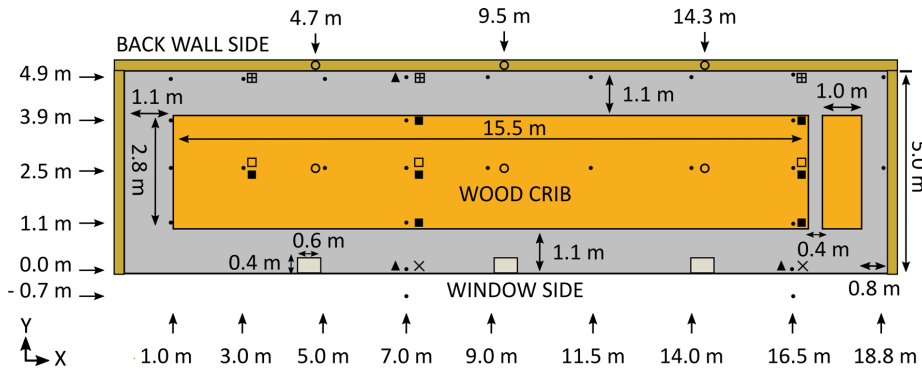
Fig. 4. Instrumentation in the XY-plane (plan view). For symbols, see Fig. 3. Figure from #FRIC-01.

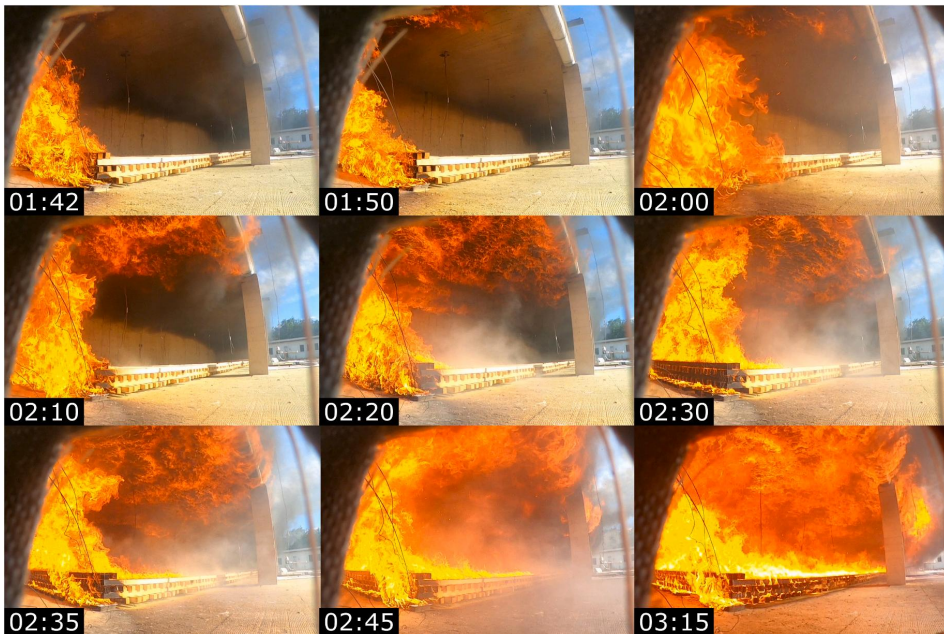
Fig. 6. Flame spread below the ceiling after ignition of CLT seen from the left side of the compartment. Time (mm:ss).

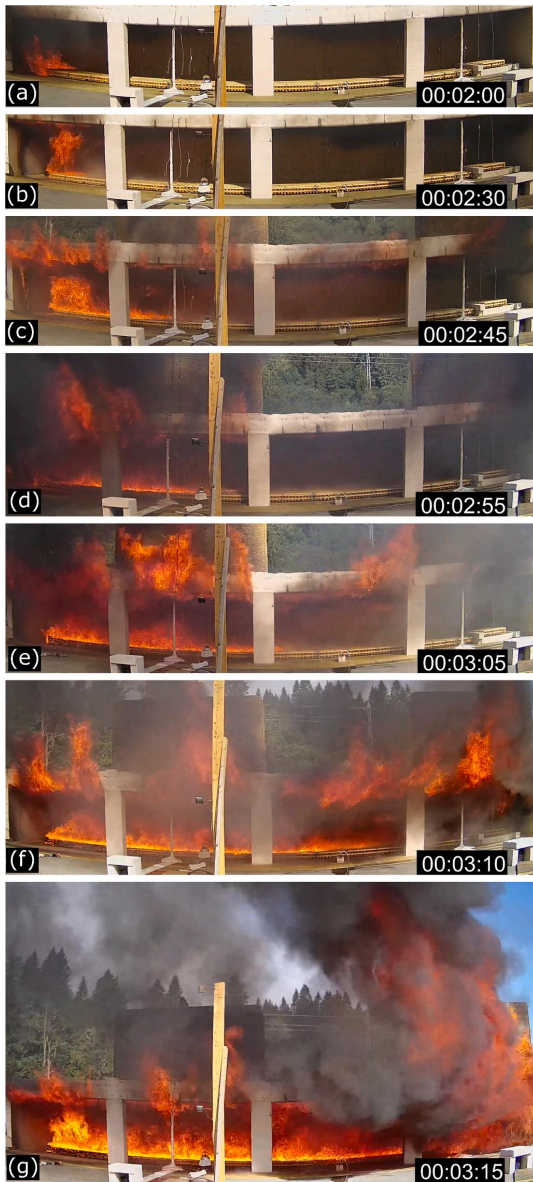
Fig. 7. (a)–(g) Fire spread across the compartment. Time (hh:mm:ss).

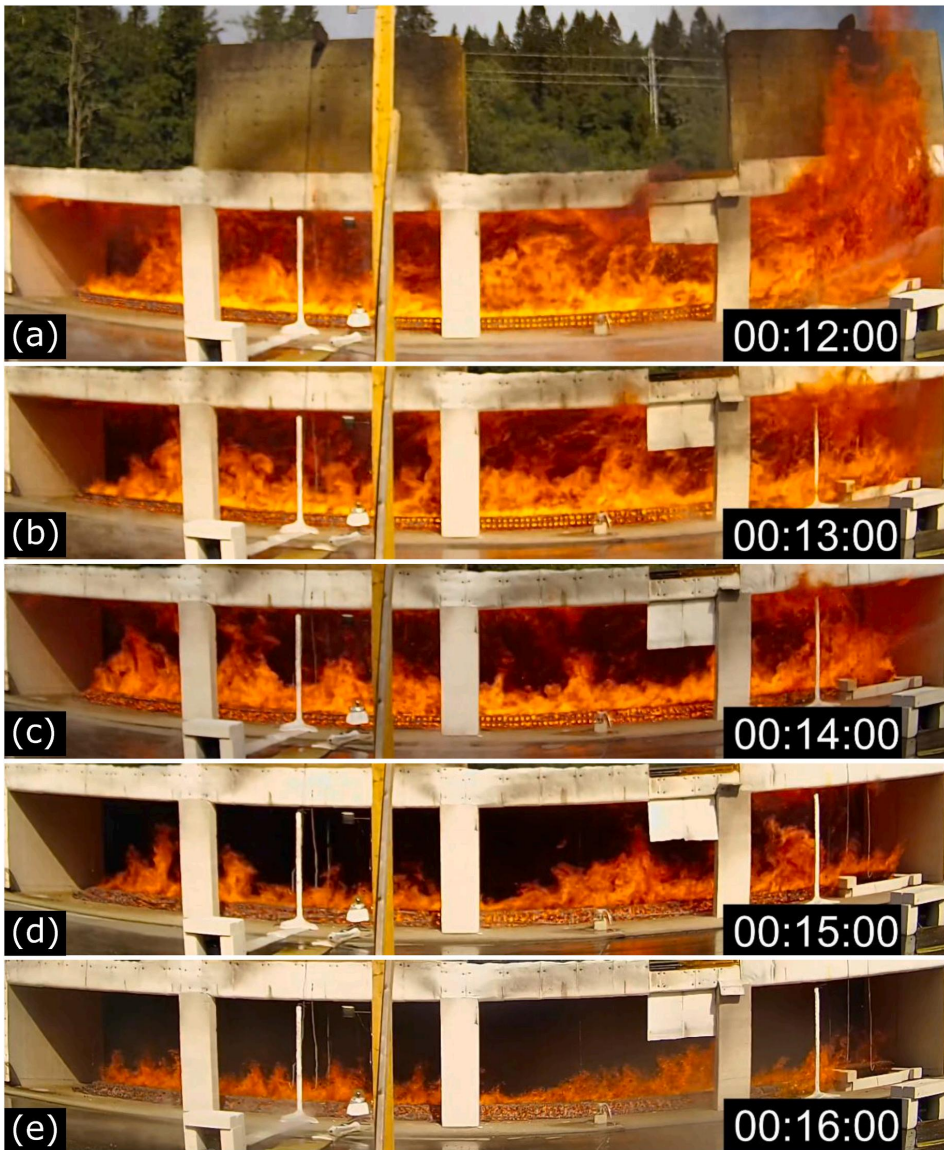
Fig. 8. (a)–(e) Development of self-extinguishment of CLT while wood crib was still burning. Time (hh:mm:ss).

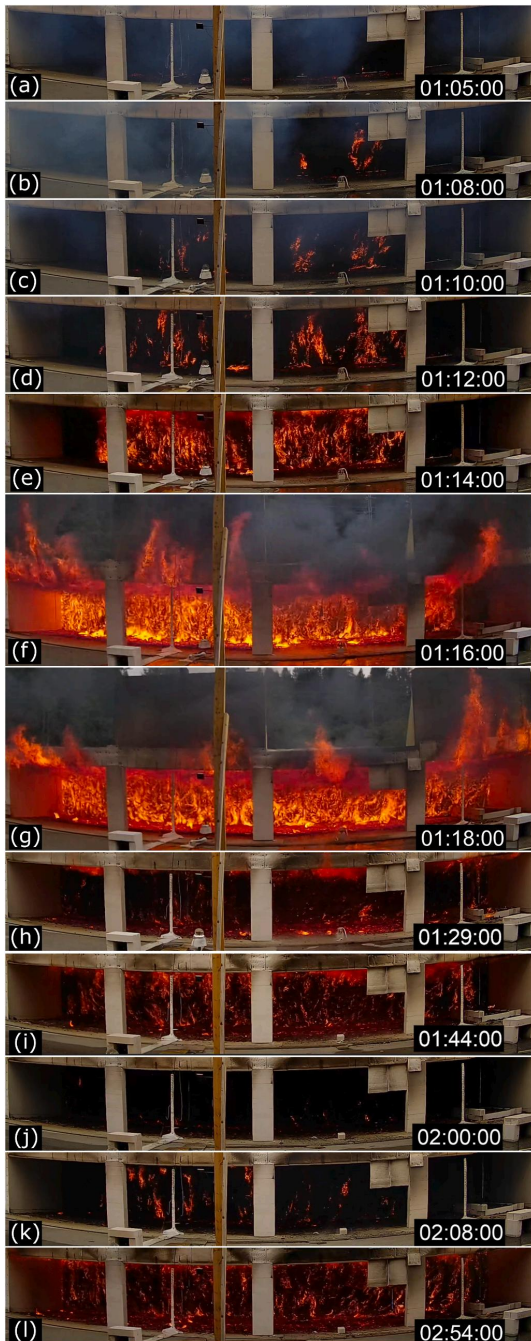
Fig. 9. (a)–(l) Development of the second flashover. (j) Fire intensity at its minimum. (k) Fire intensity at minimum compartment temperature. Time (hh:mm:ss).

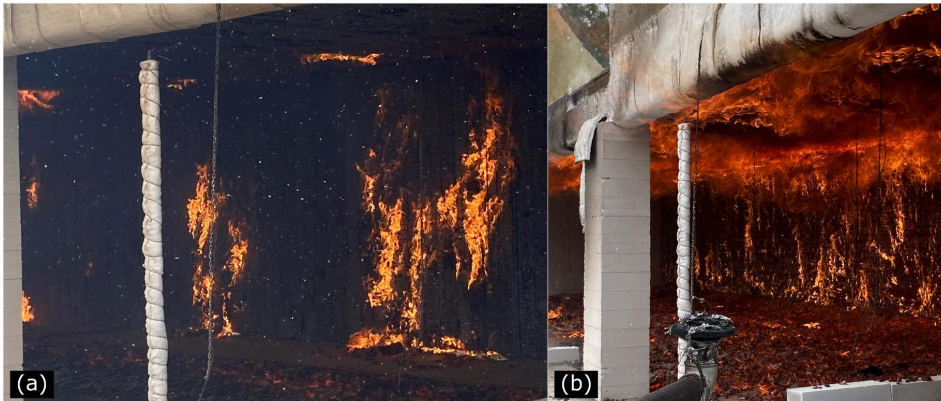
Fig. 10. (a) The first flames leading to the second flashover appeared at the lower part of the back wall and in the innermost part of the ceiling. (b) Ceiling and wall burning, and glowing embers on the floor from falling pieces. Photos were taken at 70 min (a) and 93 min (b).

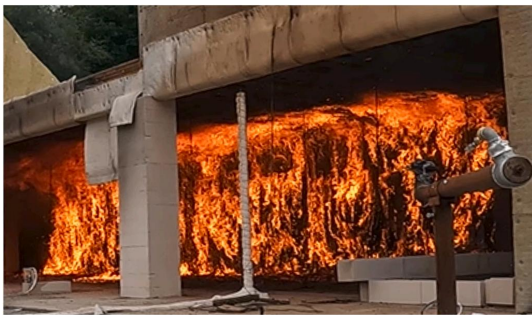
Fig. 11. In the transition to the second flashover, the full height of the back wall was burning before half of the ceiling width had been included in the fire. Photo from 74 min.

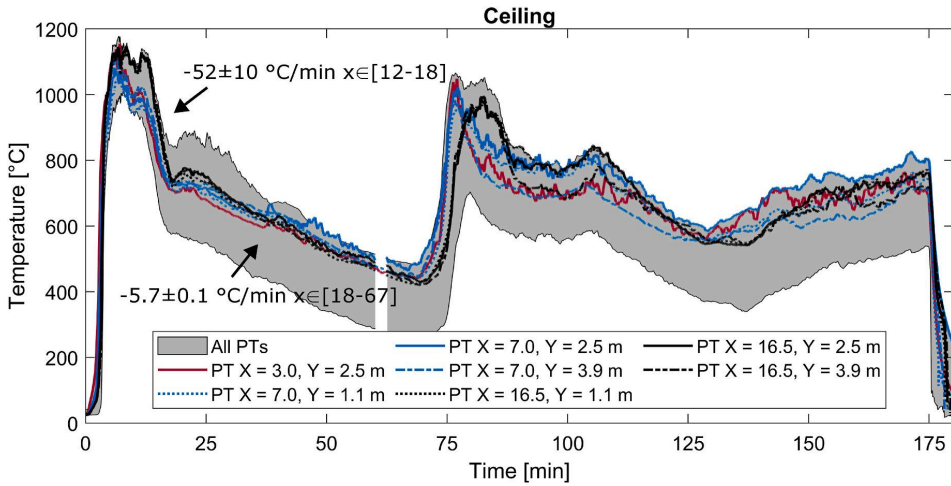
Fig. 12. Temperatures 100 mm below the ceiling measured by PTs facing downwards. The grey area covers all measurements by PTs in the compartment. X and Y represent the position of the PTs.

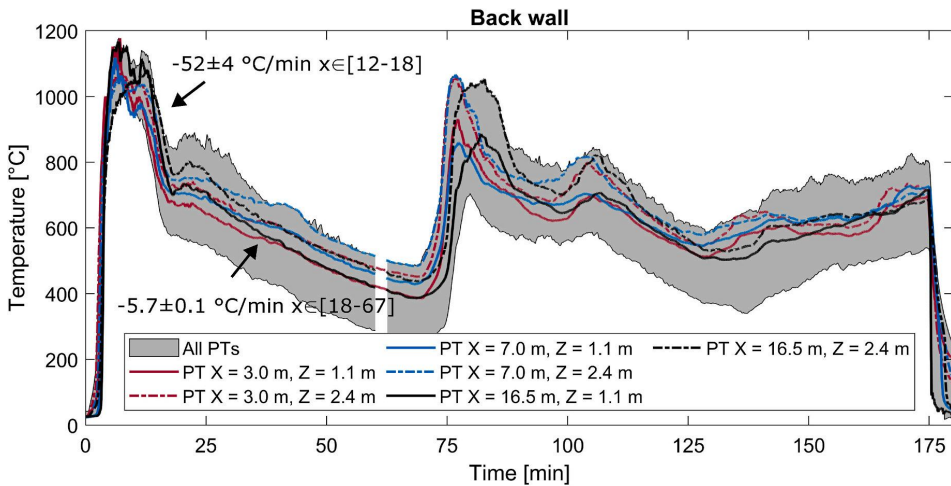
Fig. 13. Temperatures 100 mm in front of the back wall measured by PTs facing away from the wall. The grey area covers all measurements by PTs in the compartment. X and Z represent the position of the PTs.

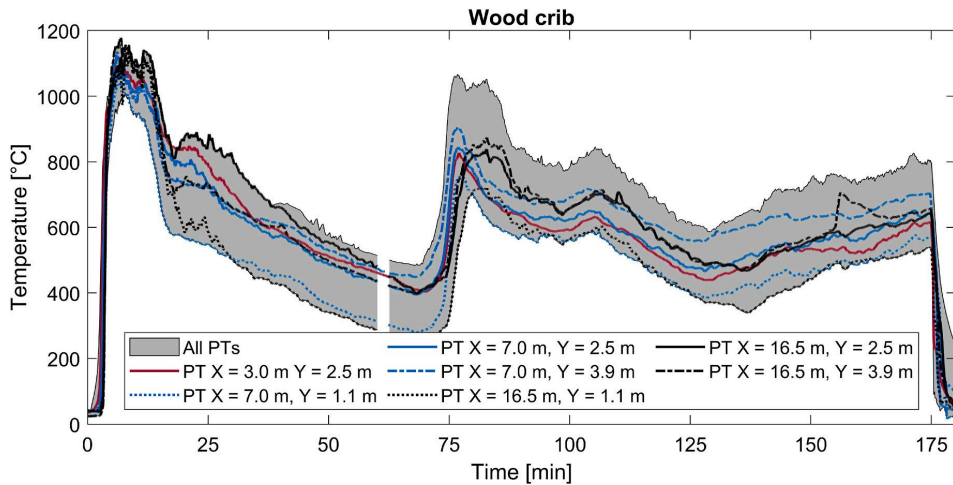
Fig. 14. Temperatures on top of the wood crib measured by PTs facing upwards. The grey area covers all measurements by PTs in the compartment. X and Y represent the position of the PTs.

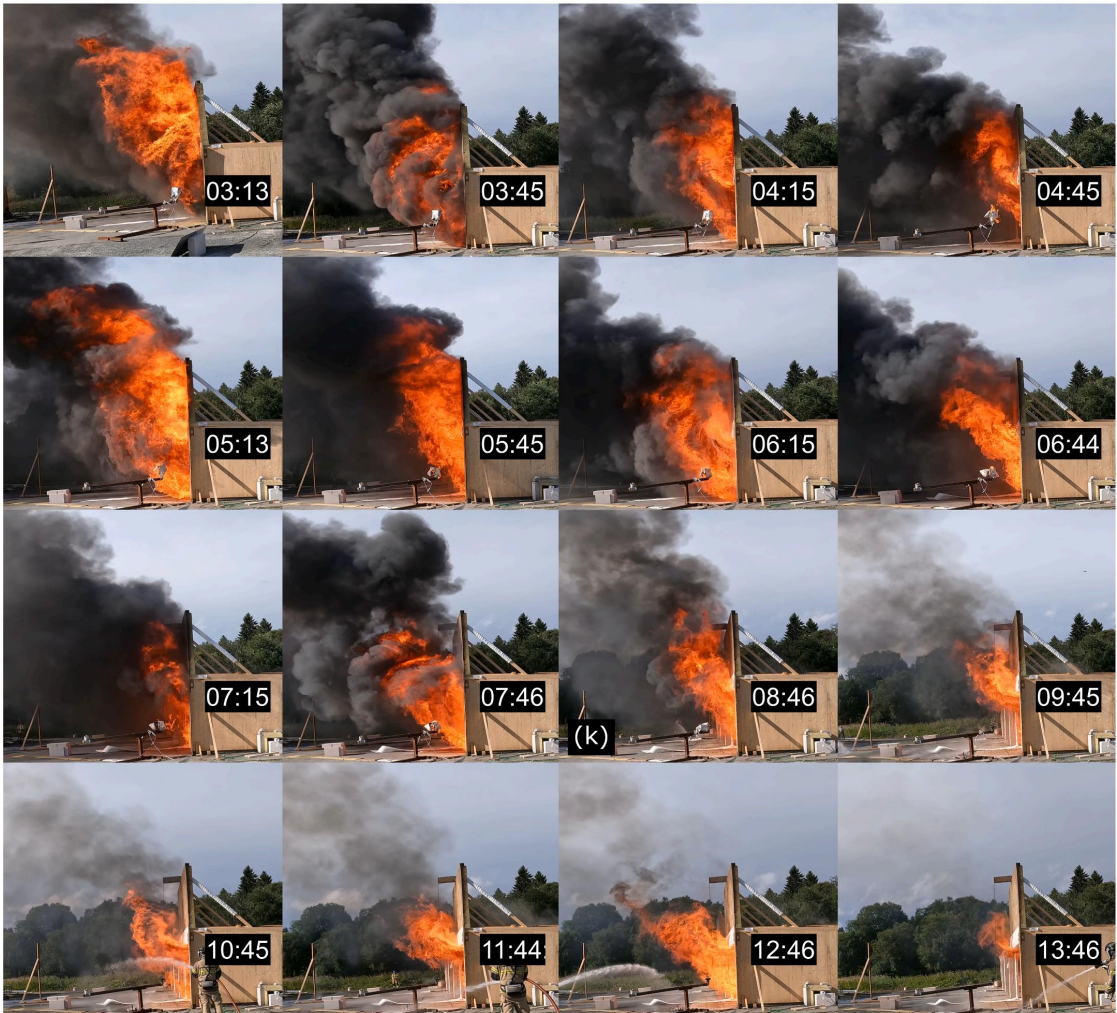
Fig. 18. Side view of external flame emerging from Window 4. Time (mm:ss) after ignition. The given times might deviate slightly (± 1 s) from the exact times as the start of ignition was not recorded.

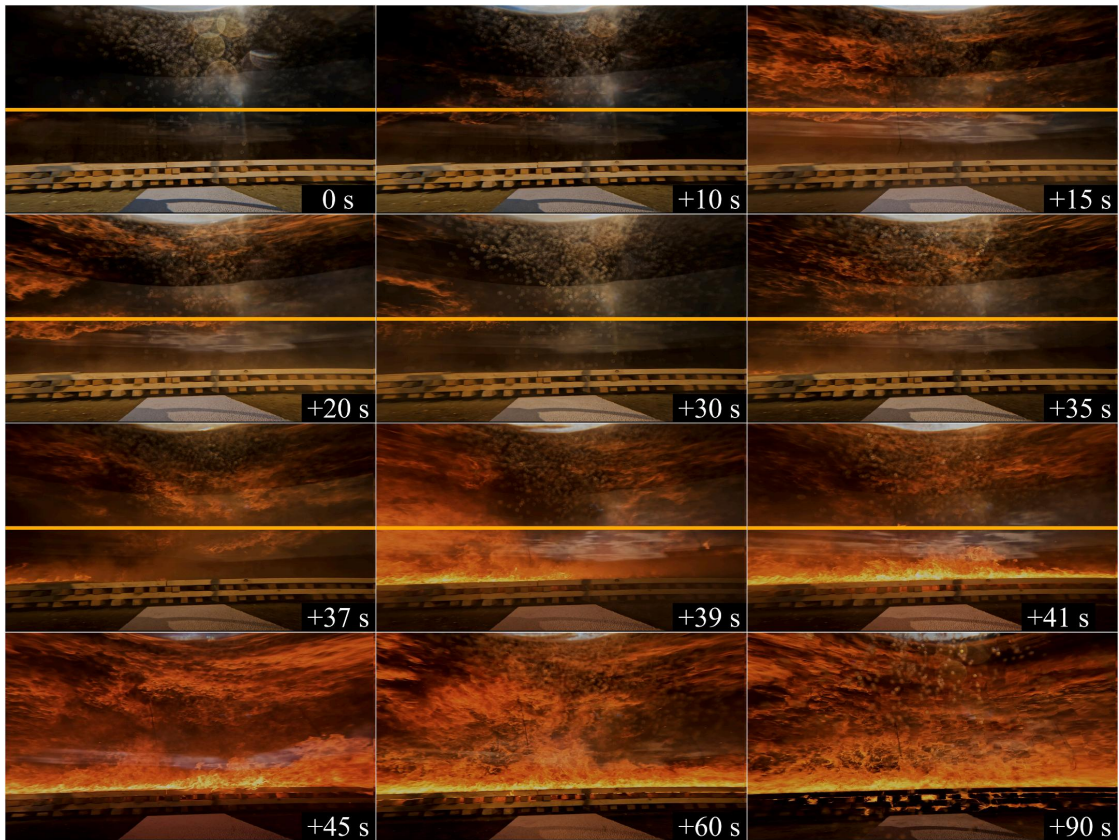
Fig. 26. The images show the fire spread sequence in the compartment. The fire spreads first across the ceiling and the upper part of the wall and then down the wall. The top layer of the wood crib ignites at about the same time the flames on the wall reach the wood crib level. The yellow line shows the top of the wall. The given time represents the number of seconds after the flame first occurs below the ceiling in this video frame. The camera was located at floor level in the centre of Window 3 inside a water-filled Pyrex column. (For interpretation of the references to colour in this figure legend, the reader is referred to the Web version of this article.)

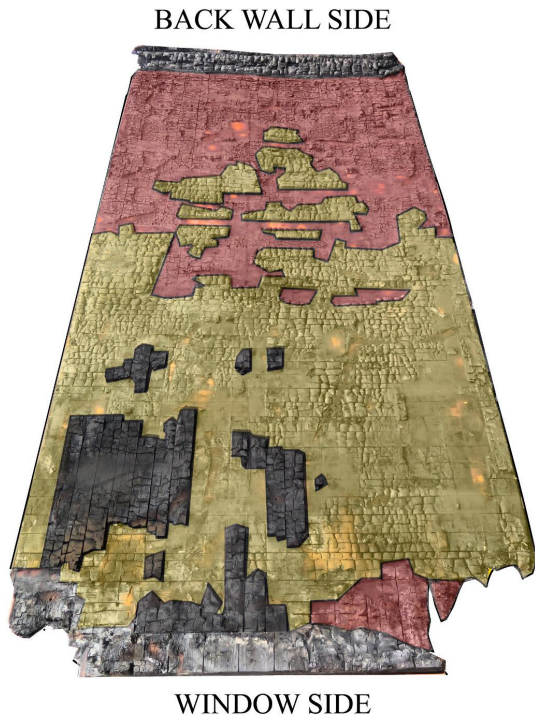
Fig. 30. Visualization of non-uniform charring for one CLT ceiling element based on a photo. Black is the 3rd layer, yellow is the 4th, and red is the 5th layer. The holes at the right and left lower corners of the window side were caused by smouldering and reignition after the end of the experiment, as this part was hard to reach with water due to safety precautions. (For interpretation of the references to colour in this figure legend, the reader is referred to the Web version of this article.)

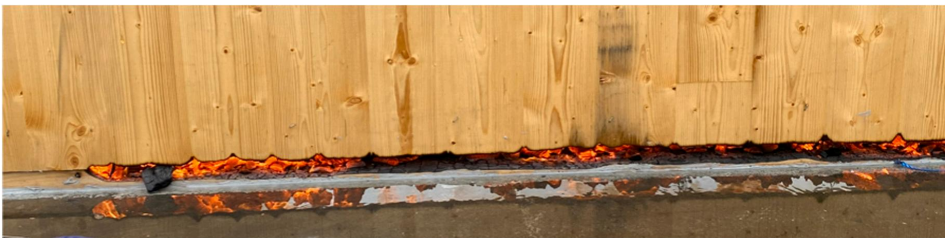
Fig. 31. The fire burned through the intersection between the back wall and the bottom plank at approximately 60 min. The image is taken at a later point when the gap had become larger. The lack of a fire sealant between the bottom plank and the CLT wall enabled this and highlights that connection details are crucial to fire safety.

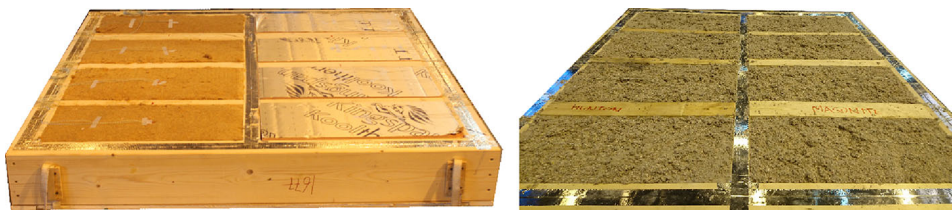
Figure 4. Left: Test specimen filled with wood fibre batt on the left half side and phenolic foam batt on the right half side. Right: Test specimen filled with wood fibre loose-fill insulation (manually packed) between the Hunton I-joists (left) and Masonite I-joists (right). The fibreboard is not installed.
