Influence of Prior Corrosion on the Fatigue Behavior of Recycled Al

Master's thesis in Mechanical Engineering

Norwegian University of Science and Technology
Faculty of Engineering
Department of Mechanical and Industrial Engineering

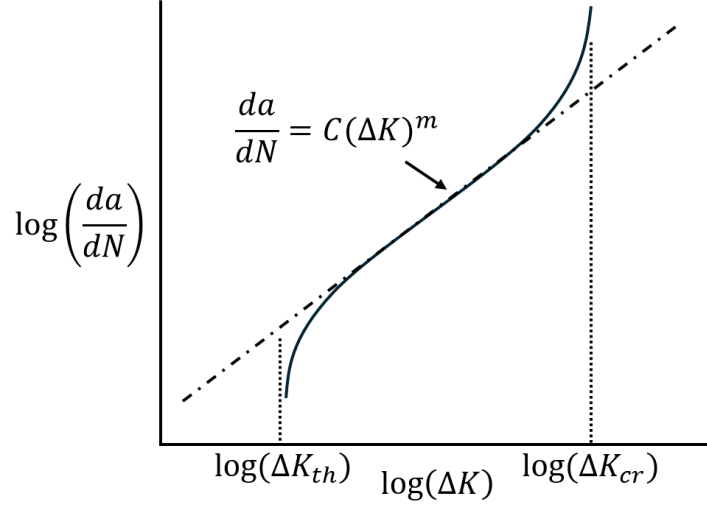
Figure 3: Crack growth rate curve. Made by author.

The Paris law is valid within the stable crack propagation phase of fatigue. In the crack initiation and early crack propagation phase this law does not apply. The Paris law also does not apply for the unstable crack growth seen in the last cycles before final failure. Figure 3 shows the shape of curve relating da/dN to ΔK , where the Paris law is applicable for stable growth area in the middle of the curve. The curve starts from ΔK_{th} , which is the threshold stress intensity factor required for a crack to propagate. The curve ends at ΔK_{cr} , which represents the critical stress intensity factor required for fracture of the remaining cross section.

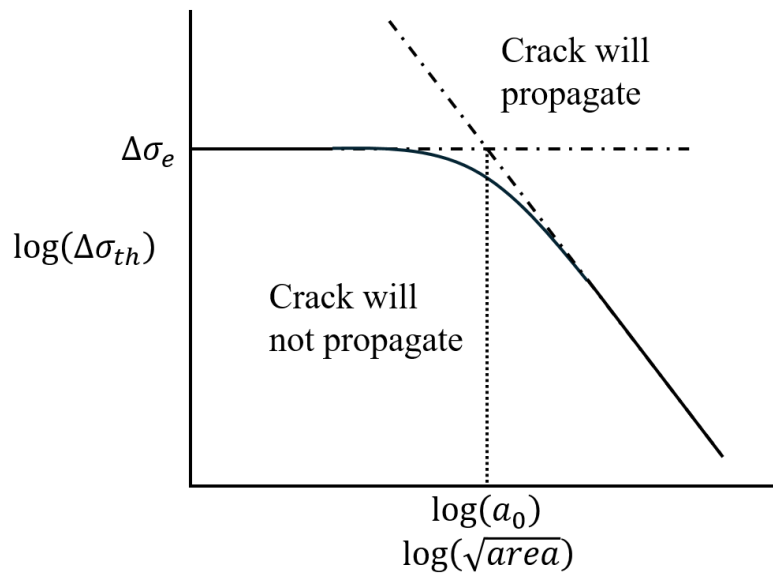
Figure 4: Kitagawa-Takahasi (KT) diagram. Made by author.

As mentioned, if the alternating stress is sufficiently low, a crack will not initiate. However, with a crack or defect already present, the threshold stress level for this crack to propagate will be affected. A Kitagawa-Takahasi (KT) diagram shows the threshold stress range as a function of defect area [27]. Figure 4 shows a KT-diagram. Up to certain defect size, a_0 , the threshold stress for crack propagation is independent of defect area and remains at the endurance limit. Over this defect size, the threshold stress is controlled by the defect area.

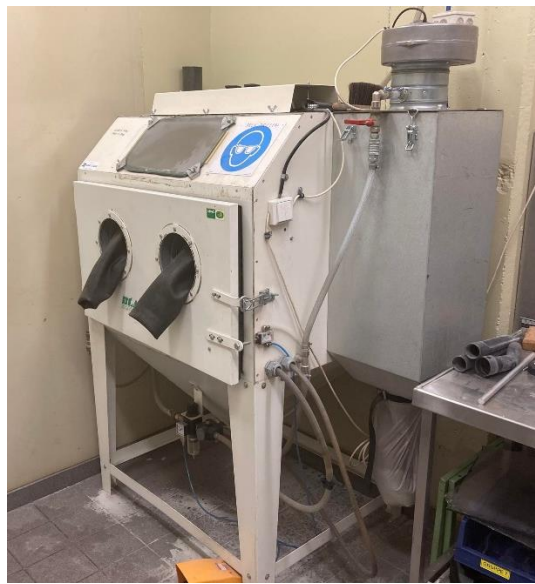
Figure 7: Sand blasting cabinet.

Glass bead blasting was done by hand in a sand blasting cabinet. Figure 7 shows the sand blasting cabinet used. The glass beads used had a size of 150-200 μm . The air pressure was approximately 300 kPa. Glass bead blasting of aluminum with these conditions should not remove any material from the surface. This was confirmed by weighing one specimen before and after glass bead blasting. Weighing showed a negligible weight loss of under 5 μg for a sample initially weighing 19.480 g. The glass bead blasting step was done before pre-corrosion and machining to fatigue specimen dimensions. The material at this stage was blocks of dimensions 77 \times 16 \times 6 mm.

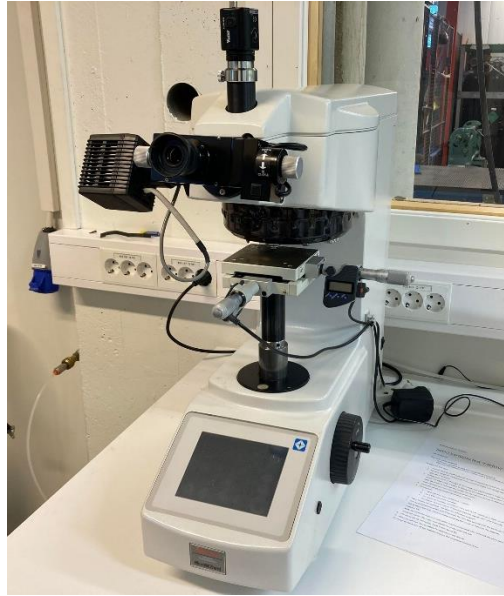
Figure 13: Mitutoyo HM-221 Microhardness testing machine.

To find the microhardness as a function of depth from the surface for the as extruded and glass bead blasted material, specimens were cut to expose their cross section and then ground to a smooth surface finish. Microhardness measurements were done at several depths along three paths going from the surface towards the center of the material. As glass bead blasting was expected to have a considerable impact only close to the surface, measurements were closely spaced at small depths and wider spaced at higher depths. The microhardness testing machine used was a Mitutoyo HM-221, as shown in Figure 13.

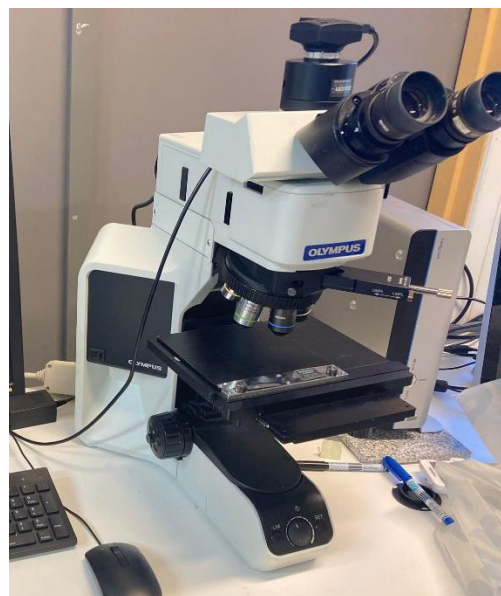
Figure 16: Olympus BX53M optical microscope.

After polishing, the cross sections were observed under optical microscope. The microscope used was an Olympus BX53M, as shown in Figure 16. The front and back sides of the cross sections were carefully examined for corrosion attacks. This means a total of four areas of the surfaces were examined per condition, two cross sections with two sides each. Areas of deep intergranular corrosion were imaged and measured. The measurements were taken from the surface perpendicularly into the material to the deepest point of visible corrosion damage. The three largest depths of intergranular corrosion were recorded for each of the four areas examined.

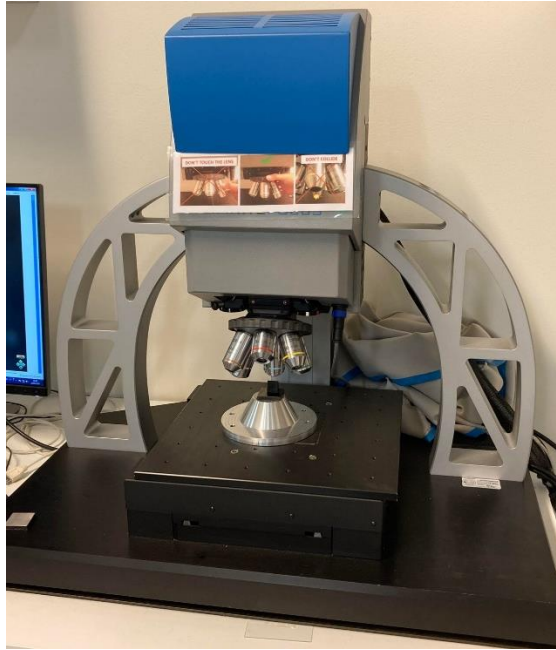
Figure 17: Alicona InfiniteFocus G4 confocal microscope.

To examine the surface topography of each condition tested, sample areas were 3D-mapped with a confocal microscope. The confocal microscope was a Alicona InfiniteFocus G4, shown in Figure 17. One specimen per condition was mapped. The form removal function in the microscope analysis software was used to remove the influence of any potential misalignment between the surface and lens. A profile length on the form removed surfaces was used for calculating the profile surface roughness values. The area surface roughness values were calculated from the entire mapped area. All specimens were mapped with identical microscope settings for consistency. The settings chosen were based on the recommendations in the manual for the confocal microscope. The 20x magnification lens was used for mapping with a vertical resolution of 100 nm. The profile length for calculating surface roughness values was 3 mm. The mapping and profile direction was in the loading direction, perpendicular to the extrusion direction.

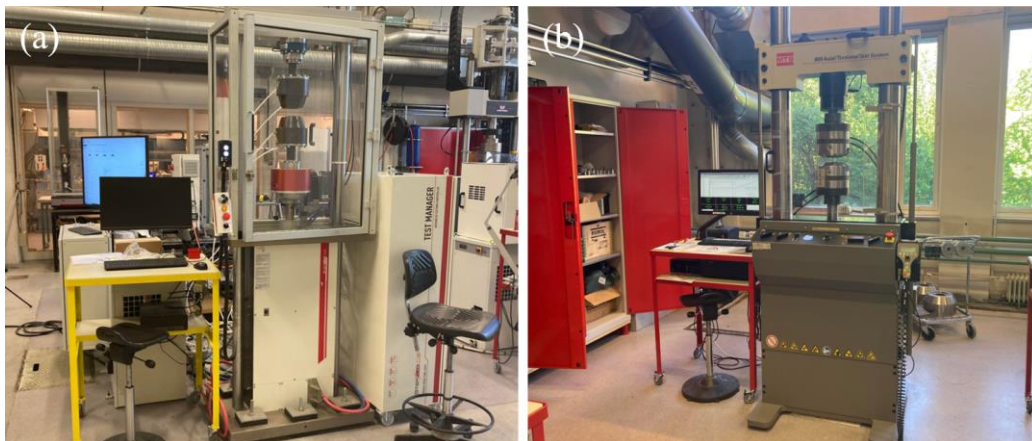
Figure 19: StepLab – Multiaxial 20 kN (a) and MTS 809 Axial/Torsional Test System (b) fatigue testing machines.

To determine the influence of pre-corrosion and glass bead blasting on fatigue behavior, three specimens of each condition were fatigue tested. Fatigue testing was done with axial loading with the same loading conditions for all specimens. As the objective of this study was to investigate fatigue behavior in terms of fatigue life in high cycle fatigue, a loading level giving all conditions fatigue lives in the finite life HCF regime was selected. The stress level used was a maximum cyclic stress $\sigma_{max} = 180$ MPa. The stress ratio was $R = 0.1$. With the specimen cross section being 6×10 mm, the maximum load was $F_{max} = 10.8$ kN and a minimum load was $F_{min} = 1.08$ kN. Due to availability, two different fatigue testing machines were used in fatigue testing. Testing of uncorroded as extruded specimens was done with the StepLab – Multiaxial 20 kN machine shown in Figure 19 (a). Results for uncorroded as extruded specimens were obtained as part of the specialization project. Testing of all other conditions was done with the MTS 809 Axial/Torsional Test System shown in Figure 19 (b). Due to the characteristics of the machines, the loading frequencies used were 25 Hz for the StepLab machine and 10 Hz for the MTS machine. Changes in loading frequency at this magnitude does not influence the fatigue behavior of aluminum in air.

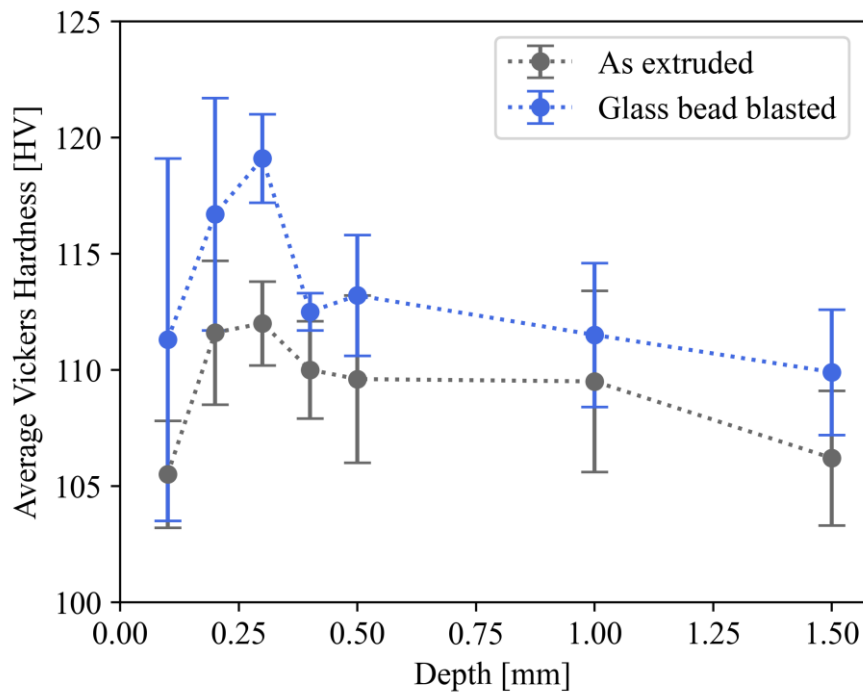
Figure 26: Hardness as a function of depth for as extruded and glass bead blasted surface conditions.

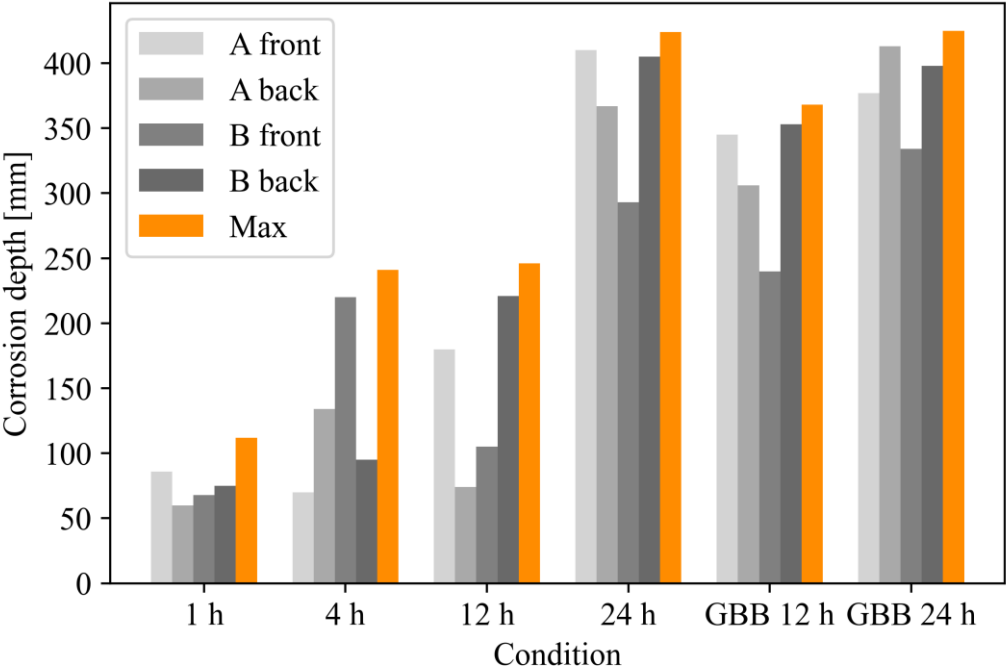
Figure 27: Average of three highest corrosion depths for each area examined compared to maximum depth per condition.

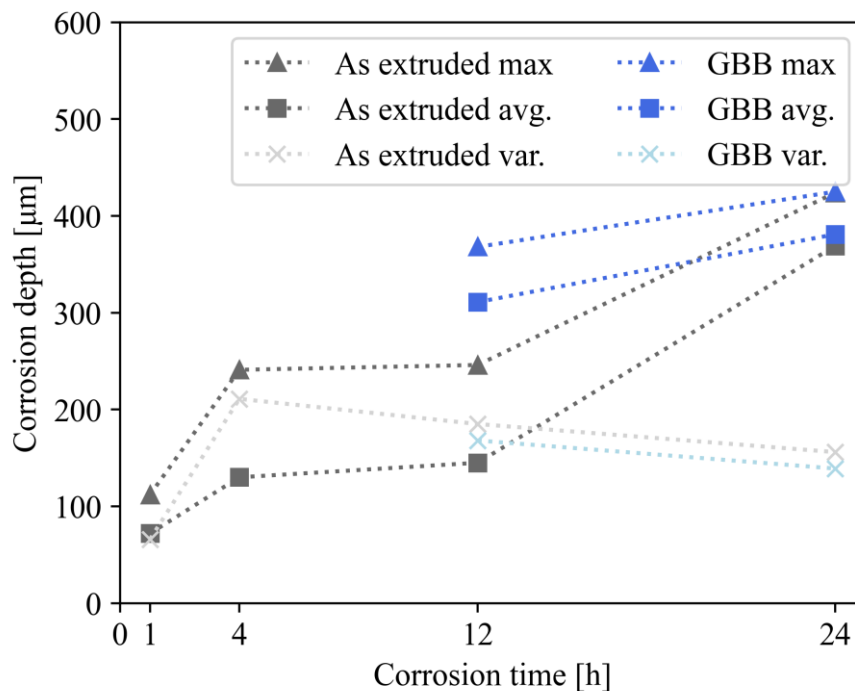
Figure 28: Maximum corrosion depth as function of corrosion time.

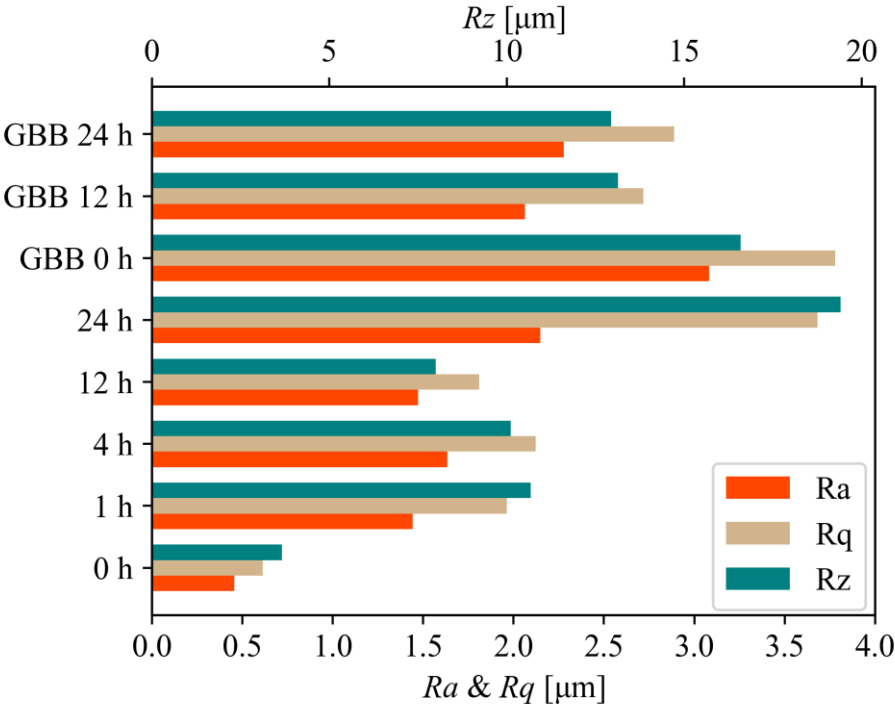
Figure 31: Bar chart of surface roughness values.

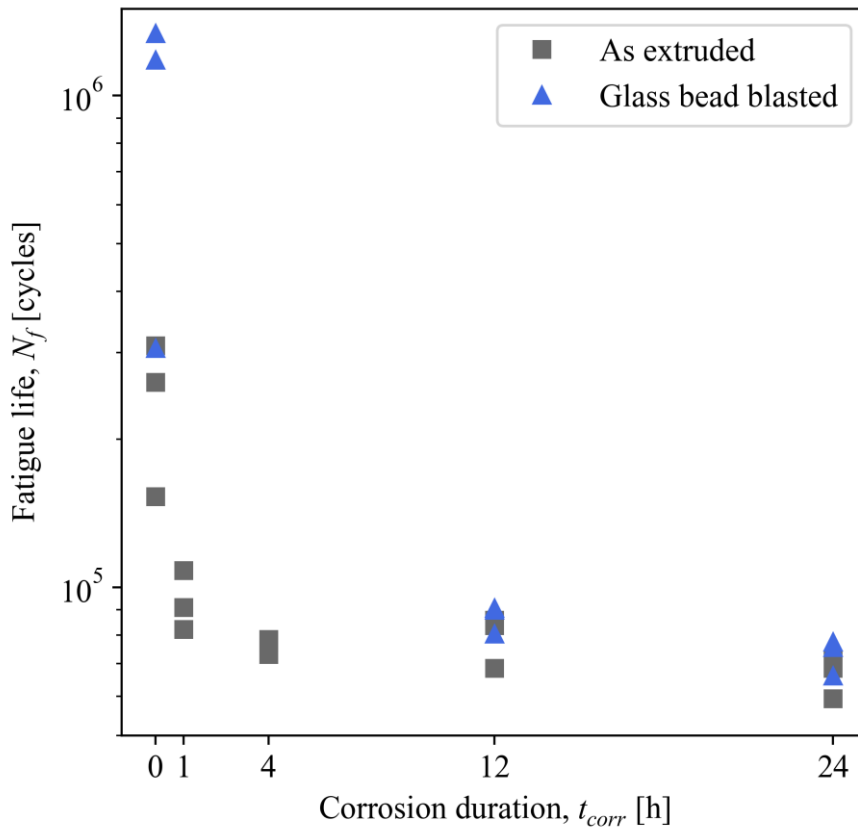
Figure 39: Fatigue life as function of corrosion time.

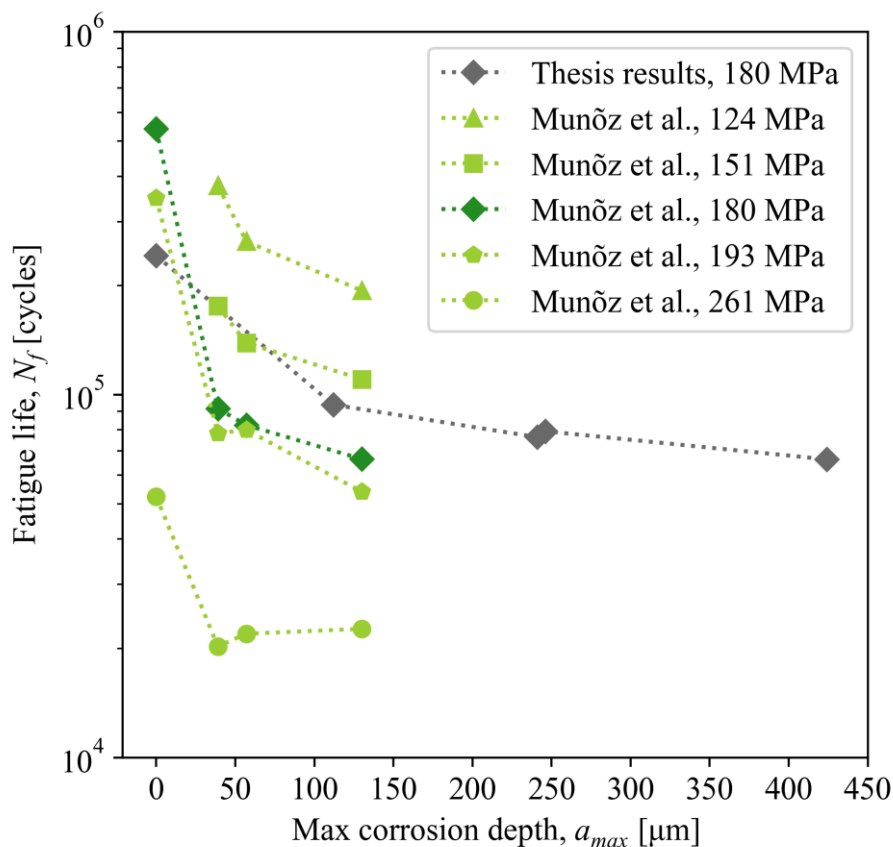
Figure 60: Comparison of experimental results in this thesis with results obtained by Munõz *et al.* [38]. Stresses are maximum cyclic stress (σ_{max}) at $R = 0.1$.
