## Evaluation of the jet distortion by sediment erosion in the needle in the Pelton turbines

To cite this article: Jim Abregu *et al* 2024 *IOP Conf. Ser.: Earth Environ. Sci.* **1385** 012005

**Abstract.** In order to succeed in the transition to a more renewable energy sector, the hydropower industry must overcome multiple challenges in the coming decades, including the need for faster and reversible turbines to support emerging renewable energy sources. In addition, the location of new projects in tropical and semi-tropical areas poses unique considerations, as does the increase in sediment.

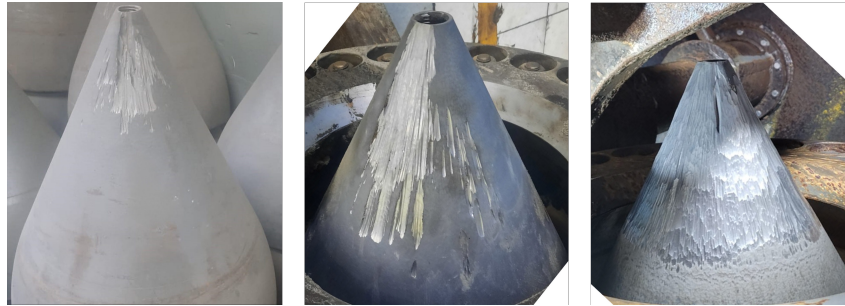
Figure 2: Stages of erosion on a coated needle, HPP at Ancash, Peru.

The erosion behavior of needles varies based on the hydraulic conditions within the power plant and the specific characteristics of the sediments. However, a significant distinction arises when the needles are coated with tungsten carbide due to the material's exceptional hardness and inherent fragility as shown in Figure 2. Certainly, the erosion-induced material loss in the needle leads to varying angles within the jet profile, significantly impacting the overall performance of the jet[3]. This research is mainly focused on erosion over the uncoated surface of a Pelton needle.

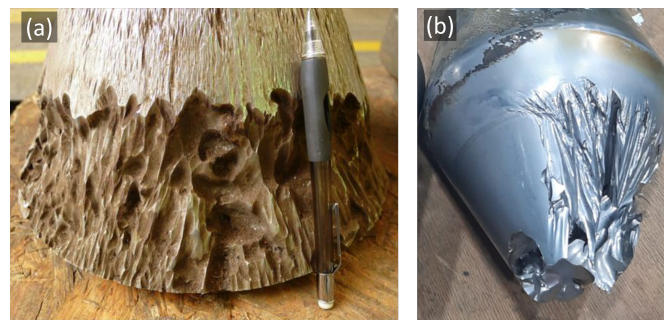
Figure 3: High erosion due to high sediment concentration during short periods (a)Uncoated needle[4]. (b)Uncoated needle during El Niño phenomena, HPP at Ancash, Peru.

Insufficient instrumentation or the inadequacy of existing instrumentation for monitoring sediment influx can lead to episodes of accelerated erosion over short intervals as shown in Figure 3(c). The scope of this research is specifically centered around normal erosion processes that occur over longer periods, allowing for analysis and prediction of their consequences.

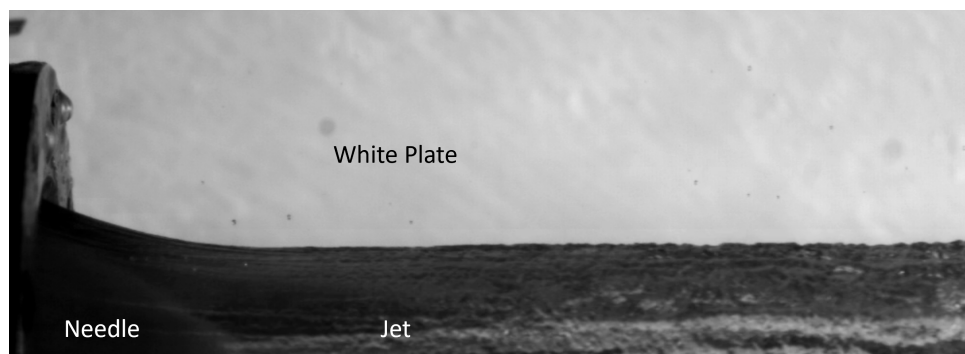
Figure 7: Camera image captured at a shutter speed of 1/400000 seconds to delineate the jet's border along the flow direction

To distinguish the edges of the water jet, it is important to create a contrast in brightness between the water surface and the background. To achieve this, a white metal plate was positioned below the jet and they were both illuminated by an 110000 lumen bright light, resulting in good, diffused light. This brightness is needed, to capture sharp images at a required shutter speed of 1/40000 seconds. This ensured that the lens received sufficient light to render the jet visible in the frames. Precisely illuminating only the plate, rather than the jet, played an important role in achieving a distinct boundary between the bright background and the dark water jet as is shown in Figure 7. Filming one side at a time, instead of both jet sides simultaneously, prevented the jet itself from appearing bright, maintaining accurate edge detection through the average statistic analysis.

For video frame analysis, the algorithm initially equalizes frames using a calibration matrix. Since the jet's edge is nearly horizontal, with the most significant brightness change occurring along the vertical axis, the algorithm computes pixel gradients along the columns of each frame. The consistent brightness of the plate ensures a low first derivative along the homogeneous white plate until it detects a rapid brightness change at the jet's edge. Subsequently, a threshold is applied to the frame's first derivative, creating a mask where pixels above a certain value appear white (255), while the rest gets black (0). To mitigate frame noise caused by water droplets or local light variations, additional mask groups connected white pixels into objects, turning them black if they exceeded a specific threshold. The program scans all columns from the image's outer edge to detect the first white pixel, storing these pixels in a data frame to create the recognized edge. This process is repeated for 800 images, while 125 frames per second are taken into consideration, which leads to statistical insights of the surface edge behavior of 6.4 seconds.

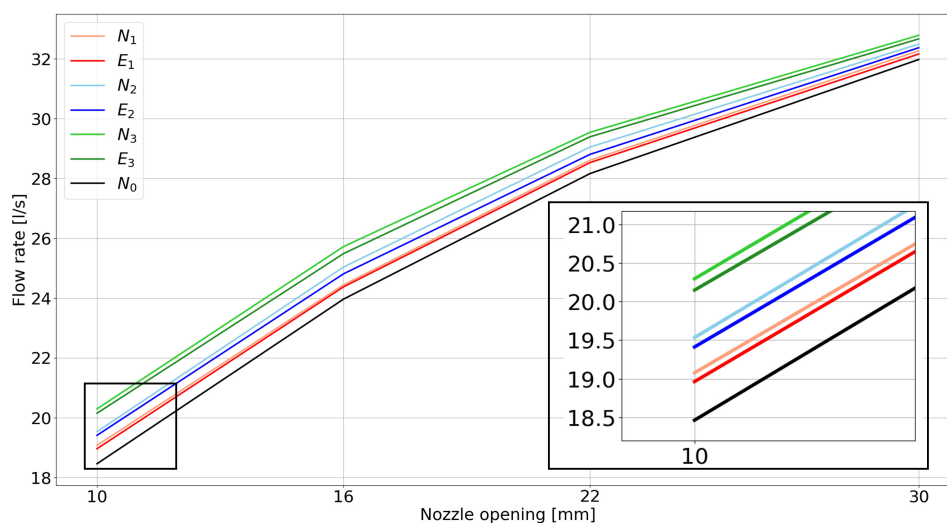
Figure 9: The Flow rate for Different Needles and Different Openings

The results presented in this study maintain a constant net head of 30 m to observe variations in flow rate, pressure, and jet behavior among different needle types. Figure 9 illustrates the flow rate behavior for six needle types across various nozzle openings (10 mm, 16 mm, 22 mm, and 30 mm) in comparison to an uneroded normal needle [ $N_0$ ] (depicted by the black line). Notably, the normal needle [ $N_0$ ], possessing the largest area, exhibits the lowest flow rate, while needles with surface-reduced areas [ $N_{1,2,3}$ ] consistently demonstrate higher flow rates for all nozzle openings.

The variation in flow rate due to an eroded surface [ $E_{1,2,3}$ ] was found to be smaller than the impact of the area-reduced needles [ $N_{1,2,3}$ ]. Specifically, at a 10 mm opening, the variation between the normal needle [ $N_0$ ] and the 0.2 mm area-reduced needle [ $N_2$ ] demonstrates an increase in flow rate of approximately 5.8%. In contrast, the variation from [ $N_2$ ] to the corresponding eroded surface [ $E_2$ ] was found to be 0.6%.
