Effects of Glacial Development on Dam Safety in Norway

Master's thesis in Hydropower Development

June 2024

Norwegian University of Science and Technology

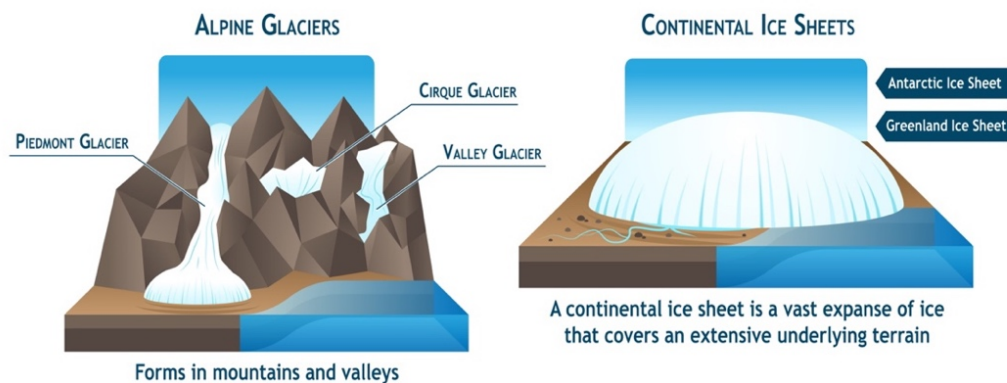
Figure 2.1 Illustration differentiating glacial formations found in nature. Sourced from (National Snow and Ice Data Center, n.d.-a).

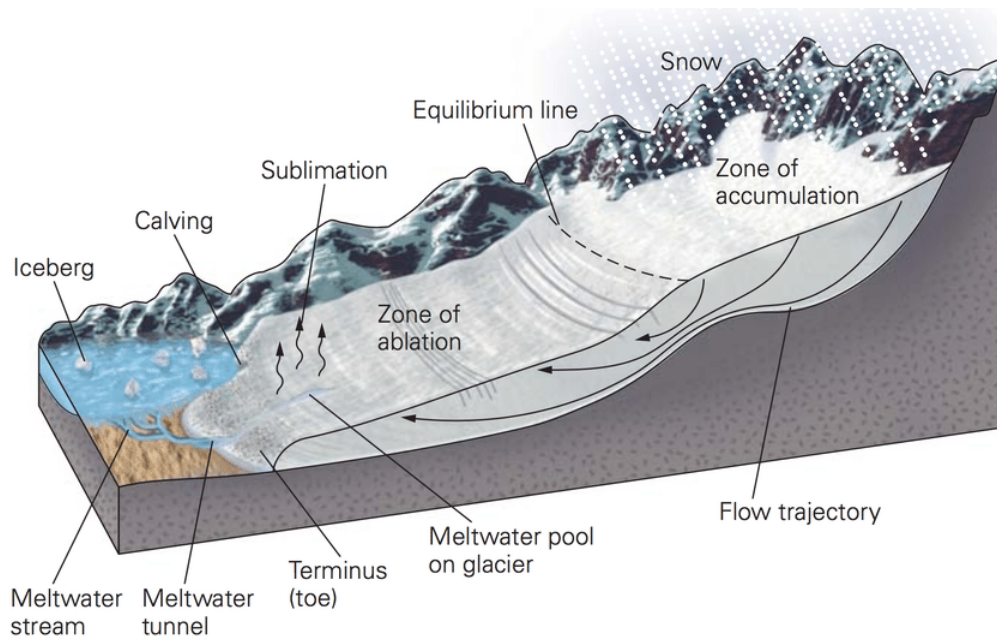
Figure 2.2 Life cycle of a glacier, showing the ELA, accumulation, and ablation zones. Sourced from (Strandberg et al., 2012).

To understand how glaciers form and fluctuate, it is important to first clarify what the mass balance process entails. This involves both *accumulation* and *ablation* phases. Both are highly sensitive to climate and environmental factors, as well as the type of glacier and topography. This overall life cycle is illustrated in Figure 2.2.

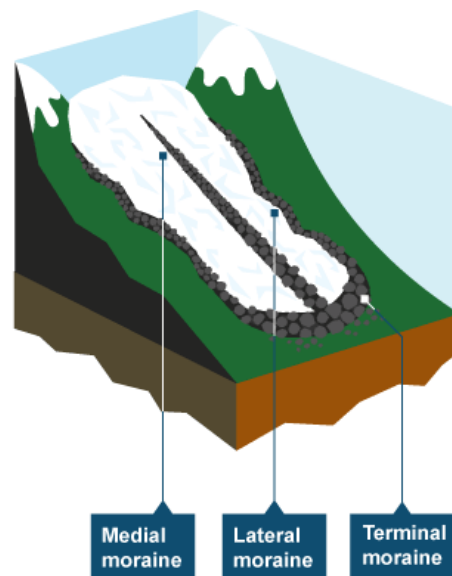
Figure 2.4 Depiction of the variations of moraine generated from glaciated regions, sourced from (BBC Bitesize, n.d.).

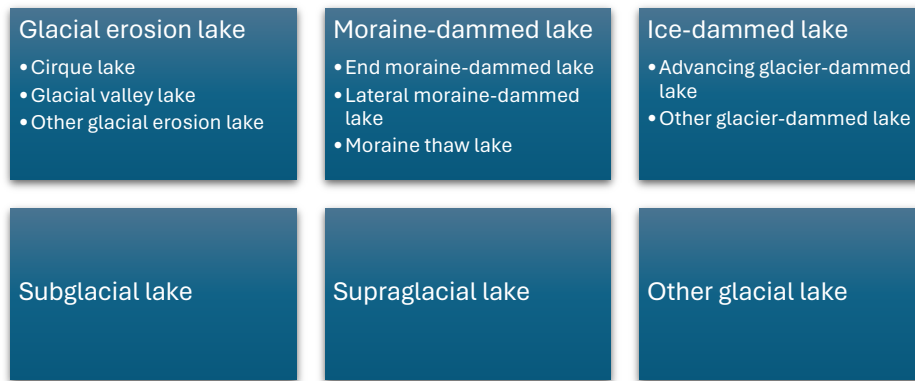
Figure 2.5 Glacial lake types, readapted directly from (Yao et al., 2018).

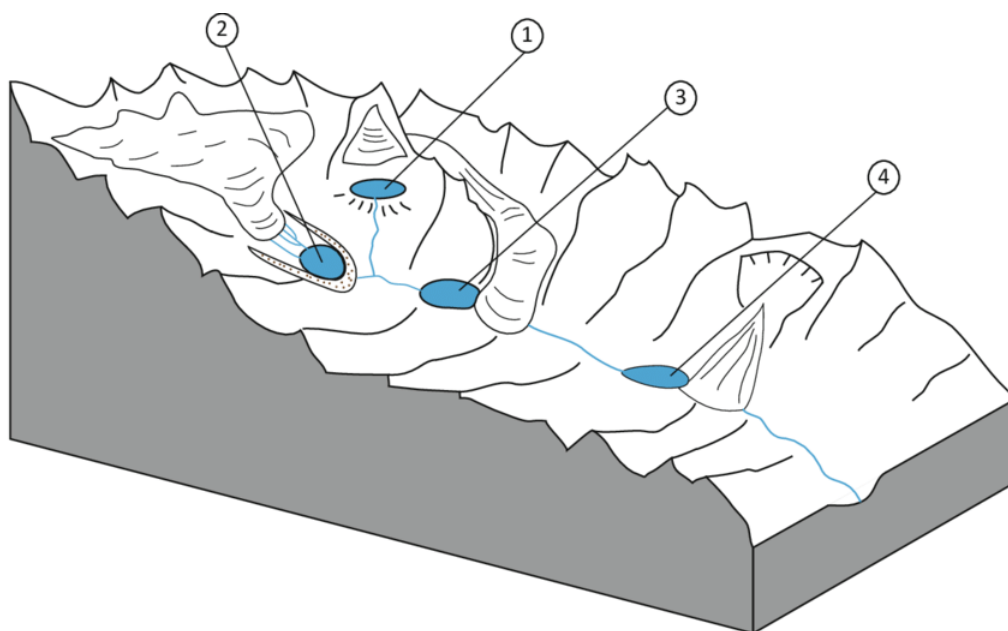
Figure 2.6 Illustrated characteristics of different types of glacial lakes, including erosion (1), moraine-dammed (2), ice-dammed (3), and landslide-dammed (4). Sourced from (Otto, 2019).

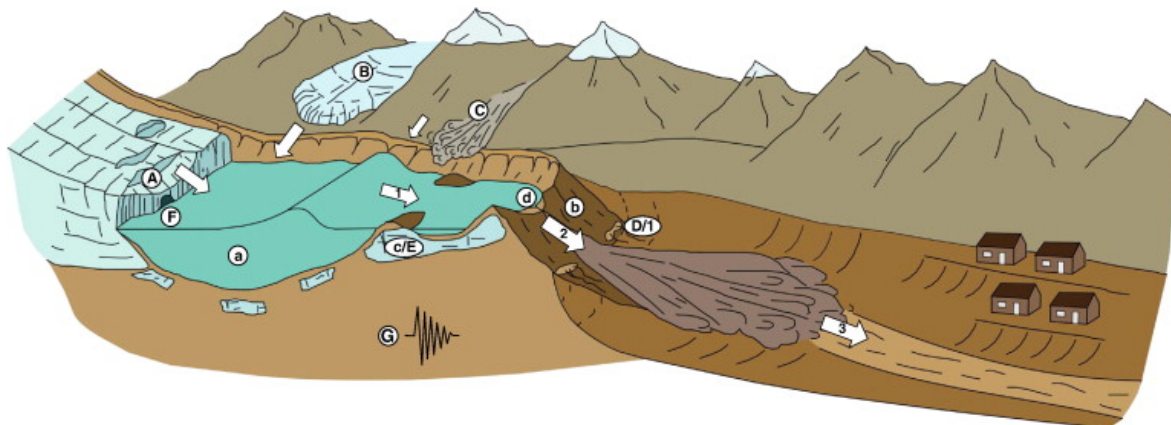
Figure 2.8 Illustration adapted from (Richardson & Reynolds, 2000) and (Westoby et al., 2014), outlining different types of GLOF mechanisms: Calving (A), avalanche/ice fall (B), landslide/rockslide (C), dam settlement (D), ice-cored moraine degradation (E), rapid inflow from supra/subglacial lakes (F), and earthquake events (G).

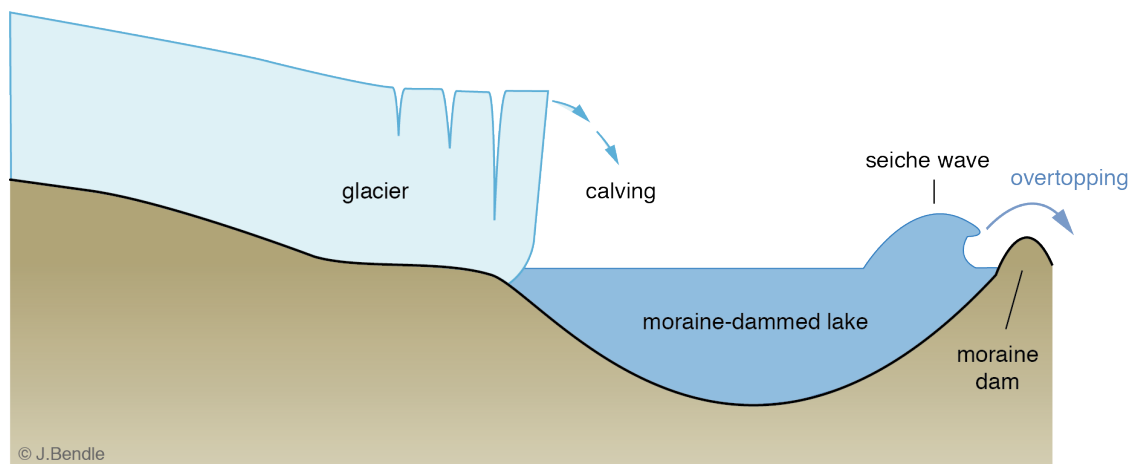
Figure 2.9 Potential calving mechanism overtopping a moraine dam, sourced from (Bendle, 2020b).

Overtopping events, as shown in Figure 2.9, result from either the entry of too high of a volume of water into the lake (high precipitation or melting), or from displacement waves caused from calving of a glacier, or avalanches or rockfalls (Bendle, 2020b). These displacement waves are also known as *seiche waves* in some literature. These overtopping events can later lead to defections in the crest and cause enlarged incisions in the dam that will continually expand and increase in discharged melt water leading to critical failure.

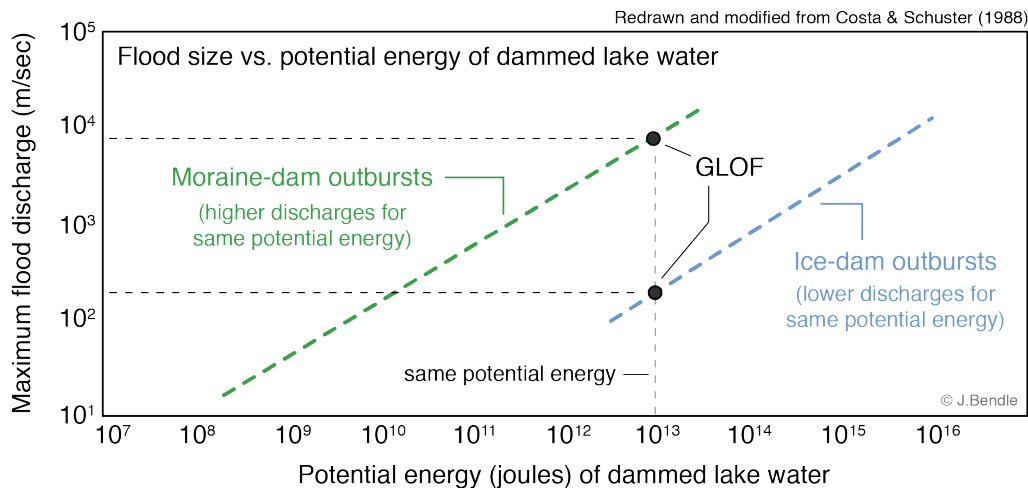
Figure 2.10 Comparison of potential energies with the failing of moraine-dammed lakes and their ice-dammed counterparts, sourced from (Bendle, 2020b).

When comparing moraine and ice-dam failures, it can be observed that moraine dams tend to release floods more violently, as seen in Figure 2.10. Although this may be the case, they tend to occur less frequently, as moraine dams tend to completely self-destruct when failing (Bendle, 2020b).

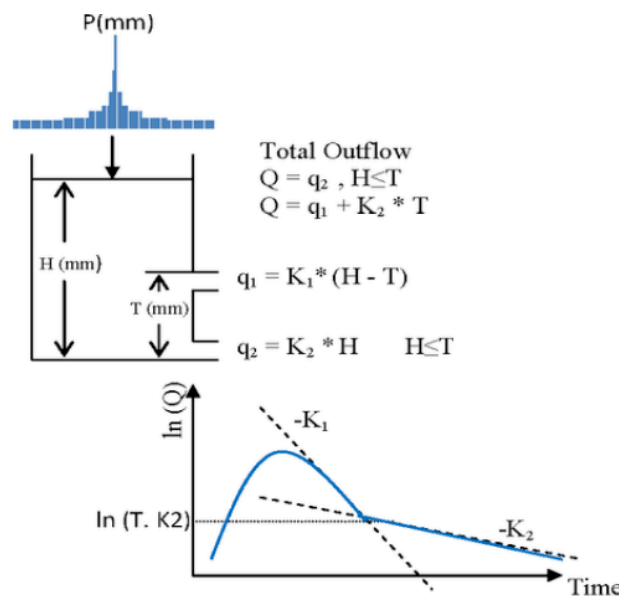
Figure 2.14 PQRUT model structure, sourced from (Chernet et al., 2012).

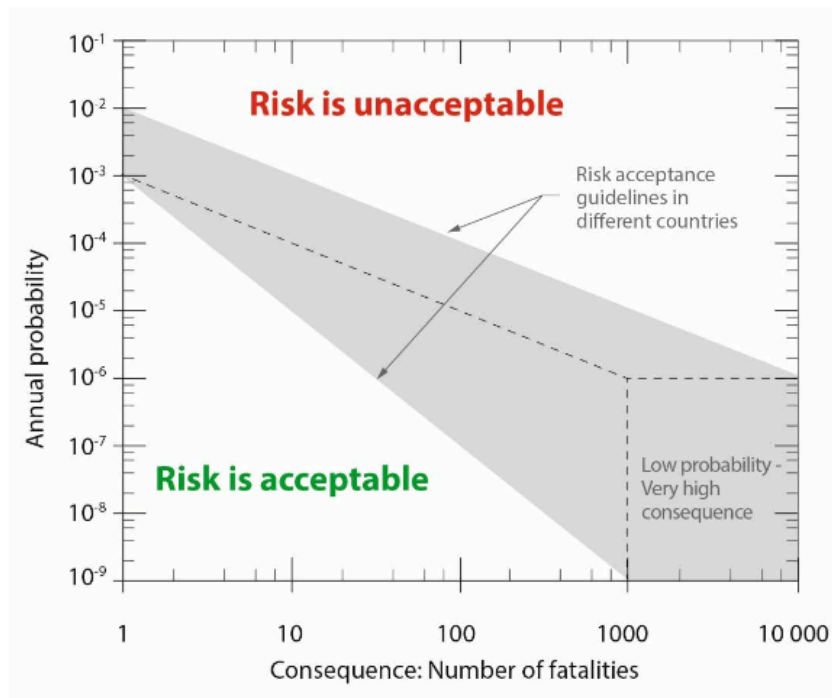
Figure 2.15 Quantitative risk diagram, from (Lacasse, 2022a). Also referred to as “failure envelope.”

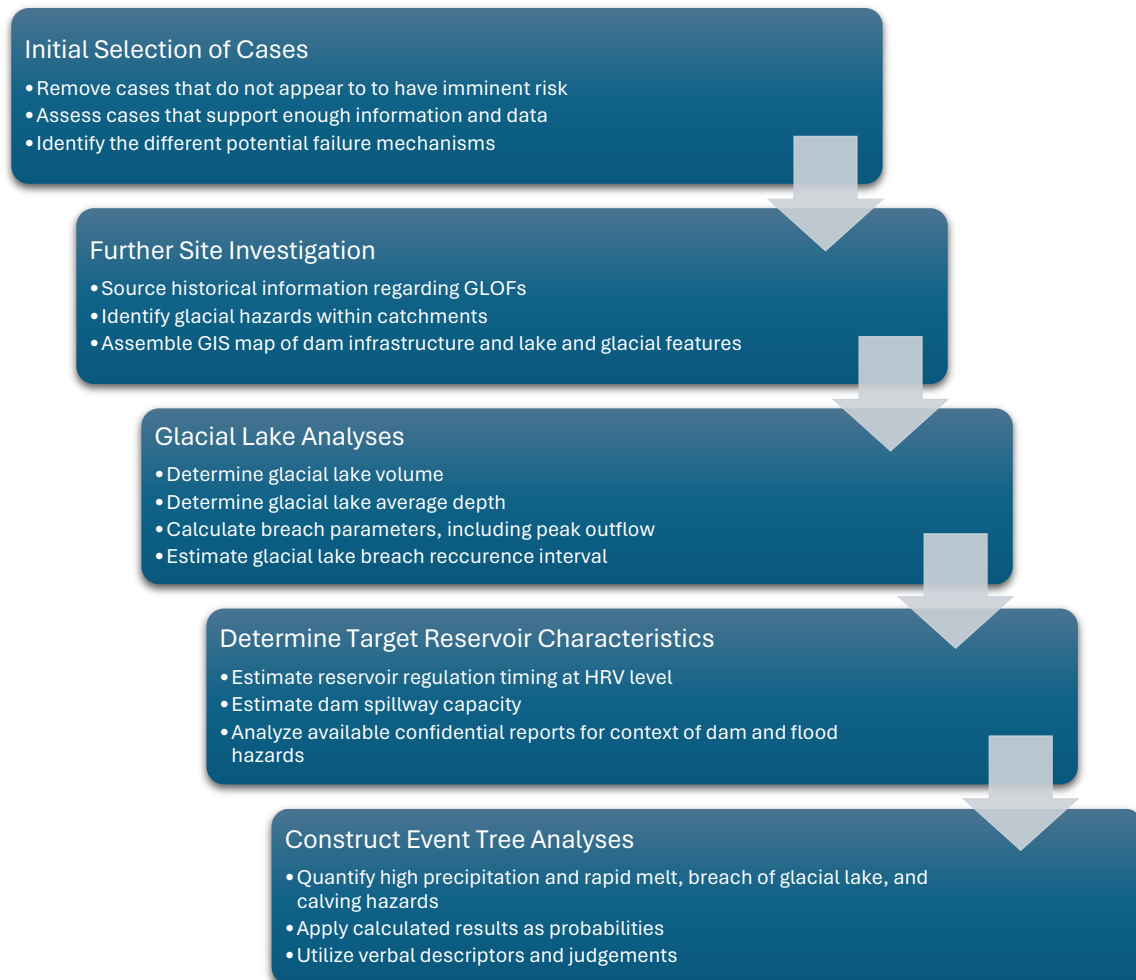
Figure 3.1 Overarching methodology applied to cases for analyzing GLOF hazards and risk.

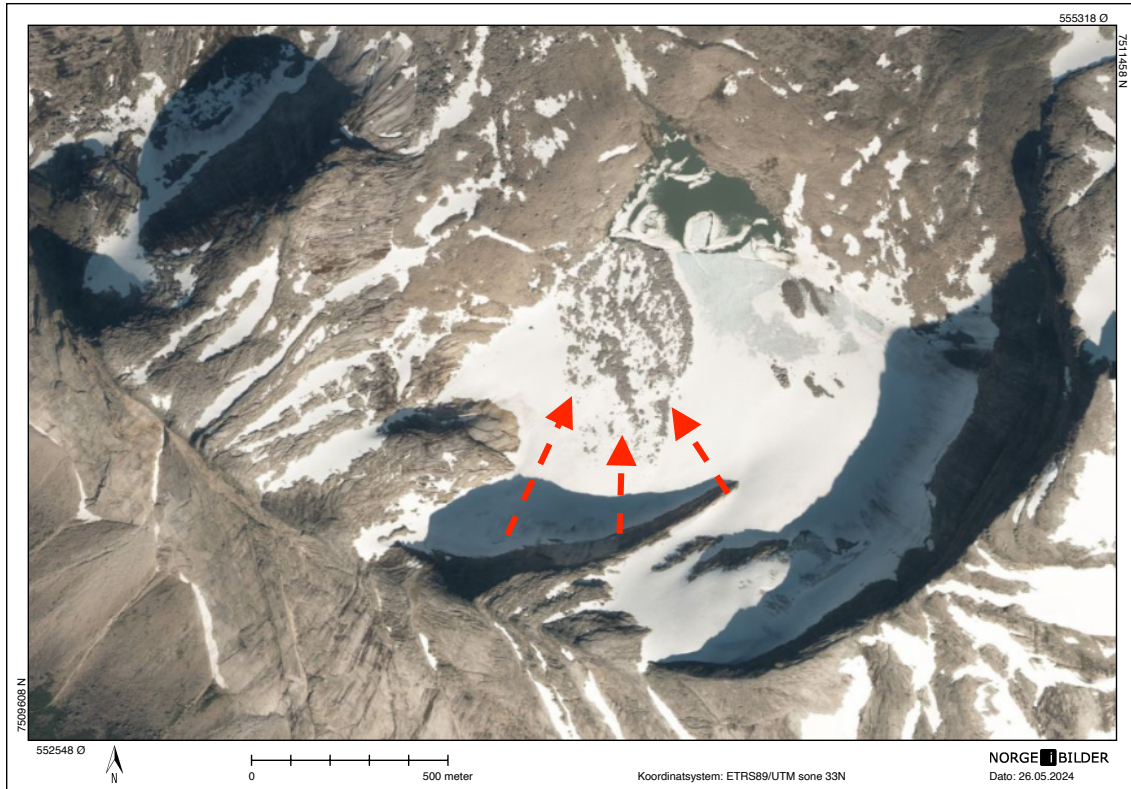
Figure 3.3 Rockslide within mountain cirque, indicating dynamic geology and potential initiator for lake failure near Slæddovagjavre. Photo sourced from NorgeiBilder.no (Norge digitalt, 2024).

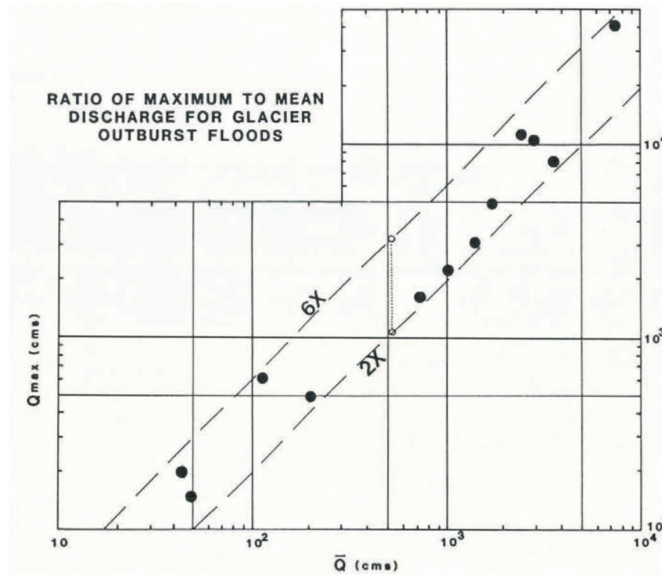
Figure 3.6 Average discharge (\bar{Q}) plotted against instantaneous discharges (Q_{max}) from glacial outburst floods in North America, Iceland, and Scandinavia. Figure from (Desloges et al., 1989).

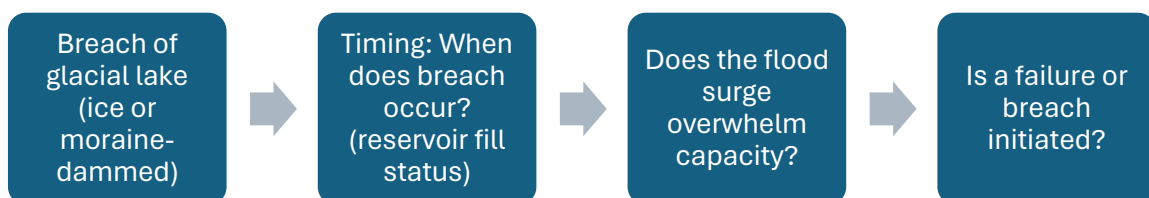
Figure 3.8 Flow chart depicting the overall process behind determining a moraine or ice-dammed glacial lake breach induced failure in a concrete or embankment dam.

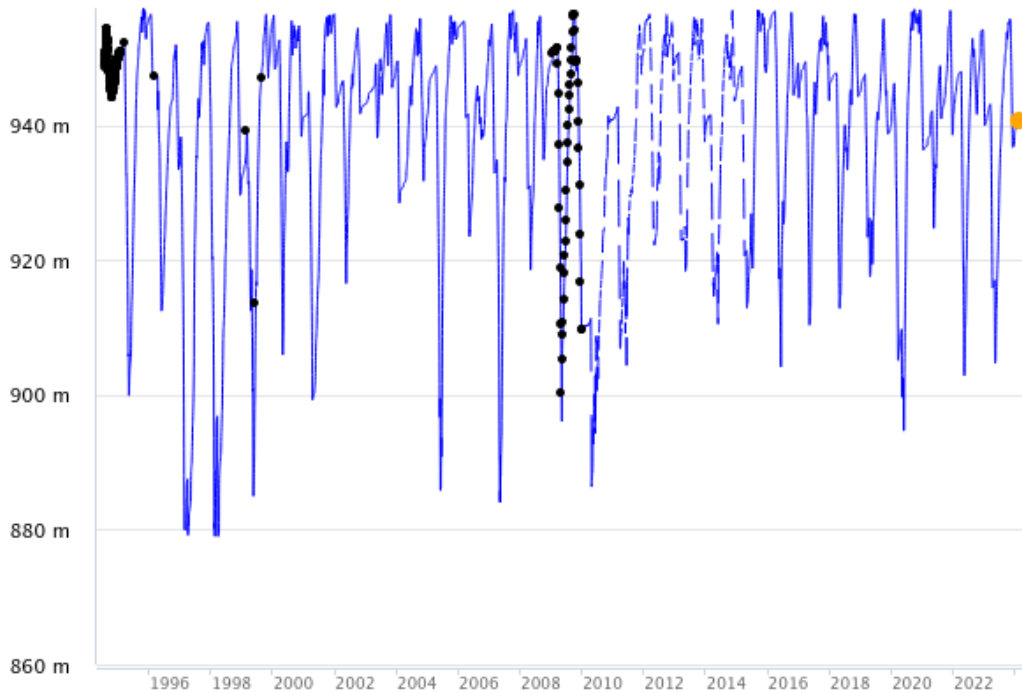
Figure 3.10 An example of available stage history from Sildre for Dravladalsvatn from 1994 until present. An operative strategy is evident from the similar cyclical formations in the data. Sourced from (NVE, 2024).

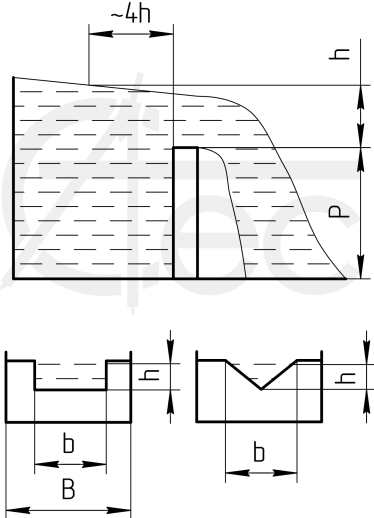
Figure 3.11 Graphic sourced from (Caetech Llc & Calcdevice.com, n.d.) outlining the parameters for Bazin’s 1898 weir flow formula.

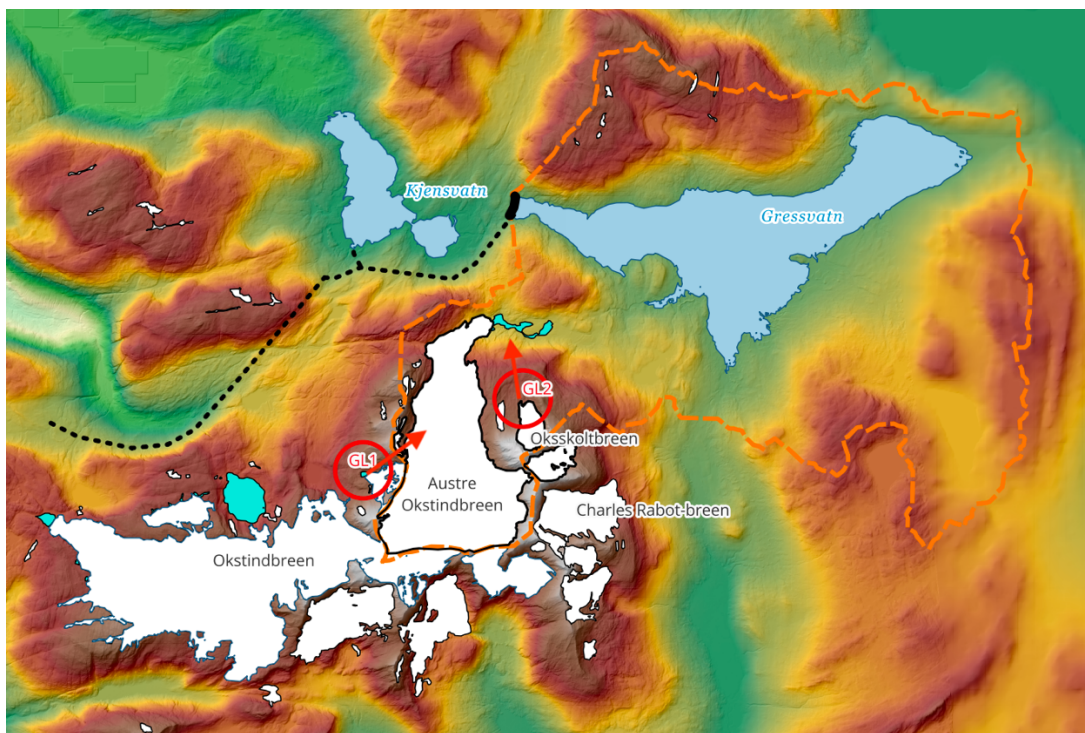
Figure 4.1 Overview of Austre Okstindbreen glacier, Gressvatn dam, and GL1 and GL2 hazards. DTM data from Høydedata.no (Kartverket, 2024).

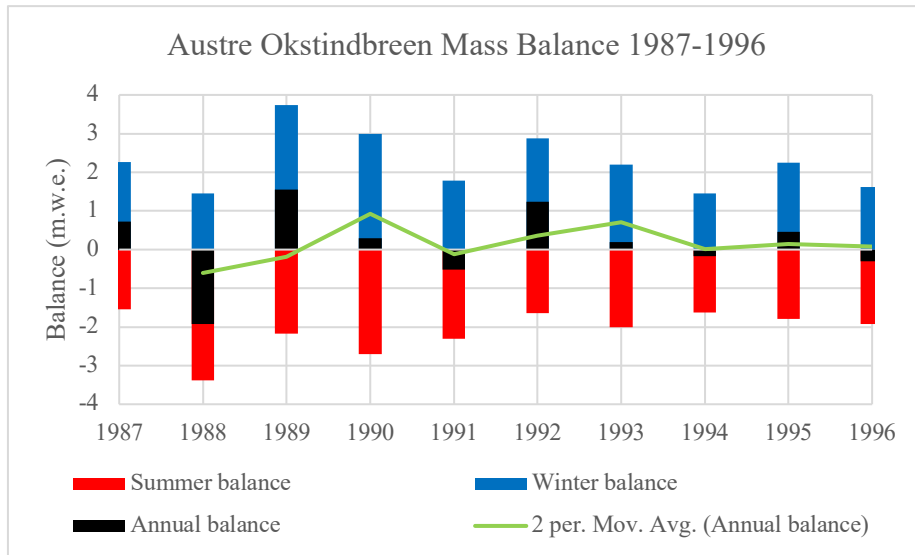
Figure 4.2 Mass balance for Austre Okstindbreen, 1987-1996, data provided by NVE.

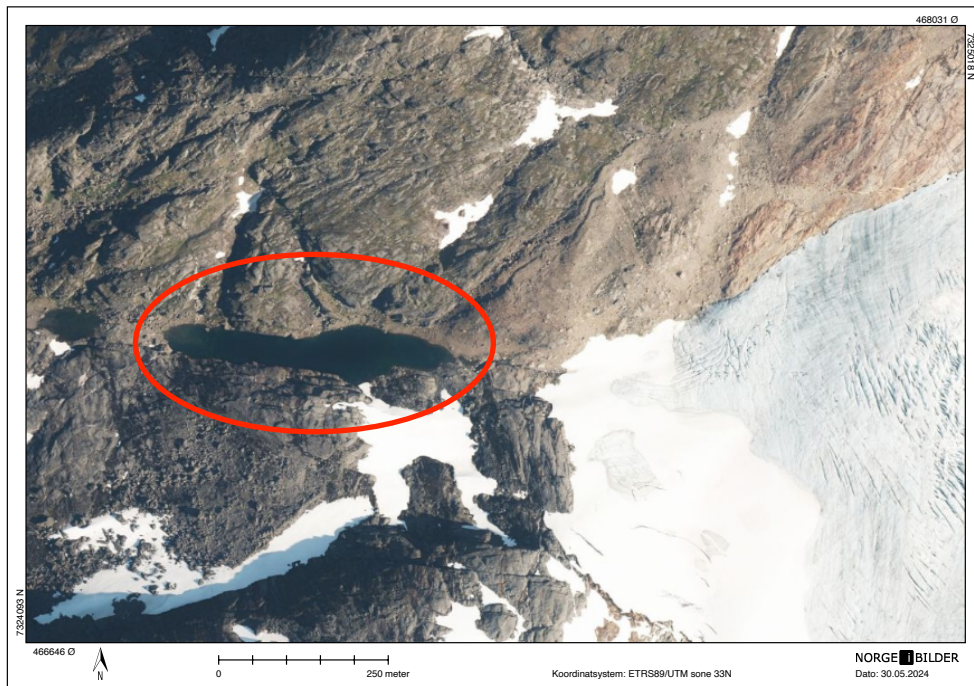
Figure 4.4 Documented ice-dammed glacial lake near Leirskardalen (GL1). After recession of snow and ice, lake appears to be bedrock dammed. Photo from NorgeiBilder.no (Norge digitalt, 2024).

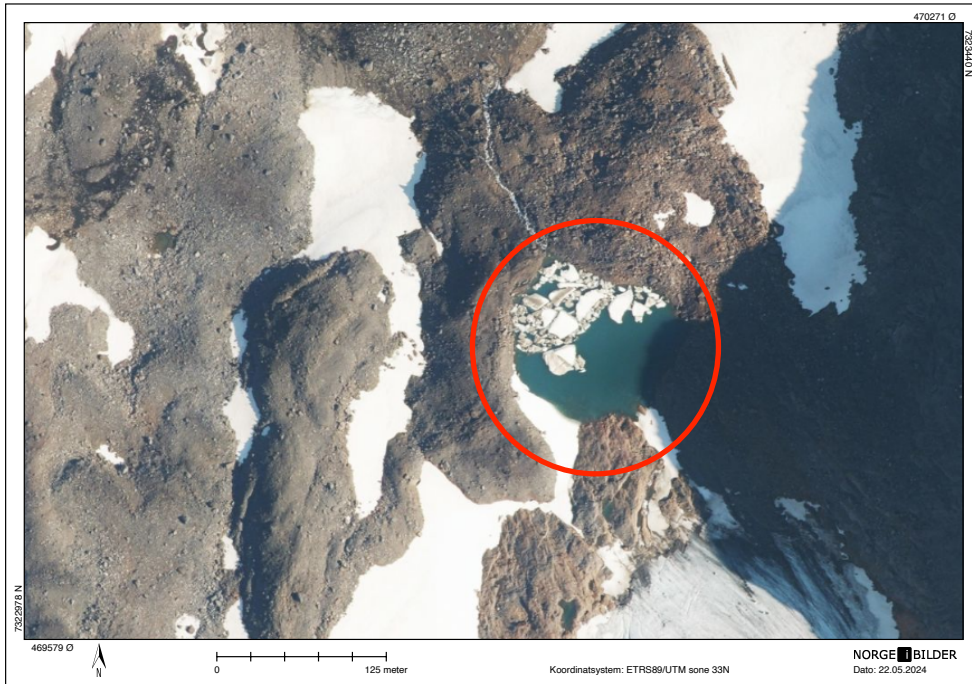
Figure 4.5 Identified moraine-dammed glacial lake in Oksskoltbreen glacier (GL2). Photo from NorgeiBilder.no (Norge digitalt, 2024).

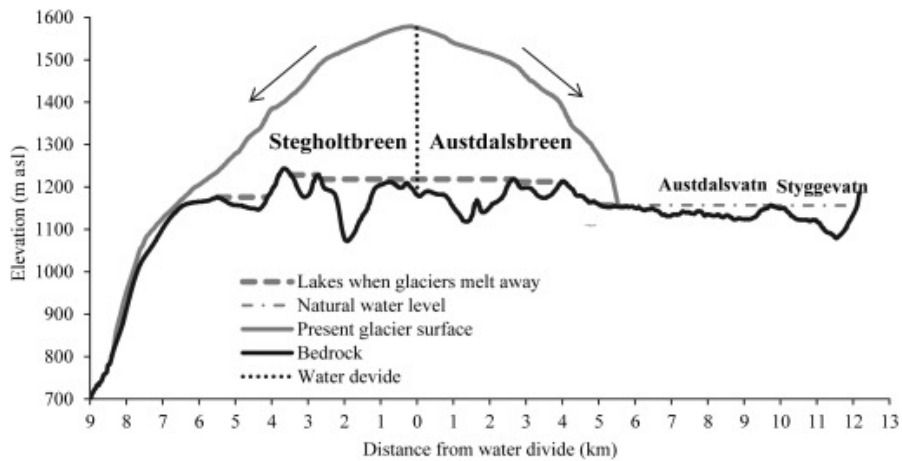
Figure 4.7 Cross section of Stegholtbreen and Austdalsbreen showing subglacial topography and differentiation between Austdalsvatn and Styggevatn (Xu et al., 2015).

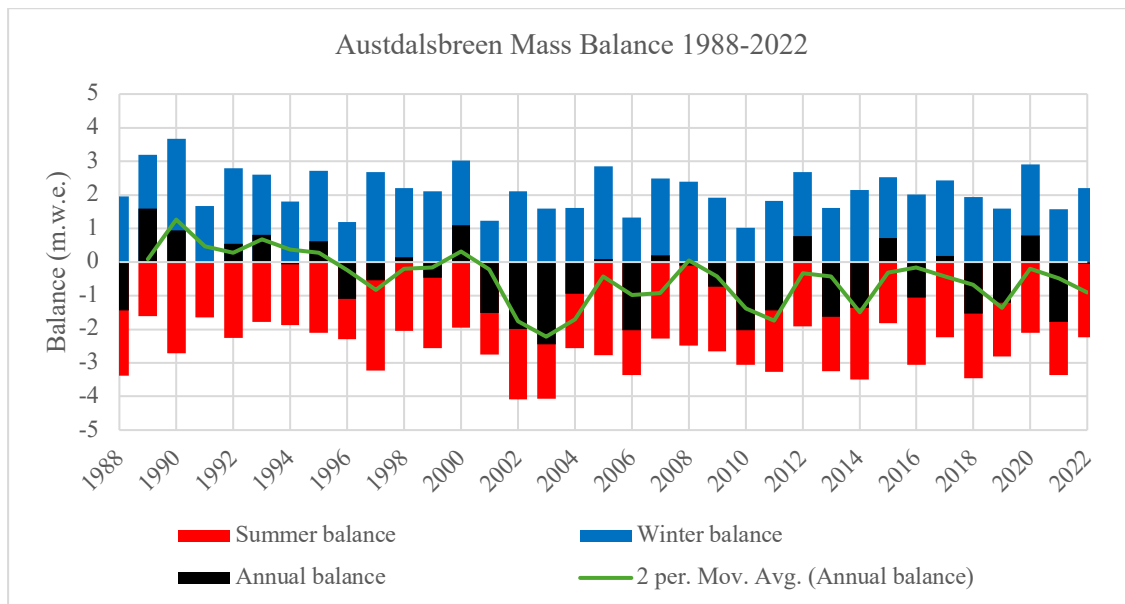
Figure 4.8 Mass balance for Austdalsbreen, 1988-2022, data provided by NVE.

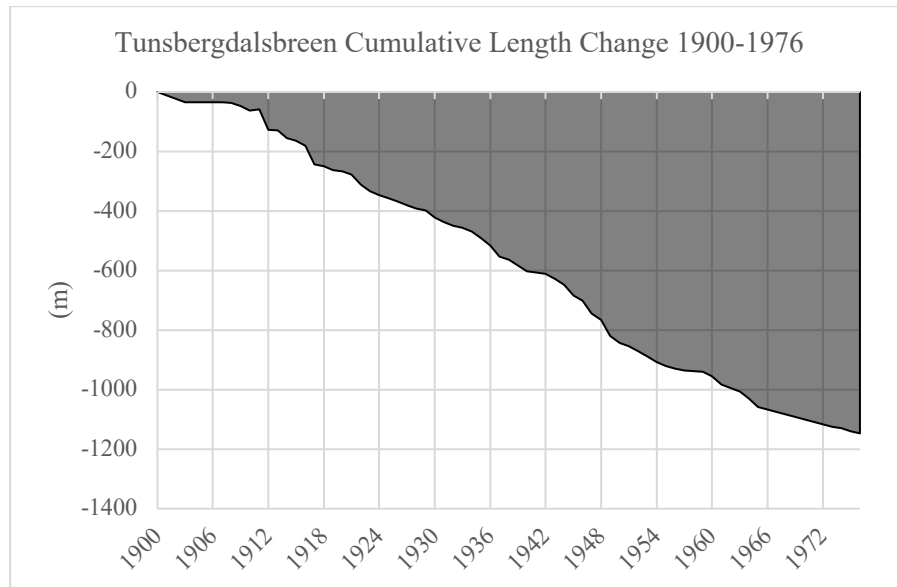
Figure 4.9 Cumulative length change for Tunsbergdalsbreen, 1900-1976, data provided by NVE.

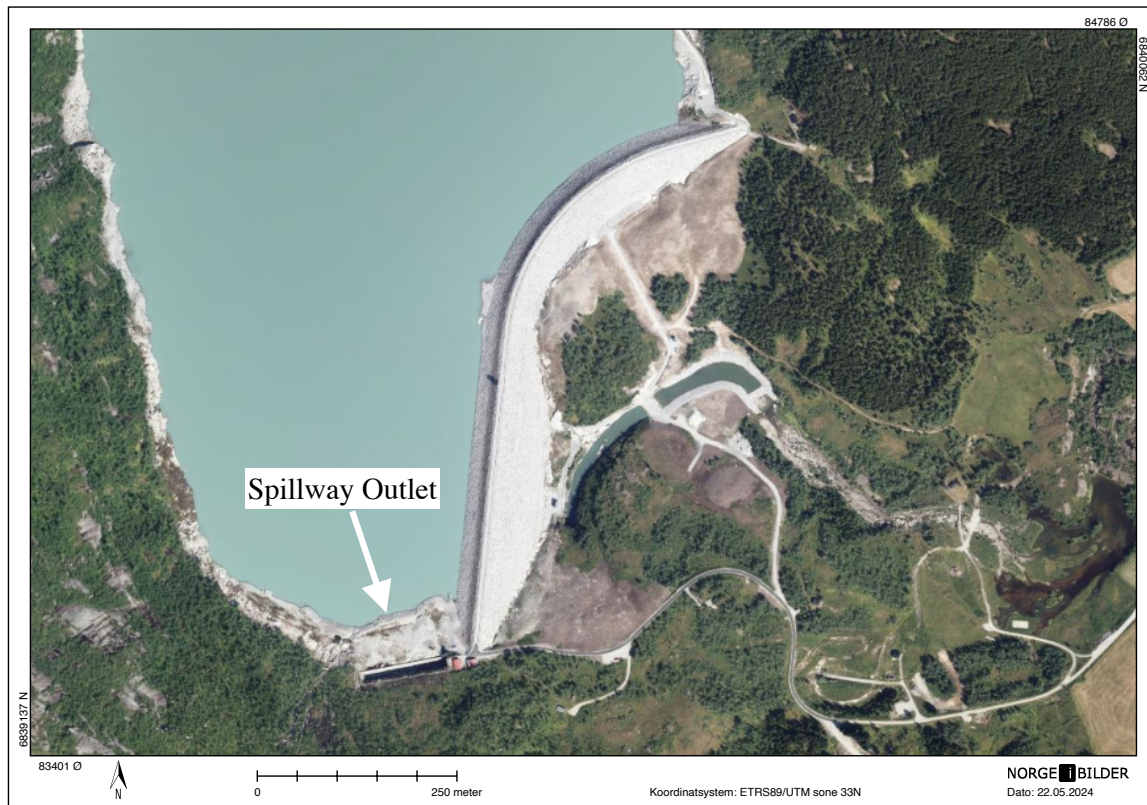
Figure 4.12 Aerial photo of Tunsbergdalsvatn dam, with concrete spillway structure at southern end. Photo from NorgeiBilder.no (Norge digitalt, 2024).

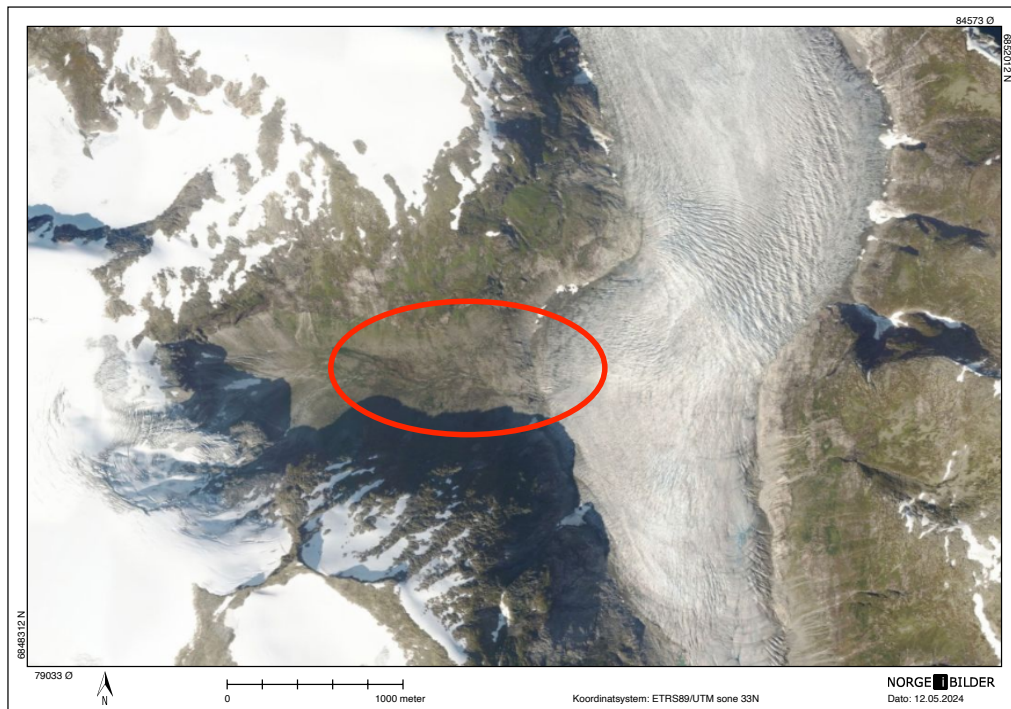
Figure 4.13 Brimkjelen ice-dammed lake (GL3) location, at unfilled state. Photo from NorgeiBilder.no (Norge digitalt, 2024).

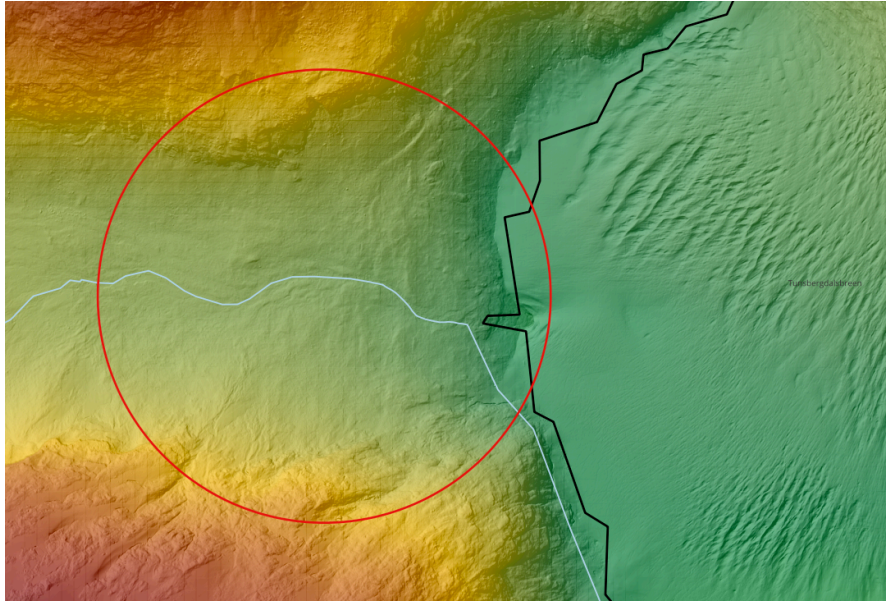
Figure 4.14 1m DTM raster showing Brimkjelen area (red boundary) in contact with Tunsbergdalsbreen to the east. A minor depression in the glacier is seen where the river changes direction southward. DTM data sourced from Høydedata.no (Kartverket, 2024).

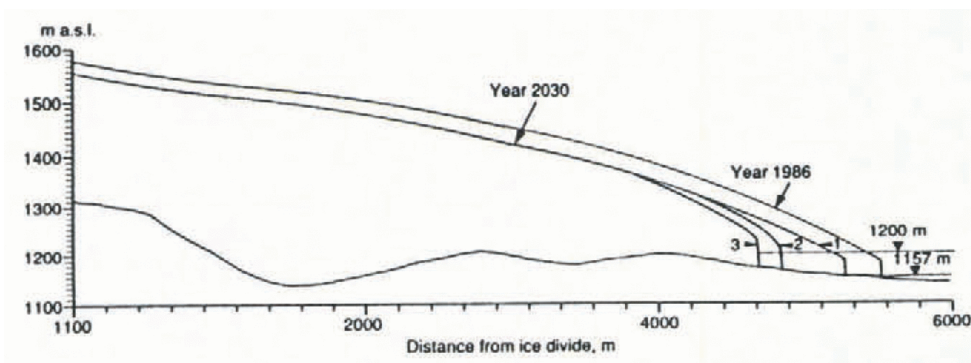
Figure 4.15 Cross section of Austdalsbreen, depicting the recession of the glacier toe from 1986 to the predicted location in 2030 (Laumann & Wold, 1992).

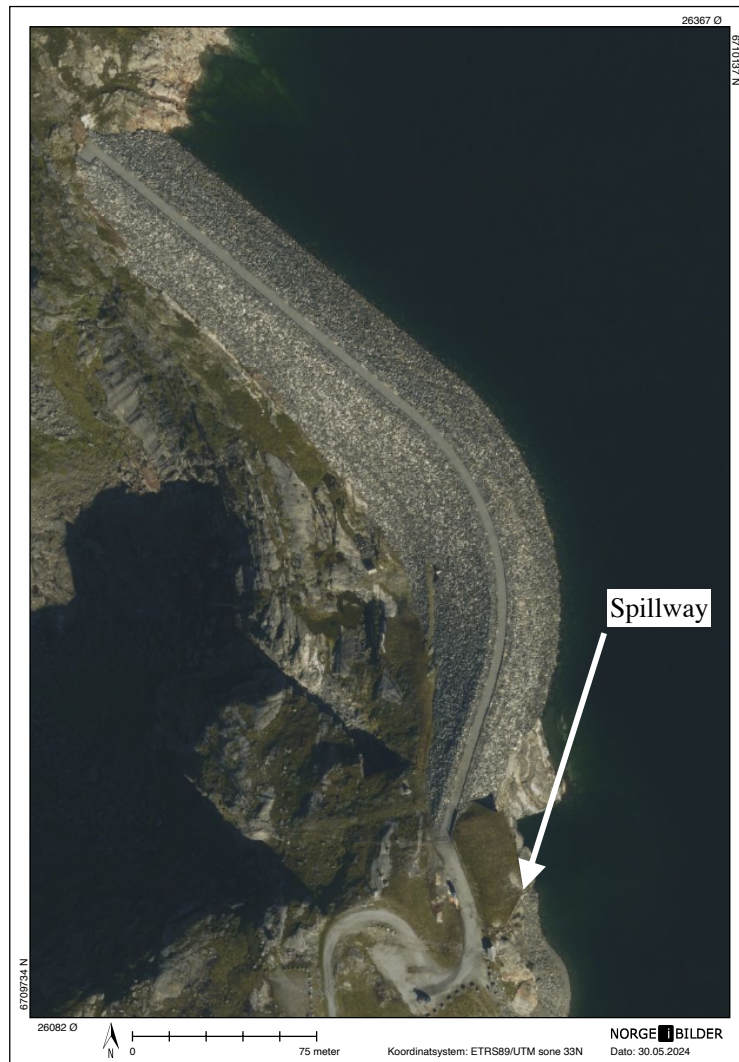
Figure 4.20 Aerial photo of Dravladalsvatn dam, with spillway structure visible out south end, leading to a flood channel underneath the road. Sourced from NorgeiBilder.no (Norge digitalt, 2024).

Dravladalsvatn is a 5.8×10^7 m³ capacity reservoir located in Ullensvang municipality, Vestland, near the northeastern flank of Folgefonna glacier. Its catchment size reaches just 27.25 km², but can be supplemented with inflow from Kvanngrovatn, Skarvabotn, and Juklavatn lakes. The dam was originally constructed between 1971 and 1972, and provides flow to the 40 MW Jukla pumped-storage hydropower plant, owned and operated between Statkraft Energi AS (85.06%) and Skagerak Energi AS (14.94%). It also contributes to the Mauranger power plant network (same owning distribution) connecting most of the western Folgefonna reservoirs, capable of 250 MW production. This Mauranger power station is unique in that it is Norway's first to utilize melt water from beneath a glacier (Bondhusbreen glacier) (Statkraft AS, n.d.). The dam has a HRV of 957 MASL and a LRV of 880 MASL, giving a very large 77 m of operating freeboard. The crest is noted to lie at 959 MASL, resulting in 2 m of freeboard from HRV (NGI, 2016). The consequence class 3 embankment dam is rock-filled, with a sealed internal moraine core, extending 340 m long and 29 m tall, and situated at 961.5 MASL. Dravladalsvatn dam consists of a concrete overflow threshold

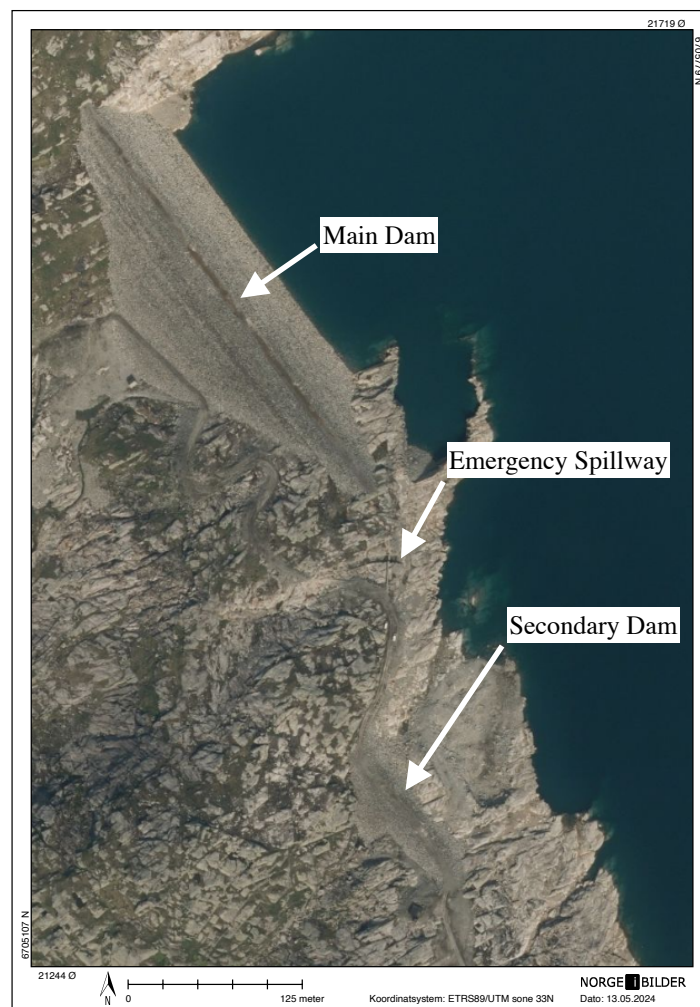
Figure 4.21 Juklavatn dams and spillway layout. Emergency spillway lies embedded in bedrock gully. Photo sourced from NorgeBilder.no (Norge digitalt, 2024).

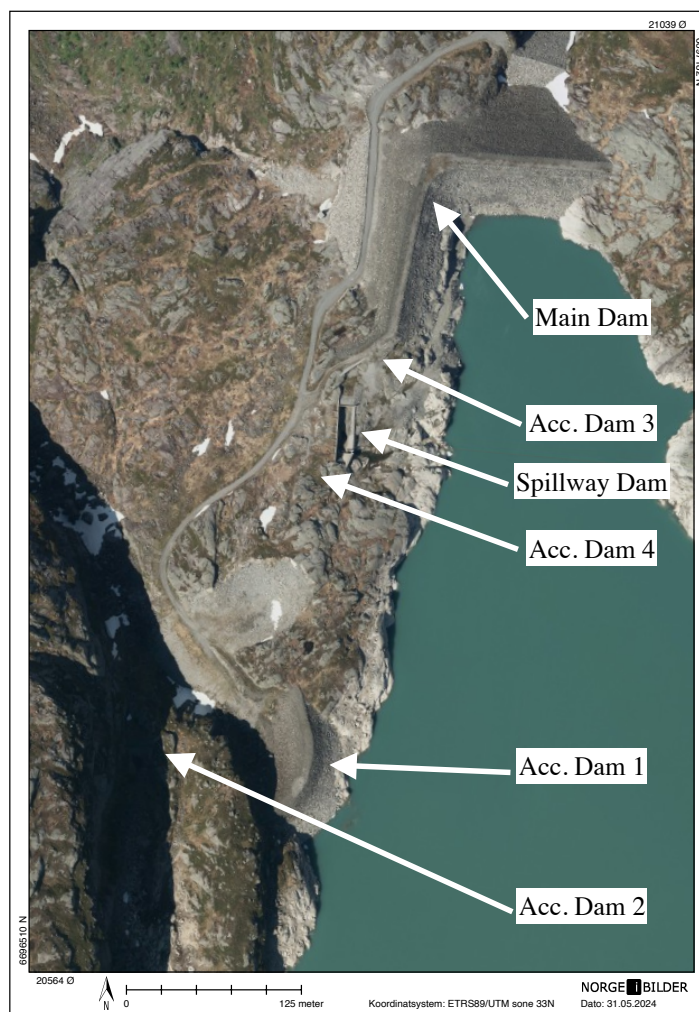
Figure 4.22 Aerial photo of the Mysevatn dams, with components lining the western bank. Acc. Dam 2 situated in shadow and difficult to discern. Sourced from NorgeiBilder.no (Norge digitalt, 2024).

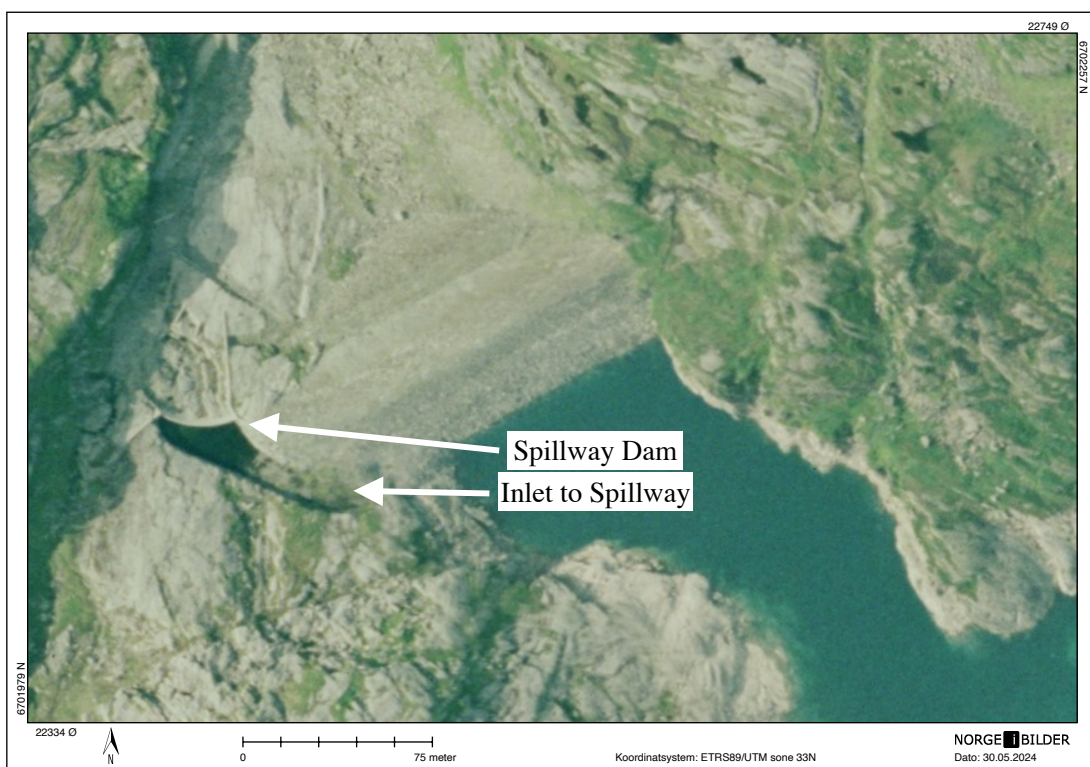
Figure 4.23 2006 Aerial photo of Svartadalsvatn dam with free-flow concrete spillway visible at the western side. Photo sourced from NorgeiBilder.no (Norge digitalt, 2024).

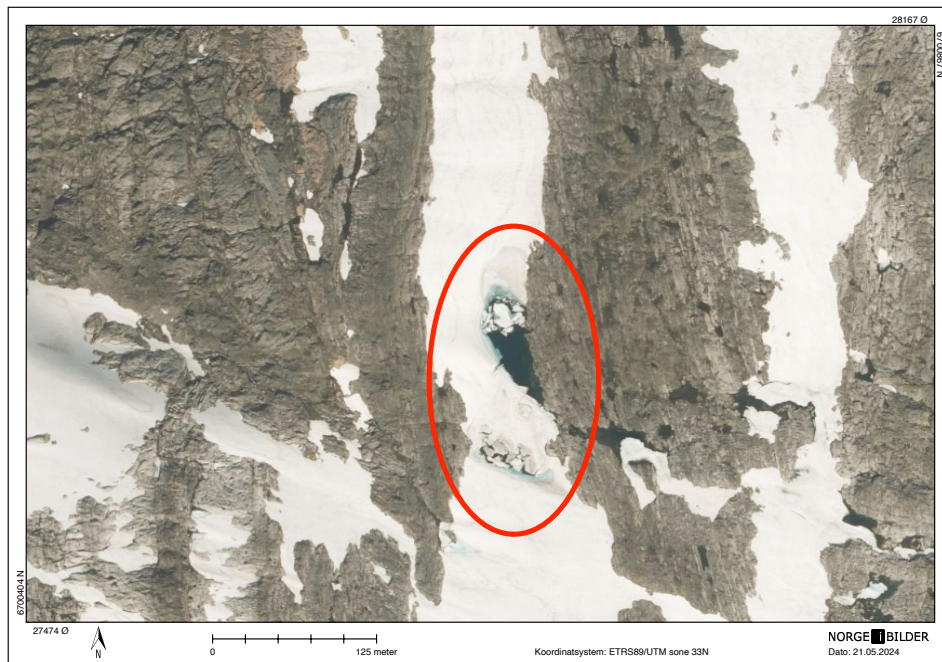
Figure 4.24 Small proglacial lake identified in Midtre Folgefonna for Svartedalsvatn (GL4). Photo sourced from NorgeiBilder.no (Norge digitalt, 2024).

As for H2 (breach of glacial lake), only one could be identified within the upper extent of the glaciers, within the catchment for Svartedalsvatn, shown in Figure 4.24. This lake is extremely small, and appears to be a small proglacial pocket exiting from Midtre Folgefonna to the north. It appears to be solidly bound by bedrock, and can either drain back into the glacier to the south, or exit into a valley to the north where dampened by other glacial valley lakes. In any case, its volume was estimated to be 3.9×10^4 m³, and was determined as not a candidate for further analysis, as it is simply too negligible in size.

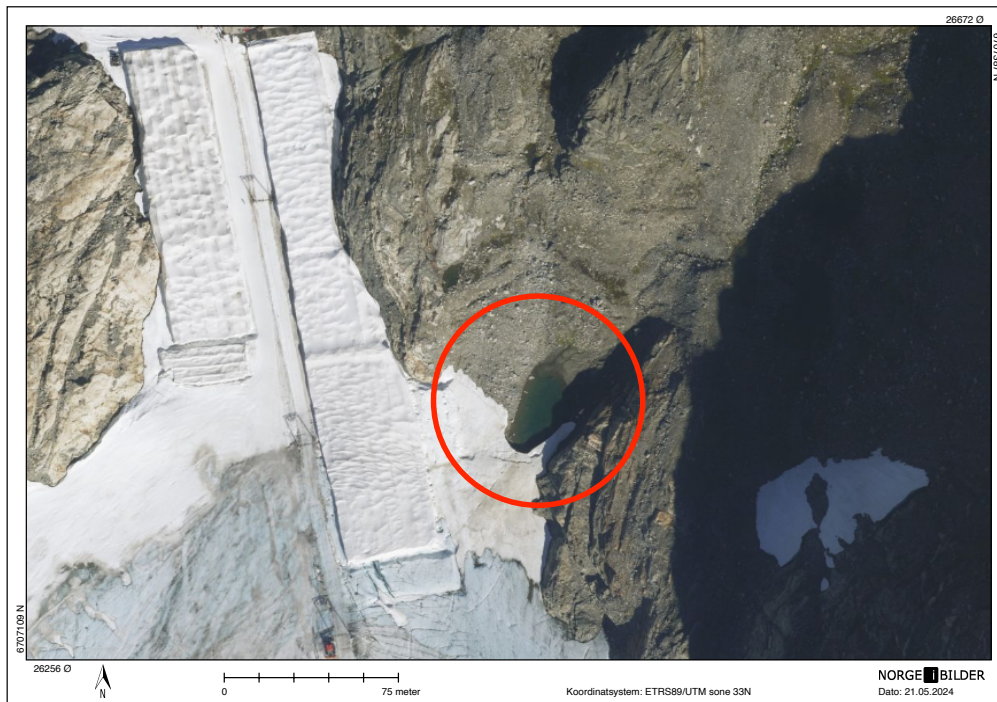
Figure 4.25 Location of previous minor flood event for Dravladalsvatn (“Sjoen forsvann pa ei natt,” 2009). Aerial photo sourced from NorgeiBilder.no (Norge digitalt, 2024).

An identified previous GLOF outburst was located in Nordre Folgefonna in 2009, where an estimated 1.2×10^4 m³ of water was released during the evening near a ski center (“Sjoen forsvann pa ei natt,” 2009). This would have ended up draining to Dravladalsvatn, however was decided as not an imminent issue or addressable hazard, as the volume was simply too

small to be of concern. Its outlet location is shown in Figure 4.25. In summary, there are no applicable glacial lakes for analyses for the applicable lakes in Folgefonna.

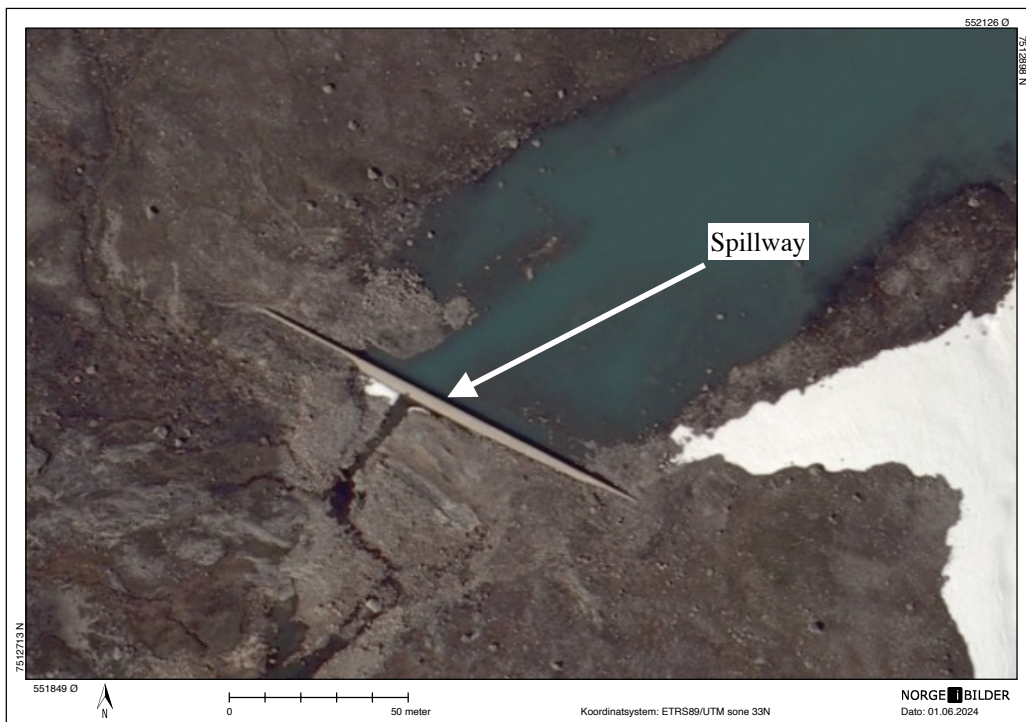
Figure 4.28 Aerial photo of Slæddovagjavre concrete dam, with spillway located in center of crest. Sourced from NorgeiBilder.no (Norge digitalt, 2024).
