Effects of Glacial Development on Dam Safety in Norway

Master's thesis in Hydropower Development

June 2024

Norwegian University of Science and Technology

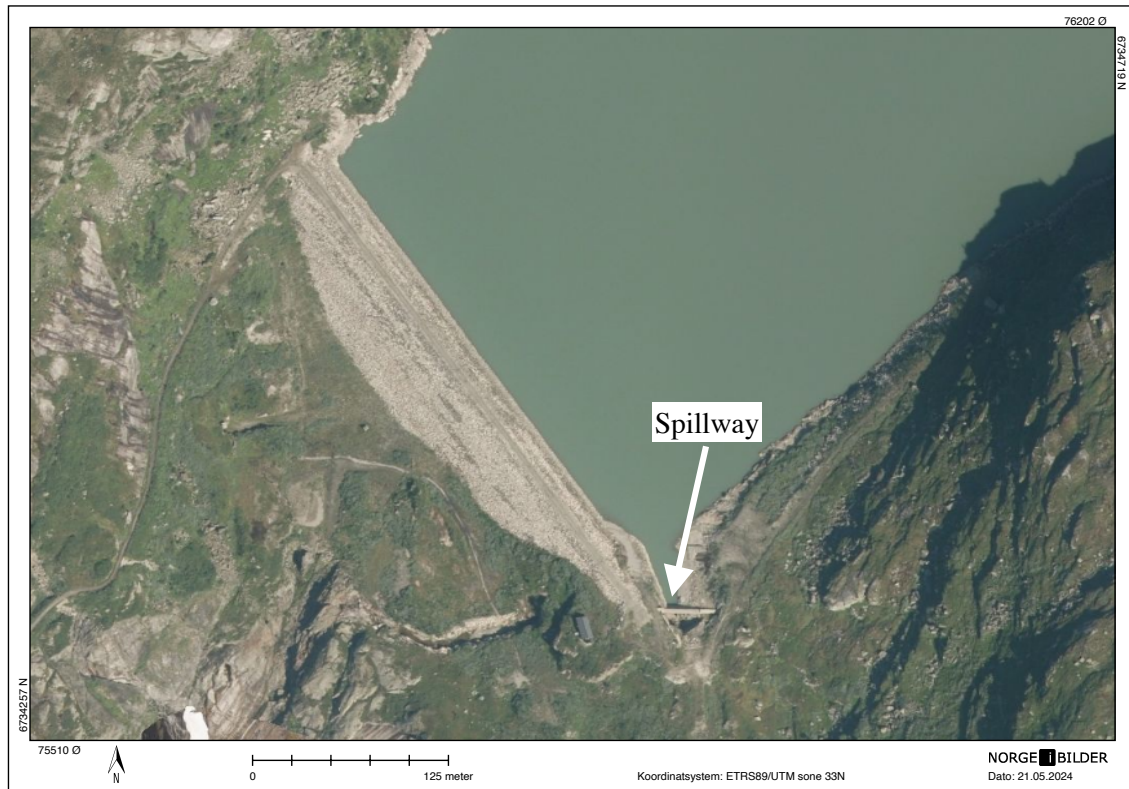
Figure 4.37 Aerial photo of Rembesdalsvatn embankment dam, with separate spillway indicated. Sourced from NorgeBilder.no (Norge digitalt, 2024).

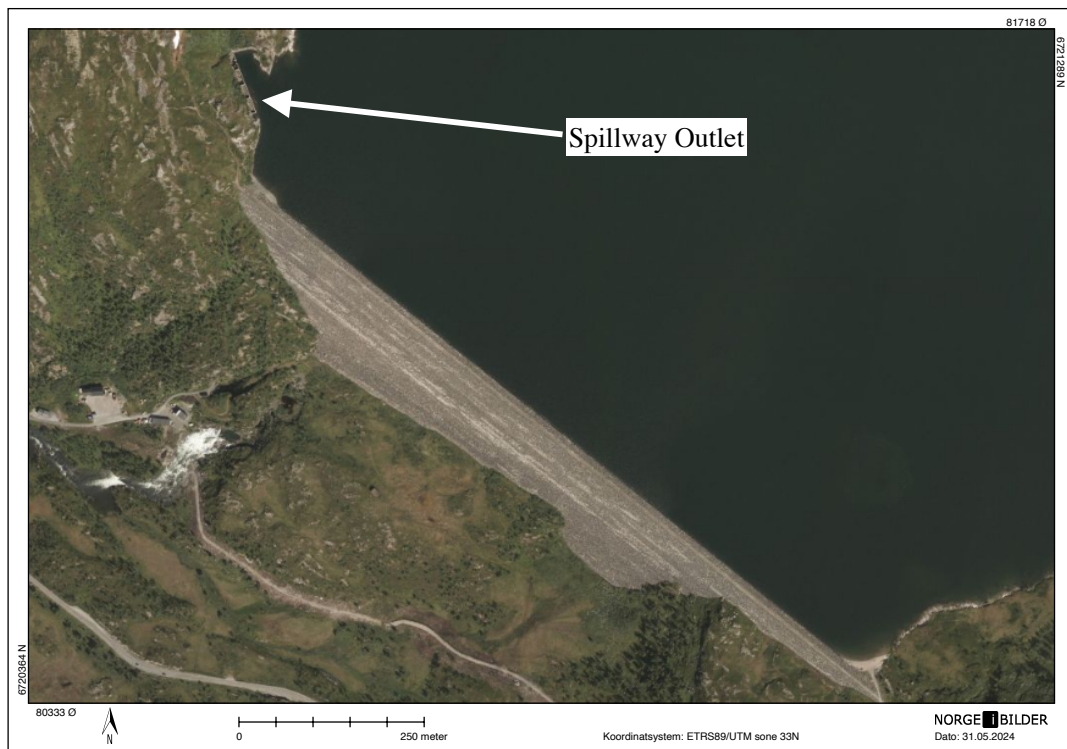
Figure 4.38 Aerial photo of Sysenvatn dam, with spillway outlet indicated on the north end. Active outflow is also visible from the embedded tunnel. Sourced from NorgeiBilder.no (Norge digitalt, 2024).

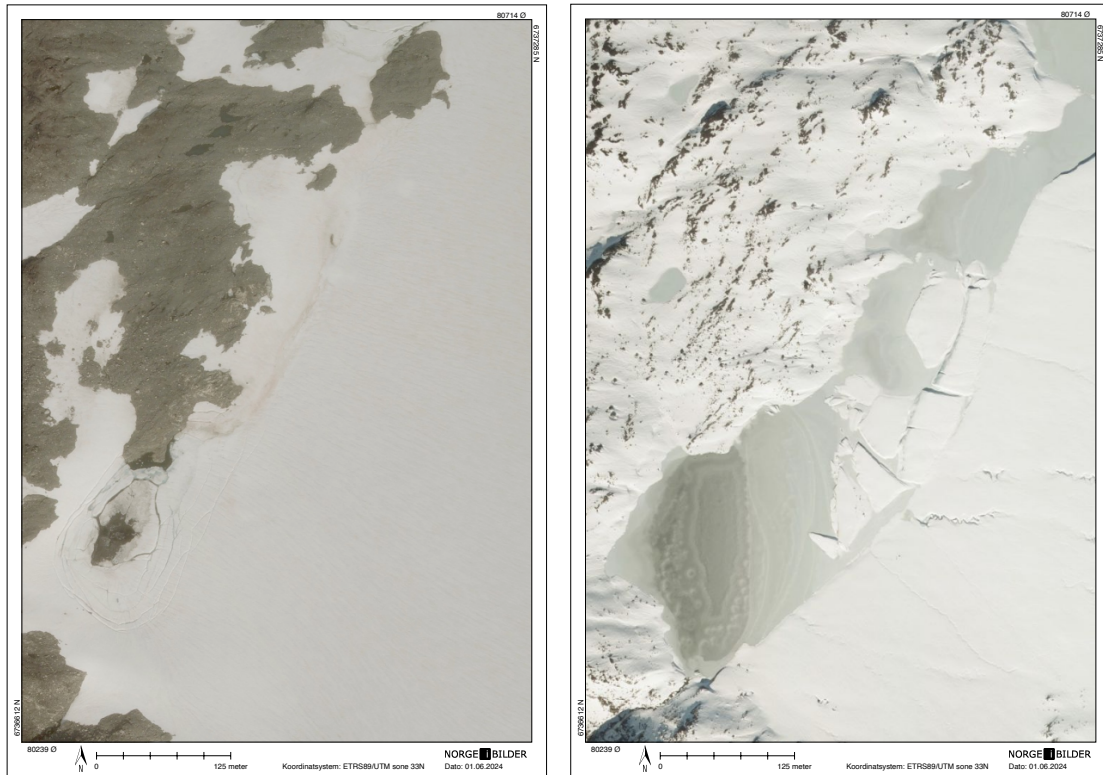
Figure 4.40 Proglacial lake identified extending to western margin of glacier 2963 (NVE ID). Timelapse showing significant growth of lake from 2008 (left) to 2019 (right). Photos sourced from NorgeiBilder.no (Norge digitalt, 2024).

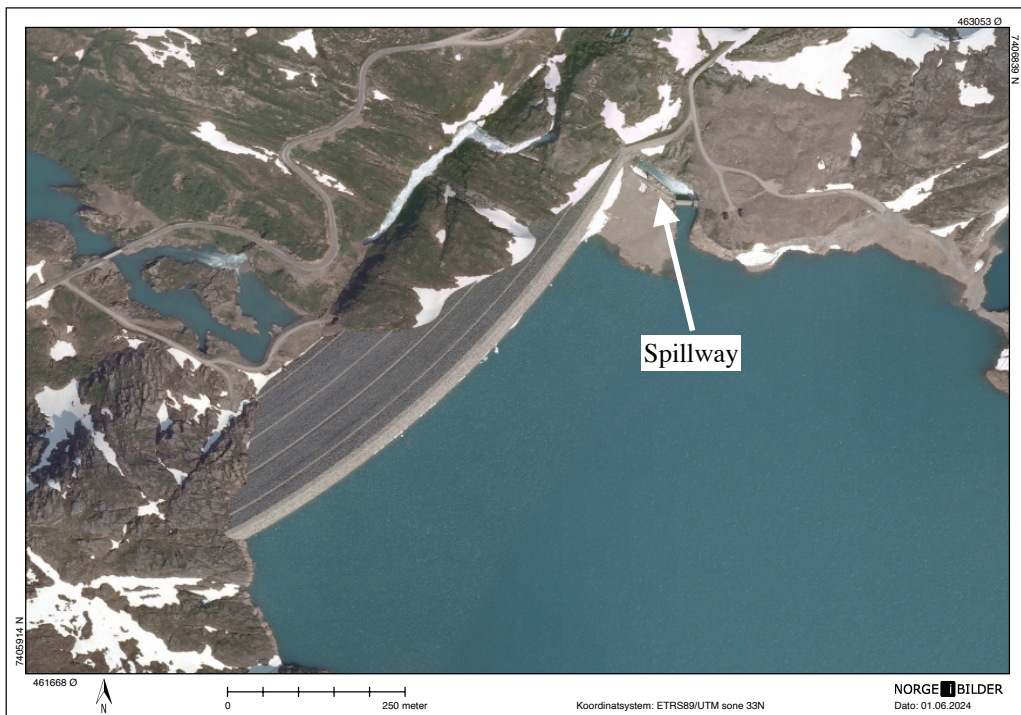
Figure 4.43 Aerial photo of Storglomvatn dam on the eastern side of Storglomvatn, with large concrete dam spillway visibly active at northern end. Photo from NorgeiBilder.no (Norge digitalt, 2024).

Located in Meløy municipality, Nordland, Storglomvatn (also referred to as *Stårglomvatn*) is an enormous 3.51×10^9 m³ reservoir, located within the Svartisen glacial system. The reservoir is dammed in two ends, one being Storglomvatn, and the other being Holmvassdammen, both labeled as consequence class 3. The lake was originally dammed from an older concrete slab dam, also under the name Storglomvatn dam (NVE, 2015). The older was built in 1942 and is now located well within the current reservoir body after decommissioning. Storglomvatn has a regulated HRV of 585 MASL and a LRV of 460 MASL, indicating an enormous variability in storage capacities. To date, it is Norway's most usable reservoir volume that can be regulated (NVE, 2015). Both current dams hold a crest height of 591 MASL, resulting in 3.4 m of freeboard. The lake supplies flow to the 600 MW Svartisen power plant, owned and operated both by Statkraft Energi AS (70%) and Nordland Fylksekommune (30%). This power plant was originally installed with 350 MW, which was enough to power approximately 80,000 homes, and was Norway's largest at the time (Benham & Dowdeswell, n.d.; Statkraft, n.d.). The lake receives flow directly from the 251 km² catchment area, as well as the potential from 50 different stream intakes across the region, with a combined 70 km long tunnel system, that can also be sent directly to the power station (Multiconsult, 2016).

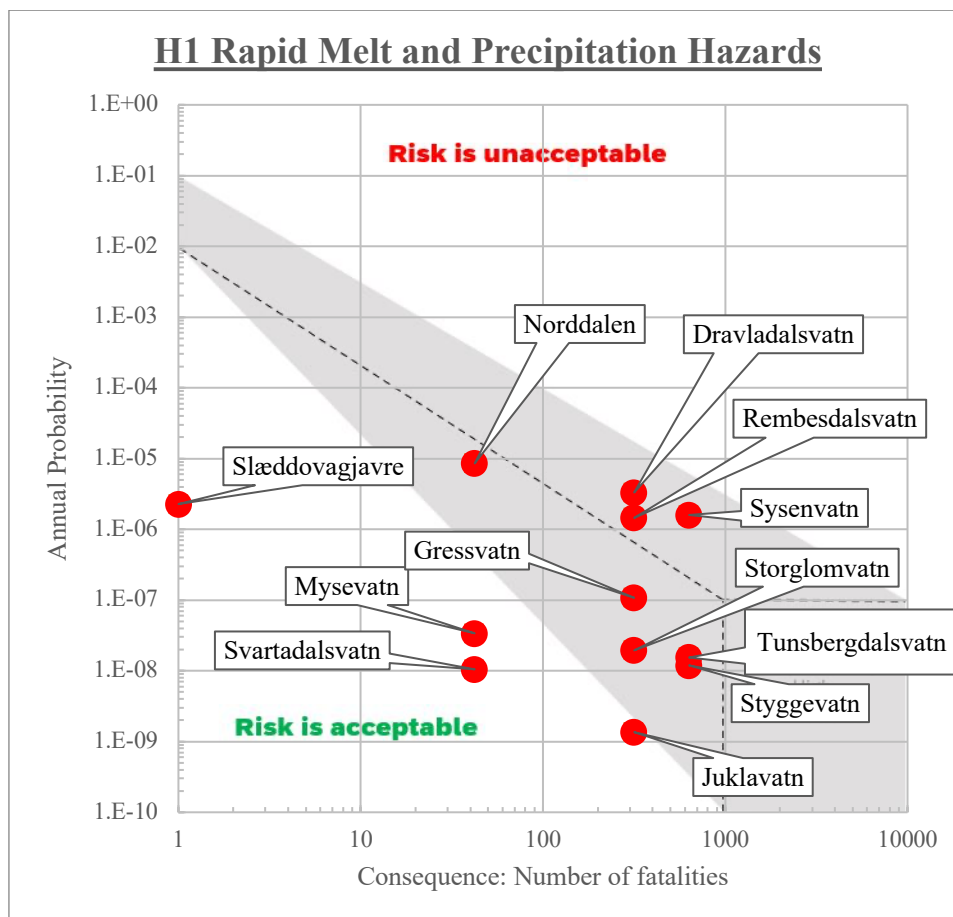
Figure 5.1 Risk envelope plot for H1 hazard condition for all applicable dams.

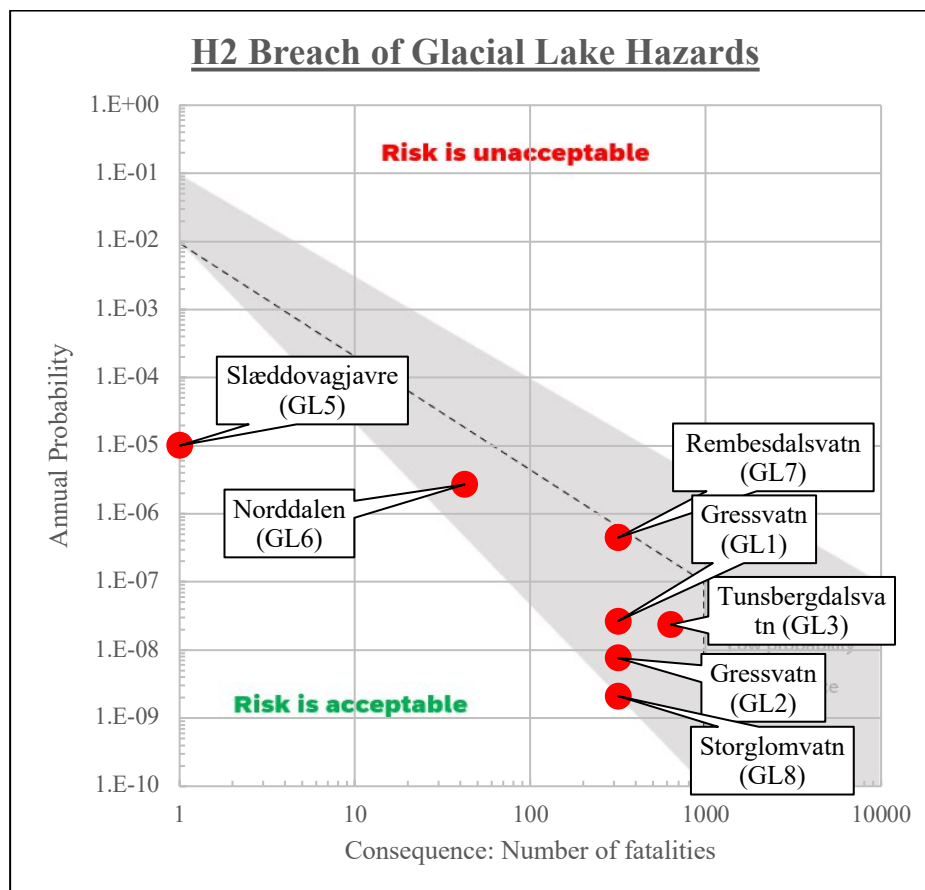
Figure 5.2 Risk envelope plot for H2 hazard condition for all applicable dams.

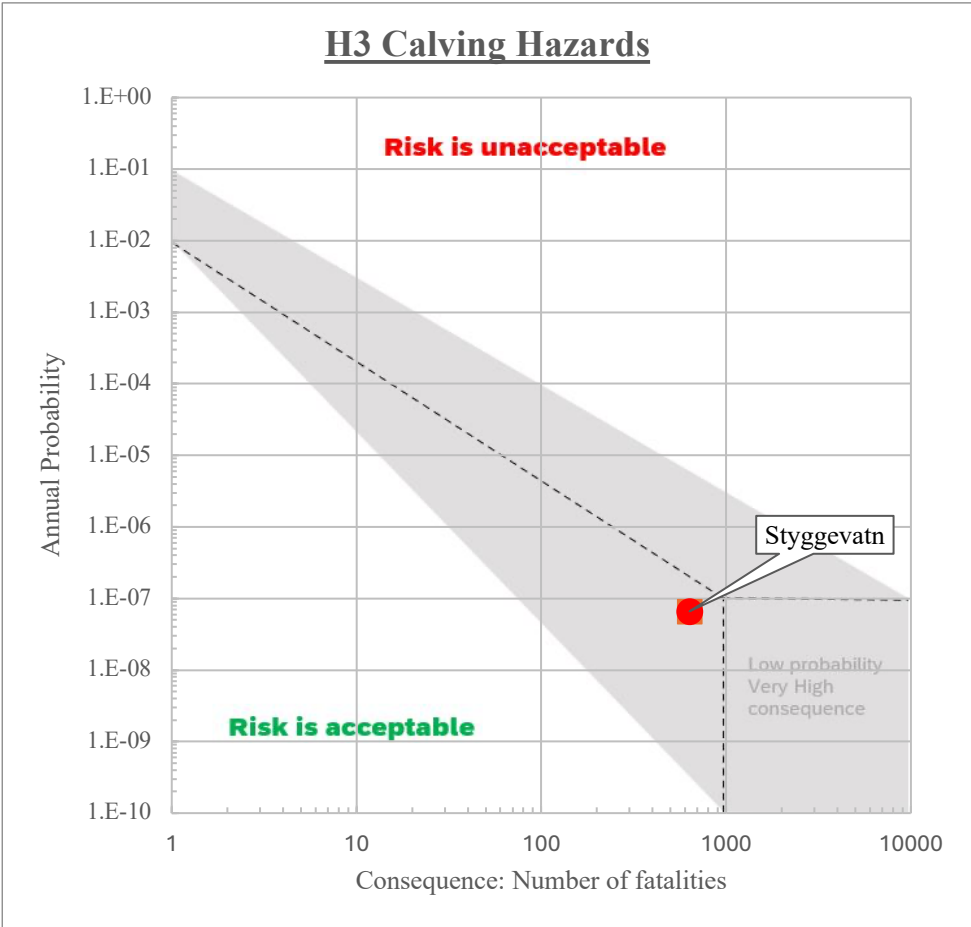
Figure 5.3 Risk envelope plot for H3 hazard condition for Styggevatn.
