# Permanent Effect of a Cryogenic Spill on Fracture Properties of Carbon Steel

**Hanne Keseler**

Chemical Engineering and Biotechnology

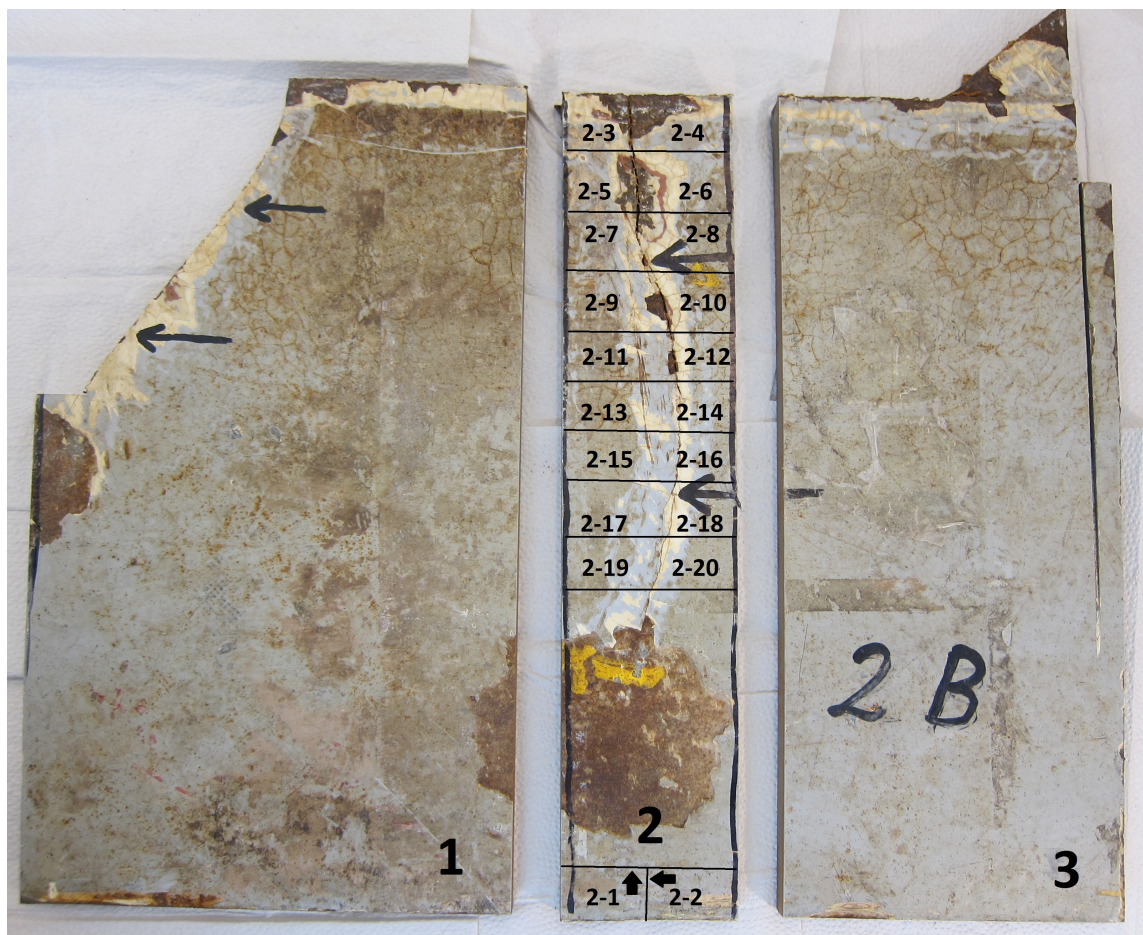
As seen in Figures 3.1, 3.2 and 3.3, the paint had cracked in certain areas. This was assumed to be caused by differences in the thermal contraction between the paint and the underlying material during the liquid nitrogen exposure. Which areas of the plate had been cooled to lower temperatures during the cryogenic spill, was indicated by cracks in the paint. In addition, the secondary cracks in the plate were believed to have propagated from brittle exposed areas and stopped when reaching more ductile material. Areas indicating cryogenic exposure will in this report be referred to as exposed areas, while those where no evidence of cryogenic exposure can be seen at the macroscopic level will be referred to as non-exposed areas.

**Figure 3.2:** The initial sectioning of the material into sections 1, 2 and 3, including the position and numbering of the specimens taken from section 2

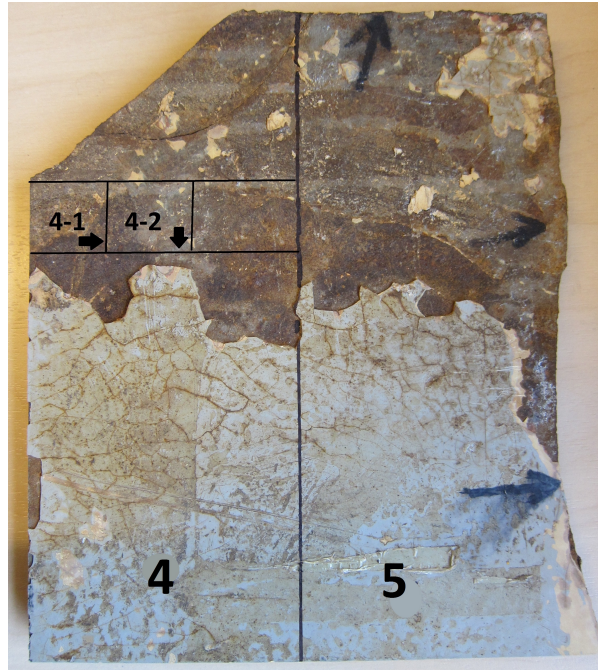
**Figure 3.3:** *The initial sectioning of the material into sections 4 and 5, including the position and numbering of the specimens taken from section 4*

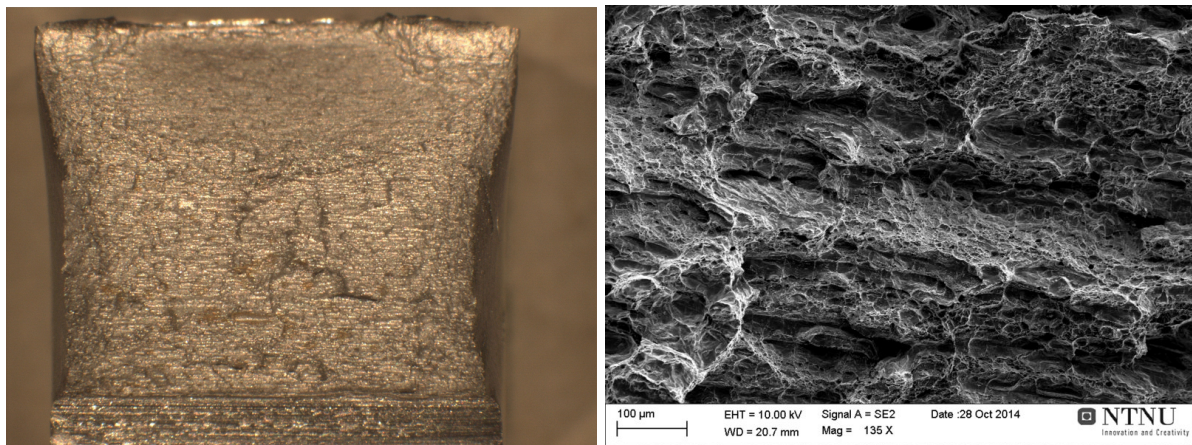
Images of the ductile fracture surface of specimen 1-33, which had an impact energy of 76,49 J, is shown in Figure 4.16. The macrograph in Figure 4.16a shows that the specimen appeared completely ductile on the macroscopic level. The notch is located in the bottom of the picture and the specimen shows lateral expansion. Also on the microscopic level the fracture surface

was completely ductile. In the SEM image in Figure 4.16b, ductile dimples as well as lines, which are directed along the rolling direction (perpendicular to the notch), can be seen. The lines are probably caused by the elongation of the micro structure, especially the manganese sulfides, in this direction.

**Figure 4.16:** Fracture surface of specimen 1-33, with a Charpy impact value of 76,49 J

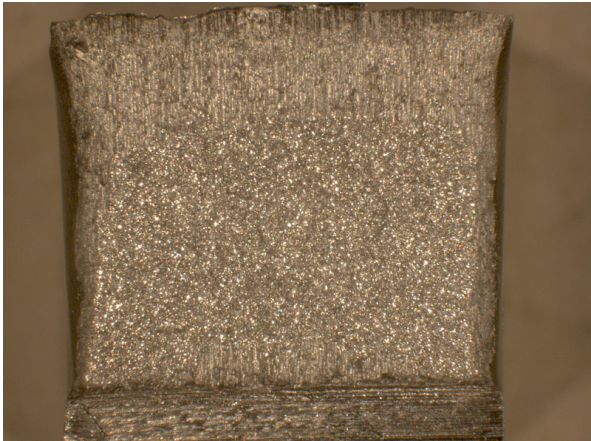
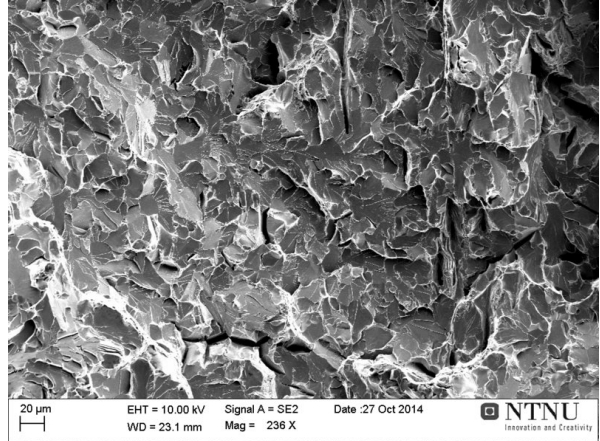
Images of the fracture surface of specimen 1-30, which had an impact energy of 36,01 J, are shown in Figure 4.17 and 4.18. The macrograph in Figure 4.17a, shows that the fracture started in a ductile mode, where fibres are seen directed perpendicular to the notch. After a small distance the fracture mode changes to brittle, identified by the flat, shimmering surface. At the end of the fracture, the mode is ductile again with some lateral expansion. A SEM image of a brittle area of the fracture surface is shown in Figure 4.17b. The image shows that the fracture mode is transgranular, with the characteristic flat surfaces and river markings. Several secondary cracks of varying sizes and directions are observed in the fracture surface. Some are located along grain boundaries and some go straight through the grains. Figure 4.18, shows the fracture surface at the beginning and the end of the fracture. In Figure 4.18a, the notch can be seen in the top of the image and the fracture is clearly ductile for a distance of approximately 1 mm, before turning brittle. Figure 4.18b, shows an area at the end of the fracture, where the fracture mode changes back from transgranular to ductile.

**Figure 4.17:** Fracture surface of specimen 1-30, with a Charpy impact value of 36,01 J

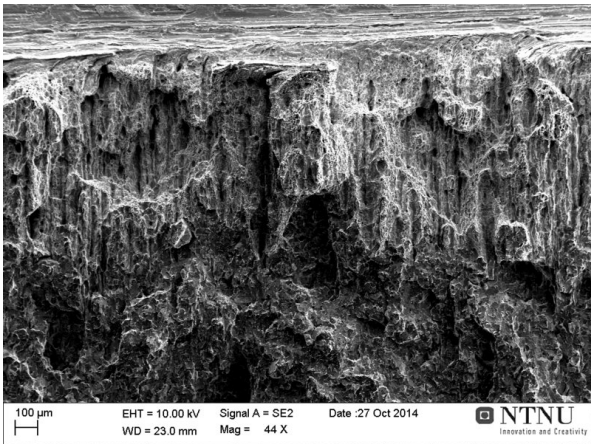
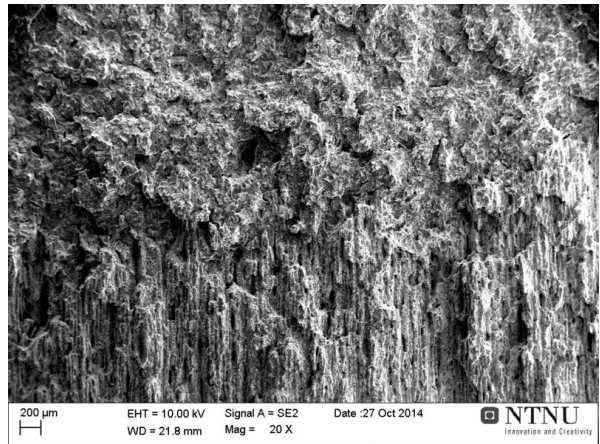
**Figure 4.18:** SEM images of specimen 1-30, with a Charpy impact value of 36,01 J

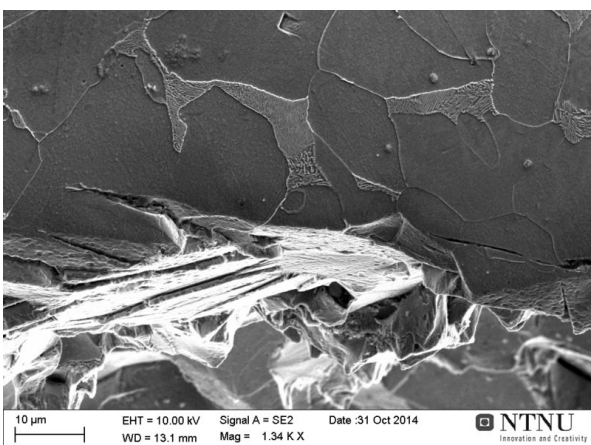
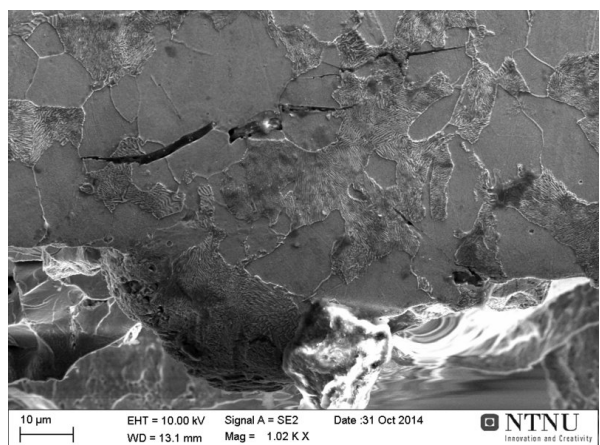
The fracture surface of specimen 1-30 is seen from the side in Figure 4.19. In Figure 4.19a, secondary cracks are observed, which is characteristic for a brittle fracture. A microcrack is also seen at a small distance below the fracture surface, in the bottom-right of the image. In Figure 4.19b, several cracks are present below the fracture surface. The cracks are mainly directed parallel to the main fracture. The largest crack, located to the left in the image, starts at a ferrite grain boundary and propagates directly through the adjacent ferrite and pearlite grains, before it stops within a ferrite grain. In this specimen, no microcracks were found after a distance of approximately 0.1 mm from the fracture surface.

**Figure 4.19:** Side-views of the fracture surface of specimen 1-30, with a Charpy impact value of 36,01 J

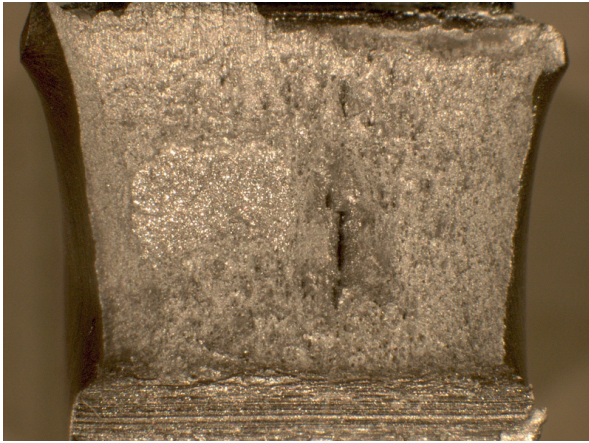
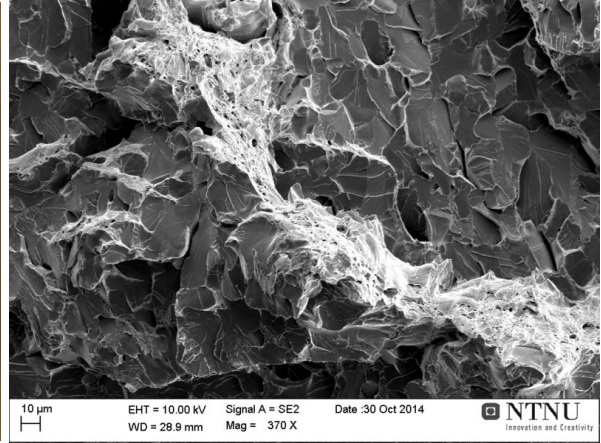
The fracture surface of specimen 3-33, is shown in Figures 4.23 and 4.24. The macrograph in Figure 4.23a shows that the surface is mainly ductile, and contains a macrocrack in addition to a brittle spot to the left of the crack. Figure 4.23b shows a SEM image from the brittle area of the fracture surface. A transgranular brittle fracture surface with several small cracks and a ductile dimpled band can be seen in the image. The transgranular facets are clearly seen in Figure 4.24a, which is from an other area of the brittle region. The image shows that the cracks are located both along grain boundaries and within grains. Some ductility can also be seen in the image, like the thin dimpled line in the top left corner of the image. A SEM image of the beginning of the macrocrack, is shown in Figure 4.24b. The fracture mode around and within the crack appeared to be ductile.

**Figure 4.23:** Fracture surface of specimen 3-33, with a Charpy impact value of 111,36 J

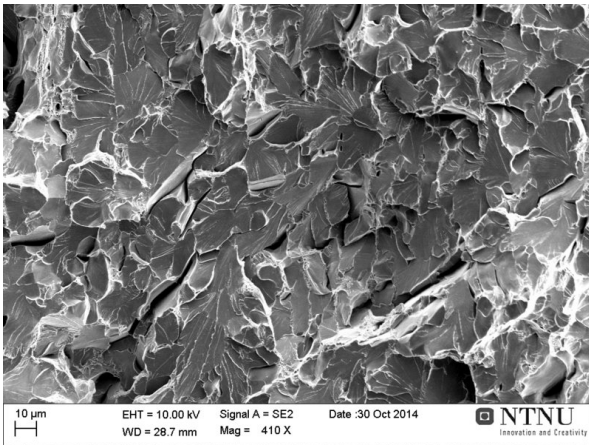
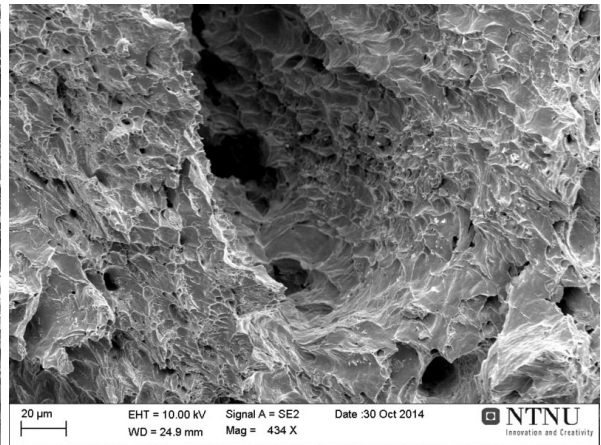
**Figure 4.24:** Fracture surface of specimen 3-33, with a Charpy impact value of 111,36 J

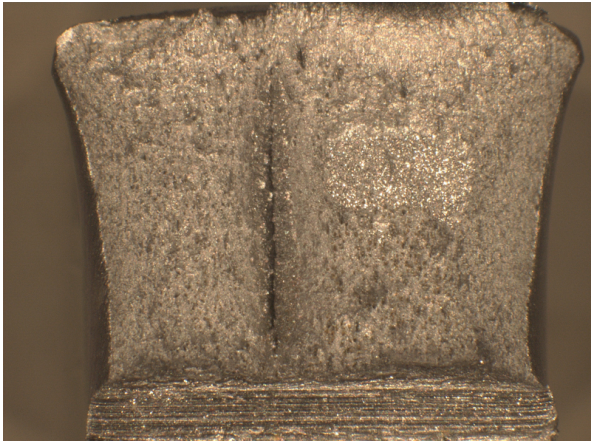
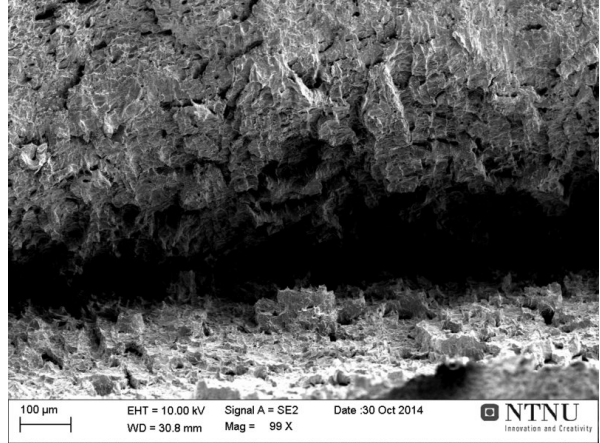
Figures 4.25, 4.26 and 4.27, show the fracture surface of specimen 3-34. The macrograph in Figure 4.25a, shows that a macrocrack is present in the fracture surface. The fracture mode appears to be ductile, except from a brittle spot on the right side of the macrocrack. A region of the macrocrack is shown at higher magnification in Figure 4.25b. The notch lies to the left in the images, meaning that the direction of fracture propagation is from left to right. The images in Figure 4.26 are from the left surface inside the macrocrack as it is shown in the macrograph. Figure 4.26a, shows characteristics of a ductile shear fracture, with elongated dimples, while Figure 4.26b, shows characteristics of both ductile and brittle transgranular fracture. A image from the right surface inside the macrocrack is shown in Figure 4.27. The fracture mode in this picture is somewhat difficult to interpret, but some elongated pores are visible indicating that the fracture is, at least partially, ductile.

**Figure 4.25:** Fracture surface of specimen 3-34, with a Charpy impact value of 107,48 J

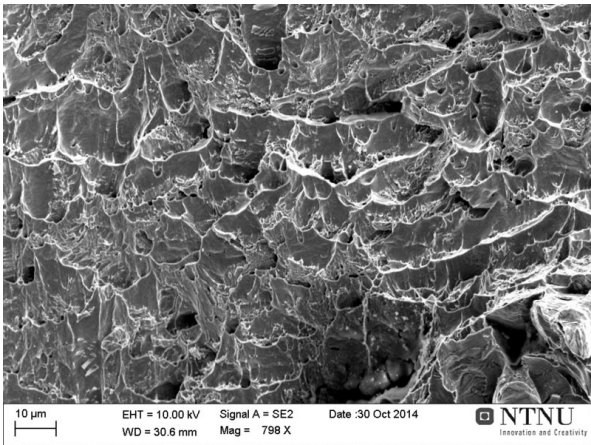
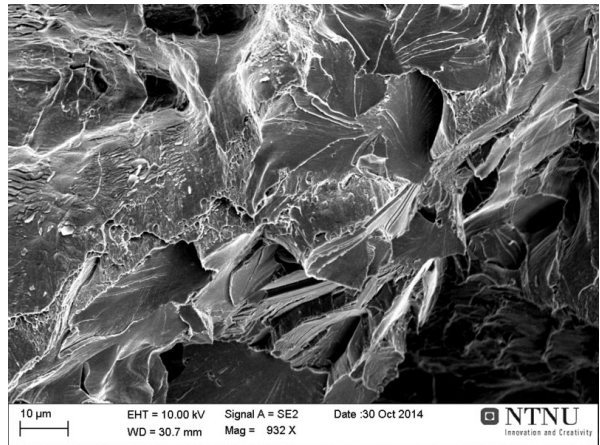
**Figure 4.26:** Fracture surface of specimen 3-34, with a Charpy impact value of 107,48 J

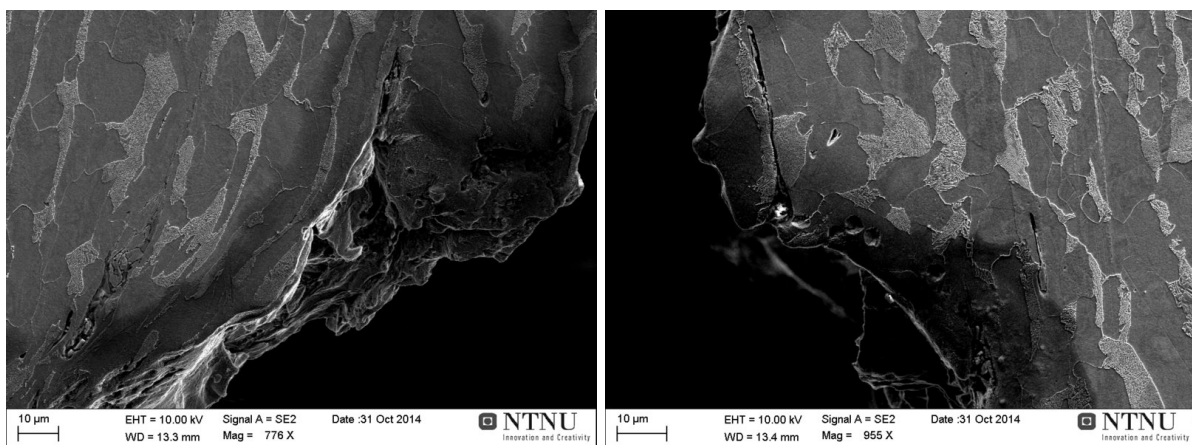
The fracture surface of specimen 3-34 was also examined from the side. A low magnification image, where a cross section of the specimen can be seen, is shown in Figure 4.28. The fracture surface is in the bottom of the image and the macroscopic crack can be seen clearly. The rolling direction is perpendicular to the fracture surface. From this image, the depth of the crack was measured to be approximately 1,5 mm. It is seen that the left wall of the macrocrack has an angle of approximately  $45^\circ$ , while the right wall is approximately perpendicular to the general fracture surface. The two side-walls of the macrocrack are shown at larger magnification in Figure 4.29. Figure 4.29a shows the left wall of the crack. The shape of the pearlite grains indicate that the material has been plastically deformed close to this fracture surface. The right side of the wall is shown in Figure 4.29b, no deformation is observed at this side. Some secondary cracks can be observed on both sides.

**Figure 4.29:** Fracture surface of specimen 3-34 viewed from the side

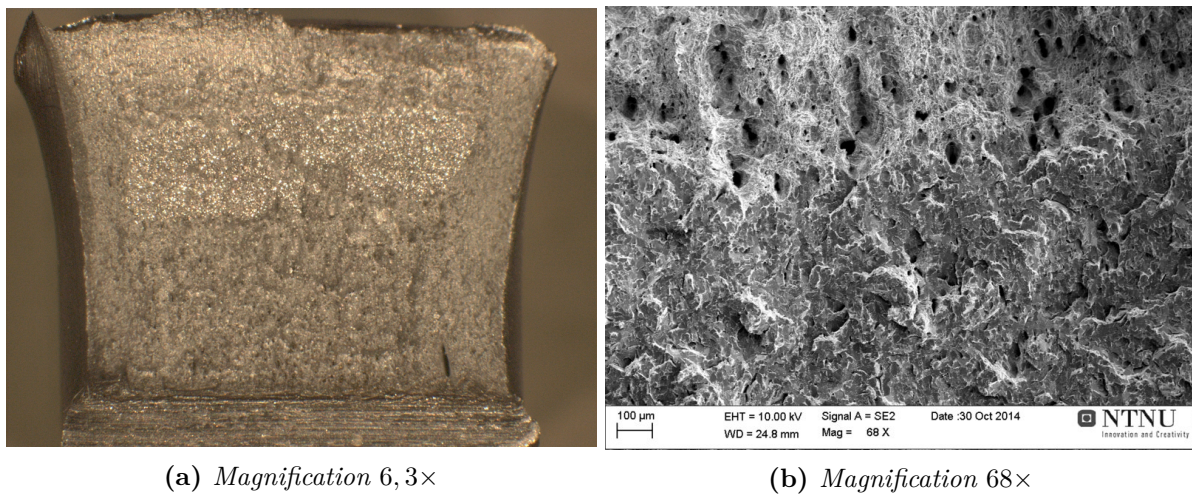
Figures 4.30 and 4.31 show the fracture surface of specimen 3-11, which had an impact energy of 107,62 J. The macrograph in Figure 4.30a, shows that the fracture surface is mainly ductile, with a brittle region close to the end of the fracture. A small macrocrack can be seen in the bottom right of the image. Figure 4.30b shows a low-magnification image from an area of the fracture surface where the fracture mode changes from ductile to brittle. The features of the ductile area of the fracture surface, which is shown at a higher magnification in Figure 4.31a, is quite different from the ductile features of the transverse specimens. The longitudinal specimens do not show the same effect of the elongated microstructure as the rolling direction in these specimens, and therefore also the direction of the microstructure, is normal to the fracture surface. Very deep voids can be observed in the ductile fracture surface, which may be due to manganese sulfides which have been elongated in the rolling direction. An image of the brittle areas of the fracture surface is shown in Figure 4.31b. The image shows transgranular facets and surface cracks, with several voids, which probably also have been caused by elongated sulfides.

**Figure 4.30:** Fracture surface of specimen 3-11, with a Charpy impact value of 107,62 J

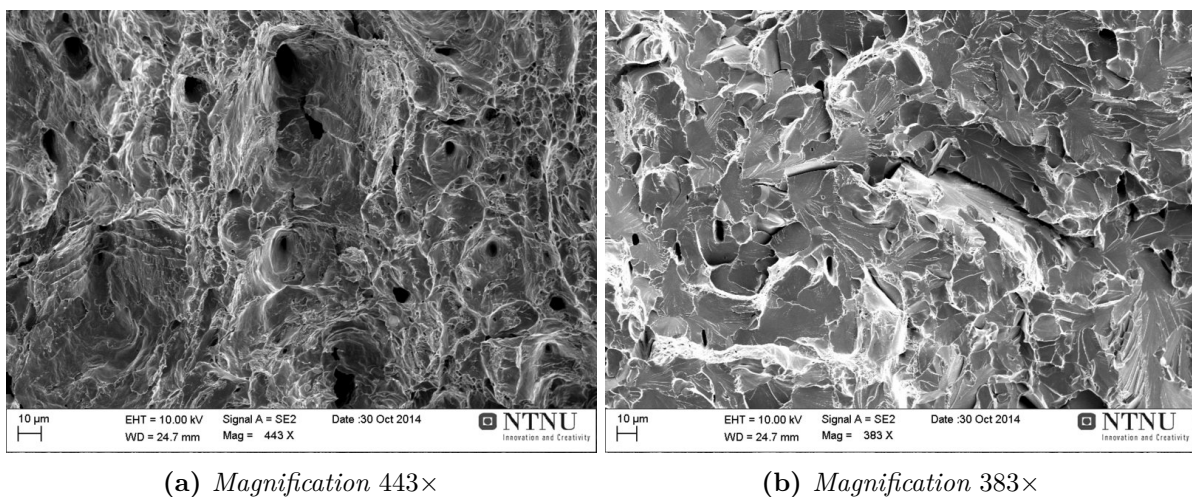
**Figure 4.31:** Fracture surface of specimen 3-11, with a Charpy impact value of 107,62 J

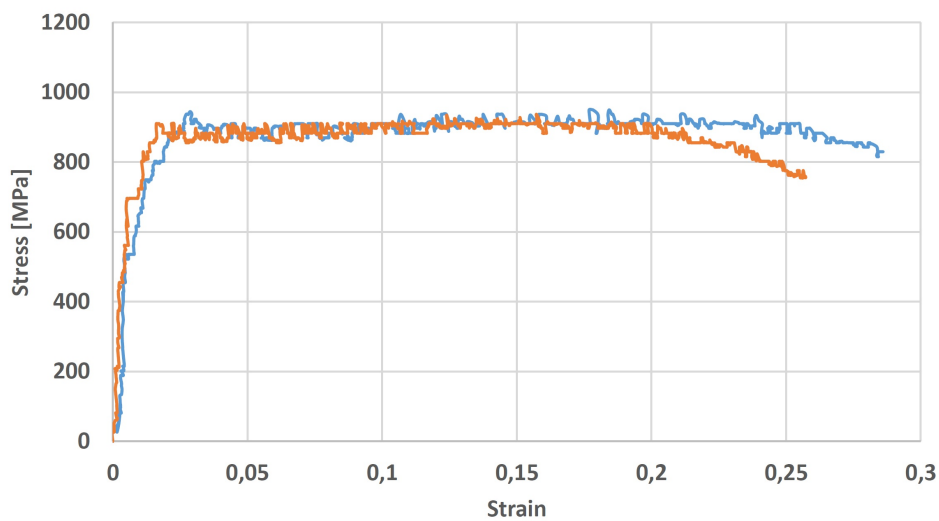
Figure 4.34 shows the engineering stress-strain curves for two specimens of the NV E36 steel, which were tested at  $-196^{\circ}\text{C}$ . The curves contain a lot of noise. This is an experimental error caused by the the MTS 880 test apparatus, which was used for the liquid nitrogen tests. This is also the reason for the deviation from linearity in the elastic region, which is seen after a stress of approximately 500 MPa has been reached. The room temperature curve obtained during a test run on MTS 880 also showed these features, confirming that this was an error caused by the apparatus and not the behaviour of the material at the low temperature. This room temperature curve is shown in Figure A.19, in appendix A.3.

The stress-strain curves show a sharp yield point, with an upper-yield strength of approximately 907 and 945 MPa. The upper yield point is followed by a long area where the engineering stress is oscillating around an approximately constant value. The lower yield point is the average value of stress in this region, which is approximately 897 and 880 MPa for the two specimens. When strains of 25,7% and 28,6% is reached, fracture occurs.

**Figure 4.34:** *Engineering stress-strain curve for material NV E36, two parallels tested at  $-196^{\circ}\text{C}$*

The stress-strain curves of the NV E36 and the S355 steel at  $-196^{\circ}\text{C}$ , are shown in Figure 4.34 and 4.38, respectively. It can be seen that lowering the temperature from ambient to  $-196^{\circ}\text{C}$  has increased the lower yield strength by approximately 167% for NV E36 and 137% for the S355 steel. A large increase in yield strength as a result of lowering the temperature is expected for ferritic steels, due to the significance of the temperature-dependent Peierls stresses in these materials. However, the fracture strength was also significantly increased and both steels showed a much larger elongation than expected at this temperature.

For the NV E36 steel, the strain at fracture in liquid nitrogen (27,2%) was approximately equal to the strain at room temperature (27,3%). However, the appearance of the stress-strain curve was quite different. Firstly, the specimens showed a more pronounced upper yield point than they did at room temperature. After the yield drop, a long horizontal region was seen, which was believed to be caused by the propagation of Lüders bands across the length of the specimen. This was confirmed by measuring the diameter along the test region of a tensile specimen after the tensile test. It was observed that the diameter had been uniformly reduced over the whole length of the test region. Necking had occurred from a distance of 1,5 mm from the fracture surface, where the diameter decreased gradually until a minimum was reached at the fracture surface. This indicates that the Lüders band spread through approximately the whole test region during the horizontal region of the stress-strain curve. When the whole specimen had yielded, necking occurred and the specimen failed. The large Lüders strain seen at  $-196^{\circ}\text{C}$ , can be explained by the work hardening rate of the material being low at this temperature. A reduced work hardening rate and increased yield strength when lowering the temperature, was observed by Goodenow and Bucher [13] when tensile testing carbon steels at temperatures between ambient and liquid nitrogen. Instead of a ductile-to-brittle transition, they observed a so-called plastic instability transition when the temperature was decreased below a certain point. They defined the plastic instability transition temperature as the temperature where the tensile stress is equal to the lower yield stress and necking occurs within the Lüders strain. In the case of the NV E36 steel tested in this report, the work hardening rate was probably just large enough for the Lüders band to spread over the length of the test region. However, when approximately the whole specimen had yielded, work hardening could no longer compensate for a reduction in cross section area and necking occurred. For this material, liquid nitrogen temperature was most likely slightly below the instability transition temperature defined by Goodenow and Bucher.

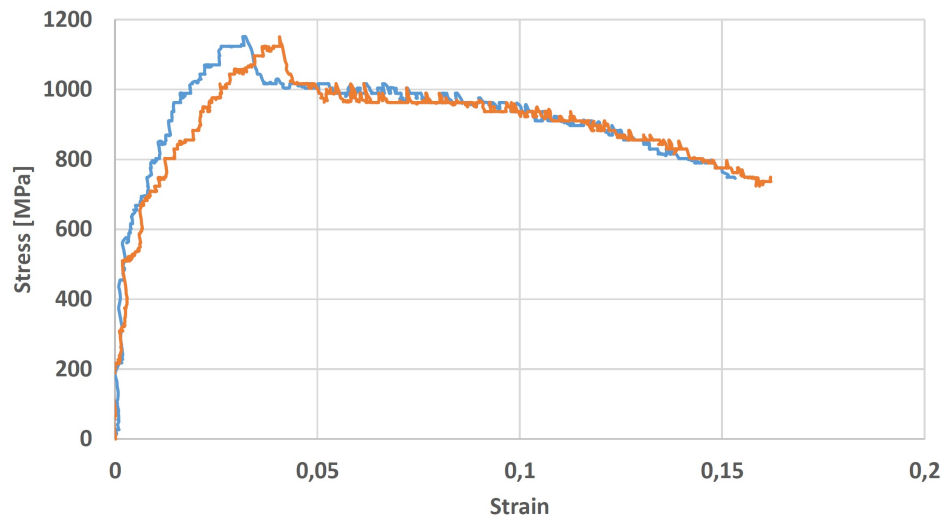
Figure 4.38 shows the engineering stress-strain behaviour of the S355 steel, when tested at  $-196^{\circ}\text{C}$ . The curves from two parallel tests are shown. The curves contain a lot of noise which, as was explained previously, is a result of the MTS 880 apparatus being used for these tests. The experimental error causes the curves to deviate from linearity at a strain of approximately 600 MPa. However, a clear upper-yield point is seen at 1151 MPa. After the upper-yield point, the stress drops to a value of approximately 1017 MPa, which is taken as the yield strength. After this, the stress decreases slowly until fracture occurs at strains of 15,3% 16,2%.

**Figure 4.38:** *Engineering stress-strain curve for material S355, two parallels tested at  $-196^{\circ}\text{C}$*

The S355 steel showed a somewhat similar behaviour to the NV E36 steel. However, the yield drop was much larger and the strain experienced by the specimen before fracture was significantly lower. In this material the total strain in liquid nitrogen (15,8%) was approximately half of that at room temperature (29,0%). It is believed that the localized deformation which occurred during the yield drop was too large and the work hardening rate too low, for the Lüders band to stabilize and spread through the specimen length. Necking would then begin immediately after the yield drop, closely followed by fracture. This is reflected in the stress-strain curve by the constantly decreasing stress after the upper yield point. These observations were also confirmed by measuring the diameter along the test region of a fractured tensile specimen. The test region showed no uniform reduction in cross section area, only a gradually decreasing diameter starting from a distance of approximately 2,5 mm from the fracture surface and reaching a minimum at the fracture surface. The yielding had therefore only spread a

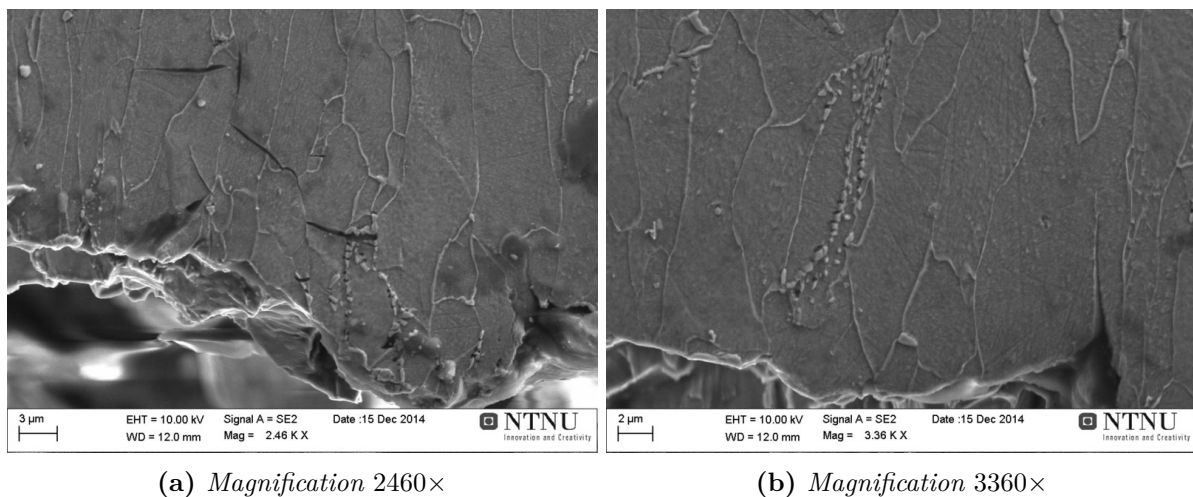
The images in Figure 4.44, show the longitudinal cross section of a specimen of the S355 steel, which had been tensile tested to fracture in liquid nitrogen. In Figure 4.44a, microcracks can be seen below the fracture surface. Such cracks were only observed in the regions closest to the fracture surface. Some cracked grain boundary carbide films were also observed, as shown in Figure 4.44b. Grain boundary carbides which had been cracked into many pieces, were also located only at relatively short distances from the fracture surface.

**Figure 4.44:** SEM image from the longitudinal cross section of material S355, tensile tested at  $-196^{\circ}\text{C}$ .

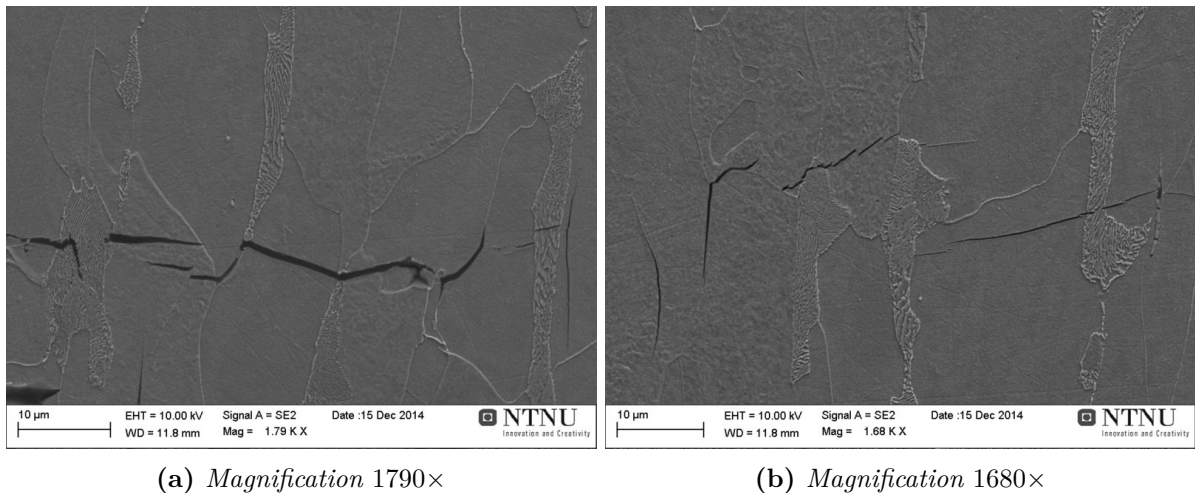
The images in Figures 4.45, 4.46 and 4.47, are from the longitudinal cross section of one of the NV E36 specimens which had been tensile tested in liquid nitrogen. The images in Figure 4.45a show a type of microcracks which were found only at small distances from the fracture surface. These cracks were oriented mainly parallel but also perpendicular to the fracture surface. Another type of microcracks found in the longitudinal cross section, is shown in Figures 4.46 and 4.47. These cracks were always directed parallel to the specimen length, and were found through the entire test region of the tensile specimen. The crack shown in Figure 4.46 has spread along several ferrite grain boundaries. However, most of the cracks had the appearance shown in Figure 4.47. In this case the cracks seem to be located around elongated manganese sulphides. Voids can also be seen under the sulphides in this image.

**Figure 4.45:** SEM image from the longitudinal cross section of material NV E36, tensile tested at  $-196^{\circ}\text{C}$ .

Also in the platform material (NV E36) which was tensile tested to fracture in liquid nitrogen, microcracks were found at very small distances from the fracture surface. This was shown in Figure 4.45. For this material, the Lüders bands had propagated through the whole test region of the specimens. The deformation in the Lüders bands was therefore not large enough to create this type of micro cracks. However, cracks of the type seen in Figures 4.46 and 4.47, were found throughout the whole test region of the NV E36 steel. All these cracks were directed parallel to the specimen length, which is the same direction as the microstructure elongation. The majority of these cracks had the appearance seen in Figure 4.47. In this figure it can be seen that the cracks are located at the interface between elongated manganese sulphide inclusions and the steel matrix. Voids are also seen beneath some of the sulphides, however these are believed to have been caused by the etching in 2% Nital. The cracks where manganese sulphides are not seen, like the one in Figure 4.46, is believed to be associated with sulphide inclusions which have been located just beneath or above the examined surface. In this image, it can be seen that the crack also has spread along some of the adjacent grain boundaries. Sulphide related cracks were only found in the NV E36 and not the S355 material. The reason for this can be that the latter contained a much smaller amount of MnS inclusions and also because the plastic deformation occurred within a much smaller region of these specimens. The reason that cracks were formed in association with the manganese sulphide inclusions in the NV E36 steel, is believed to be a combination of the low temperature and the high stresses in the material. Brooksbank and Andrews [5], showed that MnS inclusions have a linear thermal expansion coefficient of  $18 \times 10^{-6} \text{ } ^\circ\text{C}^{-1}$ , which is higher than the value of  $12 \times 10^{-6} \text{ } ^\circ\text{C}^{-1}$  for steel. This means that, when the material is cooled, the MnS inclusions will contract at a higher rate than the steel. The result is decohesion and possibly also void formation, at the inclusion-matrix interface. The simultaneous deformation of the material, is believed to have caused the formation of the observed cracks. These cracks are likely to have been formed during the Lüders band propagation. Unfortunately, there was not enough material of this steel to examine longitudinal cross sections of specimens held at stresses below the yield point, so it can not be said with certainty if the cracks formed before or after the upper-yield point.

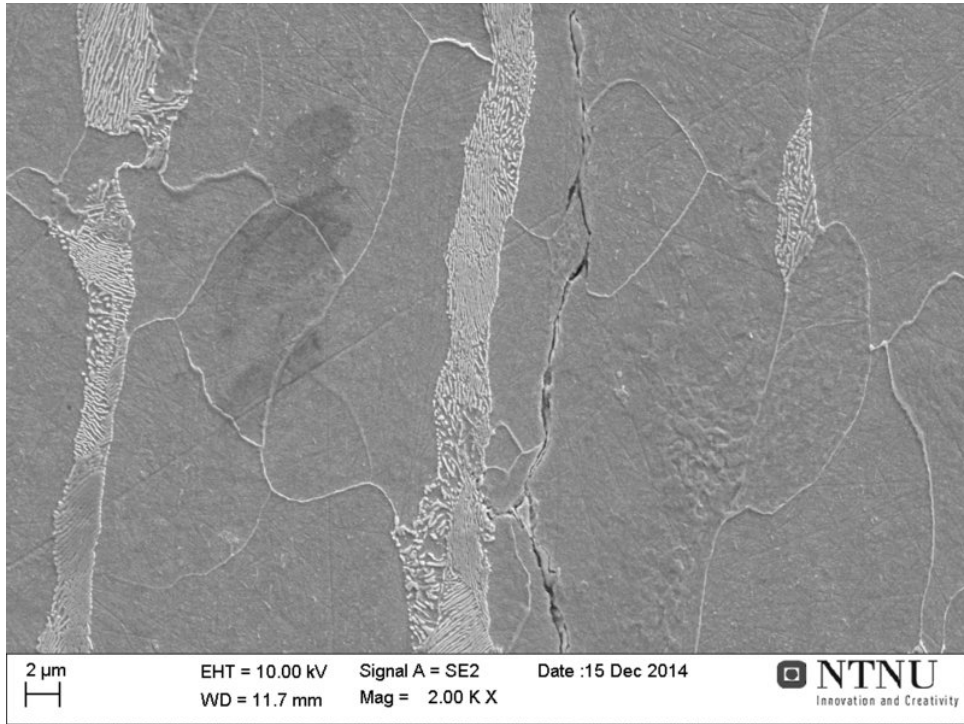
**Figure 4.46:** Longitudinal cross section of material NV E36, tensile tested at  $-196^{\circ}\text{C}$ . Magnification  $2000\times$

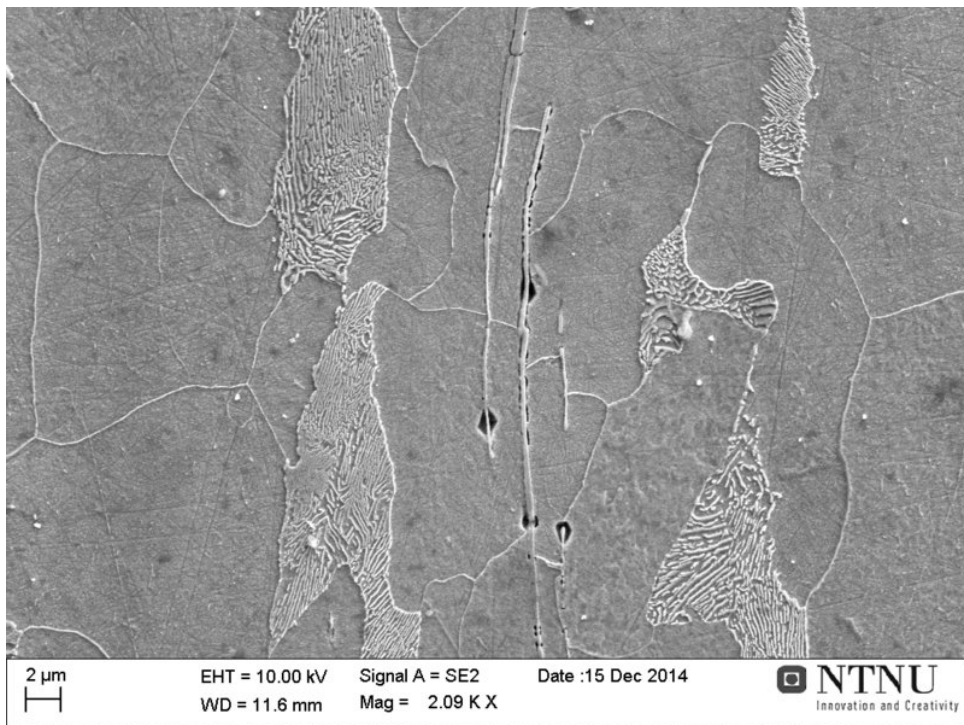
**Figure 4.47:** Longitudinal cross section of material NV E36, tensile tested at  $-196^{\circ}\text{C}$ . Magnification  $2090\times$

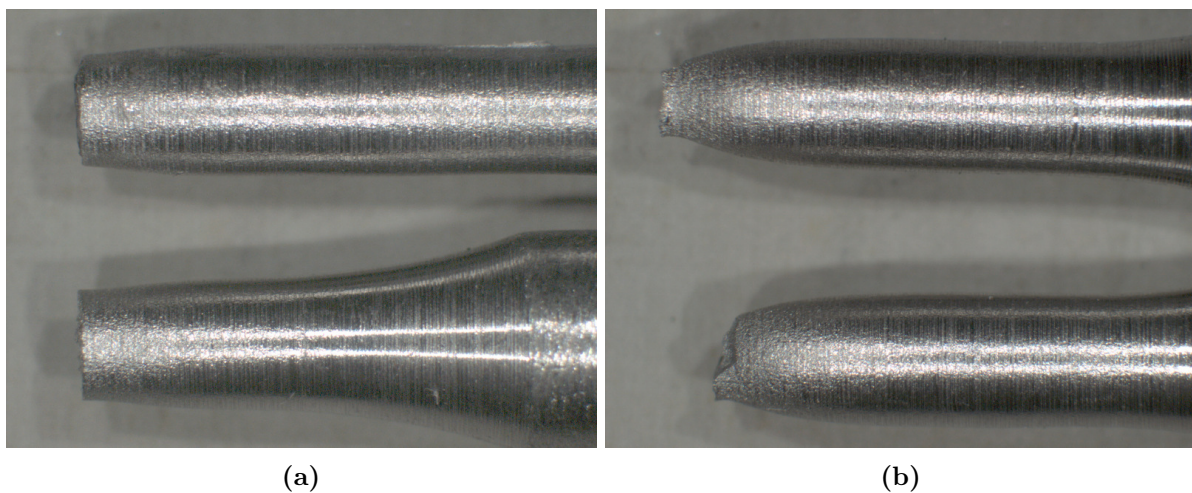
The images in Figure 4.48 show the macrographs of two fractured tensile specimens of the NV E36 steel. The specimen in Figure 4.48a was tensile tested at  $-196^{\circ}\text{C}$  and the specimen in Figure 4.48b was tested at room temperature. The specimen which had been tensile tested at room temperature showed a typical ductile cup-and cone fracture, with a large amount of necking. The specimen which had been tested at in liquid nitrogen showed brittle characteristics, with a flat fracture surface and only a very small amount of necking. Measurements of the diameter along the test area of the specimen which had been tested at  $-196^{\circ}\text{C}$ , showed that the diameter had a nearly constant value of approximately 2,8 mm, until a distance of about 1,5 mm from the fracture surface. Around this point, the diameter started to decrease gradually, before reaching its minimum value of 2,3 mm at the fracture surface.

**Figure 4.48:** Macrographs (6,3 X) of fractured tensile specimens of material NVE36, tested in (a) liquid nitrogen and (b) room temperature

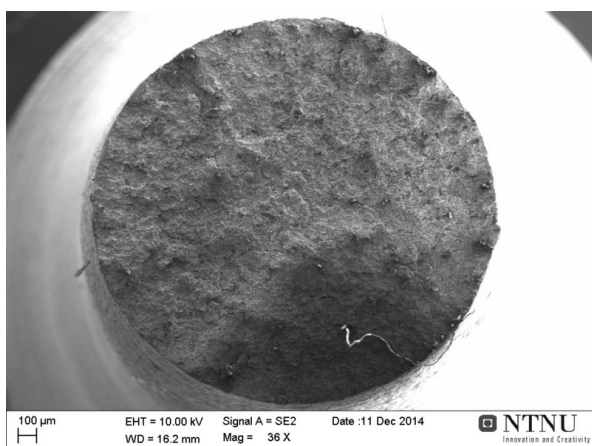
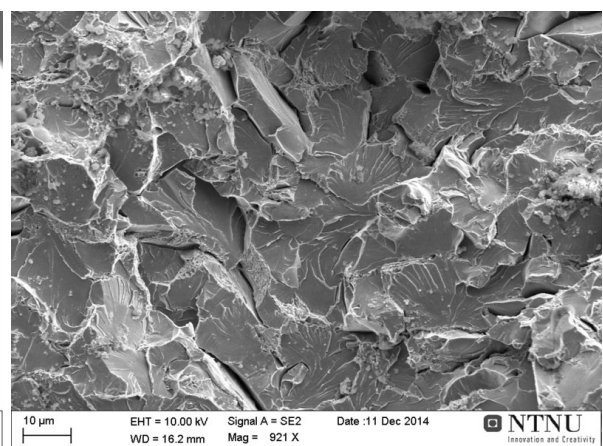
The images in Figure 4.51 show the fracture surface of a tensile specimen of the NV E36 steel, which was fractured by tensile testing at  $-196^{\circ}\text{C}$ . The low magnification image in Figure 4.51a shows that the fracture surface is relatively flat and has a uniform diameter of approximately 2,2 mm. In the higher magnification image in Figure 4.51b, it can be seen that the fracture mode is brittle transgranular and that cracks are present in the surface. Some rust can also be seen on the fracture surface.

**Figure 4.51:** Fracture surface of material NV E36, tensile tested at  $-196^{\circ}\text{C}$

Regardless of the relatively large ductility of the NV E36 and S355 specimens when tensile tested in liquid nitrogen, SEM examination of their fracture surfaces showed that they had fractured by a brittle transgranular mechanism (Figures 4.51 and 4.57). The fracture surfaces of the two S355 specimens which were tensile tested in liquid nitrogen also contained one large crack extending from the periphery towards the center. Two such cracks were also seen in the S355 specimen shown in Figure 4.55, which fractured at a constant force of 7000 N at this temperature. These cracks were always directed from the periphery towards the centre. Therefore, it is believed that they are a consequence of the anisotropic microstructure resulting from the hot rolling process. The tensile specimens were prepared in the longitudinal direction, meaning that the microstructure was elongated in the direction normal to the fracture surface and in some direction in the fracture surface. The metallographic examination of the S355 steel showed that the microstructure consists mainly of equiaxed ferrite grains. However, some elongated inclusions and pearlite grains were also present. This may be thought to initiate such cracks in the fracture surface, in a similar manner as fissure or split formation in Charpy specimens. The reason that these cracks are seen in the S355 specimens and not in the NV E36 specimens, in which the elongation of the microstructure is more pronounced, could be the larger degree of ductility in the S355 specimens. It has previously been shown that fissuring is a mainly ductile process, propagating by tearing apart of grain boundaries [24]. In the S355 specimen some ductile dimples were seen in between the transgranular facets and especially around the large cracks.

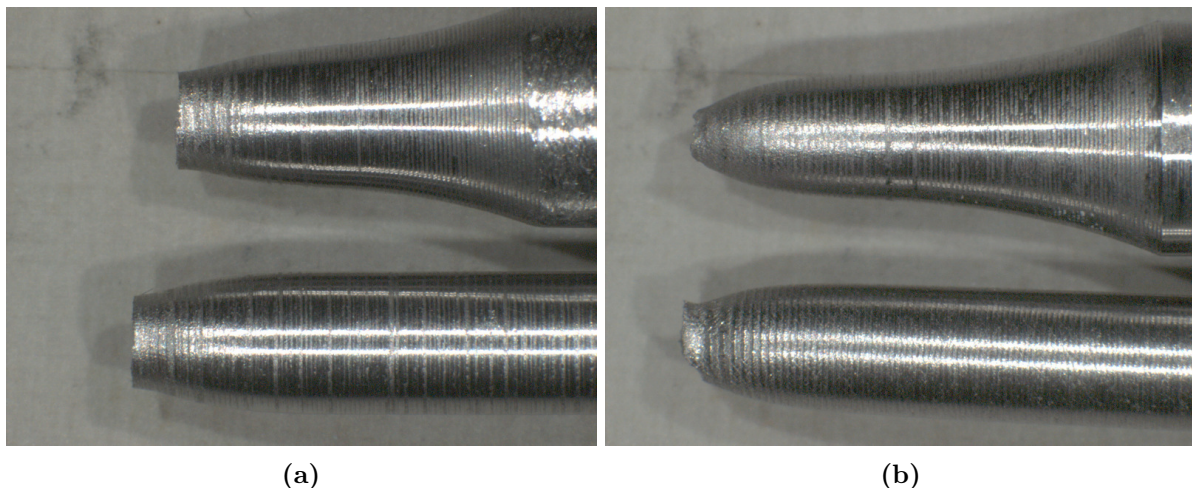
The images in Figure 4.52 show macrographs of two tensile specimens of the S355 steel. The specimen in Figure 4.52a had been tensile tested at  $-196^{\circ}\text{C}$ , and the specimen in Figure 4.52b was tensile tested at room temperature. A typical ductile cup-and-cone fracture was seen for the room temperature specimen. The specimen which was tested at low temperature showed a flat fracture surface, which is typical for brittle fractures. This specimen also showed some necking before fracture, as can be seen by the reduction in diameter close to the fracture surface. The test region of the tensile specimen fractured in liquid nitrogen had a diameter of 3 mm, until at a distance of approximately 2,5 mm from the fracture surface, where the diameter started to decrease gradually down to a value of approximately 2 mm at the fracture surface.

**Figure 4.52:** Macrographs (6,3 X) of fractured tensile specimens of material S355 MCD, tested in (a) liquid nitrogen and (b) room temperature

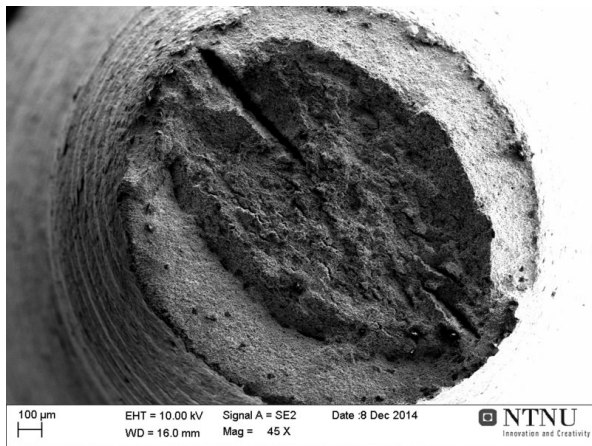
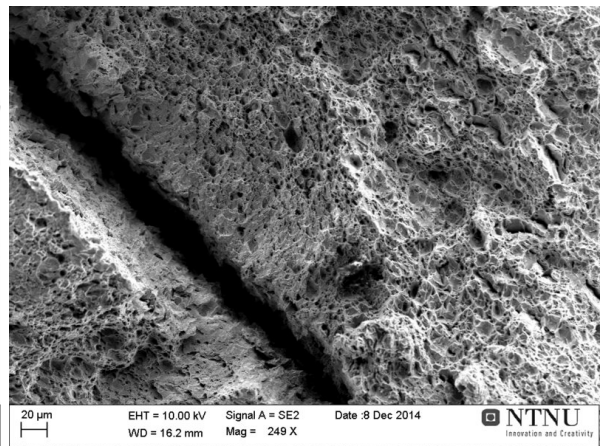
The fracture surface of the specimen which was held at a constant tensile force of 7000 N at  $-196^{\circ}\text{C}$  and fractured after a holding time of 6 min, is shown in Figures 4.55 and 4.56. The fracture surface diameter, measured from the low magnification image Figure 4.55a, was in the range of approximately 1,7-1,9 mm. This image also shows that the fracture surface contained two large cracks. The largest of the two cracks is shown at higher magnification in Figure 4.55b. It can be seen that the crack has been formed by a ductile fracture mode. Figure 4.56a shows the general fracture surface of the specimen, which was ductile and contained several surface cracks. The image in Figure 4.56b, shows an area of the fracture surface which was mostly ductile, but which also contained some single transgranular facets.

**Figure 4.55:** Fracture surface of a S355 specimen, held at a tensile force of 7000 N at  $-196^{\circ}\text{C}$ , fractured after 6 min

The S355 specimen which was held at a constant force of 7000 N in liquid nitrogen, fractured after 6 min at this force. A force of 7000 N corresponds to an engineering stress of 990 MPa, which is below the lower yield point at this temperature, which was 1017 MPa. Owen et al. [30], observed a phenomena resembling creep when tensile testing carbon steel in liquid nitrogen, at a very low cross-head speed. Their results showed that the average strain over the length of the Lüders bands increased with loading time during constant stress. This observation was explained by creep occurring in the Lüders bands at this temperature. Related phenomena are believed to have caused the time-dependent fracture of the S355 specimen at  $-196^{\circ}\text{C}$ . The fracture surface of this specimen, seen in Figures 4.55 and 4.56, showed mainly ductile features and contained several microcracks in addition to the two macrocracks. It is uncertain why these surface microcracks are present in the ductile fracture surface. It is believed that they might have been sub-critical cracks created before the main fracture.

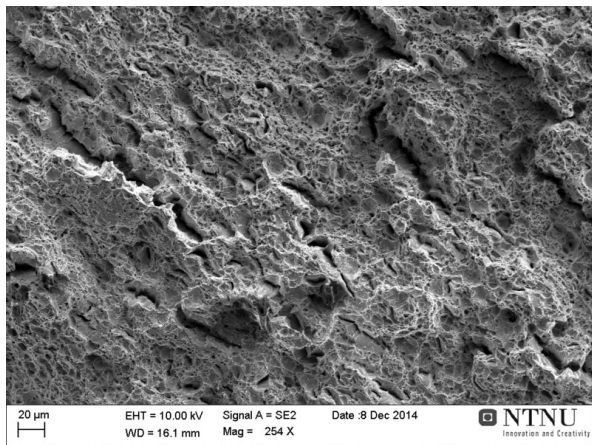
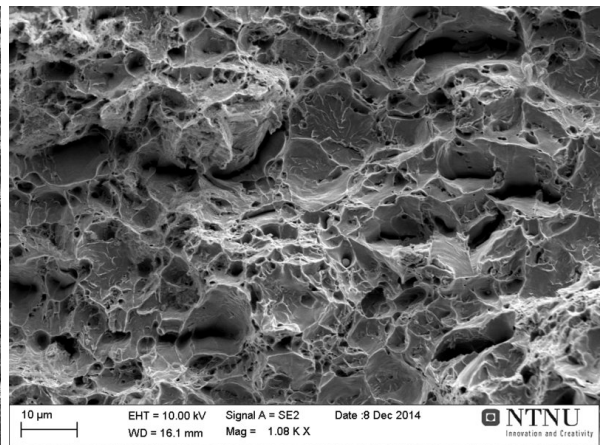
**Figure 4.56:** Fracture surface of a S355 specimen, held at a tensile force of 7000 N at  $-196^{\circ}\text{C}$ , fractured after 6 min

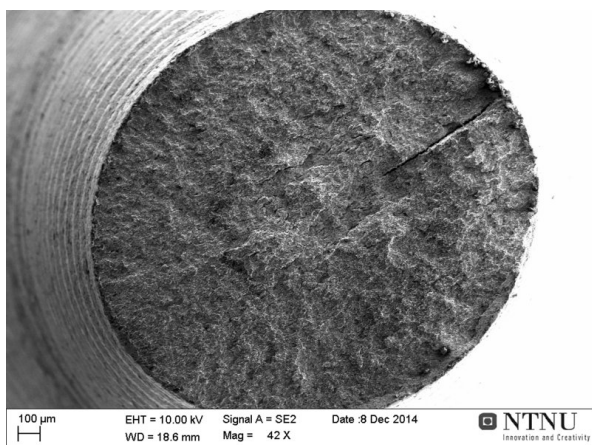
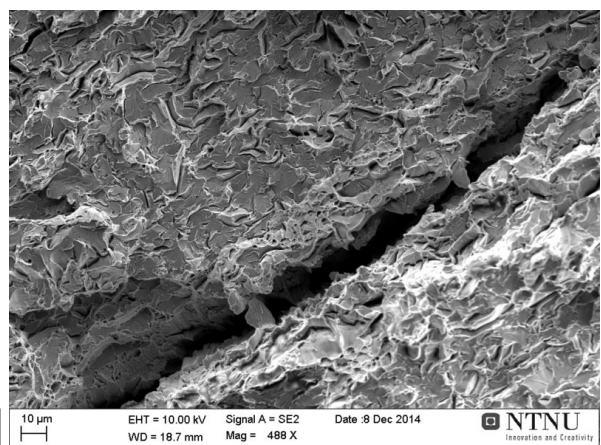
The fracture surface of a S355 steel specimen, which was fractured by tensile testing in liquid nitrogen, is shown in Figures 4.57 and 4.58. The low magnification image in Figure 4.57a, shows a relatively flat fracture surface with diameter ranging between approximately 1,9 and 2,1 mm. It can be seen that the fracture surface contains one large crack, visible at low magnification. This crack is shown at higher magnification in Figure 4.57b. The figure shows that the fracture surface was mainly brittle and contained many small cracks, but some ductile dimpled areas can be seen closest to the macrocrack. In Figure 4.58, the general fracture appearance is seen. The fracture mode is mainly transgranular and contains many microcracks. Some ductile dimples can also be observed in small regions of the fracture surface.

**Figure 4.57:** Fracture surface of material S355, fractured by tensile testing at  $-196^{\circ}\text{C}$
