# Permanent Effect of a Cryogenic Spill on Fracture Properties of Carbon Steel

**Hanne Keseler**

Chemical Engineering and Biotechnology

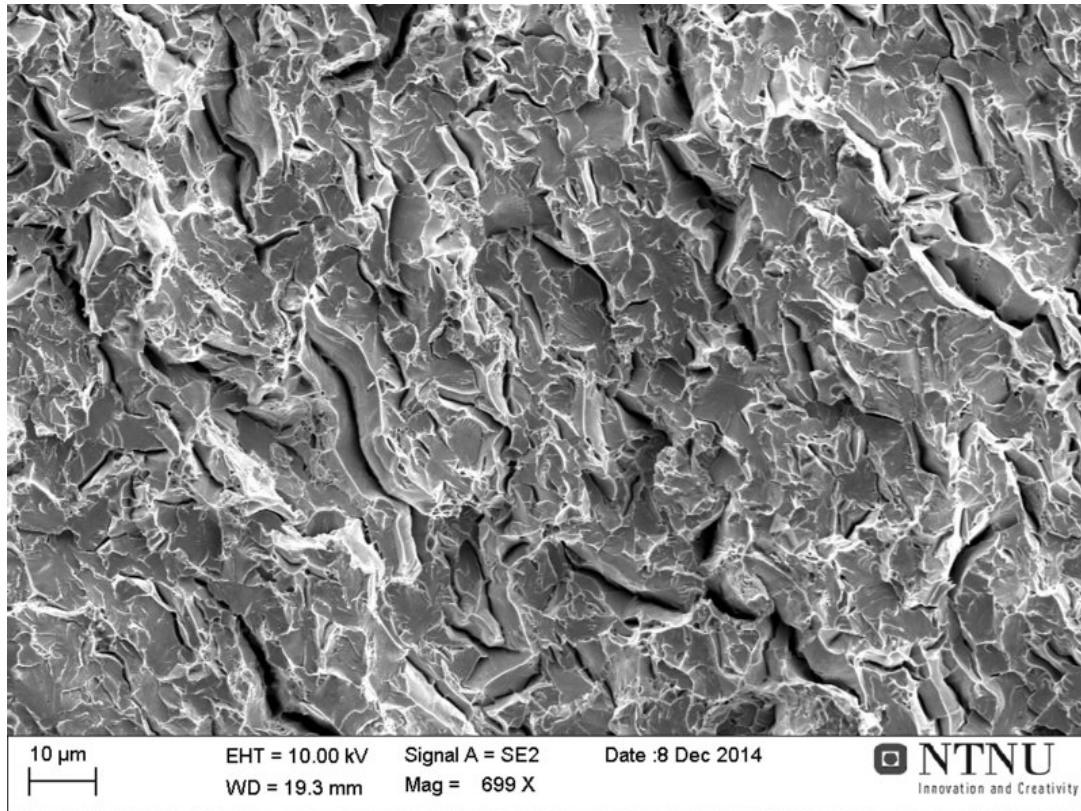
The fracture surface of a S355 steel specimen, which was fractured by tensile testing in liquid nitrogen, is shown in Figures 4.57 and 4.58. The low magnification image in Figure 4.57a, shows a relatively flat fracture surface with diameter ranging between approximately 1,9 and 2,1 mm. It can be seen that the fracture surface contains one large crack, visible at low magnification. This crack is shown at higher magnification in Figure 4.57b. The figure shows that the fracture surface was mainly brittle and contained many small cracks, but some ductile dimpled areas can be seen closest to the macrocrack. In Figure 4.58, the general fracture appearance is seen. The fracture mode is mainly transgranular and contains many microcracks. Some ductile dimples can also be observed in small regions of the fracture surface.

**Figure 4.58:** Fracture surface of material S355, fractured by tensile testing at  $-196^{\circ}\text{C}$ . Magnification  $699\times$

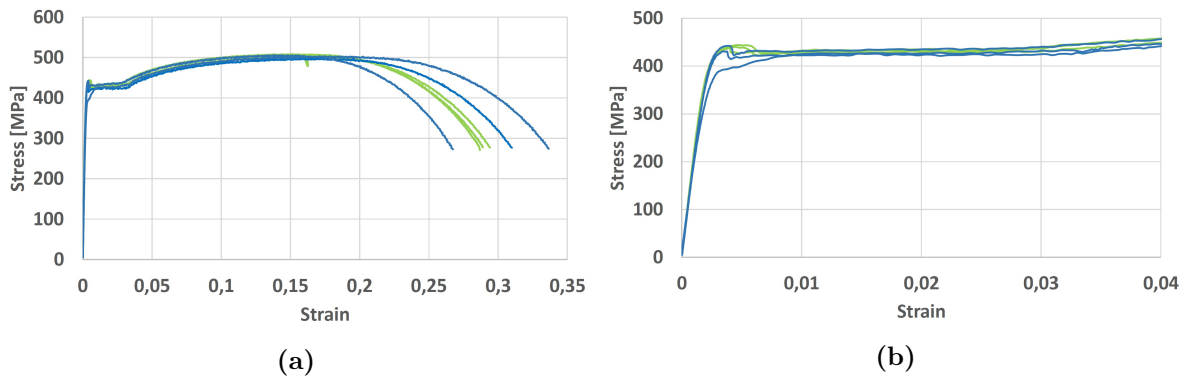
Figures 5.2, 5.3 and 5.4, show stress-strain curves of the S355 tensile specimens treated by 10 min at a constant force of 1000 N, 4000 N and 6500 N, in liquid nitrogen. The curves are plotted together with the three parallels of untreated specimens for comparison. It can be seen that there is no systematic change in the elongation as a result of the treatments. The differences which can be seen are believed to be experimental error, resulting from small differences in the specimen dimensions or inhomogeneities in the material microstructure. No significant changes in the tensile strength had occurred either. However, the sharp upper yield point, which is seen for the untreated specimens, gradually disappeared with increasing pre-treatment force. Two of the three specimens which had previously been held at 1000 N, still showed a sharp upper yield point. The specimens pre-treated at 4000 N, all showed a very small but still observable upper yield point. While for the specimens treated at 6500 N, the upper yield point can no longer be seen. These observations indicate that some dislocation motion has occurred at forces higher than 4000 N, which corresponds to a stress of 566 MPa or approximately 56% of the liquid nitrogen yield point. It was mentioned previously, that phenomena resembling creep are believed to occur at this temperature. This might have contributed to the dislocation motion at these stresses. Strain ageing with return of the sharp yield point, would be expected to occur if the specimens were stored at room temperature for some time.

**Figure 5.2:** Engineering stress-strain curves for material S355, tested at room temperature. Three parallels of untreated specimens (green) and three which had been held 10 min at a tensile force of 1000 N in liquid nitrogen (blue).

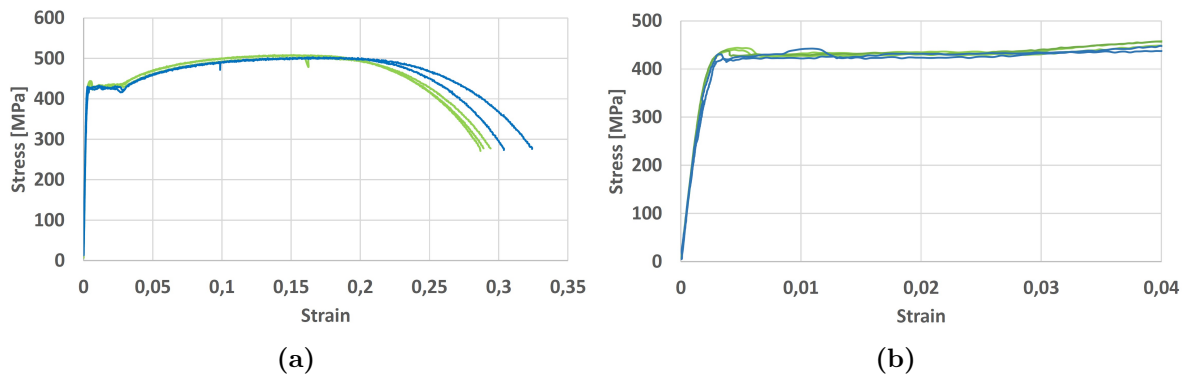
**Figure 5.3:** Engineering stress-strain curves for material S355, tested at room temperature. Three parallels of untreated specimens (green) and two which had been held 10 min at a tensile force of 4000N in liquid nitrogen (blue).

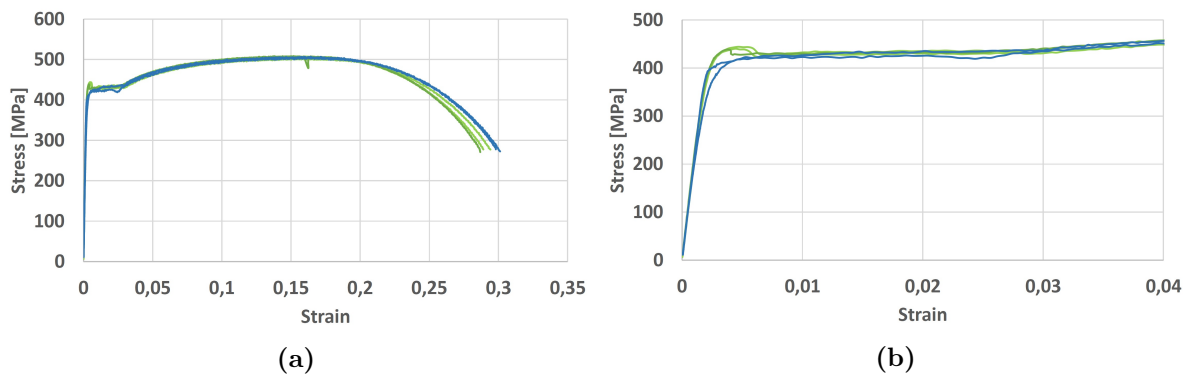
**Figure 5.4:** Engineering stress-strain curves for material S355, tested at room temperature. Three parallels of untreated specimens (green) and two which had been held 10 min at a tensile force of 6500N in liquid nitrogen (blue).

A small number of microcracks were found when examining the longitudinal cross section of a S355 specimen, which had been held 10 min at a force of 6500 N in liquid nitrogen. Although these cracks were found in very low quantities, they may indicate that such cracks can form before fracture at low temperatures. In the previously mentioned study by Owen et al. [30], microcracks were formed in all Lüders bands of the carbon steel before fracture in liquid nitrogen. These cracks were only formed during gross deformation of the material. However, phenomena resembling creep was observed both in the experiments by Owen et al. and by fracture of a specimen held at a constant force of 7000 N in the present work. If carbon steel is exposed to low temperature and tensile stresses for a certain amount of time, this low-temperature creep phenomenon might contribute to formation of microcracks at stresses below the yield point. This may explain the microcracks seen in the specimen held at 6500 N.

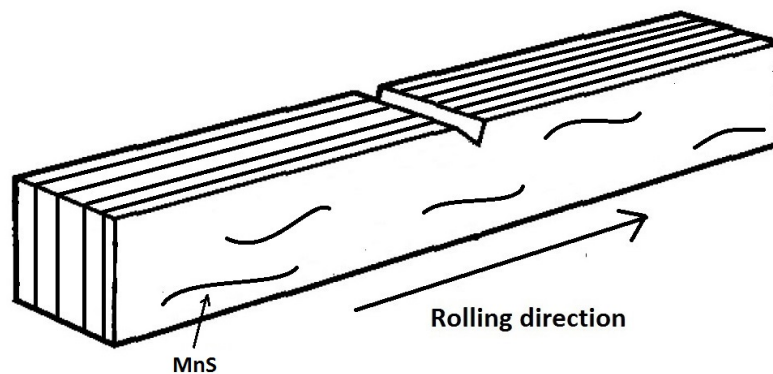
**Figure 5.6:** Sketch of the longitudinal Charpy specimens from plate 3, showing the alignment of the microstructure in the rolling direction

The reason for the orientation of the fissures can be seen in the sketches of the microstructure in Figures 5.6 and 5.7. The fissures follow the microstructure in the fracture surface, which in both cases is directed perpendicular to the notch. The fissures are deeper in the longitudinal specimens, because the MnS inclusions are directed normal to the fracture surface. This can be seen in Figures 4.28 and 4.29, which are cross section images of the macrocrack in the longitudinal specimen 3-34. In these images, the rolling direction is normal to the fracture surface. The MnS inclusions and the microstructure is therefore elongated in this direction. It is believed that the crack first propagated perpendicular to the fracture surface, following the weak planes in the rolling direction. This formed the right surface of the crack, which is nearly parallel to the rolling direction. The larger magnification image in Figure 4.29b, shows that the

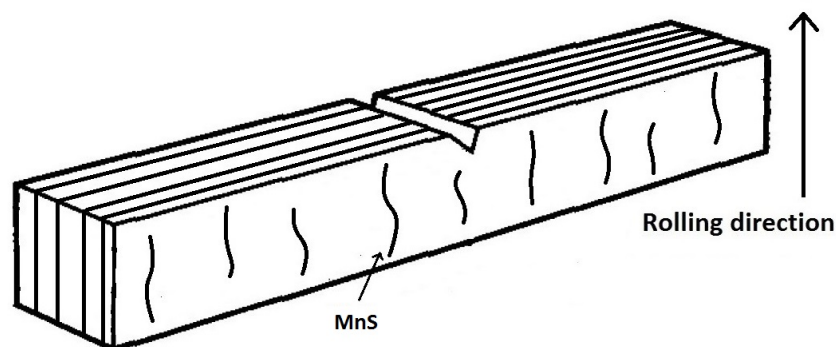
**Figure 5.7:** Sketch of the transverse Charpy specimens from plate 1, showing the alignment of the microstructure in the rolling direction

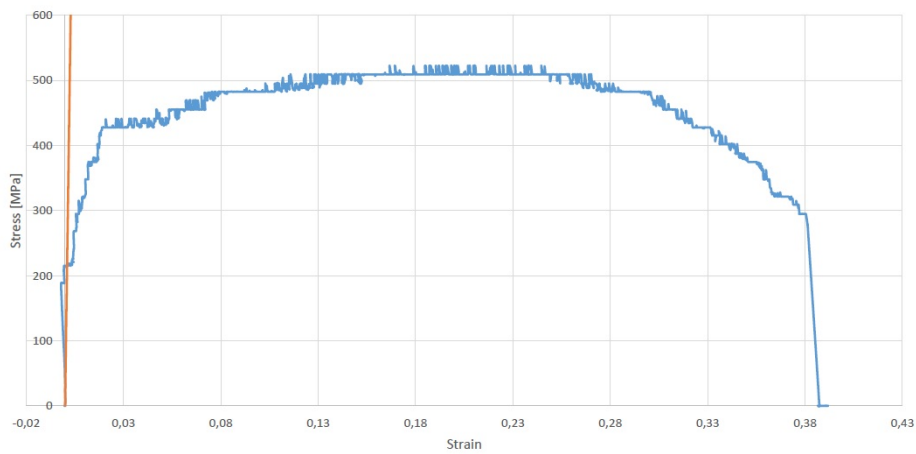
Figure A.19, is the engineering stress-strain curve which was obtained when tensile testing at room temperature on the MTS 880 apparatus. The curve is presented to show that a large amount of noise was present in the curves when using this test apparatus. The red line in the graph illustrates that the curve shows a large deviation from linearity before the yield point, which was measured to be approximately 430 MPa on the MTS 810 apparatus. This is also a consequence of the experimental error in the apparatus. The curve was obtained by the procedure explained in Appendix A.1.

**Figure A.19:** *Engineering stress-strain curve for material S355, tensile tested at room temperature on MTS 880*
