Permanent effect of a cryogenic spill on fracture properties of structural steels

2015 IOP Conf. Ser.: Mater. Sci. Eng. 102 012004

H Keseler¹, I Westermann¹, S Y Kandukuri², J O Nøkleby², B Holmedal¹

Abstract. Fracture analysis of a standard construction steel platform deck, which had been exposed to a liquid nitrogen spill, showed that the brittle fracture started at a flaw in the weld as a consequence of low-temperature embrittlement and thermal stresses experienced by the material. In the present study, the permanent effect of a cryogenic spill on the fracture properties of carbon steels has been investigated. Charpy V-notch impact testing was carried out at 0 °C using specimens, from the platform deck material. The average impact energy appeared to be below requirements only for transverse specimens. No pre-existing damage was found when examining the fracture surfaces and cross sections in the scanning electron microscope. Specimens of the platform deck material and a DOMEX S355 MCD carbon steel were tensile tested immersed in liquid nitrogen. Both steels showed a considerable increase in yield- and fracture strength and a large increase in the Lüders strain compared to the

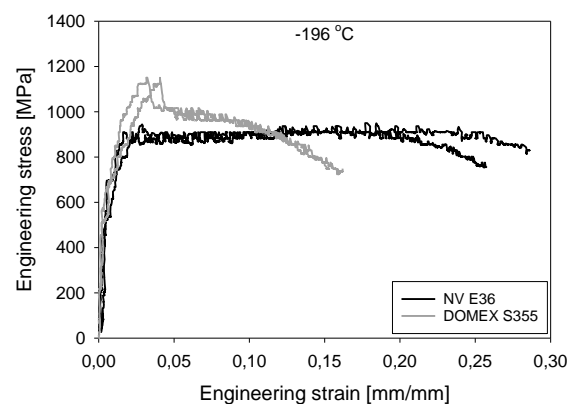
In Figure 5 the reference curves obtained at $-196\text{ }^{\circ}\text{C}$ for the NV E36 and the DOMEX S355 MCD are presented. The noise is a side effect from the test machine used and should be neglected. For the DOMEX S355 MCD a clear upper yield point is observed. Then the stress drops and slowly decreases until fracture at around a strain of 15 %. The NV E36 show a less clear upper yield point. The stress-strain curve then enters a stage where the stress is almost constant, before fracture occurs at strains around 26 %. Compared to the reference curves obtained at room temperature shown in Figure 6 the yield strength significantly increases with decreasing temperature. However, the appearance of the stress-strain curves is quite different. The long horizontal or decreasing region after the upper yield point is believed to be caused by propagation of Lüders bands across the length of the specimen. The large Lüders strains seen at $-196\text{ }^{\circ}\text{C}$ can be explained by the low work hardening rate at this temperature. This is in accordance with the observations by Goodenow and Bucher [5], who observed a reduced work hardening rate and increased upper yield strength with decreasing temperature. Instead of a ductile-to-brittle transition, they observed a so-called plastic instability transition when the temperature decreased below a certain point. At this plastic instability transition temperature, the tensile stress is equal to the lower yield stress and necking occurs within the Lüders strain. In the case of the NV E36 steel tested here, the work hardening rate was probably just large enough for the Lüders band to spread over the length of the test region.

Figure 5. The engineering stress-strain reference curves for the two materials tested at $-196\text{ }^{\circ}\text{C}$.

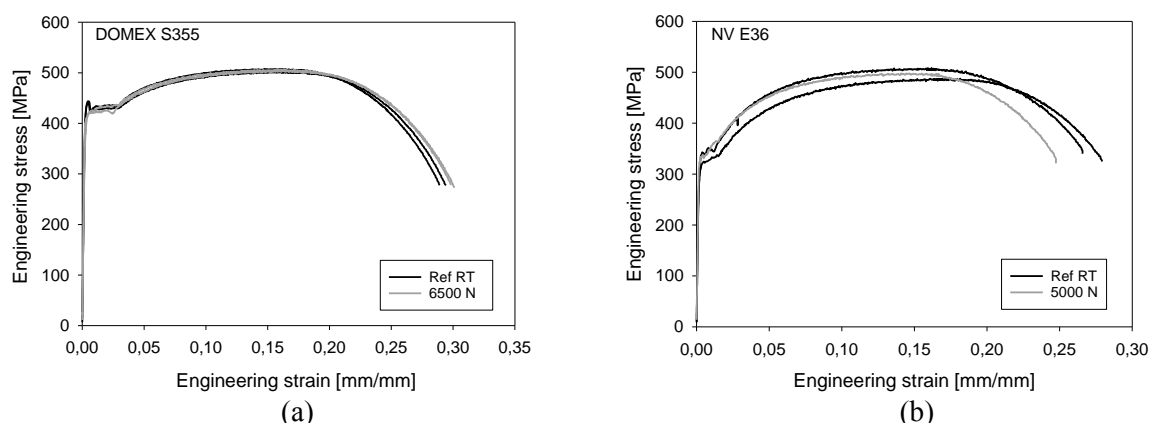
Figure 6 shows the room temperature engineering stress-curves of reference material that has not been exposed to liquid nitrogen, along with material that has been held at a force below the yield point in liquid nitrogen for 10 min. Only the stress-strain curve for the material held at the maximum constant force (6500 N) is shown here for the DOMEX S355 MCD.

Figure 6. Engineering stress-strain curves obtained at room temperature for non-exposed reference material and material strained at a force below the yield point for 10 min in liquid nitrogen. (a) DOMEX S355 MCD and (b) NV E36.

No particular difference is observed between the stress-strain curves, except that the upper yield point gradually disappeared for the DOMEX S355 MCD material when the tensile force applied under cryogenic conditions was increased. The fracture surface of the pre-strained material also appeared ductile after tensile testing at room temperature.
