The susceptibility of grade 70 anchor chain steel to HISC

Knut Ove Dahle

Materials Technology

Submission date: July 2011

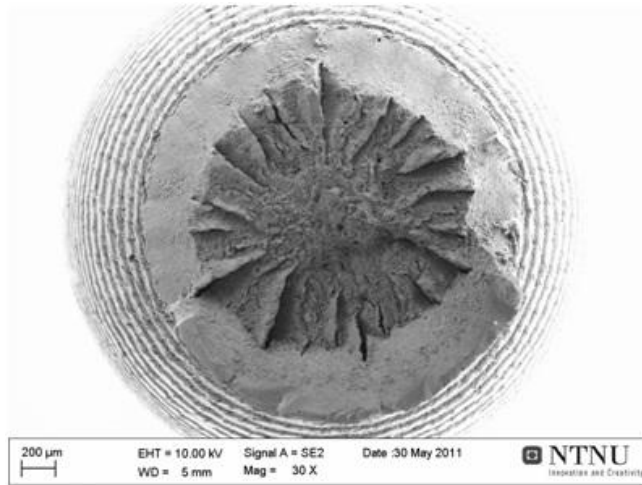
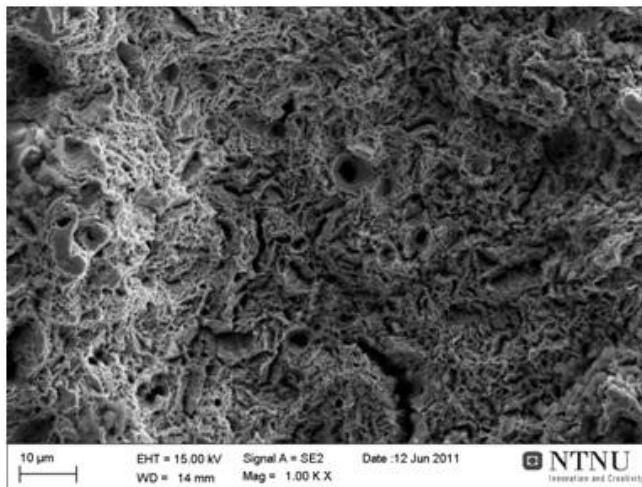
Specimen *CorTest2.f*

The following pictures are taken of sample *CorTest2.f*. Figure 34a shows a classic ductile fracture surface. Three distinct zones can be observed. The outer zone is the shear lip, while the middle zone is called the radial zone and the inner zone is called the fibrous zone. The dimples in Figure 34b verify this observation. There was unfortunately no time to take SEM pictures of *CorTest1.f* due to lack of time.

Figure 34. a) Macroscopic view of the tensile specimen *CorTest2.f* of the fractured chain at 30x. b) Fractographic photo of the center of sample *CorTest2.f* at 1000x.

All of the fractographic images point towards ductile fractures, which can be observed by the dimples in the pictures in Figure 34. Introduced hydrogen had not embrittled the steel.

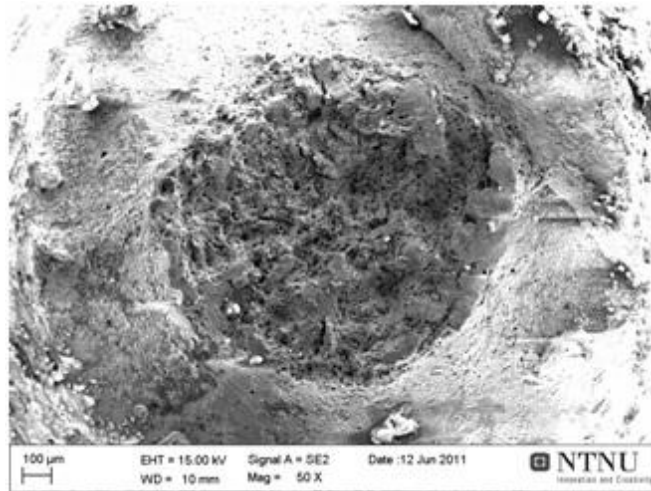
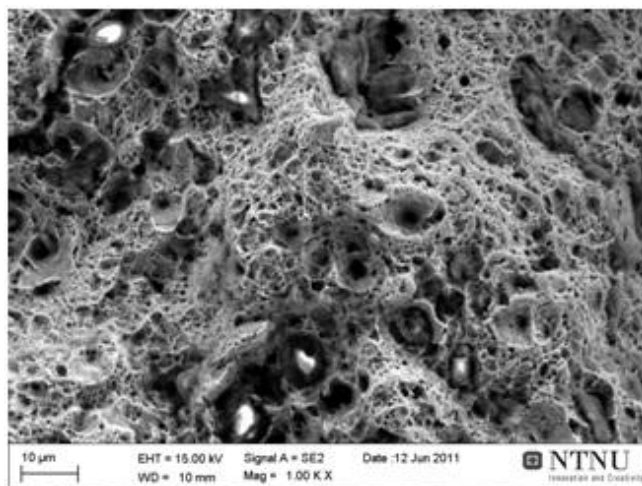
Specimen *CorTest2.s*

SEM pictures of specimen *CorTest2.s*, *CorTest3.s(free)* and *CorTest25.s(galv)* are presented in the report. The specimens from verification phase 3.B are presented in Appendix B – Attachment B.12. The specimens from the screening phase 1 have dimples in their fracture surfaces indicating ductile overload fractures.

Figure 35. a) Fractographic overview of the sandblasted tensile specimen *CorTest2.s* at 50x. b) Fracture surface of tensile specimen *CorTest2.s* at 1000x.

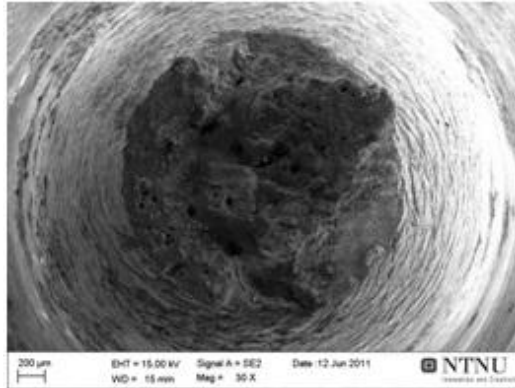
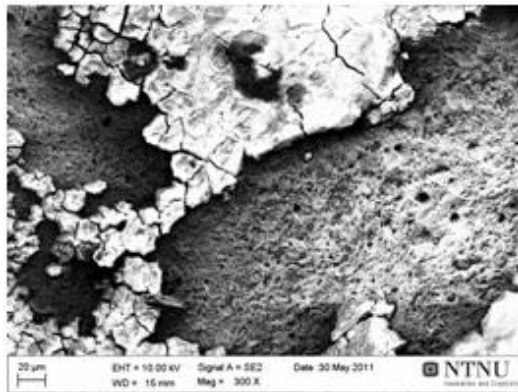
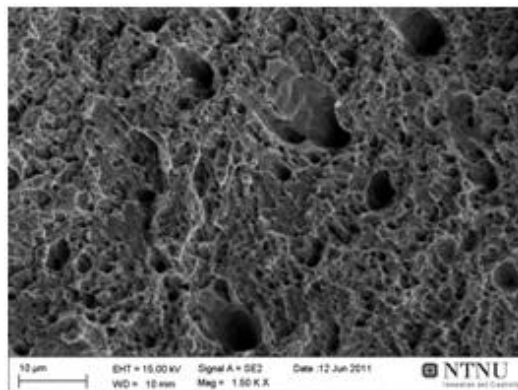
Specimen *CorTest3.s(free)*

Figure 36. a) Fractographic overview of the sandblasted tensile specimen *CorTest3.s(free)* at 30x. b) Fracture surface of tensile specimen *CorTest3.s(free)* at 300x. Corrosion product on the sample can be seen. c) Sample *CorTest3.s(free)* magnified at 1500x showing dimples, indicating a ductile fracture.

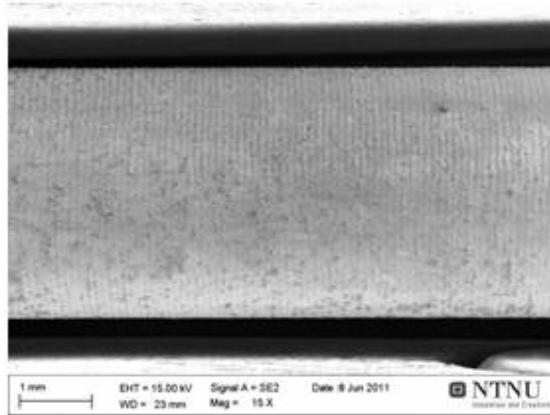
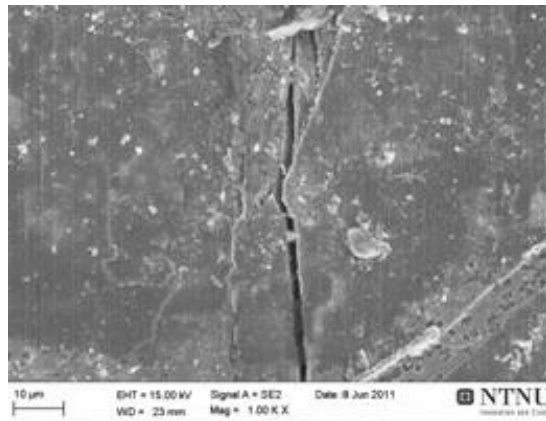
Specimen *CorTest6.s*

**Figure 38. Surface examinations of specimen *CorTest.6.s* in the SEM at; a) 15x
b) 1000x at the center of the specimen.**

Sample *CorTest.6.s* was loaded at 95% of 1070MPa for 14days. Examinations of the tensile specimen surface in SEM revealed microcracks. The microcracks are oriented along the machining groove on the specimen surface. No necking of the specimen could be observed.

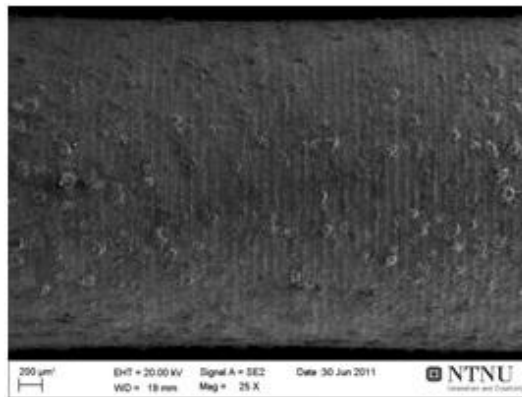
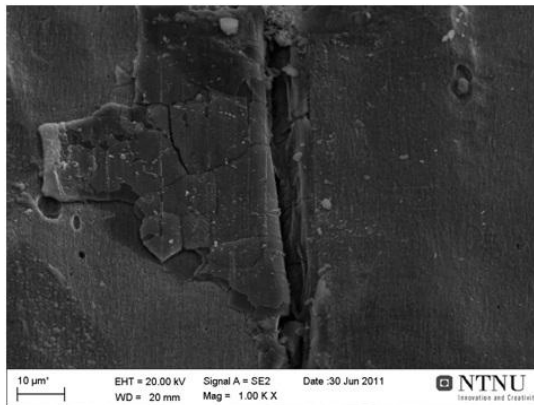
Specimen *CorTest7.s(free)*

Figure 39. Surface examinations of specimen *CorTest7.s(free)* in the SEM at; a) 25x, b) at 1000x the center of the sample.

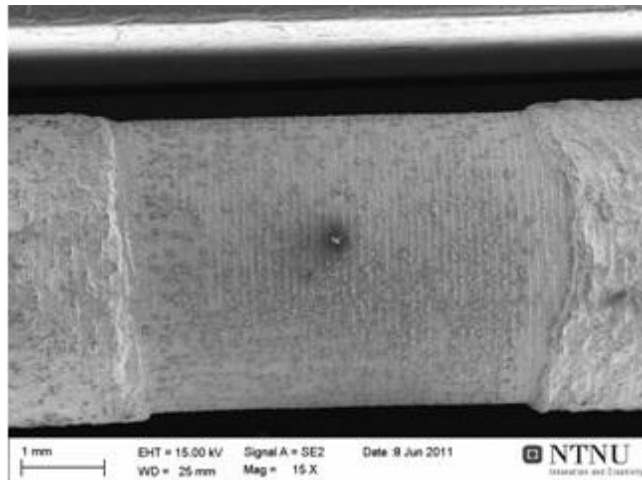
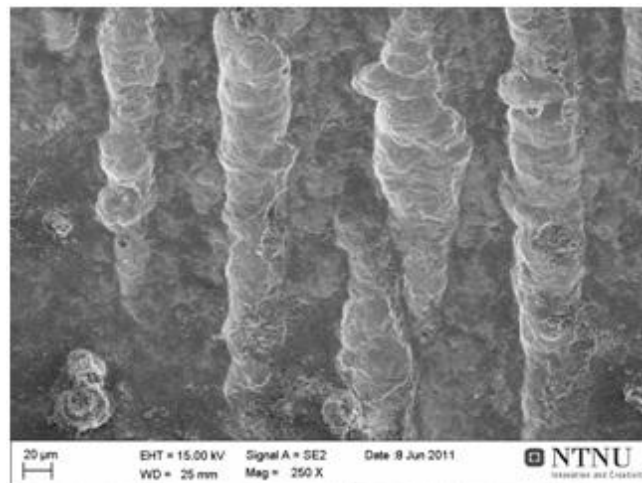
Specimen CorTest14.s(galv)

Microcracks were not observed on the “damaged” test area of specimen CorTest14s.(galv), as seen in Figure 40.

Figure 40. Microcracks examinations in the SEM at; a) 15x and b) 250x.

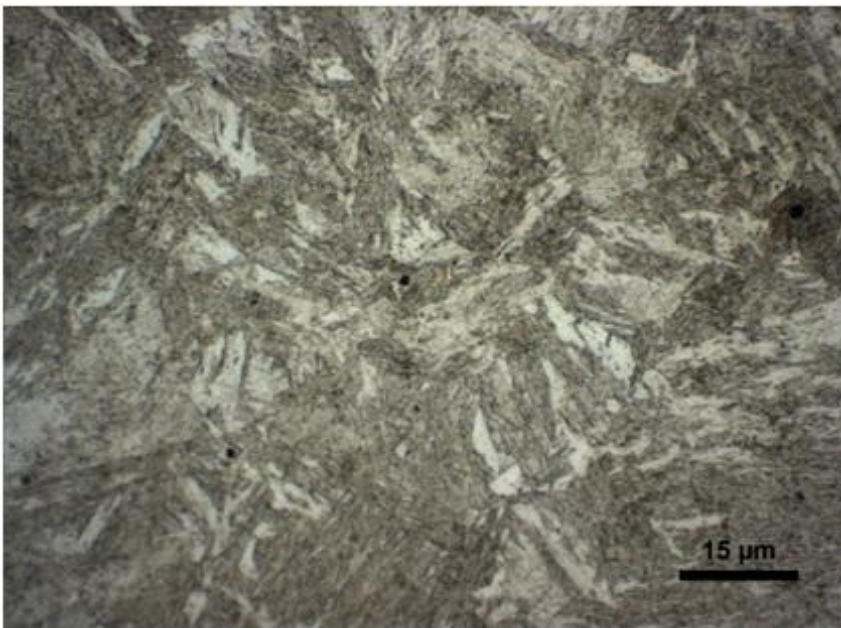
Figure 43. Microstructure of the sandblasted chain.

The microstructure of the sandblasted chain is a lath martensitic type, and appears to be in the tempered condition.

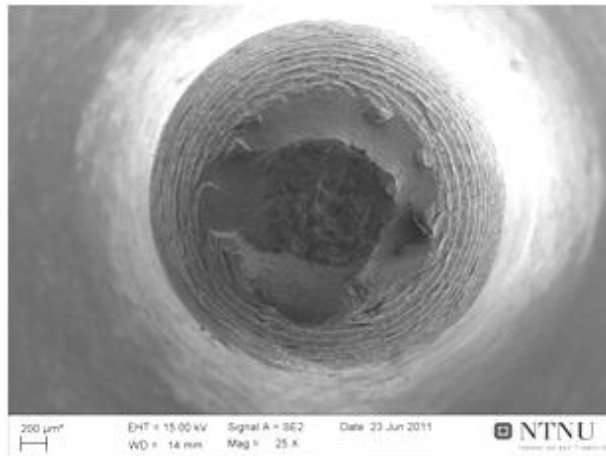
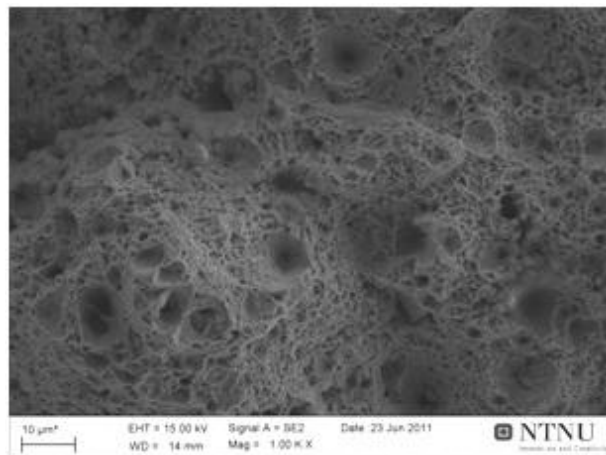
CorTest15.s

Specimen *CorTest15.s* was first subjected to constant load equivalent to 100% of its tensile strength/ fractured load. After the two week period the load was increased by 5% of its tensile strength/ fractured load. The specimen fractured during the load increase.

Figure 49. a) Macroscopic view of the tensile specimen *CorTest15.s* of the fractured chain at 25x. b) Fractographic photo of the center of sample *CorTest15.s* at 1000x with dimples.

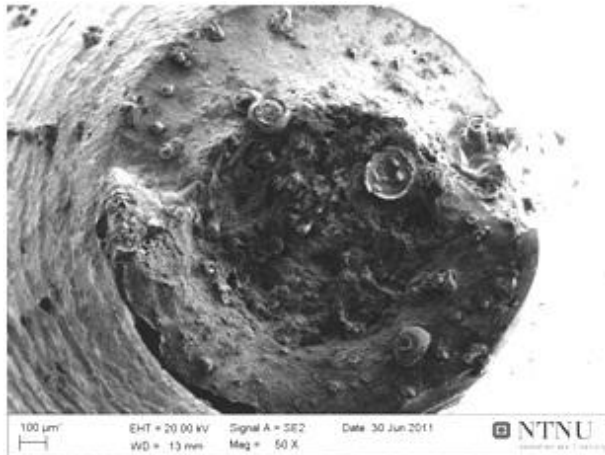
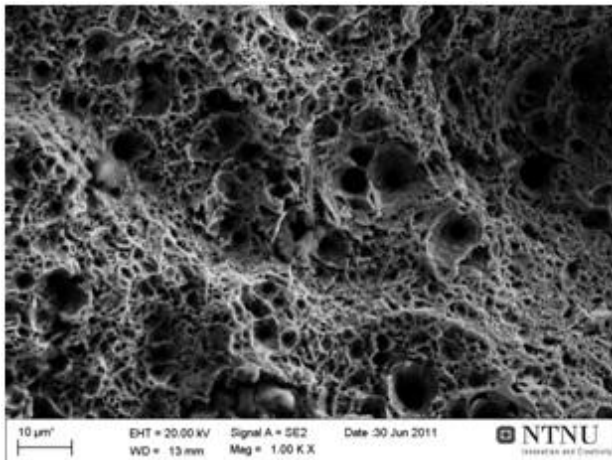
CorTest17.s(free)

Specimen *CorTest17.s(free)* was first subjected to constant load equivalent to 100% of its tensile strength/ fractured load. After the two week period the load was increased by 5% of its tensile strength/ fractured load. The specimen fractured during the load increase.

Figure 50. a) Macroscopic view of the tensile specimen *CorTest15.s(free)* of the fractured chain at 50x. b) Fractographic photo of the center of sample *CorTest17.s(free)* at 1000x with dimples.

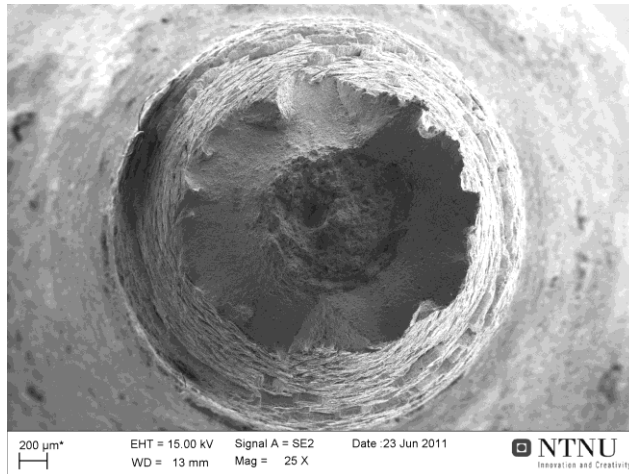
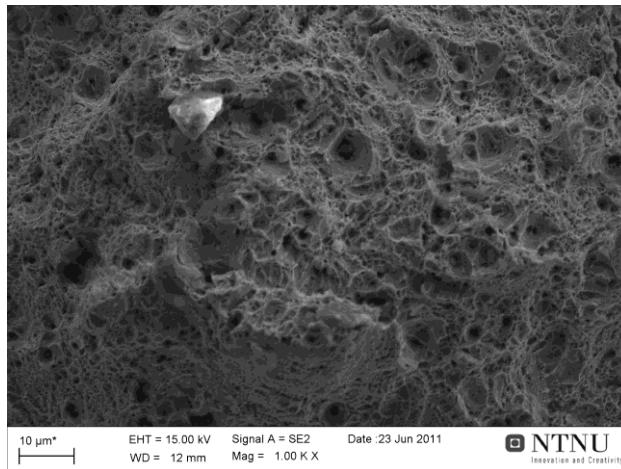
Specimen *CorTest18s.(galv)* was the only specimen not pulled to fracture deliberately. It fractured after 70.7 hours under a tension load of 1070MPa. Since it was the only specimen to fracture prematurely, it was believed to be embrittled by the hydrogen. However, examinations in the SEM revealed a ductile fracture surface, as seen in Figure 51. The fracture surface was purely covered with dimples. After 70hours it was discovered that the applied load on specimen *CorTest18.s(galv)* was too low. The applied load was consequently increased to the correct level. While increasing the load, the specimen fractured. One explanation could be that this particular specimen was weaker than the measured tensile strength of 1070MPa. Another explanation could be that the measured cross section was smaller than the actual cross section. The latter cannot be discarded due to the human factor during measuring.

Specimen *CorTest17.s(free)* was first subjected to constant load equivalent to 100% of its tensile strength/ fractured load. After 70hours it was discovered the specimen load was too low. It was decided to increase the load to the correct level. While increasing the load, the specimen fractured.

Figure 51. a) Macroscopic view of the tensile specimen CorTest18.s(galv) of the fractured chain at 25x. b) Fractographic photo of the center of sample CorTest18.s(galv)at 1000x with dimples.

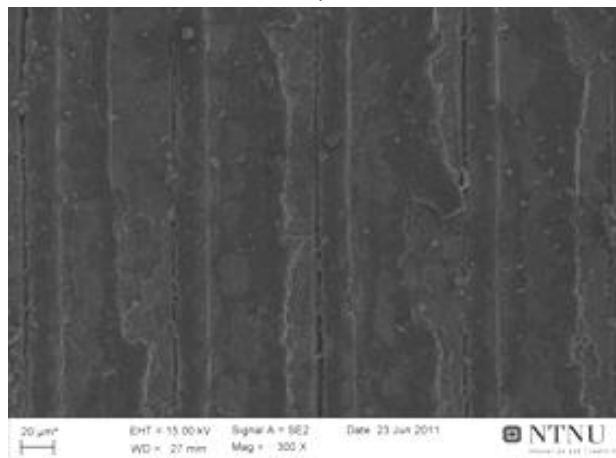
Specimen CorTest16.s

Figure 52. a) Macroscopic view of the tensile specimen *CorTest16.s* of the fractured chain at 25x. b) Several microcracks found in the center of sample *CorTest16.s* at 300x.

Several microcracks were observed on the surface of *CorTest16.s*.

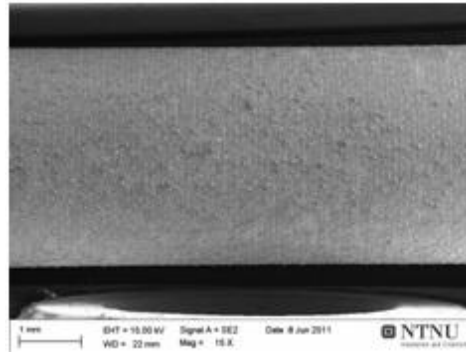
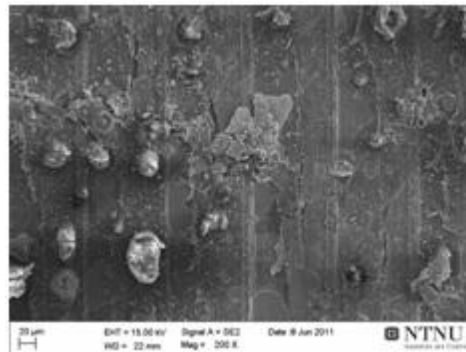
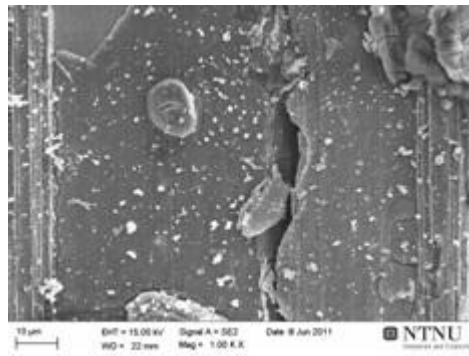
Specimen CorTest12.s.(free)

Figure 53. Microcracks examinations in the SEM at; a) 15x, b) 200x and c) 1000x.

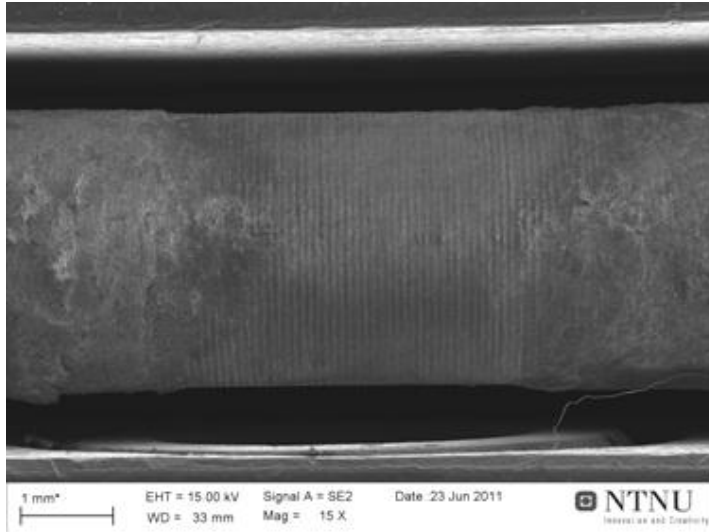
Figure 54. a) Macroscopic view of the damaged area of the HTG specimen *CorTest24.s(galv)* of the fractured chain at 15x. b) The center of *CorTest24.s(galv)* magnified at 200x.

No microcracks were observed on the surface of the “damaged” area of specimen *CorTest24.s(galv)*. No microcracks were observed on the HTG part of the specimen either.
