Long-term performance of cathodic protection (CP) of marine bridge, inspection of Sortlandsbrua 27 years after CP installation

An investigation of performance and damages on the installation.

Master's thesis in Experience-based Part-time Master programme Road and Railway Engineering
Supervisor: Mette Rica Geiker
May 2019

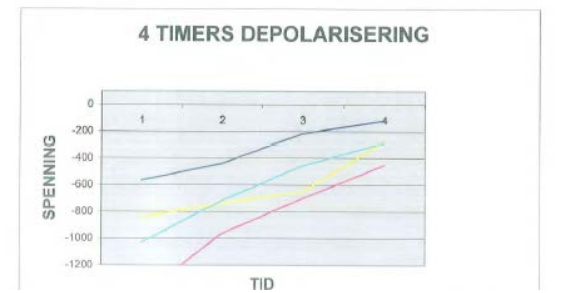
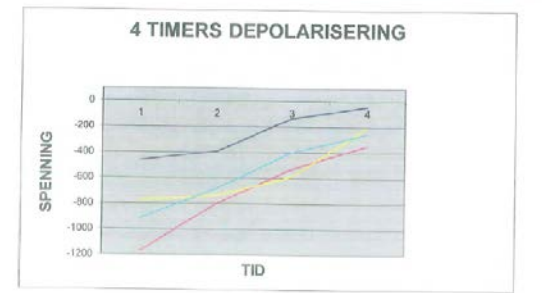
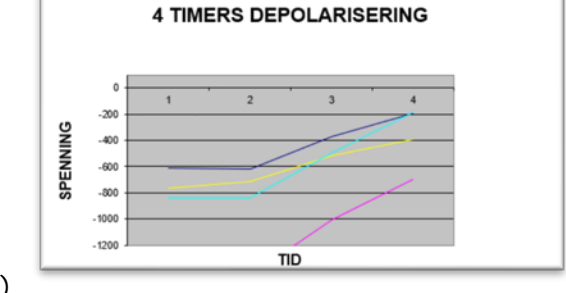
Figure 4-5 Depolarization of pillar 11 a) from 1993, b) from May 2011 c) from August 2011 and d) from 2018

The measurements show that the installation is still working. However, the numbers for pillar 11 might be concerning regarding the possibility of development of hydrogen embrittlement, as one of the reference electrodes record much lower potentials than allowed for cathodic protection. This can also be a defect reference electrode that shows wrong numbers but should be investigated further.

Generally, it seems that the current has mostly been similar for the different zones from 1991 until 2011. By comparing the area of the zones to the current applied it seems that zone 2a and 2b have had higher current per m² (Table 6) which is unexpected as those areas are higher up than area 1. Accordingly, it seems zone 2a and 2b have had somewhat higher protection than necessary.

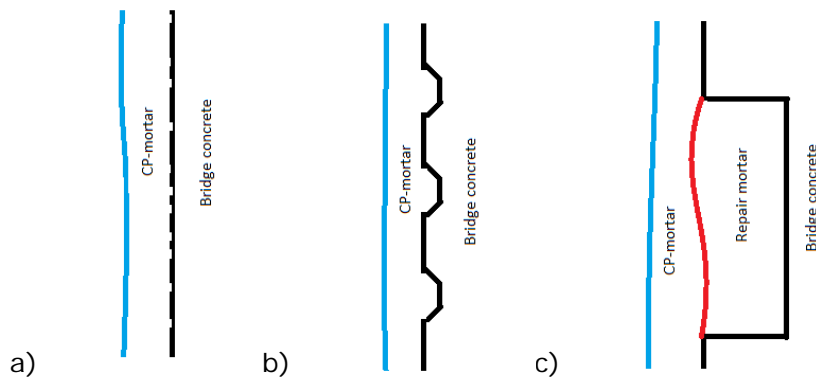
- With a rough surface on the outside of the CP-mortar varying up to 7-8mm in depth on a single core, the interface between the CP-mortar and the underlying surface may differ from what has been assumed when arranging the results. Additionally, the surface of the bridge concrete can vary depending on the method used to roughen the surface before applying the CP-mortar. Pillar 12 was sandblasted before applying the CP-mortar and the other pillars were hydrodemolished in small spots. For A1, which has repair mortar underneath the CP-mortar, it is uncertain how close to the original concrete surface the repair lies. In the results it is estimated that the repair mortar's surface is the same as the original bridge concrete.

Figure 4-12 The interface between the different layers, figure a) show a sandblasted surface, figure b) shows a surface that has been hydro demolished in small spots and figure c) shows a completely repaired surface.

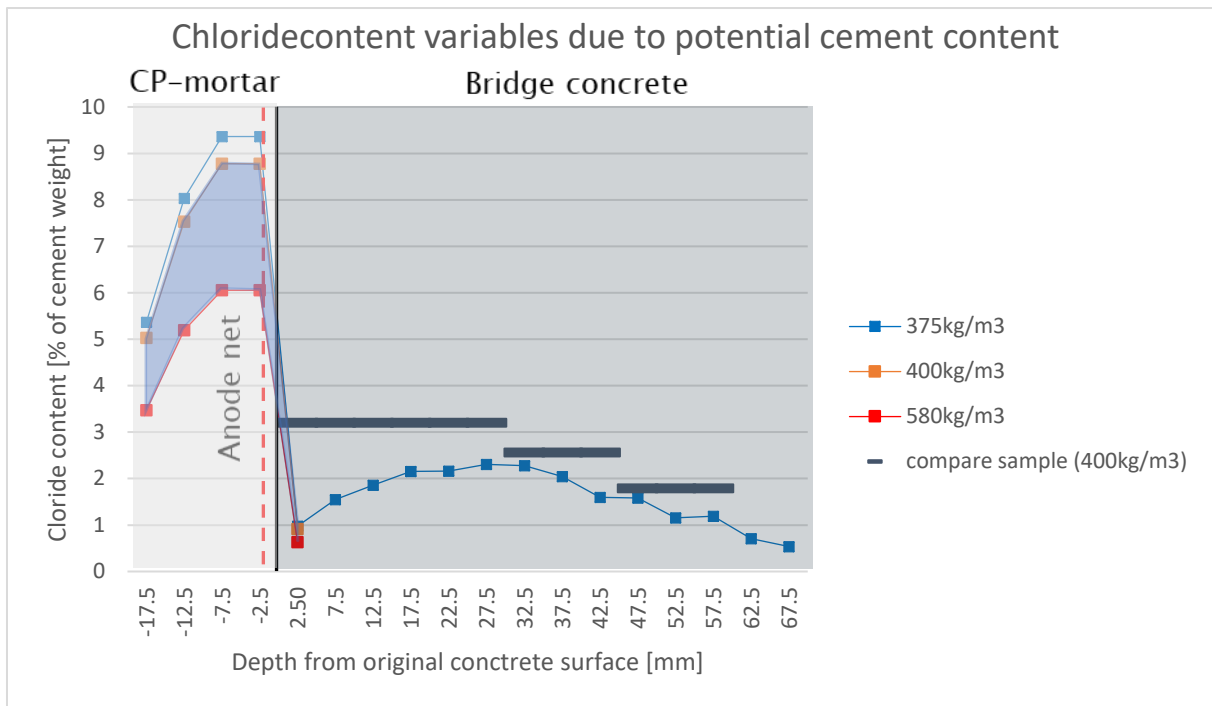
- Note to Figure 4-13: The actual graph should be somewhere between the red and orange line. It was desired to use % cl of cement weight, but it proved difficult to obtain information about the mortar recipe that was used. This is partly because the company that delivered the mortar have been bought up several times, and the company where the factory is now didn't find records further back than 2013.

Figure 4-13 possible variation due to cement content of the mortar for core A9.

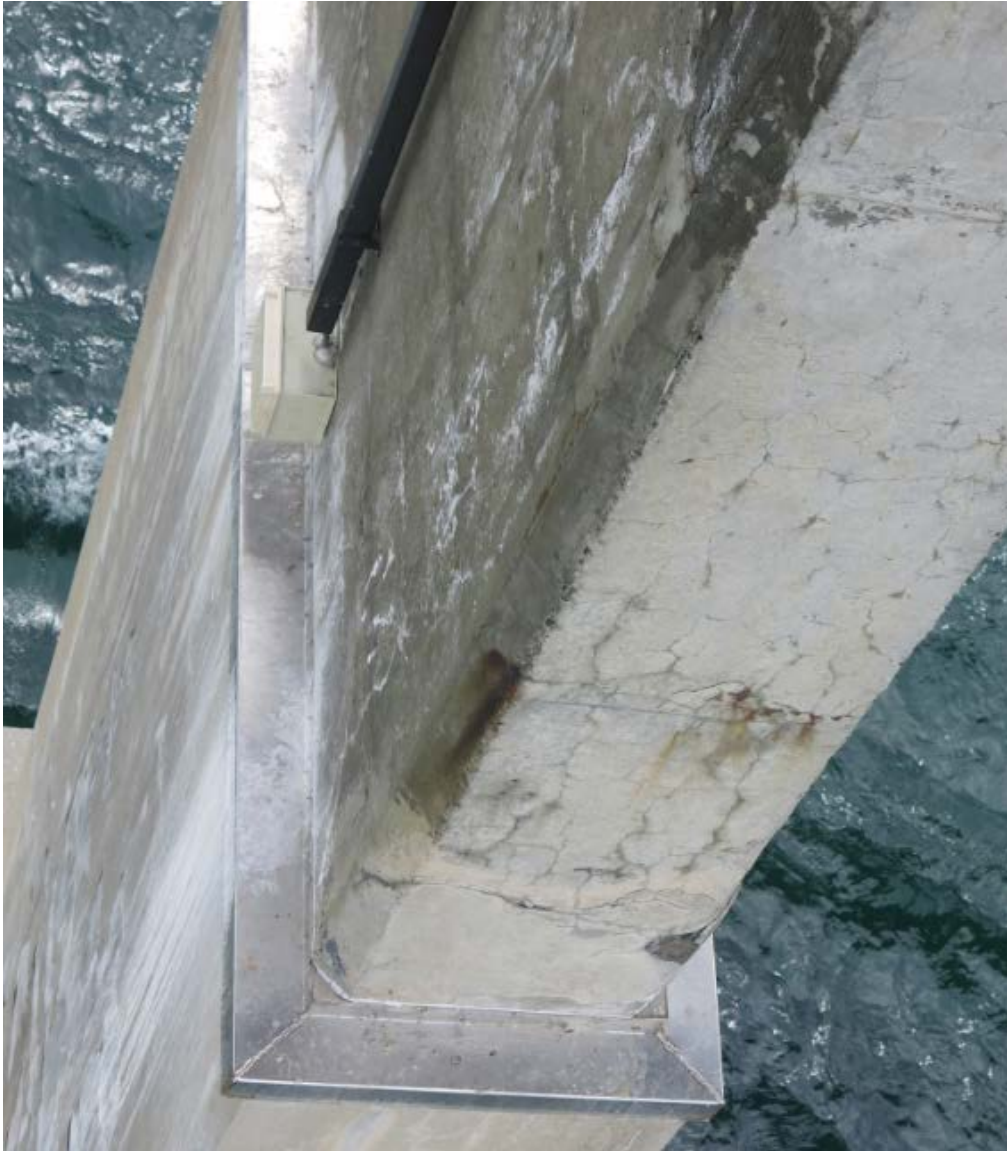
Figure 5-4 Northern side of pillar 17

One pillar has damage that resembles ASR, pillar 17 (Figure 5-4) has crack pattern on the northern side, this is one of the pillars without CP and epoxy coated rebars instead. The observed damage is above the area that was repaired in 1990-1991. And there seem to be a small repair just above the steel edge that has been performed some time later. It cannot be said for sure that the cracking is caused by ASR without further investigations and thin section samples of this pillar.

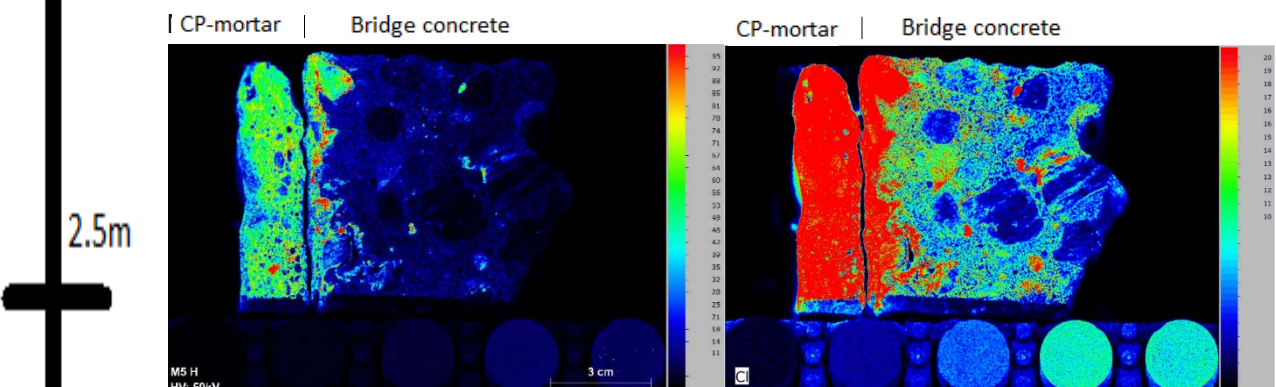
Figure 5-21 M5: taken from the eastern side at 2.5 meters above sea level, image 2 shows the same results with at different scale for the chloride mapping. The scale on the right side shows percentage of the highest measured content in the sample.

The μ -XRF scan for chlorides of M5 (Figure 5-21) show different results than the rest of the scans and the chloride profiles. There are accumulated chlorides in the outer part of the bridge concrete and in the CP-mortar, the concentration is somewhat higher in parts of the bridge concrete. This ingressions into the bridge concrete is likely due to the delamination of the CP-mortar and sea water saturating the gap. The core is from an area 2.5 meters above sea level, so waves and spray should easily have reached the area providing chloride rich moisture. When the water dries up the chlorides remain, and the concentration increases. However, the part of the bridge concrete where the concentration is highest is also the part that is carbonated. And since the carbonated concrete can't contain many bound chlorides it is puzzling that the chlorides haven't moved out of this strip as suggested earlier. There is a possibility that there has been some sort of electric contact between the bridge concrete and the CP-mortar. This could have caused some migration countering the diffusion wanting to move the chlorides further into the concrete. Since there haven't been direct connection between the bridge concrete and the CP-mortar the chlorides haven't moved into the CP-mortar from the carbonated concrete.

There is a probability that there are areas with delamination that was not discovered during these investigations. One of the sampled cores (M5 Figure 5-21) has delamination, it was not certain that the area had been delaminated before the thin section investigation observed carbonatization at the bottom of the mortar. This proves that detecting all the delaminated areas can be difficult without destructive investigations and there can be more areas where the mortar has delaminated that was not discovered.

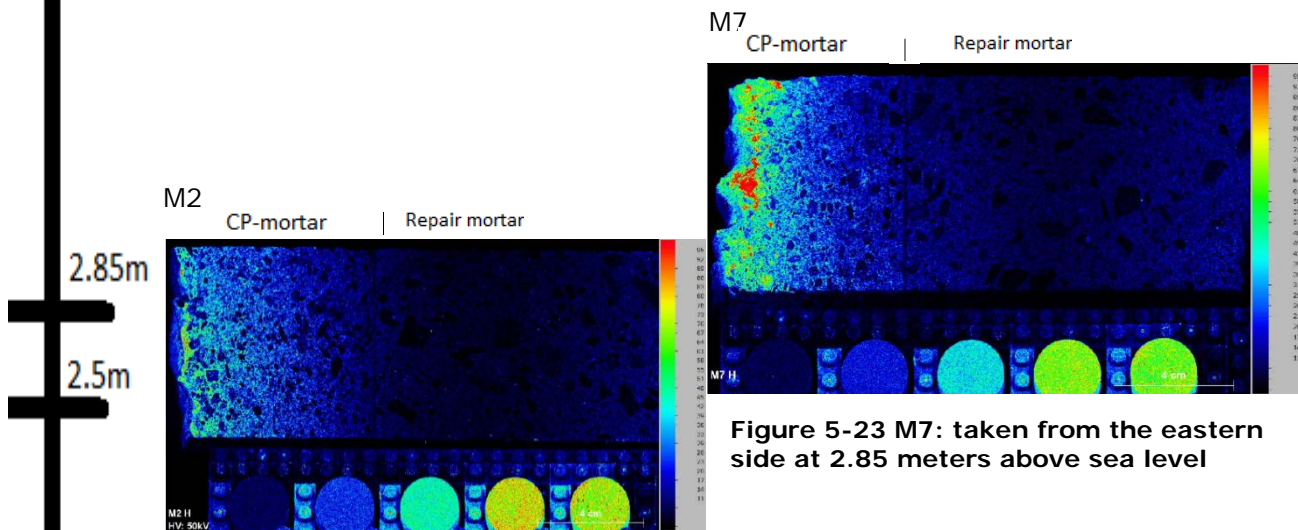
Studying the chloride ingressions makes it apparent that core M2 and M7 (Figure 5-23 and Figure 5-24) both consists of repair mortar and not original bridge concrete. It could also have been assessed by the size of the aggregates, but it was not expected that the repair would had gone as deep as the cores, as they were 210mm and 180mm long respectively. The scans show that there is not much chlorides in the middle of the extracted cores. There is a lot of penetrated chlorides in the front of the CP-mortar, but towards the right side the amount starts to increase again. This must be chlorides from the original bridge concrete that has diffused into the repair mortar. The low levels of chloride are puzzling, as this core is taken from the eastern side of the pillar, it should not have been subjected to much rainwater or other effects to wash out chlorides, the surface protection may still be intact.

Figure 5-24 M2: taken from the eastern side

Figure 5-23 M7: taken from the eastern side at 2.85 meters above sea level

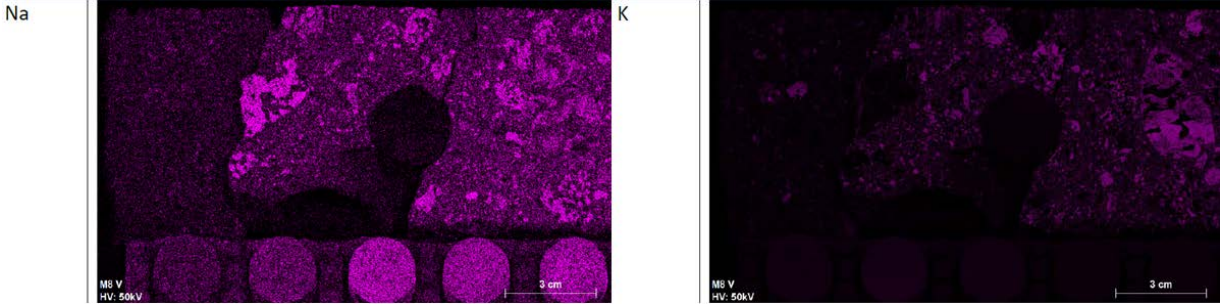
Figure 5-25 M8 μ -XRF scans for Na and K.

the rebar facing the anode net when scanning for sodium. These dots do not seem consistent with the spread of sodium through the rest of the core. There are aggregates with higher concentration of sodium throughout the core, but not much in the cement paste. If there has been any migration of sodium it is expected small amounts as they need to be dissolved in water to migrate (Andrade 1993). The accumulation of sodium can be an additional sign that migration is taking place even though there has been a low current working over time.

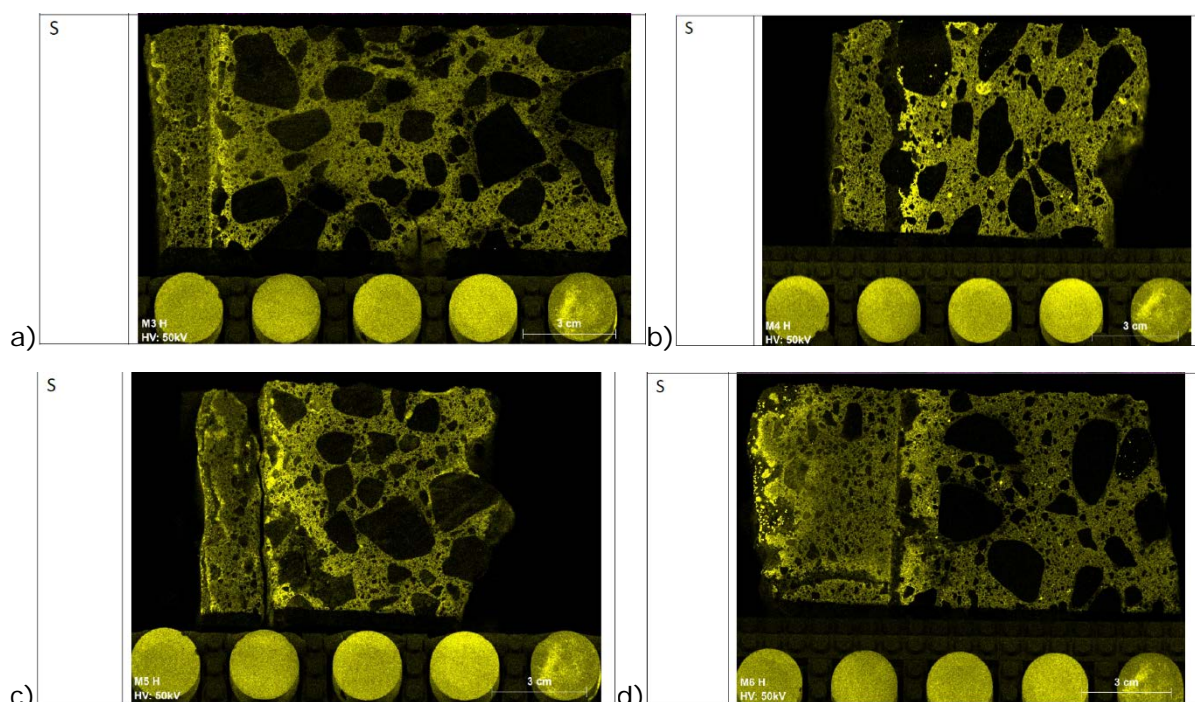
There is sulphur present in all the cores, especially in cores M3, M4, M5 and M6 Figure 5-27. As sulphates are present in sea water it is likely that the accumulations are from sea water since both the original concrete surface and the surface of the CP mortar has accumulation. The cores with sulphur accumulation do not have repair-mortar, the roughness of the sulphur in M4 Figure 5-27 b) may be a result of hydro demolishing of the surface for better bond for the CP-mortar.

Figure 5-27 Sulphur scans of cores. a)M3 b)M4 c)M5 d)M6

There is sulphur present in all the samples, with high concentration towards the interface between CP-mortar and bridge concrete for many of them (Figure 5-27). Due to the conditions there is a possibility of thaumasite formation in the interface between the CP-mortar and the bridge concrete. Though there is silicon and calcium in thaumasite the amount of these elements is expected to appear at the same rate as the rest of the concrete. However, there is not discovered thaumasite in the air voids from the thin section investigations. To identify thaumasite in the paste different investigations have to be made, such as SEM-EDX (Jakobsen 2019).

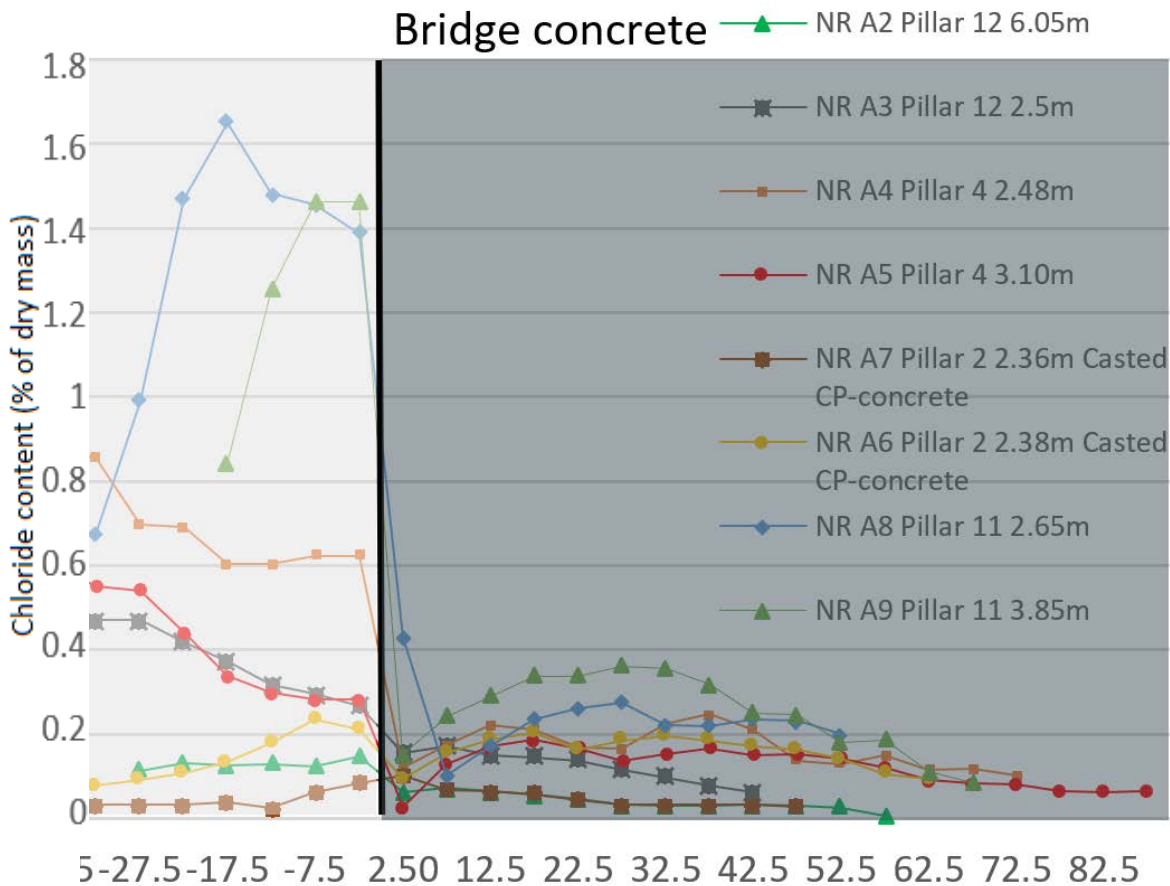
There have been movement of the chlorides in the bridge concrete of Sortlandsbrua. All chloride profiles with CP-mortar applied directly to the bridge concrete taken in 2018 (A2-A9(Appendix F)) have less chloride content compared to the samples from approximately the same places taken in 1990 (Appendix H). This can be seen in Figure 5-6 through Figure 5-14 in chapter 5.3.1. Seen in Figure 6-1 and Figure 5-6 through Figure 5-14 there are drops in most of the chloride profiles when moving into the bridge concrete from the surface of the mortar. The chloride content then increases again further in to the bridge concrete before it decreases again. The outer most area of the bridge concrete seem to contain relatively small amounts of chlorides compared to the rest of both the CP-mortar and the bridge concrete.

Figure 6-1 Drop in chloride content (close-up of Figure 5-15)

As diffusion would have worked towards evening out the chloride levels, as in Figure 3-4, it is apparent that migration also must have been working on the chlorides since diffusion would not remove chlorides from an area with lower levels to an area with higher chloride levels. The big difference between the chloride levels in the CP-mortar and the bridge concrete can't be made by diffusion. It was expected that migration and diffusion in combination would lead to a graph as proposed in Figure 3-5. This is however not the

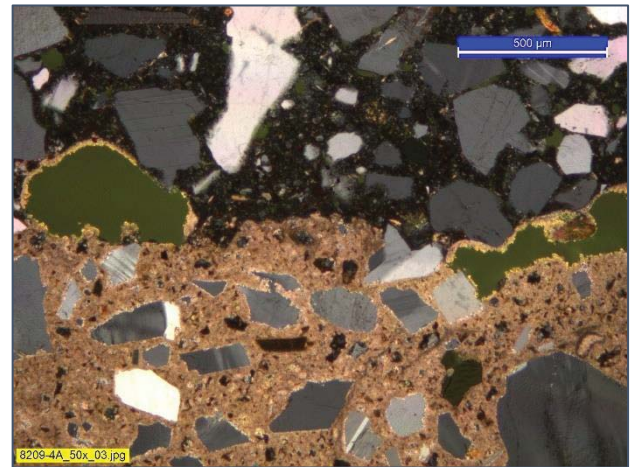
Interface between KB mortar and the intensely carbonated, very uneven concrete surface.

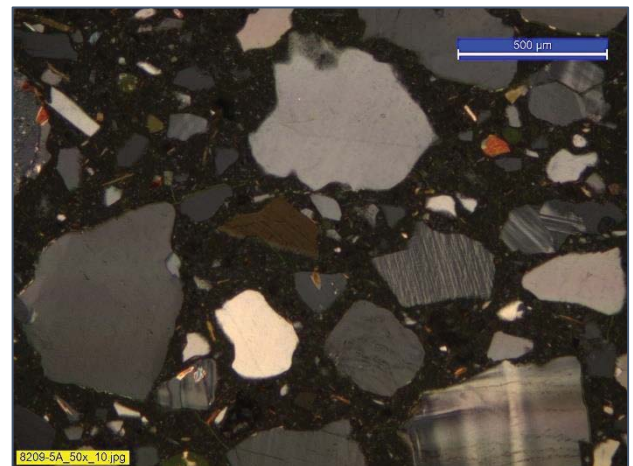
The paste of the KB mortar appears black without any presence of calcium hydroxide.

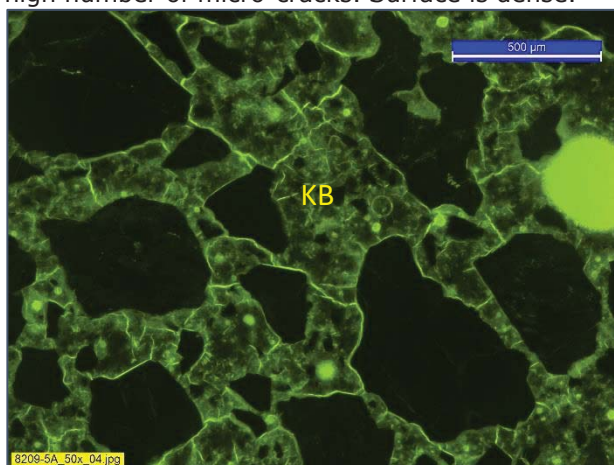
Generally, the paste of the KB mortar is dense and typically contains a lot of micro-cracks.

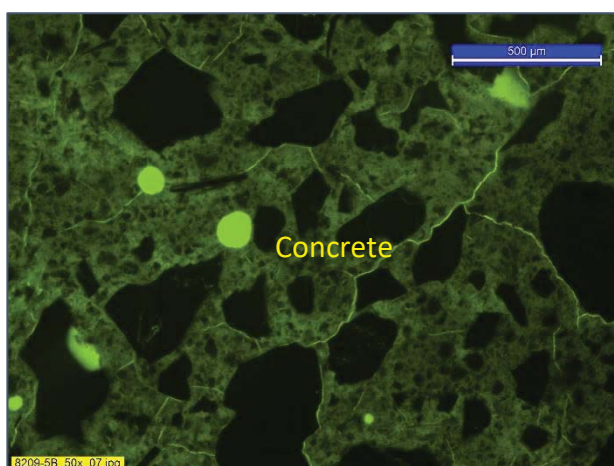
The paste of the concrete has a capillary porosity apparently like the KB paste. Micro-cracks are abundant. Fluorescent light mode.

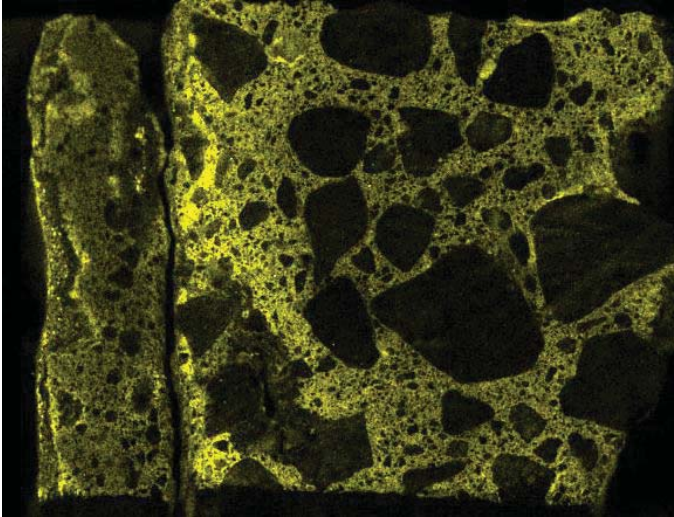
Figur 5 svovelskann av M5

4. Det er en del svovel i ytterkanten av betongen, ikke unormale mengder, men kan være nok for thaumasittdannelse eller etringitt **Det kan man ikke lige tolke, der er andre faktorer**

såsom carbonat som bestemmer om det dannes. Jeg har ikke med optisk mikroskopi kunne konstatere tilstedeværelse af thaumasit; normal kan jeg se thaumasit i luftporer men hvis det skal identifiseres i pasta behøves SEM-EDX. Kan det være små tilfeller av thaumasittdannelse i nærheten av overgangen mellom KB-mørtel og brubetong? Om det har vært tilstrekkelig med vanntilgang skal det kunne være mulig da temperaturene som brua står i ofte er i området der thaumasitt dannes.

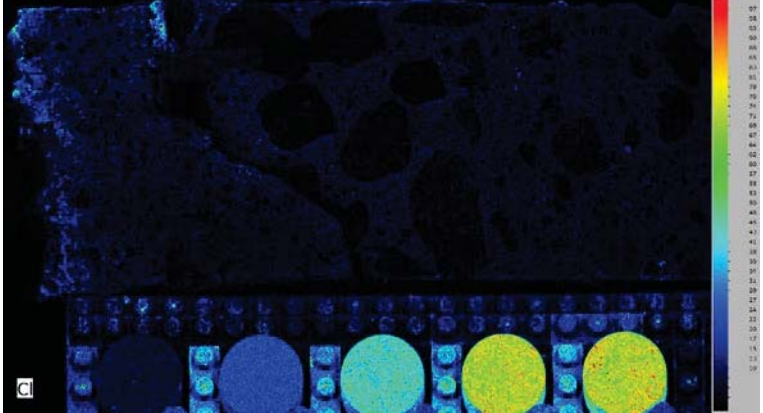
Core	Comment	Chloride ingress, normalized intensities
M1_V	<p>Broken at depth of a spacer.</p> <p>Very little chloride ingress in outermost 3 mm</p>

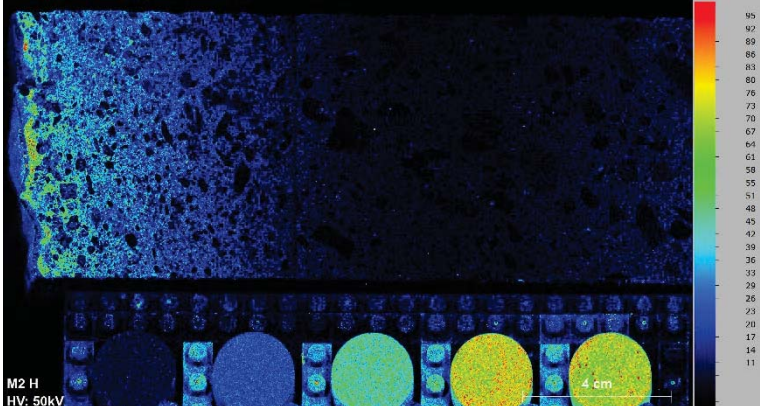
M2_H	<p>Some chloride ingress in the first 2 cm of the mortar on top of the concrete.</p>

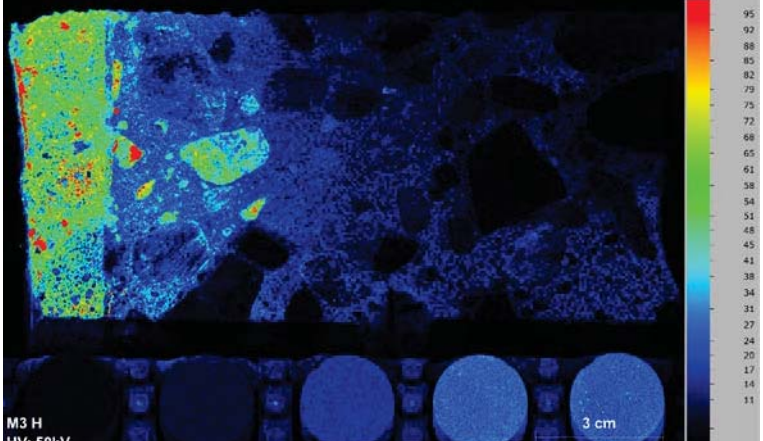
M3_H	<p>Apparently high chloride ingress in the mortar on top of the concrete.</p> <p>Chloride contamination on aggregates, maybe from cutting process</p>

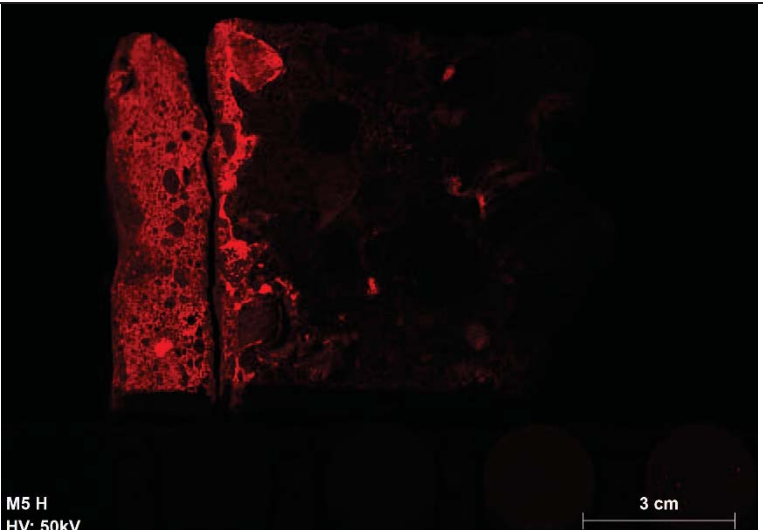
M5	
Element	Scanned Area

<p>M5_H</p>	<p>Broken at the mortar-concrete interface. High chloride ingress in the mortar and first cm of the underlying concrete</p>

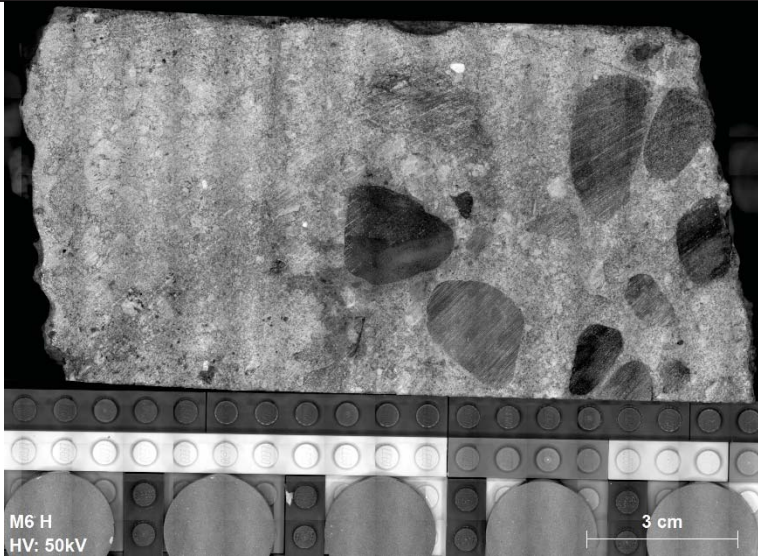
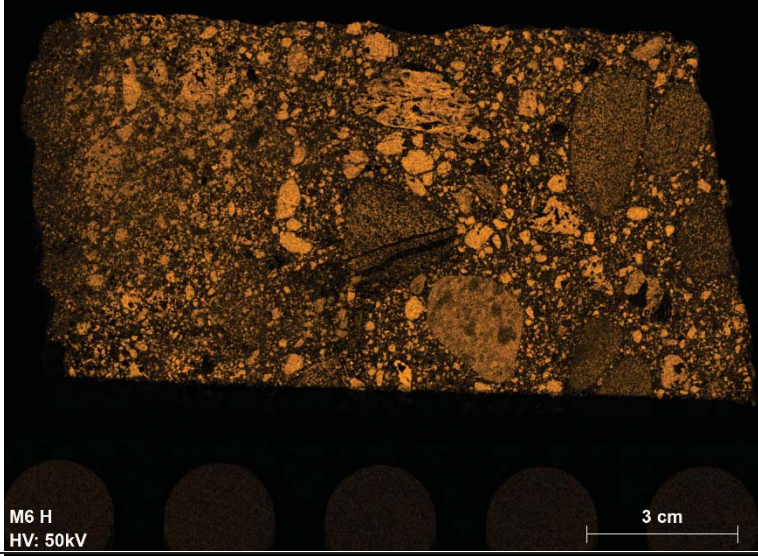
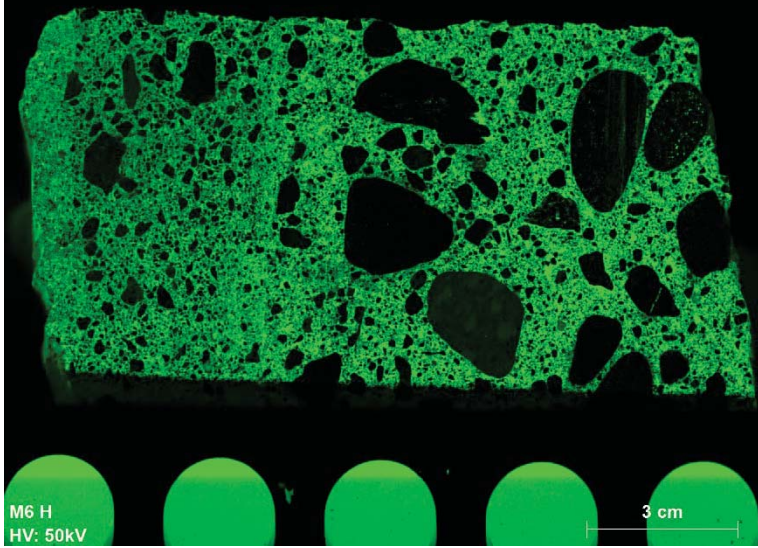
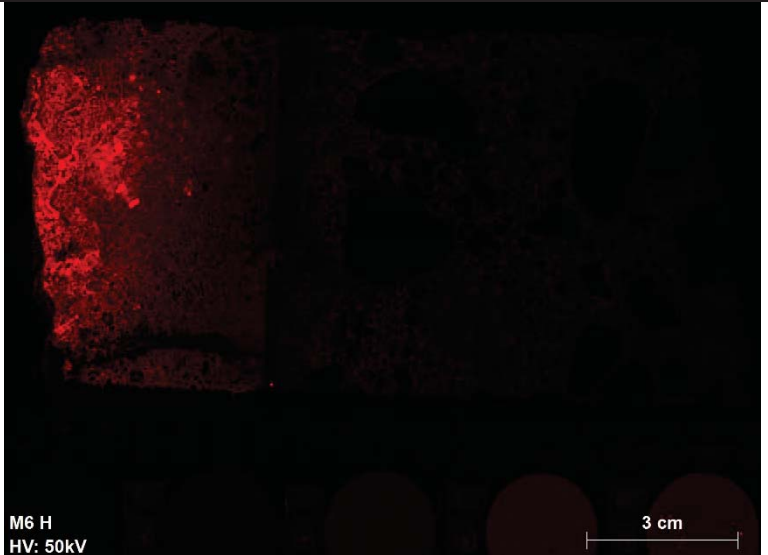
M6	
Element	Scanned Area

<p>M6_H</p>	<p>Broken at the mortar-concrete interface. High chloride ingress in the centre of the mortar.</p>

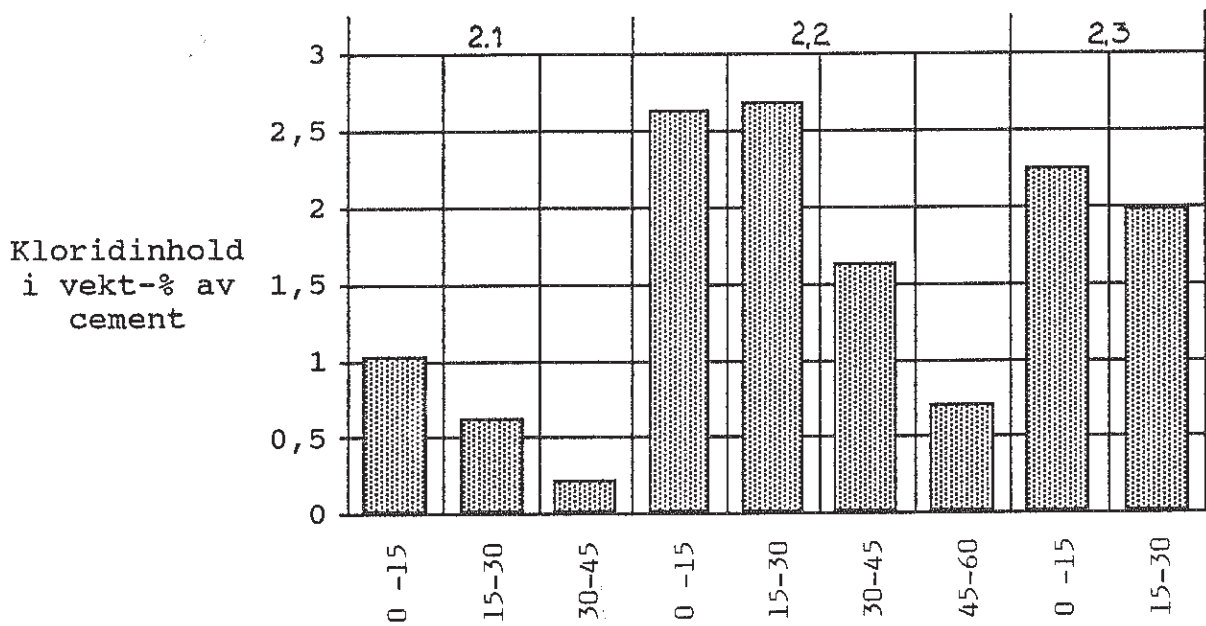
Kloridprofil pilar 2 vest og øst

RCT- MÅLINGER			Pilar nr. 2					
Nivå mm	Prøve	Dybde mm	mV	Cl-innh vekt% bet	Faktor	Cl-innh i vekt-% av sement		
360	2,1	0-15	24	0,16	6,40	1,024	Vest vegg	
		15-30	36	0,098	6,4	0,6272		
		30-45	61	0,035	6,4	0,224		
380	2,2	0-15	2	0,41	6,4	2,624	Østre vegg	
		15-30	1	0,42	6,4	2,688		
		30-45	13	0,255	6,4	1,632		
		45-60	33	0,11	6,4	0,704		
1300	2,3	0-15	6	0,35	6,4	2,24	Østre vegg	
	2,3	15-30	8	0,31	6,4	1,984

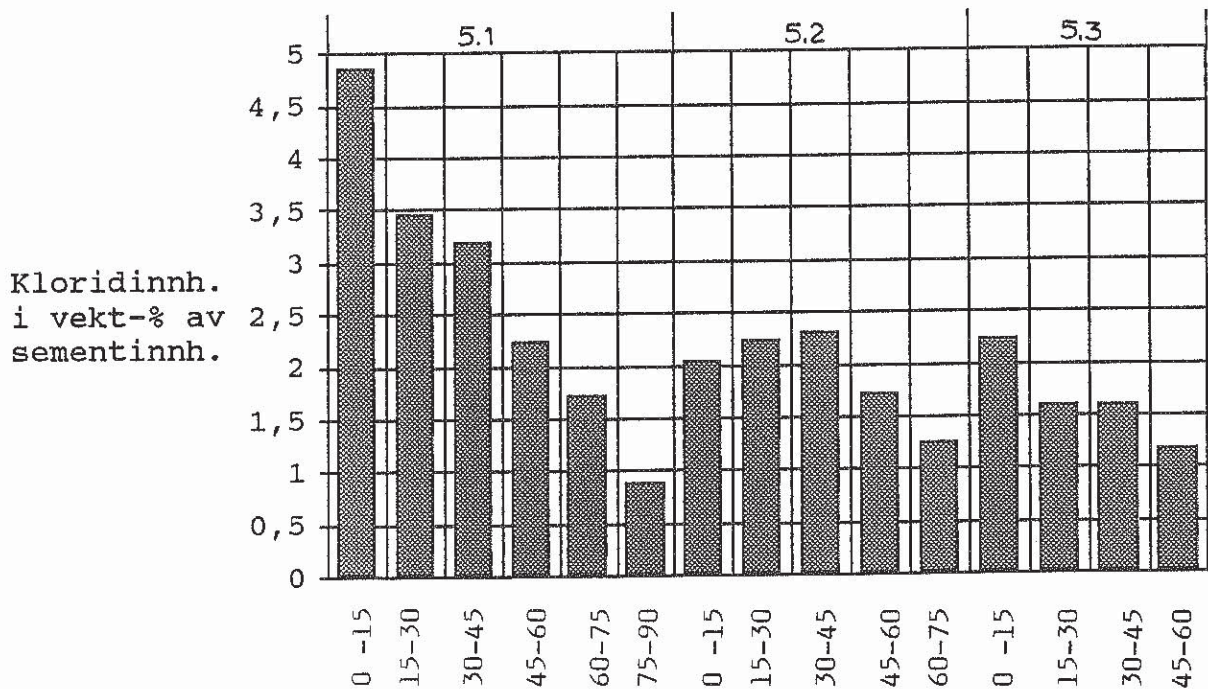
Kloridprofil pilar 5 öst

RCT- MÅLINGER		Pilar nr. 5					
	Pröve	Dybde	mV	CL-innh	Faktor	Kloridinnhold	
Nivå mm		mm		vekt% bet		i vekt-% av sement	
500	5,1	0-15	-13	0,76	6,4	4,864	Östre vegg
	5,1	15-30	-5	0,54	6,4	3,456	
	5,1	30-45	-3	0,5	6,4	3,2	
	5,1	45-60	6	0,35	6,4	2,24	
	5,1	60-75	12	0,27	6,4	1,728	
	5,1	75-90	28	0,138	6,4	0,8832	
1500	5,2	0-15	7	0,32	6,4	2,048	Östre vegg
	5,2	15-30	6	0,35	6,4	2,24	
	5,2	30-45	5	0,36	6,4	2,304	
	5,2	45-60	12	0,27	6,4	1,728	
	5,2	60-75	20	0,195	6,4	1,248	
	5,2	75-90	20	0,195	6,4	1,248	
3100	5,3	0-15	6	0,35	6,4	2,24	Östre vegg
	5,3	15-30	15	0,25	6,4	1,6	
	5,3	30-45	15	0,25	6,4	1,6	
	5,3	45-60	20	0,186	6,4	1,1904

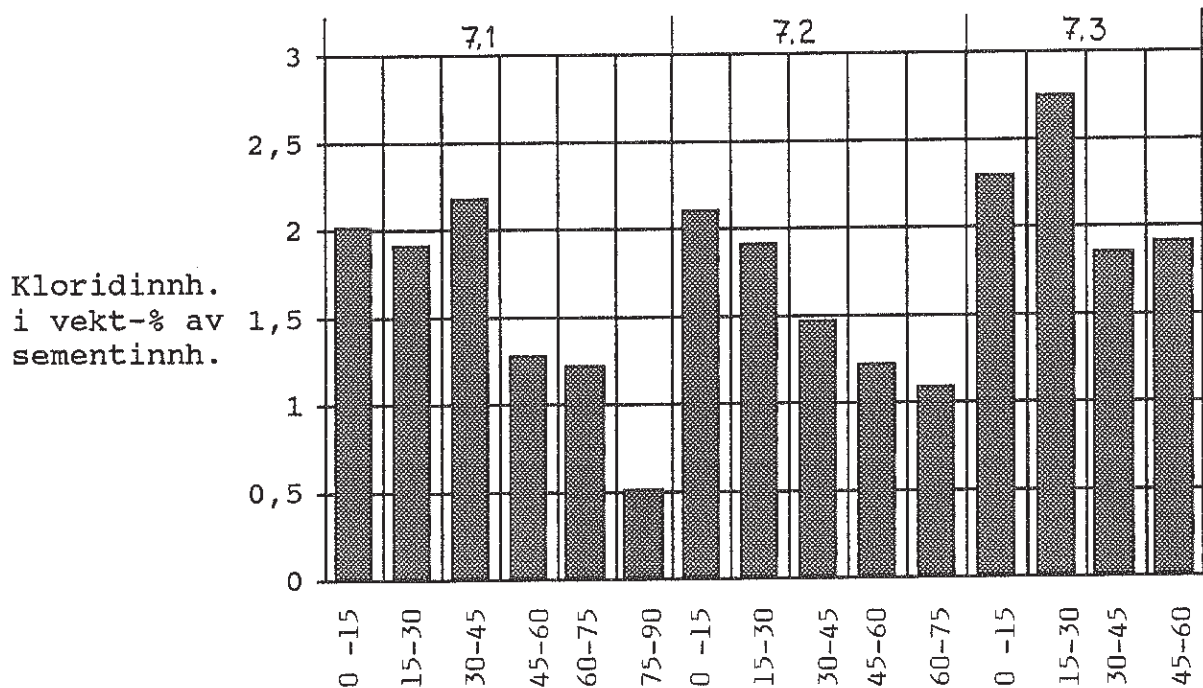
Kloridprofil pilar 7 øst

RCT- MÅLINGER		Pilar nr. 7					
	Pröve	Dybde	mV	CL-innh	Faktor	Kloridinnhold	
Nivå mm	mm	mm		vekt% bet		i vekt-% av sement	
1200	7,1	0-15	8	0,315	6,4	2,016	
	7,1	15-30	9	0,3	6,4	1,92	
	7,1	30-45	6	0,34	6,4	2,176	
	7,1	45-60	19	0,2	6,4	1,28	
	7,1	60-75	20	0,19	6,4	1,216	
	7,1	75-90	41	0,08	6,4	0,512	
2000	7,2	0-15	7	0,33	6,4	2,112	Østre vegg
	7,2	15-30	9	0,3	6,4	1,92	
	7,2	30-45	15	0,23	6,4	1,472	
	7,2	45-60	20	0,19	6,4	1,216	
	7,2	60-75	23	0,17	6,4	1,088	
3600	7,3	0-15	5	0,36	6,4	2,304	
	7,3	15-30	1	0,43	6,4	2,752	
	7,3	30-45	10	0,29	6,4	1,856	
	7,3	45-60	9	0,3	6,4	1,92

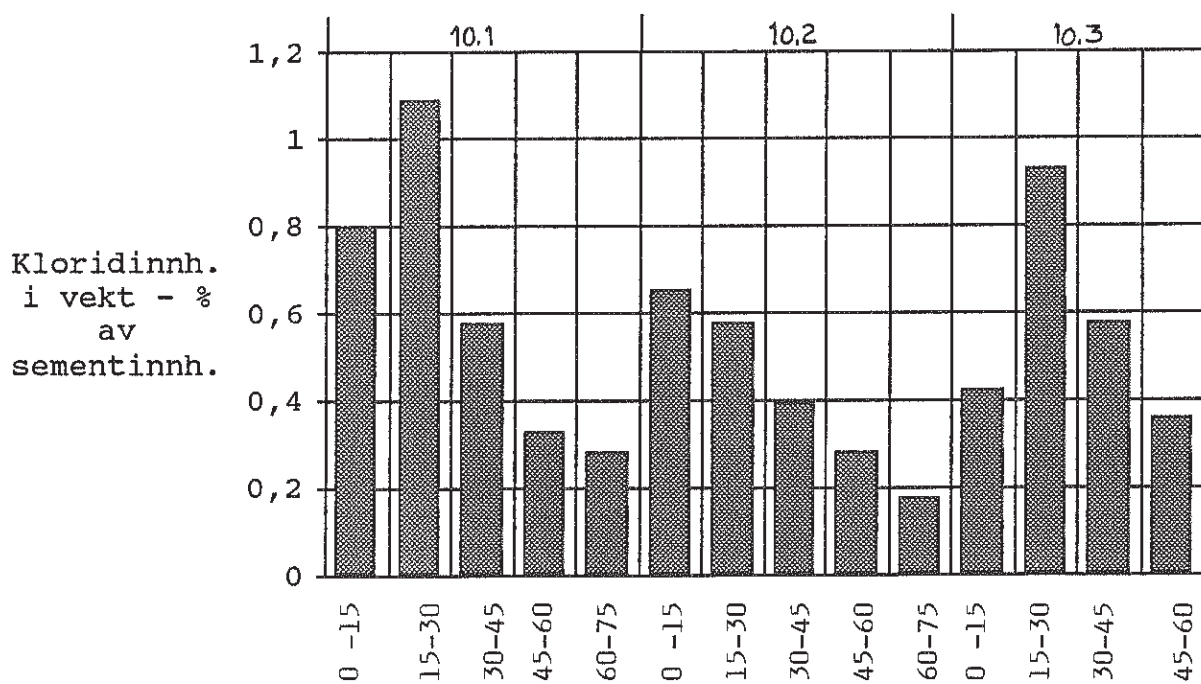
Kloridprofil pilar 10 nord

RCT- MÅLINGER		Pilar nr. 10						
	Prøve	Dybde	mV	CL-innh	Faktor	Kloridinnhold		
Nivå mm		mm		vekt% bet		i vekt-% av sement		
500	10,1	0-15	30	0,125	6,4	0,8	Nordre vegg	
	10,1	15-30	23	0,17	6,4	1,088		
	10,1	30-45	38	0,09	6,4	0,576		
	10,1	45-60	51	0,052	6,4	0,3328		
	10,1	60-75	55	0,044	6,4	0,2816		
1500	10,2	0-15	35	0,102	6,4	0,6528	Nordre vegg	
	10,2	15-30	38	0,09	6,4	0,576		
	10,2	30-45	47	0,062	6,4	0,3968		
	10,2	45-60	55	0,044	6,4	0,2816		
	10,2	60-75	65	0,028	6,4	0,1792		
3000	10,3	0-15	46	0,066	6,4	0,4224	Nordre vegg	
	10,3	15-30	27	0,145	6,4	0,928		
	10,3	30-45	38	0,09	6,4	0,576		
	10,3	45-60	50	0,056	6,4	0,3584

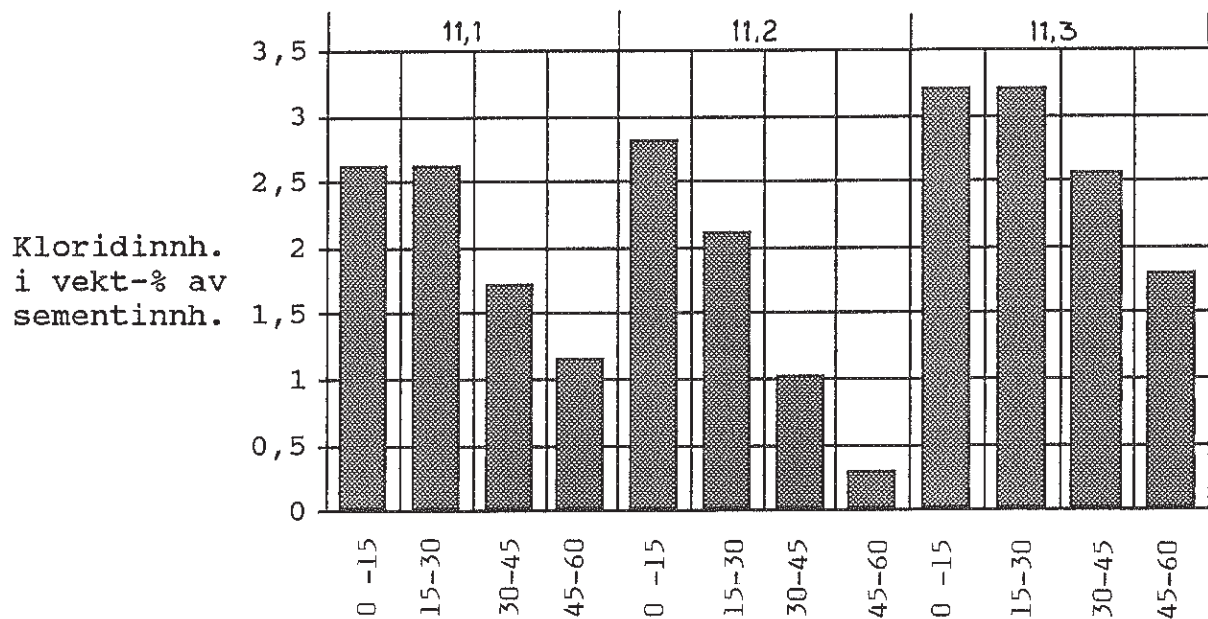
Kloridprofil pilar 11 öst 1-3

RCT- MÅLINGER		Pilar nr. 11 öst					
	Pröve	Dybde	mV	CL-innh	Faktor	Kloridinnhold	
Nivå mm		mm		vekt% bet		i vekt-% av sement	
400	11,1	0-15	3	0,41	6,4	2,624	Östre vegg
	11,1	15-30	3	0,41	6,4	2,624	
	11,1	30-45	12	0,27	6,4	1,728	
	11,1	45-60	20	0,18	6,4	1,152	
1000	11,2	0-15	0	0,44	6,4	2,816	Östre vegg
	11,2	15-30	7	0,33	6,4	2,112	
	11,2	30-45	24	0,16	6,4	1,024	
	11,2	45-60	54	0,046	6,4	0,2944	
1800	11,3	0-15	-3	0,5	6,4	3,2	Östre vegg
	11,3	15-30	-3	0,5	6,4	3,2	
	11,3	30-45	2	0,4	6,4	2,56	
	11,3	45-60	11	0,28	6,4	1,792

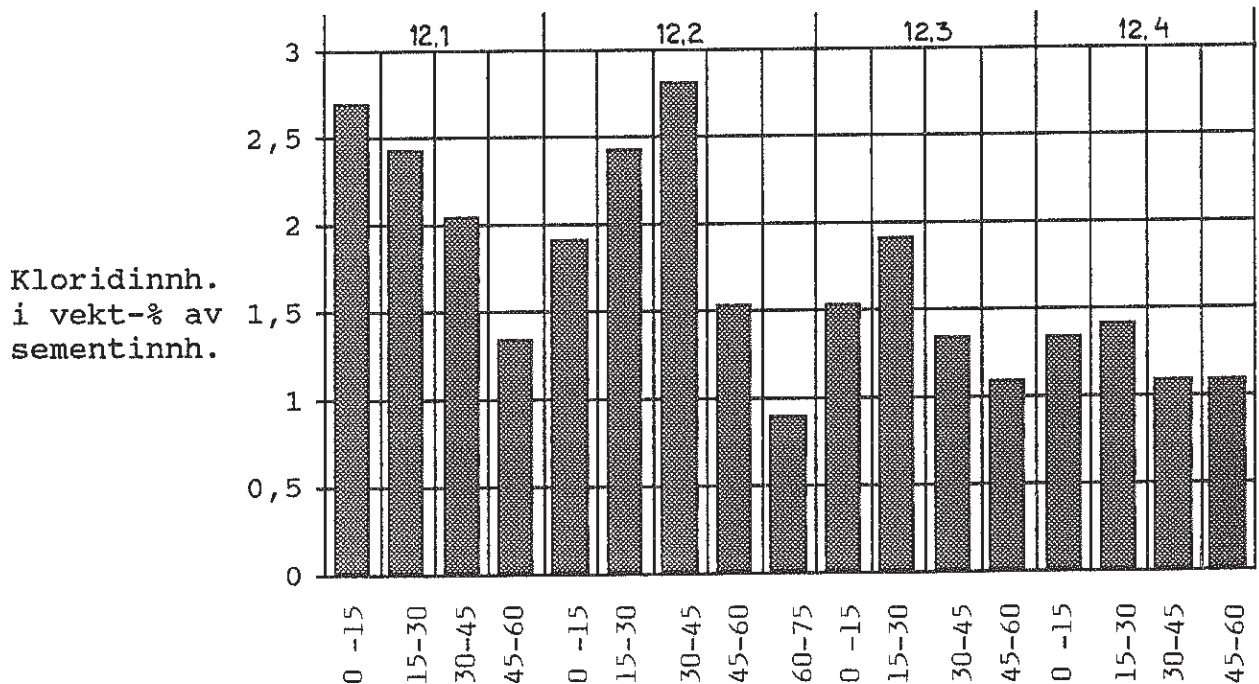
Kloridprofil pilar 12 öst og sør 1-4

RCT- MÅLINGER		Pilar nr. 12					
Nivå mm	Pröve	Dybde mm	mV	CL-innh vekt% bet	Faktor	Kloridinnhold i vekt-% av sement	
450	12,1	0-15	-1	0,42	6,4	2,688	Östre vegg
	12,1	15-30	1	0,38	6,4	2,432	
	12,1	30-45	5	0,32	6,4	2,048	
	12,1	45-60	15	0,21	6,4	1,344	
1050	12,2	0-15	7	0,3	6,4	1,92	Östre vegg
	12,2	15-30	1	0,38	6,4	2,432	
	12,2	30-45	2	0,44	6,4	2,816	
	12,2	45-60	12	0,24	6,4	1,536	
	12,2	60-75	25	0,14	6,4	0,896	
1800	12,3	0-15	12	0,24	6,4	1,536	Östre vegg
	12,3	15-30	7	0,3	6,4	1,92	
	12,3	30-45	15	0,21	6,4	1,344	
	12,3	45-60	20	0,17	6,4	1,088	
500	12,4	0-15	18	0,21	6,4	1,344	Søndre vegg
	12,4	15-30	17	0,22	6,4	1,408	
	12,4	30-45	20	0,17	6,4	1,088	
	12,4	45-60	20	0,17	6,4	1,088

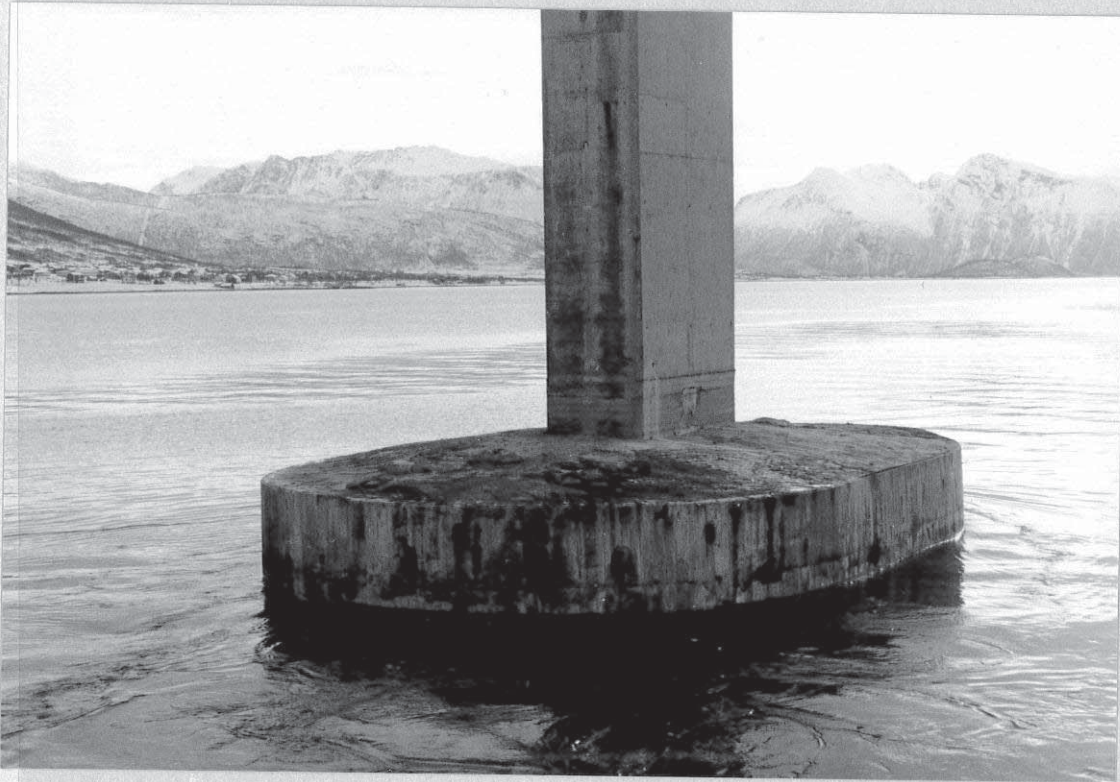
20.

Pilar 9, nordvestre hjørne - restutslag

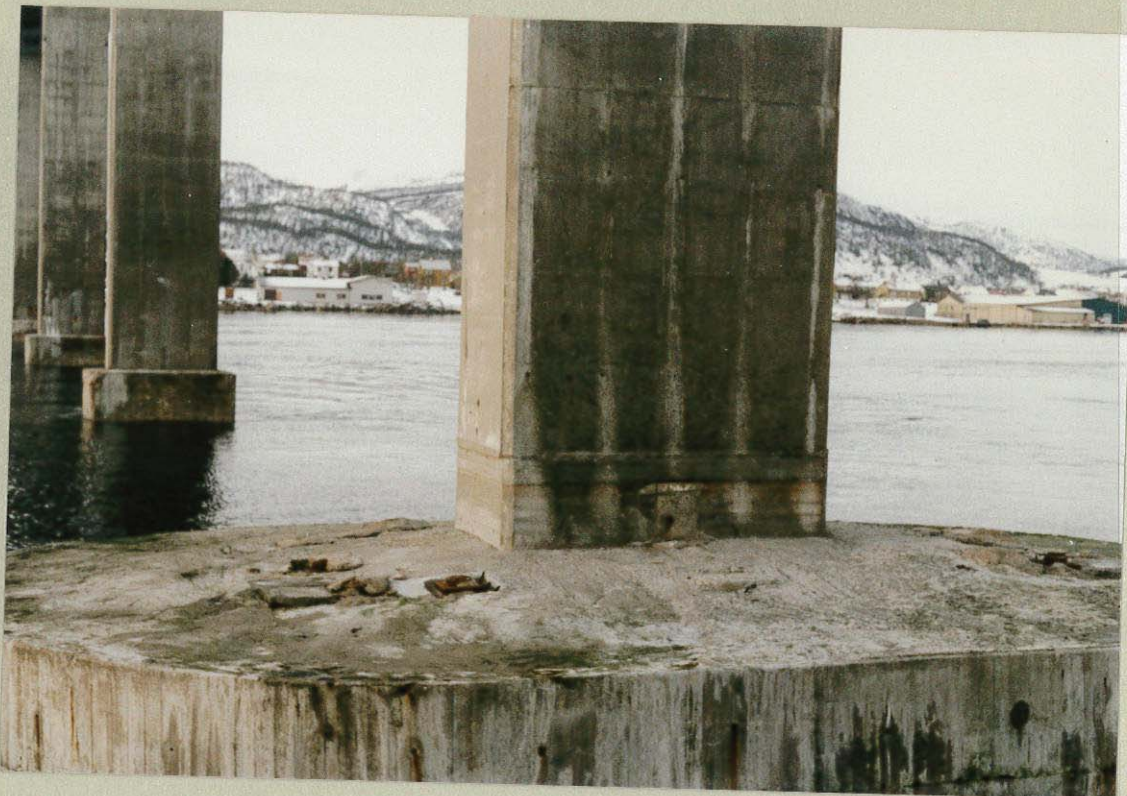
21.

Pilar 9 søndre og østre vegg - Kabel-
forankringene er frilagt og korrodert.

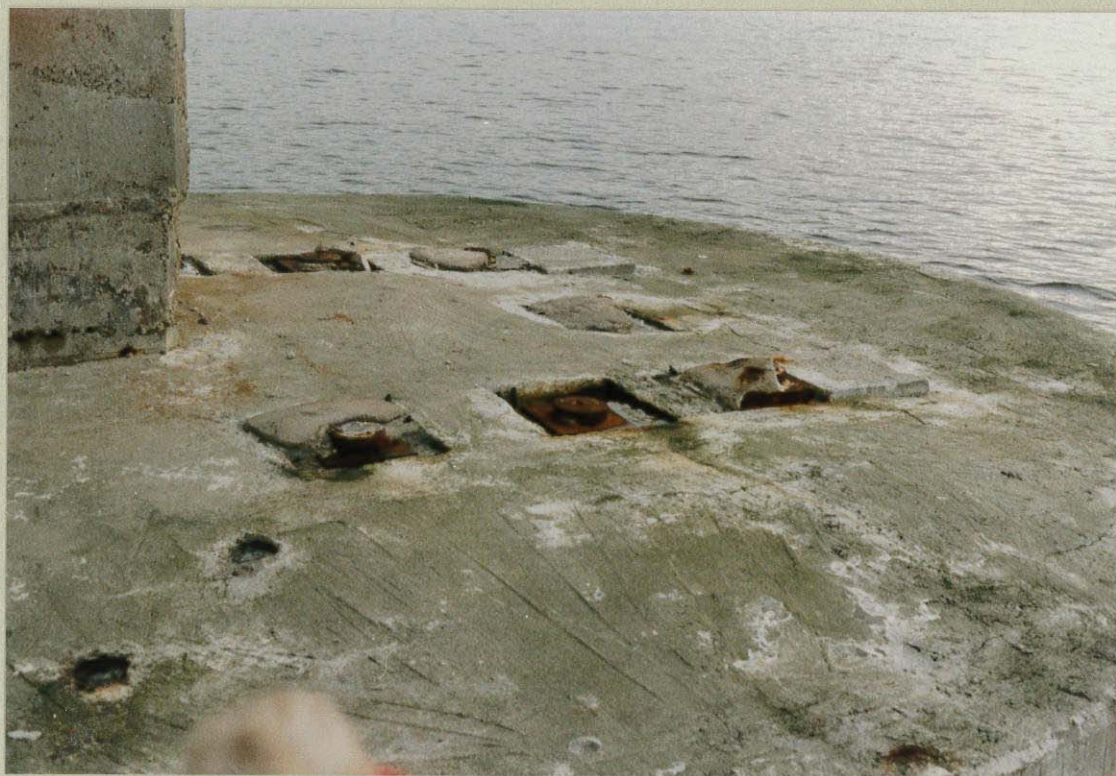
36.

Pilar 12 Frilagte armeringsklosser -
