Long-term performance of cathodic protection (CP) of marine bridge, inspection of Sortlandsbrua 27 years after CP installation

An investigation of performance and damages on the installation.

Master's thesis in Experience-based Part-time Master programme Road and Railway Engineering
Supervisor: Mette Rica Geiker
May 2019

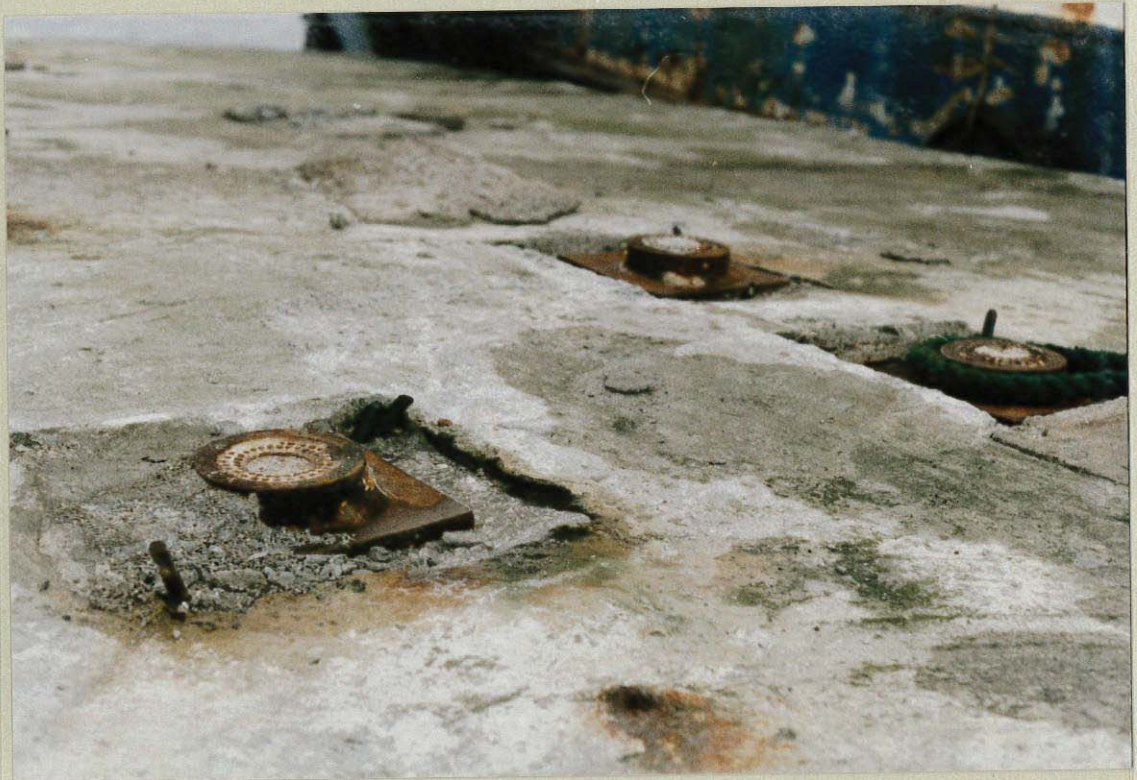
37.

Pilar 12 kabelforankringer er frilagt
sydvestre side

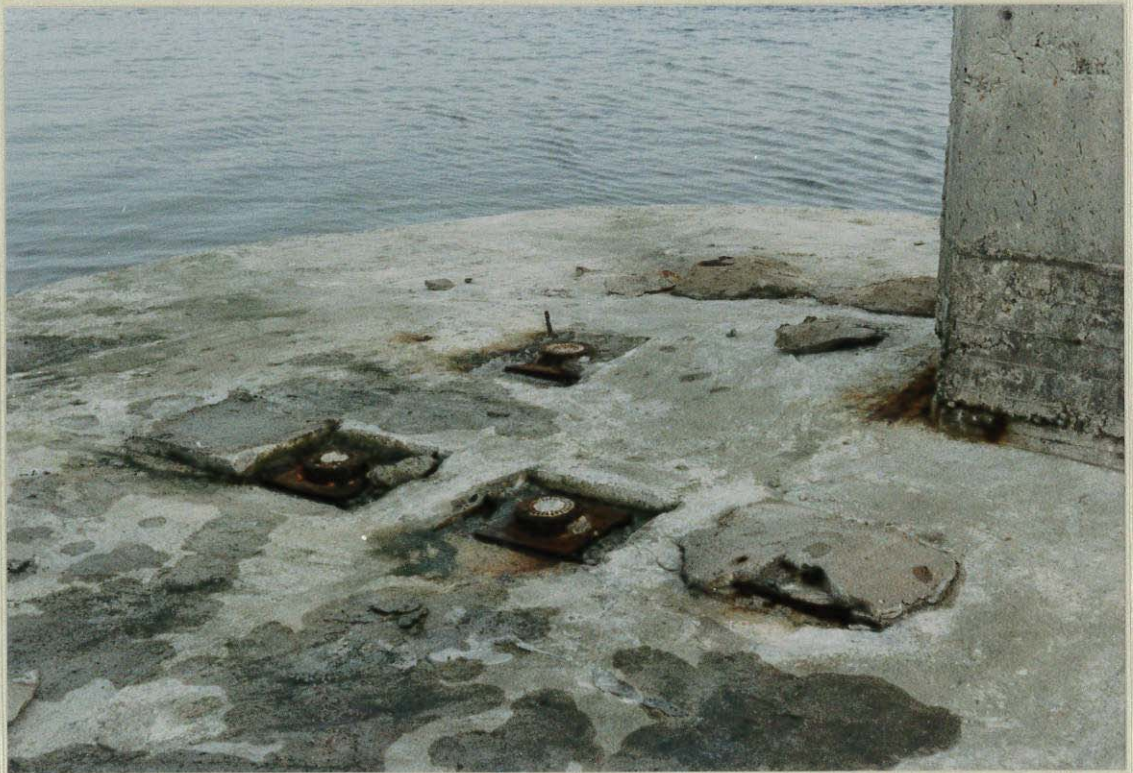
38.

Pilar 12, Frilagte kabelforankringer

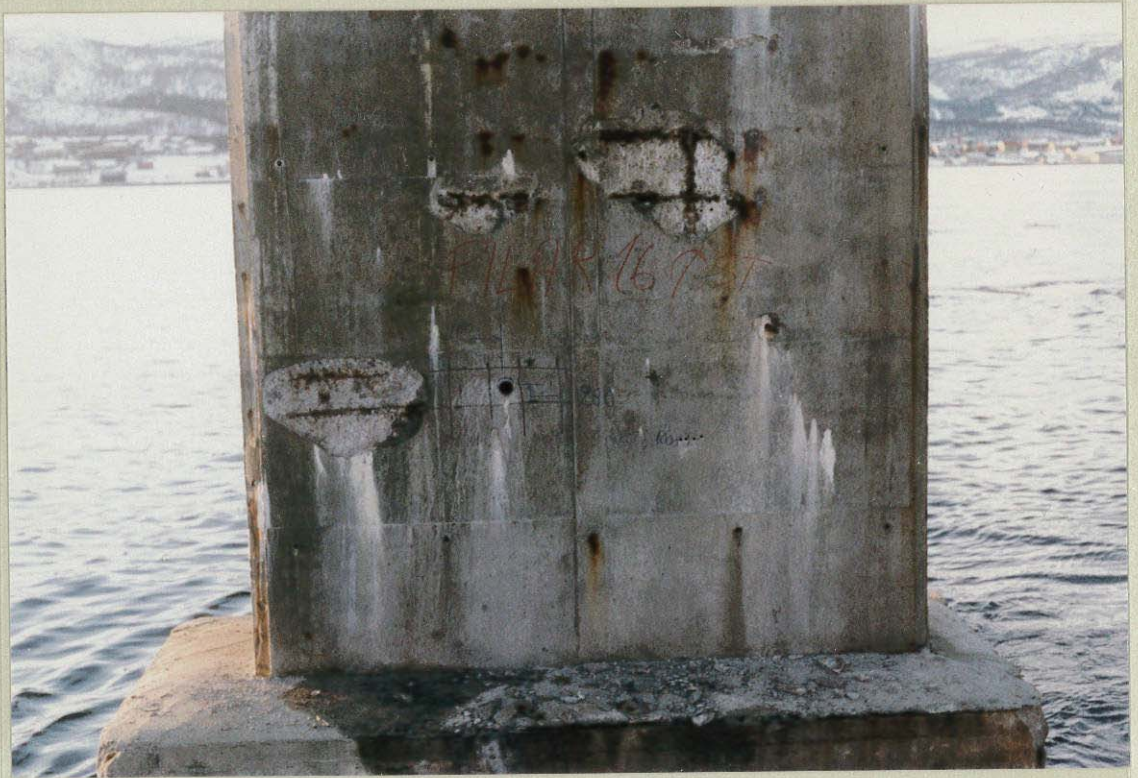
50.

På østre vegg er det i området fra ok fundament og 4 - 5 m opp registrert flere rustutslag, avskallinger og riss. I rissene er det påvist fellingsprodukter, se bildene 50 og 51. På kote + 3,0 m er avskallet betong hugget bort. Denne er 700 mm bred 400 mm høy og går inn til armeringen. Frilagt armering er meget sterkt angrepet av korrosjon, se bildene 53 og 54. Overdekningen er målt til 20 mm i dette området.

Pilar 16 østre side

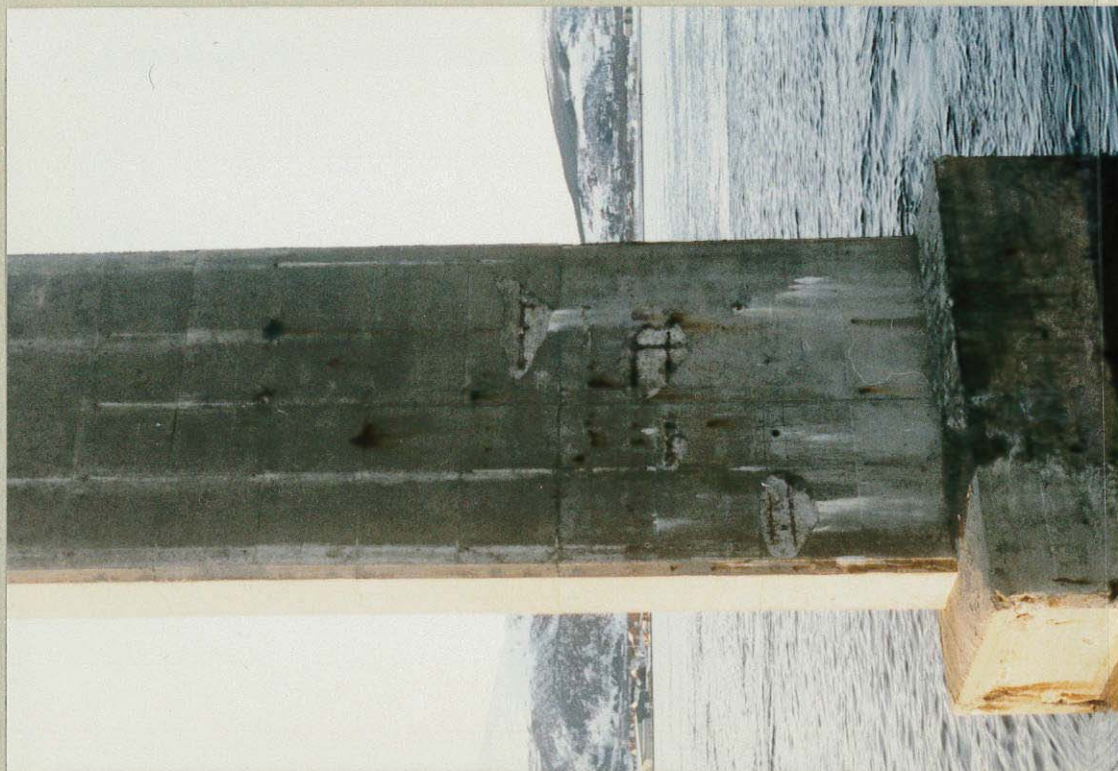
51.

Pilar 16 østre og søndre side

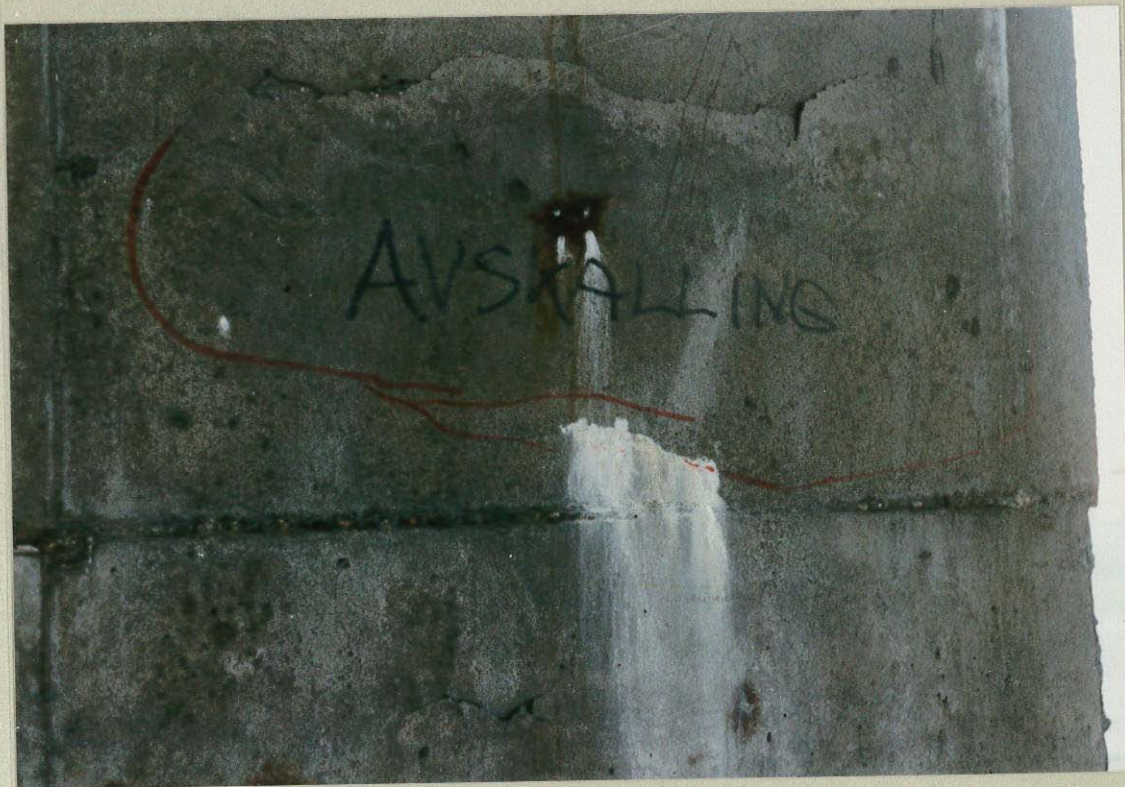
52.

Armeringen på pilarens østre side synes å være i en korrosiv tilstand i en høyde av 4 - 5 m. Ved nedslåing av avskallet betong ble det konstatert sterkt forvitret betong bak et 10 - 15 mm hardt sjikt. Dette kan indikere at betongen i denne pilaren er frostskaadet. Dette bør undersøkes nærmere.

Pilar 16 øst avskalling på kote +3000

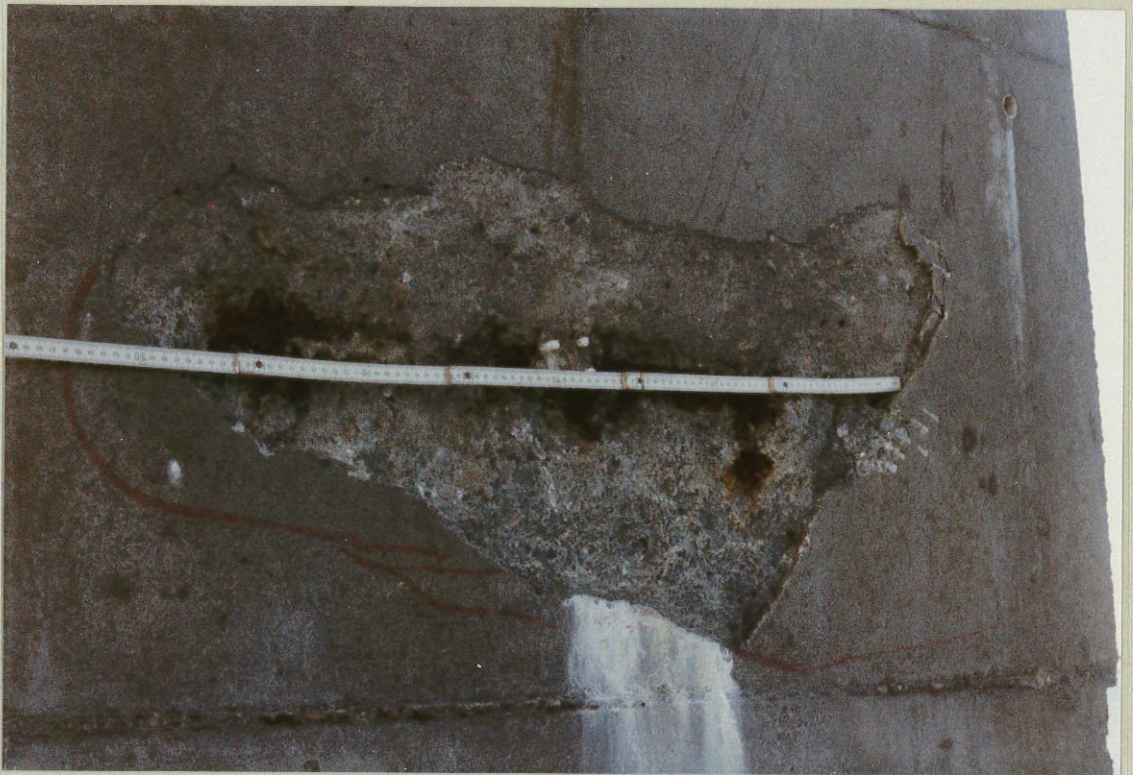
53.

Pilar 16 øst - samme som foregående, men
etter nedslåing av avstalling.

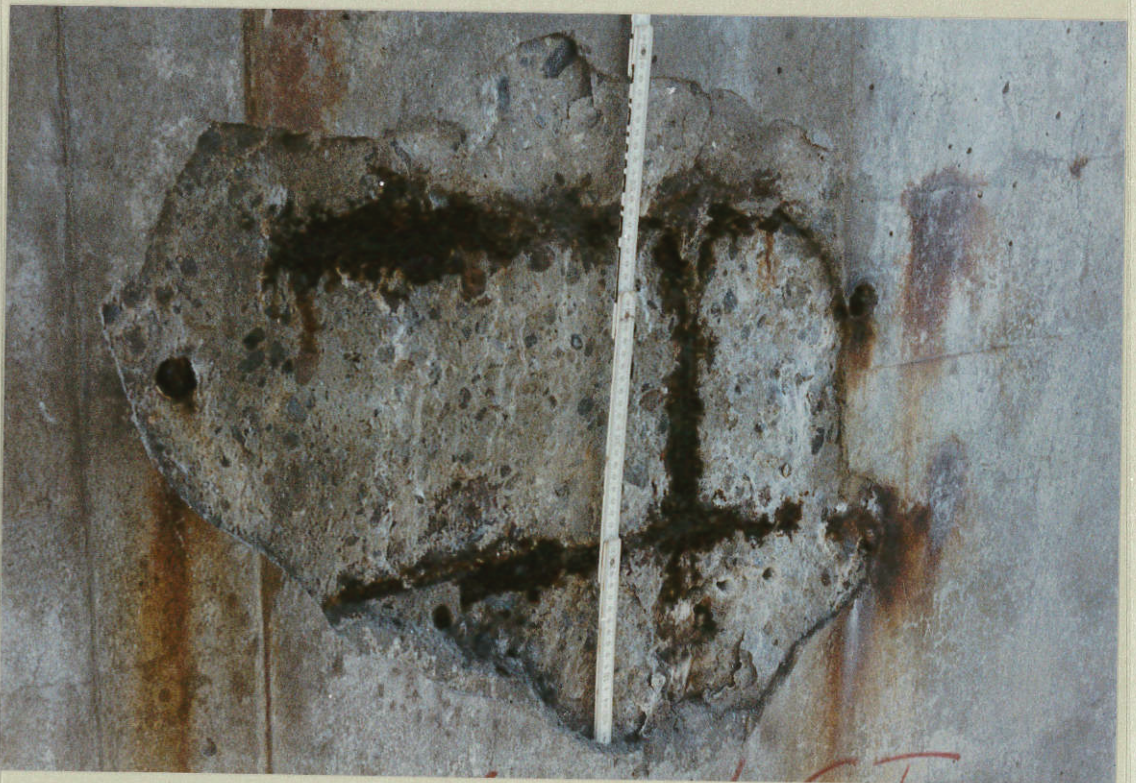
54.

Pilar 16 øst - heftig korrosjon på nivå +2000
