Comparative analysis of protective coating on Scandinavian road bridges

Bachelor's project in FTHINGMAT and FTHINGOG

May 2020

Group IMA-B-13
Karsten Tranborg Eriksen
Henrik Rødal Ler
Kristian Ringheim Moe

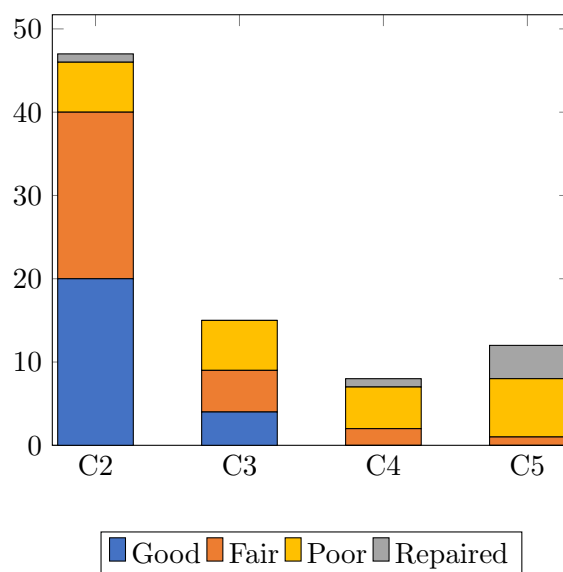
Figure 4.4: The coating condition for Norwegian bridges in different environments.

Most of the bridges were in fair or good conditions, however, most of the bridges were in kind environments as well. The more aggressive the environment the more bridges are either poor or repaired.

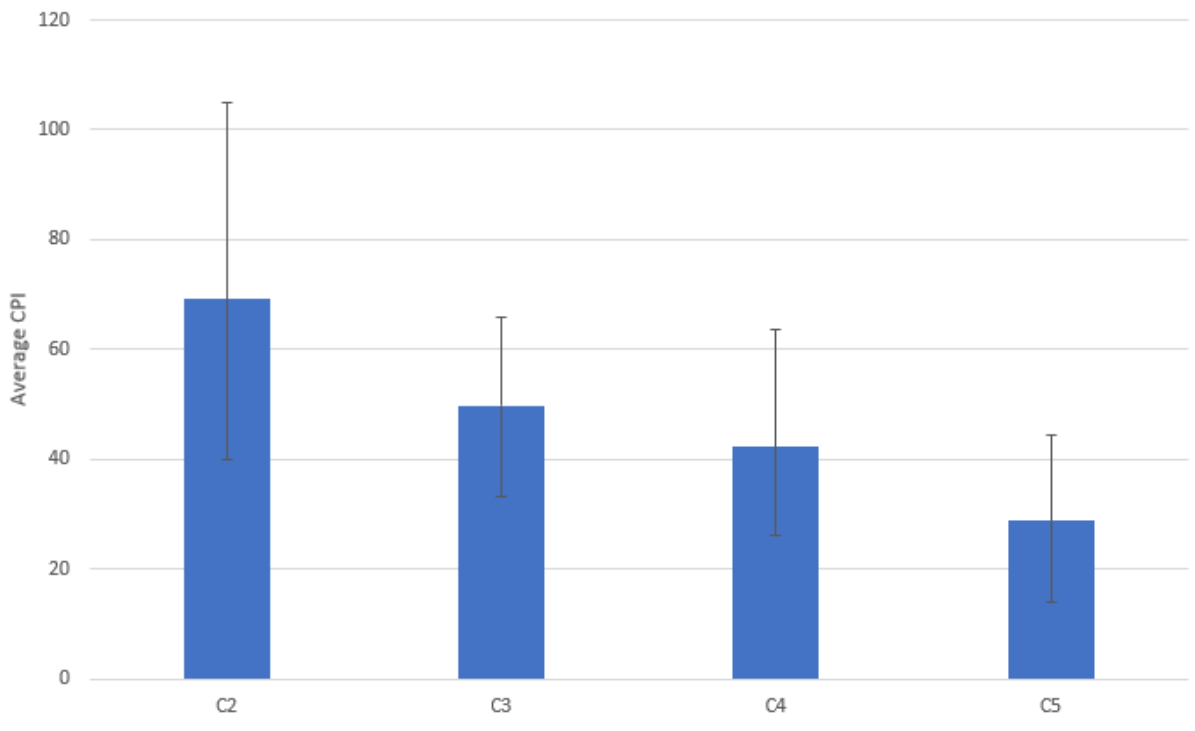
Figure 4.5: Average CPI of Norwegian Bridges by Corrosivity. The deviation lines show the highest and lowest values.

The CPI for each environment is presented in figure 4.5. From this it should be possible to estimate an expected lifetime for each coating type. Note that although Herdlesundet bridge is not of the same specification as the rest of them, it is still included in the C4 category here. Herdlesundet bridge has zinc chromate pigmented intermediate layers in the coating as it is the 1969 spec.

It is clear that the CPI of Norwegian bridges are inversely proportional to the aggressiveness of their environment.

The findings of this thesis shows that the bridges in C2 environments performed worse than the previous study by Knudsen et al. [4]. However, the trends in figure 4.5 is similar to what was found in that study. Interestingly C2 bridges deviated from the previous results by nearly 25 years in CPI. As the C2 bridges in this thesis are on average 5 years younger than those of the previous study, the CPI may be affected by as much as 10 years if the condition doesn't worsen in 5 years. This difference can be partly explained by the fact that 1995 was the cutoff year for that study (here it is 2000) and there were comparatively more of older C2 bridges. Another possibility is that the assessment has become more strict in this thesis, but an update of the coating conditions on the bridges with some doubts proved to only increase the average CPI by 5 years. If the condition was raised by 1 for each bridge in C2 and the age was 5 years higher the average CPI would be about the same as what was found by Knudsen et al. [4]. Any deviation outside of that can not be confidently explained, but handling of parts, standards of local companies and similar circumstances around construction could be of importance other than corrosivity. The bridges in the other environments showed similar CPI to what was found by Knudsen et al. The CPI for C3 environments was here found to be 50 years, for C4 environments it was found to be 42 years and for C5 it was found to be 29 years. This is a deviance of 0, 0 and +9 years respectively from the study by Knudsen et al. The higher CPI for C5 bridges is probably due to the fact that more C5 bridges have been studied here and the two that were studied by Knudsen et al. are known to have application errors in the coating, thus reducing the durability.

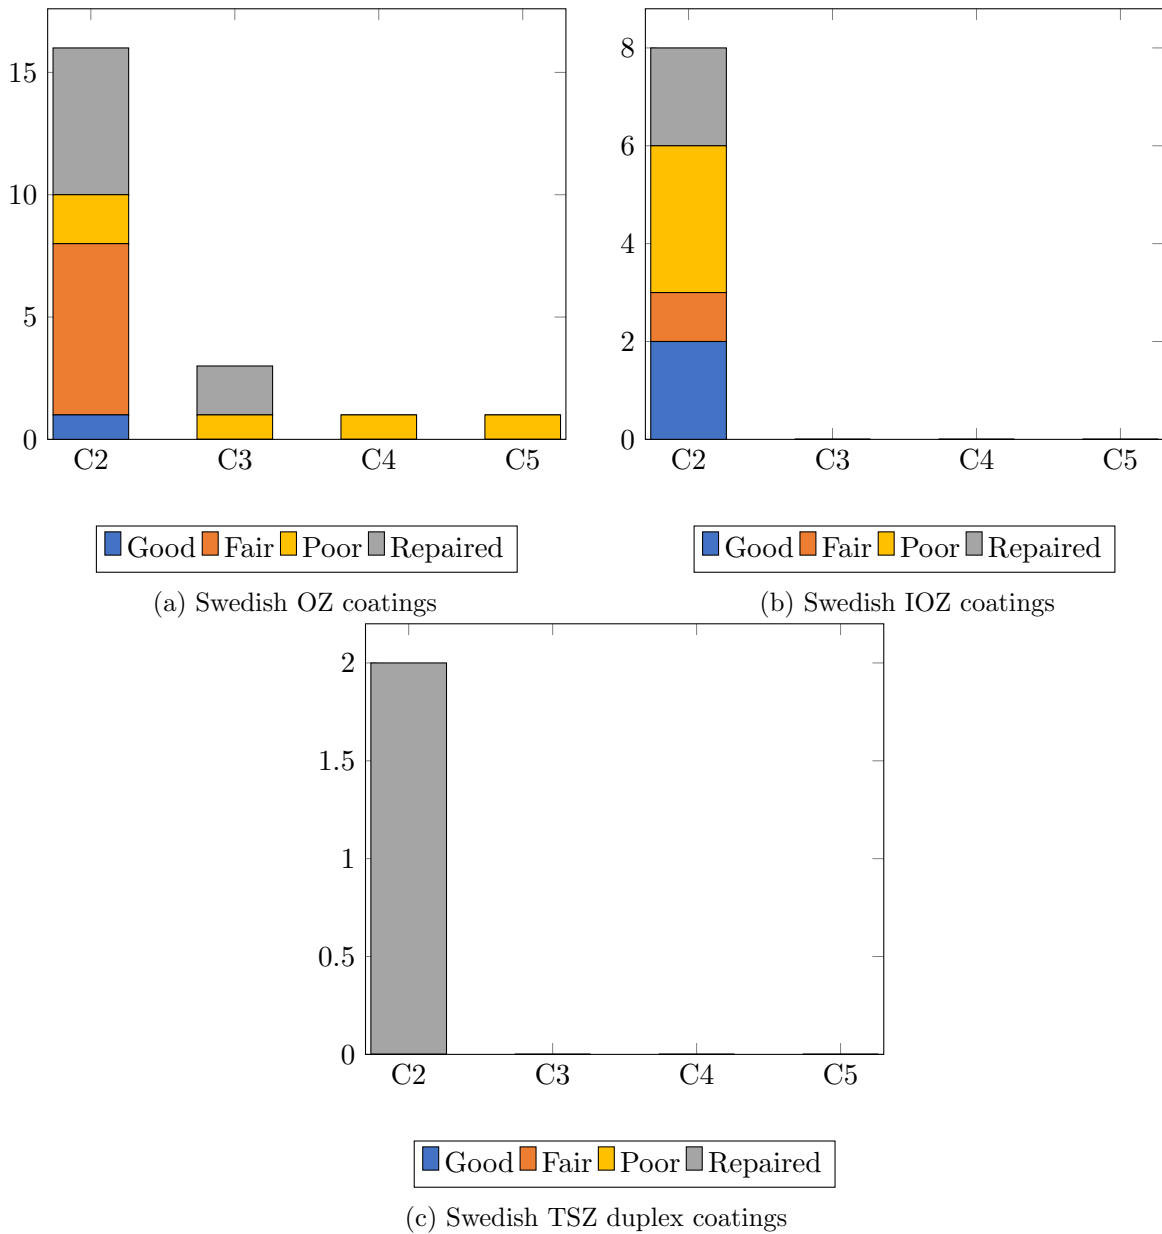
Figure 4.8: Swedish coating conditions for different coatings and environments

In order to say anything qualitative about the Swedish coatings they have been divided into three charts, one for modern coatings presented in figure 4.8a, one for IOZ presented in figure 4.8b and one for TSZ duplex in figure 4.8c. It is important to note that "modern coatings" in Sweden can be very different from one another and with the information available it was not possible to differentiate them from one another.

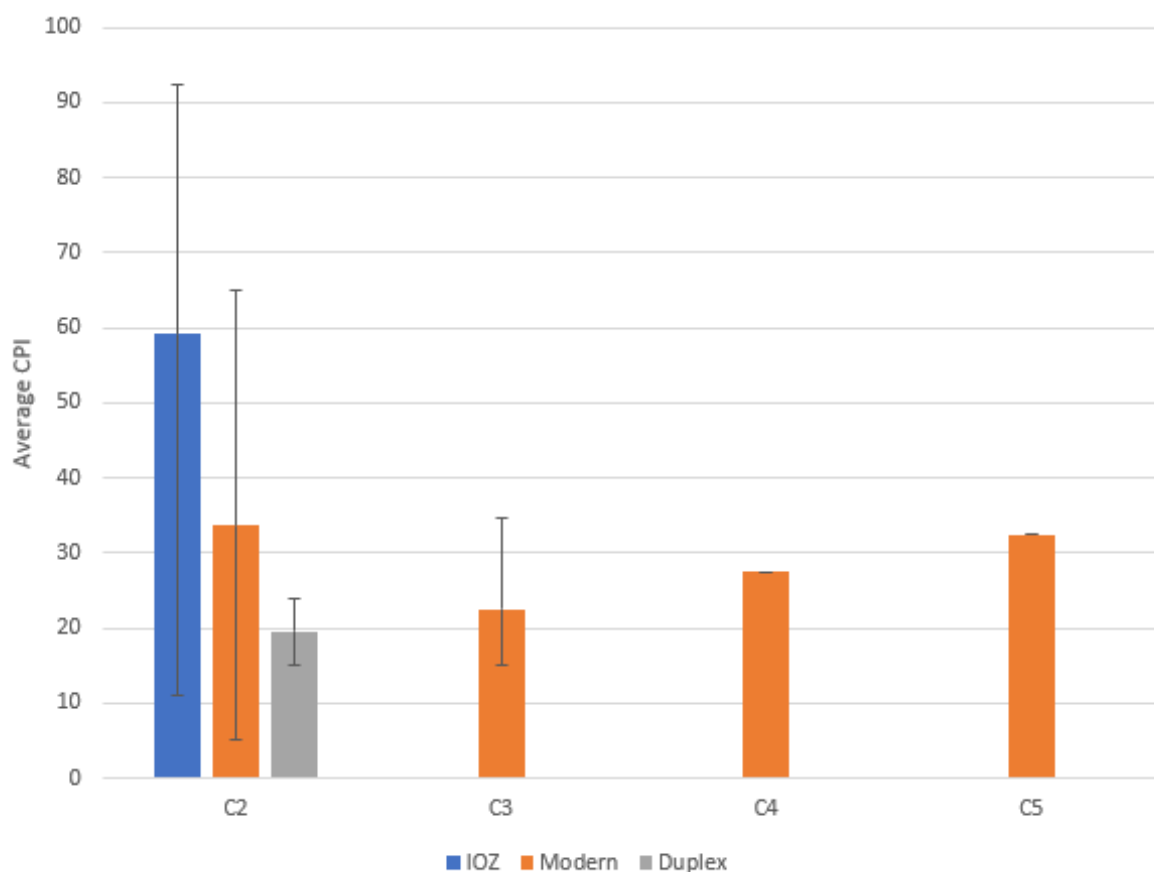
Figure 4.9: Average CPI of Swedish bridges by corrosivity. The deviation lines show the highest and lowest values.

The CPI for each coating in each environment is presented in figure 4.9. The sample size outside of C2 environments is very low (5), meaning the results can be very difficult to interpret accurately. From figure 4.9 it is clear that the IOZ coatings are performing best on average, however with a huge variance ranging from 11 to 93 years. The OZ coatings had a lower variance, from 65 to 5 years, while the duplex coatings had the least, with 24 years being the highest to 15 years being the lowest.
