The Story of a Steep River: Causes and Effects of the Flash Flood on 24 July 2017 in Western Norway

Abstract: Flash floods can cause great geomorphological changes in ephemeral fluvial systems and result in particularly severe damages for the unprepared population exposed to it. The flash flood in the Storelva river in Utvik (western Norway) on 24 July 2017 was witnessed and documented. This study assessed the causes and effects of the 2017 flood and provides valuable information for the calibration and validation of future modelling studies. The flooded area at peak discharge, maximum wetted and dry areas during the entire event, critical points and main flow paths were reconstructed using on-site and post-event (i) visual documentation, such as photographs and videos, and (ii) aerial surveying, such as orthophotographs and laser scanning, of the lowermost reach. The steep longitudinal slope together with the loose material forming the valley and riverbed contributed to a large amount of sediment transport during this extreme event. Steep rivers such as the Storelva river have very short response times to extreme hydrologic conditions, which calls for exhaustive monitoring and da

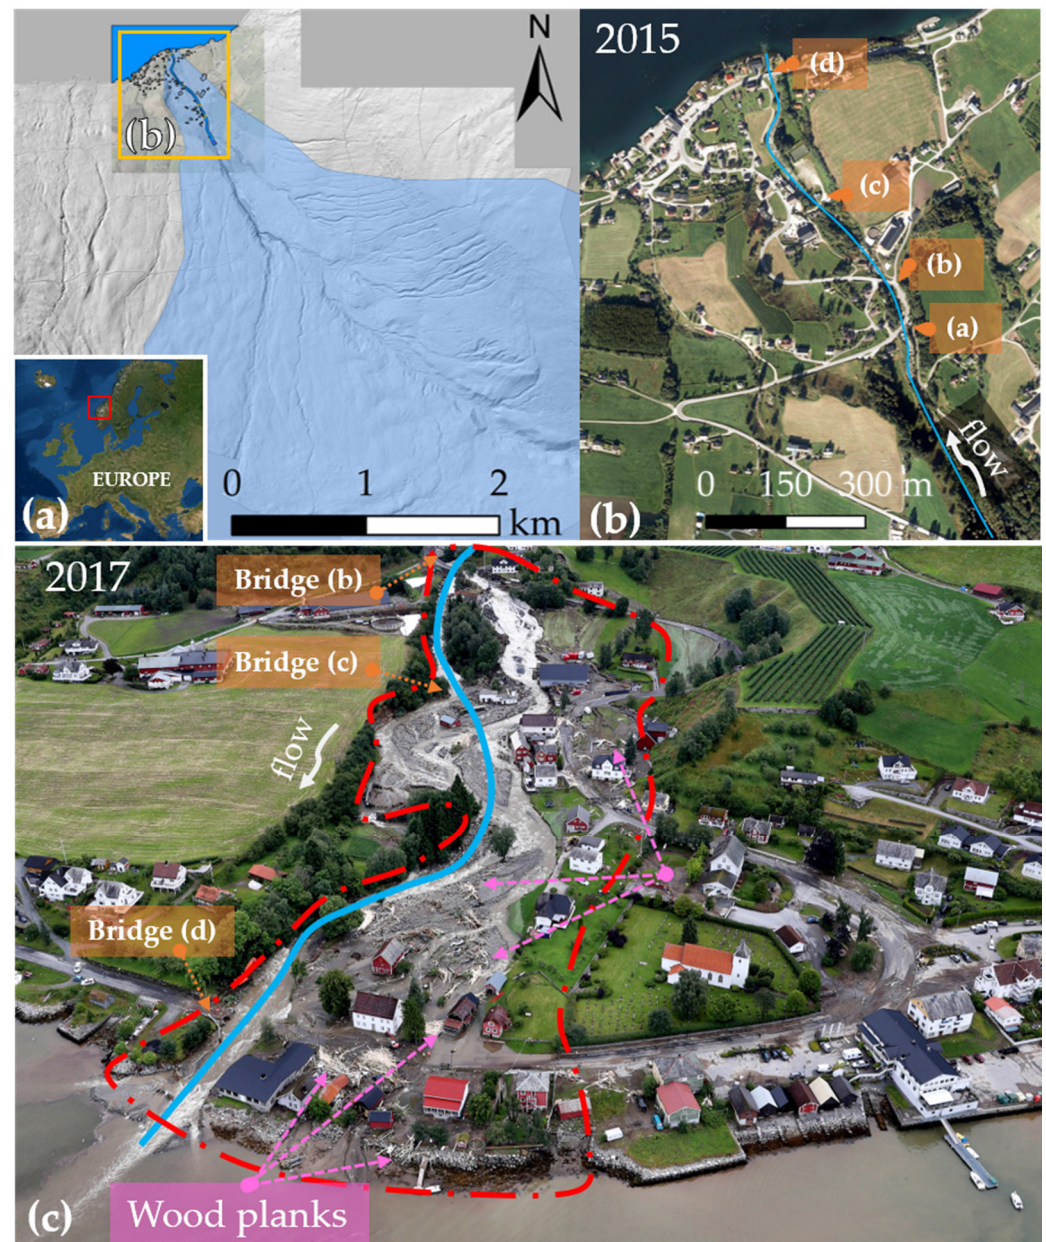
Figure 1. (a) Context map and catchment area [10] imposed over the hillshade of the hydrologic network of the Storelva river in Utvik (western Norway) [12], (b) aerial view of the area of interest before [16] and (c) during the flood (VG/H. Vågenes). Labels in (d) mark the bridges; original river thalwegs in blue lines; preferential flow zone during the flood marked by red dashed line.
