Fatigue of Smart Composite Metal Joints

Even Vardenær Lunder

Submission date: June 2013

**MASTER THESIS SPRING 2013
FOR
STUD. TECHN. EVEN VARDENÆR LUNDER**

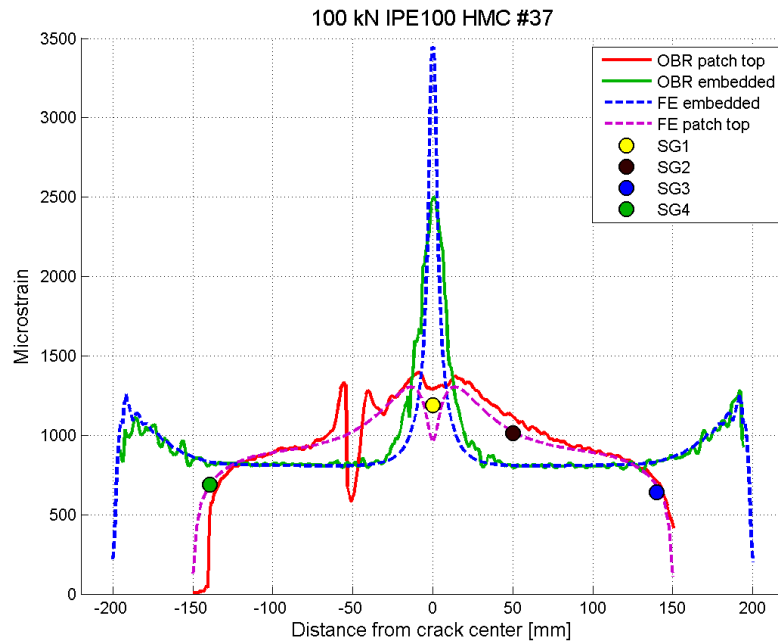
Figure 40: Comparison of OBR, FEA and strain gauges at 100kN load. Beam 37.

For beam number 37 presented in Figure 40 an irregularity occurs in the strain measured by the optical fiber on the patch top at a distance -50mm from the crack center. This is due to insufficient adhesion between the optical fiber and the composite patch at this particular point, accordingly the strain measured there is not correct. At this irregularity the area under the curve seems to equal the area over the curve, indicating that the average of these curves probably would align correctly with the rest of the strain curve.

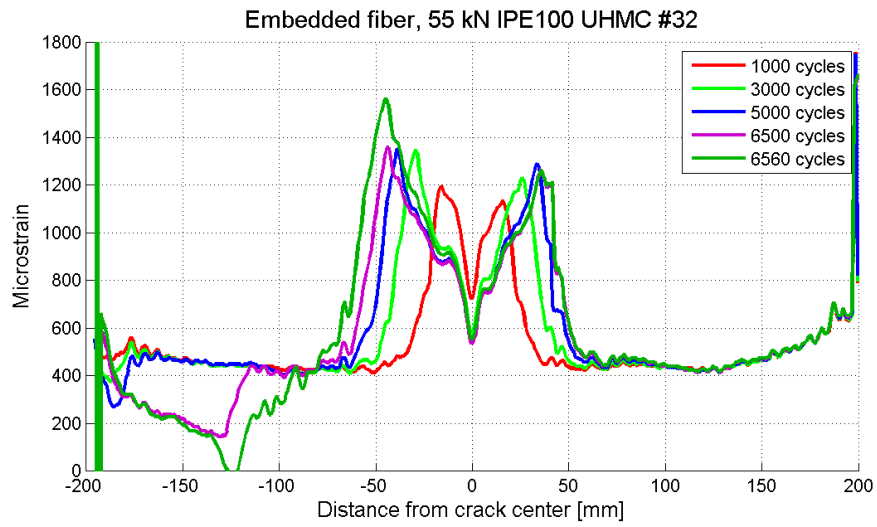
Figure 56: Embedded optical fiber at different cycles, beam 32.

From Figure 56 it can be seen that damage propagated from both center and from left side of the patch. The front of the strain curve shifts from center and towards the patch ends. This indicates a debonding or a cohesive damage propagating in the adhesive layer. The length of the damage can be seen as the length the front of the strain curve has moved. The curve moves faster towards the left side and the length of the damaged area towards the right side stays constant after 5000 cycles.

From the left side there is a small decrease in the strain at 3000 cycles. This has decreased further at 5000 cycles and at 6500 cycles the curve has moved much closer to the center. The strain in the left side of the patch decreases when the end of the patch is released from the steel. The end releases if a debonding or cohesive damage is propagating in the adhesive layer. For both scenarios the patch end or areas of the patch end is no longer connected to the beam. The loose end does not contribute to load transfer or to the joints strength and the shear stress releases, as the shear stress releases so does the axial strain.

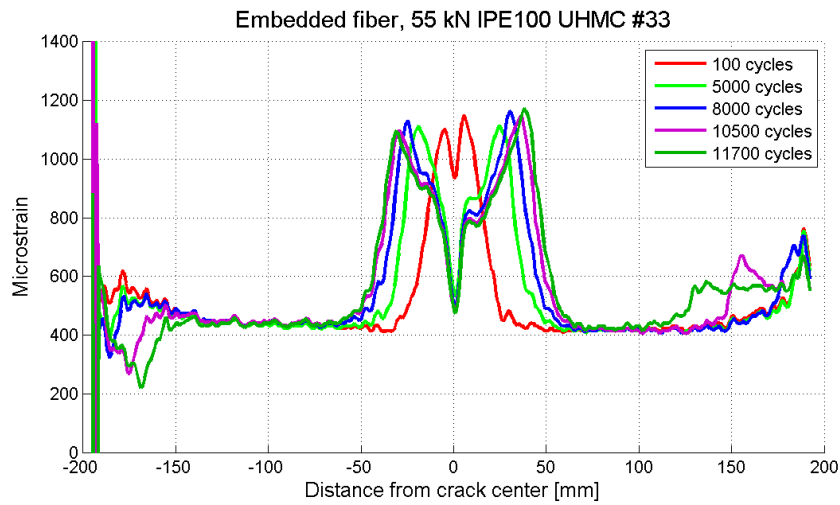
Figure 59: Embedded optical fiber at different cycles, beam 33.

In Figure 59 a similar damage propagation from the left side as for beam 32 is seen. Damage is also propagating from center of the patch towards each end but this damage

is not propagating very much between 5000 and 11700 cycles. A new phenomenon occurs at the right end of the patch, seen at 10500 and 11700 cycles. The strain curve from the right end is moving closer to the center, but the strain is not decreasing as it is from the left side. This is due to delamination in the UHMC laminate between the first and second group of plies starting at the right end of the patch. The strain increases because higher stress is transferred through the adhesive layer as the load transfer contribution from the delaminated part of patch decreases. The delamination was detected by visual inspection at 10500 cycles and could be seen from the back of the beam, see Figure 61 and 62.

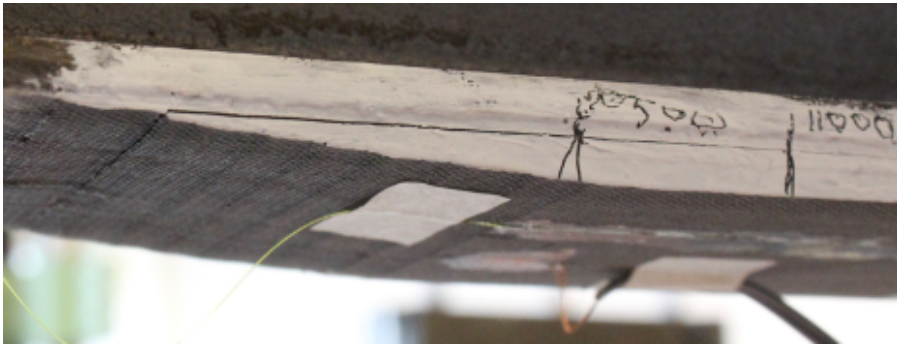
The lengths of the delamination at different cycles are presented in Table 9. These are measured on the back side of the beam at the initiation of the delamination towards center of the patch. Delamination eventually reached center of the beam as seen in Figure 63. Failure occurred along the right side of the patch as a combination of the delamination and cohesive damage in the adhesive layer from the center at 13650 cycles, see Figure 64.

Figure 62: Delamination from right side of the patch. Beam 33, seen from the back.

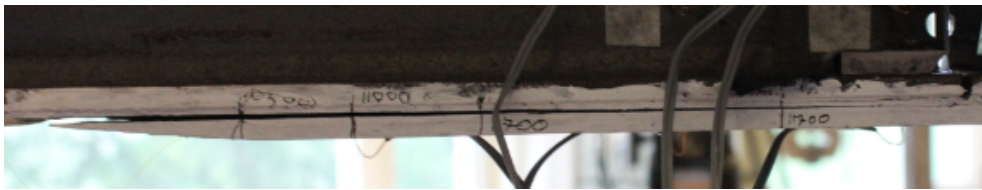
Figure 63: Delamination reaching center of the patch. Beam 33, seen from the back.

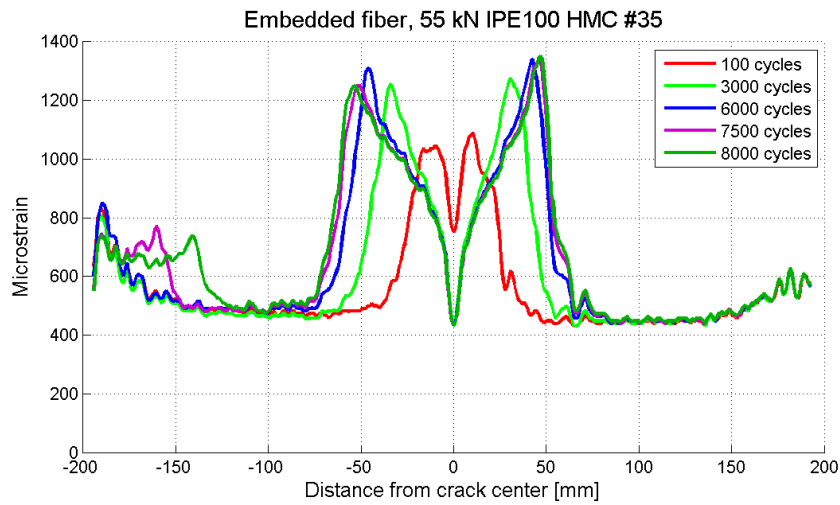
Figure 68: Embedded optical fiber at different cycles, beam 35.

As seen in Figure 68 this patch also experienced delamination in the HMC laminate, this time from the left side of the patch. The strain curve is comparable to that of the right

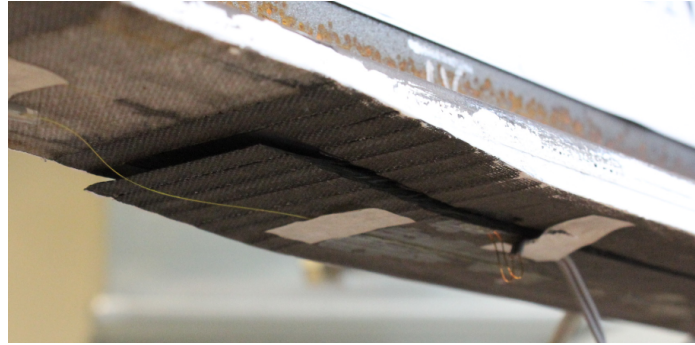
side of the embedded fibers in beam 33 presented above. The strain curve on top of the patch is again affected by the delamination, see Figure 69. The stress is released in the part of the patch that has delaminated, resulting in reduced strain that are detected by the optical fiber on the patch top. For this reason an observable shift in the strain curve is seen at 8000 cycles. 38.7 mm of the width of the patch was delaminating at this point, see Figure 70. The length of the delamination was measured to be 74 mm from the left end at 8000 cycles.

Figure 70: Delamination from left side of the patch. Beam 35, seen from the front.

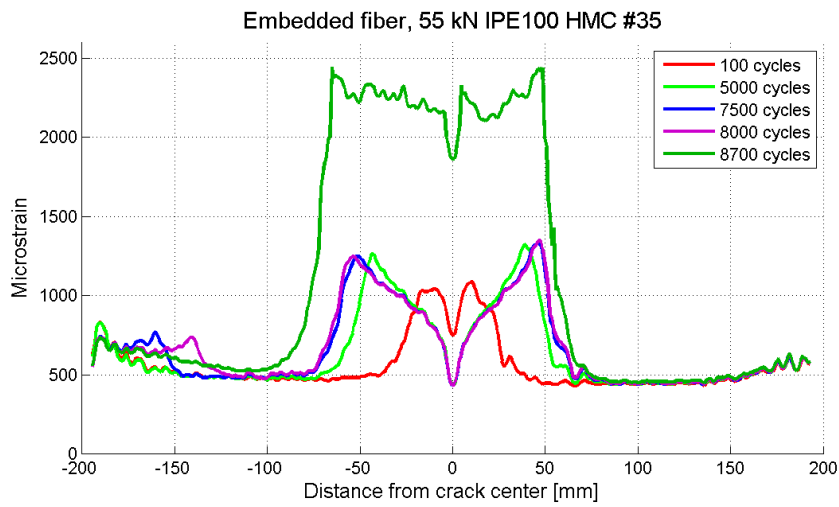
The very high strain increase in the embedded fiber at 8700 cycles is because the strength of the HMC laminate is severely reduced by the delamination. The same forces now have to be distributed to the parts of the laminate that are still intact. This increases the shear stress distributed in the bondline of the remaining laminate on the left side. It is seen as the uniform increase of axial strain from approximately 500 to 600 microstrain in the left side of the adhesive layer, see Figure 72

Figure 72: Embedded optical fiber at different cycles, beam 35.

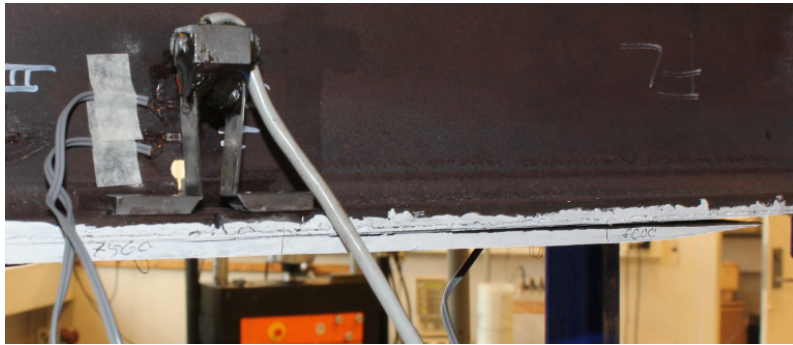
In Figure 72 and 71 the measurements done by the optical fiber at 8700 cycles are included. At this point the length of the delamination has reached the center of the beam and grown some distance across center and into the right side of the patch, see Figure 73. The optical fiber on top of the patch is glued along the delaminated part of the laminate. It is clearly seen in Figure 72 that the strain has decreased significantly from the left and across center at 8700 cycles. Forces are only being transferred to this part of the laminate at the right end which not yet have suffered from delamination. This is the reason for the higher strain curve at the right side of the patch at 8700 cycles.

Figure 73: Delamination from the left side. Beam 35, seen from the back.

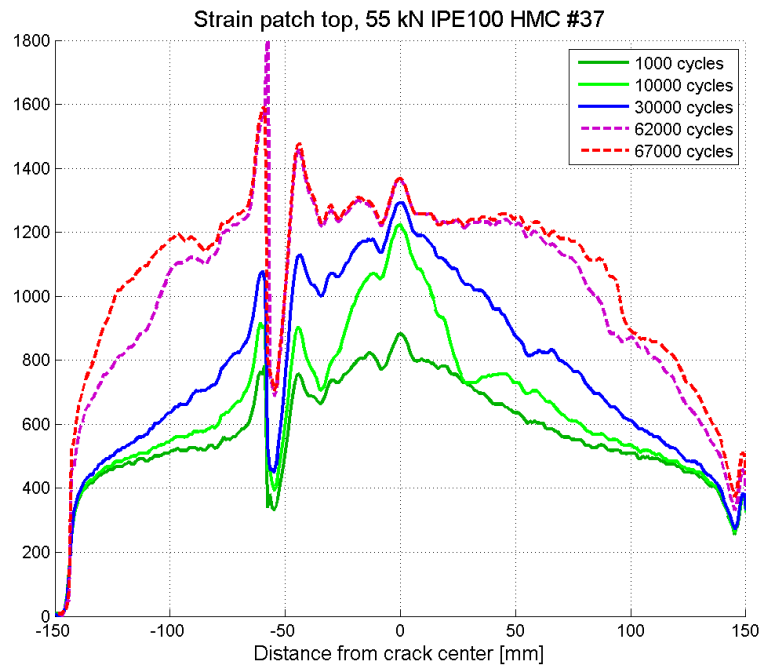
Figure 80: Optical fiber patch top at different cycles, beam 37.

From Figure 79 it can be seen that damage is propagating in the adhesive layer from center and towards both ends of the patch. At 62 000 and 67 000 cycles the damage has propagated a bit longer to the left side than the right side in the patch. This is also documented by visual inspection and the crack lengths from center were measured and are presented in Table 11. Failure occurs at 67 620 cycles in the right side of the patch. Why failure is in the right side and not in the left side is explained below in Section 7.4.

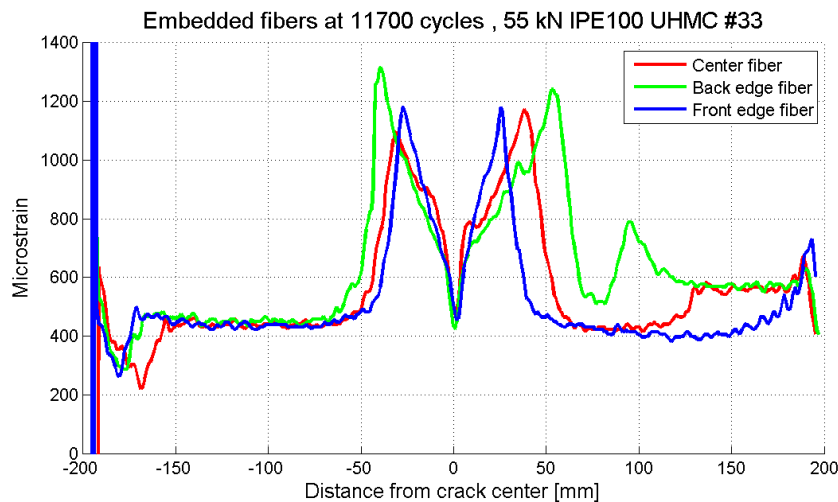
Figure 82: Three embedded optical fibers at 11 700 cycles, beam 33.

At 11700 cycles it is seen that the strain in the back edge fiber indicates a delamination from the right side and a failure propagating from center towards the right side. The front edge fiber does not indicate this delamination. Damage propagation from the left side is seen in all three fibers, but most significant in the center fiber. Figure 83 supports what detected by the optical fibers. The picture is taken from the back, and shows a delamination in the right back side of the patch. The delamination does not occur through the entire width of the patch and this is why it is not detected by the front edge fiber. The damage from the left side could not be observed by visual inspection from either sides of the beam. This supports that the left end damage is propagating from center of the patch.

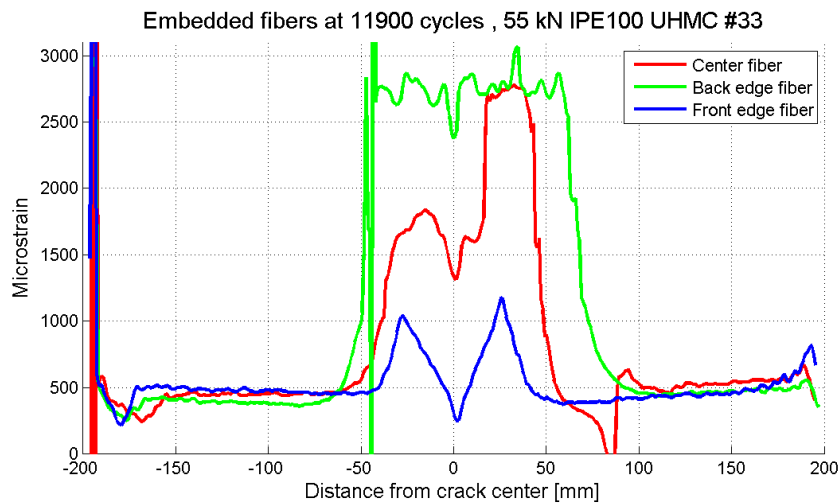
Figure 84: Three embedded optical fibers at 11 900 cycles, beam 33.

At 11 900 cycles the length of the delamination has reached the center of the patch and the strains from the embedded optical fibers are shown in Figure 85. The strain along the front of edge of the patch remains more or less the same, but the strain in the adhesive layer where no damage has propagated has increased from ≈ 400 to ≈ 500 microstrain, see Figure 84.

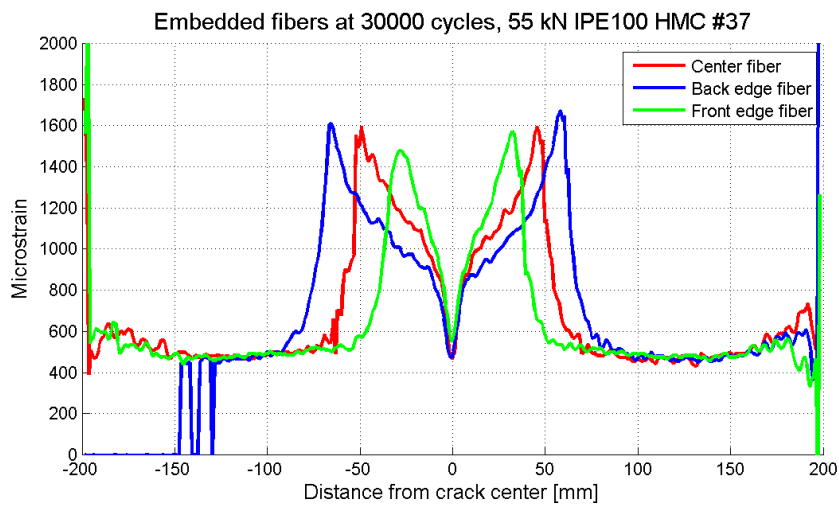
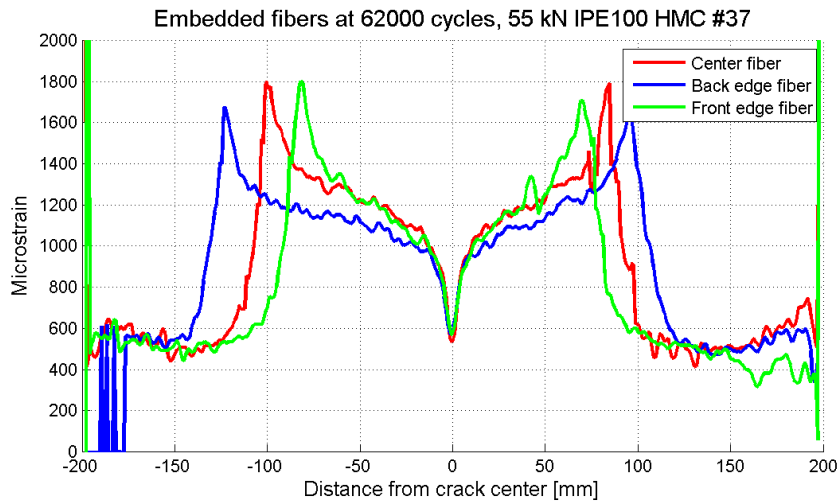
Figure 86: Three embedded optical fibers at 30 000 cycles, beam 37.

Figure 87: Three embedded optical fibers at 62 000 cycles, beam 37.

The reason for beam 37 having failure in the right side of the patch and not in the left side can be found from Figure 86 and 87. It is seen that a damage is propagating from the front edge of the right side, indicated by the decrease and movement of the front edge strain curve. This damage is not detected by the center and back edge fibers. The damage is documented as a crack measuring 21 mm from the right end towards center at 62 000 cycles, and is only detected at the front side of the beam, see Figure 88.

The curves show that the length of the damage propagating from center is longer in the back of the patch than in the front of the patch. This is supported by visual inspection and the measured lengths are presented in Table 11. This combination of damage propagating both from center and the right end leads to failure in the right side of the patch.

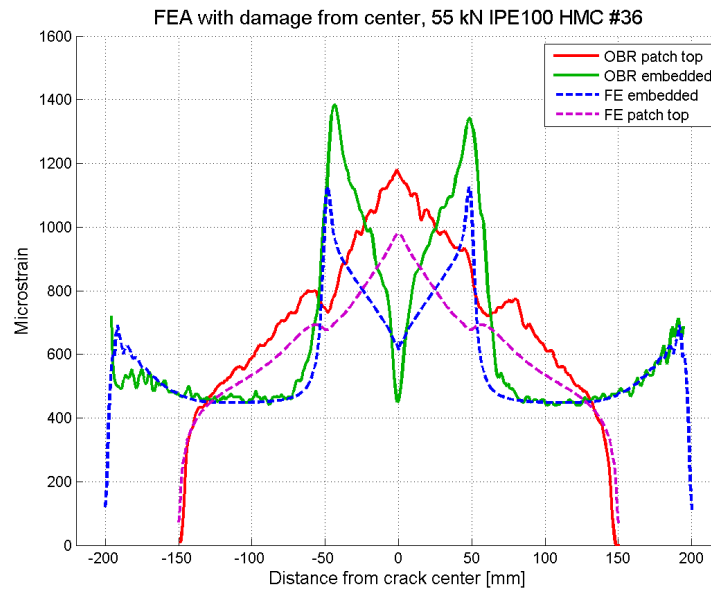
Figure 90: FEA with fictitious damage and IPE100 36 at 5000 cycles.

Figure 90 shows the comparison of the FE analysis and the strain measured by the optical fibers in beam 36 at 5000 cycles. Here the difference between the embedded fibers at the left patch end can be ignored because this damage was not simulated in the FE analysis. The shape of the curves coincide very well between the FE analysis and the measurements with the optical fibers. However, the values of the strain differ quite a bit between the FE-model and the optical fibers. This can be explained by the lack of degradation of the material in the FE-analysis. The test specimen has experienced 5000 cycles and some degradation due to shear stresses has probably occurred in the material. In the FE-analysis there is no friction involved when using hard contact interaction, this will also affect the strain.

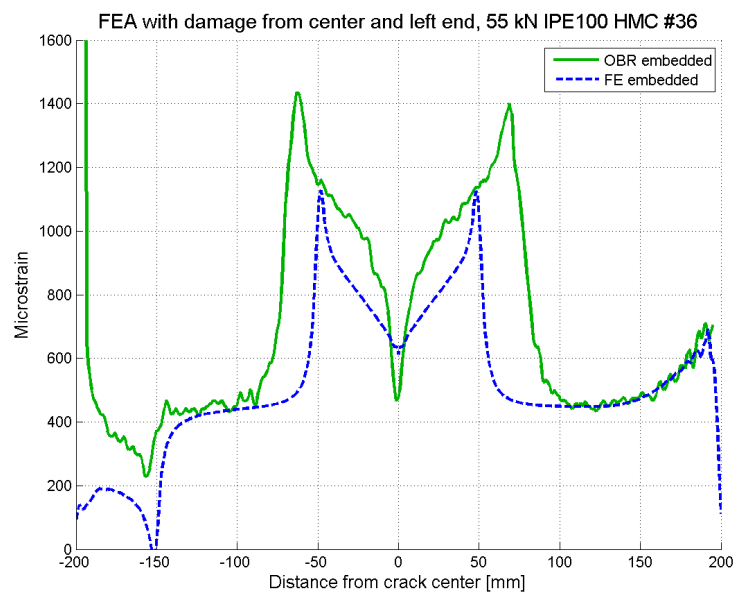
Figure 92: FEA with fictitious damage and IPE100 36 at 14 000 cycles.

In Figure 92 the FE-analysis with fictitious damages from center and end is compared with the embedded optical fiber in beam 36 at 14 000 cycles. The result of the FE-analysis is manipulated together with the result from the previous section in a way that the end damage is only seen in the left side of the patch. This result also shows a comparable shape of the curves when these types of damages are present. The case is

the same as described above with no degradation of the material or friction involved in the FE-analysis. This contributes to no shear degradation in the fe-analysis.

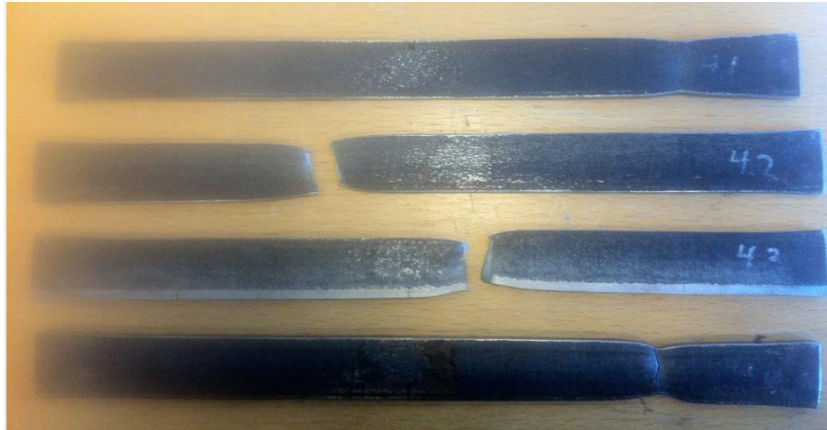
The failure modes of the specimens are shown in Figure 3-1. The necking region was close to the grips for specimen 4.1 and 4.4. For specimen 4.2 and 4.3 the necking region was located closer to the center of the specimen. Only specimen 4.2 and 4.3 had a complete rupture, this can be seen closer in Figure 3-2.

Figure 3-1: Typical failure modes of the specimens.
