## In situ evaluation of a timber structure using a drilling resistance device. Case study: Kjøpmannsgata 27, Trondheim (Norway)

# *In situ* evaluation of a timber structure using a drilling resistance device. Case study: Kjøpmannsgata 27, Trondheim (Norway)

F. Frontini\*

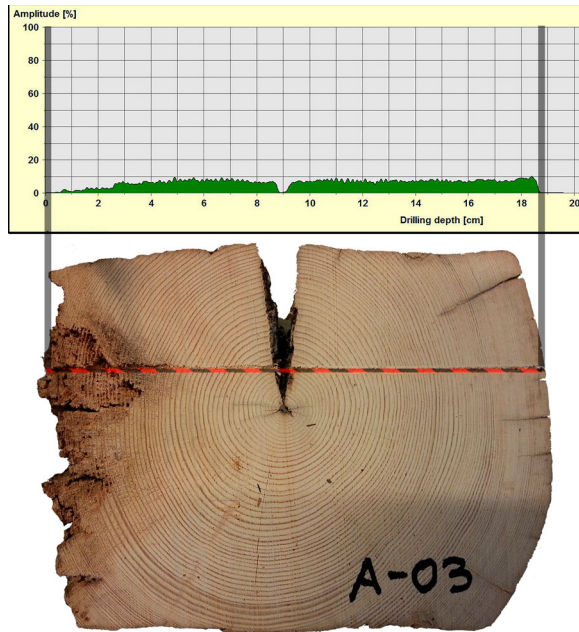
### 5 Analysis of beam cross-section

The device was first calibrated in the laboratory by performing approximately 50 measurements in eight different samples of timber from comparable 18th and 19th-century buildings. The samples used for calibration ranged in moisture content and condition. Prior to testing, each piece was cleaned and inspected to identify superficial defects and cracks. The pieces were then fixed to prevent any movement during testing and the moisture content was measured. The locations for testing were marked and identified with a code and then the drilling resistance measurements were performed. The final step was the analysis of the results which took into account both the average resistance and the amplitude of the oscillations in the data. After testing, the beams were cut to compare the cross-section with the results from the drilling resistance test as shown in Fig. 5.

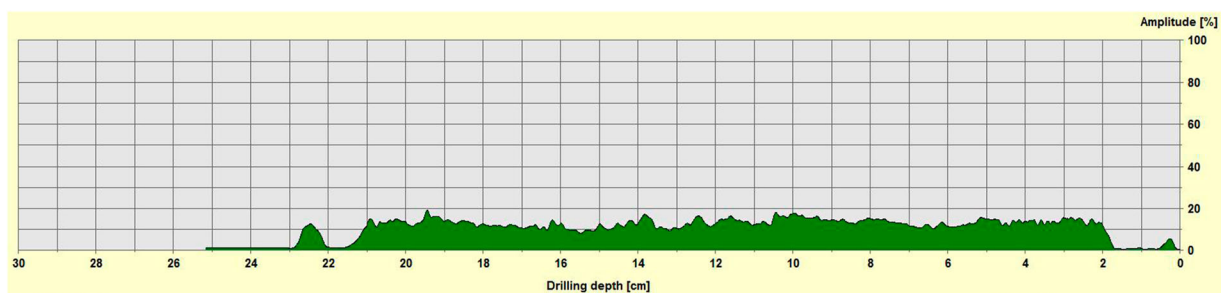
For the present study, every column and foundation beam was identified on a grid (Fig. 6). Because of the differences in cross-section and condition of the timbers, the drilling test was carried out on all of the selected columns and foundation beams, and additional tests were performed on areas of potential decay identified by the impact sounding assessment and the visual inspection.

### 6 Grid used for the identification of the elements. Basement plan

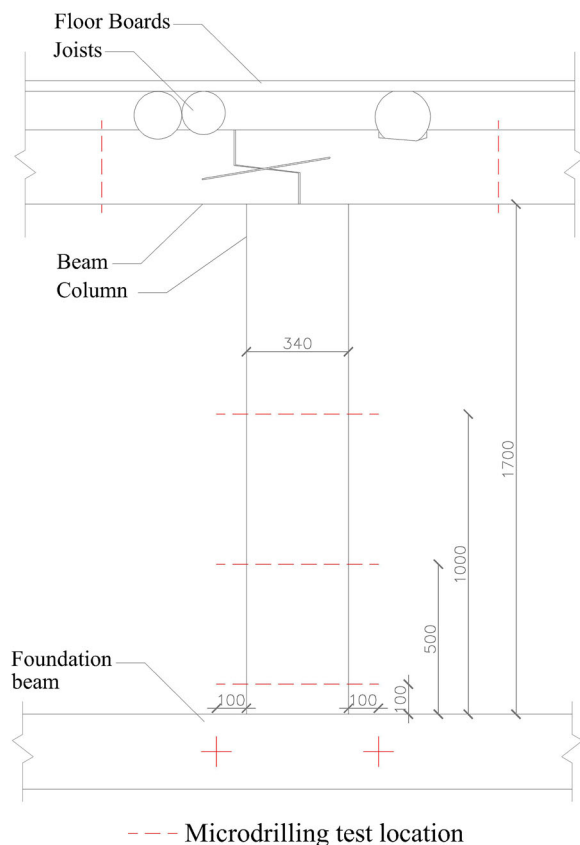
**7 Location of the drilling resistance measurement points**

A minimum of three measurements were taken for each column and foundation beam. The columns were tested at 10, 50 and 100 cm above ground level with further investigations where necessary. The beams were tested close to the joints with the columns and in any additional areas identified during the visual inspection. Figure 7 shows the location of the points where measurements were taken.
