Downhole errors

Master's thesis in MTPETR Supervisor: Pål Skalle June 2019

Norwegian University of Science and Technology Faculty of Engineering Department of Geoscience and Petroleum

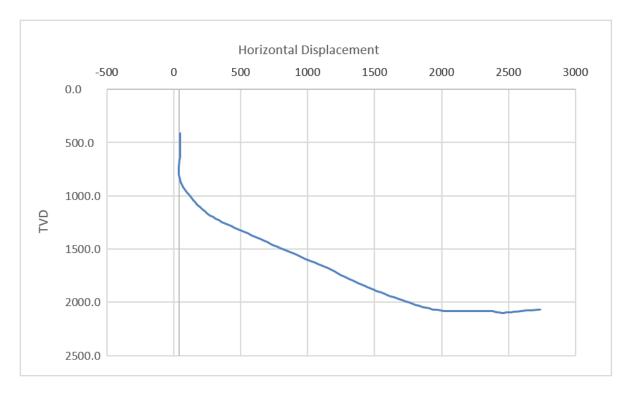
Drawing the figure showing the pathing of the well can be challenging to accurately represent. The pathing in this case changes direction regularly in both inclination and azimuth direction. The most accurate way to present the data is a 3D illustration based on the data from the well. A simple figure in 2D space was first created based on the directional data. As seen in Appendix B the data was presented in a North/South and West/East direction in meters from the origin point of the well. The 2D representation was a combination of these two directions and the vertical depth of the well (Figure 4-9). Additional figures showing the displacement of the well can be seen in Appendix A.

Figure 4-9; The figure shows the horizontal displacement of the well. A merge of the N/S and the E/W diagram with the intent of showing the most representative direction of the well in 2D space.

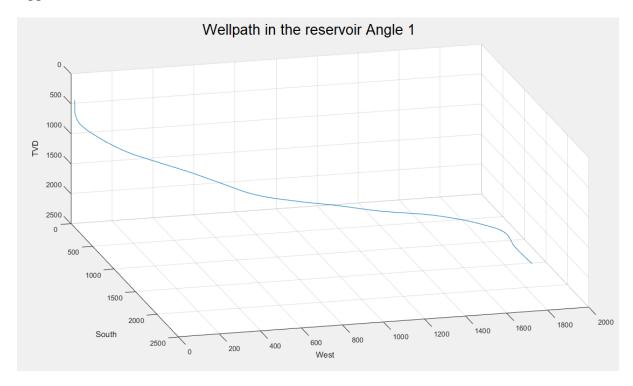
A 3D model is more representative of the pathing of the well. By using a script and importing the data onto MATLAB a rendition of the wellpath in 3D space was created (Figure 4-10). Because of the complexity of showing 3D figures on paper, the 2D renditions can help understand the pathing of the well. Another angel of the 3D wellpath is shown in

Figure 4-10; A 3D model of the wellpath in the reservoir. The camera is angled to give a top-down view from the side of the well. Showing the angle that give the longest possible representation of the well.

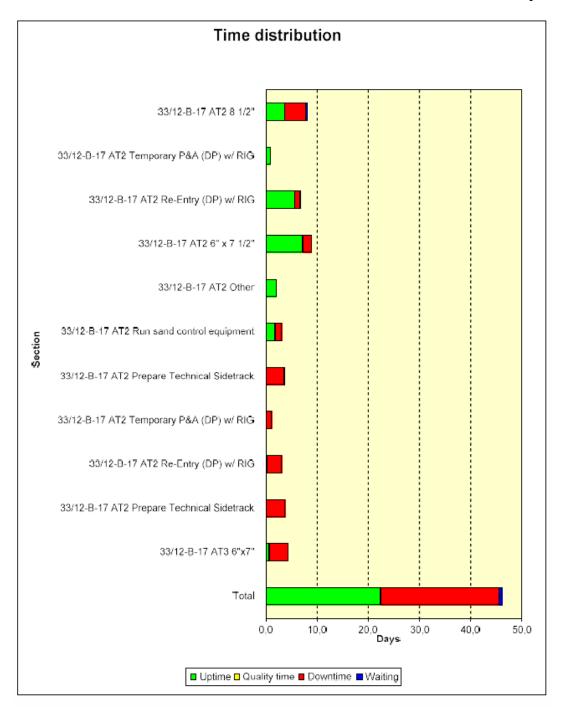
The sidetrack that caused the new section of the well 33/12-B-17 AT3 was a direct result of washout in the well. It was not possible to run production screens to target depth, and it was therefore decided that a sidetrack was the best solution. As we can see in (Figure 4-12), most of the activities following the sidetrack are listed as "Downtime", or in other words NPT. This is not entirely correct. A more fitting term would be unscheduled operations. The operations that followed the sidetrack were not taken into account and are therefore considered lost time. Had the 33/12-B-17 AT2 been a success it is possible the amount of NPT, of unscheduled operations, would be more than halved.

Figure 4-12; Time distribution during the Well 33/12-B-17 operations

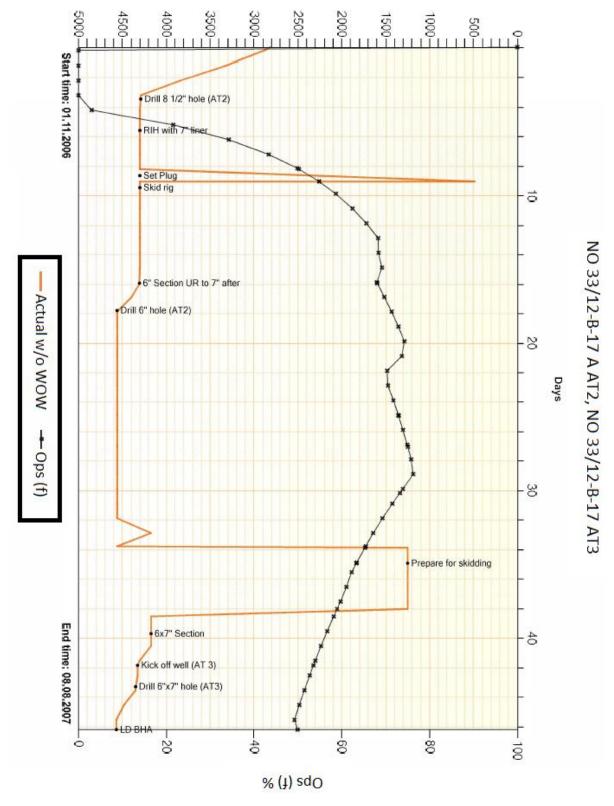
Figure 4-13; Figure representing the time distribution without the effects caused by weather and/or other logistical interruptions.
