Numerical modeling of the pressure signatures from a cracked blade

FORFATTER	Igor Iliev
PROSJEKT I HYDROCEN	WP 2, 5.2.12
DATO	01.10.2023
SAMARBEIDSPARTNERE	SINTEF Energi

Objective

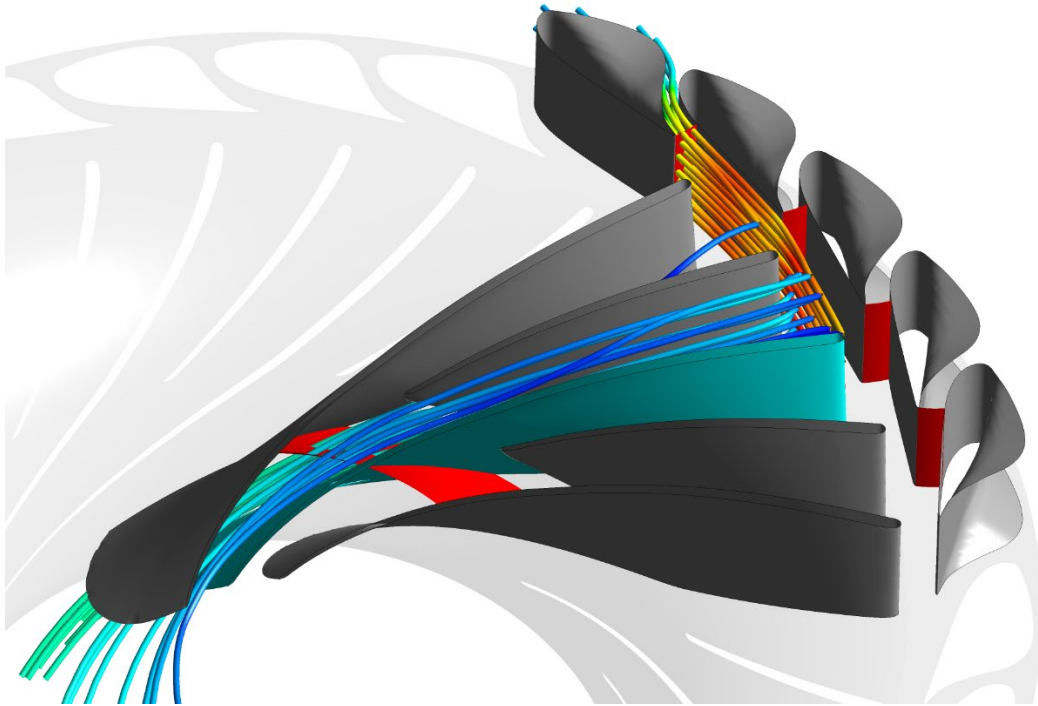
Figure 3. Top figure – the computational domain of the entire turbine, Bottom figure – A view of the open runner from the outlet of the runner showing the damaged blade in cyan color.

Apart from the monitoring points that were used to extract transient data from the locations of the pressure sensors in the distributor and the draft tube, additional control surfaces were used inside every guide vane channel and every runner channel after the splitter blades. In the postprocessing steps, the volumetric discharge through these control surfaces was extracted for every time step and correlated with the circumferential position of the damaged blade. Figure 3 shows the control surfaces in the runner and guide vanes colored in red. For better visualization, only a few of the runner blades and guide vanes are shown.

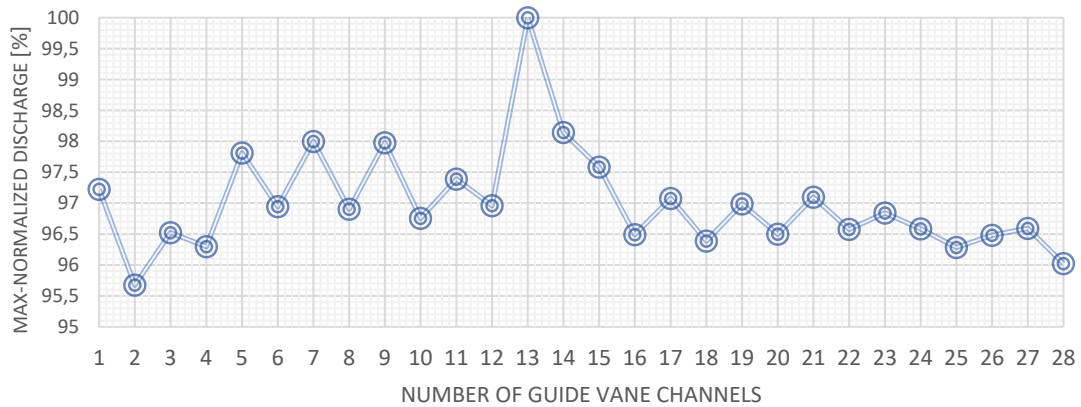
Figure 7. Instantaneous discharge in all guide vane channels, normalized by the maximum discharge found in channel number 13 for the given time step in the simulation. The leading edge of the damaged blade is closely positioned behind the channel 13 in this time step.

2. The damaged blade will introduce a local modification of the slip effects at the outlet, and this will influence the discharge through the blade channels on both sides of the damaged blades. This will result in a local increase of the discharge that can be measured as a pulse of pressure drop in the vaneless space sensors every time the damaged blade passes through the sensors with a frequency equal to the rotational frequency of the runner. The local increase of the discharge will result in a local reduction of the pressure in the stationary guide vane channels due to Bernoulli principle and conservation of energy (hydraulic energy is not transformed into mechanical work in the stationary parts of the turbine). On Figures 7 and 8 given are diagrams with instantaneous discharge through the guide vane and runner channels for a randomly selected time step in the simulation. An increase of about 9% from the mean from all runner channels can be seen for channel number 1, which is bounded by the pressure side of the damaged blade. The discharge through the runner channels is also affected by the RSI pressure field and an ND2 pattern can also be seen on Figure 8. In the guide vanes, the maximum discharge follows the leading-edge position of the runner, which is number 13 for the observed time step on Figure 7.

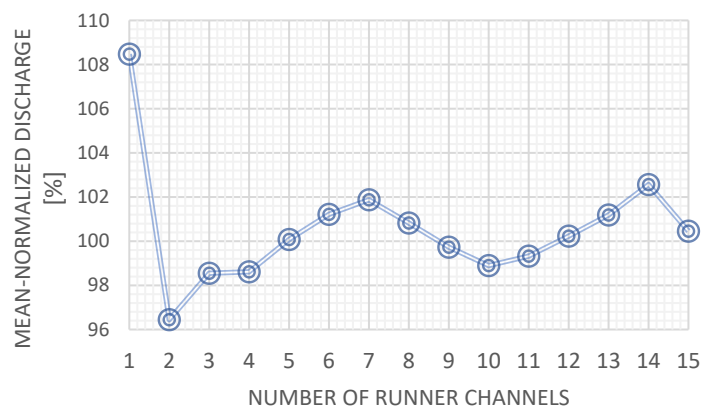
Figure 8. Instantaneous discharge in all runner channels formed by the main blades, normalized by the mean discharge for the given time step in the simulation. The channel that is bounded by the pressure side of the damaged blade is marked with number 1, and the discharge remains the highest amongst all channels for all time steps in the simulation.
