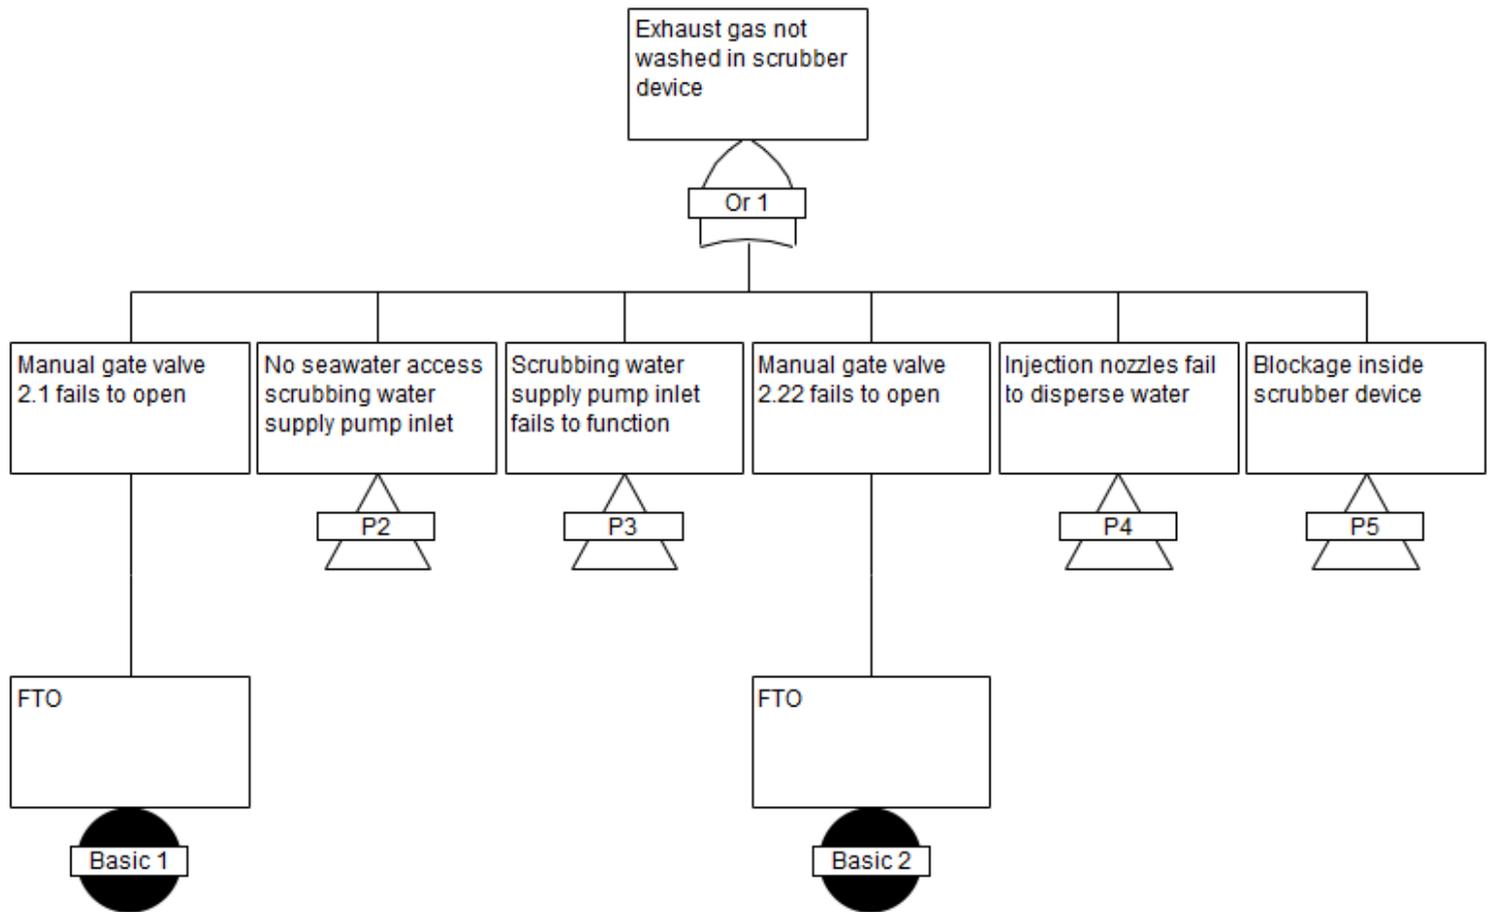
No seawater access  
scrubbing water  
supply pump inlet

Pipeline 2.23  
damaged

Inlet monitor system  
fails to function

Manual gate valve  
1.2 fails to open

Manual gate valve  
1.3 fails to open

Electronics and  
sensing element in  
inlet monitor 1.1 fails  
to function
