Revealing the Cause behind Cement Failures by Means of the Knowledge Model of Oil Well Drilling

Petroleum Geoscience and Engineering

Submission date: February 2015

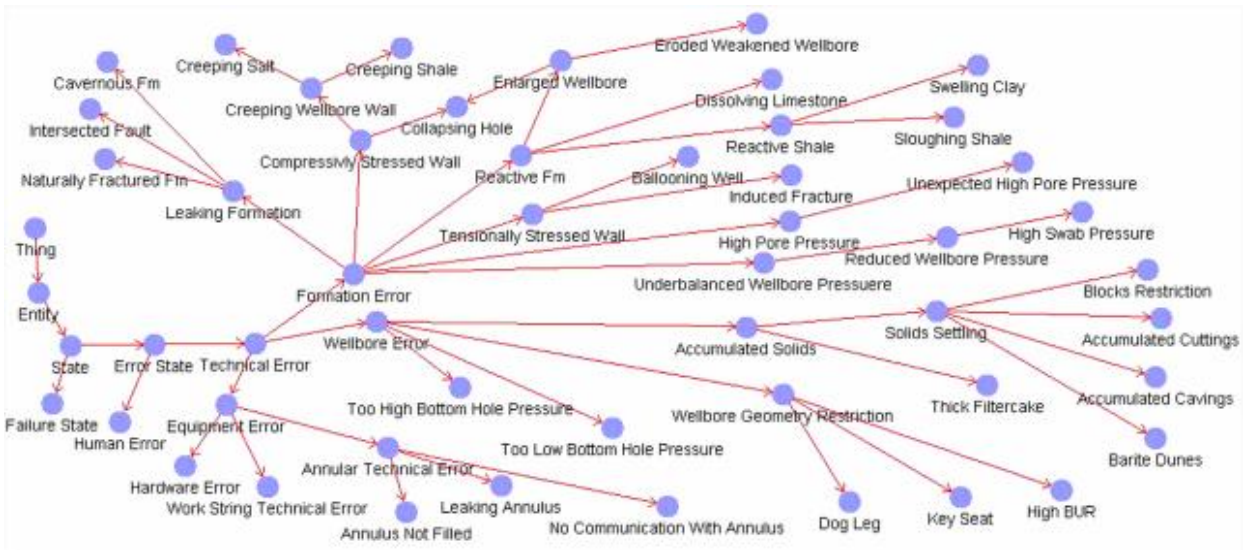
Fig. 2.3: Subclasses of technical errors in the drilling process (Skalle 2012).

Before a failure occurs the drilling process enters into an error state. Fig. 2.3 demonstrates a subclassification of technical errors in the drilling process. An error occurs when a parameter, a process or an object exhibit a deviatory performance. The deviation may rectify itself or it may be persistent, so that it leads to a failure in the long run.

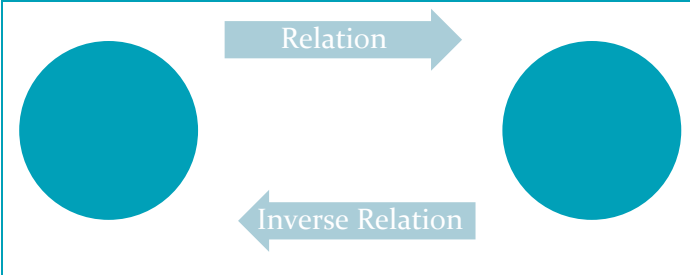
Table 2: Relations and strength between entities. Inverse Relation have the same strength as Relation (Abdollahi 2007).

Relations	Subclass	Strength
Structural	has subclass	1.0
	has synonym	1.0
Causal	causes always	1.0
	causes	0.9
	leads to	0.8
	implies	0.7
	causes sometimes	0.6
	enables	0.5
	reduces effort of	0.5
	involves	0.5
	Indicates	0.4
	causes occasionally	0.3

The symbolic concepts will be related through different relationships. The relations are created depending on the strength between the concepts and its subclass. The strength of the relationship represents the certainty/uncertainty of the relation between two symbolic concepts. It is possible for all relations to be inverted, i.e. “A causes B” can also be expressed as “B is caused by A” (Abdollahi 2007). Table 1 gives an overview of the relations and their numerical value.

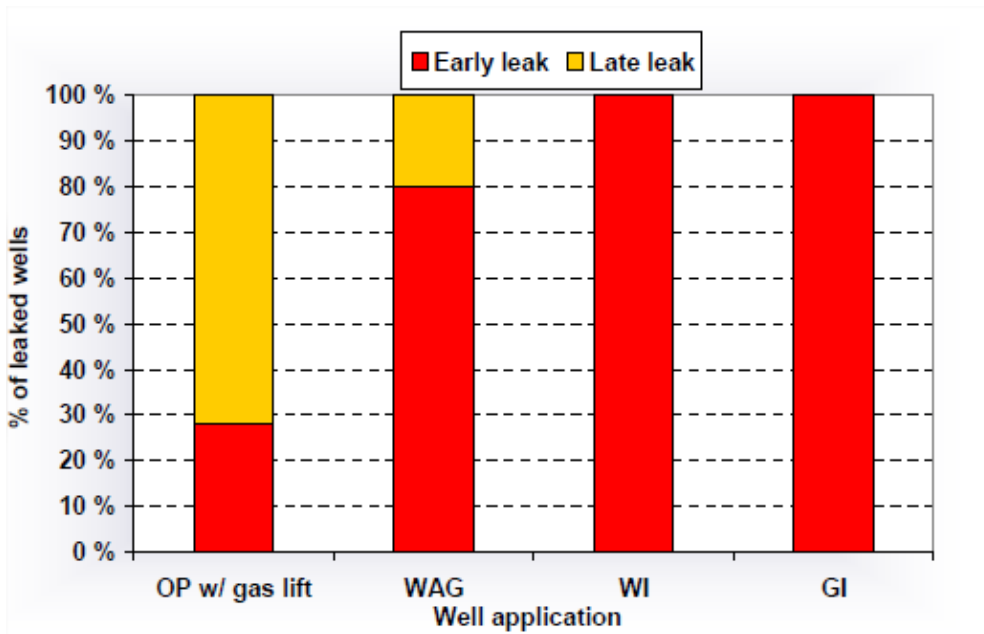
Fig. 3.6: Early and late leaks for different well applications for three NCS fields (Abdollahi 2008).

A study of 18 cases on the Norwegian Continental Shelf (NCS) (Abdollahi et al. 2008) showed that most of the injection wells studied were reported leaking in the early phase of operation. Most of the production wells using gas lift systems were reported leaking in the later phases of the operation. Injector wells were exposed to large temperature and pressure changes in the beginning of the operation, leading to extra loads on the strings and connections which resulted in leakages. The injection wells did most likely suffer from thermal and pressure loads in the beginning of the operation phase, which resulted in weakening of the cement and thereby the leaks.

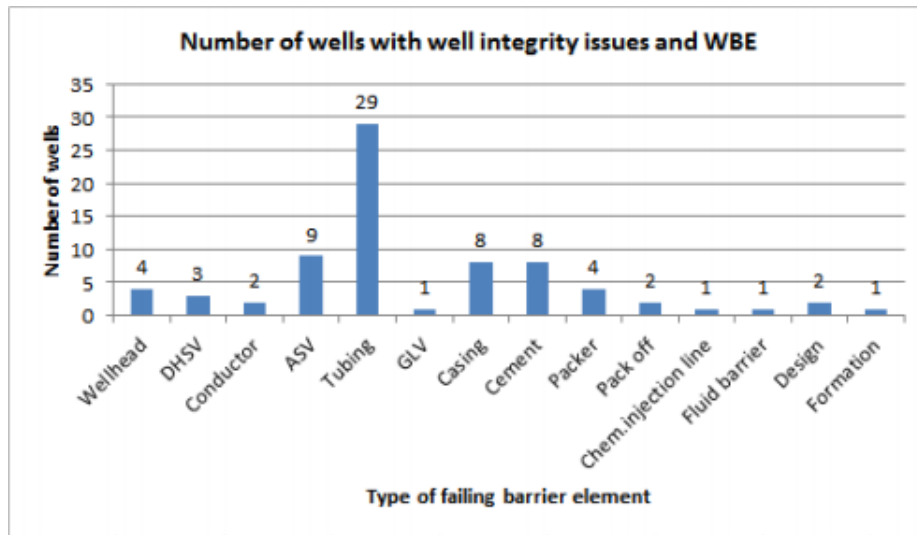
Fig. 3.7: Illustration of in which well barrier element (WBE) the wells with integrity issues experience problems on the NCF (Vignes, 2011).

A cement job of high quality will decrease the chance of late leaks and increase the chance of reusing old casing strings in slot recovery operations. Fig. 3.7 indicates that cement failures is one of the greatest challenges regarding well integrity on the NCS (Vignes 2011). 11% of the total number of wells with issues in a survey based on well integrity information from seven operating companies, 12 offshore facilities and 406 wells had problems with the cement barrier at one point of the wells life cycle.

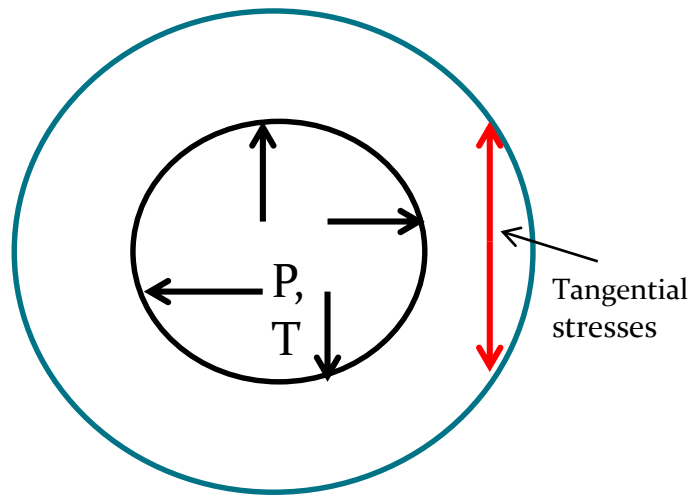
Fig. 3.12: Stresses on the cement when the casing is expanding (Goodwin and Crook 1992).

Long-term effects in the cement integrity occur due to the change in temperature and down-hole pressure during production of a well. The factors act as stress generators within the cement. If the set cement is exposed to more stress than it is designed to manage, the results could be fissures in the cement, debonding of cement from the formation or creation of a microannuli between the casing and the cement. Studies carried out by Goodwin and Crook in 1992 showed that when the cement was exposed to an increase in stress by casing expansion, the result was that the cement failed in the lower parts of the string. When the temperature difference was even more significant in the upper parts of the well, where tensile cracks were formed. An increase in the temperature leads to expansion of the casing outwards, and this expansion was proved to generate tensile stresses in the cement. The effect on the casing caused by temperature alternation is demonstrated in Fig. 3.12.

Casing contraction occurs when the pressure in the wellbore decrease. This will cause the casing to pull away from the cement, and that may cause debonding between the casing and the cement. If this debonding happens, there will be created a microannuli which makes way for fluids to migrate up the borehole on the outside of the casing, and thus cause an annular leak.

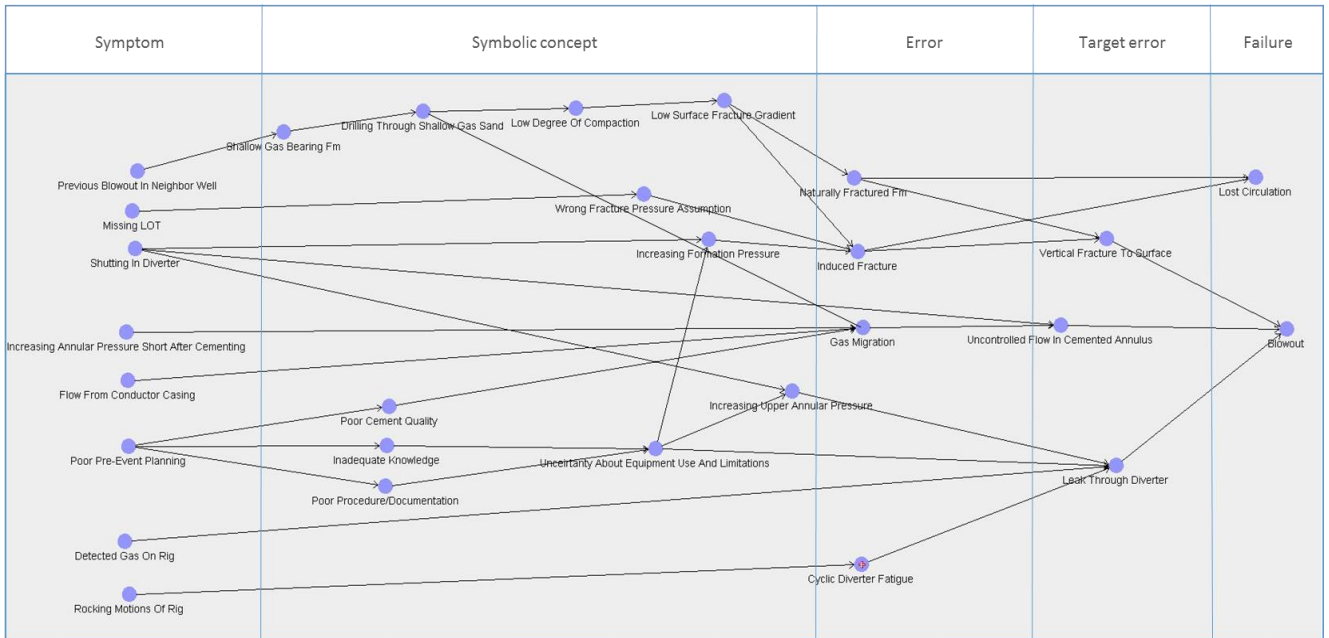
Fig. 5.1: The path of all observations and derived symptoms (left) from Case 1, leading to relevant error concepts and target errors. All observations are leading to the failures Blowout and Lost Circulation (right).

Fig. 5.1 exemplifies a structural hierarchy of the observations/symptoms from Case 1, and how they lead to the relevant errors, target errors and failures. We see that Blowout and Lost Circulation is identified as the most probable failures of the incident. Vertical Fracture To Surface, Uncontrolled Flow In Cemented Annulus and Leak Through Diverter is identified as target errors, while Naturally Fractured Formation, Induced Fracture, Gas Migration and Cyclic Diverter Fatigue is identified as errors leading directly or indirectly to the failures. The figures below just gives an impression of which failures and failure causes are the most probable. Calculations presented in Chapter 5.4 and 6 will reveal the definitive probability percent.

When experiencing leaks through the cement sheath while drilling in shallow depths, Blowout and Lost Circulation are logically resulting failures. The observations will be expected to mainly point towards these two failures.

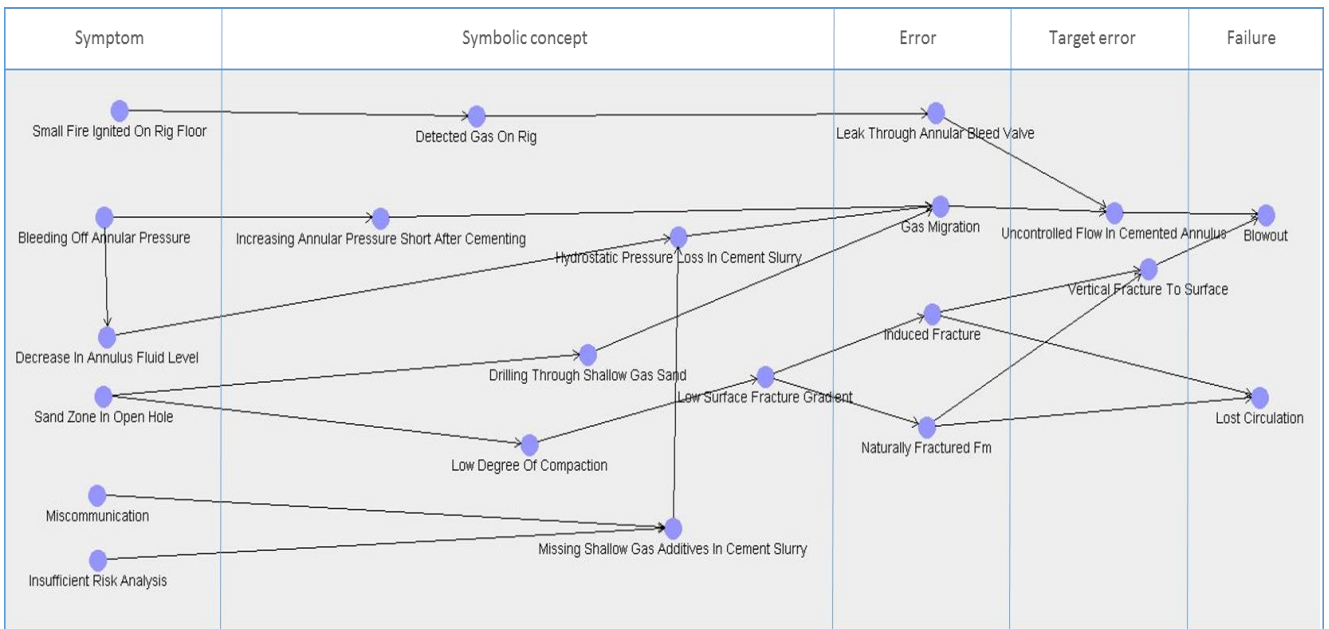
Fig. 5.2: The path of all observations and derived symptoms (left) from Case 2, leading to the failures Blowout and Lost Circulation (right).
