Keywords: Offshore jacket wind turbine Ship collision Finite element analysis; USFOS	Advisor: Professor Jørgen Amdahl

NTNU
Norwegian University of Science and Technology
Department of Marine Technology

Master Thesis

High energy ship collisions with bottom supported offshore wind turbines

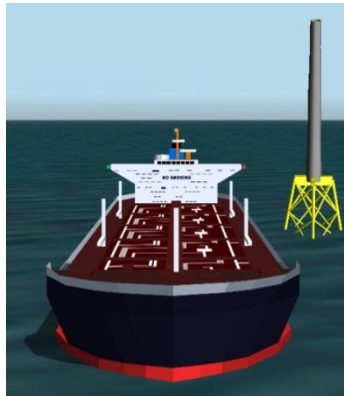
Figure 1: Illustrating picture of ship-wind turbine impact

However, offshore wind farms also involve new challenges. Collision between a large oil tanker and a jacket supported offshore wind turbine is of concern. Faulty manoeuvring or machinery blackout might lead to consequences of economic loss, environmental pollution and human lives. Figure 1 illustrates this impact scenario. The wind turbine represents the model used in this research, while the 160 000 dwt tanker "Cap Diamant" with a beam of 53 m and approximately 15 m draught is illustrating the ship (www.MarineTraffic.com, 2011, www.jpfil.com).

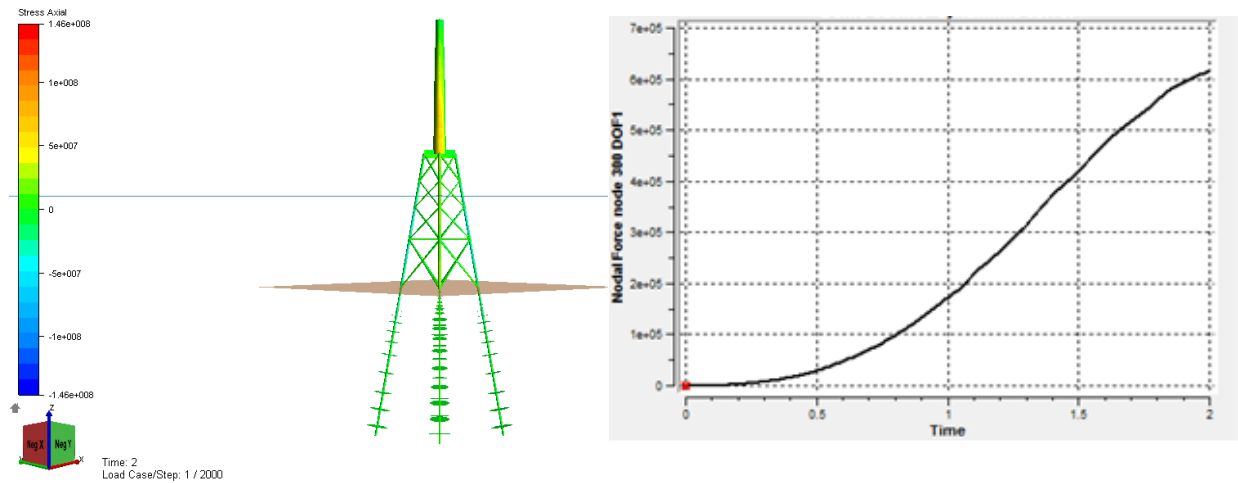
In the dynamic analyses, both horizontal directions is allowed to be free. However, this requires that the functional loads, including the thrust force, are applied dynamically due to the static restriction. Thereby, the axial forces in the elements are not fully developed before the impact begins. The functional loads are applied during the first second, while the impact begins after two seconds. The effect of applying the functional loads dynamically is observed to have small effect on the results, see the axial stress in the installation and the force in top of the tower in Figure 28.

Figure 28: Axial stress at 2 s and force in top of tower when applying functional loads dynamically

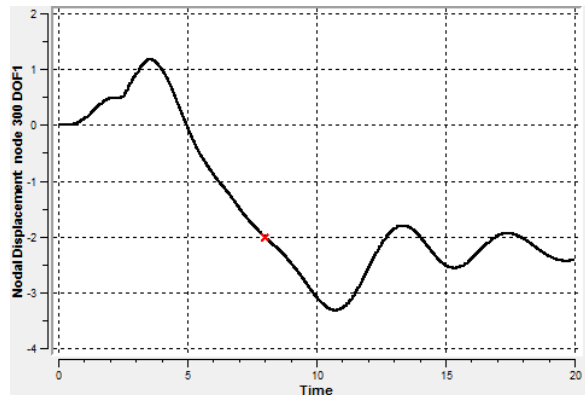
the tower is given in Figure 59. As seen, equilibrium is reached with the tower oscillating around 2.25 m in the negative x- and y-direction. The global energy is given in Figure 60. As seen, the equilibrium is reached at an earlier stage compared to the original case study.

Figure 59: Displacement in top of tower for ballast ship joint impact fixed at seabed

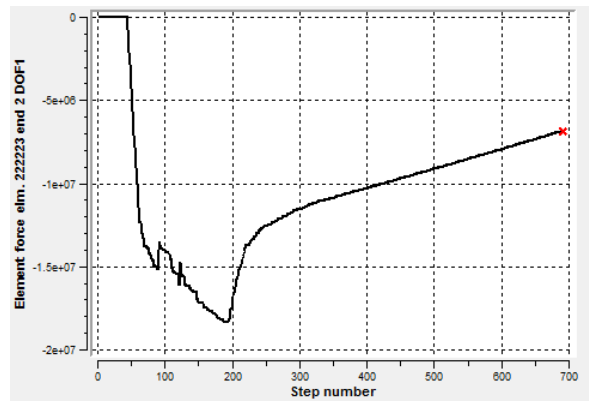
Static spring force for ballast ship joint impact

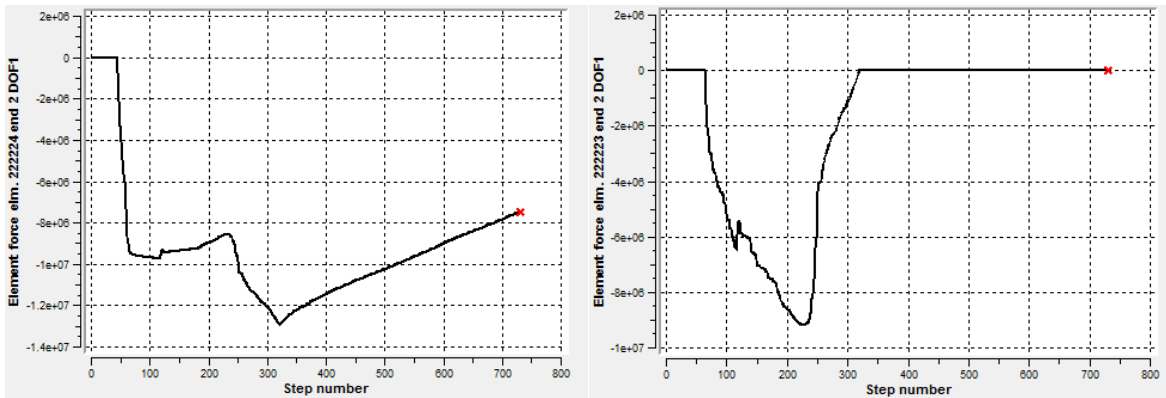
Static spring force for ballast ship joint impact
