# Human related root causes behind oil well drilling accidents

**Marthe Pernille Voltersvik  
Hernæs**

Earth Sciences and Petroleum Engineering

Department of Petroleum Engineering and Applied Geophysics

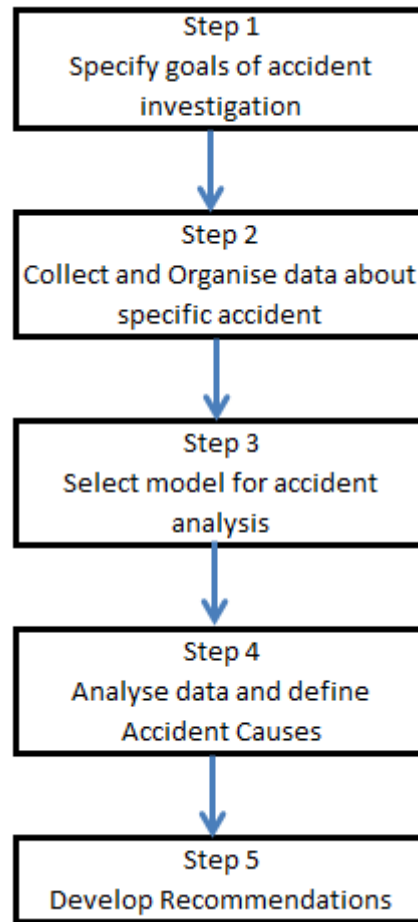
In order to achieve the purpose of accident investigation, a set of procedures need to be implemented. Figure 1 shows Cacciabue's (2004) guideline to accident investigation. This process has been simplified according to the scope of the present thesis. Originally there were 7 steps, but two steps have been eliminated [select models of organisation and Human Machine Interaction (HMI) and evaluate organisation by ethnographic studies and Cognitive Task Analysis (CTA)]. This is because they are considered too complex compared to the goals of the present thesis. The goal of finding the root cause does not require multiple models or an ethnographic study into the specific culture.

**Figure 1 - Stepwise procedure for accident investigation (redrawn from Cacciabue 2004)**

To initiate the analysis, all information available related to the accident must be made available. Now steps 1-3 of the stepwise procedure for accident investigation is completed (Figure 1, Chapter 2.1) and step 4: Analyse data and define accident causes, can be initiated.

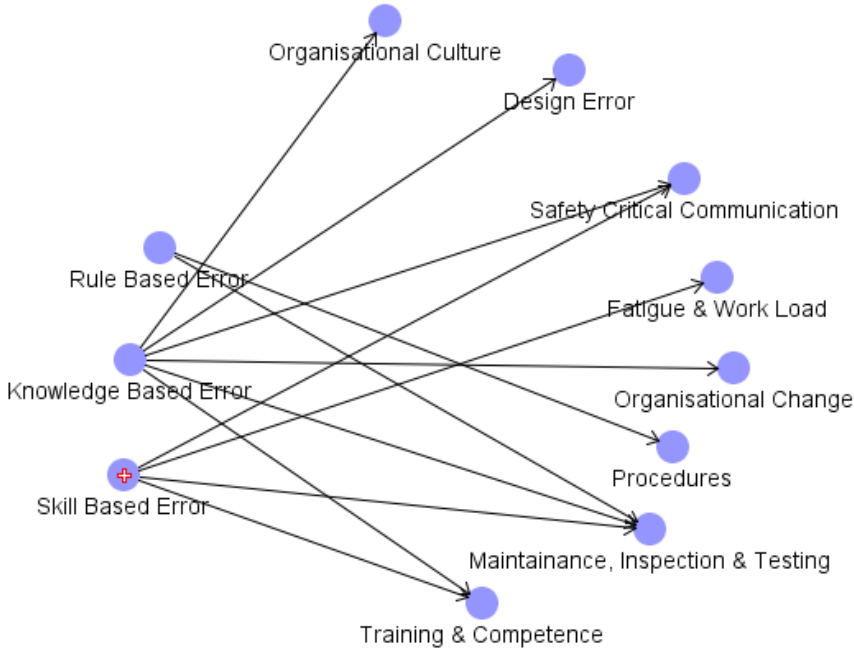
Humans show three types of behaviour when executing tasks, skill based, rule based and knowledge based (Human factors briefing note no. 12 2012). The three types of behaviour refer to the level of consciousness we contribute to the task at hand. Skill based error refers to slips and lapses while executing routine and simple tasks errors (Reason 1990). Rule based error refers to mistakes made in execution as a result of forgetting a step in an operation or applying the wrong rule to the given situation. Knowledge based errors are mistakes made as a result of inaccurate conclusions or incomplete analysis based on the information available. Each HF can be related to one or more of these error behaviour types as shown in Figure 6.

**Figure 6 – Relation between behavioural error and HF (free after Skalle 2012)**

The eight HFs shown in Figure 6 are from Skalle (2012), but as this model is bottom-up modelling and open to adaptation, one new HF has been introduced to the model, management and supervision. Safety critical communication, fatigue and workload and maintenance, inspection and training have been re-defined. The explanations can be seen below. Now there are nine HFs, they are briefly described below and their corresponding

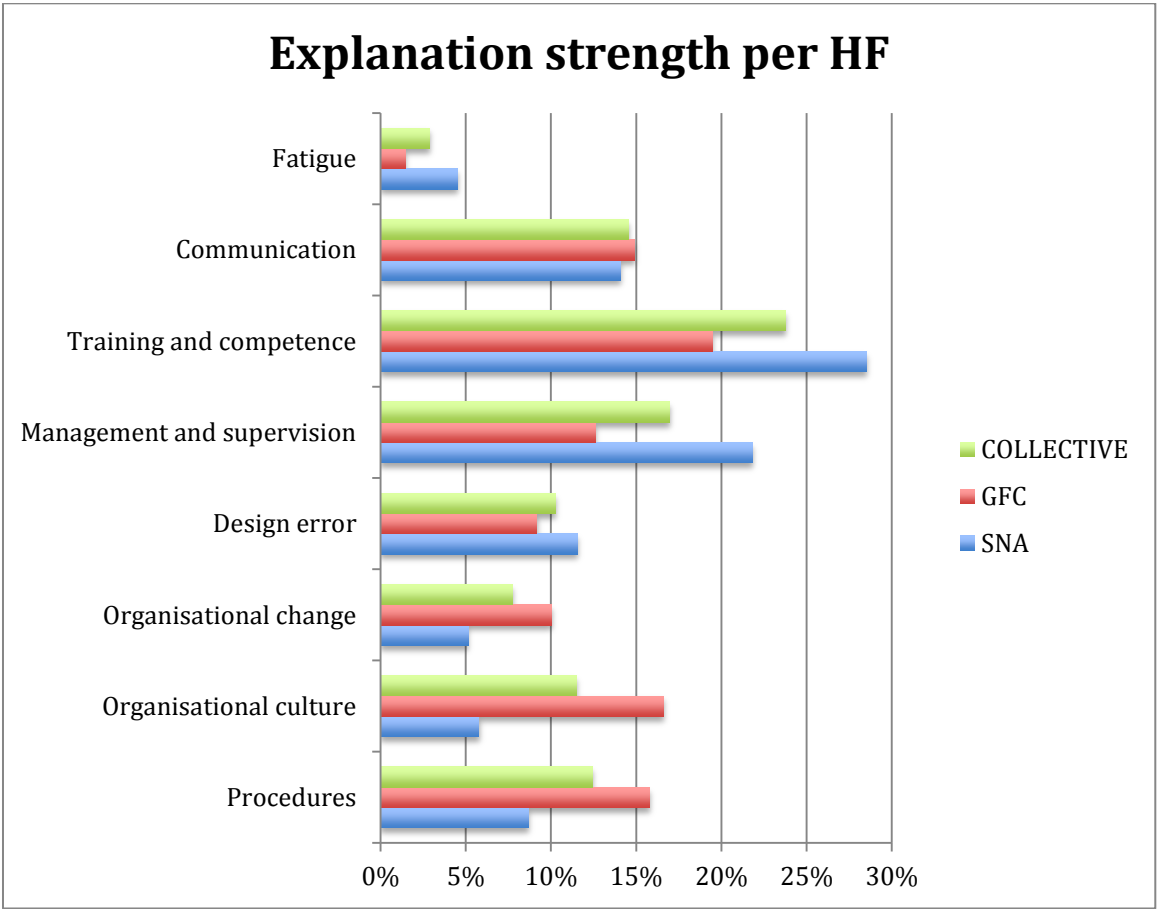
The results in Figure 8 show that training and competence is the HF with the highest explanation strength, but it is not significantly higher compared to the other seven. In order to see whether it is possible to make a conclusion as to the human related root cause of these accidents (reference goal no. 1), breaking down the HF into their subclasses and looking at the explanation strengths of the subclasses separately may allow for more conclusive results.

Figure 8 - Explanation strength per HF

The graphical representation of the results based on the information in Table 10 are shown in Figure 8, presenting the explanation strengths for SNA and GFC separately as well as the

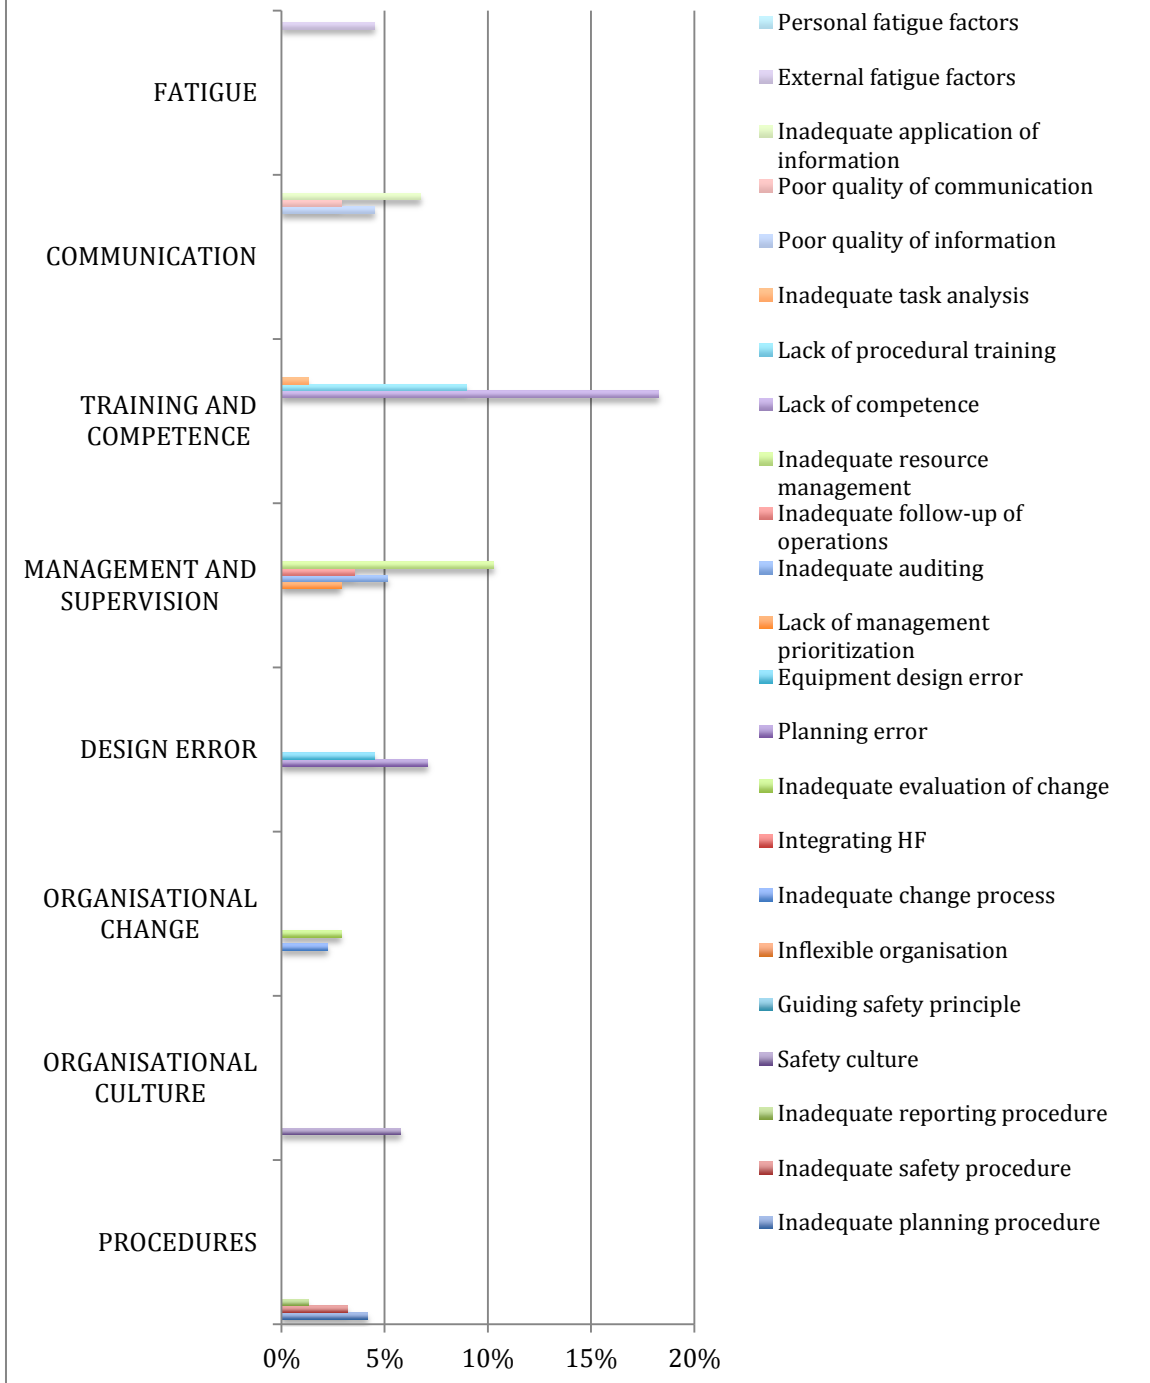
Figure 9, Figure 10 and Figure 11 on the following pages show the explanation strengths of each subclass. By breaking down the HF into their subclasses, lack of competence represents a majority of the observations made, with the highest explanation strength.

Figure 9 - Explanation Strength subclasses of HF – SNA

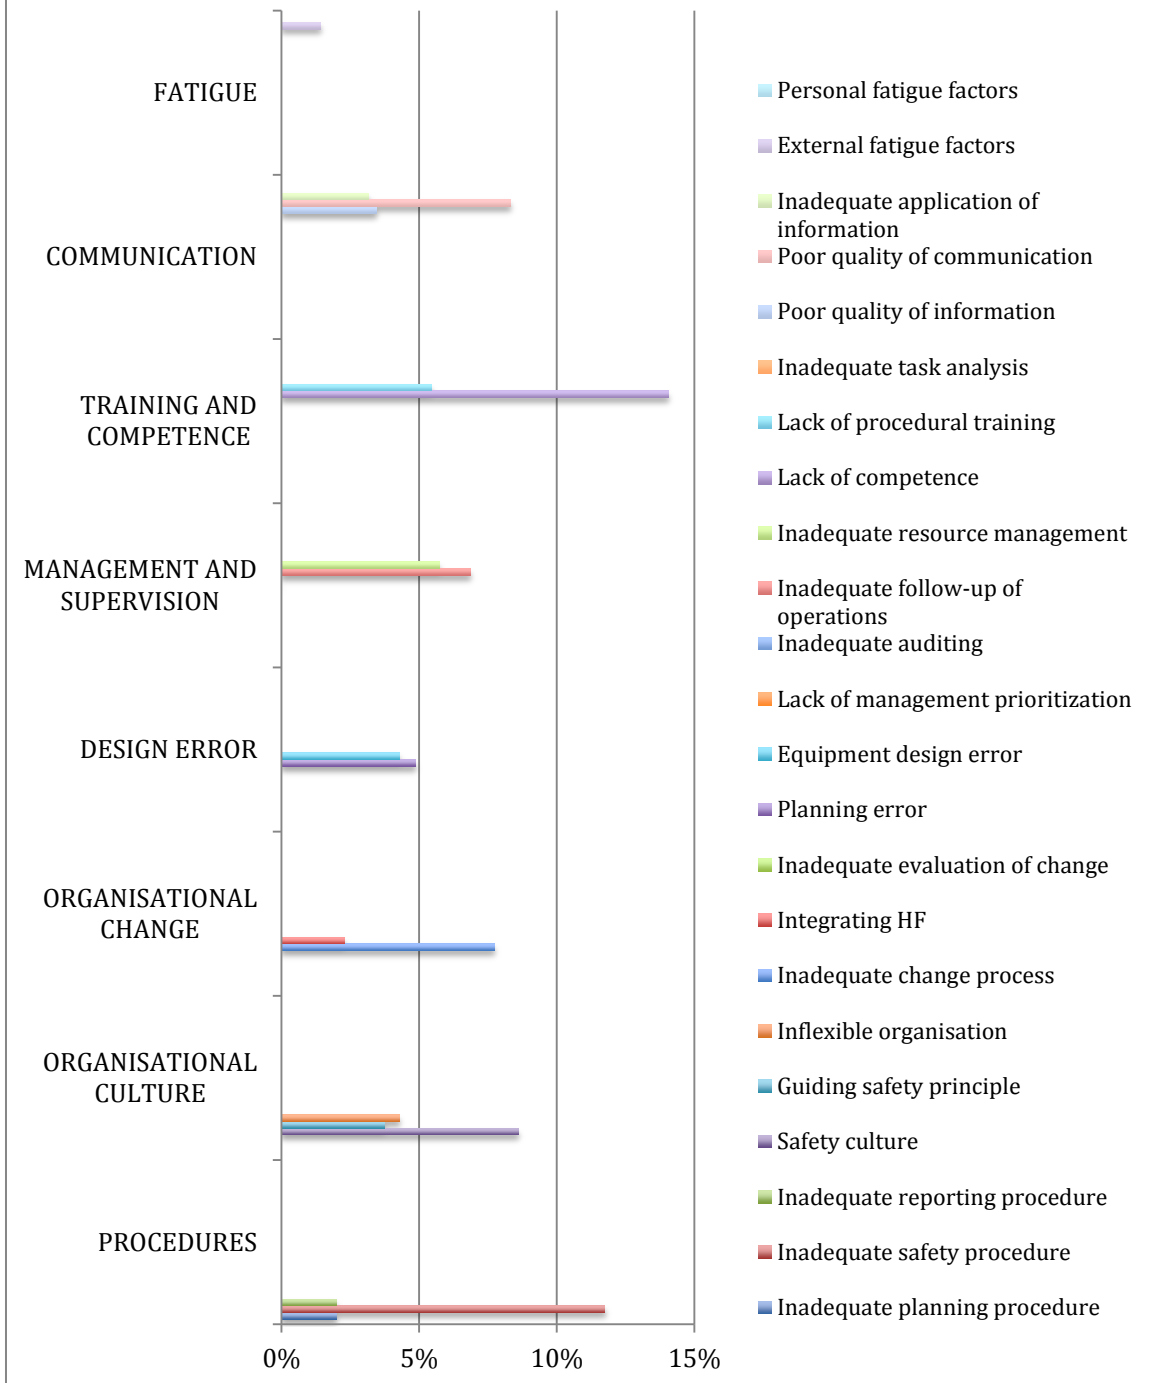
Figure 10 - Explanation Strength subclasses of HF – GFC
