# Repair Coatings for Thermally Sprayed Aluminium

Materials Science and Engineering

Submission date: June 2016

**Repair coatings for thermally sprayed aluminium**

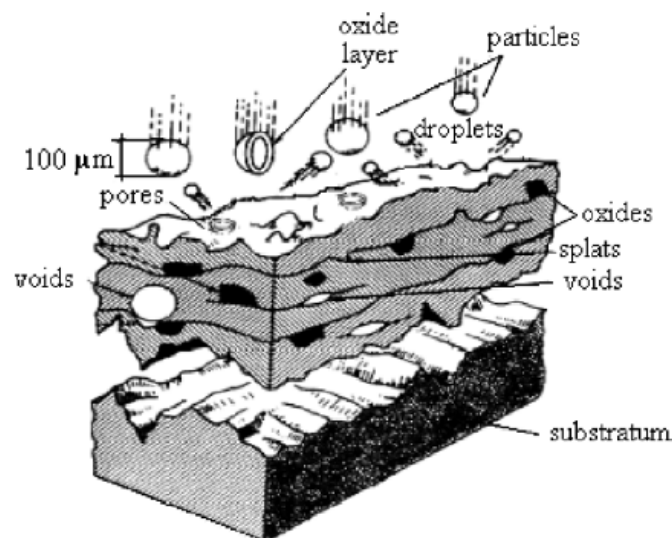
TSA has a lamellar structure with layers of overlapping particles. The lamellar microstructure is shown in Figure 2.1. Combustion of gases or an electric arc of plasma melts or heats the coating material. A carrier gas (compressed air) accelerates the particles towards the substrate surface. The adhesion of the particles is established parallel to the surface by interlocking of the particles with asperities located on the roughened surface. The lamellar structure is established by further deposition of new particles, which leads to an coating layer [6].

Figure 2.1: Sketch of the lamellar coating layers formed by a thermal spray process [6].

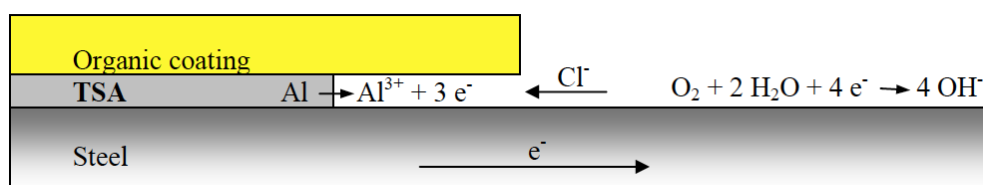
- I. The corrosion rate is initially equal inside and outside of the crevice, and the anodic (1) and cathodic reaction (2) occurs on the entire metal surface. Figure 2.2 shows the duplex coating system with the electrochemical reactions occurring at the metal surface and inside the crevice [1].

Figure 2.2: Duplex coating system with the crevice corrosion mechanism occurring under the organic coating [1].

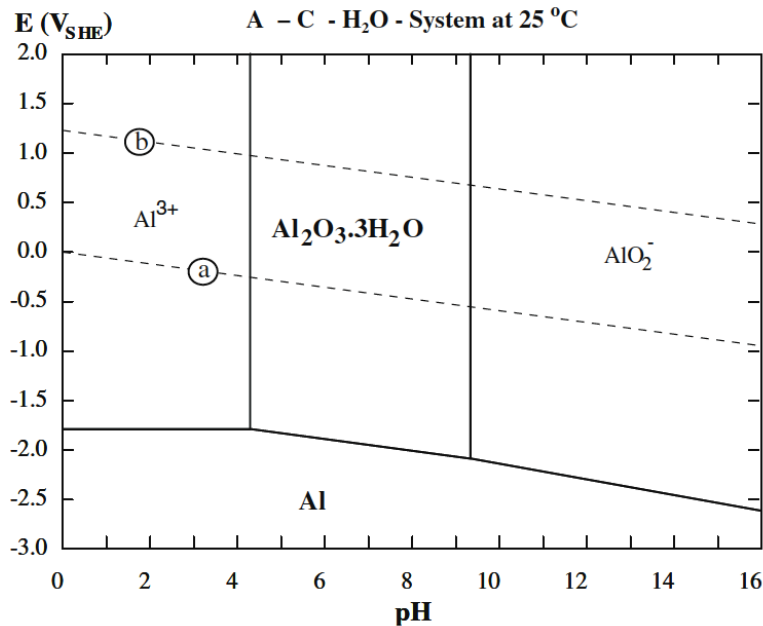
Figure 2.3 presents the Pourbaix diagram for pure aluminium. The diagram presents the area for immunity (Al), active corrosion (Al<sup>3+</sup> and AlO<sub>2</sub><sup>-</sup>) and passivation of the metal (Al<sub>2</sub>O<sub>3</sub> · 3H<sub>2</sub>O) relative to pH and potential vs. standard hydrogen electrode (SHE). Between the dashed lines (a) and (b) water stability is present. Water is reduced to hydrogen below (a) and oxidized to form oxygen gas above (b) [19]. The diagram shows that the protective oxide is stable between approximately pH 4.5 and 9.5 [20]. Note that the diagram uses SHE as reference electrode, not silver/silver chloride (Ag/AgCl) electrode that is applicable for the experiments performed during this project. The potentials are therefore converted to potentials vs. Ag/AgCl, and not SHE as for Figure 2.3. The artificial seawater used for the laboratory work has a pH of approximately 8.2 before exposure. The boundary line between the immune and passive area for aluminium, at pH 8.2, is approximately -2200 mV vs. Ag/AgCl. The corresponding value at pH 4 is approximately -2000 mV vs. Ag/AgCl. The thermodynamic reduction potential for iron at 10<sup>-5</sup> is approximately -787 mV [21]. This potential corresponds to the passive region at pH 8.2 and the active region at pH 4.

Figure 2.3: Pourbaix diagram of pure Al (Cl-H<sub>2</sub>O systems at 25°C) when 0.67 activity of Cl<sup>-</sup> is present, equivalent to 1 M NaCl [20].

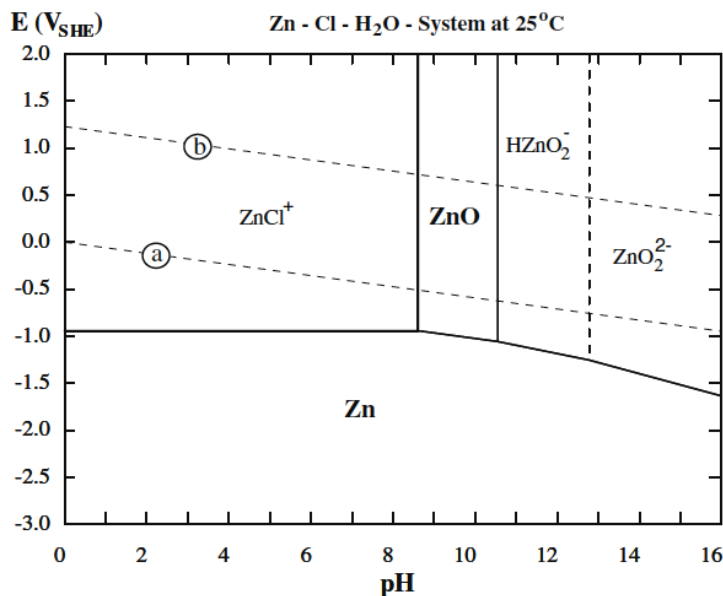
Figure 2.4 presents the Pourbaix diagram for pure zinc. The diagram shows the area for immunity (Zn), active corrosion (ZnCl<sup>+</sup> and HZnO<sub>2</sub><sup>-</sup>/ZnO<sub>2</sub><sup>2-</sup>) and passivation of the metal (ZnO) relative to pH and potential vs. SHE. The diagram shows that zinc oxide (ZnO) is stable between approximately pH 8.5 and 10.5. The passive pH range is higher and more narrow compared to aluminium, see Figure 2.3.

However, the passive area for ZnO is located at alkaline pH values. The boundary line between the active and passive region at pH 8.2, is approximately -1120 mV vs. Ag/AgCl. Note that the potentials are converted to potentials vs. Ag/AgCl, and not SHE as for Figure 2.4. The conversion is done because an Ag/AgCl reference electrode was used during the experiments.

Figure 2.4: Pourbaix diagram of pure Zn (Cl-H<sub>2</sub>O systems at 25°C) when 0.67 activity of Cl<sup>-</sup> is present, equivalent to 1 M NaCl [20].

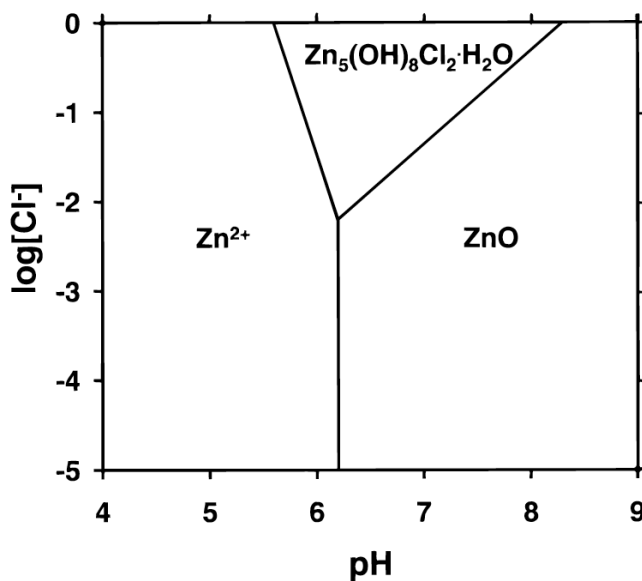
Corrosion products such as simonkolleite ( $\text{Zn}_5(\text{OH})_8\text{Cl}_2 \cdot (\text{H}_2\text{O})$ ), hydrozincite ( $\text{Zn}_5(\text{OH})_6(\text{CO}_3)_2$ ) and sodium carbonate ( $\text{Na}_2\text{CO}_3$ ) are formed at ambient levels of  $\text{CO}_2$  at 350 ppm. The sodium carbonate is preferably formed in the secondary spreading area and in the inner edge of the NaCl droplet. At lower values of  $\text{CO}_2$ ,  $<5$  ppm  $\text{CO}_2$  and in the case of crevice corrosion, corrosion products such as simonkolleite ( $\text{Zn}_5(\text{OH})_8\text{Cl}_2 \cdot (\text{H}_2\text{O})$ ) and zincite (ZnO) are observed [23]. This emphasized that the corrosion products formed during zinc corrosion is dependent on the environment and design of the structure. Another study of the corrosion products formed in the presence of  $\text{CO}_2$  revealed traces of hydroxy carbonate ( $\text{Zn}_4(\text{CO}_3(\text{OH})_6 \cdot (\text{H}_2\text{O}))$ ) together with simonkolleite when pH decreased, due to the thermodynamically instability of zincite [24]. The thermodynamically stability of different zinc corrosion products is shown in Figure 2.5. A triple point is present approximately at chloride concentration  $10^{-2.3}$  and pH 6.2.

Figure 2.5: Stability diagram in aerated aqueous solution with a zinc ionic species concentration of 0.1 M at 25°C [24].

The thermodynamically instability of various zinc corrosion products relative to different pH and chloride values are shown in Figure 2.5 in Section 2.5. The logarithmic chloride concentration for the artificial seawater is calculated (7) to be able to determine the corrosion product in Figure 2.5. The zinc containing coatings were attached to the same multi-cell and the pH of the artificial seawater decreased towards 8. See Figure 4.23 for the pH development. Composition of the artificial seawater used during exposure is presented in Appendix C. The chloride concentration was 0.55952 moles Cl/l.

With a pH of approximately 8 and a logarithmic chloride concentration of -0.25, the actual corrosion product should be ZnO according to equation (7) and Figure 2.5.

Based on the pH development towards 8.00 and the chloride concentration in the electrolyte, the type of corrosion product could be estimated for the zinc according to Figure 2.5. This is only an estimate, and further testing for either X-ray diffraction (XRD) analysis or by EPMA analysis should be carried out to find the exact corrosion products. This was not conducted during the Msc project due to lack of time. The ICP-QQQ analysis performed after the cyclic coating test revealed more aluminium in the

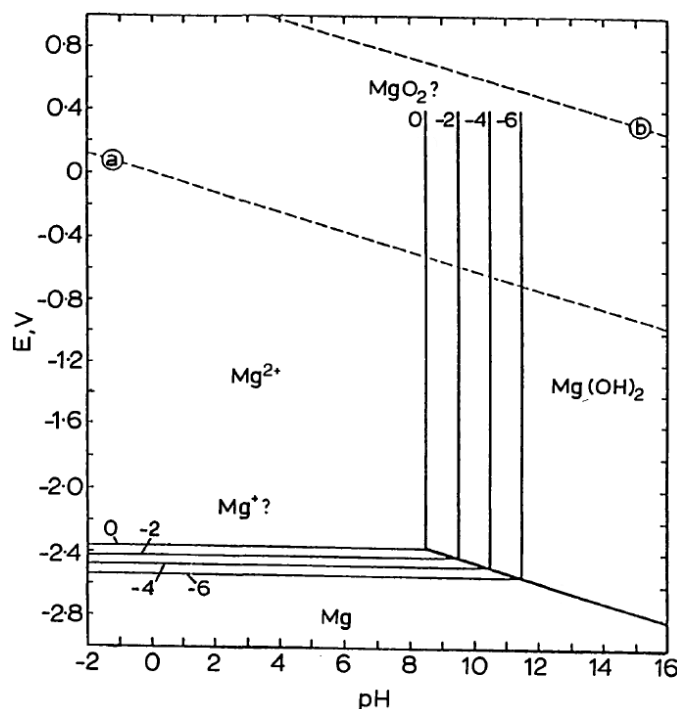
The Pourbaix diagram showing potential-pH for magnesium is presented in Figure 2.6. The diagram presents the area for immunity ( $\text{Mg}$ ), active corrosion ( $\text{Mg}^{2+}$  and  $\text{Mg}^+$ ) and passivation of the metal ( $\text{Mg}(\text{OH})_2$ ) relative to pH and potential vs. SHE [19]. The  $\text{Mg}(\text{OH})_2$  formation shows that magnesium can resist reasonably strong bases. A thick white precipitated film of  $\text{Mg}(\text{OH})_2$  form at pH 9, which contributes to relative corrosion protection between pH 8.5 and 11.5. Above pH 11.5 the passive  $\text{Mg}(\text{OH})_2$  film dominates the electrochemical behavior of Mg [26]. The boundary line between the immune and passive region, at pH 8.2, is approximately -2800 mV vs. Ag/AgCl at  $10^{-6}$ . This potential is clearly more negative compared to aluminium and zinc, see Figure 2.3 and Figure 2.4. Note that the potentials are converted to potentials vs. Ag/AgCl, and not SHE as for Figure 2.4. The conversion is done because an Ag/AgCl reference electrode was used during the experiments.

Figure 2.6: Pourbaix diagram vs. SHE for magnesium-water system at 25°C showing the phase equilibrium [19].

Earlier studies has revealed brucite ( $\text{Mg}(\text{OH})_2$ ) as the outer layer of the corrosion products. As seen in Figure 2.6, brucite is formed at alkaline pH values.  $\text{OH}^-$  ions are formed during magnesium dissolution, from the cathodic reaction, which leads to increased pH and formation of the magnesium hydroxide layer [29].

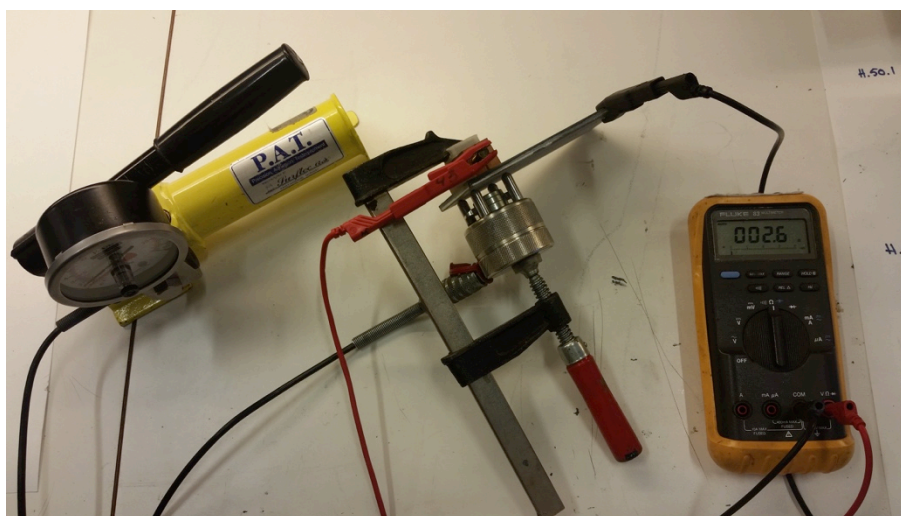
After the repair coatings were applied, the electrical resistance was measured. The rear side of the samples remained uncoated to obtain electrical contact during the measuring. A copper piece was pressed towards the coated side with a screw clamp, and P.A.T. Precision Adhesion Test equipment measured the pressure. A constant pressure of 200 psi was applied and the electrical resistance was measured with a multimeter. One measurement was conducted for each coating thickness. See Figure 3.1 for the test equipment and the setup. The measurements were performed according to MIL-DTL-81706B, Detail Specification: Chemical conversion materials for coating aluminum and aluminum alloys.

Figure 3.1: Electrical resistance setup with P.A.T Precision Adhesion, multimeter and the copper piece pressed towards the sample.

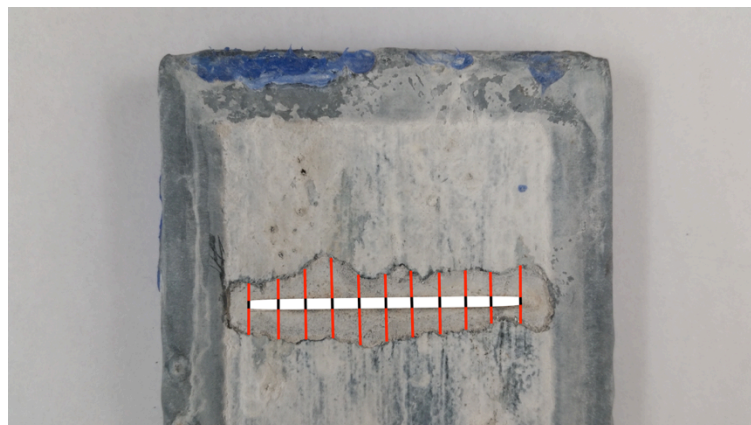
After the test was completed, the samples were examined visually and the coating cross sections were investigated in Olympus GX15 Metallurgical Microscope. The samples were machined by Discotom-2, casted in EpoFix resin and grinded to SiC #2400 or #4000 with Struers Rotopol-31 before the light microscope investigations. Element analysis by Triple Quadropol (QQQ) inductively coupled plasma mass spectroscopy (ICP-MS) was carried out by SINTEF, to determine the main elements in the corrosion products. The corrosion products were dissolved in concentrated HCl and HNO<sub>3</sub> in an ultrasonic cleanser at 60°C for 2 hours. Elements such as <sup>45</sup>Sc, <sup>89</sup>Y and <sup>115</sup>In were added and all samples were quantified against standards from Inorganic Ventures. Finally, the TSA corrosion creep (M) was calculated (6) based on the average corrosion creep from 11 points (C), 5 mm apart. See Figure 3.2 for the corrosion creep on both sides of the scribe. The width of the scribe (W) was 2 mm.

Figure 3.2: Corrosion creep marked in red around the scribe at 11 points, 5 mm apart.

The average corrosion creep was measured for all samples after exposure. Two parallels were used as basis for each coating thickness. The corrosion creep at 11 points was measured for each scribe, 5 mm apart, and the average value was calculated. See Figure 3.2 for the measuring method and Figure 4.4 for the average corrosion creep calculated for the various samples. As can be seen in Figure 4.4, highest corrosion creep was seen for the Zn epoxy, followed by the inorganic copolymer coating, high Zn primer and the modified Zn epoxy. ISO 20340 states that the corrosion creep after qualification

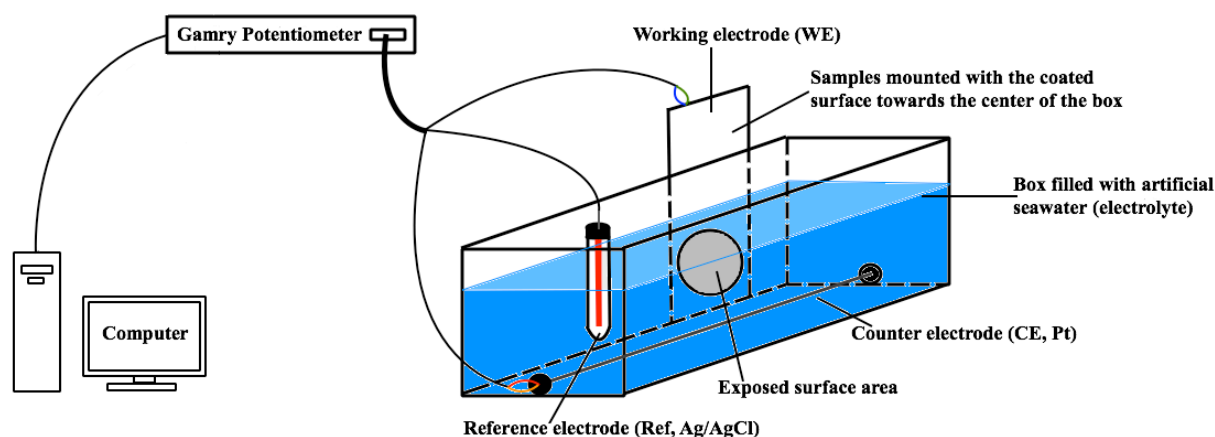
The samples (working electrode), the Ag/AgCl reference electrode and the platinum counter electrode were connected to a potentiostat. The samples mounted on the same multi-cell shared one reference and one counter electrode. Each sample was connected to a Gamry Instrument, Interface 1000 Potentiostat, during the impedance measurements. The initial and final frequencies were set to  $10 \times 10^4$  Hz and 0.001 Hz. The number of points within one decade of frequency was set to 5. The amplitude of the AC signal was set to 10 root mean square (rms) mV, and a constant potential of -1200 mV vs. Eref was applied during the logging. In addition to the mentioned values, the exposed surface area was set to 1886  $\text{mm}^2$ . The test setup for one sample is presented in Figure 3.3.

Figure 3.3: Test setup for the electrochemical impedance test with mounted sample (working electrode). A reference electrode is located in the filled multi-cell (to the left) and the counter electrode is connected along the bottom of the multi-cell. The reference, counter and working electrode are connected in a circuit through a Gamry Potentiostat.

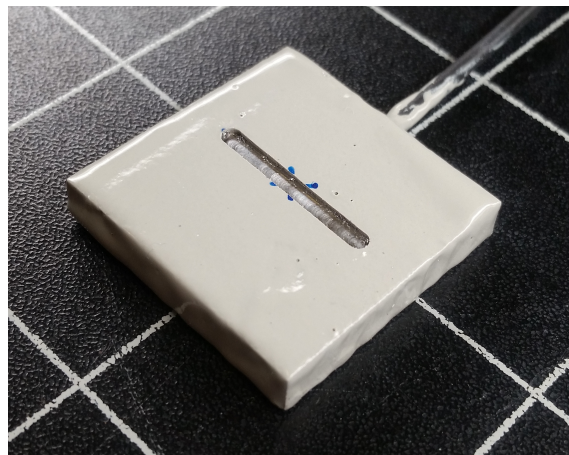
The samples were machined to squares of 30 mm x 30 mm and the repair coatings presented in 3.1.1 were applied on one side. A centered scribe of 20 mm x 2 mm was machined down to the steel on the side with repair coating. A steel wire with shrink sleeve was attached to each sample and silicone sealed the connection. A two-component epoxy coating was applied at the rear side and on the edges of all samples. One sample with TSA without additional repair coating was tested, and the two-component epoxy coating was then applied on both sides (around the scribe) and on the edges. See Figure 3.4 for the sample geometry. The epoxy coating cured for 2 days at 40°C before the samples were continuously immersed in artificial seawater.

Figure 3.4: Sample geometry of the TSA coated with epoxy. Silicone around the steel wire connection was not yet applied, and is therefore not present in the figure.

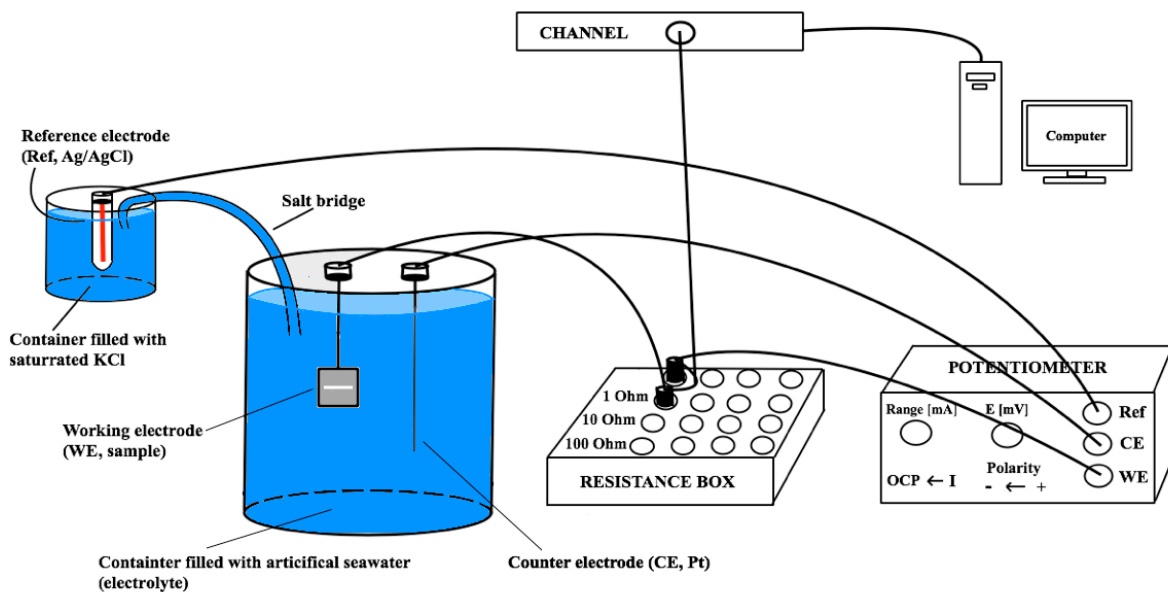
Figure 3.5 illustrates the test setup for one sample. Each sample (working electrode) was attached to an Ag/AgCl reference electrode and a platinum counter electrode. The electrodes and the samples were connected to a potentiostat, and a potential of  $-700$  mV was applied to initiate corrosion reactions and to simulate the polarization of the TSA by steel in the field. The boundary line between active and immune region for iron at  $10^{-5}$ , at pH 8.2, is located approximately at  $-787$  mV vs. Ag/AgCl [21], and a potential in the active area was chosen. Anodic current to each individual sample was logged as potential drop over a  $1 \Omega$  resistor. The samples and the counter electrode were placed in a container filled with artificial seawater, while the reference electrode was placed in a container filled with saturated KCl. A salt bridge connected the two containers. The test was run for 14 days.

Figure 3.5: Test setup for the crevice corrosion test with sample (working electrode) and counter electrode (Pt) immersed in artificial seawater. The Ag/AgCl electrode (reference electrode) was immersed in a separate container filled with saturated KCl. The three electrodes were connected in a circuit by a potentiometer and a resistance box at  $1 \Omega$ .

The test arrangement was equal to the setup shown in Figure 3.5, except for the sample design shown in Figure 3.6 and that a potential of  $-780$  mV was applied. The boundary line between immune and active area for iron at  $10^{-5}$ , at pH 8.2, is located approximately at  $-787$  mV vs. Ag/AgCl [21]. A potential of  $-780$  mV was therefore chosen to avoid corrosion of the steel, and rather initiate corrosion of the TSA or repair coating. Anodic current to each individual sample was logged as potential drop over a  $1 \Omega$  resistor. The test was run twice with test periods of respectively 16 days and 30 days.

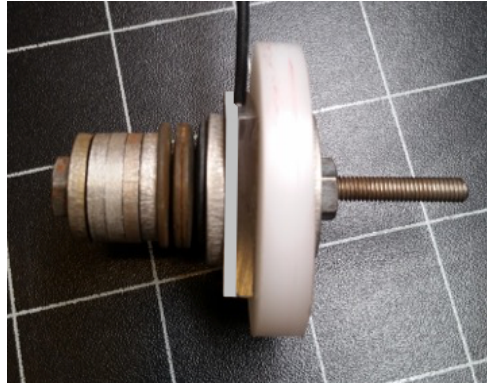
The samples were machined to squares of  $30 \text{ mm} \times 30 \text{ mm}$ , with a centered hole of  $7 \text{ mm}$  diameter. The repair coatings presented in Section 3.1.1 were applied on one side. A steel wire with shrink sleeve was attached to each sample and silicone sealed the connection. A two-component epoxy coating was applied at the rear side, inside the centered hole and halfway up on the edges starting from the rear side. One sample with TSA without repair coating was also tested and the two-component epoxy coating was applied at both sides, in addition to inside the centered hole and halfway up on the edges starting from the rear side. The epoxy coating cured for 2 days at  $40^\circ\text{C}$ . After curing, a crevice former was attached to the repair coating surface. Silicone was applied around the bolt on both sides of the sample to ensure no penetration of electrolyte. See Figure 3.6 for the arrangement of the crevice former. The nut was tightened with  $2 \text{ Nm}$ . The samples were then continuously immersed in artificial seawater.

Figure 3.6: Sample attached to a crevice former (white disc) with repair coating towards the crevice former. The epoxy (light grey coating) was applied on the rear side and halfway up on the sides starting from the rear side. Silicone around the steel wire connection was not yet applied, and is therefore not present in the figure.

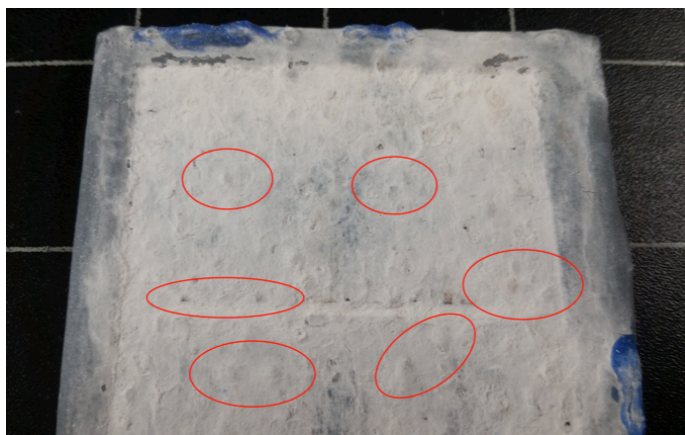
Only examples of the different types of damage found on the samples are shown in this section. Images of all the samples with blistering are presented in Appendix B, Section B.3. The amount of blistering or cracking of the repair coating near the scribe varied for the different samples. The blistering was concentrated around the scribe, as for the high Zn primer DFT 150  $\mu\text{m}$  in Figure 4.1. The blistering is marked with red circles.

Figure 4.1: Blistering near the scribe on the high Zn primer DFT 50  $\mu\text{m}$ . The picture is taken after 20 cycles of exposure.

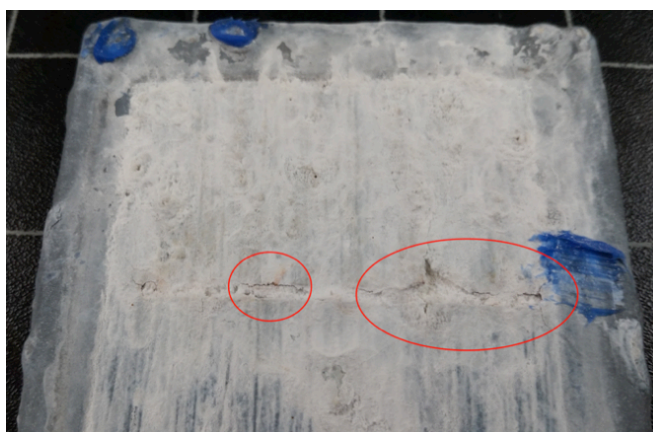
Blistering on the Zn epoxy DFT 150  $\mu\text{m}$  was seen after 4 cycles of exposure. Some blisters transformed to cracks of the repair coating after further exposure. This occurred due to increased amount of corrosion products from the TSA formed below the repair coating. The cracks were concentrated around the scribe and are shown in Figure 4.2.

Figure 4.2: Blistering and cracking of the topcoat near the scribe on the Zn epoxy DFT 150  $\mu\text{m}$ . The picture is taken after 20 cycles of exposure.

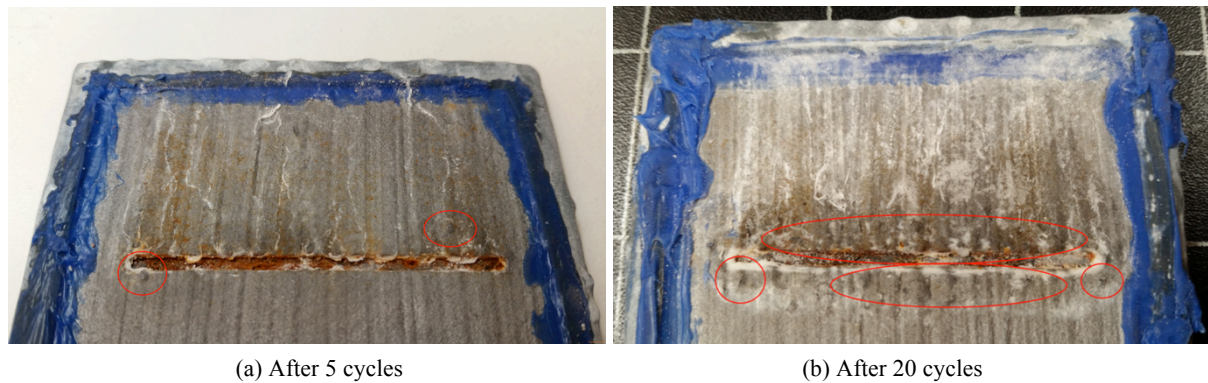
The inorganic copolymer coating was tested with a coating thickness of 150  $\mu\text{m}$  and showed blistering after 5 cycles of exposure. The blistering occurred around the scribe, and the amount of blistering increased with increasing exposure time. No cracks in the repair coating were seen even though the first blister occurred only after 5 cycles, and a total exposure of 20 cycles was performed. Figure 4.3 presents the sample after 5 cycles (a) and 20 cycles (b) of exposure.

Figure 4.3: Blistering near the scribe on the inorganic copolymer coating after 5 cycles (a) and 20 cycles (b) of exposure.

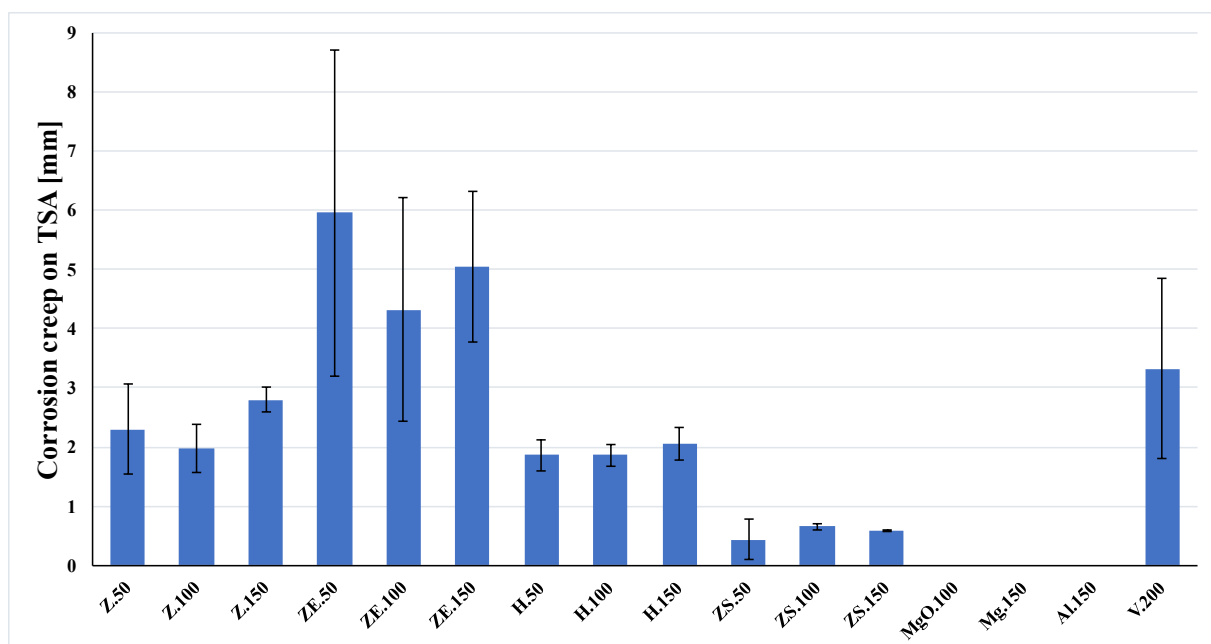
The average corrosion creep for the samples is shown in Figure 4.4. Two parallels were evaluated per sample and the average value of 22 measurements (11 measurement for each parallel) is shown in this section. The equation used for calculation is shown in Section 3.3. The standard deviation for each sample is also marked in Figure 4.4.

Highest amount of corrosion creep on the TSA was seen for the Zn epoxy (ZE), followed by the inorganic copolymer coating (V), the high Zn primer (Z) and the modified Zn epoxy (H). The silicate coatings revealed very low degree of corrosion creep, except for the Zn silicate (ZS) with approximately corrosion creep of 0.6 mm. Complete overview of the measurements taken is presented in Appendix B, Section B.4. The numbers stated after the labeling indicates the average DFT.

Figure 4.4: Average corrosion creep on TSA for each sample with standard deviations included in the graph. The following labeling is used for the various repair coatings (starting from the left): high Zn primer (Z), Zn epoxy (ZE), modified Zn epoxy (H), Zn silicate (ZS), MgO silicate (MgO), Mg silicate (Mg), Al silicate (Al) and the inorganic copolymer coating (V).

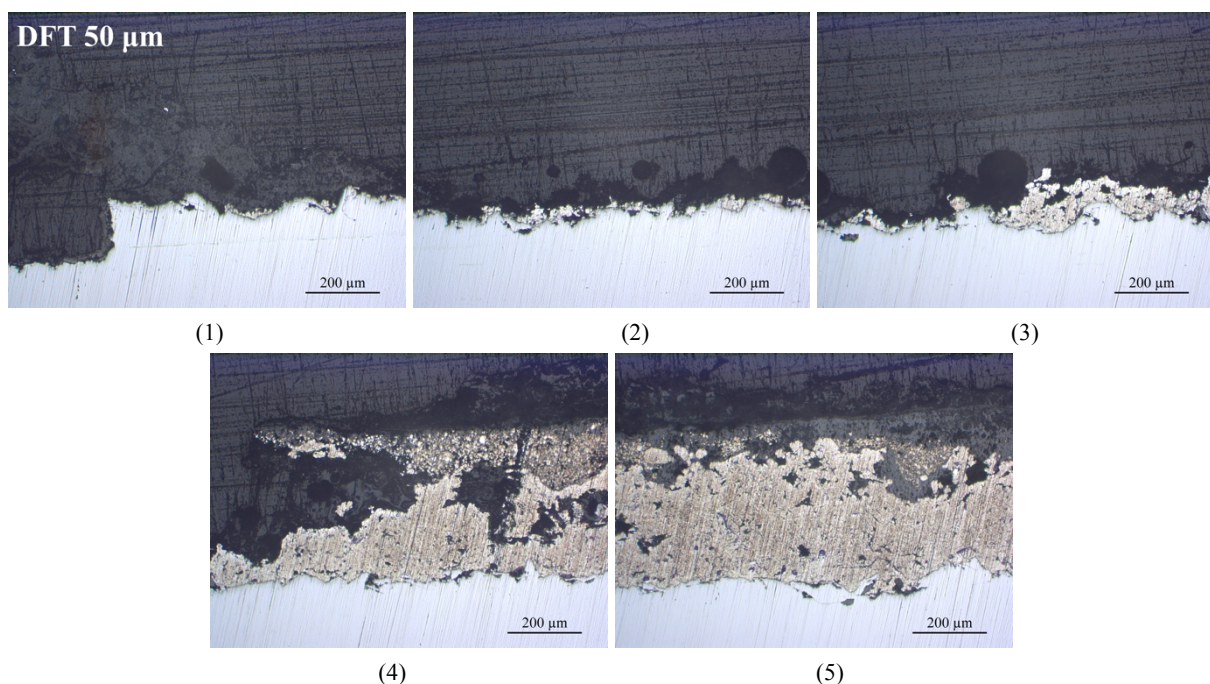
Figure 4.5 shows that both the repair coating and the TSA had corroded approximately 3.6 mm into the crevice. Total reduction of the TSA can be seen in image (1) and (2), and partly in image (3). Some of the dark areas on the TSA layer are air bobbles present in the epoxy resin. In image (4), some zinc particles is seen in the repair coating.

Figure 4.5: Light microscope images of the high Zn primer DFT 50  $\mu\text{m}$  at the crevice opening (1) and further into the crevice (5). Combined corrosion creep and flaking had occurred approximately 3.6 mm into the crevice.

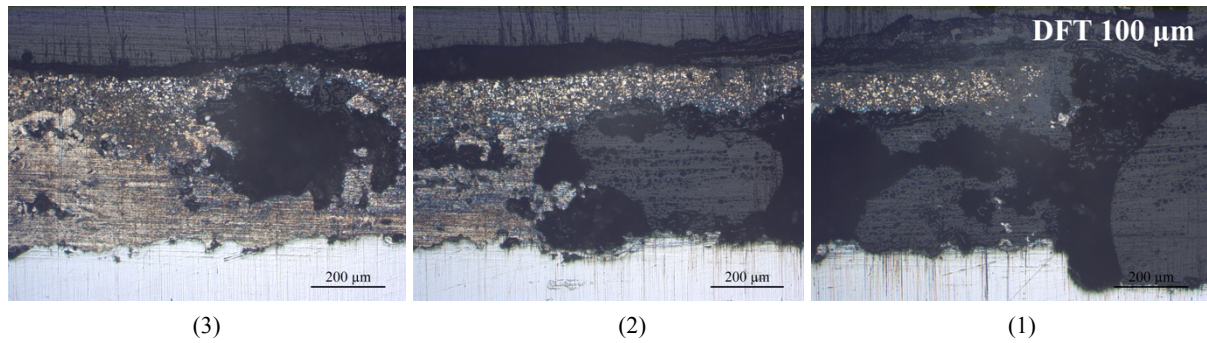
Figure 4.6 reveals both continuous TSA corrosion approximately 1.4 mm into the crevice and some reduction of the repair coating. However, the reduction of the zinc is greatest at the crevice opening. Some combined corrosion of both the TSA and the high Zn primer can be seen in images (3) from 1.5 mm to 2.3 mm for the DFT 100  $\mu\text{m}$ . Continuous corrosion of the TSA can be seen approximately 2.2 mm into the crevice in Figure 4.7 for the DFT 150  $\mu\text{m}$ .

Figure 4.6: Light microscope images of the high Zn primer DFT 100  $\mu\text{m}$  at the crevice opening (1) and further into the crevice (3). Corrosion creep of approximately 1.4 mm had occurred from the crevice opening.

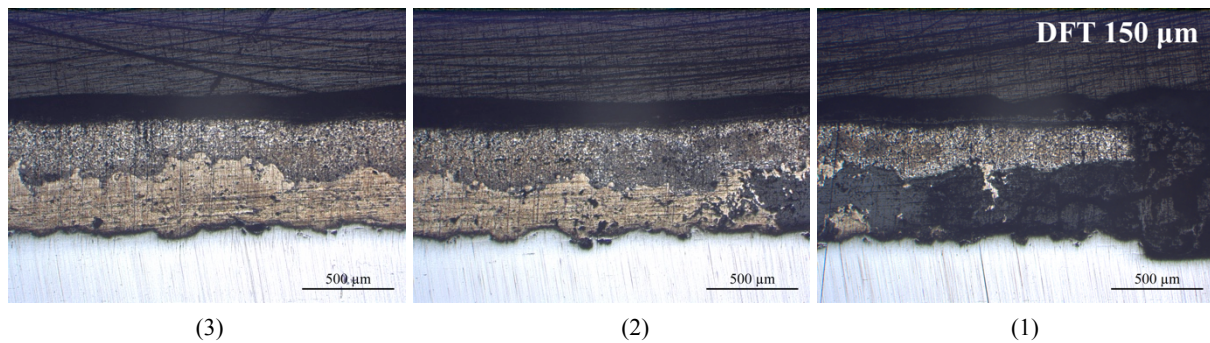
Figure 4.7: Light microscope images of the high Zn primer DFT 150  $\mu\text{m}$  at the crevice opening (1) and further into the crevice (3). Corrosion creep of approximately 2.2 mm had occurred into the crevice.

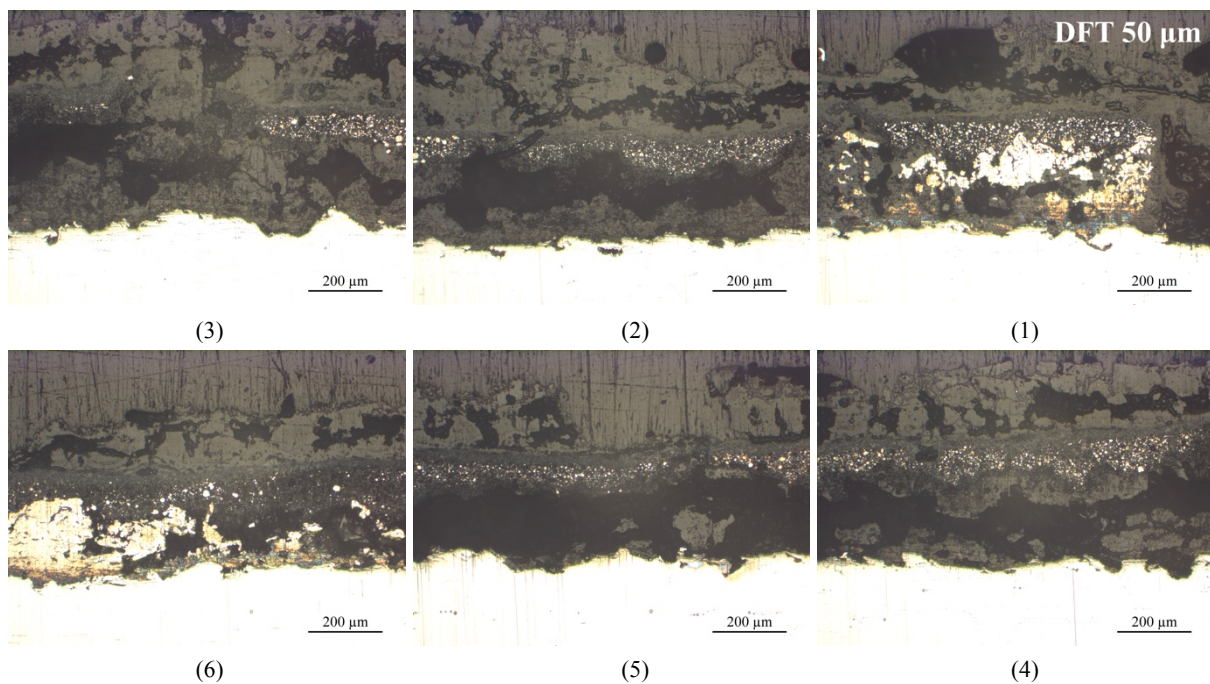
Figure 4.8 reveals high amount of continuous TSA corrosion approximately 6.1 mm into the crevice, in addition to reduction of the zinc particles.

Figure 4.8: Light microscope images of the Zn epoxy DFT 50  $\mu\text{m}$  at the crevice opening (1) and further into the crevice (6). Corrosion creep of approximately 6.1 mm had occurred into the crevice.

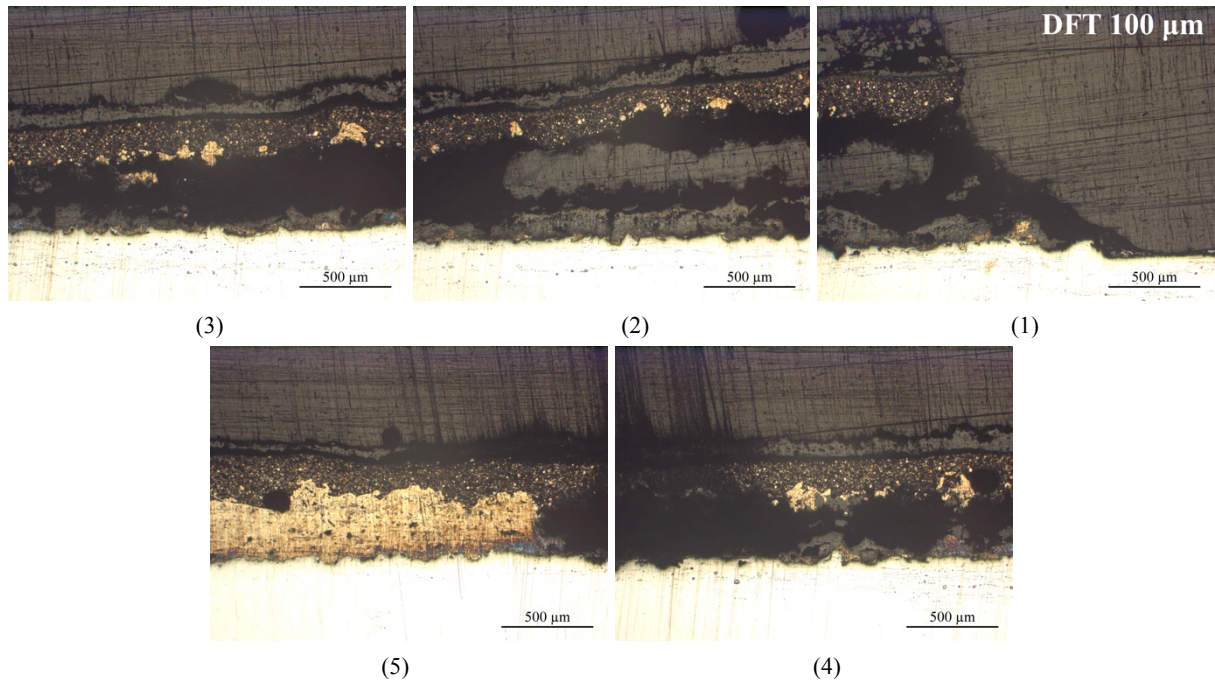
Corrosion products from the TSA had clearly cracked the repair coating on the DFT 100  $\mu\text{m}$  and 150  $\mu\text{m}$ , see Table 4.2. See Figure 4.9 and Figure 4.10 for the corrosion morphology. Continuous corrosion creep was seen respectively 7.8 mm and 7.5 mm into the crevice. The cracking appeared as lifting of the repair coating in the images.

Figure 4.9: Light microscope images of the Zn epoxy DFT 100  $\mu\text{m}$  at the crevice opening (1) and further into the crevice (5). Corrosion creep of approximately 7.8 mm had occurred into the crevice.

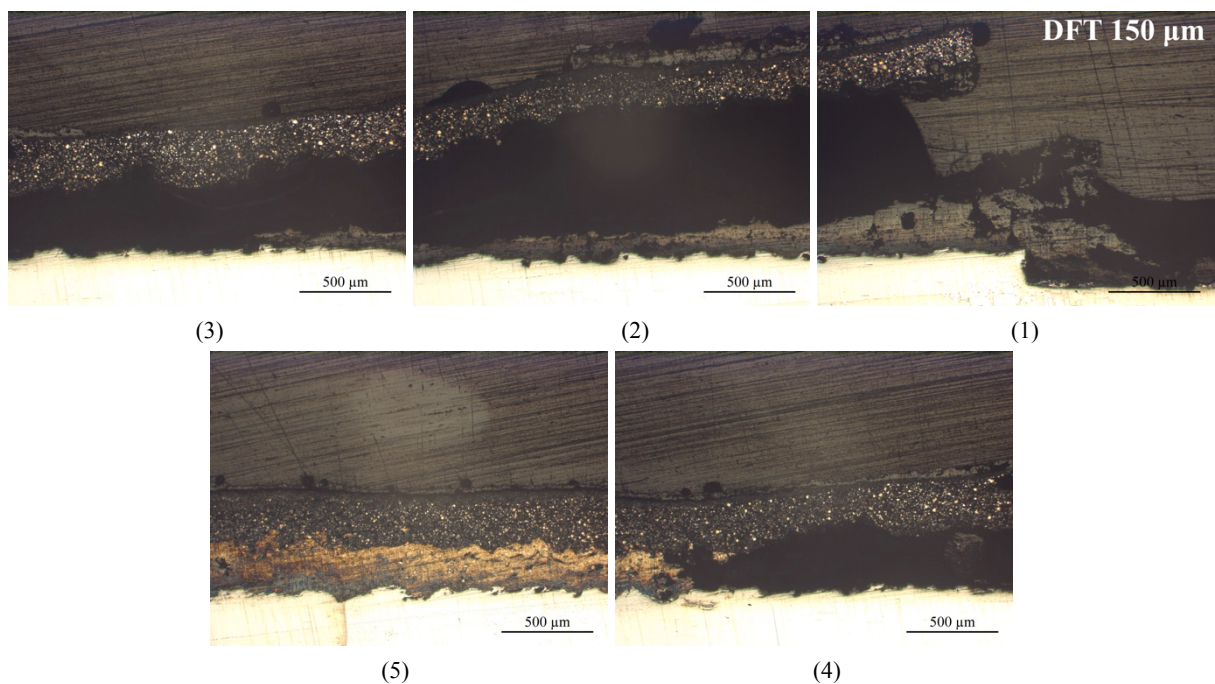
Figure 4.10: Light microscope images of the Zn epoxy DFT 150  $\mu\text{m}$  at the crevice opening (1) and further into the crevice (5). Corrosion creep of approximately 7.5 mm had occurred into the crevice.

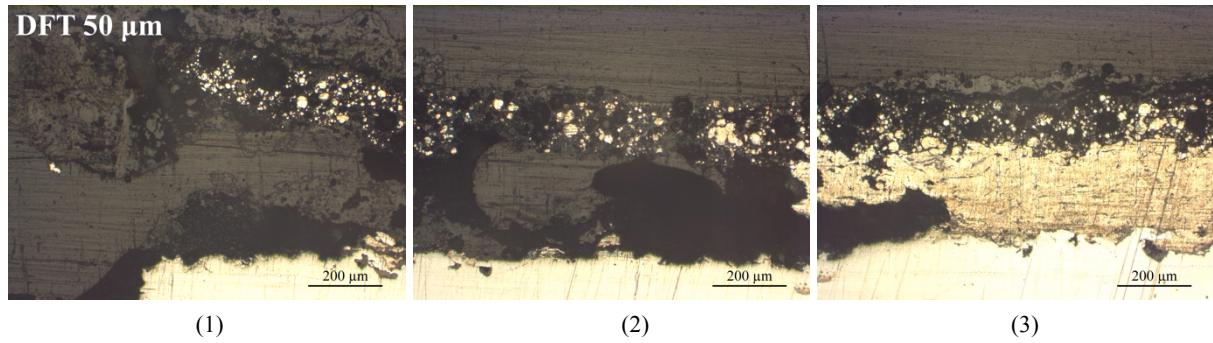
Continuous corrosion of the TSA can be seen for approximately 2.2 mm in Figure 4.11, for 2.3 mm in Figure 4.12 and for 2.0 mm in Figure 4.12. Some intact zinc particles can be seen in the repair coatings for all coating thicknesses, in addition to the glass spheres. Smallest amount of TSA corrosion can be seen for the DFT 150  $\mu\text{m}$ .

Figure 4.11: Light microscope images of the modified Zn epoxy DFT 50  $\mu\text{m}$  at the crevice opening (1) and further into the crevice (3). Corrosion creep of approximately 2.2 mm had occurred into the crevice.

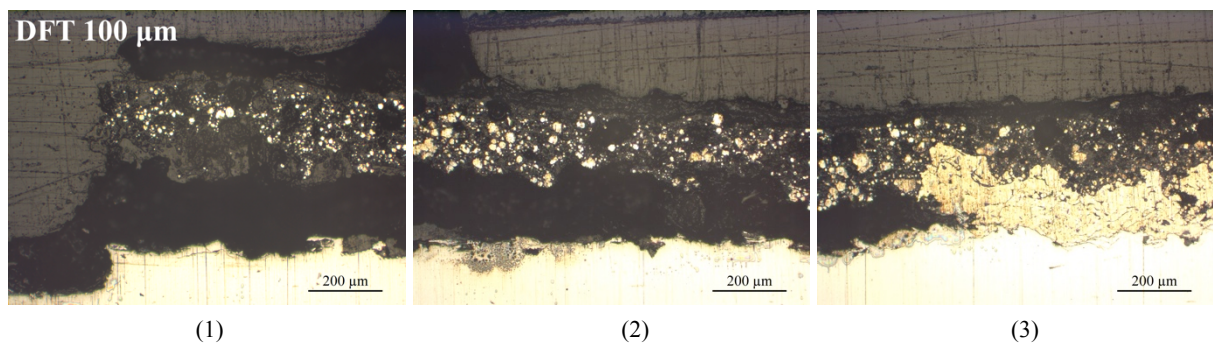
Figure 4.12: Light microscope images of the modified Zn epoxy DFT 100  $\mu\text{m}$  at the crevice opening (1) and further into the crevice (3). Corrosion creep of approximately 2.3 mm had occurred into the crevice.

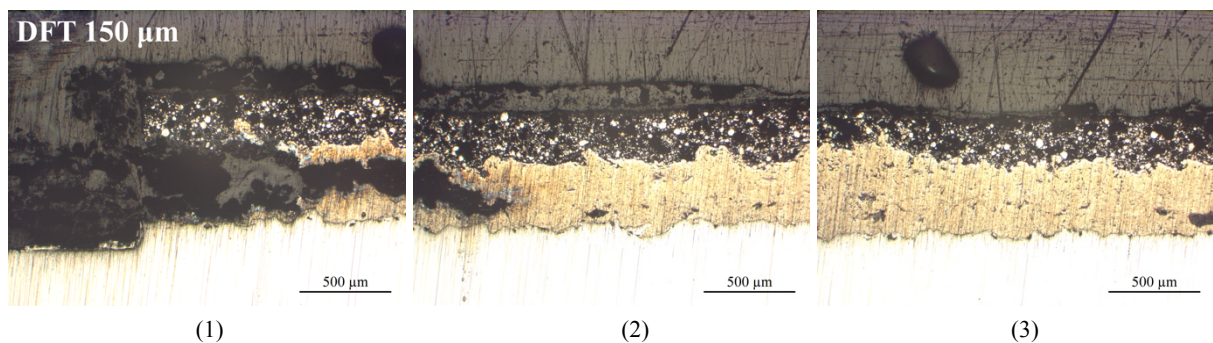
Figure 4.13: Light microscope images of the modified Zn epoxy DFT 150  $\mu\text{m}$  at the crevice opening (1) and further into the crevice (3). Corrosion creep of approximately 2.0 mm had occurred into the crevice.

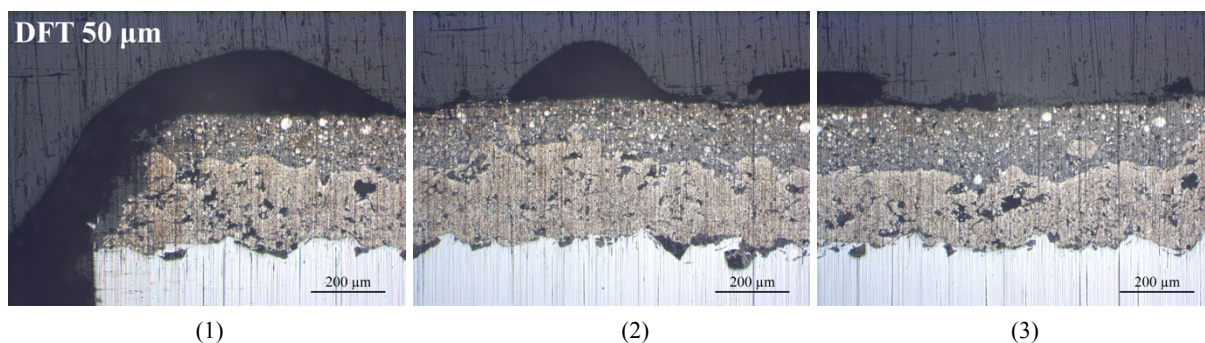
Figure 4.14: Light microscope images of the Zn silicate DFT 50  $\mu\text{m}$  at the crevice opening (1) and further into the crevice (3). The TSA had only corroded at the crevice opening, in addition to some sporadic corrosion further into the crevice. Machining of the samples may have led to reduction at the crevice opening.

TSA corrosion can be seen at the crevice opening for DFT 50  $\mu\text{m}$  in Figure 4.14 and 100  $\mu\text{m}$  in Figure 4.15. Figure 4.16 presents DFT 150  $\mu\text{m}$  (1) with only sporadic TSA corrosion. Figure 4.17 presents continuous corrosion of the TSA approximately 2.6 mm into the crevice for DFT 150  $\mu\text{m}$  (2). Small amount of reduced zinc particles can be seen for DFT 50  $\mu\text{m}$  and 150  $\mu\text{m}$ . Highest amount of reduced zinc particles was seen for the DFT 100  $\mu\text{m}$  and side 2 of the DFT 150  $\mu\text{m}$ .

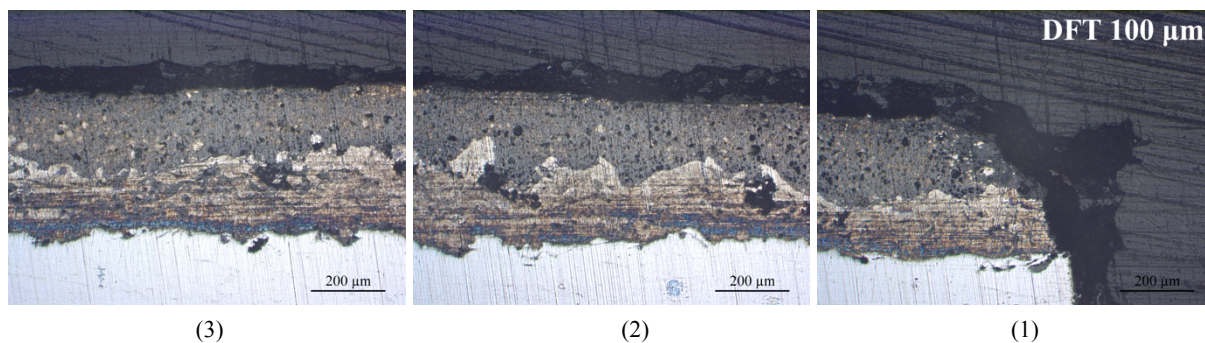
Figure 4.15: Light microscope images of the Zn silicate DFT 100  $\mu\text{m}$  at the crevice opening (1) and further into the crevice (3). The TSA had only corroded at the crevice opening, in addition to some sporadic corrosion further into the crevice. Machining of the samples may have caused reduction at the crevice opening.

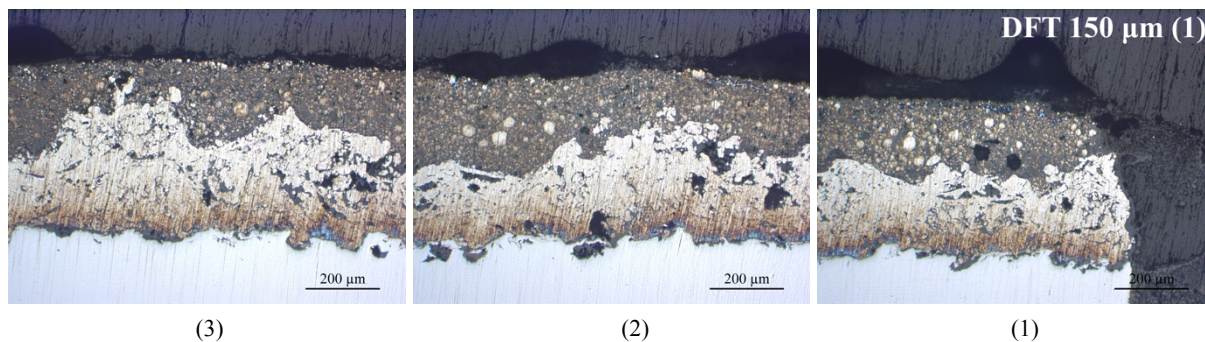
Figure 4.16: Light microscope images of the Zn silicate DFT 150  $\mu\text{m}$  at the crevice opening (1) and further into the crevice (3). The dark areas may either be corrosion or voids from the coating application, or a combination of both.

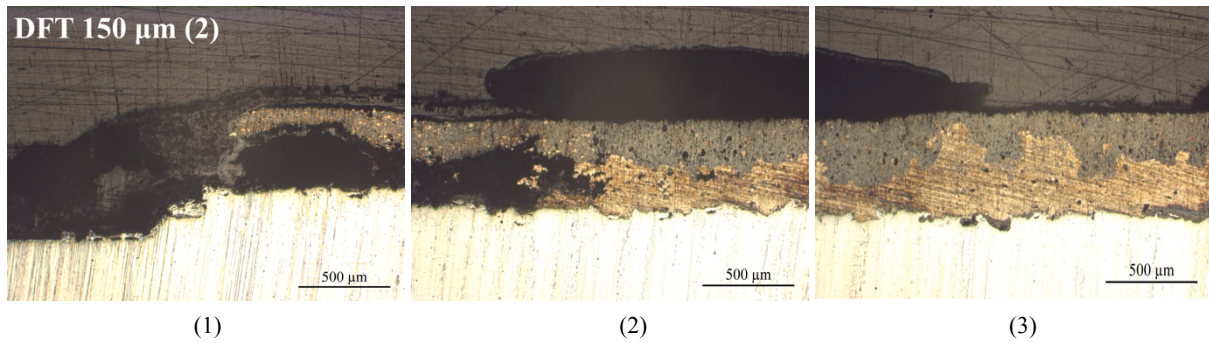
Figure 4.17: Light microscope images of the Zn silicate DFT 150  $\mu\text{m}$  at the crevice opening (1) and further into the crevice (3). Corrosion creep of approximately 2.6 mm had occurred into the crevice.

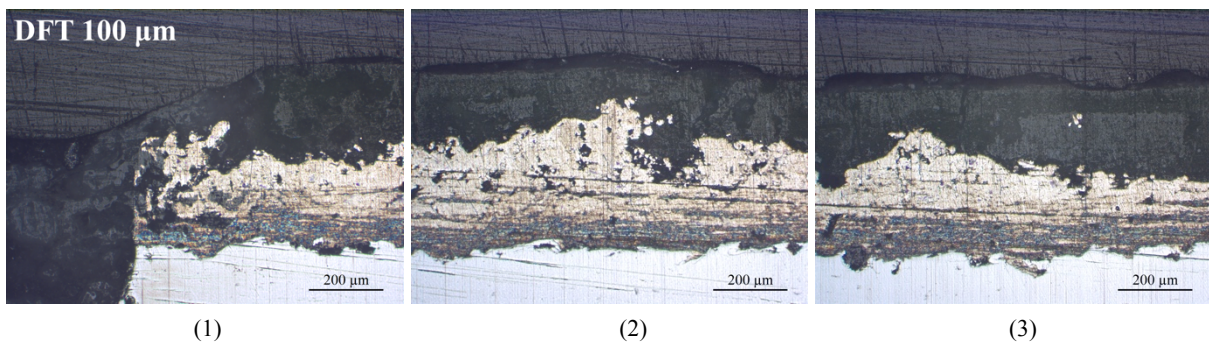
Figure 4.18: Light microscope images of the MgO silicate DFT 100  $\mu\text{m}$  at the crevice opening (1) and further into the crevice (3). The TSA layer had only corroded at the crevice opening, and the dark areas further into the crevice may either be corrosion or voids from the coating application, or a combination of both.

Small amount of TSA corrosion was seen for both MgO- and Mg-silicate in Figure 4.18 and Figure 4.19.

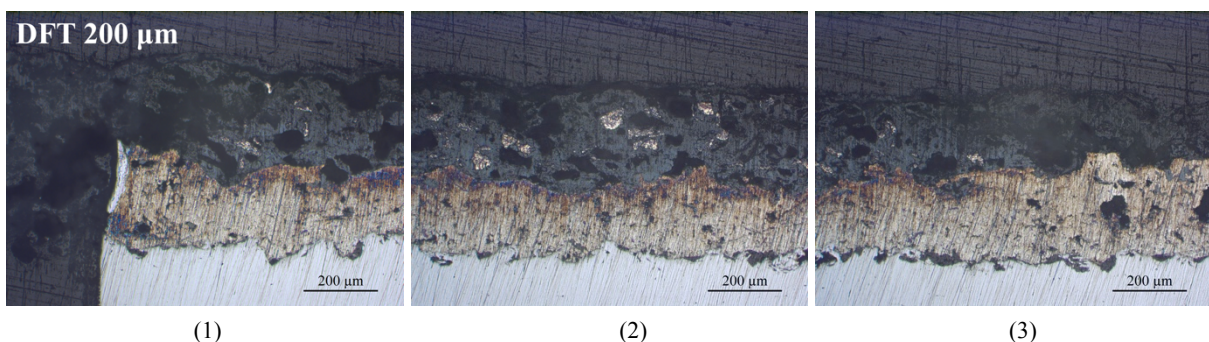
Figure 4.19: Light microscope images of the Mg silicate DFT 200  $\mu\text{m}$  at the crevice opening (1) and further into the crevice (3). No TSA corrosion was seen at the crevice opening and the dark areas may either be corrosion or voids from the coating application, or a combination of both.

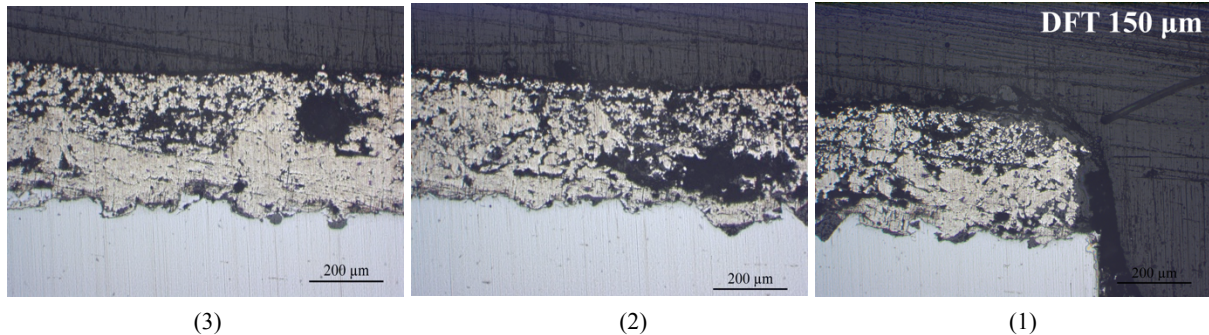
Sporadic corrosion of both the TSA and Al silicate can be seen in Figure 4.20. No continuous corrosion appeared, and the amount of intact aluminium particles was high.

Figure 4.20: Light microscope images of the Al silicate DFT 150 µm at the crevice opening (1) and further into the crevice (3). The TSA had only corroded sporadically. Machining of the samples may have reduced the TSA at the crevice opening.

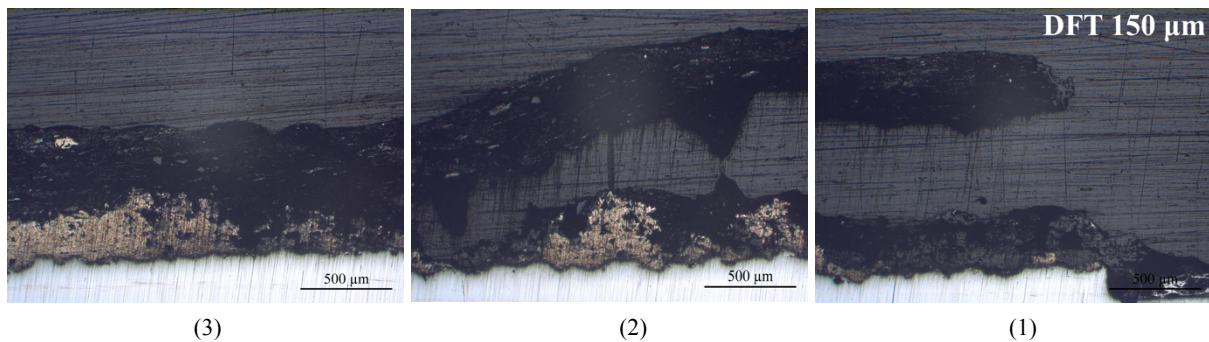
High amount of TSA corrosion was seen, and corrosion products caused cracking of the repair coat. The TSA corroded approximately 4.8 mm into the crevice. Active particles are not present in the repair coating.

Figure 4.21: Light microscope images of the inorganic copolymer coating DFT of 150 µm at the crevice opening (1) and further into the crevice (3). Corrosion creep of approximately 4.8 mm had occurred into the crevice.
