# Repair Coatings for Thermally Sprayed Aluminium

Materials Science and Engineering

Submission date: June 2016

**Repair coatings for thermally sprayed aluminium**

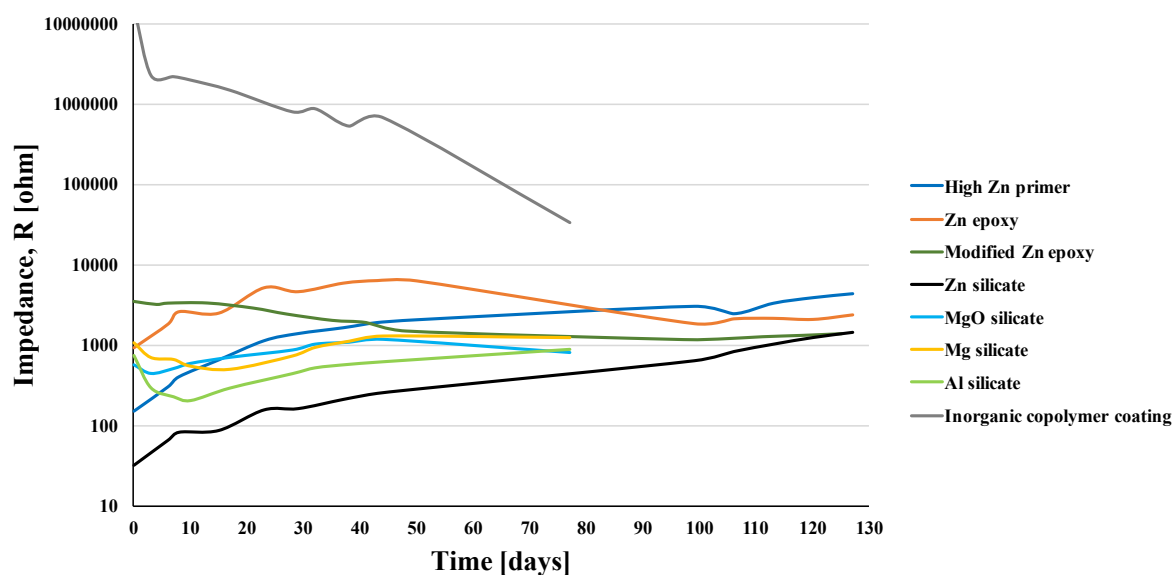
Several spectra were obtained for each repair coating. Spectra were recorded more frequently at the beginning of the test period. The electrochemical impedance at 0.001 Hz is presented in Figure 4.22 for the different repair coatings. This frequency was chosen due to lowest value and most similar conditions as to the DC. The resistance against ion diffusion through the coating is therefore measured best at this frequency. The silicate coatings (Zn-, MgO-, Mg- and Al-silicate) showed increasing impedance at 0.001 Hz with increasing exposure time. High Zn primer showed the same tendency. The Zn epoxy, the modified Zn epoxy and the inorganic copolymer coating showed decreasing impedance at 0.001 Hz with increasing exposure time. The highest impedance was shown for the inorganic copolymer coating, followed by the high Zn primer, Zn epoxy and the modified Zn epoxy. The silicate coatings showed lower impedance, and the Zn silicate revealed the lowest impedance. Impedance values from each specter with Bode plots are presented in Appendix D, Section D.2.

Figure 4.22: Electrochemical impedance at 0.001 Hz (y-axis) plotted against exposure time (x-axis).

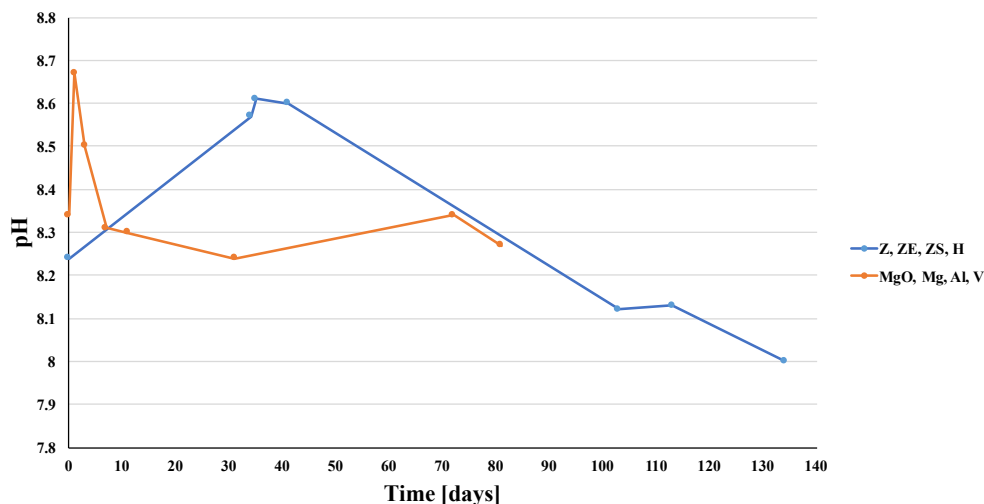
Development of the pH during the test period is presented in Figure 4.23. The pH of the electrolyte in the multi-cell holding the zinc containing coatings decreased from 8.24 to 8.00, while the pH values decreased from 8.34 to 8.27 for the MgO-, Mg-, Al-silicate and the inorganic copolymer coating mult-cell. Exact pH values are presented in Appendix D, Section D.3.

Figure 4.23: Development of pH (y-axis) plotted against the number of days from test initiation (x-axis).

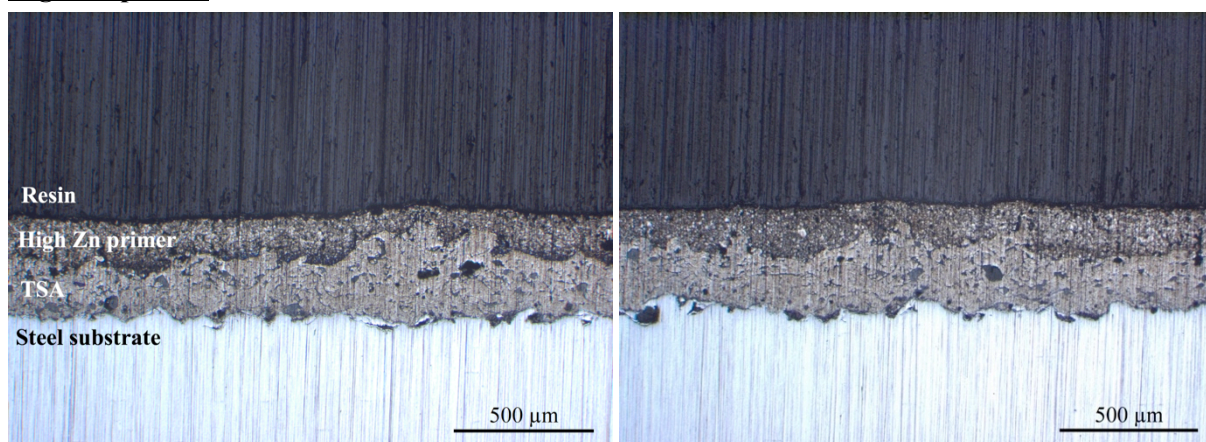
Figure 4.24: Light microscope images of the high Zn primer from the exposed surface areas. No extensive corrosion of the TSA occurred. Some smaller dark areas can be seen in the TSA, which may either be corrosion or voids from the coating application process.

The EIS measured the resistance of ion diffusion through the coatings. No damages were introduced to the coating layers, and the cross sections of the various coatings are shown from Figure 4.24 to Figure 4.31. The light microscope images revealed sufficient ion diffusion through the repair coating to avoid severe TSA corrosion. No indication of cracks can be seen in the repair coatings.

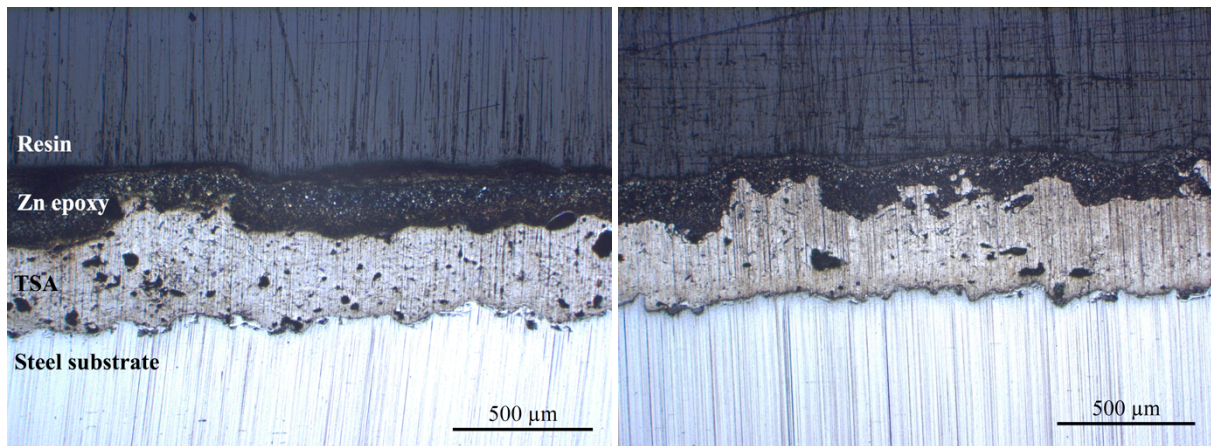
Figure 4.25: Light microscope images of the Zn epoxy from the exposed surface areas. Some dark areas can be seen in the TSA, which may either be corrosion or voids from the coating application process. Some larger dark areas may be corroded TSA.

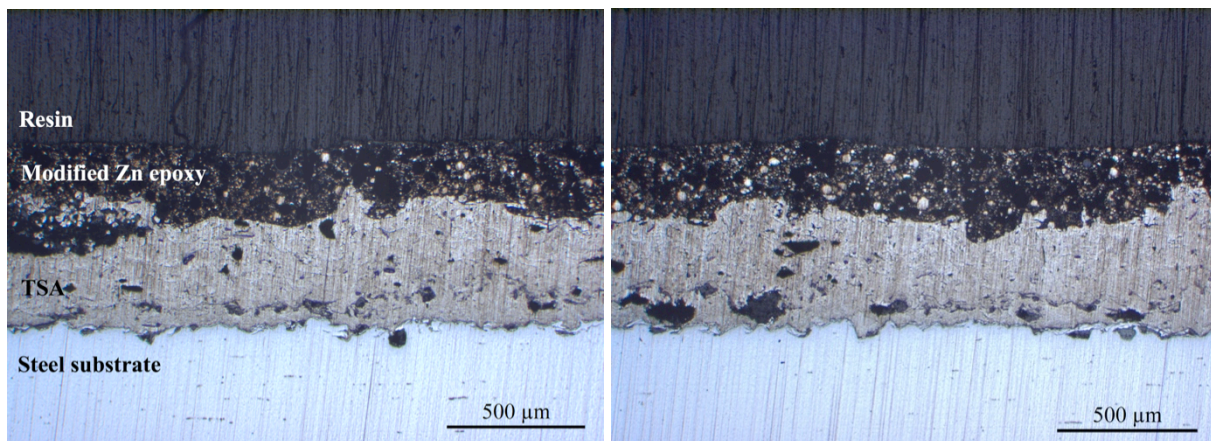
Figure 4.26: Light microscope images of the modified Zn epoxy from the exposed surface areas. Some dark areas can be seen in the TSA, which may either be corrosion or voids from the coating application process. Some larger dark areas may be corroded TSA.

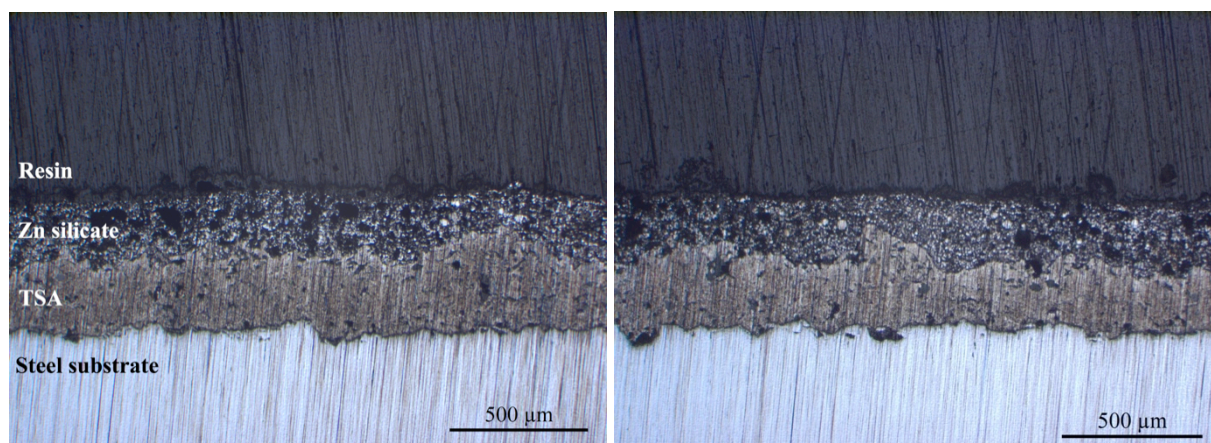
Figure 4.27: Light microscope images of the Zn silicate from the exposed surface areas. No extensive corrosion of the TSA occurred, and the TSA appeared relative unaffected.

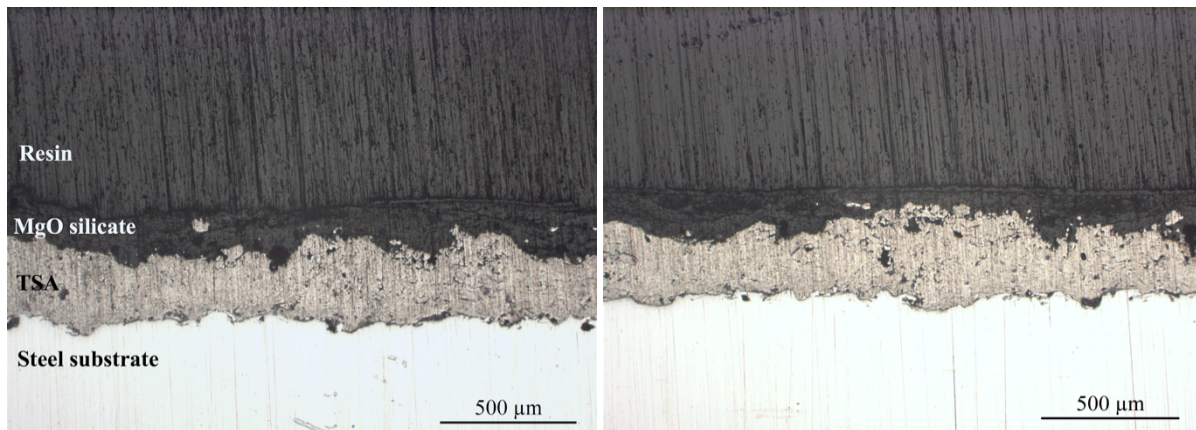
Figure 4.28: Light microscope images of the MgO silicate from the exposed surface areas. Some dark areas can be seen in the TSA, which may either be corrosion or voids from the coating application process. A thin layer can be seen on top of the repair coating.

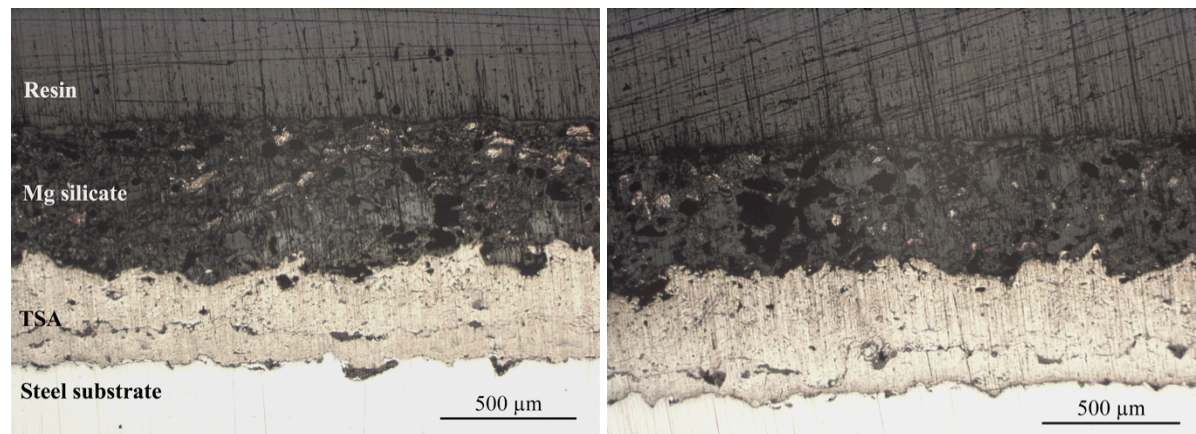
Figure 4.29: Light microscope images of the Mg silicate from the exposed surface areas. Some dark areas can be seen in the TSA, which may either be corrosion or voids from the coating application process. A thin layer can be seen on top of the repair coating.

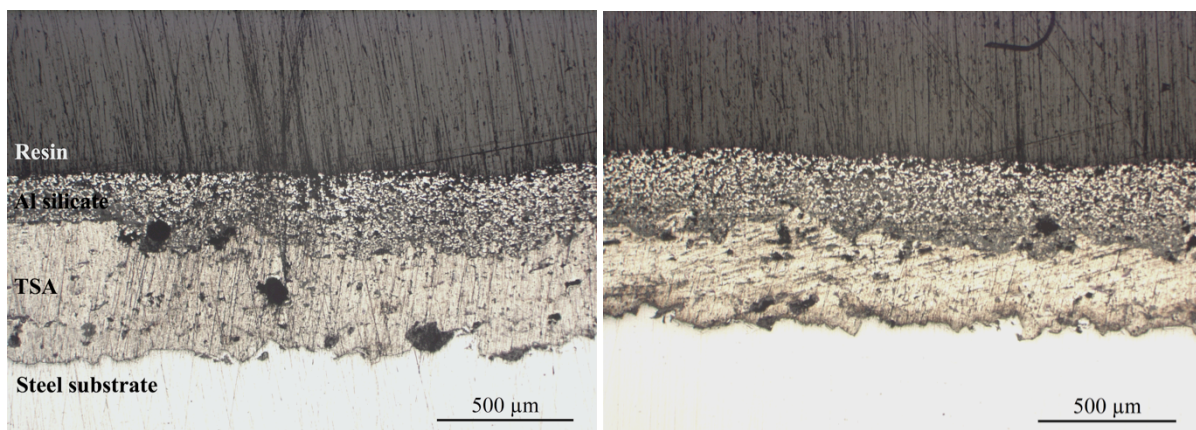
Figure 4.30: Light microscope images of the Al silicate from the exposed surface areas. Some concentrated dark areas can be seen in the TSA and the Al silicate, which may either by corrosion or voids from the coating application.

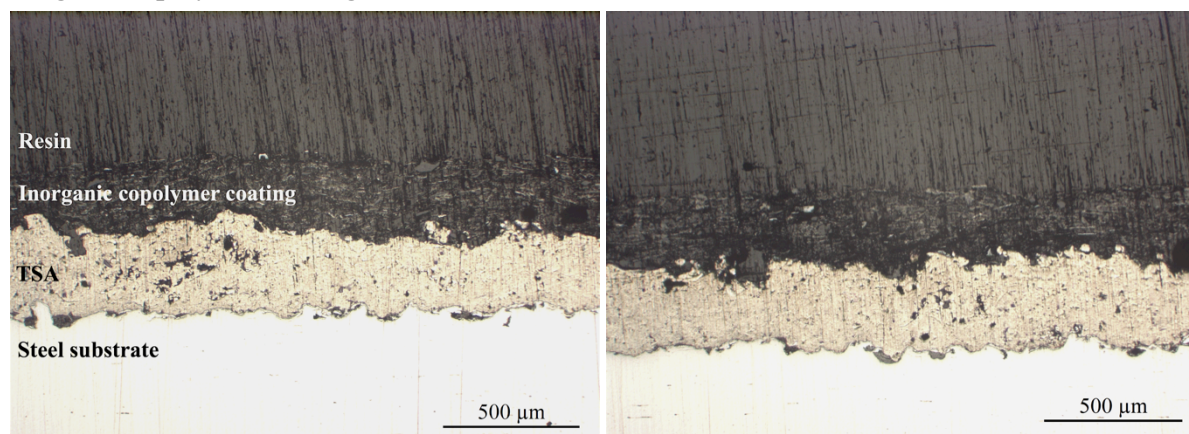
Figure 4.31: Light microscope images of the inorganic copolymer coating from the exposed surface areas. Some concentrated dark areas could be seen in the TSA layer, which may be corrosion or voids.

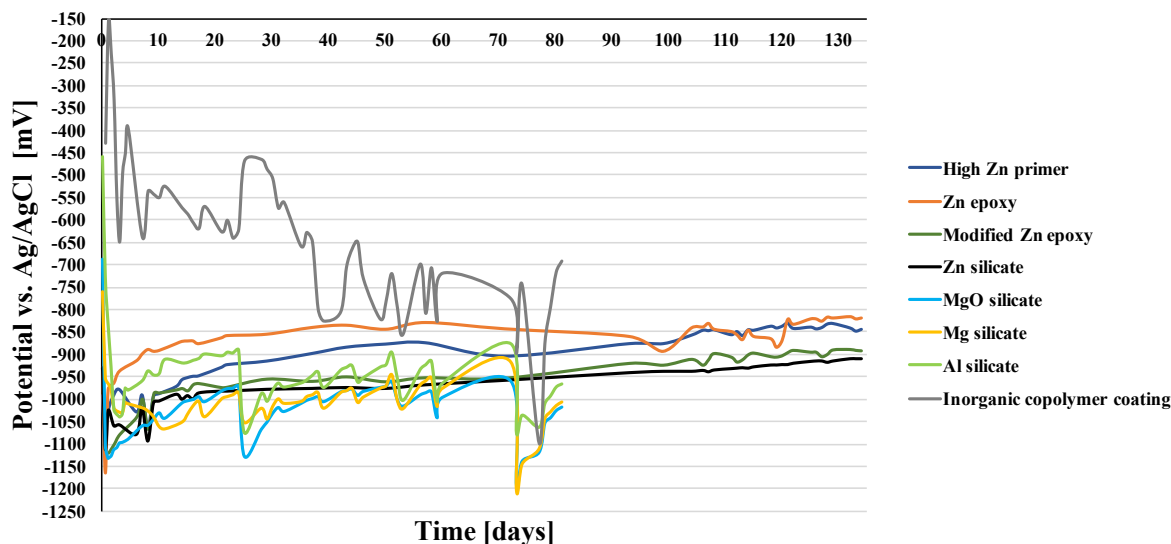
The same reference electrode was used both for the OCP measurements and the electrochemical impedance test, i.e. an Ag/AgCl electrode. Figure 4.32 presents the OCP as function of immersion times. The zinc containing repair coatings were exposed for 134 days, while MgO-, Mg-, Al-silicate and the inorganic copolymer coating were exposed for 81 days. The different exposure times were due to different start dates. The exact OCP values measured are presented in Appendix E.

Figure 4.32: OCP for the different repair coatings with potential vs. Ag/AgCl (y-axis) plotted against the number of days from test initiation (x-axis).

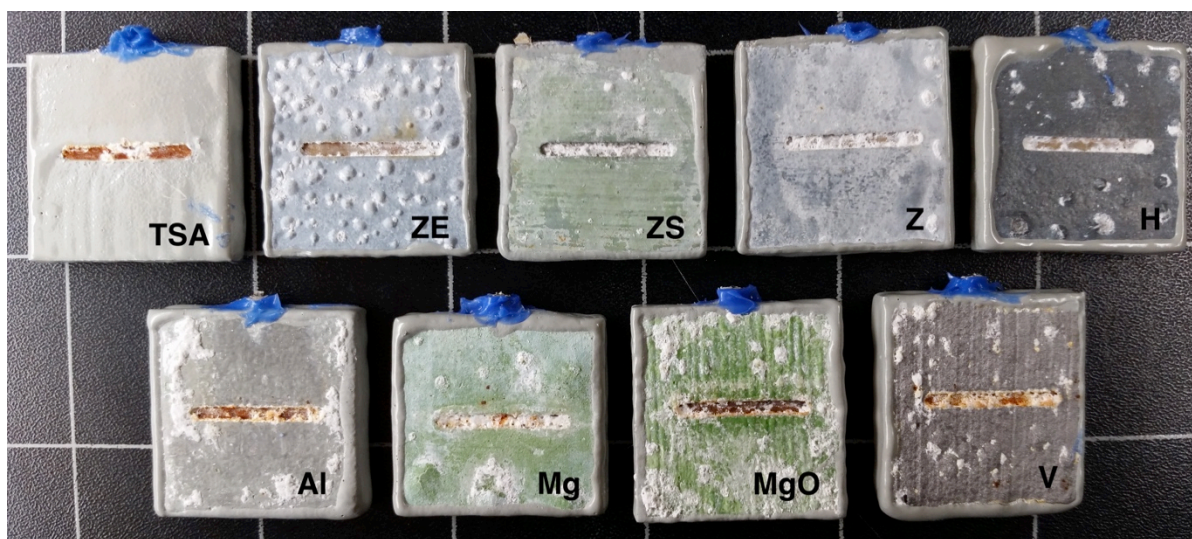
The test was carried out for 14 days and Figure 4.33 presents the samples after exposure. Blisters were seen on the Zn epoxy (ZE), the modified Zn epoxy (H) and the inorganic copolymer coating (V).

Figure 4.33: Visual appearance of the samples after 14 days of exposure. The order of the repair coatings on the upper row is: TSA coated with epoxy (TSA), Zn epoxy (ZE), Zn silicate (ZS), high Zn primer (Z) and modified Zn epoxy (H). The order on the lower row is: Al silicate (Al), Mg silicate (Mg), MgO silicate (MgO) and the inorganic copolymer coating (V).

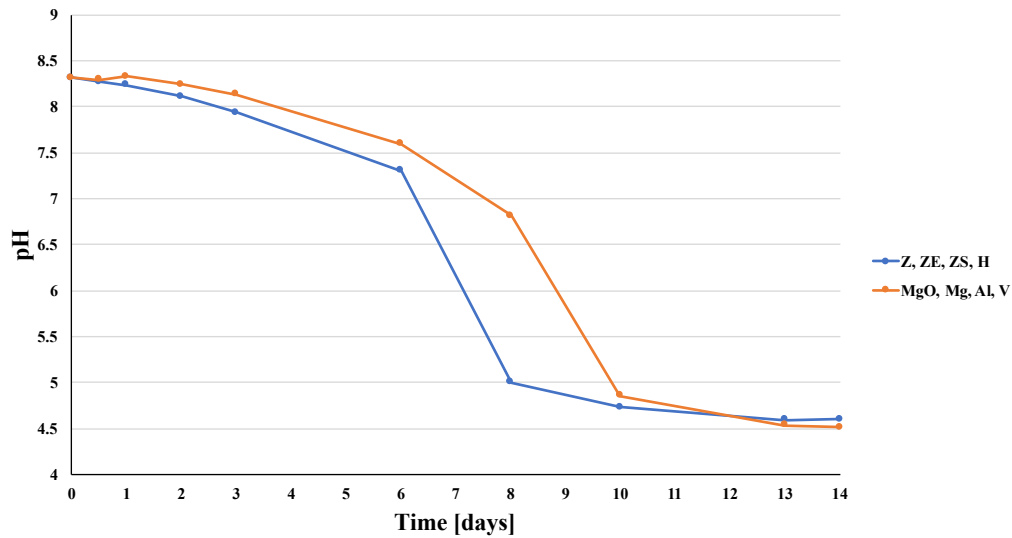
The pH development for both containers is shown in Figure 4.34. The pH of the electrolyte in the MgO-, Mg-, Al-silicate and the inorganic copolymer coating container decreased from 8.31 to 4.51 due to increased concentration of Al in the electrolyte. The corresponding value for the high Zn primer, Zn epoxy, Zn silicate and the modified Zn silicate was 8.31 to 4.60. Both containers revealed the same trend with relatively gentle decrease initially, a steeper decrease at the middle of the test period and no significant change at the end. Exact pH values are presented in Appendix F, Section F.1.

Figure 4.34: Development of the pH. The blue line represents the high Zn primer, Zn epoxy, Zn silicate and the modified Zn epoxy, while the orange line represents the MgO-, Mg-, Al-silicate and the inorganic copolymer coating.

The samples were divided into two containers during the test period and the same pH development was seen for both containers, see Figure 4.34. After respectively 7 and 9 days of exposure, the pH dropped before the values stabilized between pH 4.50 and 4.60. Aluminium oxide formed during corrosion of coated TSA appears unstable below pH 4, as stated in Section 2.2. Aluminium was exposed both from the TSA at the crevice openings, and the freely exposed Al silicate surface. Based on pH decrease, it was assumed that active corrosion of the aluminium had occurred. The test was finished after 14 days because the anodic current showed either decreasing or stabilizing values. The

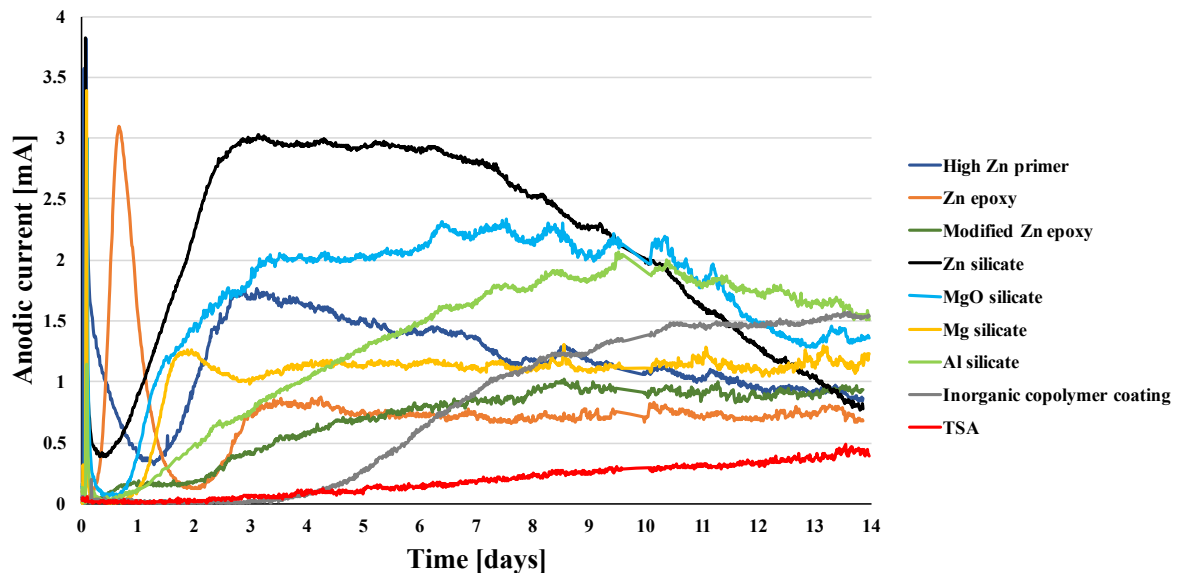
See Figure 4.35 for the anodic current measured during the test period. The Zn-, MgO-silicate and the high Zn primer revealed a steep increase early before the current decreased after some days. Mg silicate and Zn epoxy showed the same tendency of increase early, while the current stabilized instead of decreasing further. A high current peak was also seen for the Zn epoxy early. The anodic current for Al silicate increased steadily before a decrease was seen. The steady increase could also be seen for the TSA coated with epoxy, the inorganic copolymer coating and the modified Zn epoxy, without a decrease towards the end.

Figure 4.35: Anodic current for the repair coatings for test setup 1 with anodic current (y-axis) plotted against time (x-axis).

anodic current curves for all the repair coatings are shown in Figure 4.35. It was then assumed that the main corrosion processes had occurred, and that further corrosion would not lead to change in results.

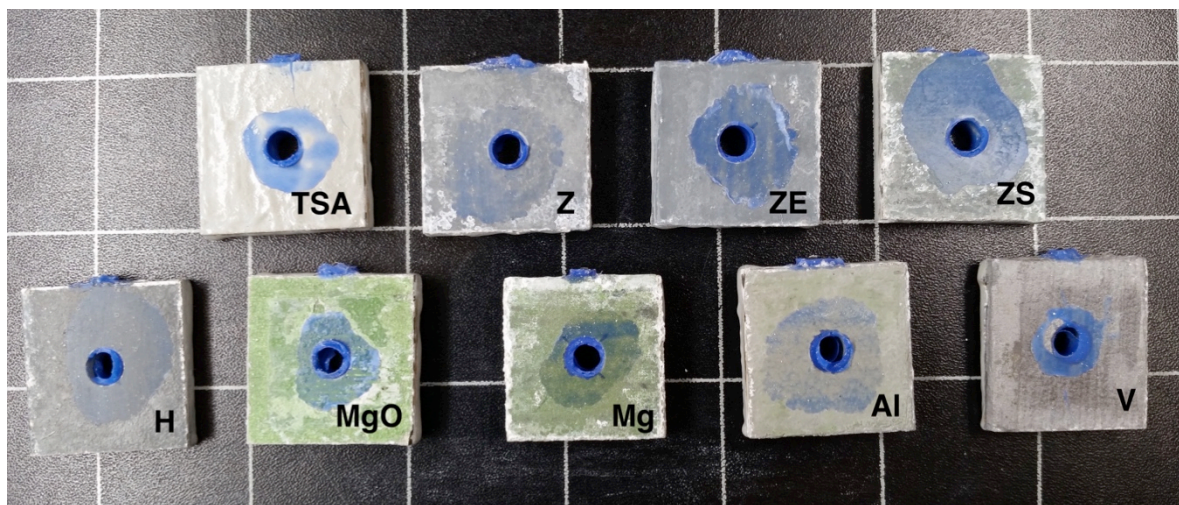
Test setup 2 was tested twice, with test periods of 16 days and 30 days. The 30 days test was conducted to have a parallel to the 16 days exposure. Only the test conducted for 16 days will be emphasized in this section, due to similar tendency of anodic current, pH development and corrosion of the TSA. However, the corrosion after 30 days was more severe due to longer exposure time. Test results obtained after 30 days are presented in Appendix F, Section F.2. All repair coatings were exposed in the same container. The samples tested for 16 days are presented in Figure 4.36. No blistering was seen after exposure.

Figure 4.36: Visual appearance of the samples after 16 days of exposure. The order of the repair coatings on the upper row is: TSA coated with epoxy (TSA), high Zn primer (Z), Zn epoxy (ZE) and Zn silicate (ZS). The order on the lower row is: modified Zn epoxy (H), MgO silicate (MgO), Mg silicate (Mg), Al silicate (Al) and the inorganic copolymer coating (V).

Table 4.6 presents the degree of corrosion for both TSA and the repair coating. Corrosion of the TSA is emphasized. The TSA corrosion was estimated from light microscope images presented in Appendix F, Section F.2. The “Blistering” evaluations are based on Figure 4.36. Highest degree of TSA corrosion was observed for the silicate coatings and the modified Zn epoxy. The high Zn primer, Zn epoxy and the inorganic copolymer coating showed TSA corrosion just at the crevice opening. A corroded field was also seen between the coating layers for the Zn epoxy. The inorganic copolymer coating, the epoxy applied on TSA and the MgO silicate did not contain active particles and the column “Amount of corroded metal particles” was therefore not estimated for these coatings. The results in Table 4.6 will be compared to the results obtained from the cyclic coating test, in Section 5.6.

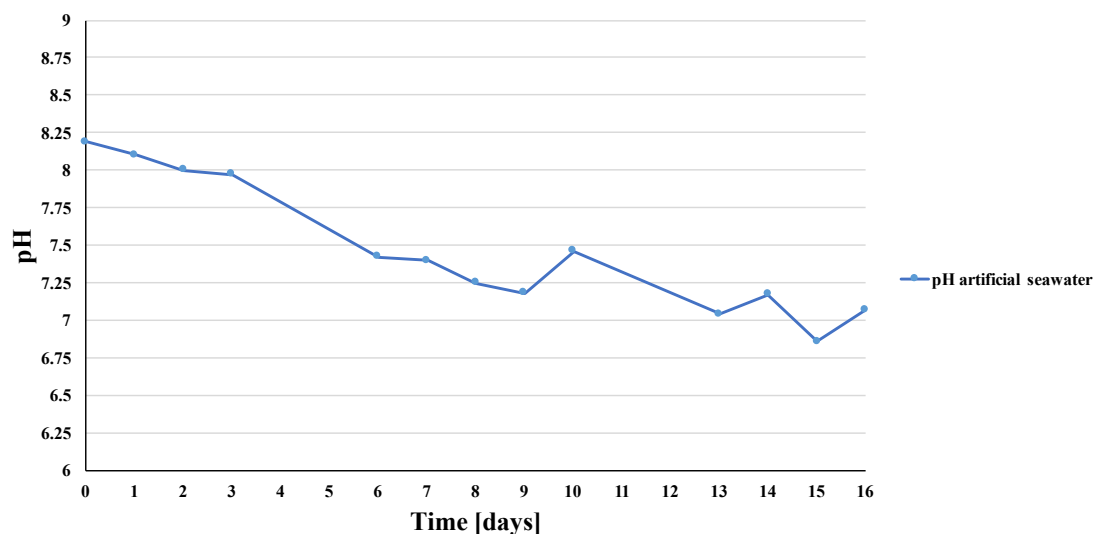
The pH development is presented in Figure 4.37. A general pH decrease from 8.19 to 7.07 was seen during the test period. Exact pH values are presented in Appendix F, Section F.2.

Figure 4.37: Development of the pH for the test run for 16 days.

Test setup 2 presented in Section 3.5.2 was run twice, respectively for 16 and 30 days. Only the test run for 16 days is presented in Section 4.5.2 due to similar trends of pH development, anodic current and corrosion degradation. However, the corrosion was more severe on the samples exposed for 30 days, but the tendency was consistent. A potential of -780 mV was applied. This potential was chosen in order to initiate corrosion reactions on the aluminium from the TSA, or the aluminium, magnesium or zinc from the repair coatings. The steel was then located in the immune region [21]. The pH decreased initially from 8.19 to 7.07. The decrease in pH was smaller and more gradual compared to test setup 1. No Al silicate surface was freely exposed in the electrolyte and the TSA was only exposed on the lateral sides of the samples. It was therefore assumed that the amount of aluminium ions was smaller in the electrolyte for test setup 2, compared to test setup 1. This caused smaller pH reduction. A potential of -700 mV was applied during test setup 1, while a potential of -780 mV was applied during test setup 2. More corrosion was therefore initiated during test setup 1 due to more positive potential, and less pH decrease was seen during test setup 2. The tests were completed when the anodic current showed decreasing or stabilizing values as explained for test setup 1. The pH development and anodic current are presented in Figure 4.37 and Figure 4.38.

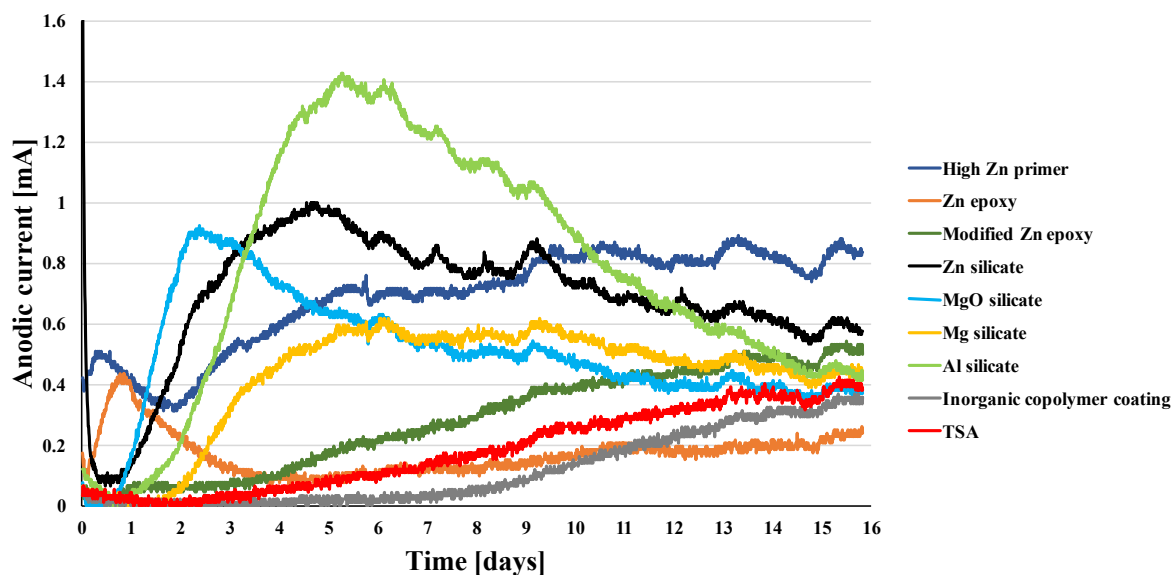
See Figure 4.38 for the anodic current measured during the test period. The Zn-, MgO- and Al-silicate showed a current increase before a decrease towards the end of the test. The Mg silicate showed the same trend with initial increase, but the decrease was gentler towards the end of the test. The high Zn primer and the Zn epoxy revealed both a current increase and decrease, before an increase towards the end of the test. The anodic current for the modified Zn epoxy, the TSA coated with epoxy and the inorganic copolymer coating showed a steady increase from the test initiation.

Figure 4.38: Anodic current for the repair coatings for the test setup run for 16 days with anodic current (y-axis) plotted against time (x-axis).

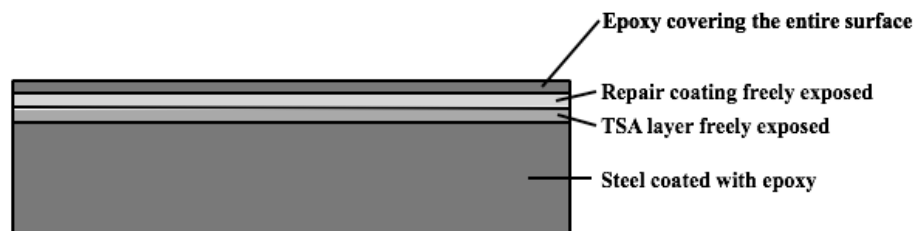
- Further development of the design regarding the short-term crevice corrosion test should be carried out to be able to actually test the TSA crevice corrosion mechanism for the various repair coatings. Steel samples coated with TSA and the repair coatings may be fully coated with epoxy, except for the entire lateral sides. Figure 7.1 shows the lateral side of the sample with freely exposed TSA and repair coating. No steel or freely exposed surface on top of the samples will then be exposed, except for the cross sectional coating layers. Other potentials than -700 mV and -780 mV vs. Ag/AgCl should be applied.

Figure 7.1: Proposal for further work regarding the crevice corrosion design.

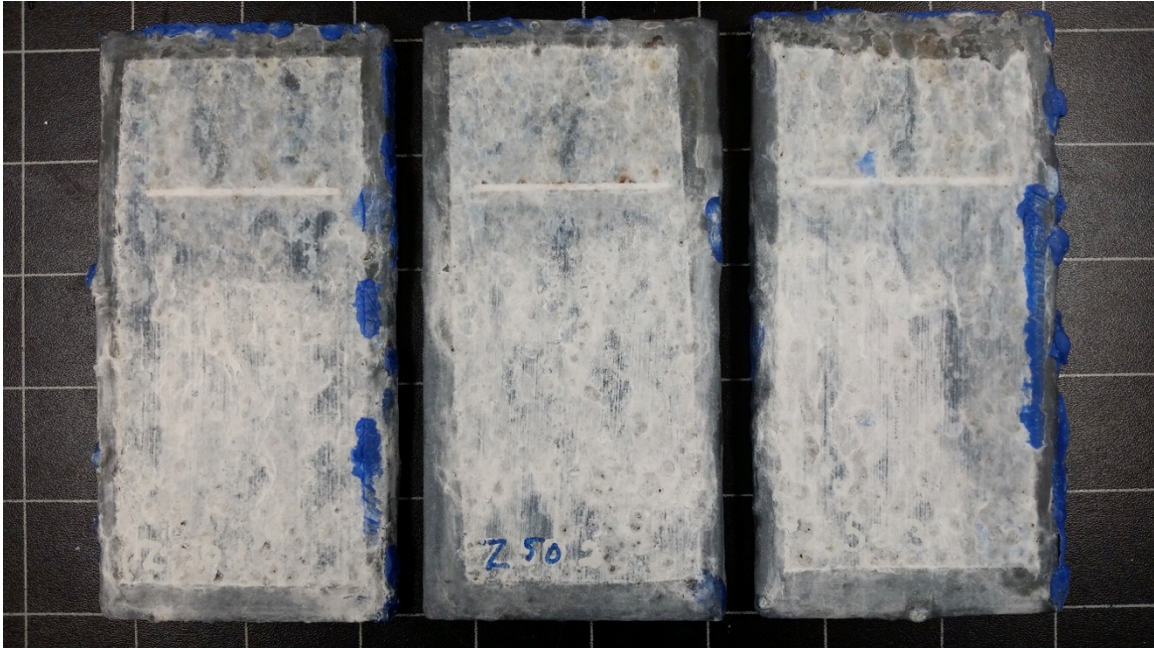
#### DFT 50 $\mu\text{m}$

Figure B.1: Visual appearance of the high Zn primer with DFT 50  $\mu\text{m}$  after 20 cycles of exposure.

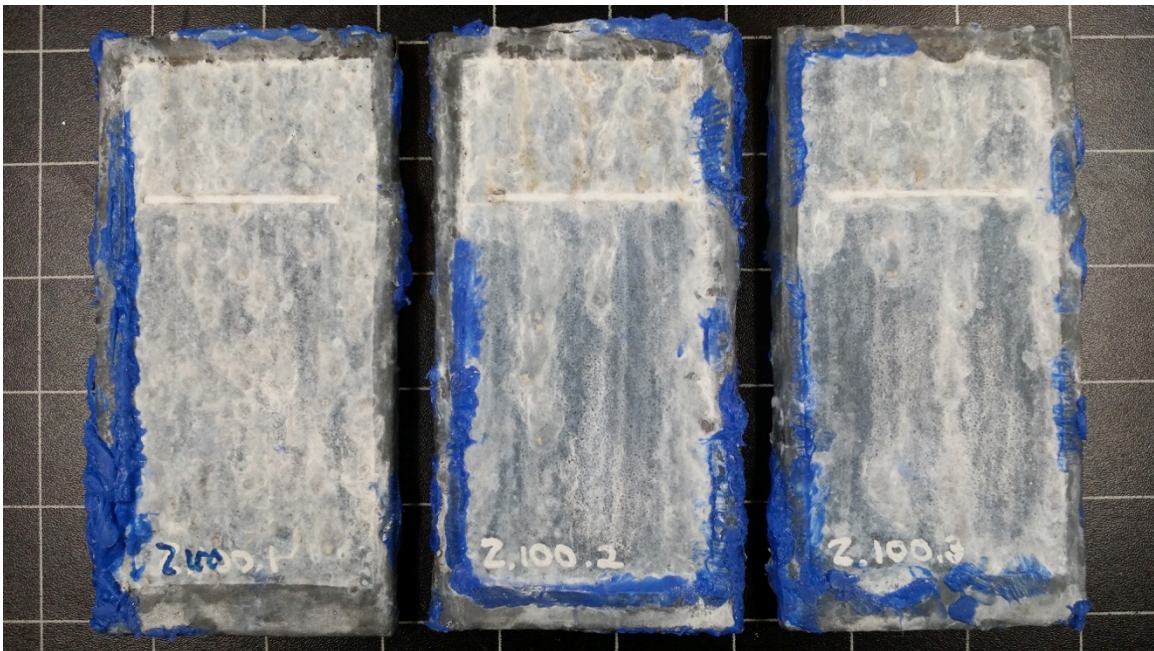
#### DFT 100 $\mu\text{m}$

Figure B.2: Visual appearance of the high Zn primer with DFT 100  $\mu\text{m}$  after 20 cycles of exposure.

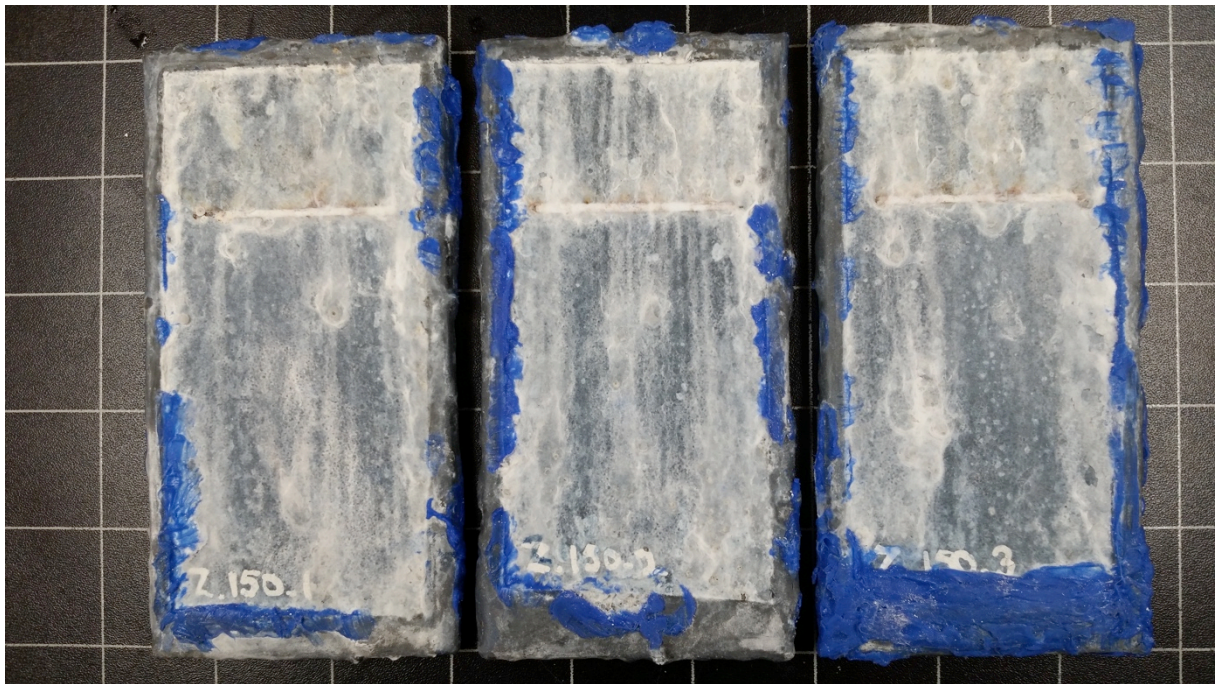
**DFT 150  $\mu$ m**

Figure B.3: Visual appearance of the high Zn primer with DFT 150  $\mu$ m after 20 cycles of exposure.

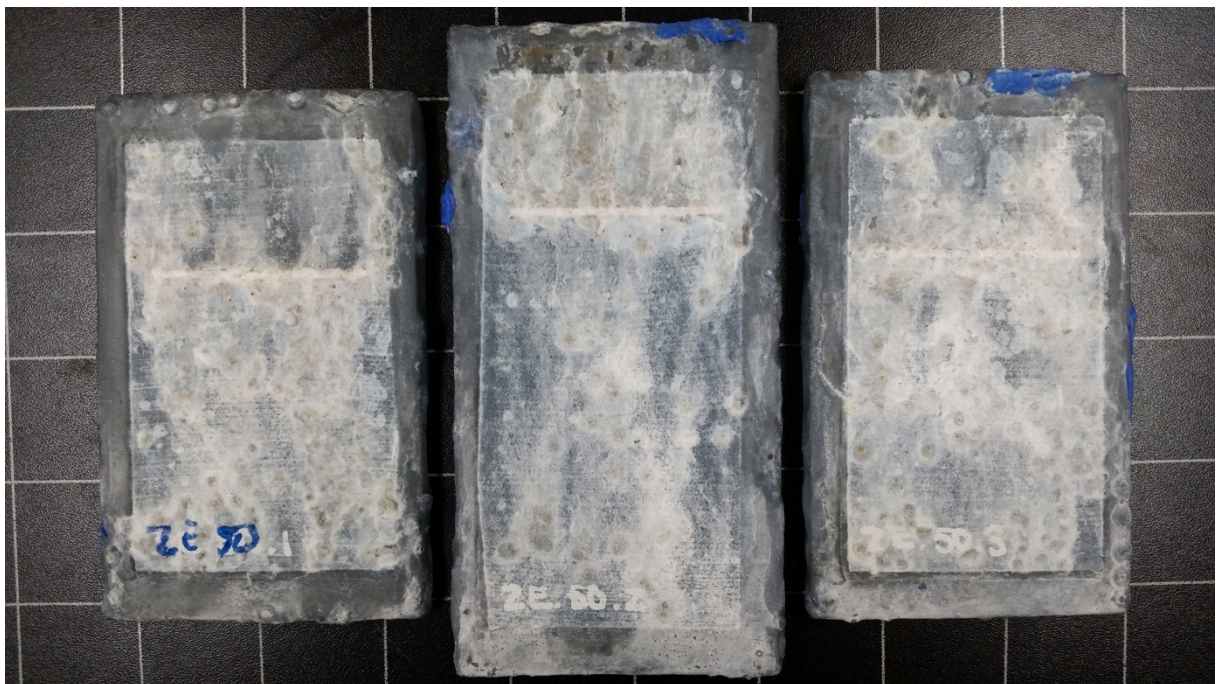
**DFT 50  $\mu$ m**

Figure B.4: Visual appearance of the Zn epoxy with DFT 50  $\mu$ m after 20 cycles of exposure.

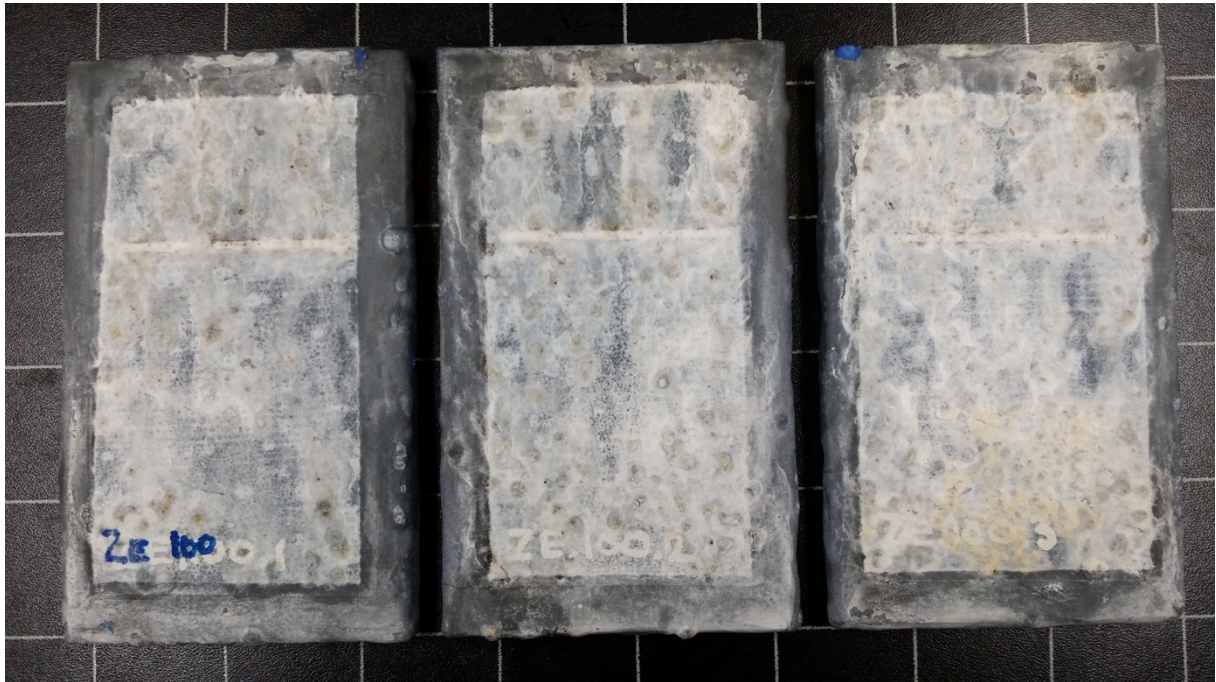
**DFT 100  $\mu$ m**

Figure B.5: Visual appearance of the Zn epoxy with DFT 100  $\mu$ m after 20 cycles of exposure.

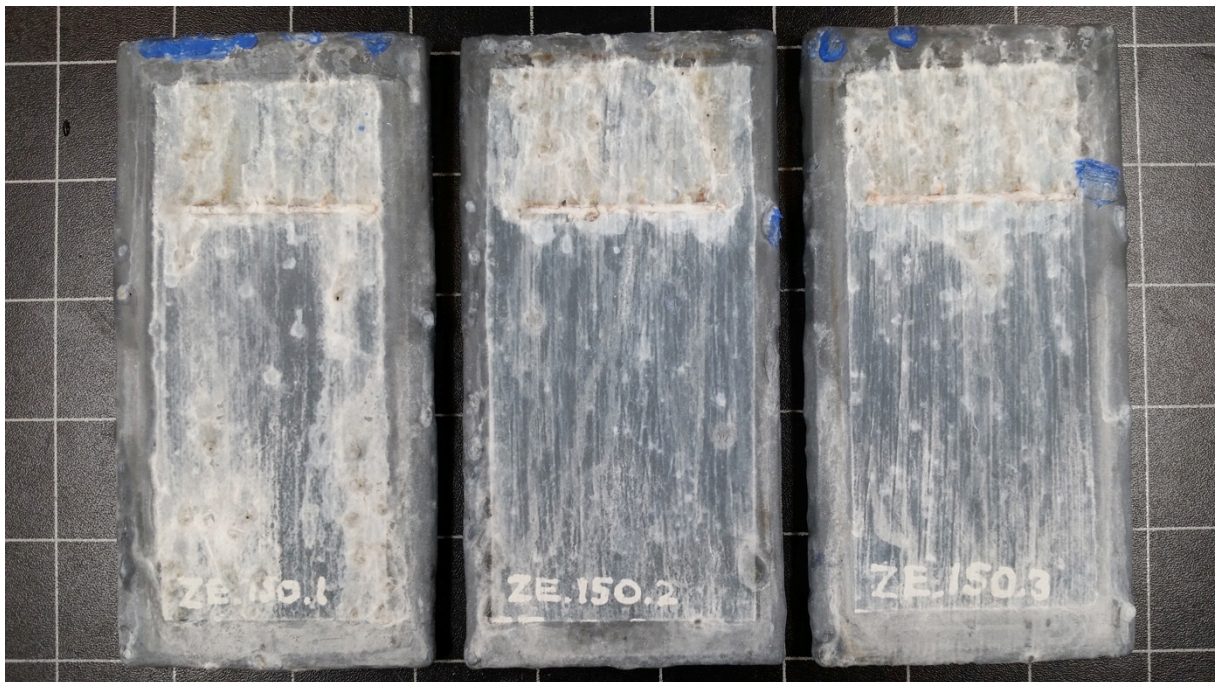
**DFT 150  $\mu$ m**

Figure B.6: Visual appearance of the Zn epoxy with DFT 150  $\mu$ m after 20 cycles of exposure.

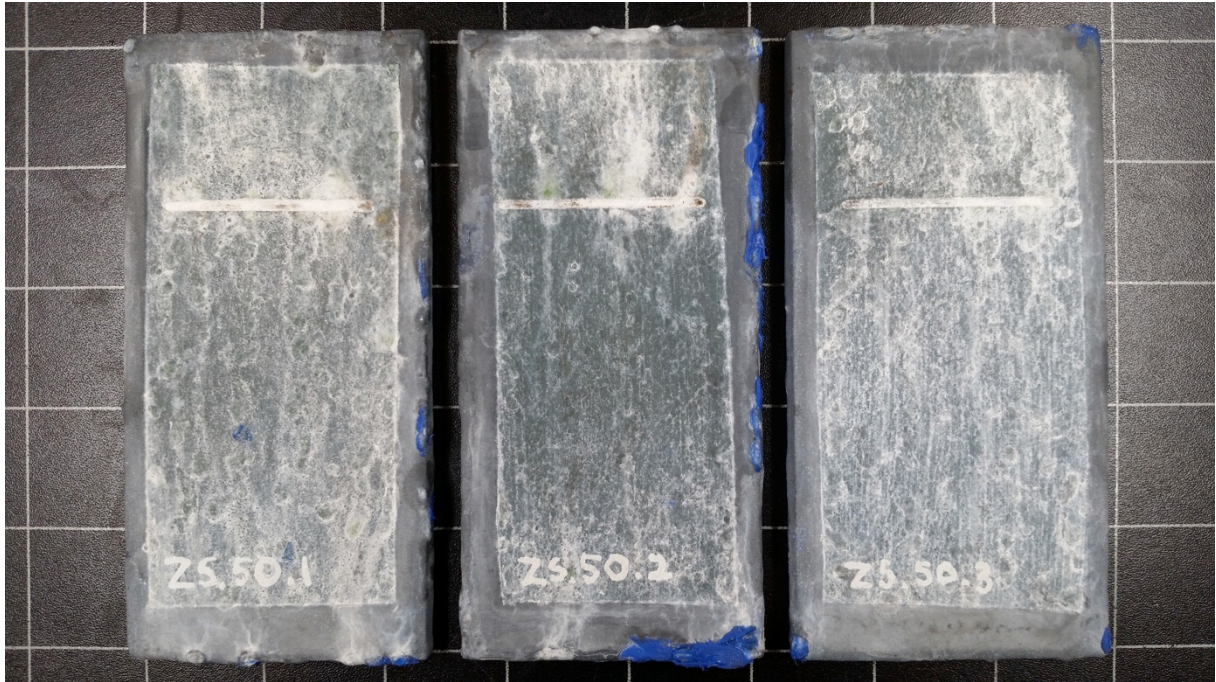
**DFT 50  $\mu\text{m}$**

Figure B.7: Visual appearance of the Zn silicate with DFT 50  $\mu\text{m}$  after 20 cycles of exposure.

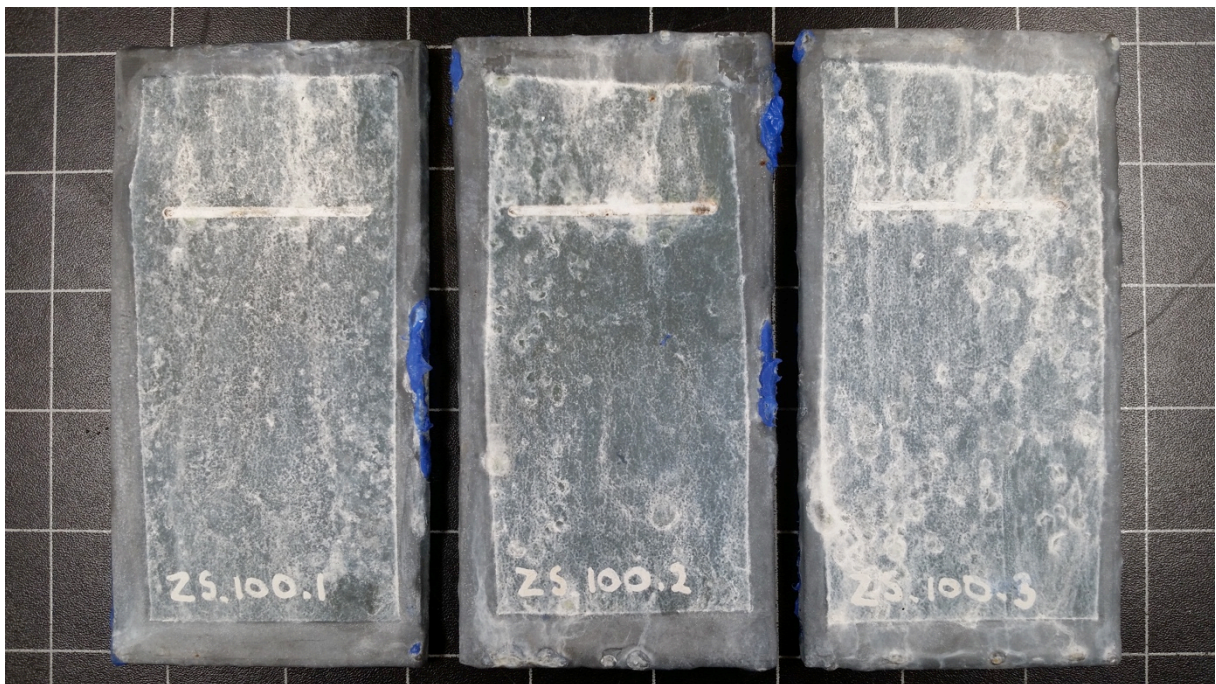
**DFT 100  $\mu\text{m}$**

Figure B.8: Visual appearance of the Zn silicate with DFT 100  $\mu\text{m}$  after 20 cycles of exposure.

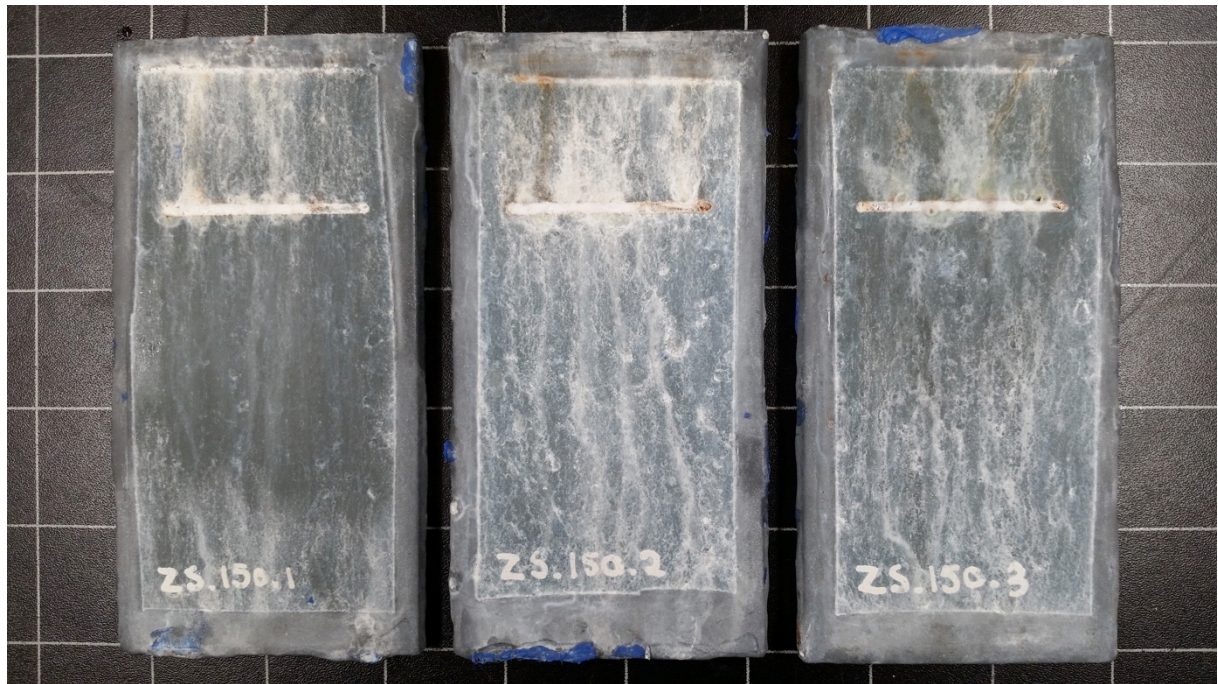
**DFT 150  $\mu\text{m}$**

Figure B.9: Visual appearance of the Zn silicate with DFT 150  $\mu\text{m}$  after 20 cycles of exposure.

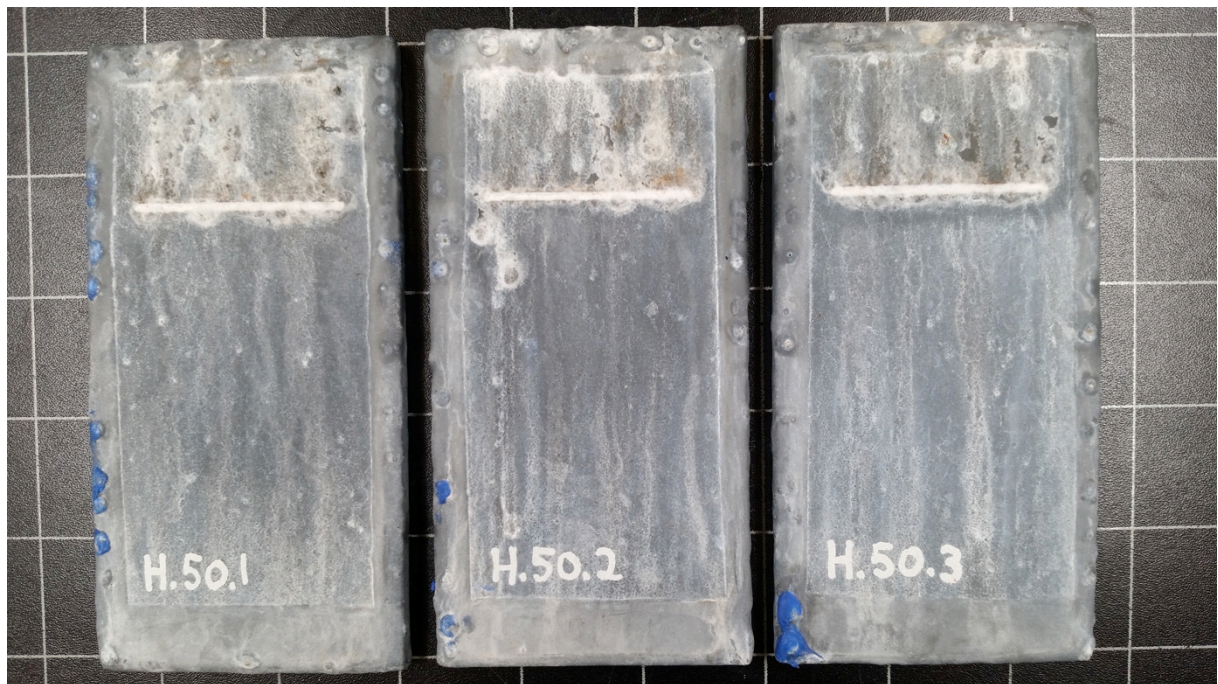
**DFT 50  $\mu\text{m}$**

Figure B.10: Visual appearance of the modified Zn epoxy with DFT 50  $\mu\text{m}$  after 20 cycles of exposure.

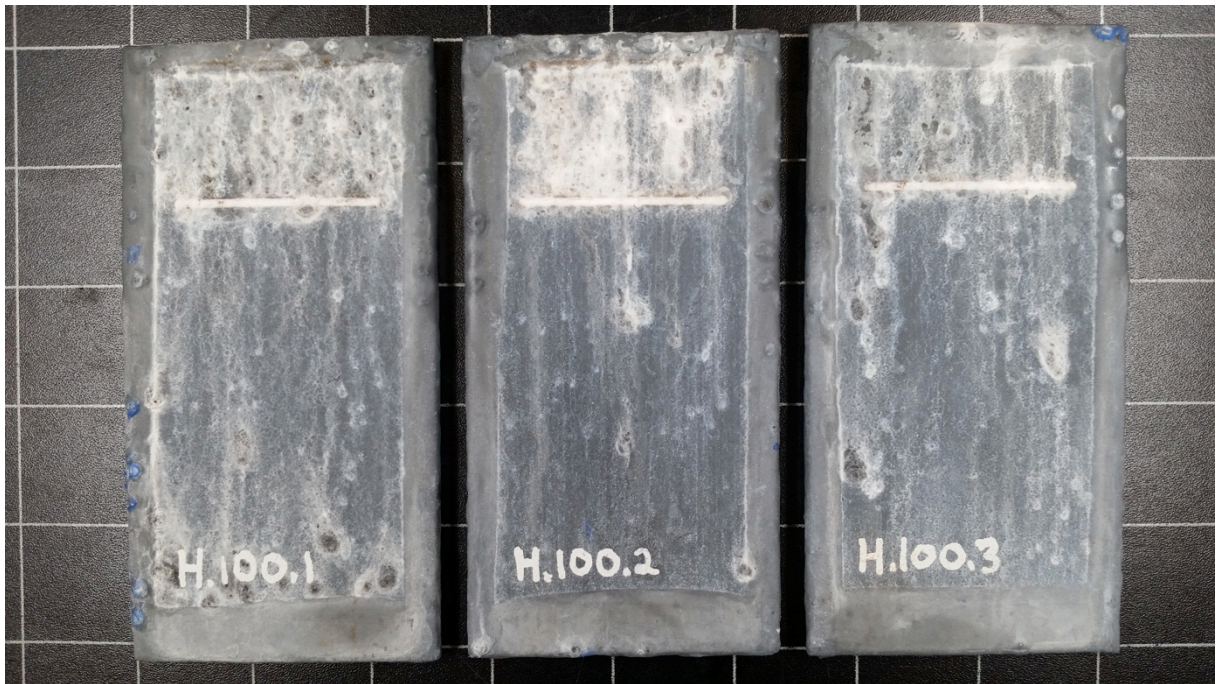
**DFT 100  $\mu\text{m}$**

Figure B.11: Visual appearance of the modified Zn epoxy with DFT 100  $\mu\text{m}$  after 20 cycles of exposure.
