# Repair Coatings for Thermally Sprayed Aluminium

Materials Science and Engineering

Submission date: June 2016

**Repair coatings for thermally sprayed aluminium**

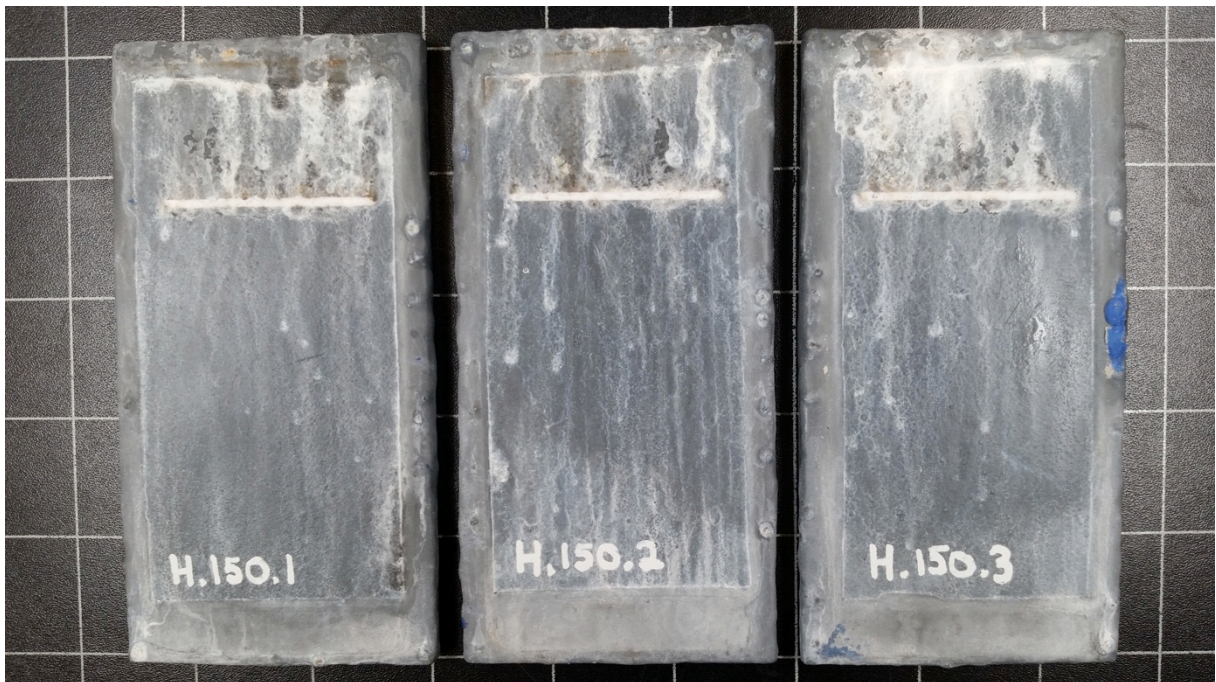
**DFT 150  $\mu\text{m}$**

Figure B.12: Visual appearance of the modified Zn epoxy with DFT 150  $\mu\text{m}$  after 20 cycles of exposure.

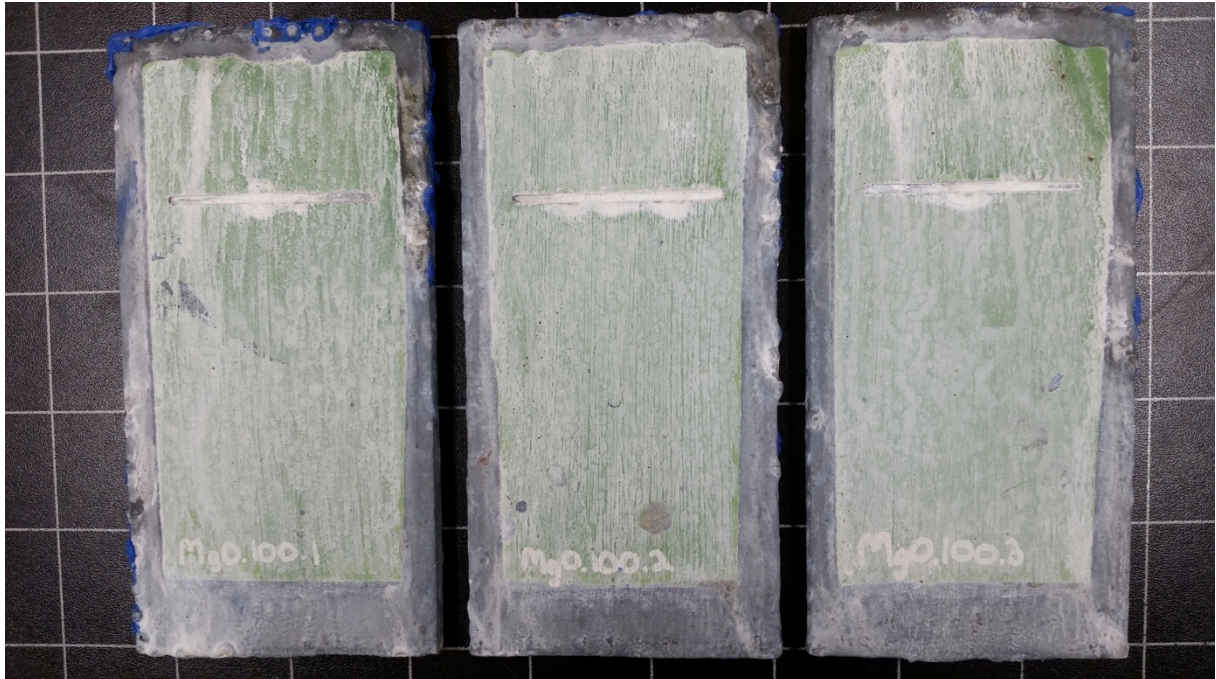
**DFT 100  $\mu\text{m}$**

Figure B.13: Visual appearance of the MgO silicate with DFT 100  $\mu\text{m}$  after 20 cycles of exposure.

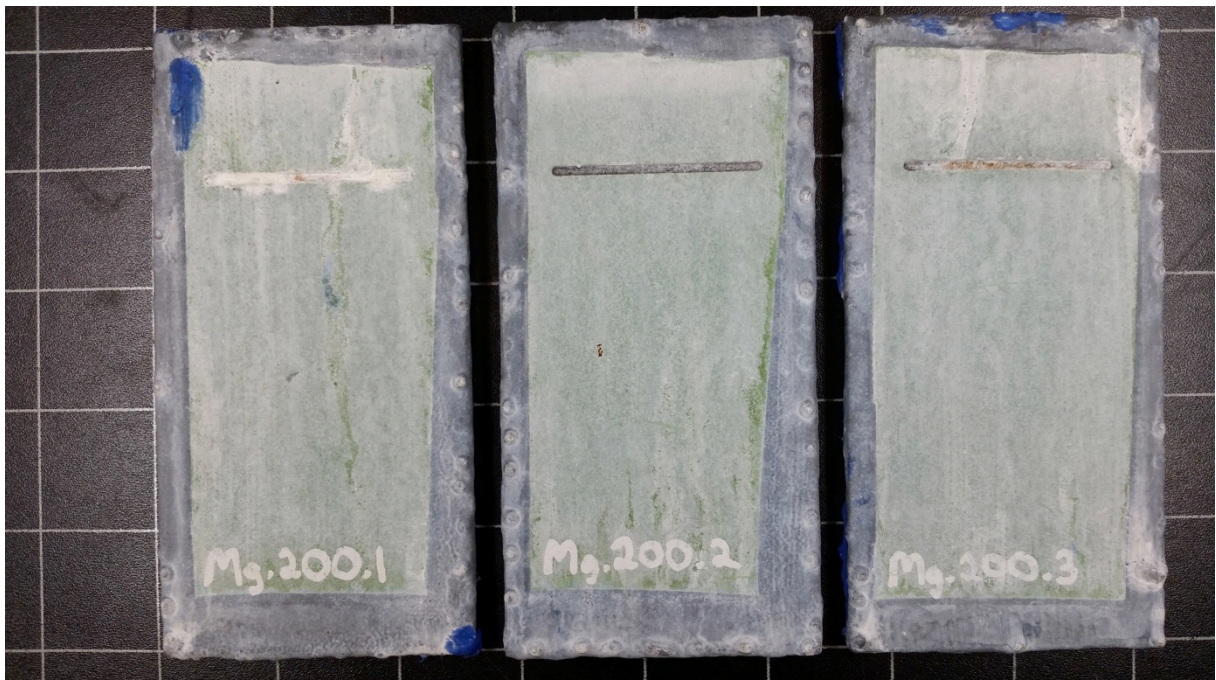
**DFT 200  $\mu\text{m}$**

Figure B.14: Visual appearance of the Mg silicate with DFT 200  $\mu\text{m}$  after 20 cycles of exposure.

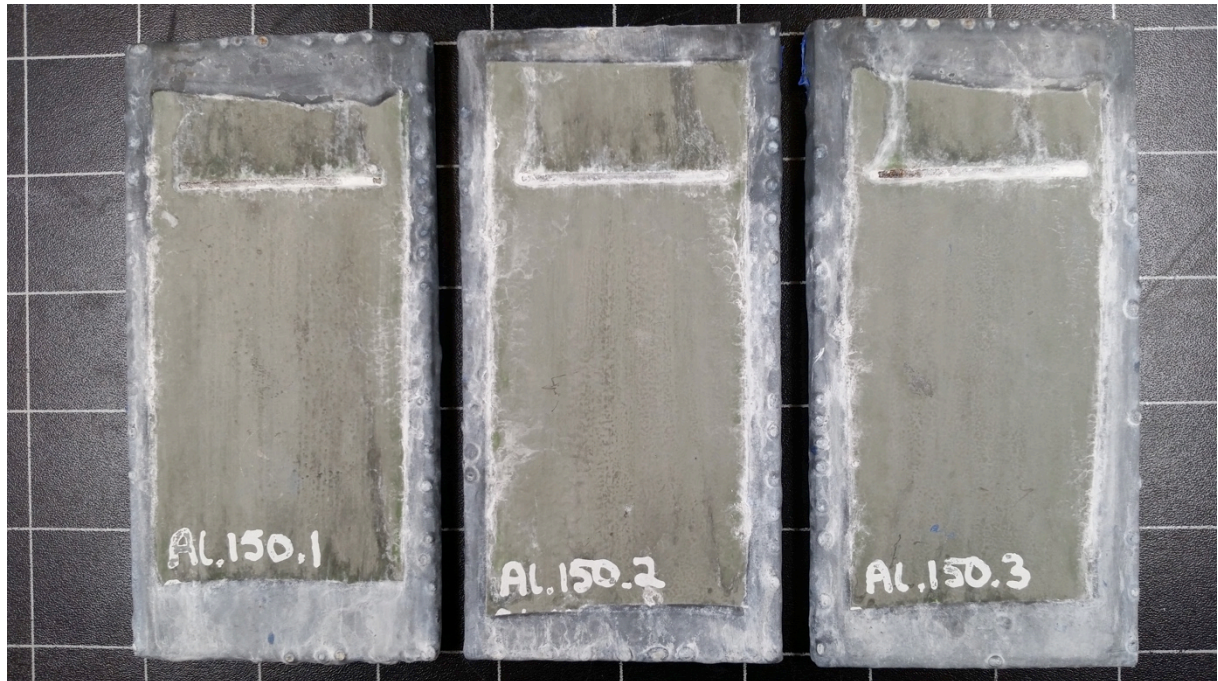
**DFT 150  $\mu\text{m}$**

Figure B.15: Visual appearance of the Al silicate with DFT 150  $\mu\text{m}$  after 20 cycles of exposure.

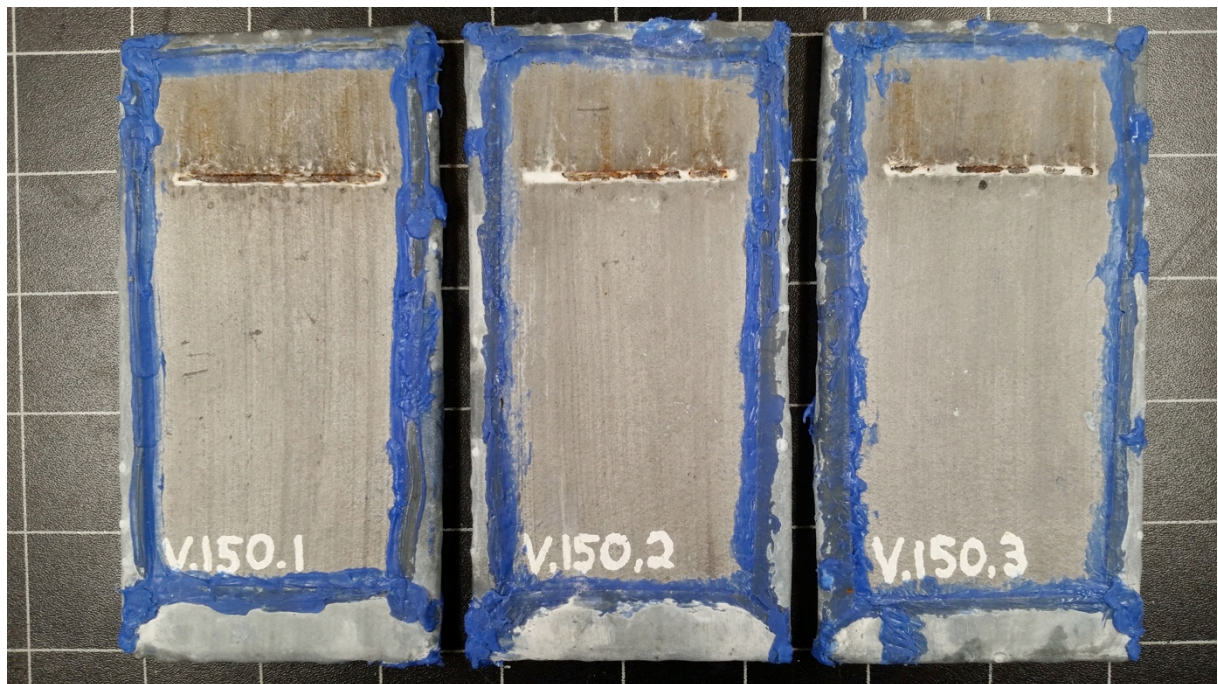
**DFT 150  $\mu\text{m}$**

Figure B.16: Visual appearance of the inorganic copolymer coating with DFT 150  $\mu\text{m}$  after 20 cycles of exposure.

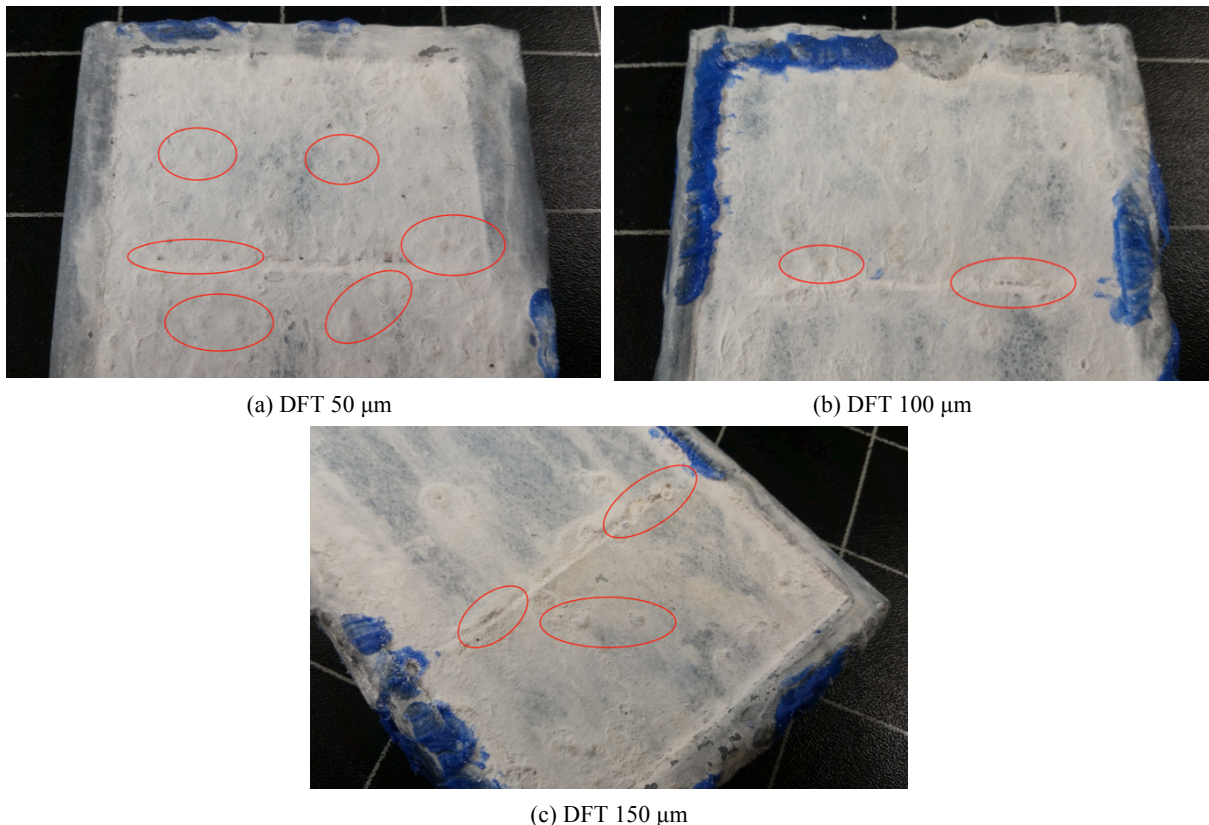
The inorganic copolymer coating is only shown in Section 4.2.1. Figure B.17 presents the blistering and cracking of the high Zn primer for DFT 50  $\mu\text{m}$  (a), DFT 100  $\mu\text{m}$  (b) and DFT 150  $\mu\text{m}$  (c). The DFT 50  $\mu\text{m}$  are also shown in Section 4.2.1. Highest amount of visual blistering was seen on the DFT 50  $\mu\text{m}$ , while DFT 100  $\mu\text{m}$  and 150  $\mu\text{m}$  showed both blistering and cracking of the repair coating. The pictures present the samples after 20 cycles of exposure and the blistering was concentrated around the scribe. The blistering and the cracking of the topcoat are marked with red circles.

Figure B.17: Blistering near the scribe on the high Zn primer DFT 50  $\mu\text{m}$  (a), in addition to blistering and cracking of the topcoat on DFT 100  $\mu\text{m}$  (b) and DFT 150  $\mu\text{m}$  (c). The pictures are taken after 20 cycles of exposure.

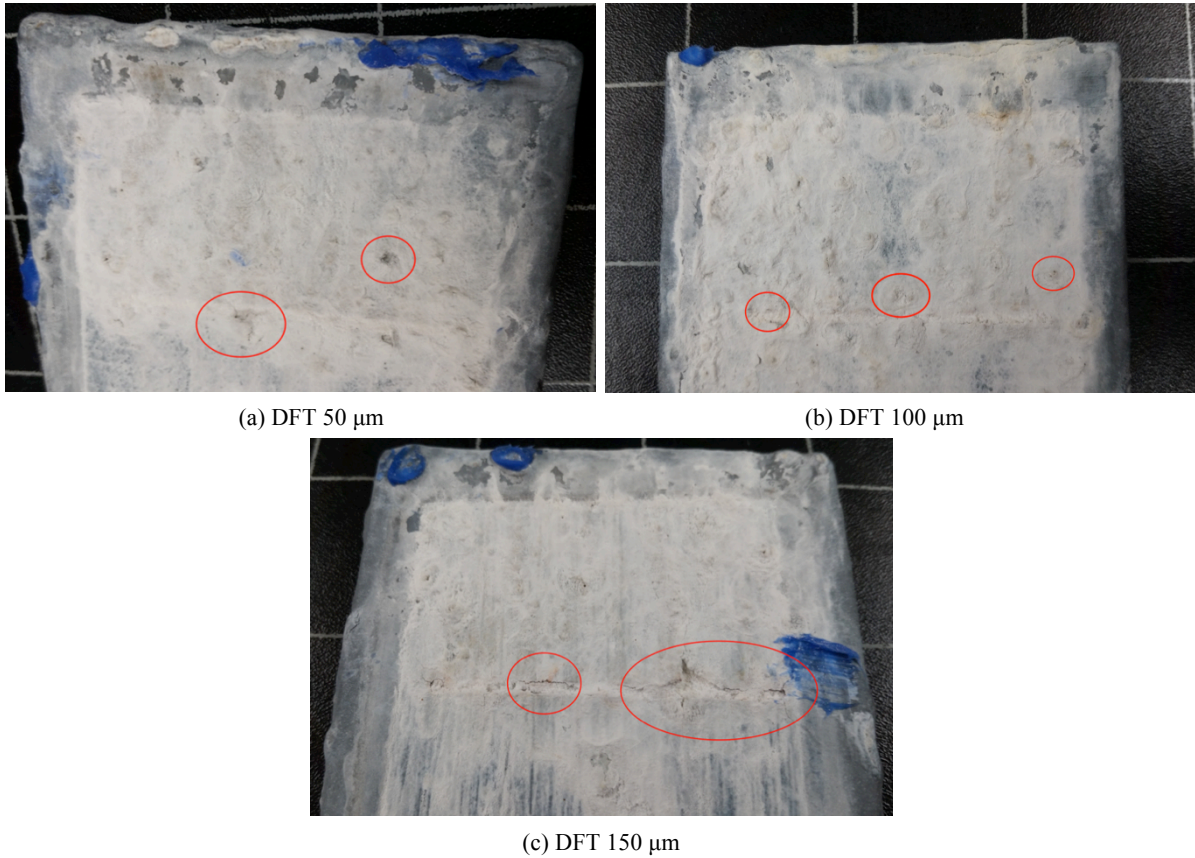
Blistering on the Zn epoxy DFT 150  $\mu\text{m}$  was seen after 4 cycles of exposure. The 100  $\mu\text{m}$  and 50  $\mu\text{m}$  samples revealed blistering after 5 and 6 cycles respectively. The blistering on the Zn epoxy DFT 50  $\mu\text{m}$  (a), DFT 100  $\mu\text{m}$  (b) and DFT 150  $\mu\text{m}$  (c) are presented in Figure B.18. The DFT 150  $\mu\text{m}$  are also shown in Section 4.2.1.

Figure B.18: Blistering and cracking of the topcoat near the scribe on the Zn epoxy DFT 50  $\mu\text{m}$  (a), DFT 100  $\mu\text{m}$  (b) and DFT 150  $\mu\text{m}$  (c). The pictures are taken after 20 cycles of exposure.

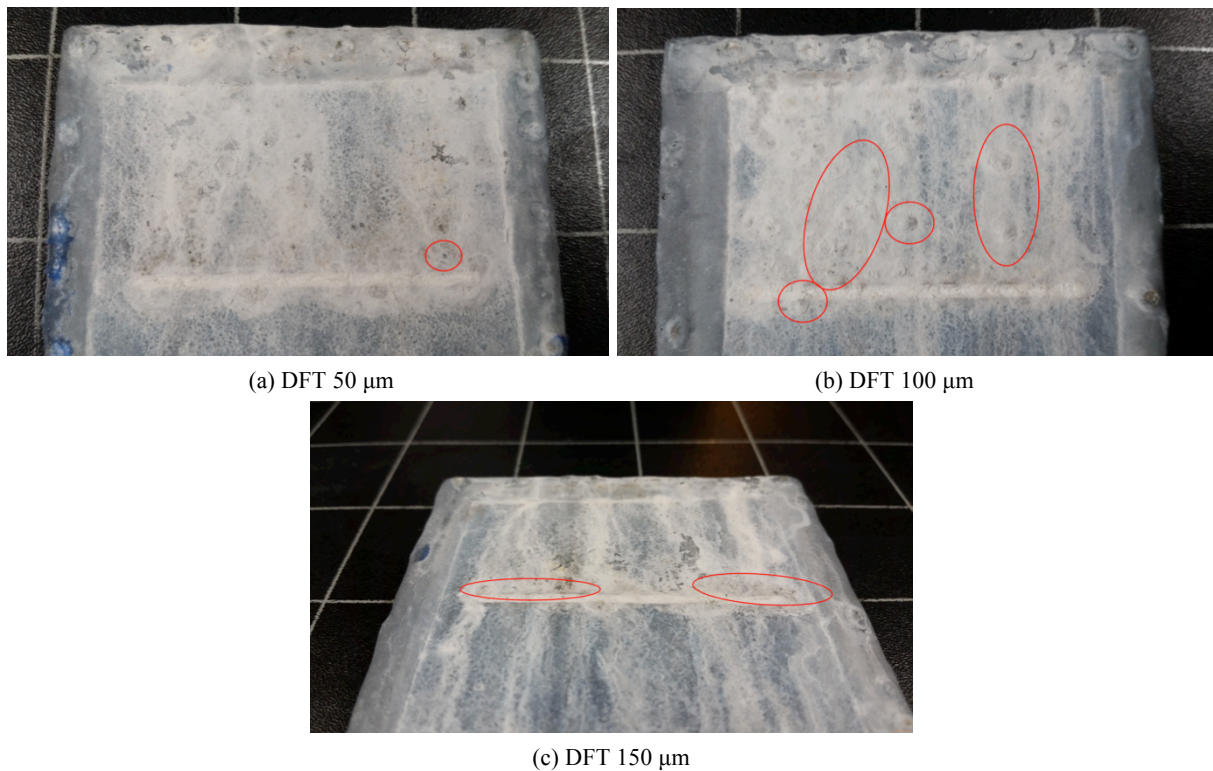
Blistering on the modified Zn epoxy DFT 150  $\mu\text{m}$  occurred after 13 cycles of exposure. See Figure B.19 for blistering on the DFT 50  $\mu\text{m}$  (a), DFT 100  $\mu\text{m}$  (b) and 150  $\mu\text{m}$  (c). The blistering on the DFT 100  $\mu\text{m}$  and 50  $\mu\text{m}$  was first discovered after the test was terminated. The modified Zn epoxy had less comprehensive blistering tendency compared to the other repair coatings that showed blistering.

Figure B.19: Blistering near the scribe on the modified Zn epoxy DFT 50  $\mu\text{m}$  (a) and DFT 100  $\mu\text{m}$  (b), in addition to both blistering and cracking of the topcoat on DFT 150  $\mu\text{m}$  (c). The pictures are taken after 20 cycles of exposure.

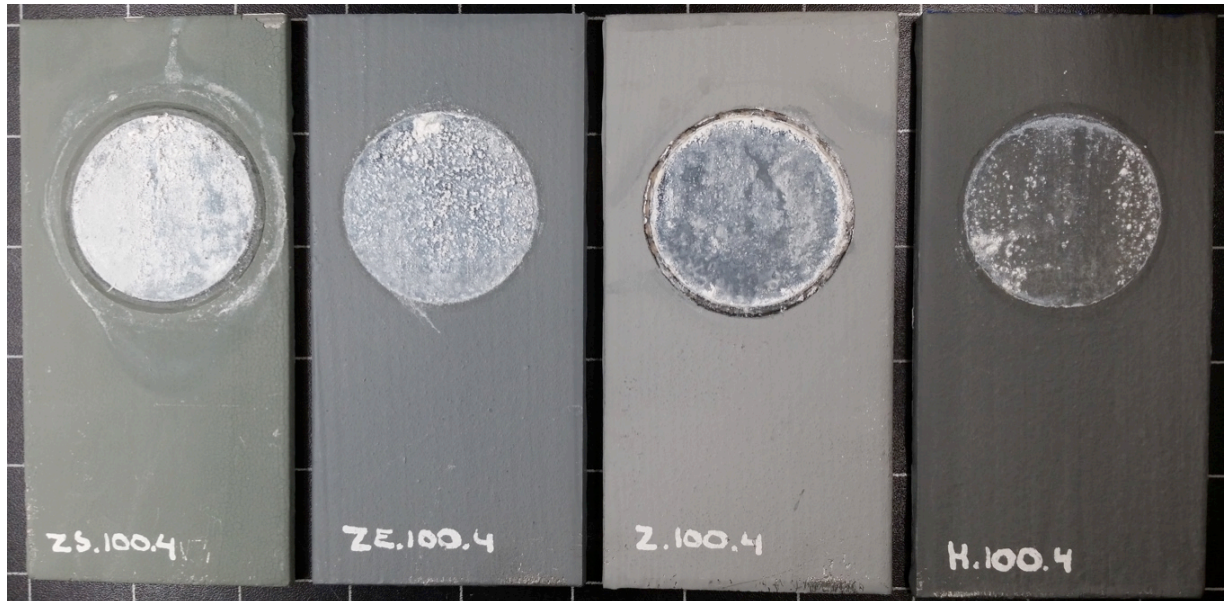
Figure D.1 and Figure D.2 present the samples after exposure. The amount of corrosion products formed on the exposed surface diverges between the different repair coatings. The number stated on each sample after the labeling, i.e. 100, 150 or 200, represents the average dry film thickness of the coatings.

Figure D.1: Samples coated with respectively Zn silicate (ZS), Zn epoxy (ZE), high Zn primer (Z) and modified Zn epoxy (H). The exposed surface area is where the white corrosion products are present.

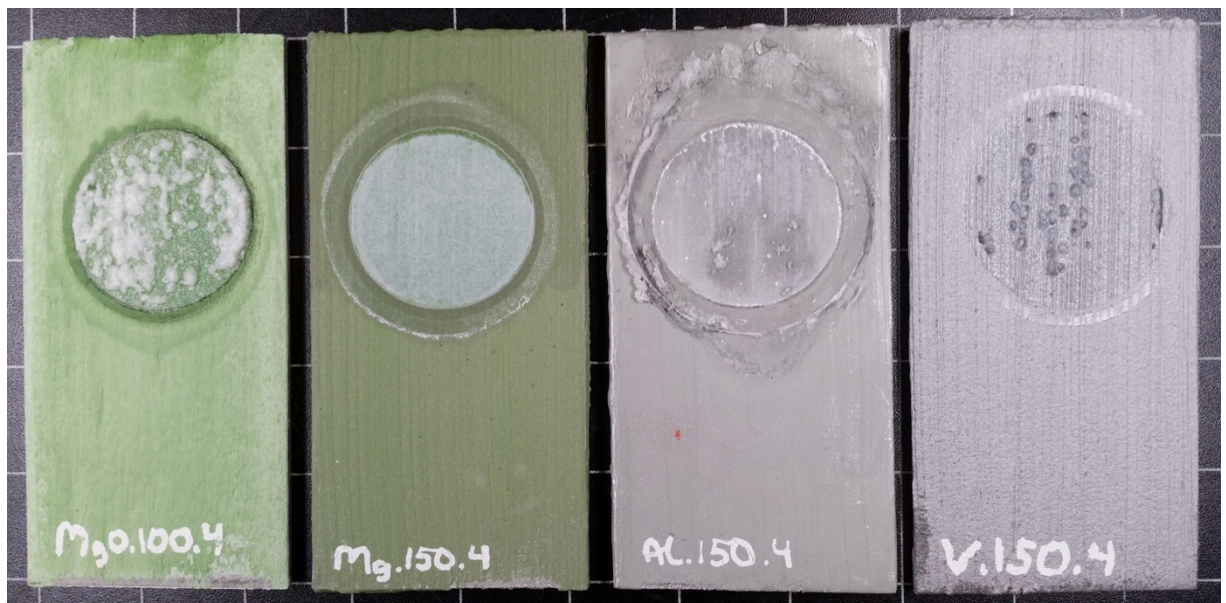
Figure D.2: Samples coated with respectively MgO silicate (MgO), Mg silicate (Mg), Al silicate (Al) and the inorganic copolymer coating (V). The exposed surface area is where the white corrosion products are present. The number 150 stated on the Mg silicate should be changed to 200.

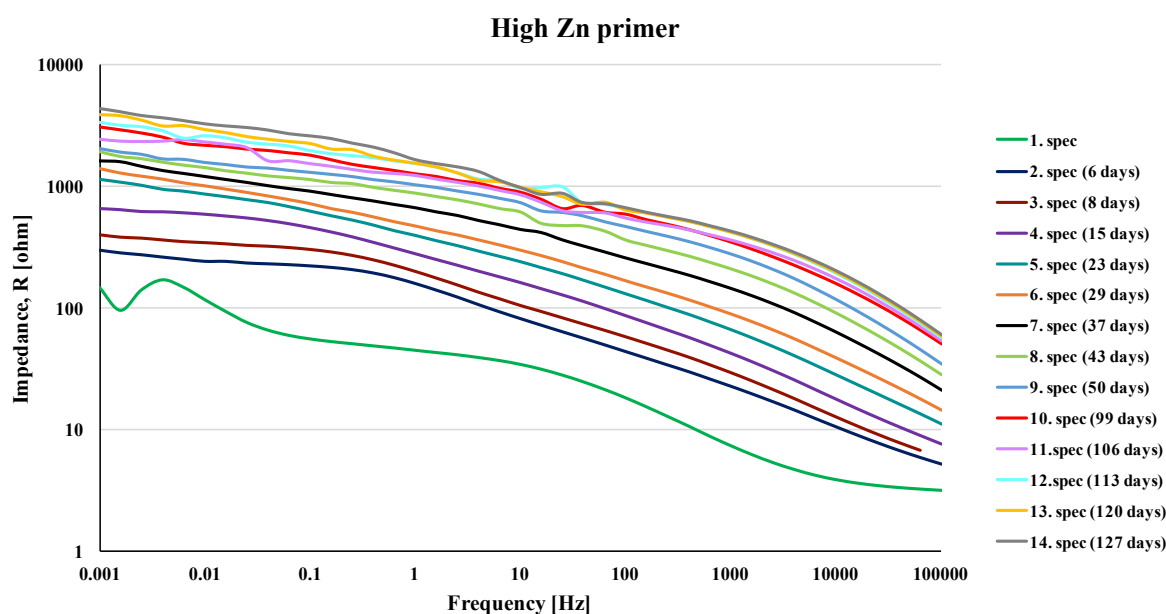
Figure D.3: Electrochemical impedance (y-axis) plotted against frequency (x-axis) for the high Zn primer. 14 spectra were taken, and the numbers stated in the parentheses indicate the number of days from test initiation.

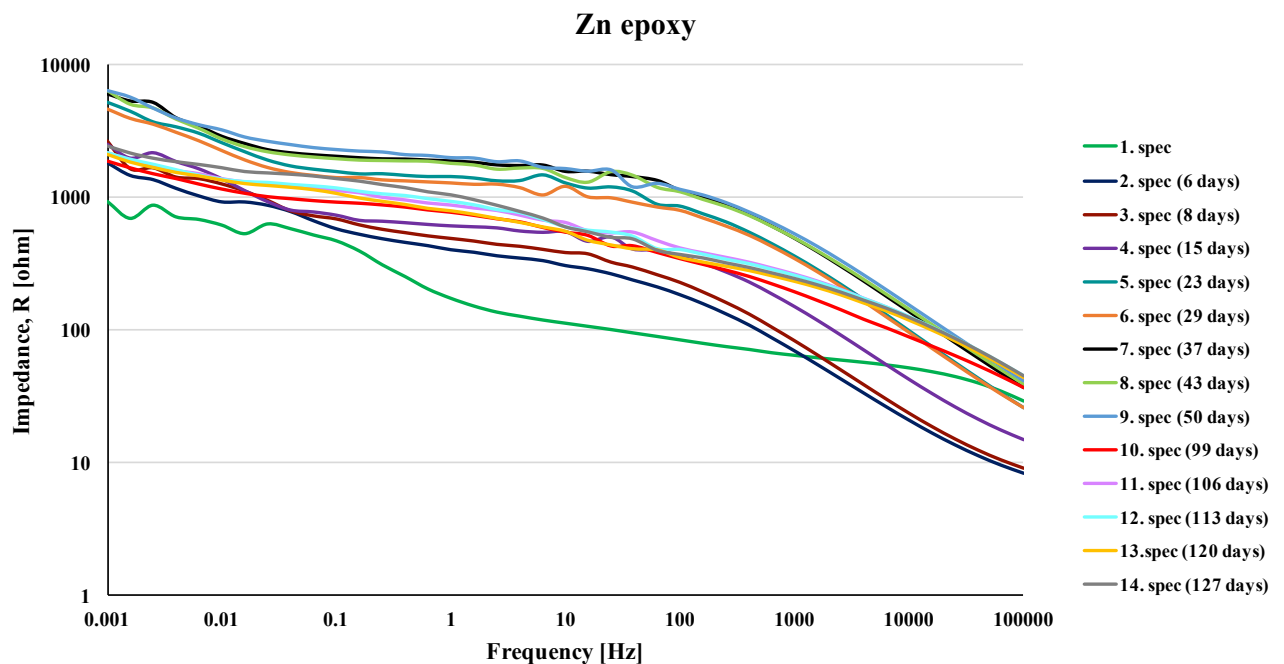
Figure D.4: Electrochemical impedance (y-axis) plotted against frequency (x-axis) for the Zn epoxy. 14 spectra were taken, and the numbers stated in the parentheses indicate the number of days from test initiation.

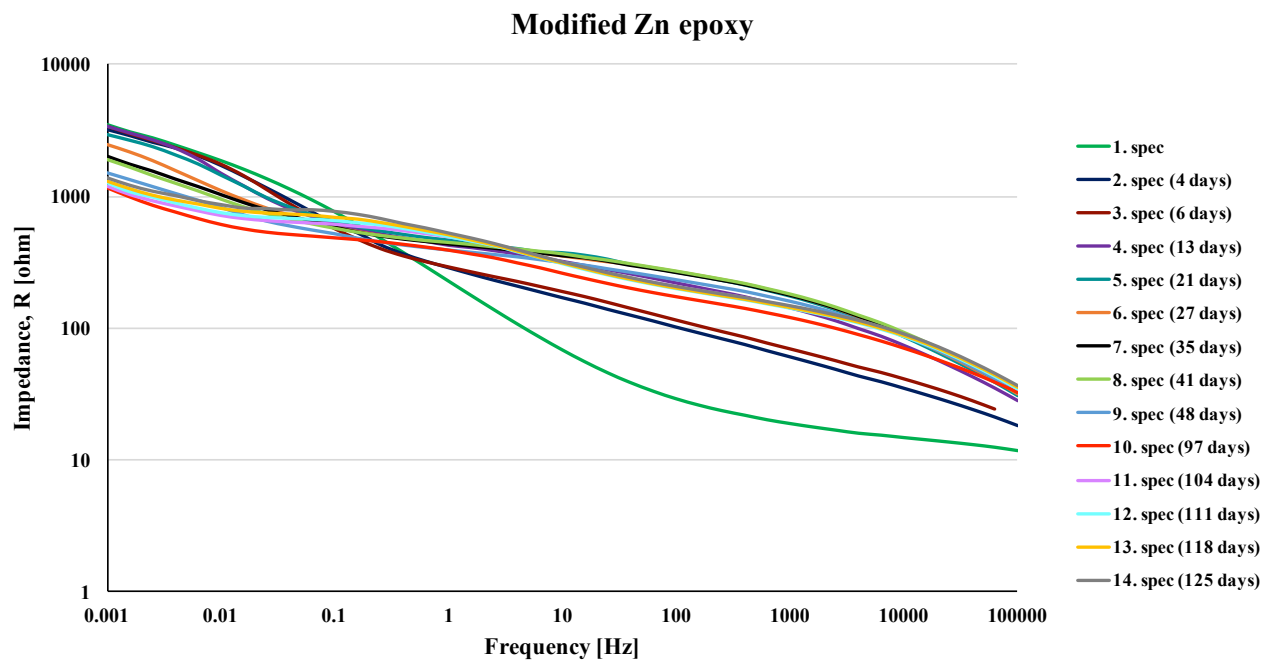
Figure D.5: Electrochemical impedance (y-axis) plotted against frequency (x-axis) for the modified Zn epoxy. 14 spectra were taken, and the numbers stated in the parentheses indicate the number of days from test initiation.

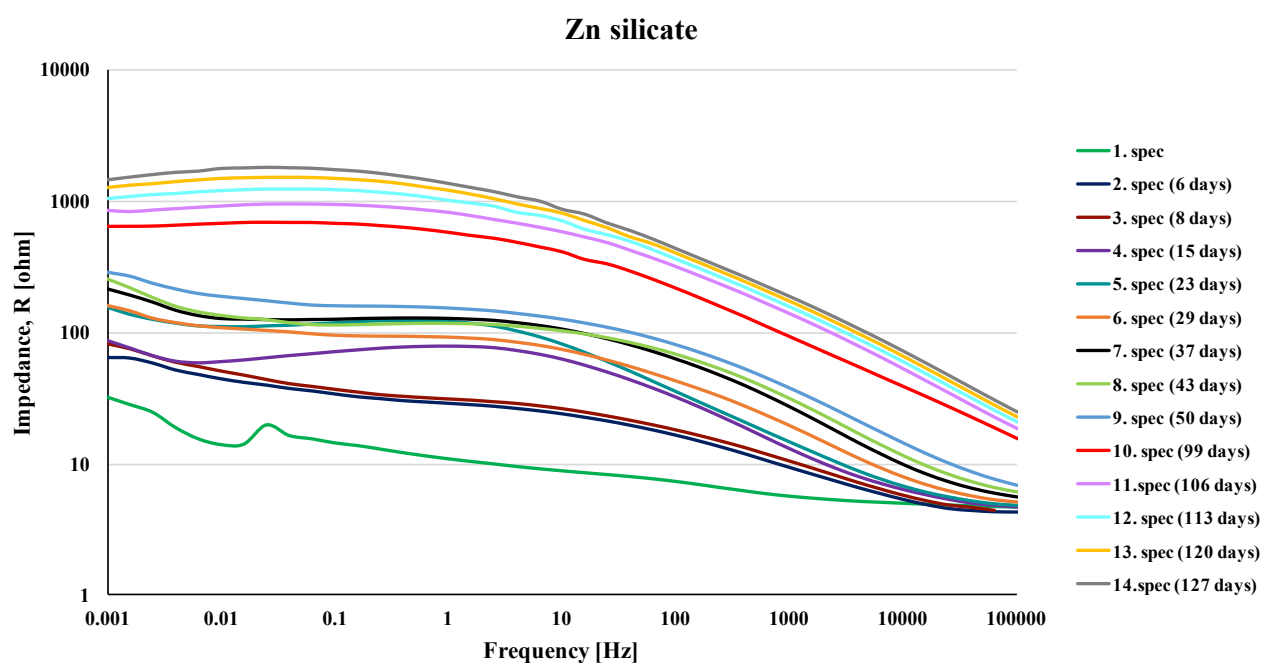
Figure D.6: Electrochemical impedance (y-axis) plotted against frequency (x-axis) for the Zn silicate. 14 spectra were taken, and the numbers stated in the parentheses indicate the number of days from test initiation.

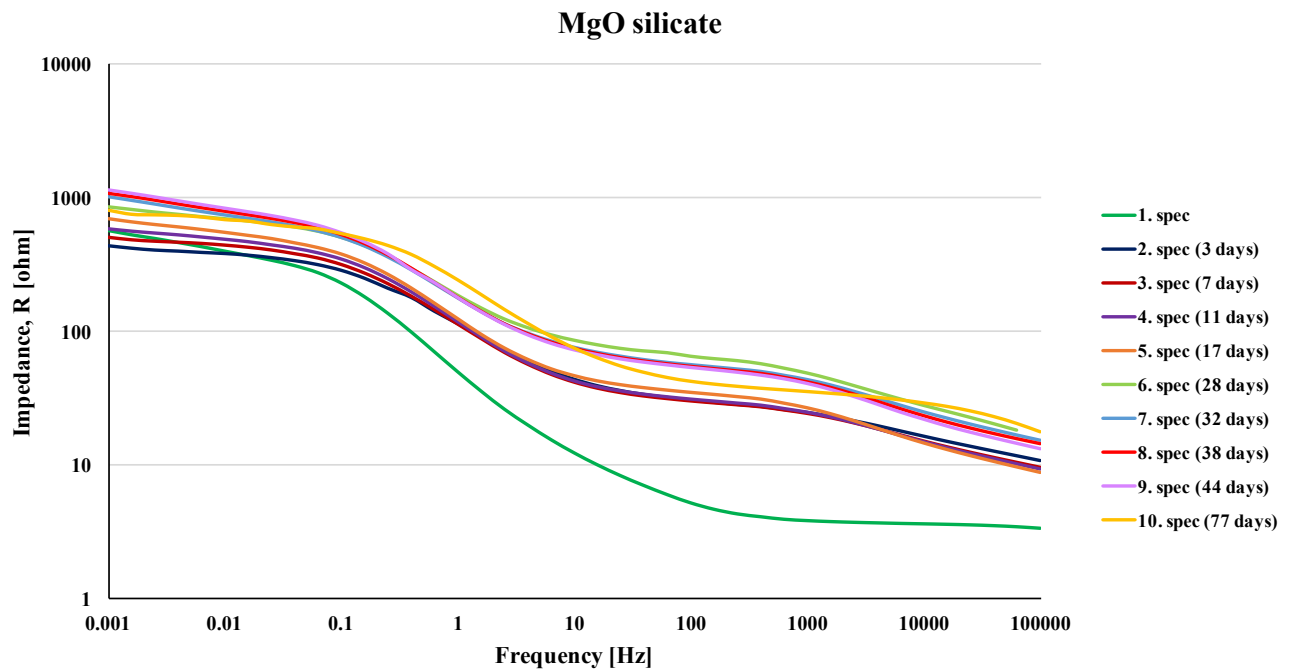
Figure D.7: Electrochemical impedance (y-axis) plotted against frequency (x-axis) for the MgO silicate. 10 spectra were taken, and the numbers stated in the parentheses indicate the number of days from test initiation.

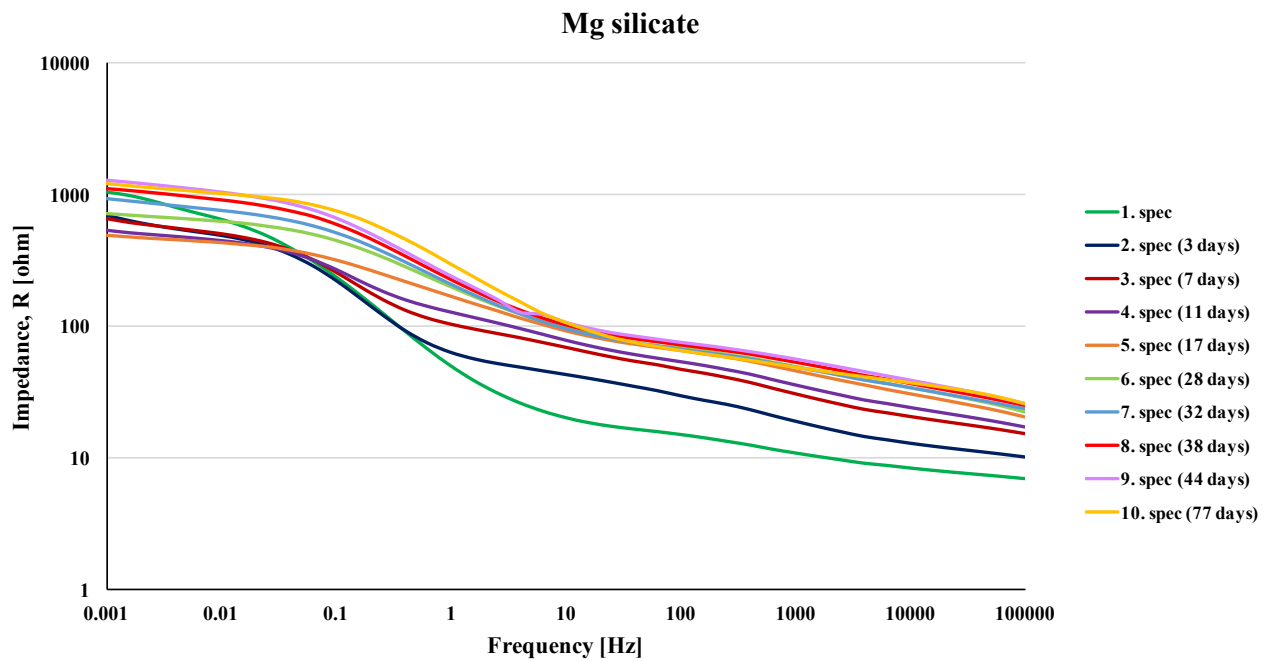
Figure D.8: Electrochemical impedance (y-axis) plotted against frequency (x-axis) for the Mg silicate. 10 spectra were taken, and the numbers stated in the parentheses indicate the number of days from test initiation.

The electrochemical impedance values for the different repair coatings at each specter are stated in Table D.1 to Table D.8. Accompanying Bode plots with frequency plotted against electrochemical impedance are presented from Figure D.3 to Figure D.10. The number stated in the parentheses for each specter indicates the number of days from test initiation.

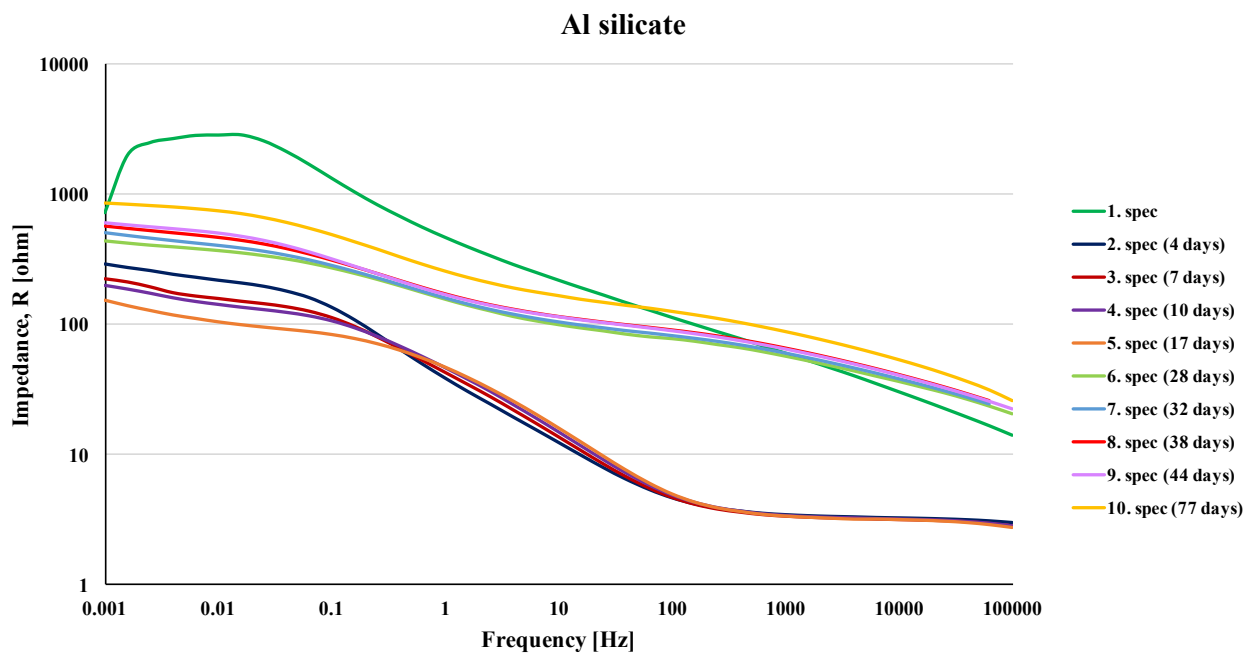
Figure D.9: Electrochemical impedance (y-axis) plotted against frequency (x-axis) for the Al silicate. 10 spectra were taken, and the numbers stated in the parentheses indicate the number of days from test initiation.

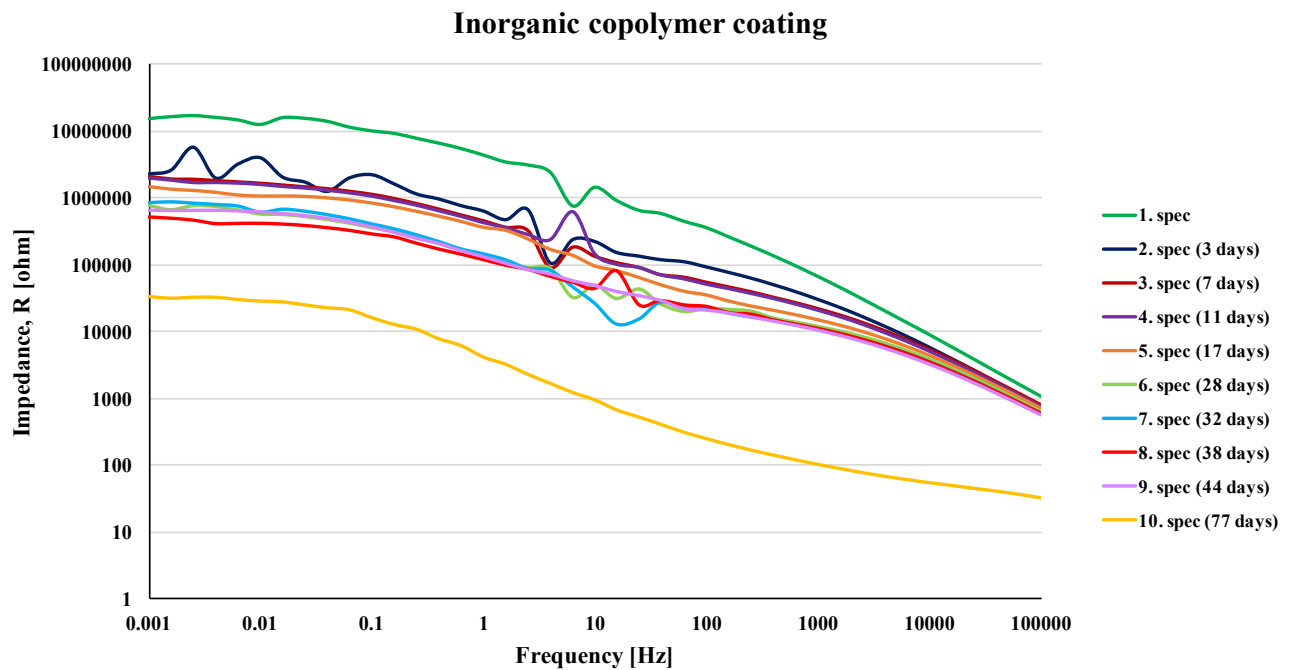
Figure D.10: Electrochemical impedance (y-axis) plotted against frequency (x-axis) for the inorganic copolymer coating silicate. 10 spectra were taken, and the numbers stated in the parentheses indicate the number of days from test initiation.

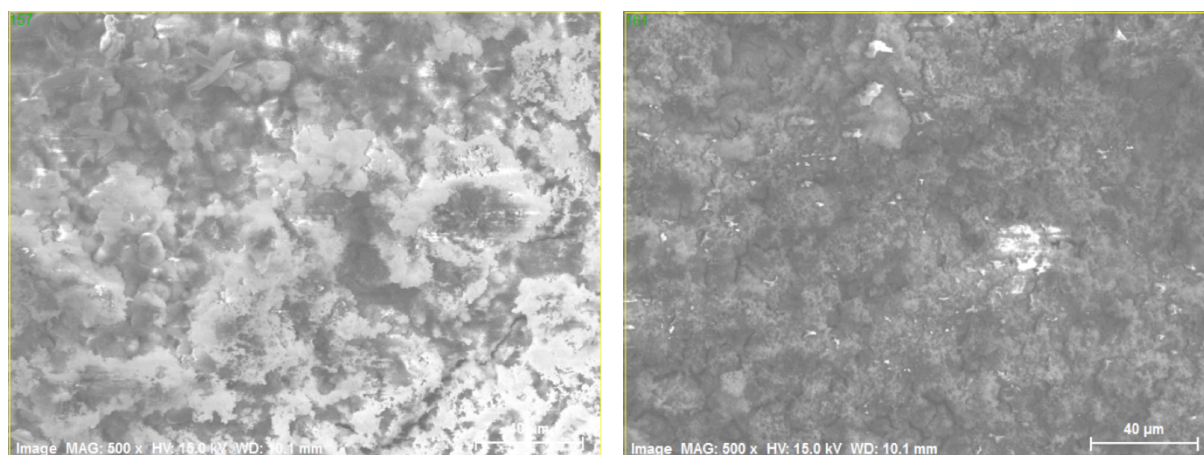
Figure D.11: SEM images of the scanned areas 157 (left image) and 161 (right image). Magnification (500X), accelerating voltage (15.0 kV) and working distance (10.1 mm) are given in each image.

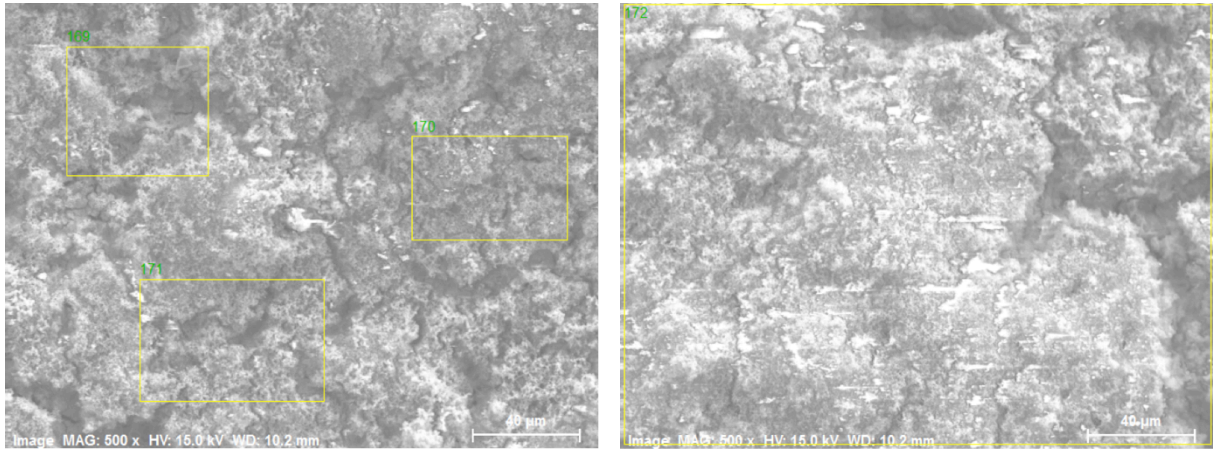
Figure D.12: SEM images of the scanned areas 169, 170 and 171 (left image) and 172 (right image). Magnification (500X), accelerating voltage (15.0 kV) and working distance (10.2 mm) are given in each image.

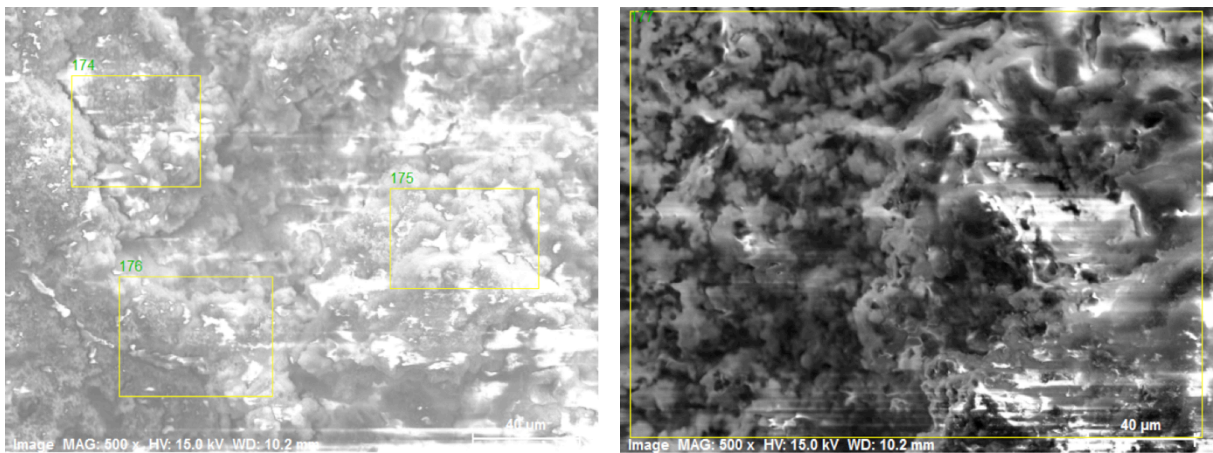
Figure D.13: SEM images of the scanned areas 174, 175 and 176 (left image) and 177 (right image). Magnification (500X), accelerating voltage (15.0 kV) and working distance (10.2 mm) are given in each image.

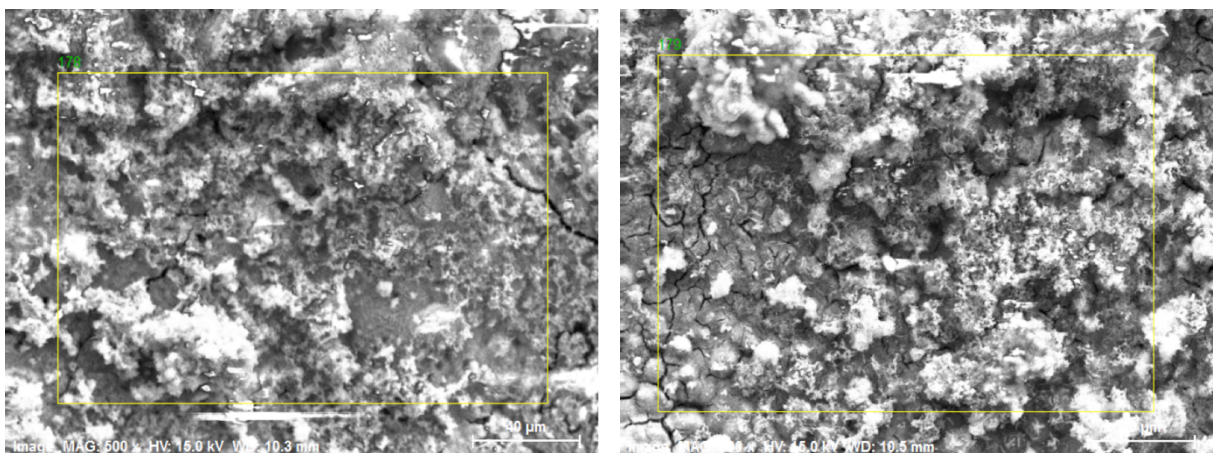
Figure D.14: SEM images of the scanned areas 178 (left image) and 179 (right image). Magnification (500X), accelerating voltage (15.0 kV) and working distance (10.3 mm and 10.5 mm) are given in each image.

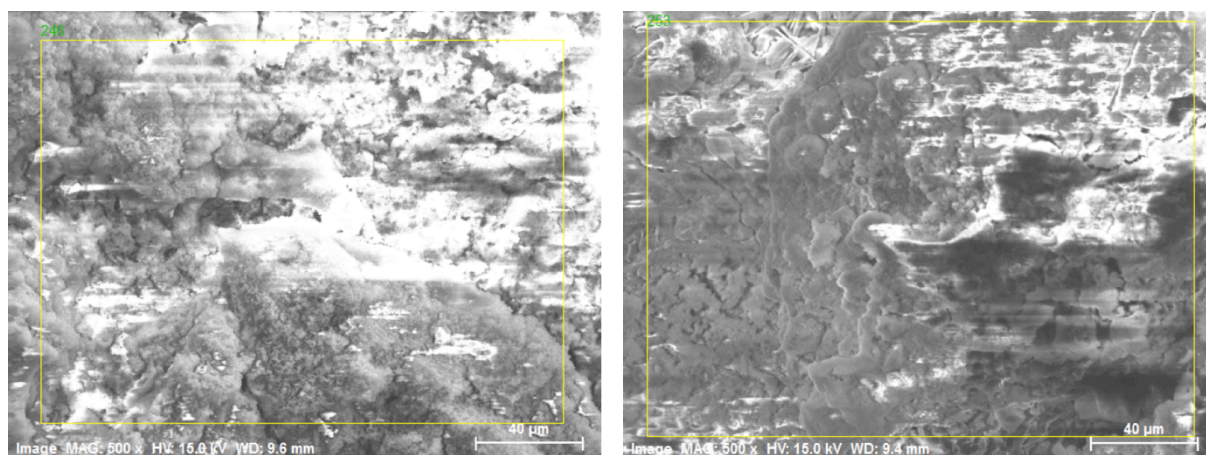
Figure D.15: SEM images of the scanned areas 246 (left image) and 253 (right image). Magnification (500X), accelerating voltage (15.0 kV) and working distance (9.6 mm and 9.4 mm) are given in each image.

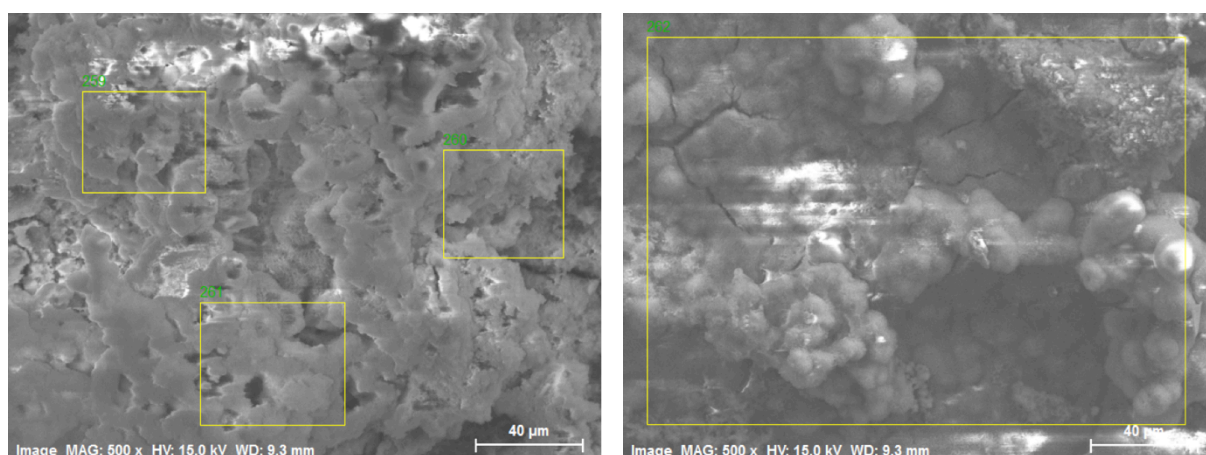
Figure D.16: SEM images of the scanned areas 259, 260 and 261 (left image) and 262 (right image). Magnification (500X), accelerating voltage (15.0 kV) and working distance (9.3 mm) are given in each image.

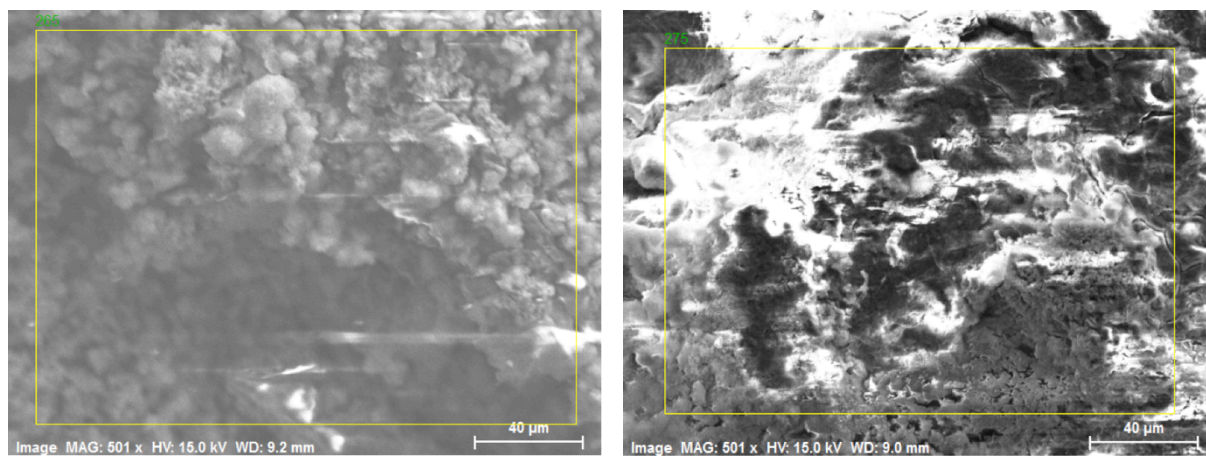
Figure D.17: SEM images of the scanned areas 265 (left image) and 275 (right image). Magnification (500X), accelerating voltage (15.0 kV) and working distance (9.2 mm and 9.0 mm) are given in each image.

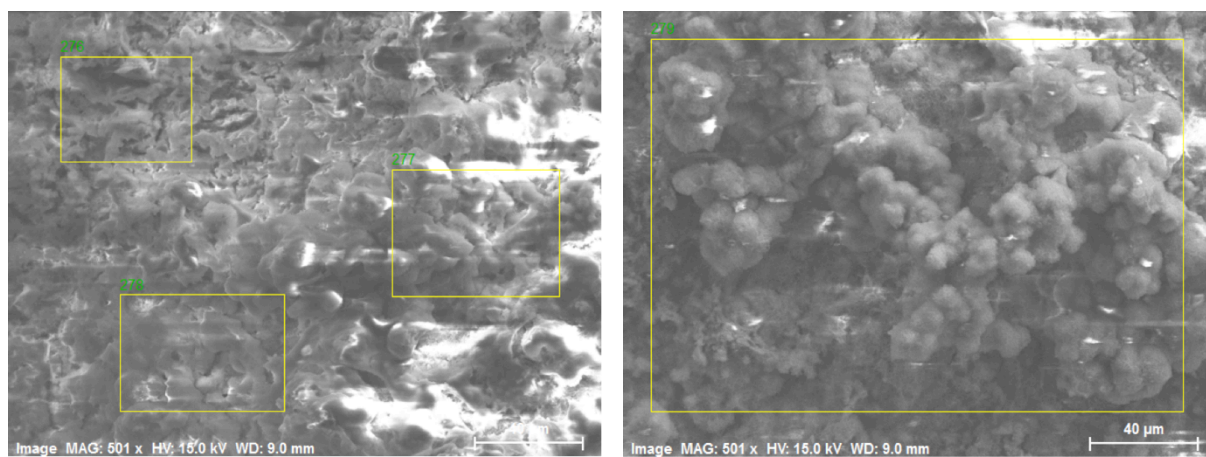
Figure D.18: SEM images of the scanned areas 276, 277 and 278 (left image) and 279 (right image). Magnification (500X), accelerating voltage (15.0 kV) and working distance (9.0 mm) are given in each image.

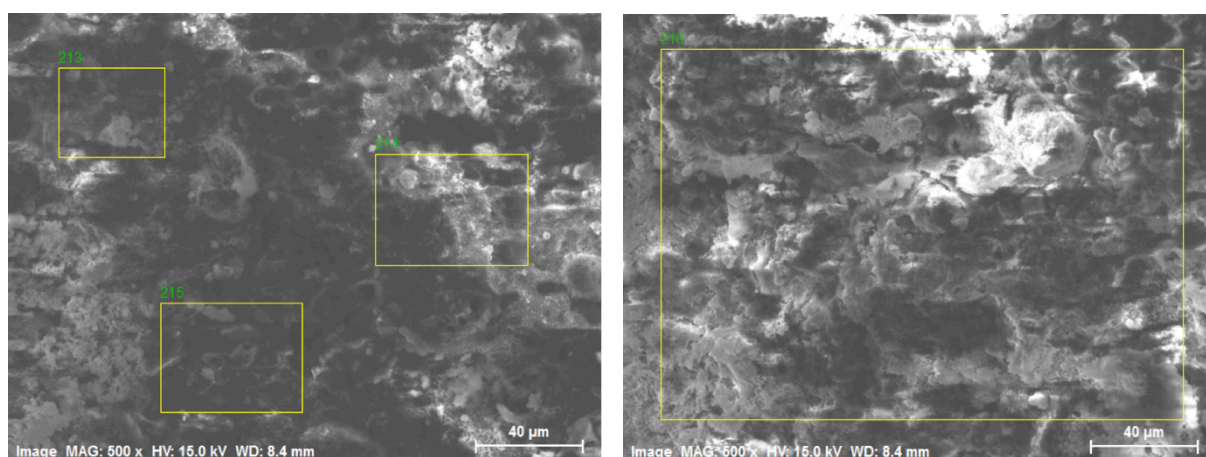
Figure D.19: SEM images of the scanned areas 213, 214 and 215 (left image) and 216 (right image). Magnification (500X), accelerating voltage (15.0 kV) and working distance (8.4 mm) are given in each image.

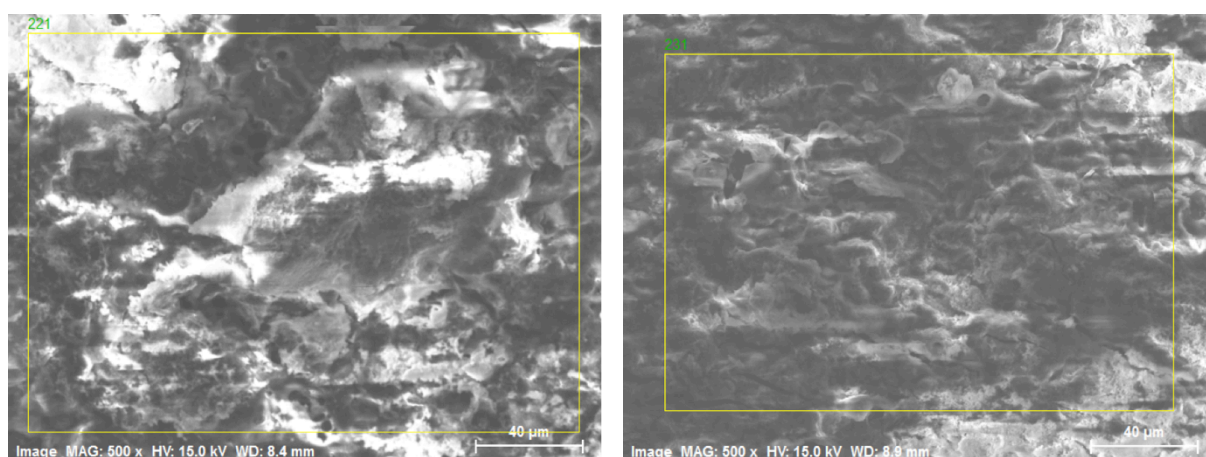
Figure D.20: SEM images of the scanned areas 221 (left image) and 231 (right image). Magnification (500X), accelerating voltage (15.0 kV) and working distance (8.4 mm and 8.9 mm) are given in each image.
