# Repair Coatings for Thermally Sprayed Aluminium

Materials Science and Engineering

Submission date: June 2016

**Repair coatings for thermally sprayed aluminium**

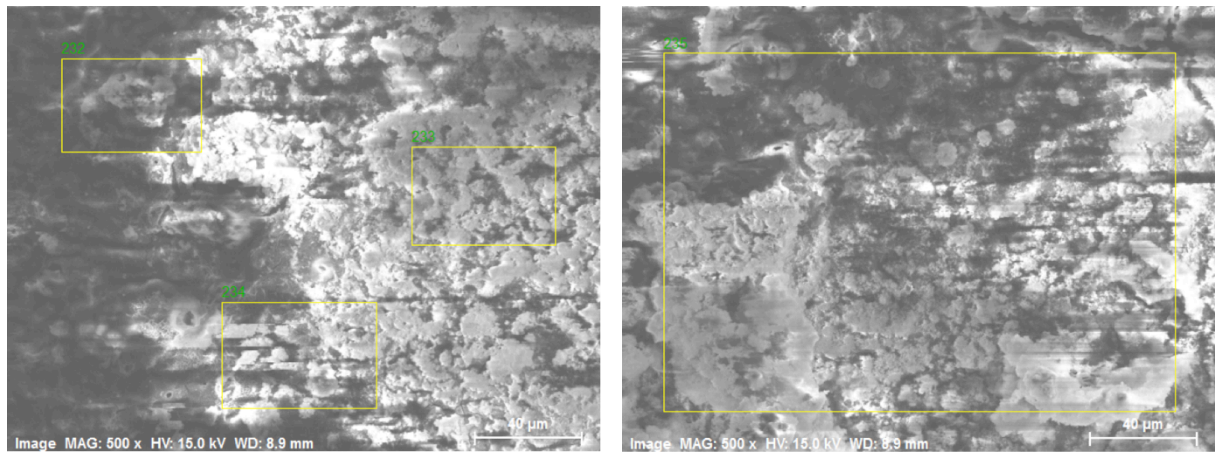
Figure D.21: SEM images of the scanned areas 232, 233 and 234 (left image) and 235 (right image). Magnification (500X), accelerating voltage (15.0 kV) and working distance (8.9 mm) are given in each image.

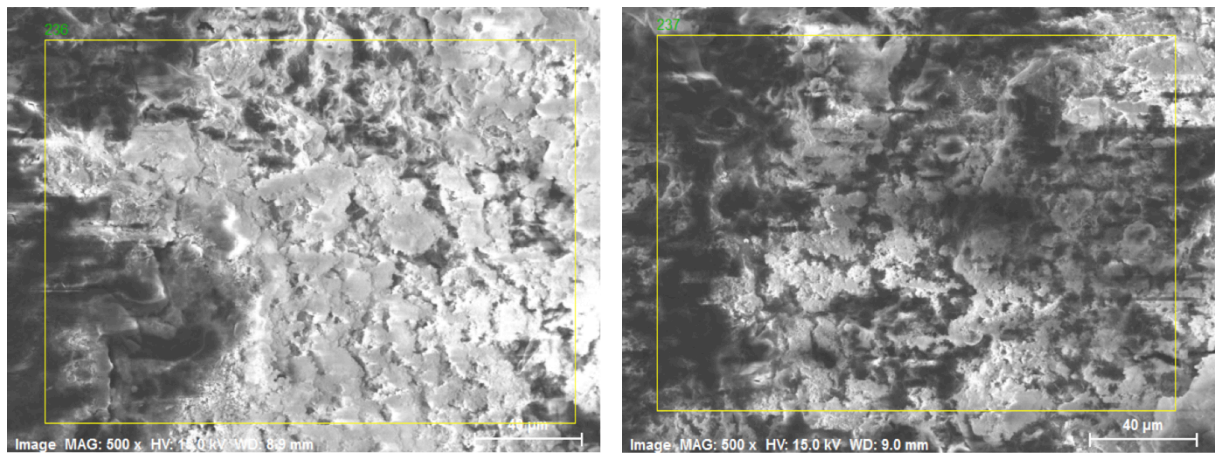
Figure D.22: SEM images of the scanned areas 236 (left image) and 237 (right image). Magnification (500X), accelerating voltage (15.0 kV) and working distance (8.9 mm and 9.0 mm) are given in each image.

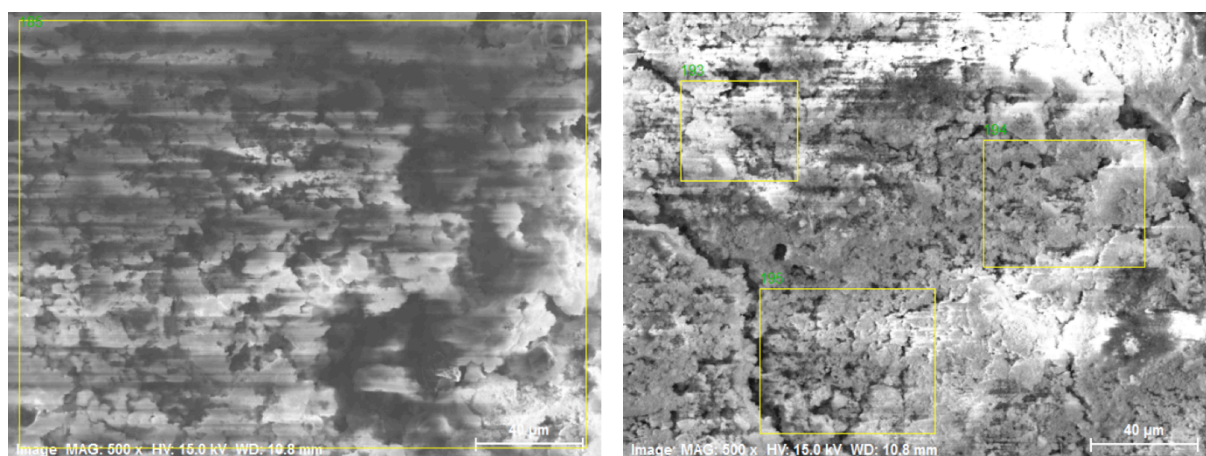
Figure D.23: SEM images of the scanned surface 185 (left image) and 193, 194 and 195 (right image). Magnification (500X), accelerating voltage (15.0 kV) and working distance (10.8 mm) are given in each image.

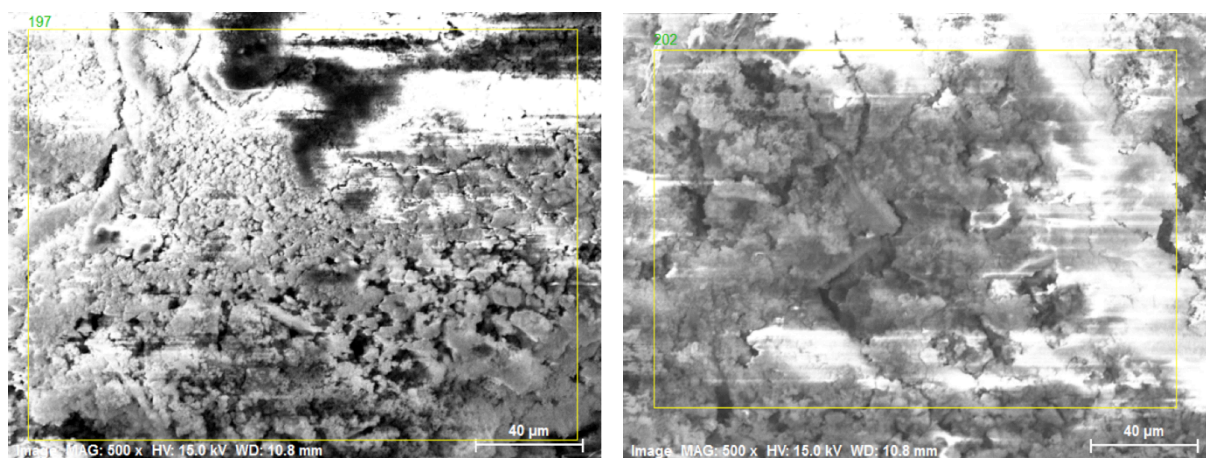
Figure D.24: SEM images of the scanned areas 197 (left image) and 202 (right image). Magnification (500X), accelerating voltage (15.0 kV) and working distance (10.8 mm) are given in each image.

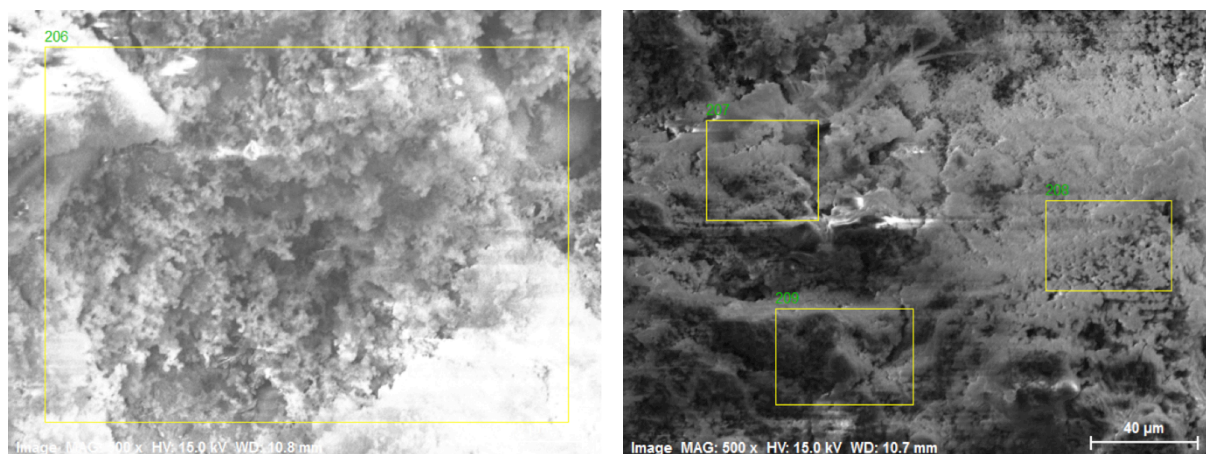
Figure D.25: SEM images of the scanned areas 206 (left image) and 207, 208 and 209 (right image). Magnification (500X), accelerating voltage (15.0 kV) and working distance (10.8 mm and 10.7 mm) are given in each image.

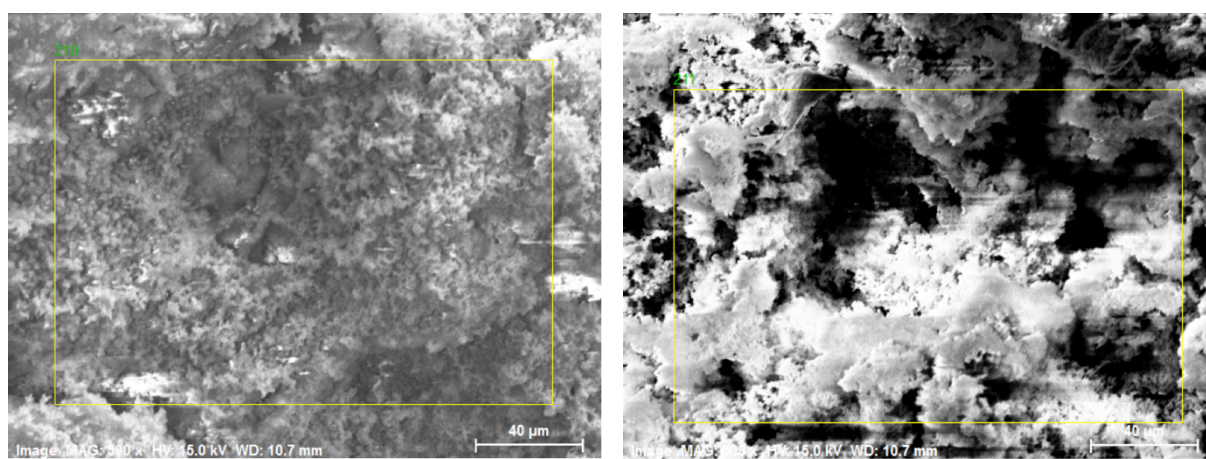
Figure D.26: SEM images of the scanned areas 210 (left image) and 211 (right image). Magnification (500X), accelerating voltage (15.0 kV) and working distance (10.7 mm) are given in each image.

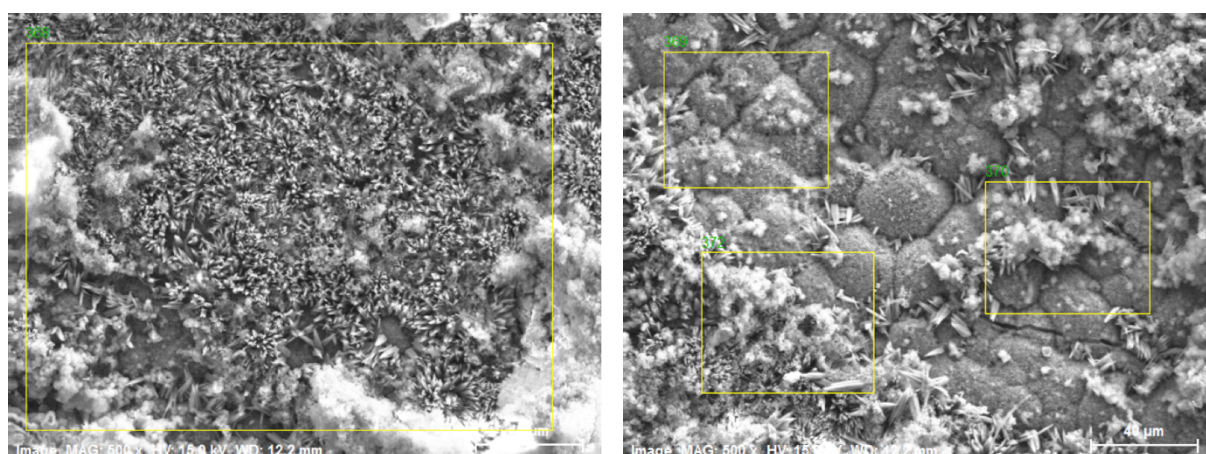
Figure D.27: SEM images of the scanned areas 368 (left image) and 369, 370 and 371 (right image). Magnification (500X), accelerating voltage (15.0 kV) and working distance (12.2 mm) are given in each image.

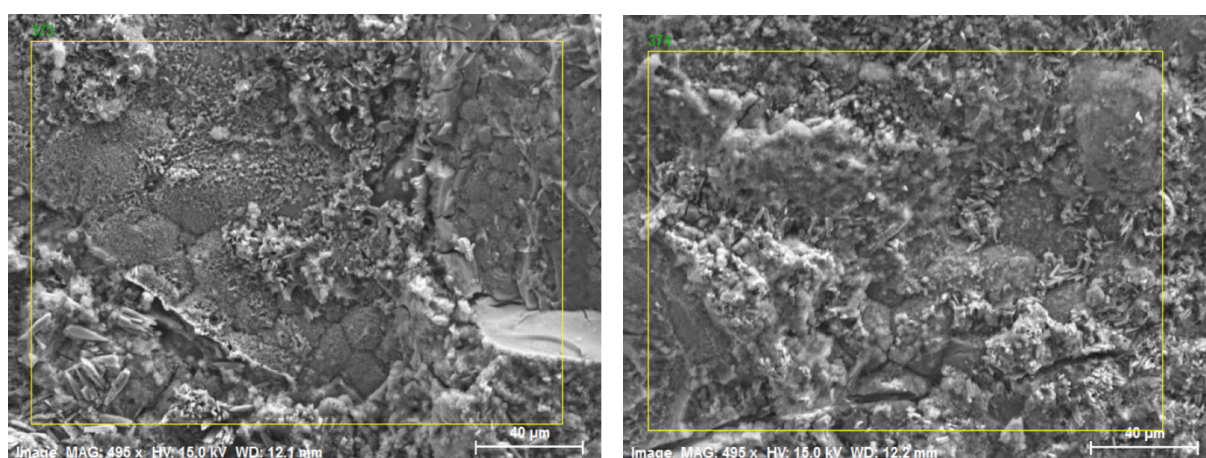
Figure D.28: SEM images of the scanned areas 373 (left image) and 374 (right image). Magnification (495X), accelerating voltage (15.0 kV) and working distance (12.1 mm and 12.2 mm) are given in each image.

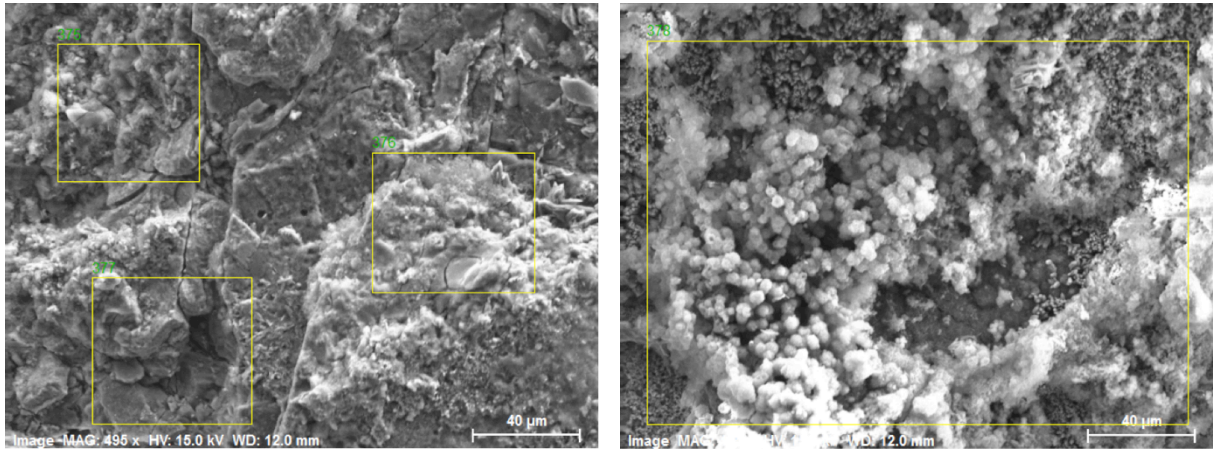
Figure D.29: SEM images of the scanned areas 375, 376 and 377 (left image) and 378 (right image). Magnification (495X), accelerating voltage (15.0 kV) and working distance (12.0 mm) are given in each image.

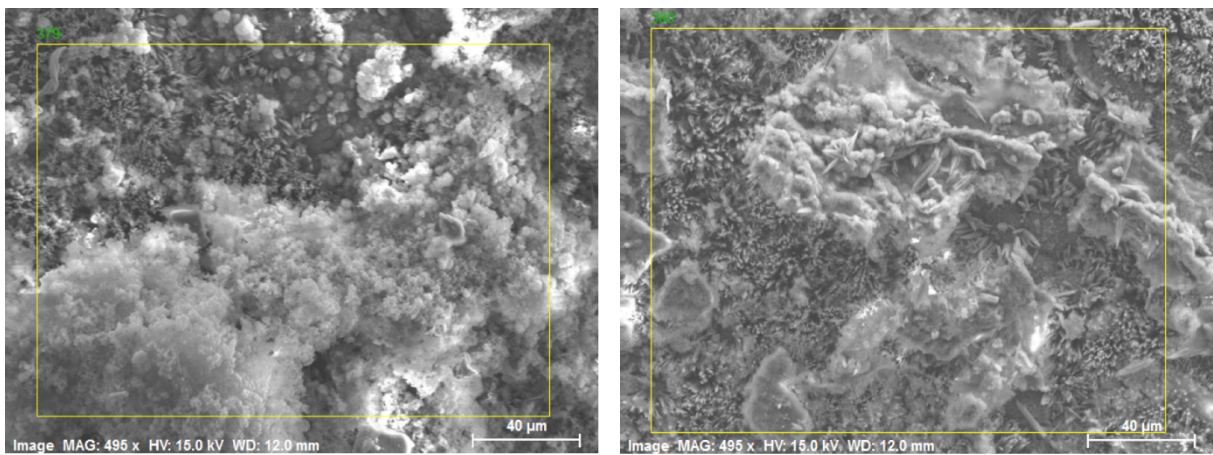
Figure D.30: SEM images of the scanned areas 379 (left image) and 389 (right image). Magnification (495X), accelerating voltage (15.0 kV) and working distance (12.0 mm) are given in each image.

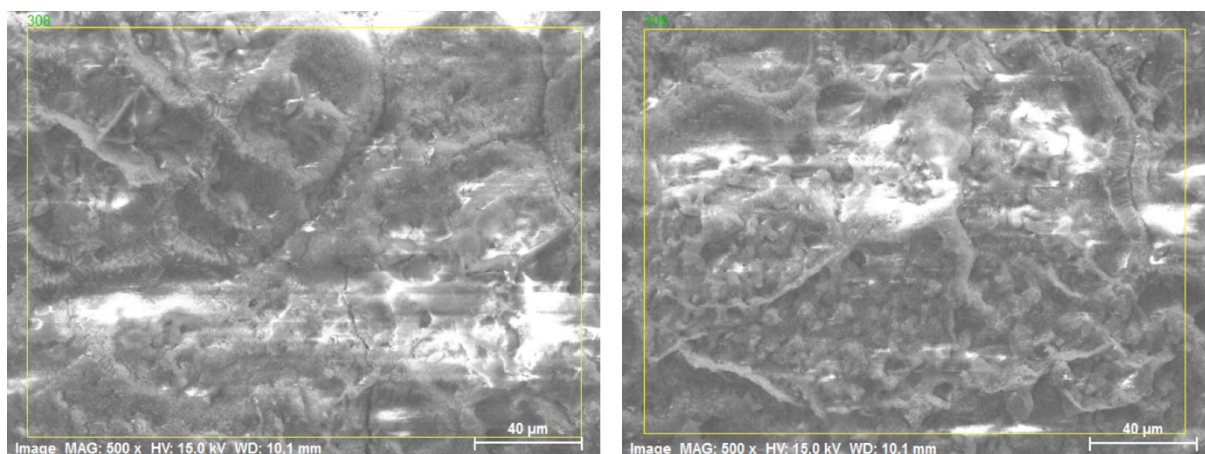
Figure D.31: SEM images of the scanned areas 308 (left image) and 309 (right image). Magnification (500X), accelerating voltage (15.0 kV) and working distance (10.1 mm) are given in each image.

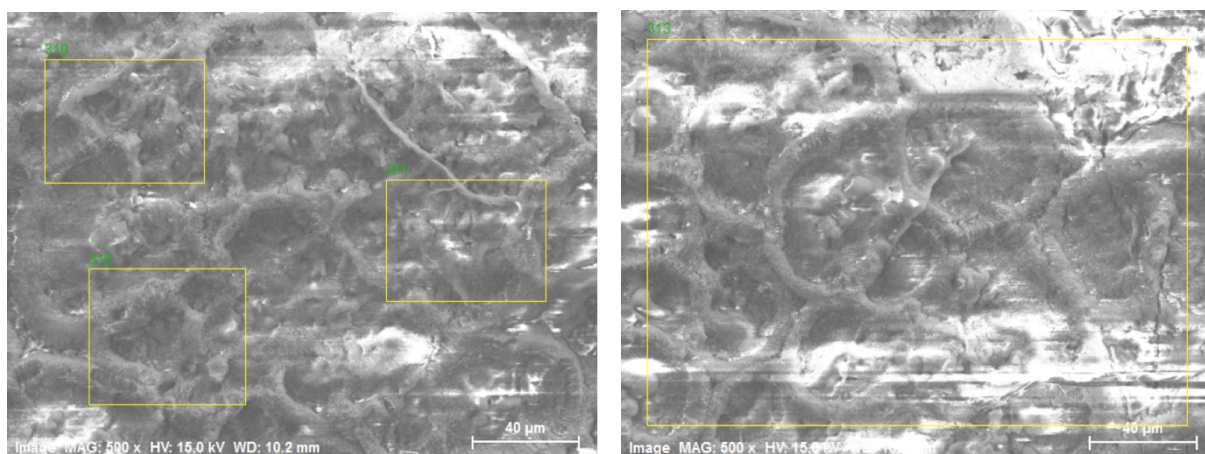
Figure D.32: SEM images of the scanned areas 310, 311 and 312 (left image) and 313 (right image). Magnification (500X), accelerating voltage (15.0 kV) and working distance (10.2 mm) are given in each image.

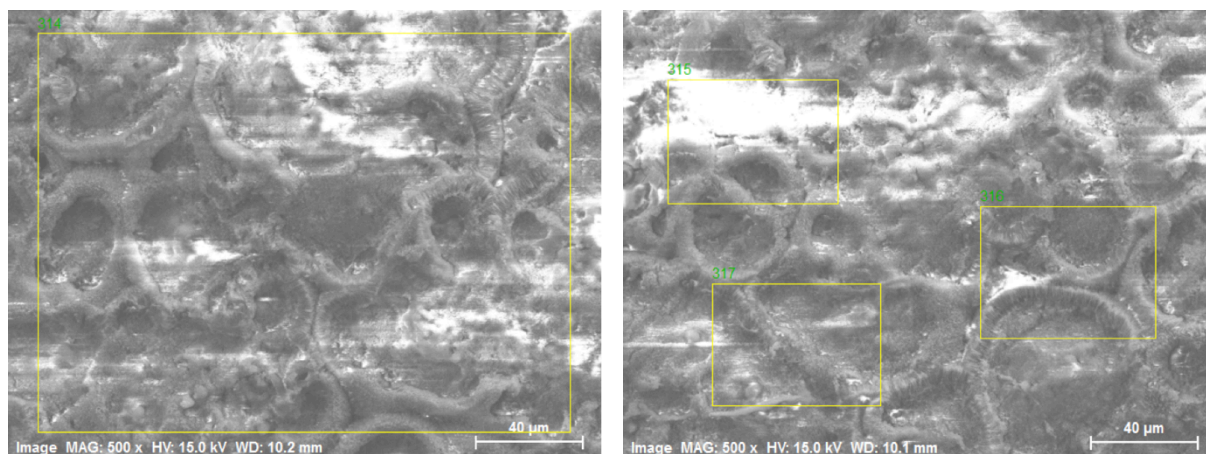
Figure D.33: SEM images of the scanned areas 314 (left image) and 315, 316 and 317 (right image). Magnification (500X), accelerating voltage (15.0 kV) and working distance (10.2 mm and 10.1 mm) are given in each image.

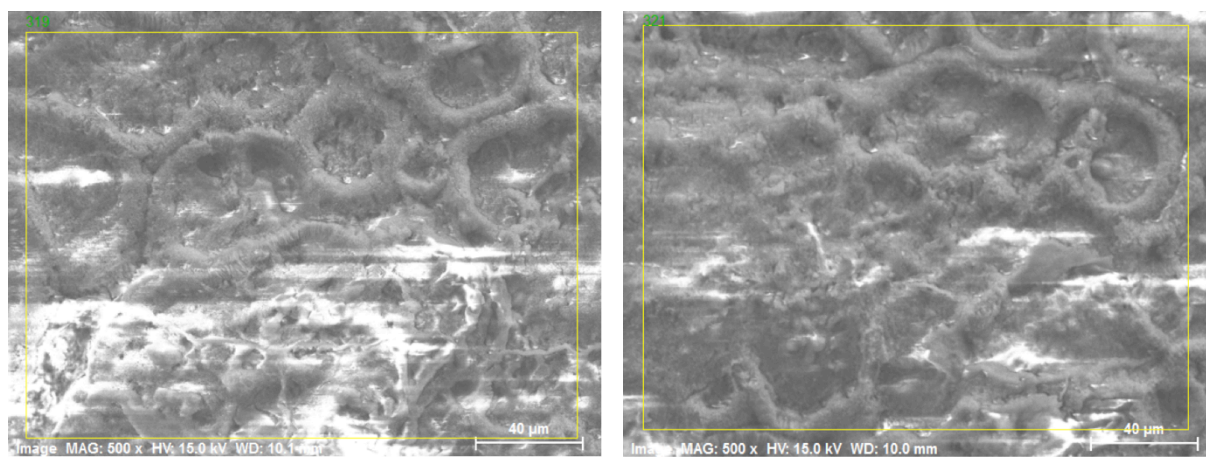
Figure D.34: SEM images of the scanned areas 319 (left image) and 321 (right image). Magnification (500X), accelerating voltage (15.0 kV) and working distance (10.1 mm and 10.0 mm) are given in each image.

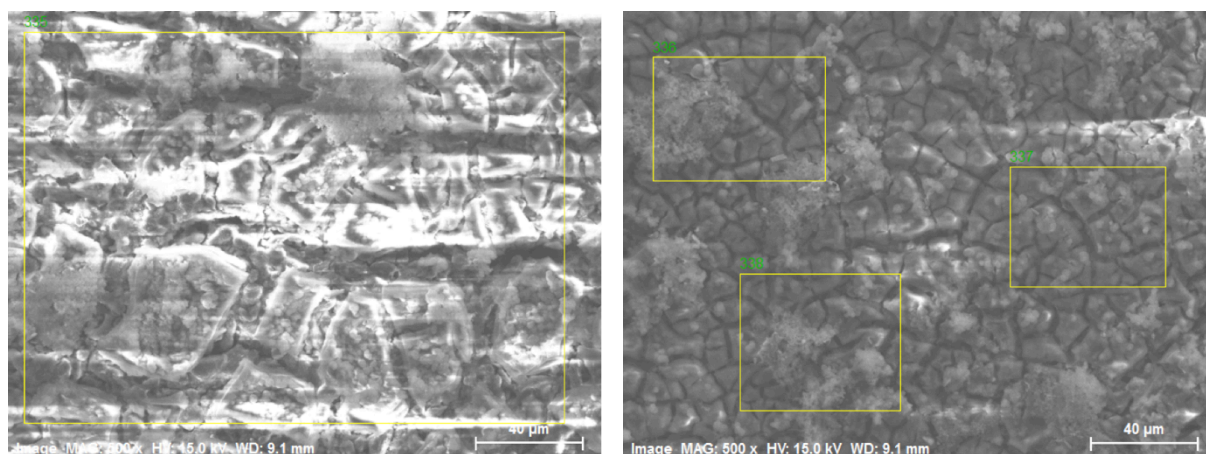
Figure D.35: SEM images of the scanned areas 335 (left image) and 336, 337 and 338 (right image). Magnification (500X), accelerating voltage (15.0 kV) and working distance (9.1 mm) are given in each image.

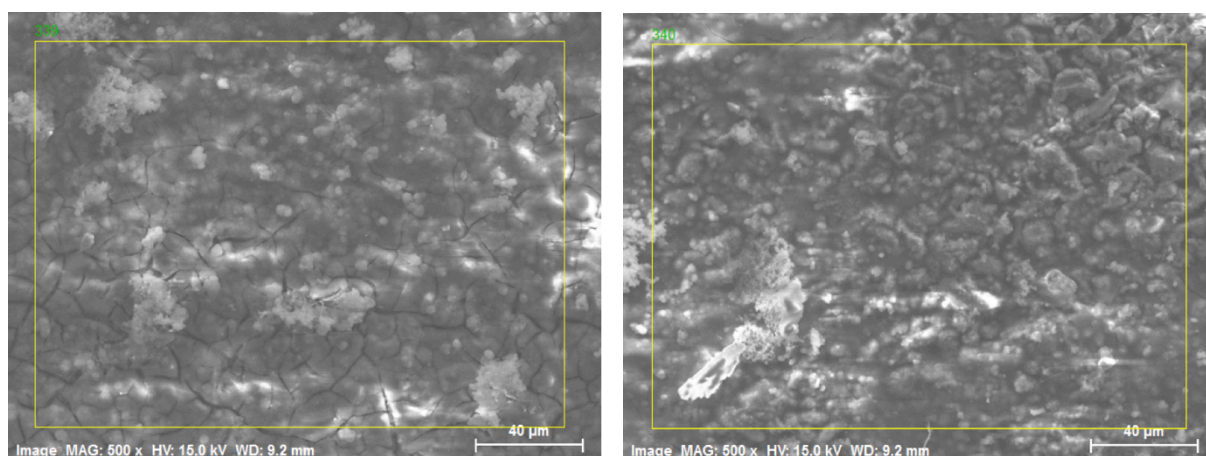
Figure D.36: SEM images of the scanned areas 339 (left image) and 340 (right image). Magnification (500X), accelerating voltage (15.0 kV) and working distance (9.2 mm) are given in each image.

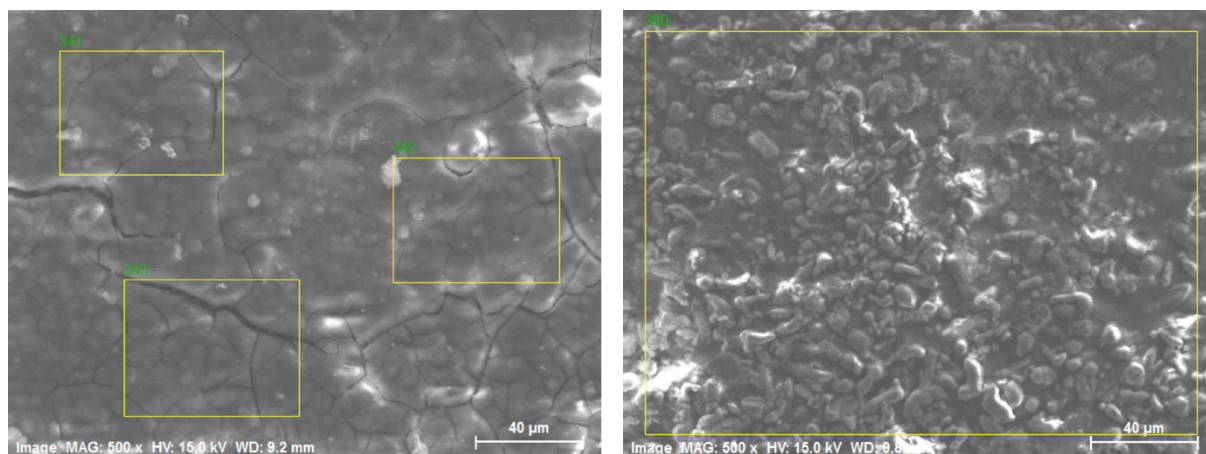
Figure D.37: SEM images of the scanned areas 341, 342 and 343 (left image) and 360 (right image). Magnification (500X), accelerating voltage (15.0 kV) and working distance (9.2 mm) are given in each image.

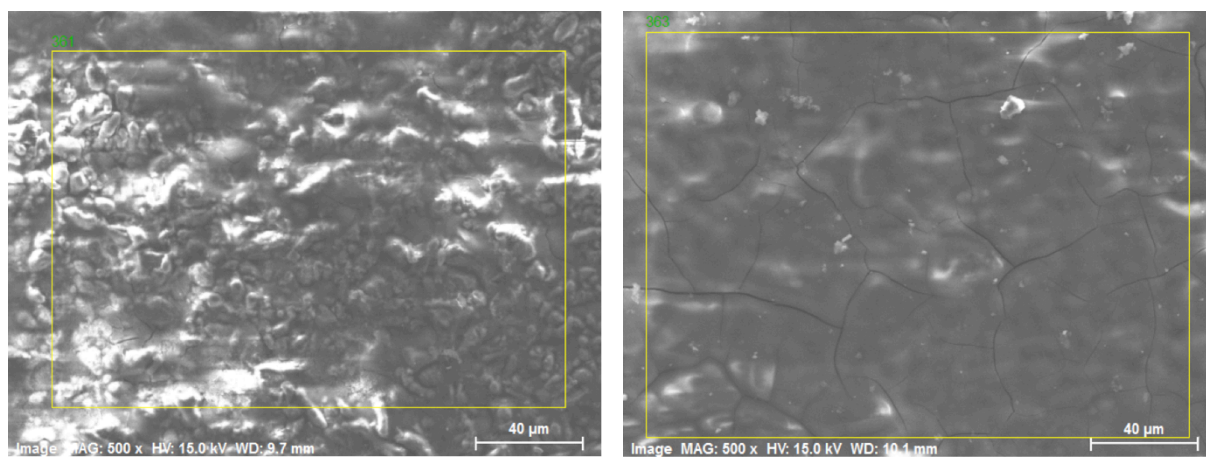
Figure D.38: SEM images of the scanned areas 361 (left image) and 363 (right image). Magnification (500X), accelerating voltage (15.0 kV) and working distance (9.7 mm and 10.1 mm) are given in each image.

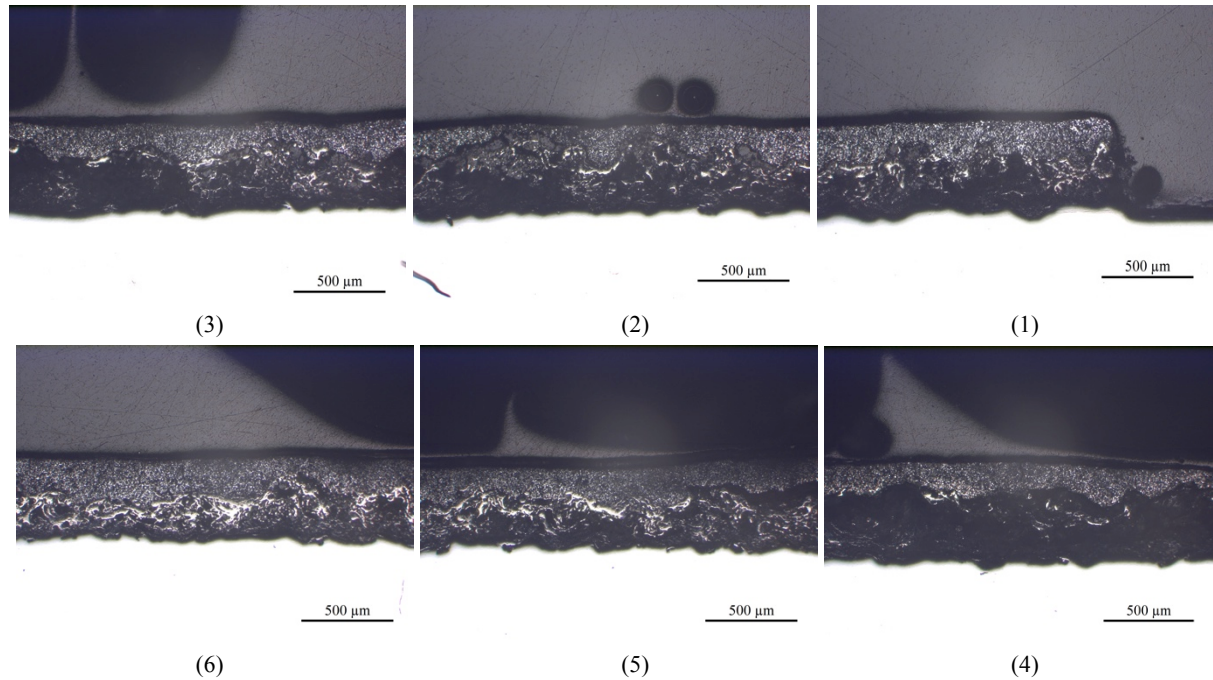
Figure F.1: Light microscope images of the high Zn primer at the crevice opening (1) and further into the crevice (6). Corrosion creep can be seen approximately 12.3 mm into the crevice, in addition to some corrosion of the high Zn primer.

Light microscope images, presented from Figure F.1 to Figure F.9, revealed the amount of TSA corrosion and corrosion creep into the crevice. All cross section images contain a steel substrate coated with TSA and the current repair coat. Lowest degree of TSA corrosion was seen on the modified Zn epoxy, Al silicate and the TSA coated with epoxy. The numbers stated in the parentheses indicate the orientation related to the crevice opening. Note that the order of the numbers varies.

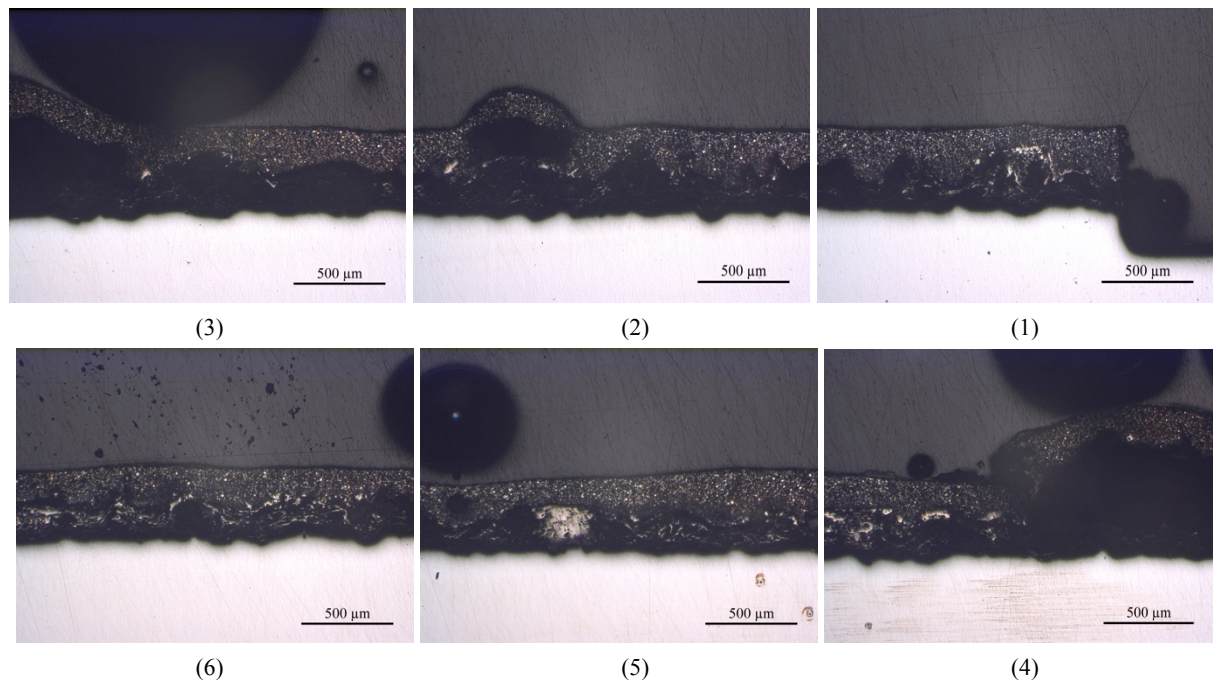
### Zn epoxy

Figure F.2: Light microscope images of the Zn epoxy at the crevice opening (1) and further into the crevice (6). Corrosion creep for the TSA can be seen in the entire crevice, in addition to blistering. The Zn epoxy was also reduced.

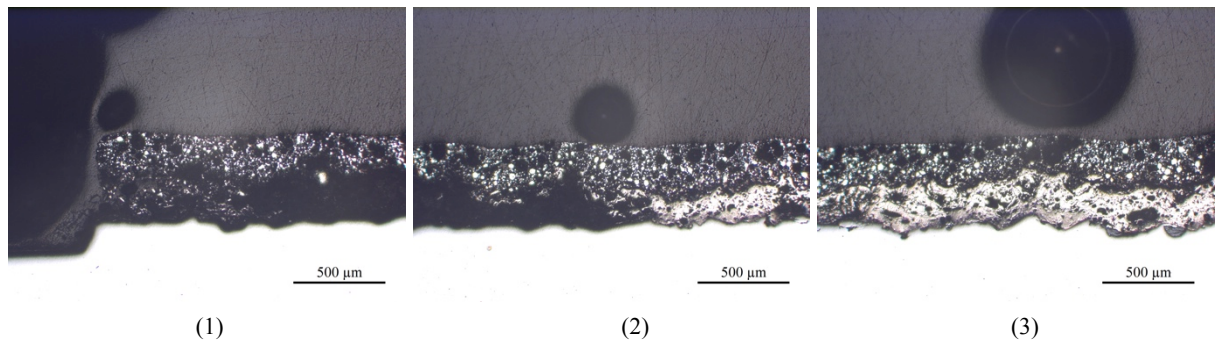
**Modified Zn epoxy**

Figure F.3: Light microscope images of the modified Zn epoxy at the crevice opening (1) and further into the crevice (3). Corrosion creep of the TSA can be seen approximately 3 mm into the crevice, in addition to sporadic TSA corrosion. Intact zinc particles can be seen in the modified Zn epoxy.

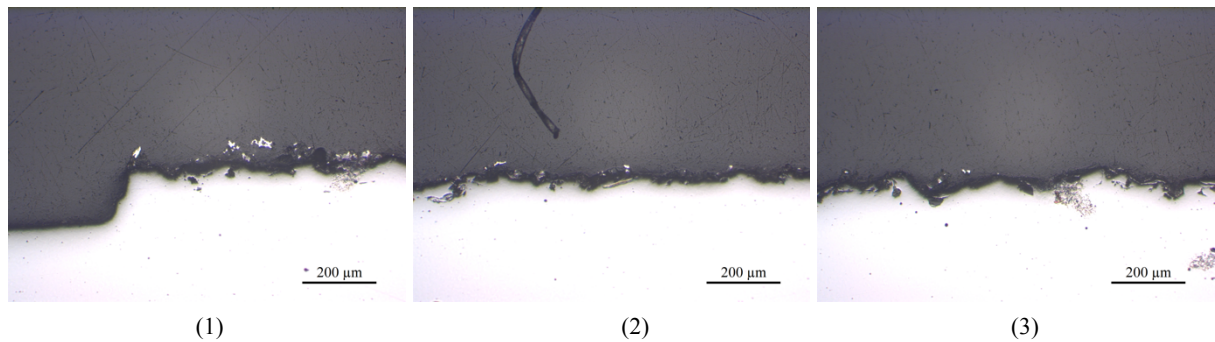
**Zn silicate**

Figure F.4: Light microscope images of the Zn silicate at the crevice opening (1) and further into the crevice (3). During the machining of the sample, the Zn silicate layer flaked off. The TSA layer was totally reduced where the repair coating had flaked off.

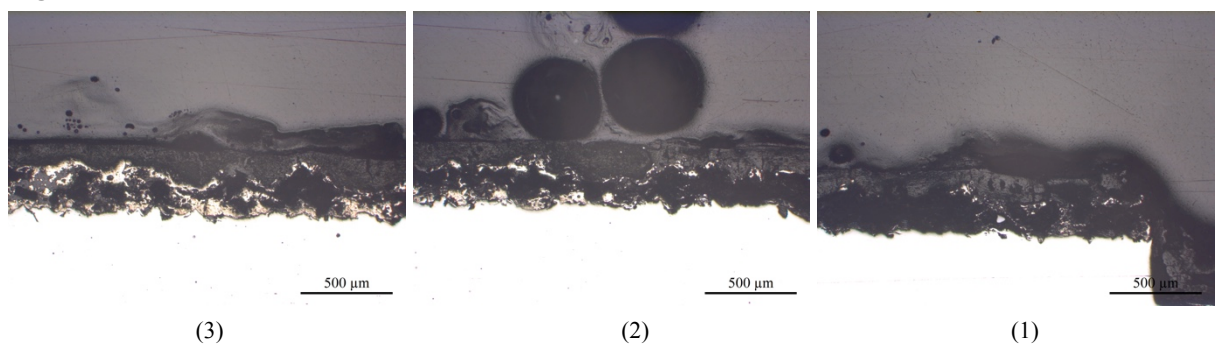
**MgO silicate**

Figure F.5: Light microscope images of the MgO silicate at the crevice opening (1) and further into the crevice (3). High amount of corrosion for both coating layers can be seen, in addition to corrosion creep and sporadic corrosion of the TSA.

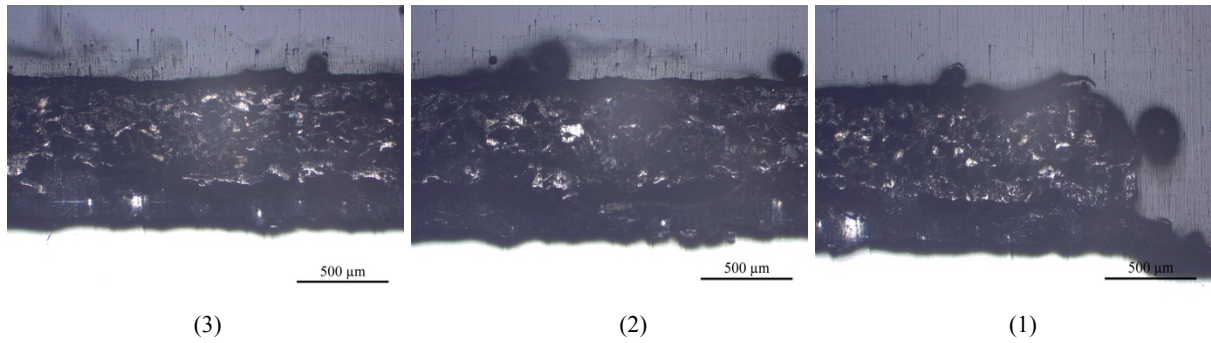
**Mg silicate**

Figure F.6: Light microscope images of the Mg silicate at the crevice opening (1) and further into the crevice (3). High amount of corrosion for both coating layers can be seen, in addition to corrosion creep of the TSA in the entire crevice.

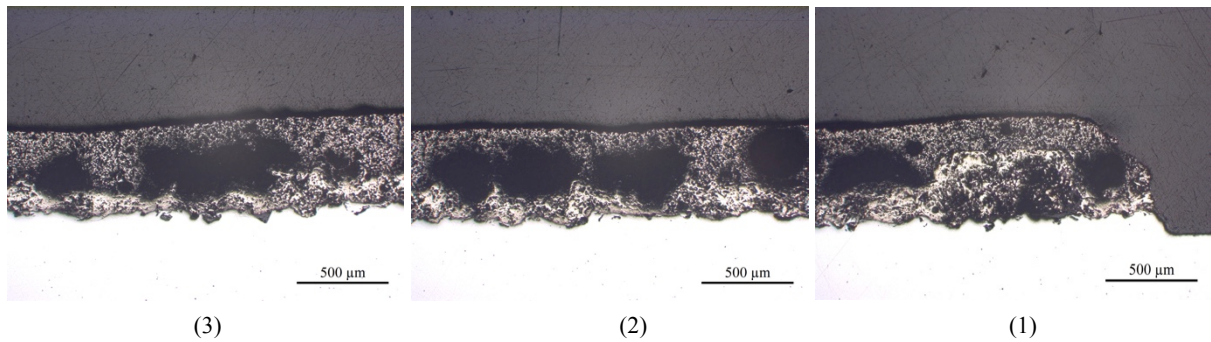
**Al silicate**

Figure F.7: Light microscope images of the Al silicate at the crevice opening (1) and further into the crevice (3). The TSA was only sporadically corroded, while the Zn silicate corroded in clusters.

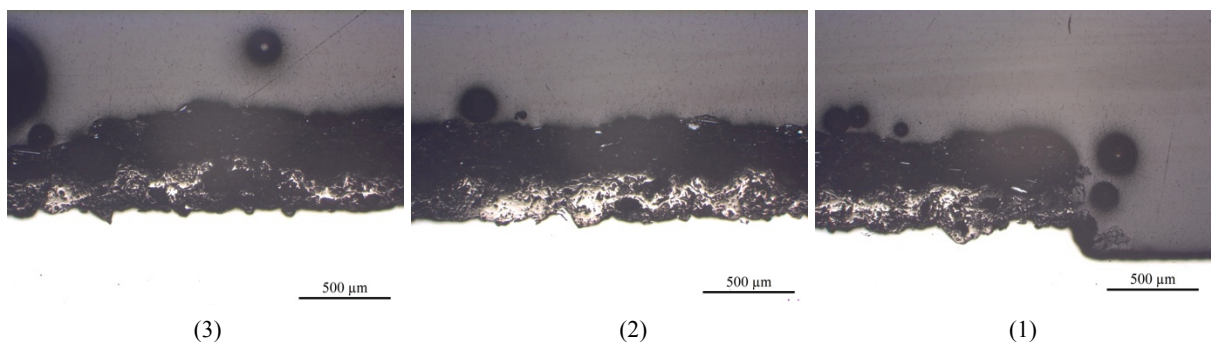
**Inorganic copolymer coating**

Figure F.8: Light microscope images of the inorganic copolymer coating at the crevice opening (1) and further into the crevice (3). The amount of TSA corrosion was high, like for the inorganic copolymer coating.

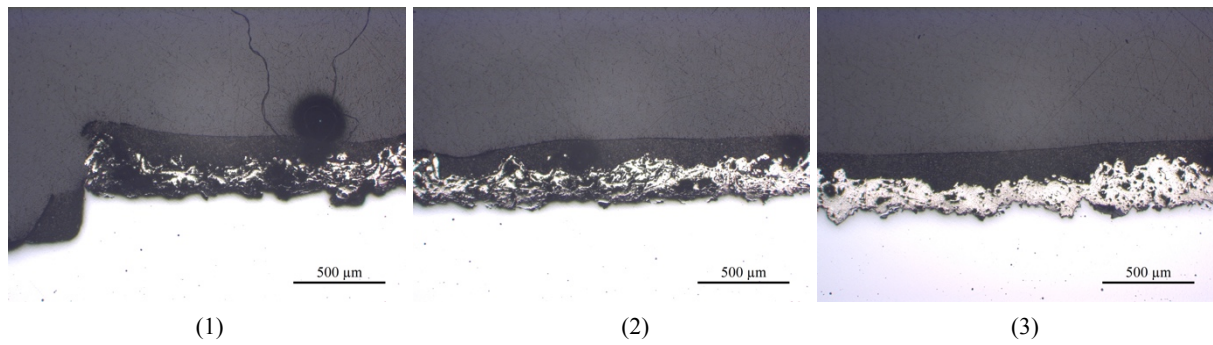
**TSA coated with epoxy**

Figure F.9: Light microscope images of the TSA coated with epoxy at the crevice opening (1) and further into the crevice (3). Continuously corrosion of the TSA can be seen approximately 3.8 mm into the crevice, while dark areas of either corrosion or voids can be seen further into the crevice.

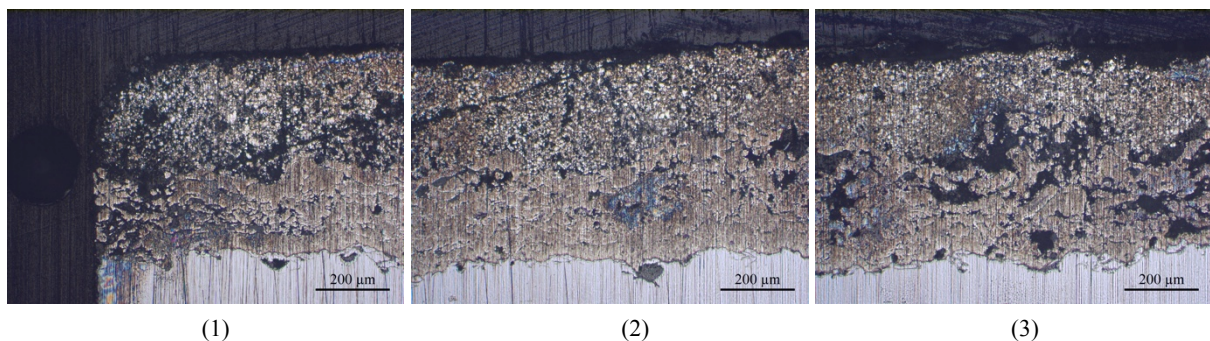
### High Zn primer

Figure F.10: Light microscope images of the high Zn primer at the crevice opening (1) and further into the crevice (3). The TSA had only corroded at the crevice opening, in addition to sporadically further into the crevice. High amount of intact zinc particles can be seen.

Light microscope images of the cross sections are presented from Figure F.10 to Figure F.18. All images contain a steel substrate coated with TSA and a topcoat of the current repair coating. The numbers stated in the parentheses below the images indicate the orientation related to the crevice opening. Note that the order of the numbers varies between the different coatings. The amount of TSA corrosion and repair coat reduction are explained in the figure text.

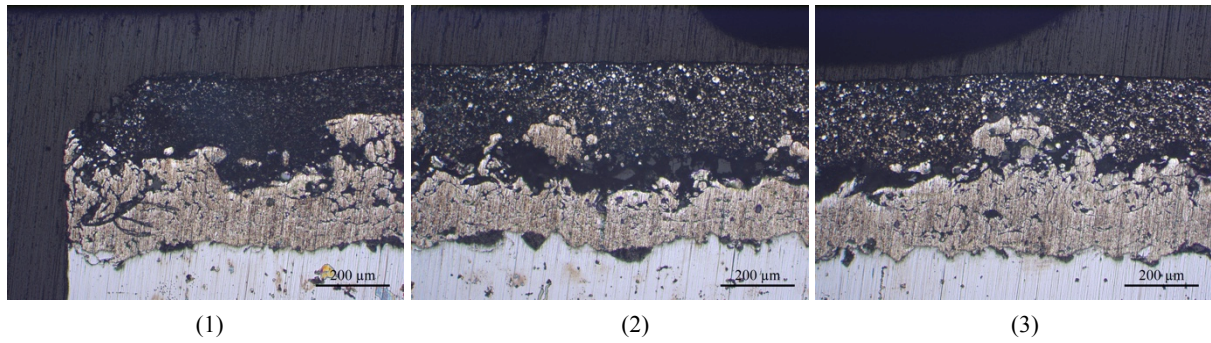
**Zn epoxy**

Figure F.11: Light microscope images of the Zn epoxy at the crevice opening (1) and further into the crevice (3). The TSA had only corroded at the crevice opening, and some corrosion between the two coating layers can be seen. Highest amount of zinc corrosion occurred at the crevice opening.

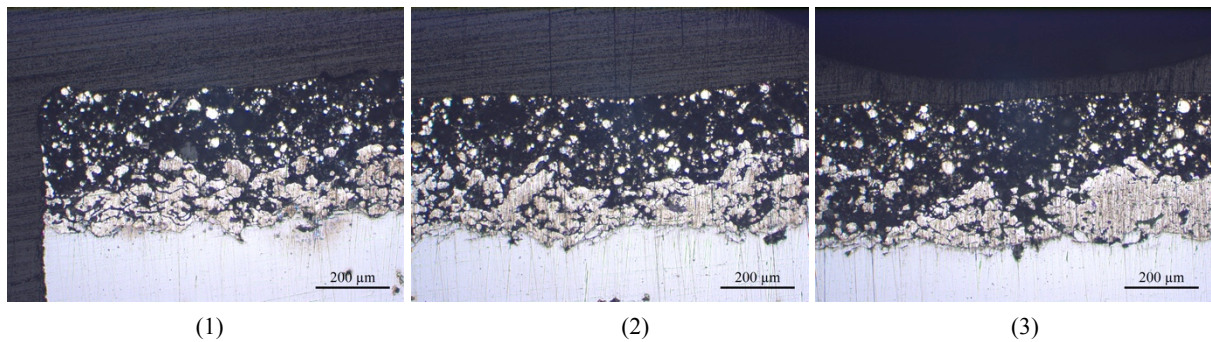
**Modified Zn epoxy**

Figure F.12: Light microscope images of the modified Zn epoxy at the crevice opening (1) and further into the crevice (3). General corrosion of both the TSA and the modified Zn epoxy had occurred.

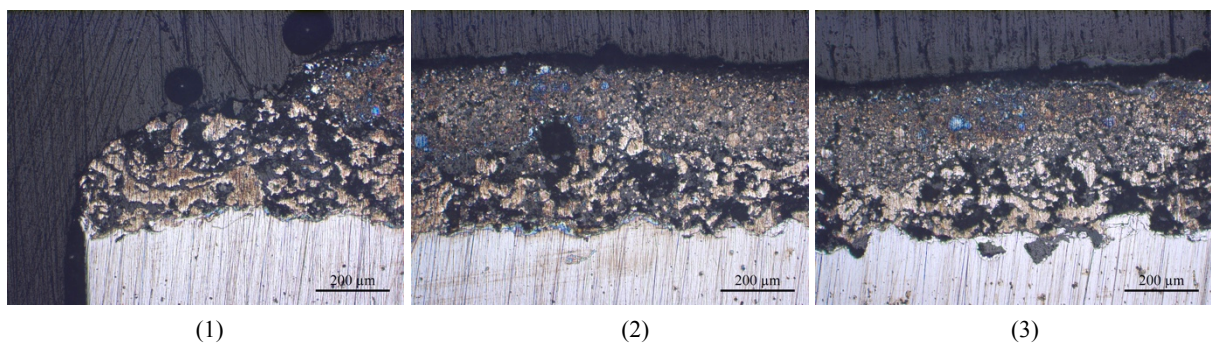
**Zn silicate**

Figure F.13: Light microscope images of the Zn silicate at the crevice opening (1) and further into the crevice (3). General corrosion of the TSA had occurred, and total reduction of the Zn silicate could be seen at the crevice opening.

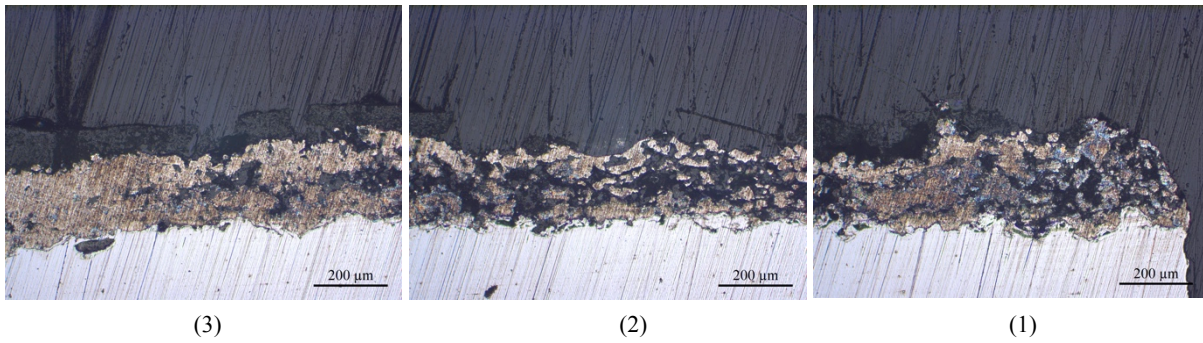
**MgO silicate**

Figure F.14: Light microscope images of the MgO silicate at the crevice opening (1) and further into the crevice (3). General corrosion of the TSA had occurred approximately 3 mm into the crevice, in addition to high degree of MgO silicate reduction.

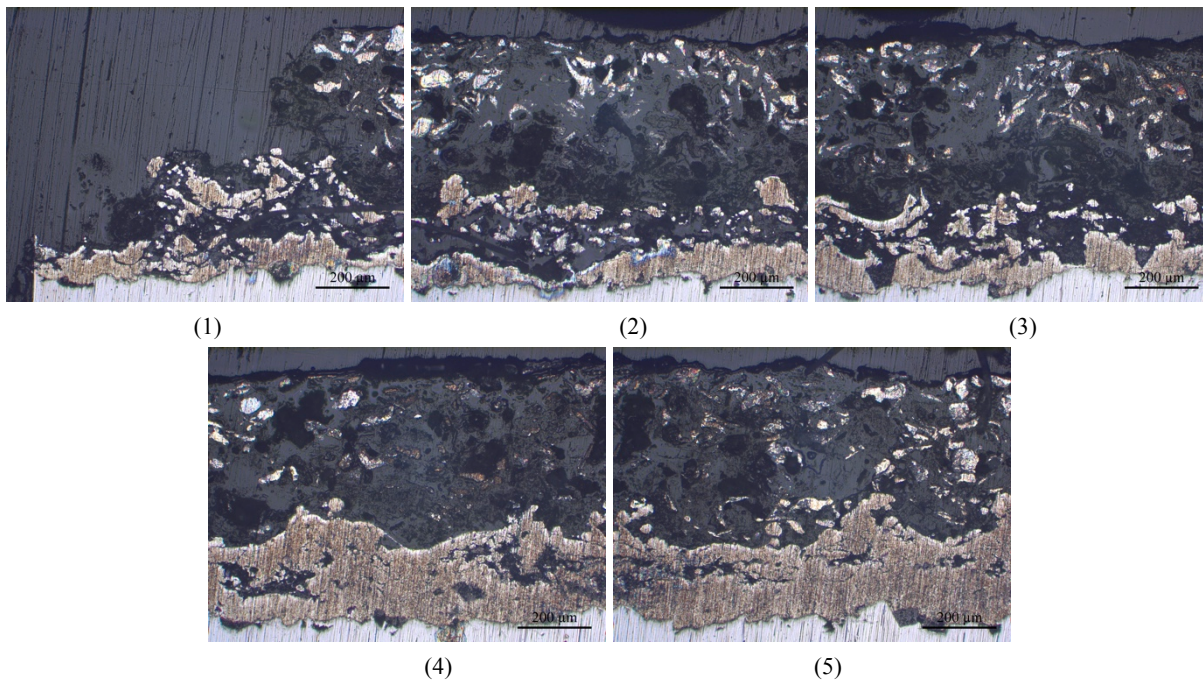
**Mg silicate**

Figure F.15: Light microscope images of the Mg silicate at the crevice opening (1) and further into the crevice (5). Continuous corrosion of the TSA had occurred from the crevice opening, in addition to high degree of Mg silicate reduction. Machining may have caused the reduction of the Mg silicate at the crevice opening.

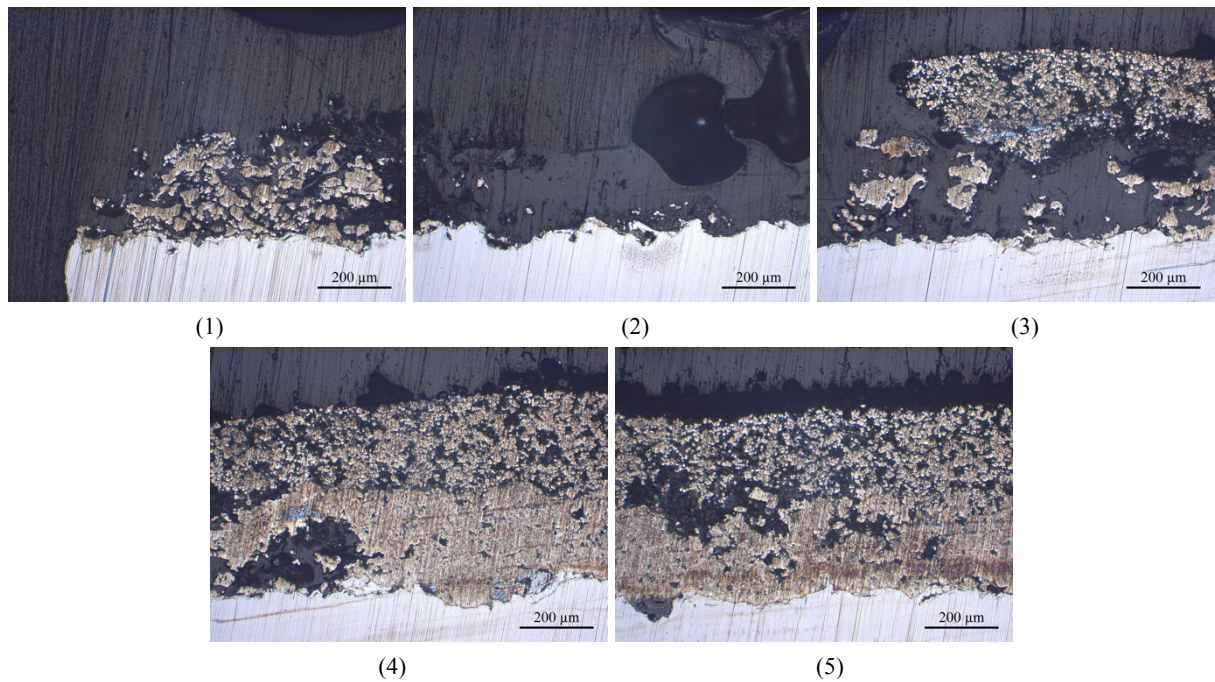
**Al silicate**

Figure F.16: Light microscope images of the Al silicate at the crevice opening (1) and further into the crevice (5). High degree of TSA corrosion had occurred approximately 2.5 mm into the crevice, in addition to general corrosion of the Al silicate.

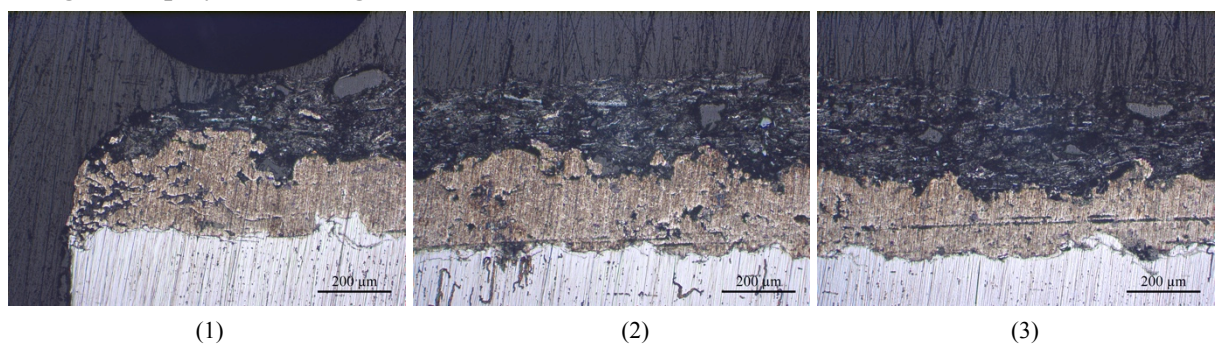
**Inorganic copolymer coating**

Figure F.17: Light microscope images of the inorganic copolymer coating at the crevice opening (1) and further into the crevice (3). The TSA had only corroded at the crevice opening, and appeared intact further into the crevice.

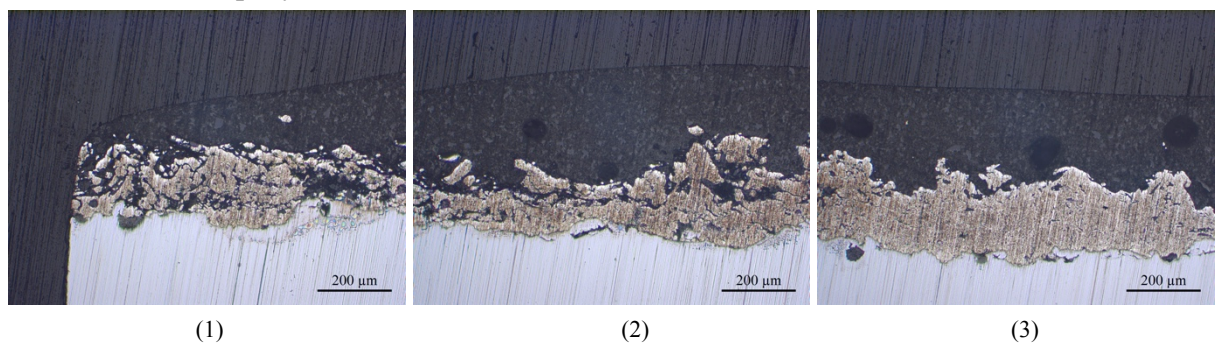
**TSA coated with epoxy**

Figure F.18: Light microscope images of the TSA coated with epoxy at the crevice opening (1) and further into the crevice (3). The TSA had corroded sporadically approximately 2 mm into the crevice, while the TSA was intact further into the crevice.

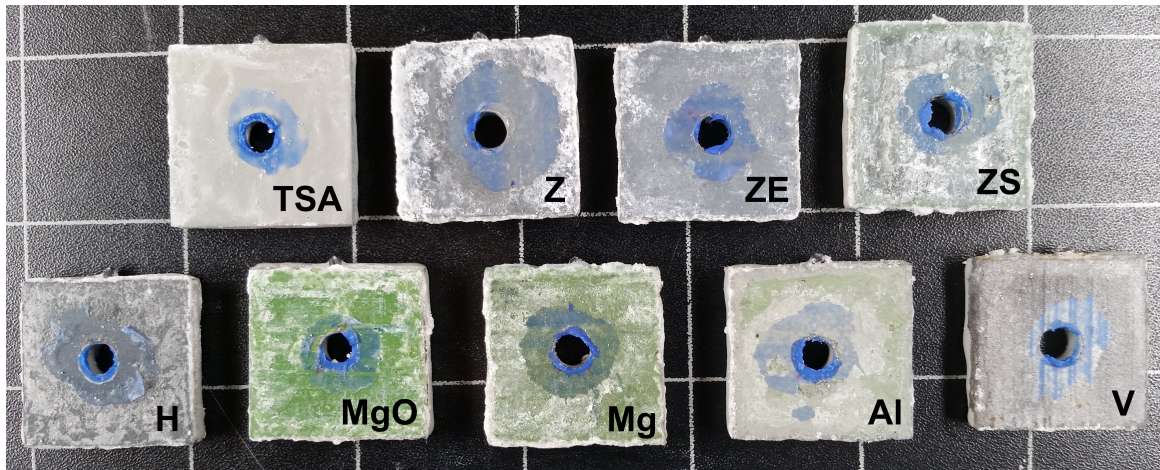
Figure F.19: Visual appearance of the samples after 30 days of exposure. The order of the repair coatings on the upper row is: TSA coated with epoxy (TSA), high Zn primer (Z), Zn epoxy (ZE) and Zn silicate (ZS). The order on the lower row is: modified Zn epoxy (H), MgO silicate (MgO), Mg silicate (Mg), Al silicate (Al) and the inorganic copolymer coating (V).

Figure F.19 presents the samples after 30 days of exposure. The pH values measured during the test period is presented in Table F.3, in addition to pH development presented in Figure F.20. Furthermore, the anodic current is presented in Figure F.21, and the coating cross sections are presented from Figure F.22 to Figure F.30. The amount of TSA corrosion and repair coat reduction are explained in the figure text.
