# Repair Coatings for Thermally Sprayed Aluminium

Materials Science and Engineering

Submission date: June 2016

**Repair coatings for thermally sprayed aluminium**

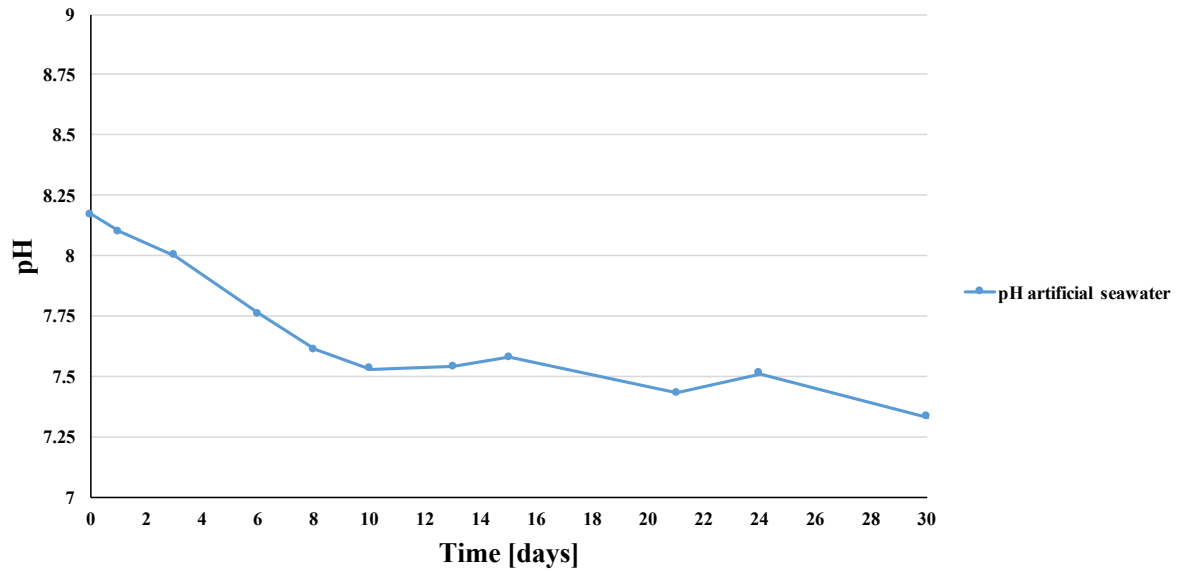
Figure F.20: Development of the pH during the test run for 30 days.

Figure F.19 presents the samples after 30 days of exposure. The pH values measured during the test period is presented in Table F.3, in addition to pH development presented in Figure F.20. Furthermore, the anodic current is presented in Figure F.21, and the coating cross sections are presented from Figure F.22 to Figure F.30. The amount of TSA corrosion and repair coat reduction are explained in the figure text.

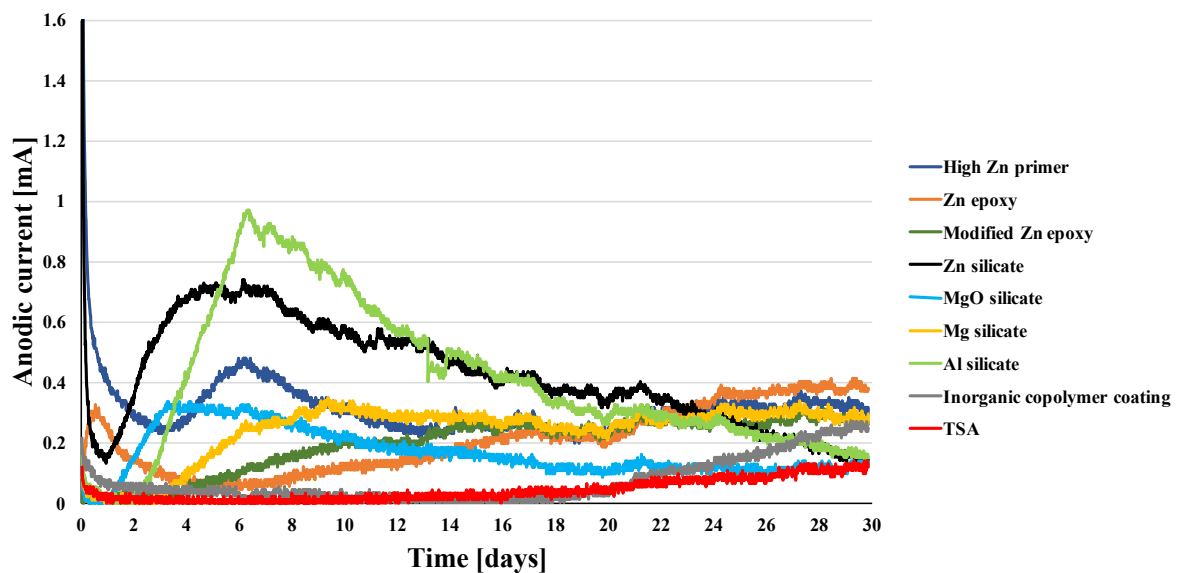
Overall, the anodic current was lower for the test that ran for 30 days, compared to the 16 days exposure, but the trend was consistent. The TSA coated with epoxy and the inorganic copolymer coating showed the same increasing tendency, but the increase started after approximately 18 days of exposure. The corresponding exposure time before the increase started for the 16 days exposure was approximately 2 days for the TSA coated with epoxy, and 7 days the inorganic copolymer coating.

Figure F.21: Anodic current for the repair coatings for test setup 2 run for 30 days with anodic current (y-axis) plotted against time (x-axis).

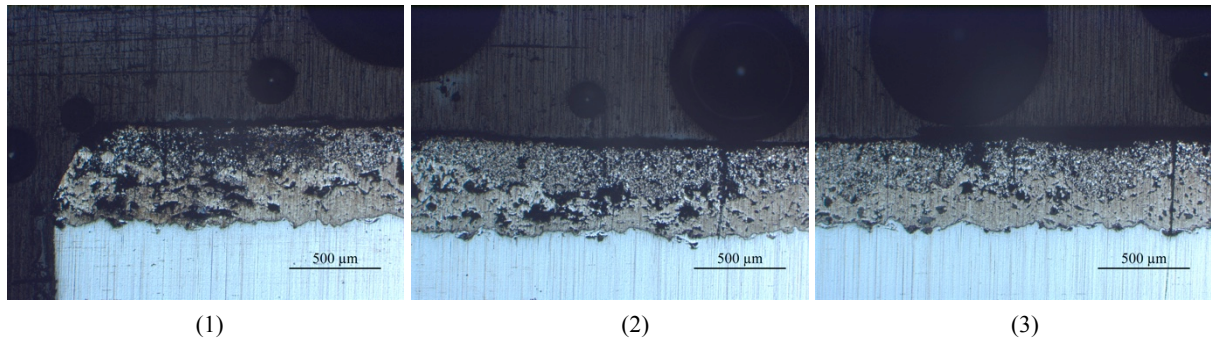
**High Zn primer**

Figure F.22: Light microscope images of the high Zn primer at the crevice opening (1) and further into the crevice (3). Most severe TSA corrosion was seen at the crevice opening, in addition to some sporadic TSA corrosion further into the crevice. Most corroded zinc particles were also seen at the crevice opening.

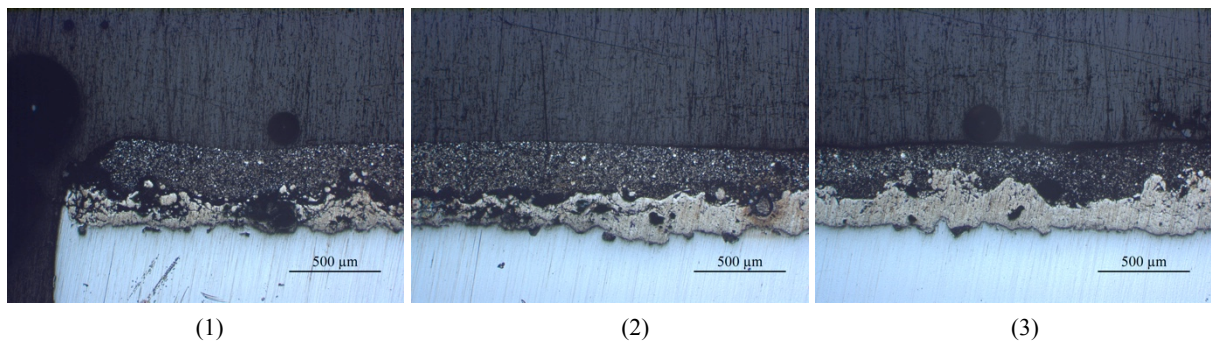
**Zn epoxy**

Figure F.23: Light microscope images of the Zn epoxy at the crevice opening (1) and further into the crevice (3). TSA corrosion was seen at the crevice opening, in addition to sporadic further into the crevice. A corroded field between the two coating layers can also be seen.

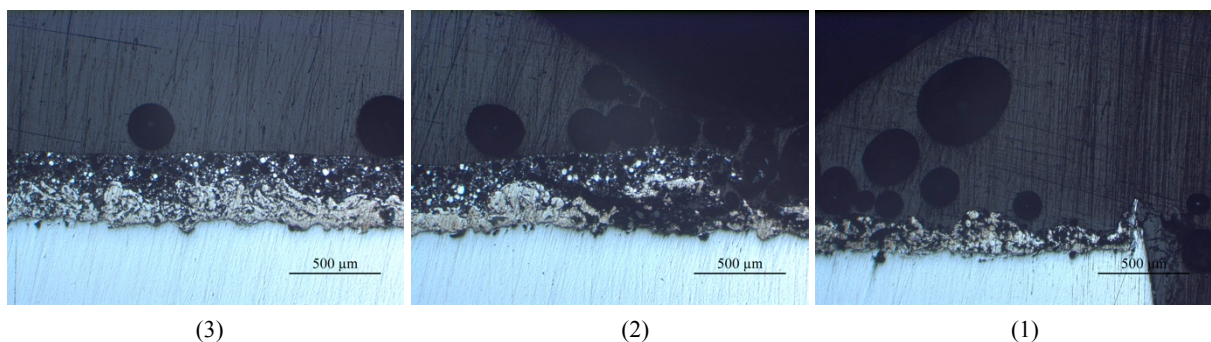
**Modified Zn epoxy**

Figure F.24: Light microscope images of the modified Zn epoxy at the crevice opening (1) and further into the crevice (3). The modified Zn epoxy was totally corroded or flaked off approximately 2.5 mm into the crevice. General TSA corrosion was seen in the entire crevice.

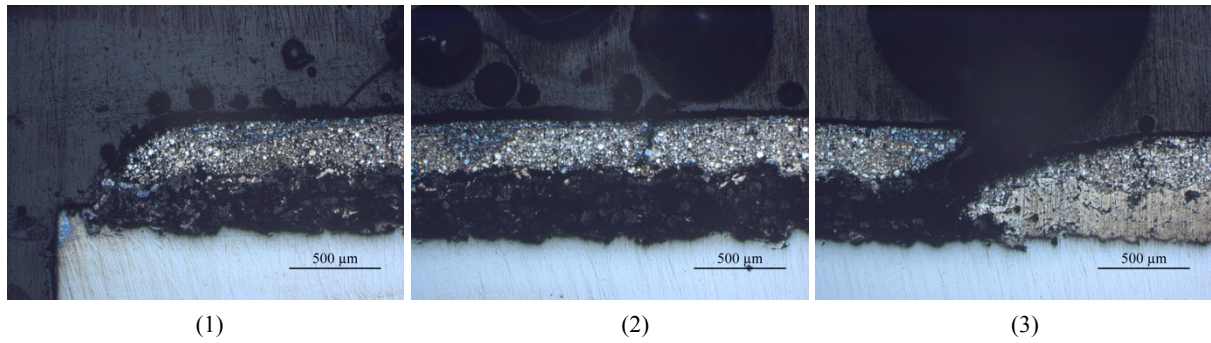
**Zn silicate**

Figure F.25: Light microscope images of the Zn silicate at the crevice opening (1) and further into the crevice (3). Continuous TSA corrosion was seen approximately 5.4 mm into the crevice. A crack in the repair coating was seen approximately 5.1 mm into the crevice. However, the amount of intact zinc particles appeared high.

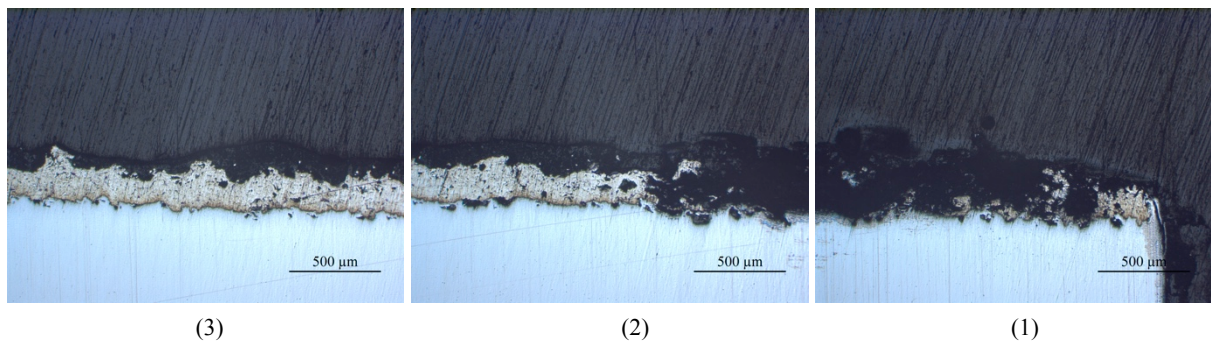
**MgO silicate**

Figure F.26: Light microscope images of the MgO silicate at the crevice opening (1) and further into the crevice (3). Continuous TSA corrosion was seen approximately 2.9 mm into the crevice. Complete reduction of the MgO silicate was also seen for the same distance.

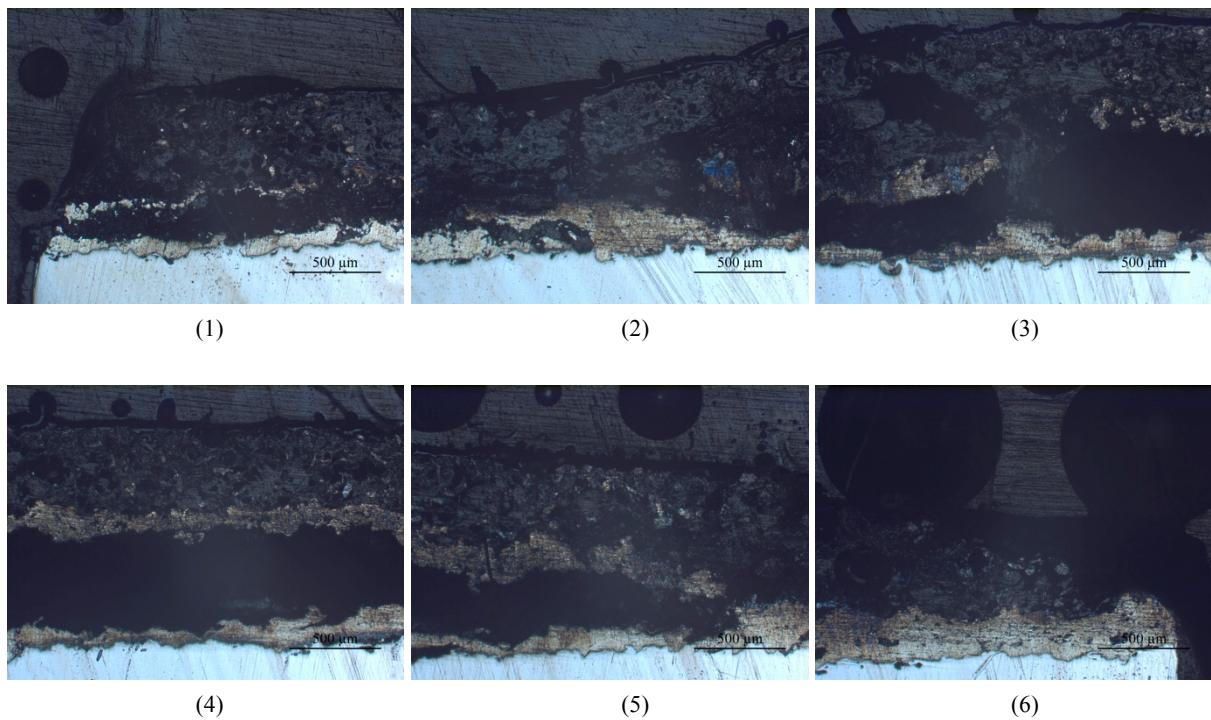
**Mg silicate**

Figure F.27: Light microscope images of the Mg silicate at the crevice opening (1) and further into the crevice (6). Severe corrosion of both the TSA and Mg silicate was seen, with continuous corrosion of the TSA approximately 10.4 mm into the crevice.

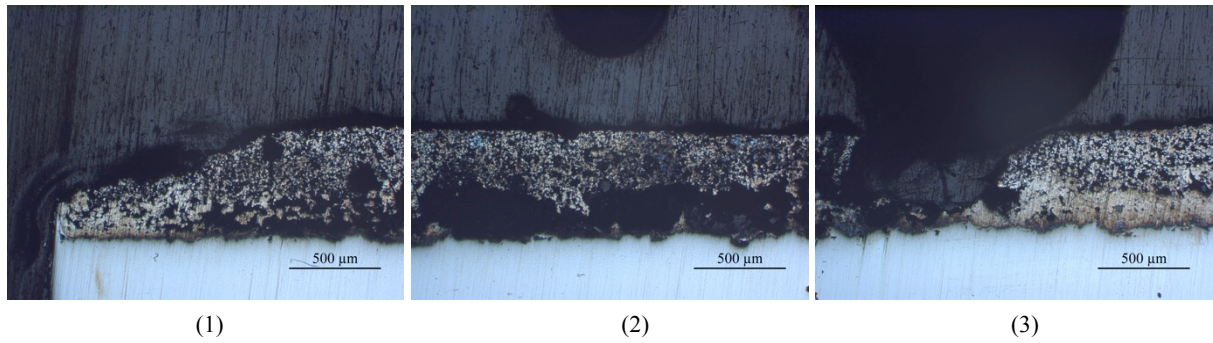
**Al silicate**

Figure F.28: Light microscope images of the Al silicate at the crevice opening (1) and further into the crevice (3). Continuous TSA corrosion was seen approximately from 0.7 mm to 5.2 mm into the crevice. Some TSA corrosion was also seen at the crevice opening, but not so severe. The amount of intact aluminium particles appeared high.

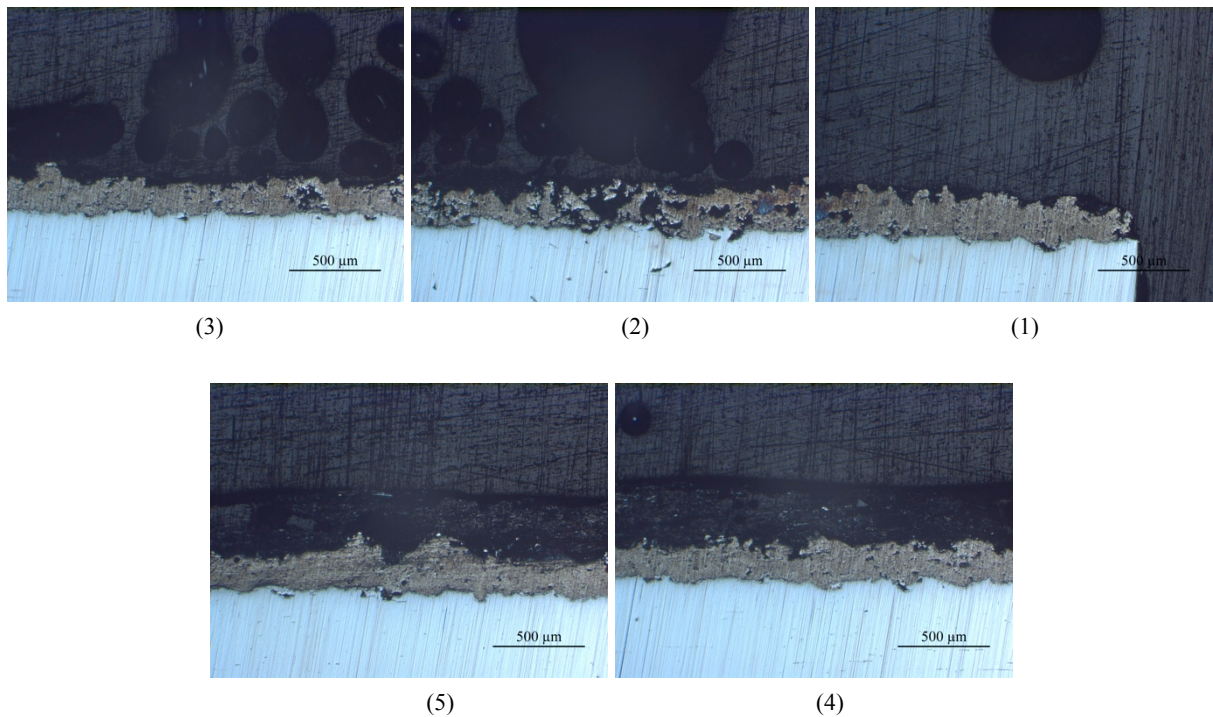
**Inorganic copolymer coating**

Figure F.29: Light microscope images of the inorganic copolymer coating at the crevice opening (1) and further into the crevice (5). The inorganic copolymer coating was almost completely reduced approximately 6.1 mm into the crevice. A thin remaining layer can be seen. Some sporadic TSA corrosion can be seen a distance into the crevice.

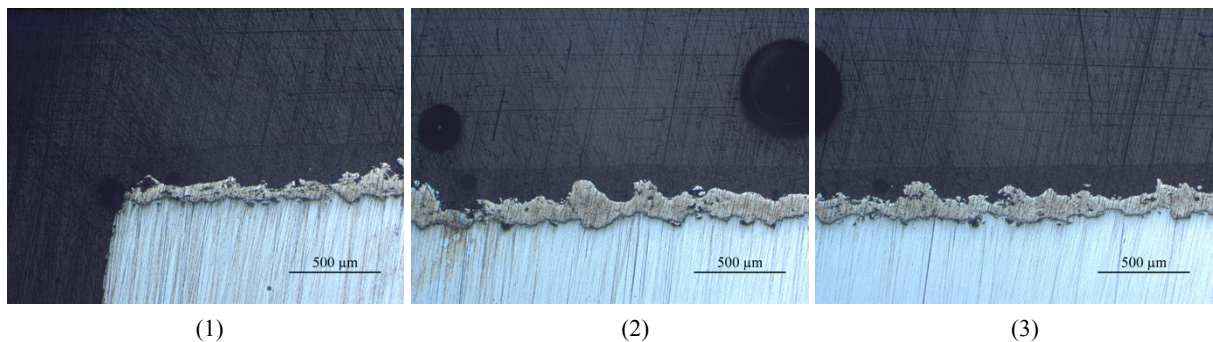
**TSA coated with epoxy**

Figure F.30: Light microscope images of the TSA coated with epoxy at the crevice opening (1) and further into the crevice (3). Some TSA corrosion at the crevice opening can be seen. Further into the crevice, the TSA appeared unaffected.
