# Norwegian Pitched Roof Defects

**Abstract:** The building constructions investigated in this work are pitched wooden roofs with exterior vertical drainpipes and wooden load-bearing system. The aim of this research is to further investigate the building defects of pitched wooden roofs and obtain an overview of typical roof defects. The work involves an analysis of the building defect archive from the research institute SINTEF Building and Infrastructure. The findings from the SINTEF archive show that moisture is a dominant exposure factor, especially in roof constructions. In pitched wooden roofs, more than half of the defects are caused by deficiencies in design, materials, or workmanship, where these deficiencies allow moisture from precipitation or indoor moisture into the structure. Hence, it is important to increase the focus on robust and durable solutions to avoid defects both from exterior and interior moisture sources in pitched wooden roofs. Proper design of interior ventilation and vapour retarders seem to be the main ways to control entry from interior moisture sources into attic and roof spaces.

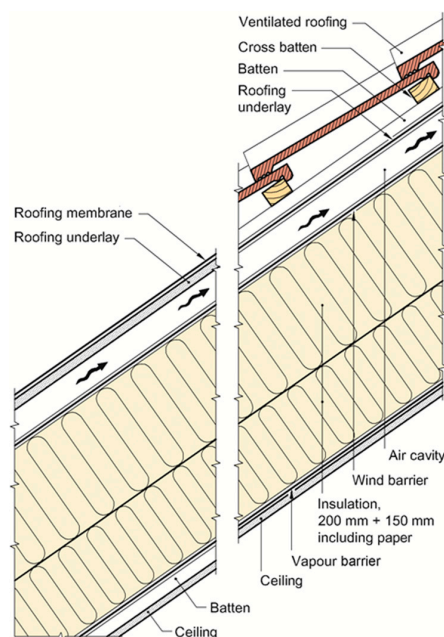
Roof construction Type A is a typical roof built before the year 2000 (see Figure 1). The outer part of the roof consists of:

- raintight roofing;
- drainage and ventilation cavity;
- vapour-tight underlayer roof;
- ventilation cavity; and
- vapour open wind barrier.

**Figure 1.** Roof Type A, which separates the rain and wind barrier [13]. Here shown with two common types of roofing.

Type A separates the rain and wind barrier with roofing directly on wooden sheets or with the roofing and underlayer above a separate wind barrier. The roof is ventilated both between the wind barrier and rain barrier and between the rain barrier and the roofing. The rain barrier can be vapour tight. This detail results in additional materials and often higher labour costs compared with the more developed and modern construction of Type B (see Figure 2).

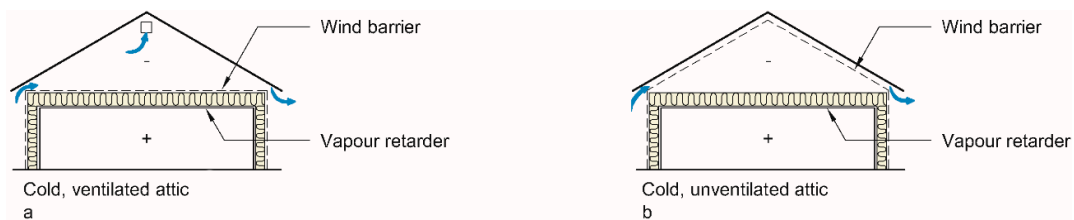
Type C consists of roofs with an air volume (attic) between the insulation and the roofing. During most of the year, the air temperature in the attic will be close to the ambient temperature, but during sunny summer days, the temperatures in the attic can be higher than the ambient temperature. The roof with cold attics can be built up in two different ways (see Figure 3):

designed in order to avoid penetration of snow and rain into the attic. Only the vapour retarder contributes to the airtightness of the building (ceiling), making the solution vulnerable to holes and imperfections in the vapour retarder, which again can cause condensation because of air (containing moisture) leakages through the construction. Hagentoft *et al.* [15] found that the moisture level of cold ventilated lofts is improved if the attic floor is airtight, has low built-in moisture content, and has well-ventilated indoor air.

- (b) Cold, unventilated attic space with all ventilation between the underlayer roof and roof covering. The construction is a further development of a) and an improved roof design. The underlayer roof is a vapour open and watertight wind barrier. Both the wind barrier and vapour retarder should be used continuously, thus making it easier to ensure airtightness of the building.

**Figure 3.** Roof Type C with cold attic. (a) Cold, ventilated attic space with air stream flowing through the attic itself. (b) Cold, unventilated attic space with all ventilation between the underlayer roof and the roof covering. Image further developed from [16].

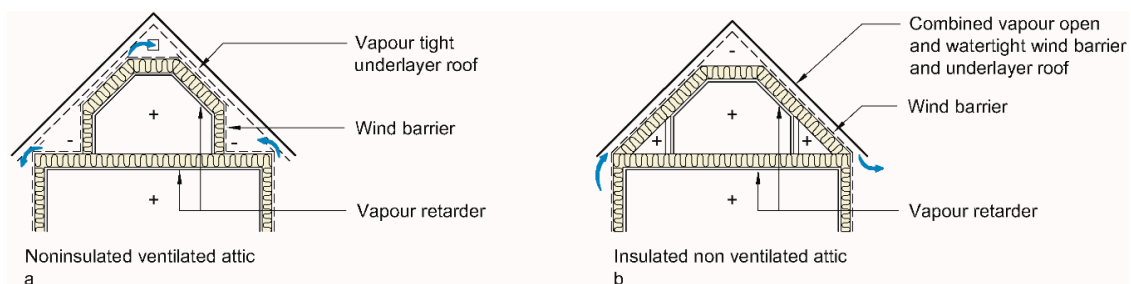
Type D consists of roofs with heated rooms in part of the attic and is thoroughly described by [13]. This type of construction is, according to Uvsløkk, particularly vulnerable to moisture damage and heat loss from air leakages because the vapour retarder is not continuous through the floor construction. The construction type can be built up in two different ways, or a combination of these:

- (a) Thermally non-insulated ventilated attic. The underlayer roofing can be vapour tight. There are ventilation openings in the ridge and between the underlayer roof and the thermal insulation along the purlin of the building. Ventilation openings have to be designed in order to avoid penetration of snow and rain into the attic. The vapour retarder and wind barrier are not continuous through the floor construction and the roof is therefore particularly vulnerable to moisture damage due to air leakages.
- (b) Thermally insulated non-ventilated attic. The underlayer roof has to be vapour open. The construction is a further development of a) and an improved solution. It is possible to make a continuous and airtight joint between the wind barrier on the wall and the underlayer roof, thus making the construction more resistant to moisture compared to a).

**Figure 4.** Roof Type D with heated rooms in part of the attic. Thermally insulated non-ventilated attic rooms (a) and thermally non-insulated, ventilated (from outside) attic rooms (b). Further developed from [13].

Roof Type D is rather common in Norwegian dwellings due to the efficient utilization of space. There are approximately 100% more building defect cases registered in this category compared to Type A and B. Many (41%) of the building defects are caused by indoor moisture. Type D has difficulties regarding airtightness of the floor construction; in particular, it is complicated to achieve a continuous and airtight joint of the vapour barrier in the floor construction (see Figure 4). As Figure 4 shows, the attic rooms can be ventilated, thus making the construction very vulnerable to air leakages from the inside.
