# Effects of three metal coupling on galvanic crevice corrosion

Chemical Engineering and Biotechnology

Submission date: June 2017

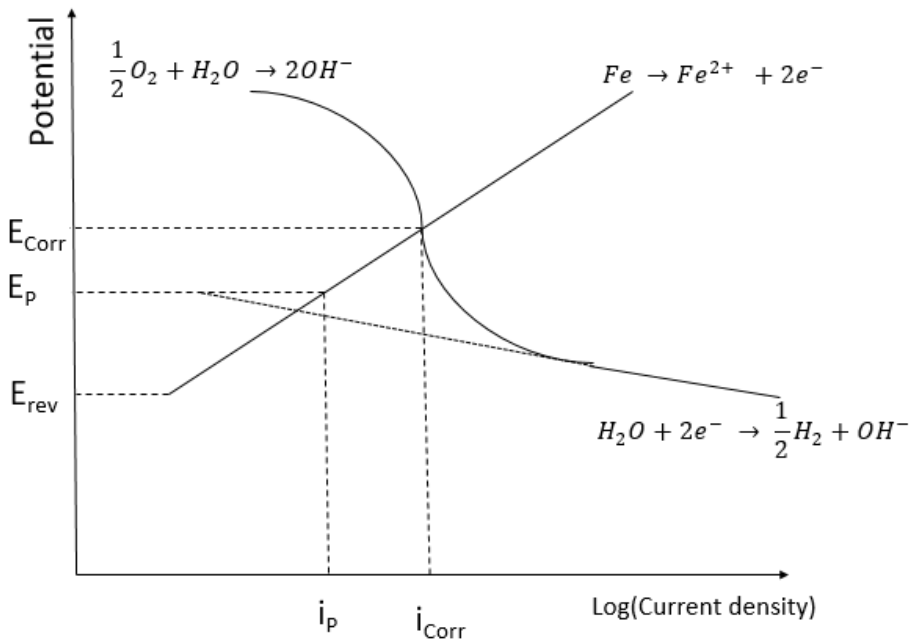
Illustrated in figure 2.2 the corrosion potential  $E_{Corr}$  is lowered to a protection potential  $E_P$  by the active metal, this will in turn decrease the corrosion current  $i_{Corr}$  to the protection current  $i_P$ . For complete protection of the structure the protection potential would have to be lowered below the reversible potential  $E_{rev}$ .

**Figure 2.2:** Schematic Evans diagram adapted from Andresen et al [4] showing relationship between potential lowering and the logarithm of current density on a steel surface in seawater

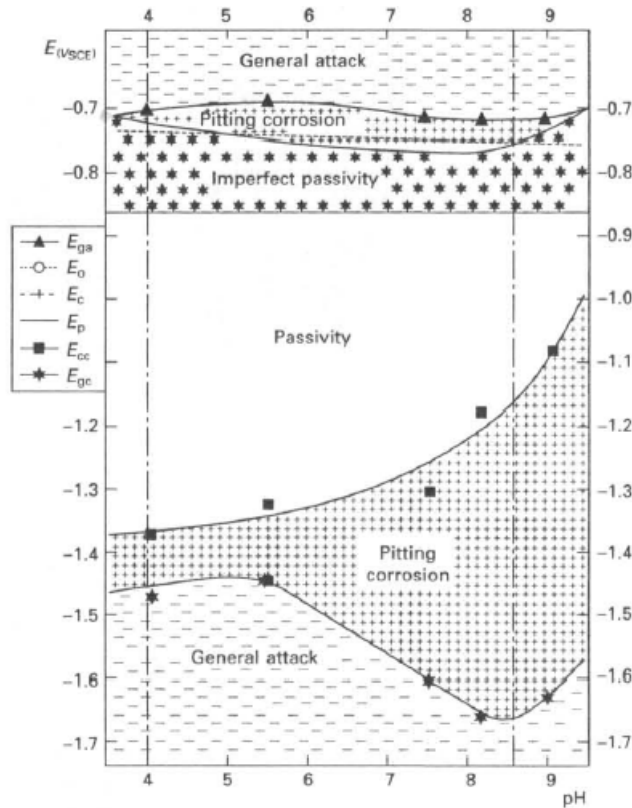
In a study by Perault it was found that there was no immune region for aluminium due to the presence of hydrides on the aluminium surface[15]. It was also found that these hydrides would destabilize the oxide layer and thus cause the aluminium to be more susceptible to corrosion. An experimental construction of a pourbaix diagram of an aluminium alloy in NaCl were created by Gimenez[16]. This diagram can be seen in figure 2.6. It was found that aluminium is susceptible to pitting or general attack at lowered potential levels and no immune zone was detected.

**Figure 2.6:** Experimental potential-pH diagram for the 5086 alloy in 3% NaCl solution at 20°C. Figure is taken from [16]

This is due to the repassivation of the pits after particle detachment which in conjunction with calcareous formation will decrease the current during polarization. Since the oxide is not stable in alkaline environments there is a danger of "over protection" of the surface. If the surface is polarized to far in the cathodic direction the alkaline etching caused by  $\text{OH}^-$  ions will continuously expose new intermetallic particles and the oxide layer will not be able to stabilize again[17]. This mechanism is often referred to as cathodic corrosion[3]. This is the pitting zone in figure 2.6 which is located below and to the right of the passive zone.

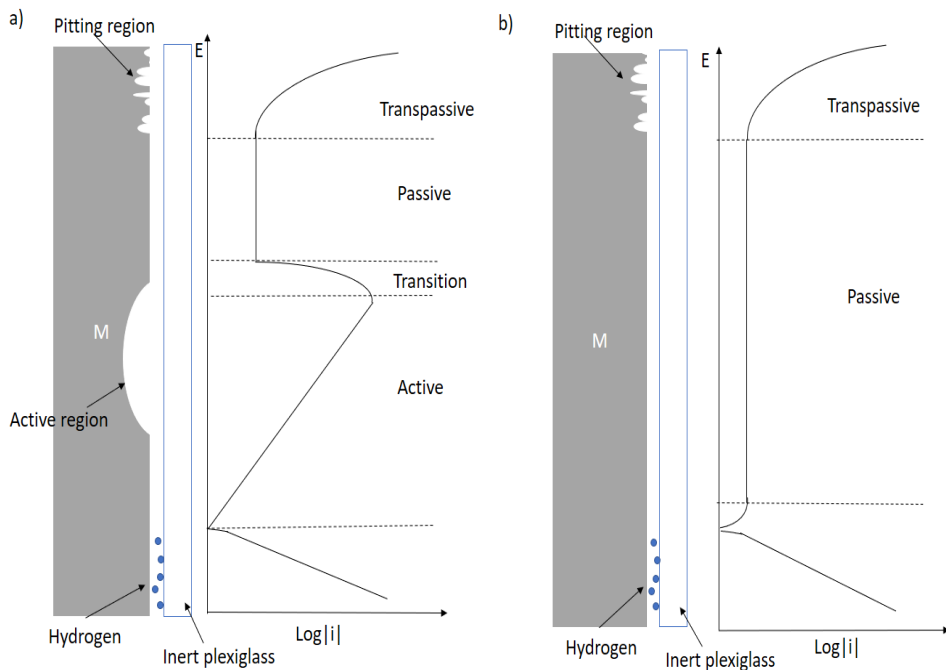
An ohmic potential drop inside the crevice will develop in the crevice due to the formation of corrosion products and evolution of hydrogen gas bubbles. Both hydrogen gas and the various corrosion products will not appear uniformly along the crevice and thus the potential distribution will also be non uniform. This nonuniform distribution of potential will also yield a nonuniform current distribution inside the crevice. The distribution inside the crevice will resemble the polarization curve of the metal and its influence on corrosion is illustrated in the figure below.

(a) Schematic representation of the relationship between corrosion morphology and polarization curve of an active metal.

(b) Schematic representation of the relationship between corrosion morphology and polarization curve of an active metal.

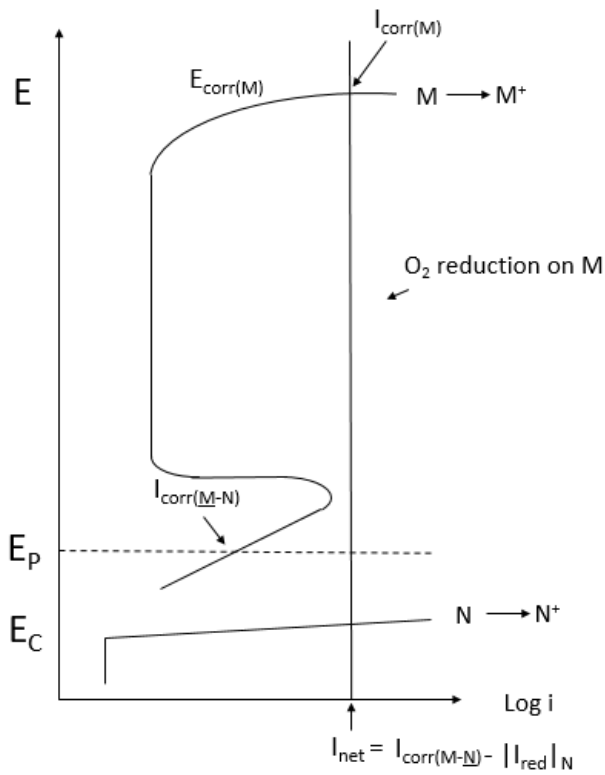
The AlZnIn anode is one of the most commonly used anodes in the industry and will keep a stable potential at low current densities[3]. This is due to the fact that the AlZnIn alloy is an active-passive metal which will experience pitting corrosion during operation. This is illustrated in the figure 2.13 where an Evans diagram of cathodic protection in practise is shown. The corrosion of the anode will occur along the pitting line and thus a stable potential is expected in the system

**Figure 2.13:** Schematic illustration of an Evans diagram of cathodic protection with a passive-pitting anode. Illustration is adapted from Nisancioglu [3]

The potentials for all parallels are as expected very stable due to the mechanism described in figure 2.13. The potential vary a bit more at 25 °C and is also shifted a few mV in the anodic region in comparison to the potentials at 10°C. With a more cathodic potential hydrogen evolution will be favoured. This also seems to be the case when the current behaviour between 10°C and 25°C are taken into consideration. The currents decay in a more linear fashion at 10°C, which is an indication of hydrogen evolution being dominant. The potential without AlZnIn is in the range of the aluminium in figure 2.12. This is expected as aluminium will then act as an anode.

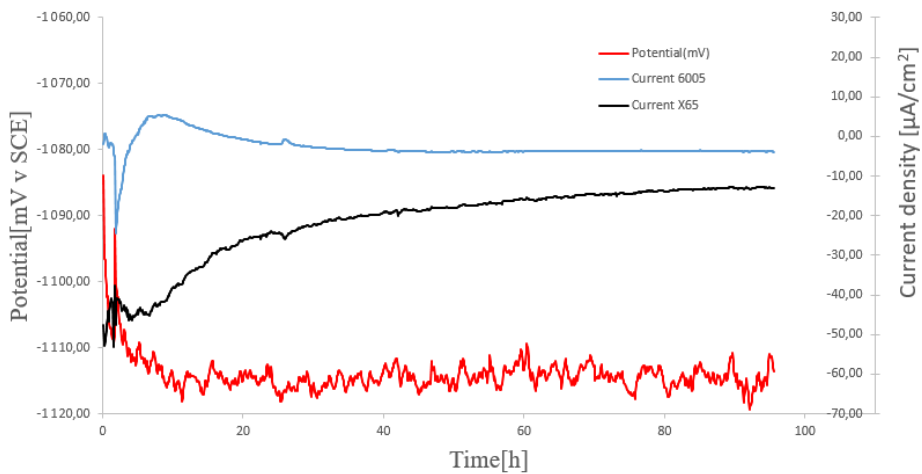
The electrochemical behaviour for the galvanic corrosion test showed the same behaviour as is shown in figure 2.16 with a decaying current on both metals. For the crevice corrosion testing it was also found that the aluminium experienced an anodic current and suffered from corrosion. It was however found in the 96 hour parallel that this current turned cathodic as shown in figure 2.20. This was an indication that the CP system could protect both metals at the same time. During such a long polarization time there was also found indication of calcareous deposits blocking the crevice.

**Figure 2.20:** Crevice corrosion test between 6005 aluminium and X65 steel with cathodic protection. Crevice size is 100 μm and run time is 96 hours at 25 °C. Potential is measured with a saturated calomel electrode. The pH measured after conducted experiment was 9. Figure is taken from [25]

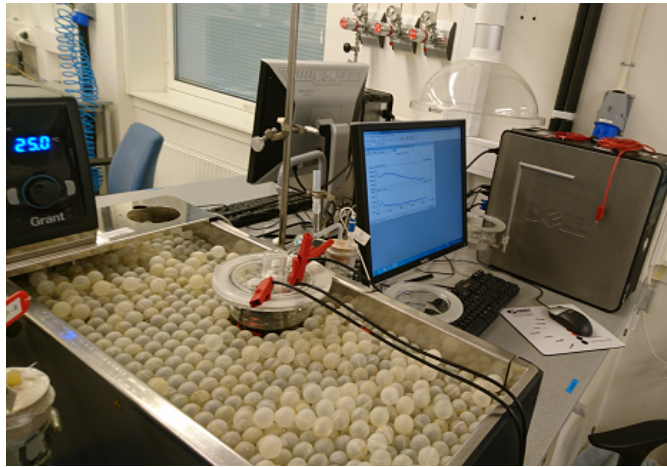
**Figure 3.6:** Picture of the setup on the lab. The cell is submerged in an water bath holding 25°C. The reference electrode is connected through a salt bridge. One of the potentiostats are pictured with a plot of the ongoing recordings

The whole cell was submerged into a water bath which held a constant temperature at 25°C or 10°C during the experiments. The duration at both temperatures was 72,96 or 120 hours. A picture of the complete setup on the lab is shown in figure 3.6.

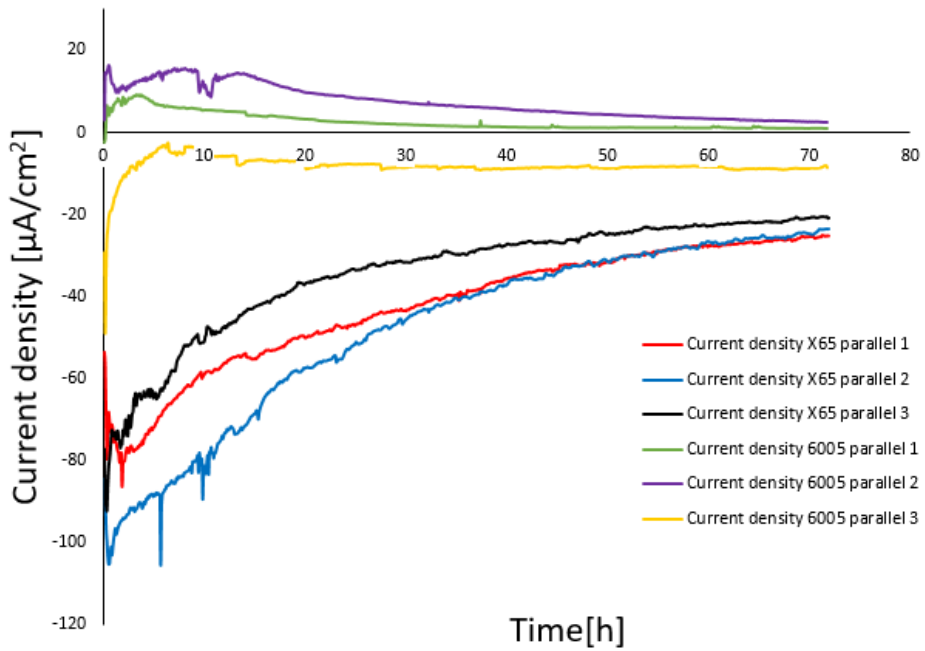
In figure 4.1 parallel 1 and 2 for aluminium show an initial anodic peak before they start to decay. Parallel 1 starts decaying after 4 hours at  $10 \mu\text{A}/\text{cm}^2$  and decays steadily down to  $1 \mu\text{A}/\text{cm}^2$ . Parallel 2 start decaying after 12 hours and has a anodic peak of  $15 \mu\text{A}/\text{cm}^2$ , before decaying to  $2 \mu\text{A}/\text{cm}^2$ . A logarithmic plot of parallel 1 and 2 found in the appendix presented in figure 6.2, which show that both are still decaying when the experiment is stopped. Parallel 3 deviates from the two other with a cathodic current during the entire experiment. The current moves in the anodic direction initially before steadily stabilizing at  $-8 \mu\text{A}/\text{cm}^2$ .

The currents on X65 show similar behaviour with a cathodic current for the entire test period. The parallels start at different levels, but all steadily decay. Initially the decay is sharp and almost exponential before becoming linear after 30 hours. At the end of the experiments the currents are at  $-23 \pm 2 \mu\text{A}/\text{cm}^2$

**Figure 4.1:** Plot of current as a function of time during galvanic crevice corrosion testing with X65, 6005 and AlZnIn as anode in synthetic seawater at 25°C. Parallel 1 and 2 is from previous work[25]

In figure 4.14 a) and b) photographs of the metal surfaces from parallel 3 in figure 4.1 before chemical cleaning is presented. Both surfaces are covered with a calcareous layer. On the aluminium it can be seen that the layer is denser close to the edges. Deposits can also be observed on the outside of the teflon strips.

The SEM micrograph presented in figure 4.23 is of parallel 3 in figure 4.1, which is photographed in a) in figure 4.17. Alkaline etching of the matrix can be observed to the left. A large pit with several intermetallic particles is to the left of the center. In the top left the corrosion attack is in the form of many hemispherical pits. Grain boundaries can also be observed. To the right the matrix is intact, but small pits with particles buried at the bottom can be observed. The same behaviour were found at the bottom of the sample and is shown in the appendix in figure 6.7. The matrix in the middle were found to be intact and without pits. This is shown in figure 6.6 in the appendix.

**Figure 6.2:** Logarithmic representation of currents on 6005 aluminium for parallel 1 and 2 from figure 4.1.

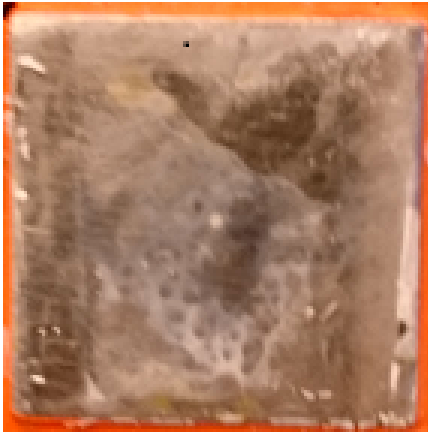
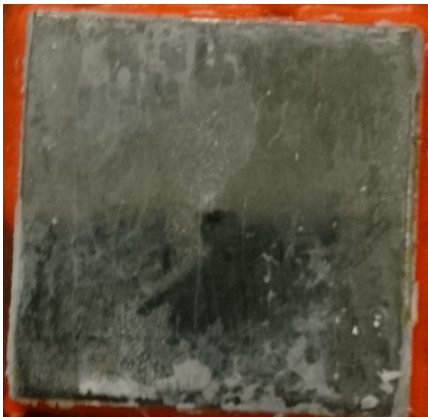
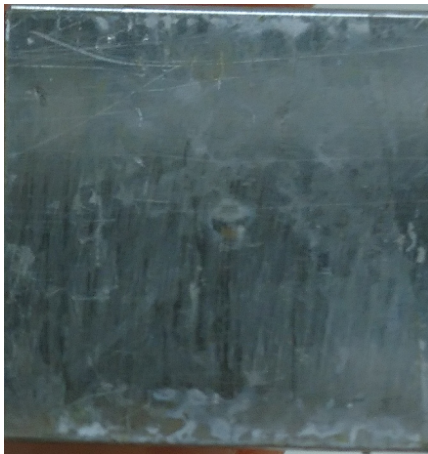
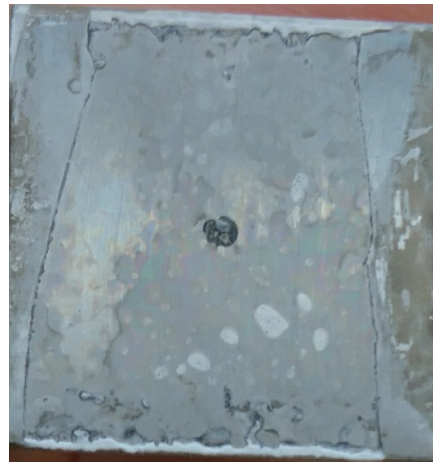
In c) and d) photographs of the metal surfaces from parallel 2 in figure 4.5 before chemical cleaning is presented. Both surfaces are covered with a calcareous layer. On the aluminium the calcareous layer is found to be thicker closer to the edge. Calcareous layer is also found on the outside of the teflon strip placement.

In e) and f) photographs of the metal surfaces from figure 4.9 before chemical cleaning is presented. Both surfaces are covered with calcareous deposits. The aluminium sample show a well developed layer close to the edges in the form of white strips. The picture indicate that the teflon strip did not stay in place during assembly of the crevice device.

(a) X65 72 hours at 25°C

(b) 6005 72 hours at 25°C

(c) X65 96 hours at 25°C

(d) 6005 96 hours at 25°C

(e) X65 120 hours at 25°C

(f) 6005 120 hours at 25°C

**Figure 4.14:** Images of surfaces from galvanic crevice corrosion tests with cathodic protection at 25°C .Images is taken before chemical cleaning

The image of the carbon steel presented in figure 4.32 was typical for all parallels performed at 25 °C. The image is from figure 4.9, which is pictured in e) in figure 4.14. The image show an entirely intact surface similar to the one received in figure 4.22.

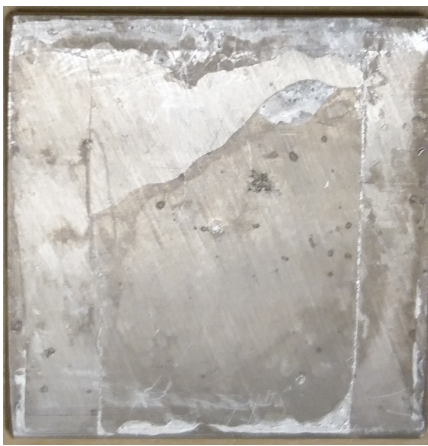
Figure 4.15 a) show that the corrosive attack on aluminium is predominantly at the edge of the sample near the crevice mouth. It also seems that a region close to top of the sample was not covered with electrolyte. The sample photographed in b) show that the corrosive attack on aluminium is predominantly at the edge of the sample near the crevice mouth. Also a region placed in the center of the sample show pitting. The sample in c) show that the corrosive attack on aluminium is predominantly at the edge of the sample near the crevice mouth. Pitting in the middle of the sample and along the boundary of the teflon can be observed.

(a) Aluminium for 72 hours at 25°C

(b) Aluminium for 96 hours at 25°C

(c) Aluminium for 120 hours at 25°C

**Figure 4.15:** Photographs of 6005 surfaces after chemical cleaning

The SEM micrograph presented in figure 4.25 is of parallel 2 in figure 4.5, which is photographed in b) in figure 4.15. The figure shows pit growth around the intermetallic particles in the middle of the sample. Image of the top of the sample is given in the appendix in figure 6.8 to give a reference on how far away from the edge the alkaline etching occurred. The figure shows that the alkaline etching is visible 0.5 mm down into the crevice. Image of the bottom in figure 6.9 shows the same behaviour as for previously

The SEM micrograph presented in figure 4.26 is from figure 4.9, which is photographed in c) in figure 4.15. The image show alkaline etching exposing grain boundaries in the top left of the picture. Hemispherical pits is found in the middle of the picture. Some of these pits has multiple intermetallic particles in them. The same behaviour as the previous parallels is found in the middle of the sample, presented in figure 6.11 in the appendix. The image of the top presented in figure 6.10 show that the alkaline etching occur approximately 0.3 mm into the crevice.

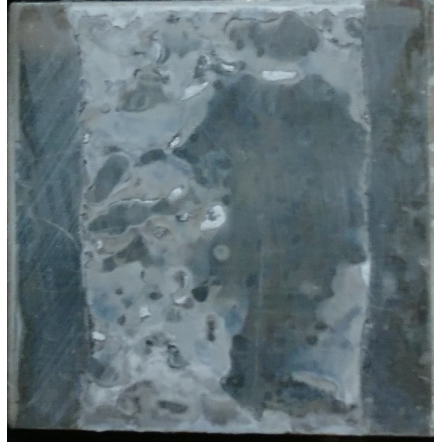
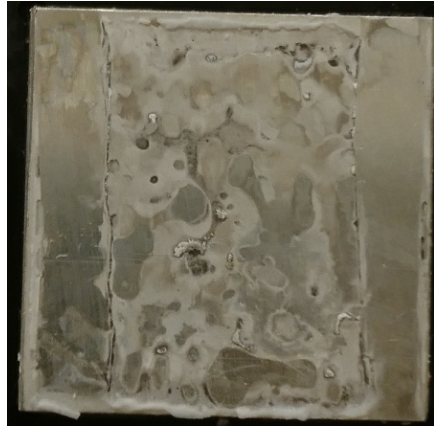
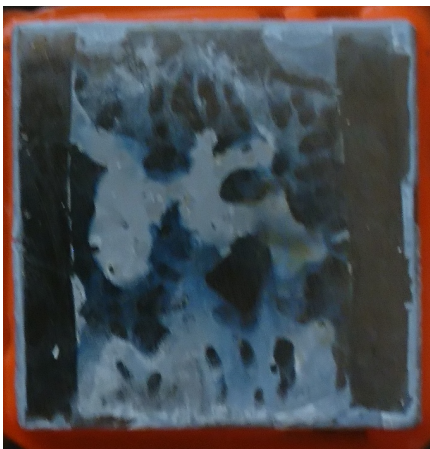
In figure 4.16 photographs a) and b) are of the metal surfaces from figure 4.3 before chemical cleaning. Both surfaces are covered with calcareous deposits. On the aluminum sample the layer is thick on half of the sample as well as the edges near the crevice mouth.

In c) and d) photographs of the metal surfaces from figure 4.7 before chemical cleaning is shown. Both surfaces are covered with calcareous deposits. The layer covers both samples with a thick layer over the entire surface which also is found at the edges.

In e) and f) photographs of the metal surfaces from figure 4.11 before chemical cleaning is presented. Both surfaces are covered with calcareous deposits. The layer covers both samples with a thick layer over the entire surface which also is found at the edges.

(a) X65 72 hours at 10°C

(b) 6005 72 hours at 10°C

(c) X65 96 hours at 10°C

(d) 6005 96 hours at 10°C

(e) X65 120 hours at 10°C

(f) 6005 120 hours at 10°C

**Figure 4.16:** Images of surfaces from galvanic crevice corrosion tests with cathodic protection at 10°C. Images are taken before chemical cleaning

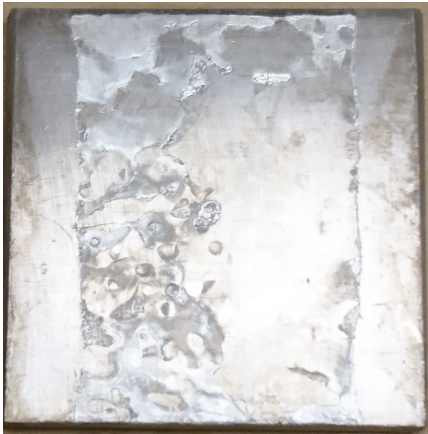
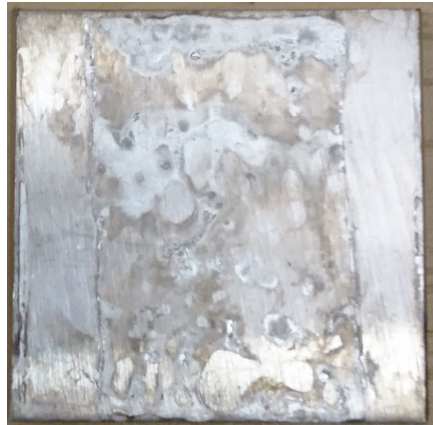
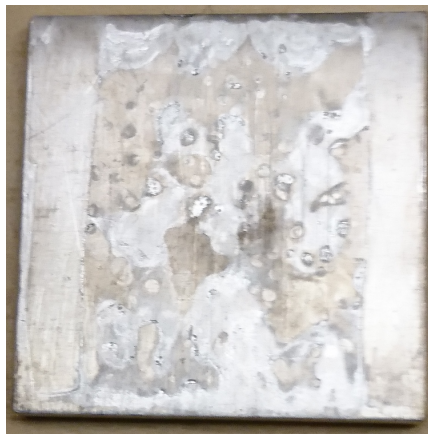
In figure 4.17 all pictures reveal that the corrosive attack is spread out on the surface where the thick calcareous layer is found. A clear sign of pitting corrosion which is not only concentrated at the edge of the sample or in the center.

(a) Aluminium for 72 hours at 10°C

(b) Aluminium for 96 hours at 10°C

(c) Aluminium for 120 hours at 10°C

**Figure 4.17:** Photographs of 6005 surfaces after chemical cleaning

The SEM micrograph presented 4.27 is from figure 4.3, which is photographed in a) in figure 4.17. The image presents the middle of the sample where alkaline etching can be observed at the top of the image. In the bottom of the picture clusters of hemispherical pits, some with intermetallic particles can be seen. Image of the top of the sample in figure 6.12 show that the corrosive attack starts 0.5 mm into the crevice. Image of the bottom given in figure 6.13 show similar behaviour as for earlier parallels.

The SEM micrograph presented 4.28 is from figure 4.7, which is photographed in b) in figure 4.17. The image show similar behaviour as found before with alkaline etching shown at the top of the picture. Hemispherical pits is also found in the middle and to the left. Alkaline etching of the matrix were found both at the top and the middle of the sample and is shown in figure 6.14 and 6.15 in the appendix.

The SEM micrograph presented 4.29 is from figure 4.11, which is photographed in c) in figure 4.17. The image show alkaline etching pits which are separated by an intact matrix. Alkaline etching and buried intermetallic particles can be seen in a picture of the middle which is found in figure 6.16 in the appendix. In figure 6.17 the grain boundaries can be seen in an etched matrix at the bottom of the sample.

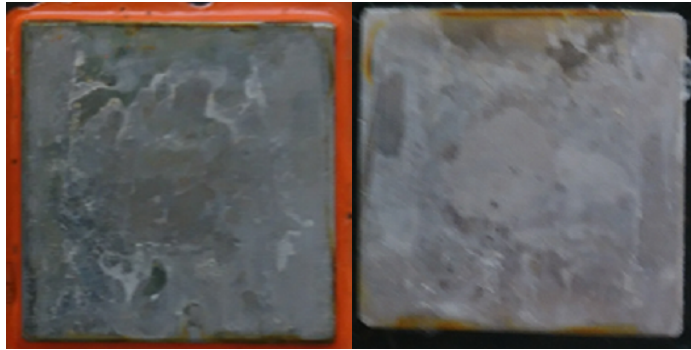
**Figure 4.18**

From figure 4.18 surfaces from figure 4.13 is presented. It can be seen that both surfaces are covered by a layer which resembles calcareous deposits. The layer does not have the characteristic white colour. Orange products looking like rust can be seen near the edge of both samples and is especially clear on the aluminium.

(a) X 65 steel from galvanic crevice corrosion testing without cathodic protection. Image is taken before chemical cleaning

(b) 6005 aluminium from galvanic crevice corrosion testing without cathodic protection. Image is taken before chemical cleaning

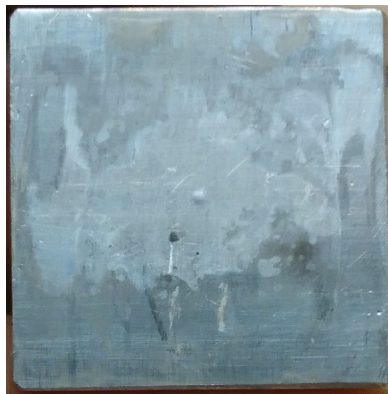
The figure 4.19 is showing the aluminium after chemical cleaning. The surface morphology is intact. No signs of pitting around the edges. And the black spot in the middle was further analyzed and concluded to be from mechanical damage.

**Figure 4.19:** Photograph of 6005 surface after chemical cleaning

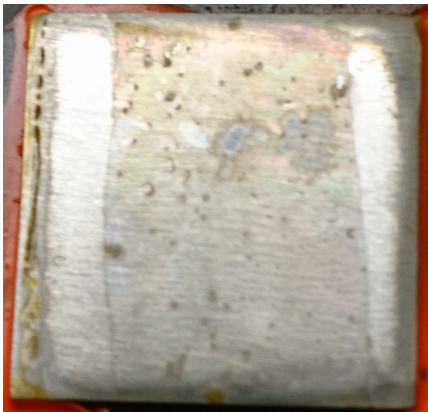
As seen in figure 4.20 surfaces in a) and b) has as well developed white surface with calcareous deposits. The deposits are thickest at the edges of the samples. Picture in c) show a layer formed on the carbon steel. The layer does not have a characteristic white colour and orange colour can be seen near the edges. In picture d) no white layer can be seen, but a matte finish resembling the oxide layer is seen in the middle of the sample.

Around the edges orange products resembling rust can be observed

(a) X65 96 hours at 10°C with CP

(b) 6005 96 hours at 10°C with CP

(c) X65 96 hours at 10°C without CP

(d) 6005 96 hours at 10°C without CP

**Figure 4.20:** Pictures of parallels run for calcareous deposit analysis

Without cathodic protection the aluminum experience an anodic current during the entire experiment. This is expected since it's less noble in comparison to steel. The mass loss show that the 6005 is not able to protect the steel. The picture in 4.20 d) show no signs of calcareous deposits, but rather an intact oxide layer. The clear pitting morphology from the three metal coupling is not seen picture 4.19 either. The closer analysis from figure 4.30 show that the matrix is intact, but corrosion around intermetallic particles can be seen. Considering the potential during the experiment it's likely that these pits are the acid pits which was described in the theory. These pits initiate at the top of the experimental pourbaix diagram in figure 2.6 which is in the potential range of what was seen in figure 4.13. From the pourbaix diagram it can also be seen that in this potential region the aluminium will be susceptible to a general or uniform corrosive attack. This is probably what is observed in figure 4.31 where the aluminium show corrosion at the bottom of the sample. The weight loss is not larger than for the comparable parallels with cathodic protection. The aluminum does not suffer from cathodic corrosion in this instance and thus not show a large mass loss. However considering the potential and current behaviour it's expected that the aluminium will continue to corrode. Measurements performed by Røstbø in figure 2.15 show the largest corrosion rate in a crevice without cathodic protection.

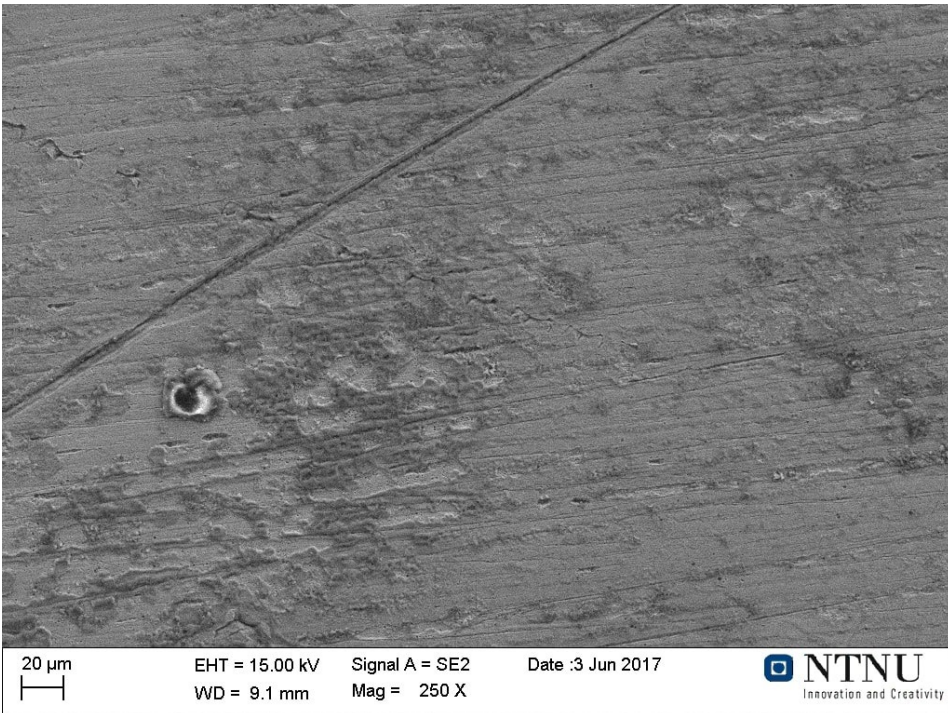
In figure 4.33 an image of a steel surface after an experiment performed at 10 degrees is presented. The surface is now clearly deformed and seems to have experienced an uniform corrosion attack.

**Figure 4.33:** SEM Image of X65 carbon steel from galvanic crevice corrosion at 10°C run for 120 hours with cathodic protection. Image is taken after chemical cleaning and is taken of the top of the sample

With experiments conducted at 10 °C the steel current show a more active behaviour at the beginning of the experiment. The sharp initial decrease in current is not found. In figure 4.7 and 4.11 an increase can be seen at the start of the experiments. With a decrease in temperature the solubility of oxygen will increase even if the diffusion is lower. Calcium is more soluble at lower temperatures and thus the calcareous layer will be less protective at lower temperatures due to less CaCO<sub>3</sub> forming. Studies by Barchiche et al [11] found that temperature would not effect the layers ability to reduce current at the potentials found in this report. This is not the case when a crevice is present as is clear from the electrochemical data. Thus a possible explanation for the different behaviour in the beginning is that the larger amount of oxygen cause a larger demand for current before being depleted. With more calcium solved the calcareous layer is less effective at reducing the current. The reduction rate will be high and the surface is kept alkaline and favouring Mg(OH)<sub>2</sub> formation . The currents on aluminum show active peaks which are "mirroring" the behaviour of the carbon steel at 10 °C. The peaks are most likely from cathodic corrosion which in turn is a result of the oxygen reduction in equation (2.2) that cause the alkaline environment to develop. So the activity in the beginning is most likely a combination of the large amount of oxygen inside the crevice and the slower kinetics of the calcareous layer at lower temperatures. After the initial activity a linear decay is observed for all parallels which indicate that hydrogen evolution is the dominant reaction. The "jumps" experienced in figure 4.11 might also be explained by H<sub>2</sub> evolution as the gas could be trapped inside the crevice, but eventually detaches, causing a new area to be exposed. Even if it was hypothesized that the slower kinetics of the calcareous layer caused an active current in the beginning, the pictures in figure 4.16 show a more developed layer at 25 °C. This might be due to the fact that the steel experience corrosion at this temperature. The porous corrosive products will then act as barriers for the electrolyte and thus create an environment which favour calcareous formation, and hence catalyze the process[31]. The weight found in table 4.9 show that the steel is not completely protected at 10 °C the SEM image in 4.33 also show a corroded surface. The weight loss is however

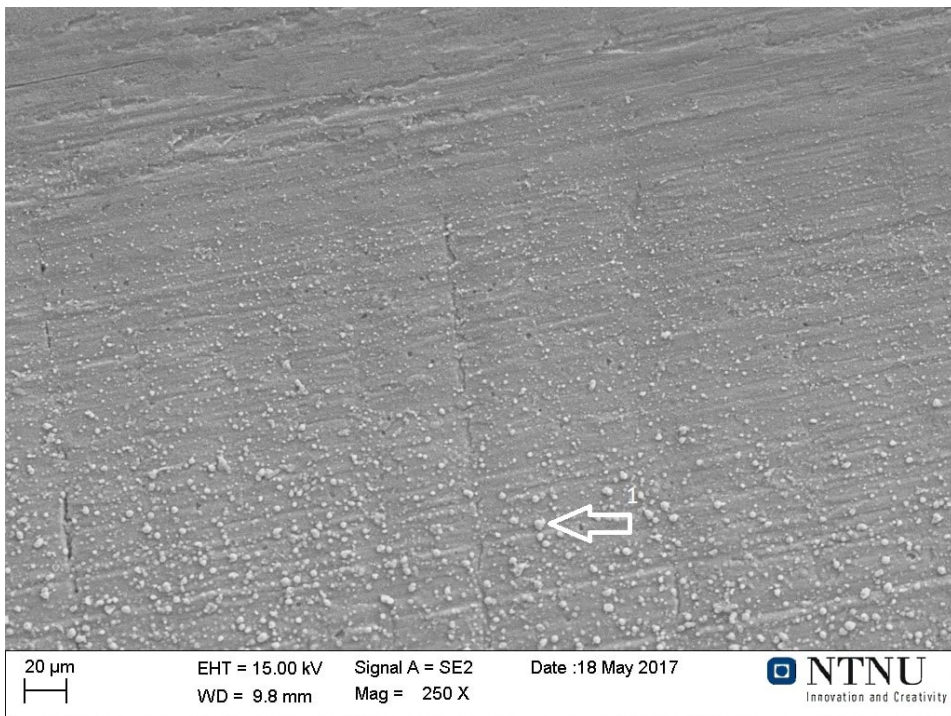
The figure 4.35 show the aluminium surface photographed in d) in figure 4.20. It can be seen that the matrix is intact with small spherical particles located closer to the edge. An EDS analysis is performed on one of these particles with results given in table 4.3. The EDS analysis reveal that the particles are corrosion products from the carbon steel, containing mostly iron together with ions from the electrolyte.

**Figure 4.35:** SEM Image of 6005 aluminum from galvanic crevice corrosion without cathodic protection at 10°C run for 96 hours. Image is taken before chemical cleaning and is taken at the bottom of the sample. EDS analysis is performed on the particle marked in white

The calcareous layer form more readily with the AlZnIn anode system. This is evident from figures 4.34 and 4.35, where only corrosion products is found at the surface. This is expected considering the pH inside the crevice being shifted in the acidic region.

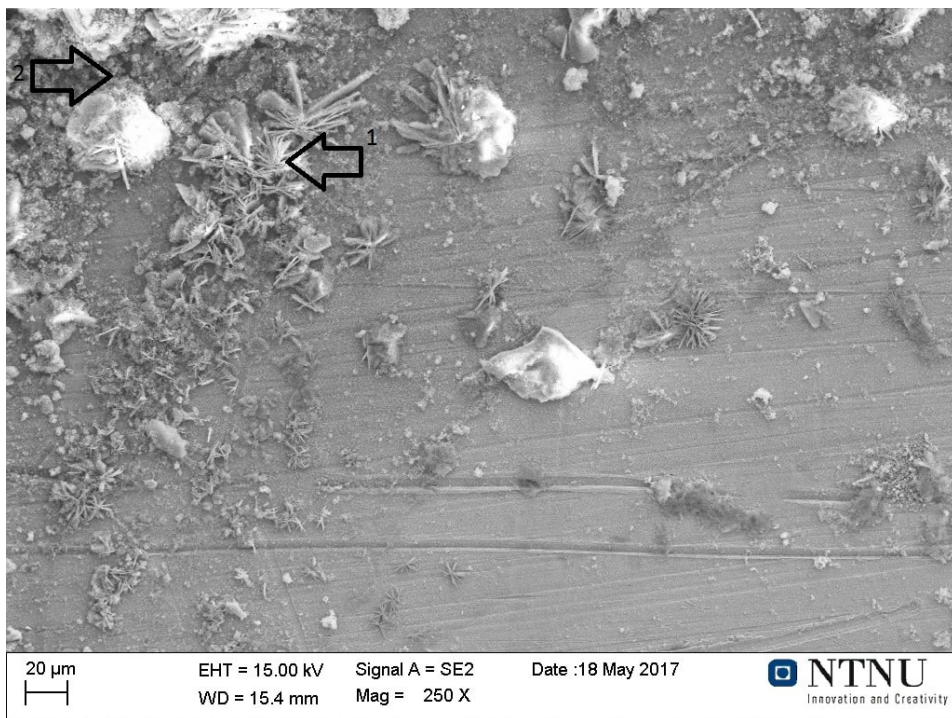
The figure 4.37 is a closer look of the calcareous deposits formed on steel presented in figure 4.20 a). It is of the black area indicated on figure 4.36. Visible from the image, the characteristic needle structure of argonite can be seen. An EDS analysis of the needle structure was performed and the results are presented in 4.5. The EDS reveal the calcium phase on the needle shaped surface while magnesium is found on the adjacent area.

**Figure 4.37:** SEM Image of X65 carbon steel from galvanic crevice corrosion with cathodic protection at 10°C run for 96 hours. Image is taken before chemical cleaning and is taken of the area which was indicated in black on figure 4.36. EDS analysis is performed at the points indicated in black

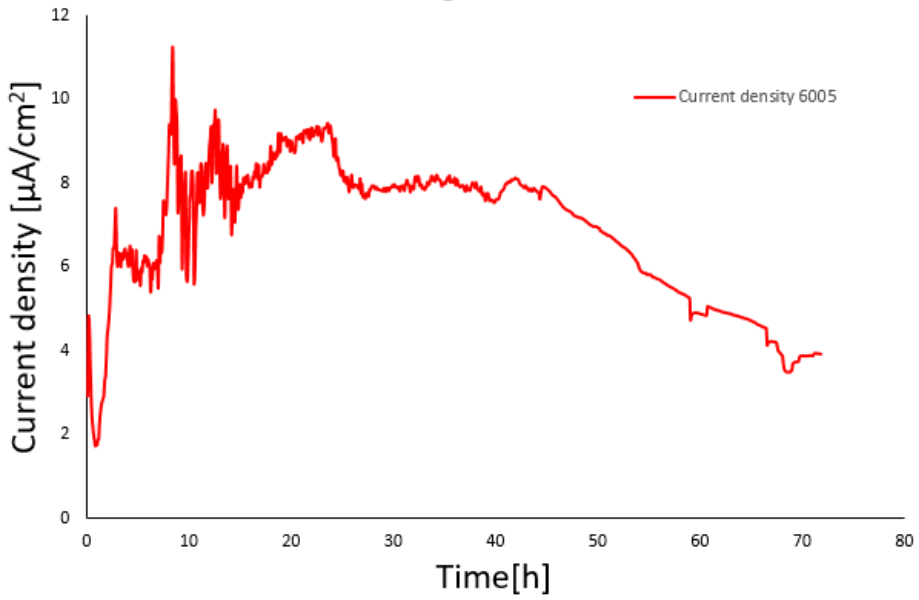
**Figure 6.3:** Logarithmic representation of current on 6005 aluminium from figure 4.3.

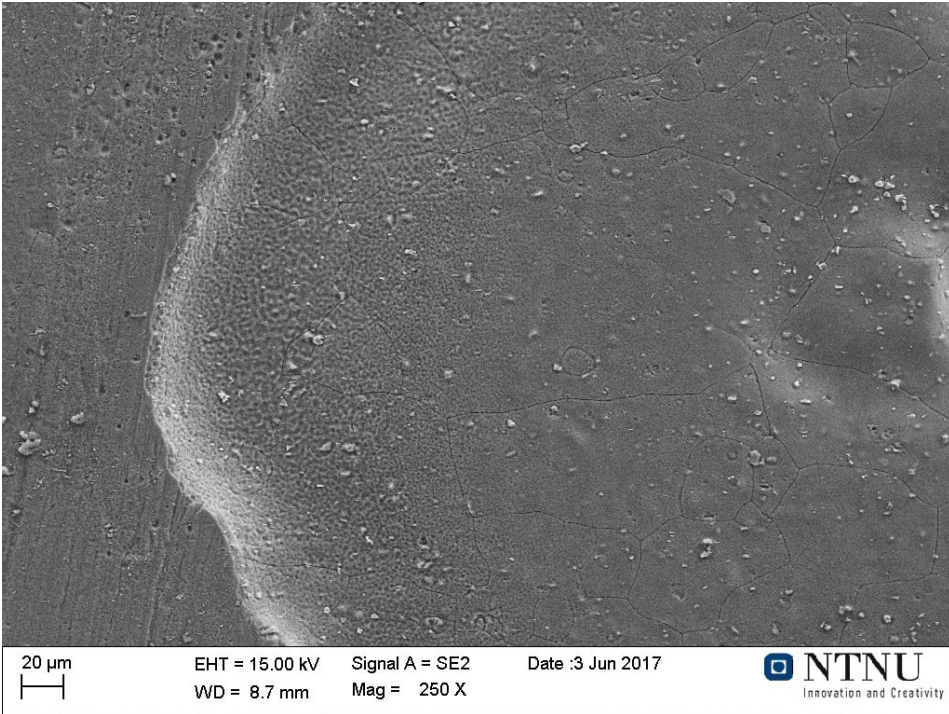
**Figure 6.16:** SEM Image of 6005 aluminum from galvanic crevice corrosion at  $10^\circ$  run for 120 hours. Image is taken after chemical cleaning and is taken in the middle
