Master's thesis

2019

Monitoring of Composite Repair on Risers

Materials Science and Engineering

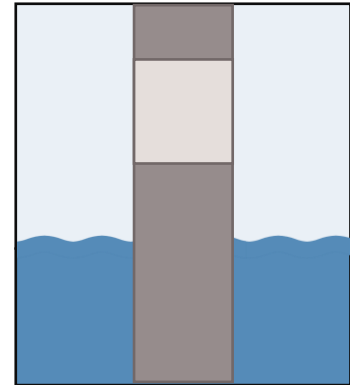
Figure 1 – A repair (light gray) applied on a riser (dark gray) in the splash zone.

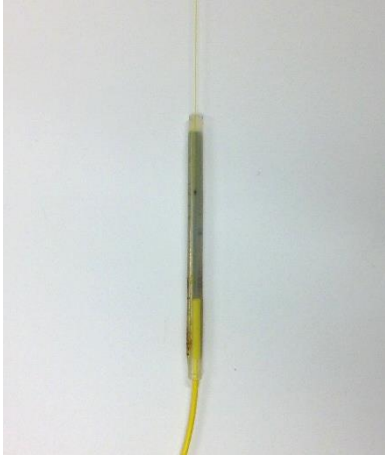
Figure 2 – Primary and secondary optical fiber spliced.

The optical fiber must be prepared before installation. A section of primary and secondary optical fiber was cut to the desired length, and these two sections were connected or spliced together as shown in Figure 2. These connections may be sensitive and are likely to introduce additional noise, but if connected precisely the connections will not pose as a problem. The optical fiber was prepared by using the equipment shown in Figure 3: wipes, fiber preparation fluid, Fitel S178 Fusion Splicer, scissors, Fitel S325 High Precision Fiber optic cleaver, and a lighter. The primary coated optical fiber was prepared by burning off the coating on a small section at one end. This end section was cleaned by using a wipe and a fiber preparation fluid. A Fitel S325 High Precision Fiber Optic Cleaver was used to give the end of the fiber a clean cut. The primary coated optical fiber was carefully placed in a Fitel S178 Fusion Splicer. Further, the secondary coated optical fiber was prepared by using scissors to remove the coating over a small section at one end, and the remaining fiber was cleaned and cut and placed in the fusion splicer, as described for the primary coated optical fiber. The fusion splicer checks to see if the cut is sufficient and will splice the two ends together. A protector is placed over the spliced area and heated to be secured. The secondary coated optical fiber is to be connected to the OBR, moreover a pigtail needs to be connected to it, i.e. two secondary coated optical fibers are to be connected using the same procedure and equipment.

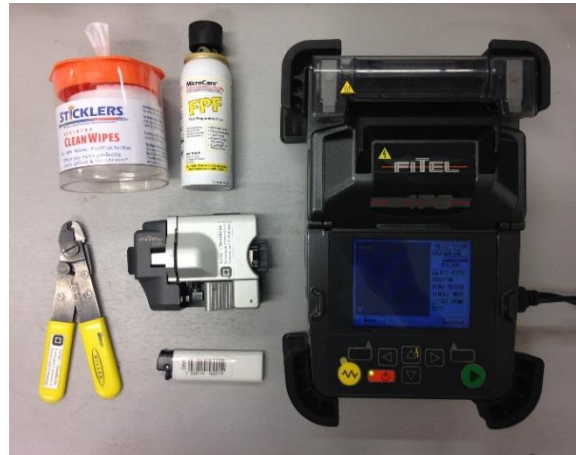
Figure 3 – Equipment used for the preparation of optical fibers.

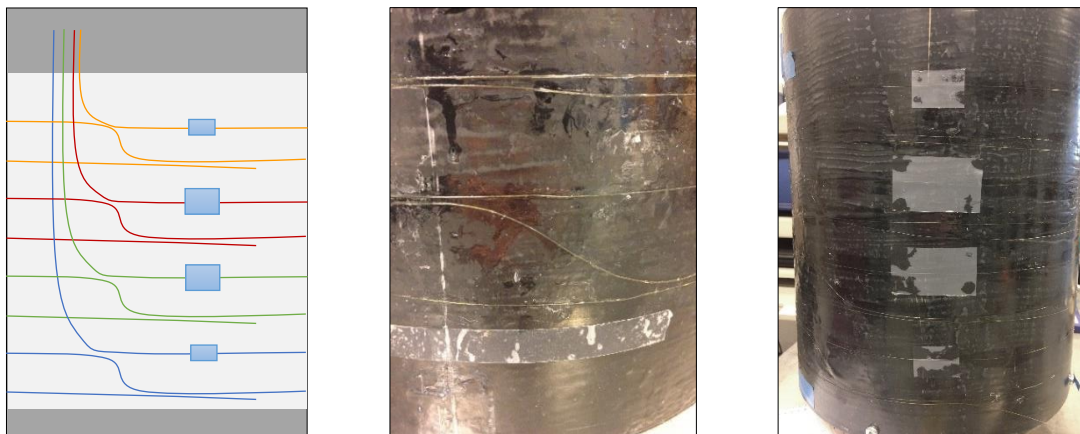
Figure 4 – A: Configuration of optical fibers and Teflon films. B: Turns were kept smooth. C: Four pieces of Teflon film. Two different sizes were used.

Four optical fibers were prepared as described in Chapter 5.3. Using several rather than one optical fiber made for easier handling during application, as well as adding redundancy in case any of the optical fibers would break. The optical fiber was placed in the circumferential direction, around the pipe section twice with a smooth turn between each circumferential placement. Fastening the optical fiber with a cyanoacrylate adhesive along its entire length ensure that it stayed in place during the production of glass fiber composite. A section of 28 cm was to be “repaired”, and the optical fiber was placed 1 cm from each edge and configured with 3.25 cm spacing between each fiber, as shown in Figure 4A. This would give a good representation of the entire glass fiber composite repair.

A piece of Teflon film was placed on the surface of the pipe-piece prior to composite production as a predefined failure. At the two outer optical fibers the Teflon film was 2 x 3,5 cm while at the two middle optical fibers the Teflon film was 3,5 x 7 cm.

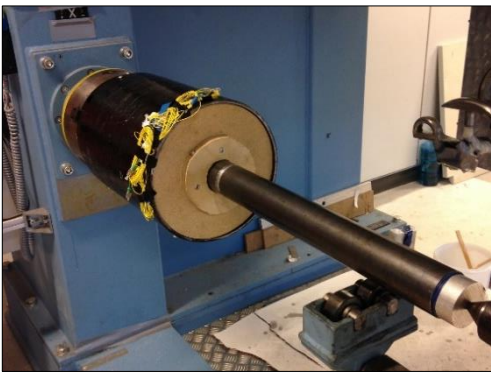
Figure 5 – The test sample assembled in the filament winding machine.

The pipe section was 33 cm long, and the glass fiber composite was applied over a 28 cm segment using the filament winding machine. A setup consisting of an axle and wooden disks

were made to support the pipe section in the filament winding machine, which was used to make the pipe rotate while the actual application of glass fiber composite was executed manually. The composite was applied according to the installation guide in the datasheet enclosed in Appendix A and guidelines provided by Kongsberg Ferrotech's. The first layer was applied by hand without tension, before increasing the tension incrementally. The glass fiber composite was applied in 6 layers with 25 % overlap. At each end of the section where the glass fiber composite was applied, one round of the composite was applied without overlap. To avoid a composite repair with sharp edges every additional layer was 20 mm shorter than the previous, stopping the overlap 10 mm before the edge on each side. The tension was decreased incrementally to finish the application without tension. Each layer was sprayed with water during application to induce the curing process. The final test sample was left to cure in room temperature for a minimum of 72 hours.

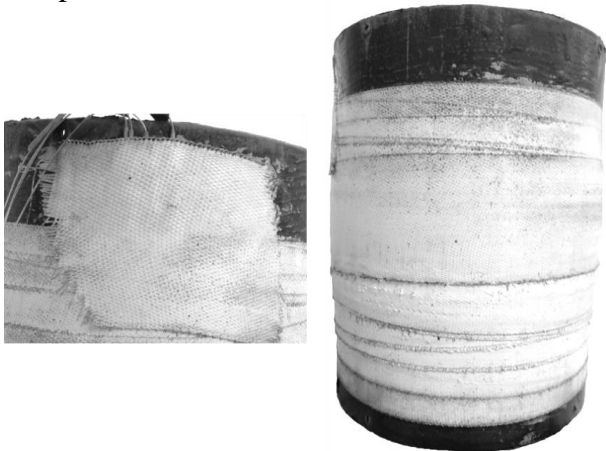
Figure 6 – The glass fiber composite patch protected the optical fibers. The repair possessed good quality. These images were taken after the testing.

The application of optical fibers is cumbersome and good results require practice. In the first test model, 50 % of the optical fibers broke either during production or de-assembling of the production setup. In the second test sample, a patch of prepreg glass fiber composite was applied where the optical fibers egress the repair. Consequently, all the optical fibers remained intact in the second test sample.

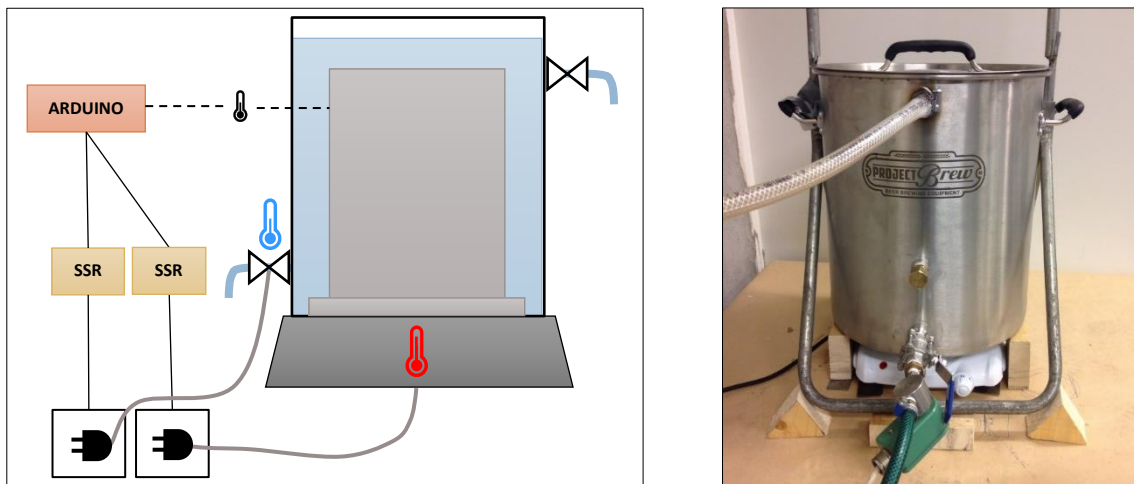
Figure 7 – A: Schematic of the test setup. B: Test setup.

The pot was insulated with Superwool. The set up was secured by a stand and wooden blocks to make sure it would not fall over. A stir rod with a motor was used to ensure uniform temperature in the water. A few square steel beams were placed on the bottom of the pot to raise the test sample, this to ensure uniform temperatures both in the water and the pipe section.

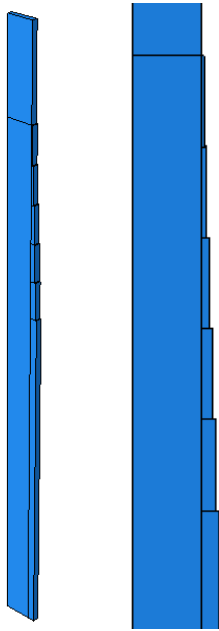
Figure 8 – Model of riser and repair.

The model of the riser and repair is shown in Figure 8. Two displacement/rotation boundary conditions were defined, one to support the bottom surface in the z-direction of the cylindrical coordinate system, and one to support the side surface in the θ -direction of the cylindrical coordinate system. The boundary conditions are shown in Figure 9A.

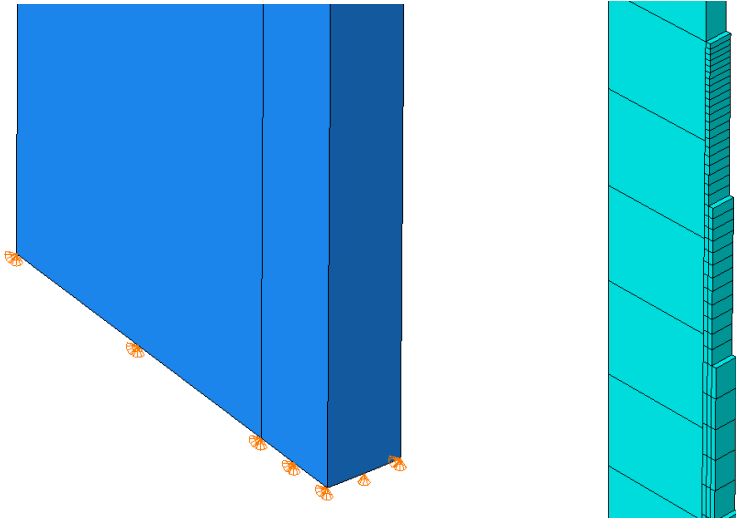
Figure 9 – A: Two boundary conditions were defined. B: Mesh of the model.

The riser was assigned a structured mesh with size 6 mm, while the repair was assigned a sweep mesh, see Figure 9B. The repair was modeled with the thickness of 6 layers, i.e. 1.98 mm, and each layer in the staircase configuration was modeled with the thickness corresponding to the thickness of the given point, i.e. 0.33 mm at the smallest. The size of the mesh was assigned to be 1.98 mm to most of the repair. The two bottom layers closest to the edge of the repair was assigned a smaller mesh size using bias, moreover the size of the mesh would gradually increase from 0.33 to 0.99 mm as the distance from the edge increased.

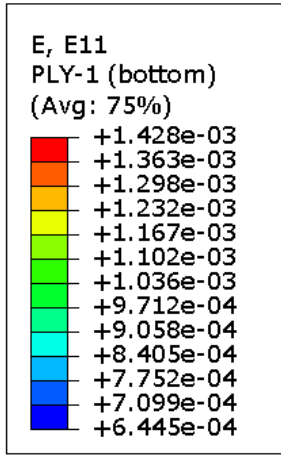
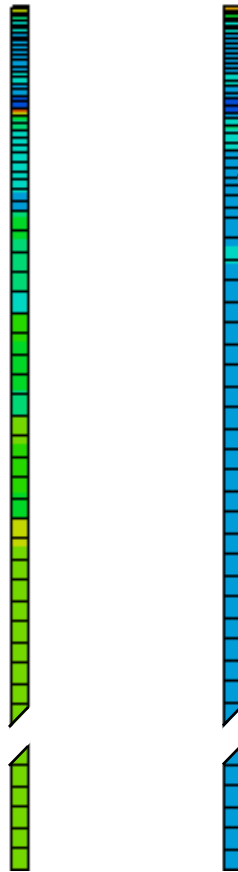
Figure 10 – Strain distribution for the top surface (left) and bottom surface (right).

The hoop strain detected from the physical tests can be expected to have a strain value as enclosed in Table 2, which corresponds well with the value found by the analytical estimate. The strain distribution for the top and bottom surface of the repair is shown in Figure 10, which gives an idea of the comprehensive response of the repair rather than the detailed display of Table 2. From Table 2 it is clear that the strain response is the highest along the edges of the repair.

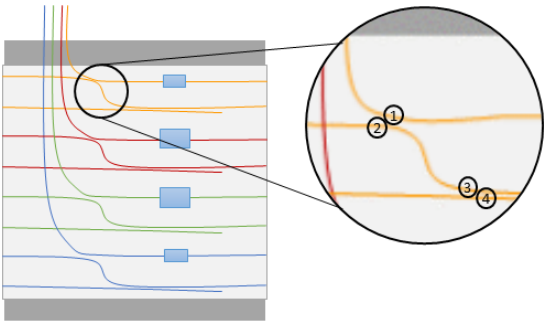
Figure 11 – Configuration of optical fibers and location of reference points.

Prior to the application of the repair, reference points in the optical fiber were defined. These points were located as shown in Figure 11. A small point load was applied to the reference points while performing a scan with the OBR. The location of reference points and Teflon films were found and are presented in Table 3.

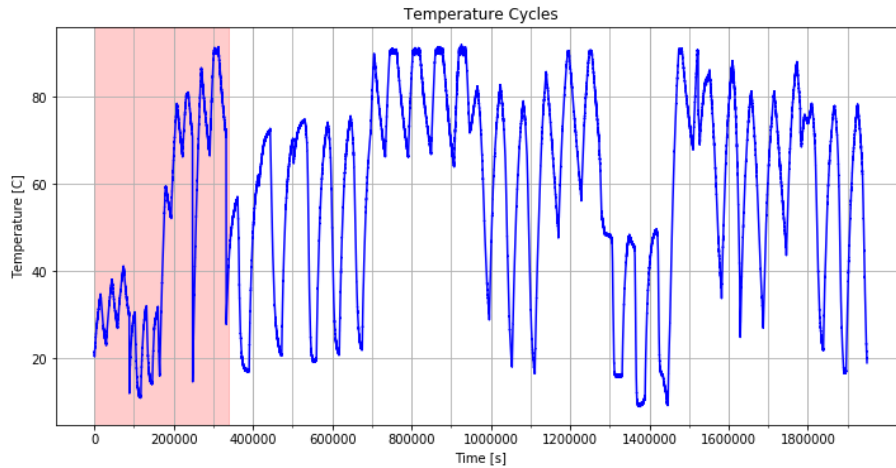
Figure 12 – Temperature cycles. The area marked in red was not considered part of the main test execution and was in some cases disregarded.

The temperature cycles that the test sample was subjected to is revealed in Figure 12. Clearly, the temperature amplitude was irregular. The area marked in red was not considered as part of the main test duration, meaning that only some strain data was collected from this time period. The optimal test parameters were found on 17.04.19, i.e. $t = 330\,000$ s, and is from here on referred to as $t = 0$. Although the test sample had been exposed to temperature cycles prior to this time, the test parameters after this point were as expected. What was the most interesting to study was the development of the areas around the predefined failures, and if there were some strain development that needed more explanation, strain data could be obtained from the measurements in the marked area. This part of the test is from now on referred to as trial cycles. Further, the measurements originating from the temperature cycles after 1 300 000 s in Figure 12 were affected by computer issues and are therefore limited.

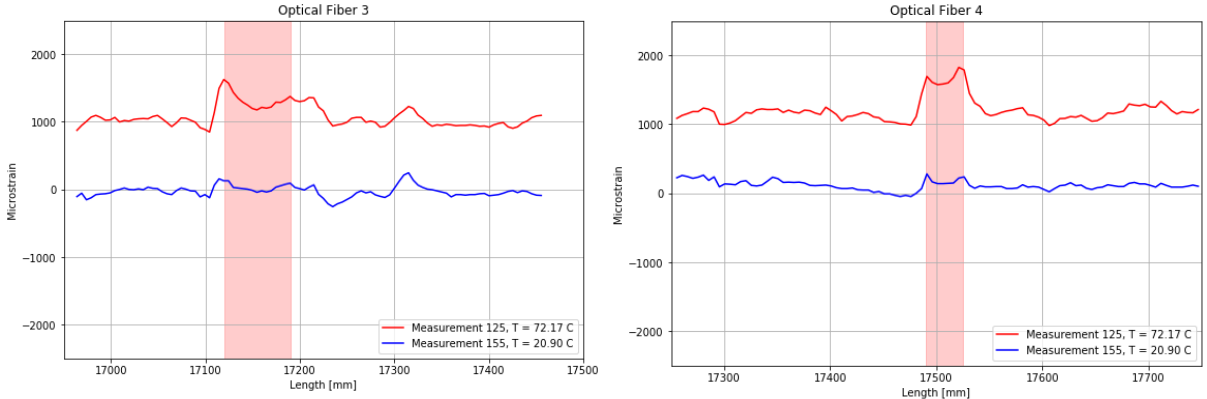
Figure 15 – The debonding characteristic changes according to the temperature.

The predefined failures could clearly be recognized in the strain data obtained from optical fiber 3 and 4, as seen in Figure 15, with an indication of what strain response a debonding failure gives. As the temperature increases, the difference in strain value of the debonding failure and the area around increases. As the temperature decreases, on the other hand, this debonding characteristic and the difference in this strain value fades. Optical fiber 1 showed no such characteristic. The full development of the areas around the predefined failures of optical fiber 1, 3 and 4 are presented in films enclosed in Appendix E, F, G and H, where Appendix F includes the strain development detected by optical fiber 3 during the trial cycles.

The peak strain from Figure 15 and Figure 16 is in the range of 1500 – 2000 $\mu\epsilon$ at high temperatures. This value deviates significantly from the findings in FEA, hence, this could be values to expect in the case of debonding failures.

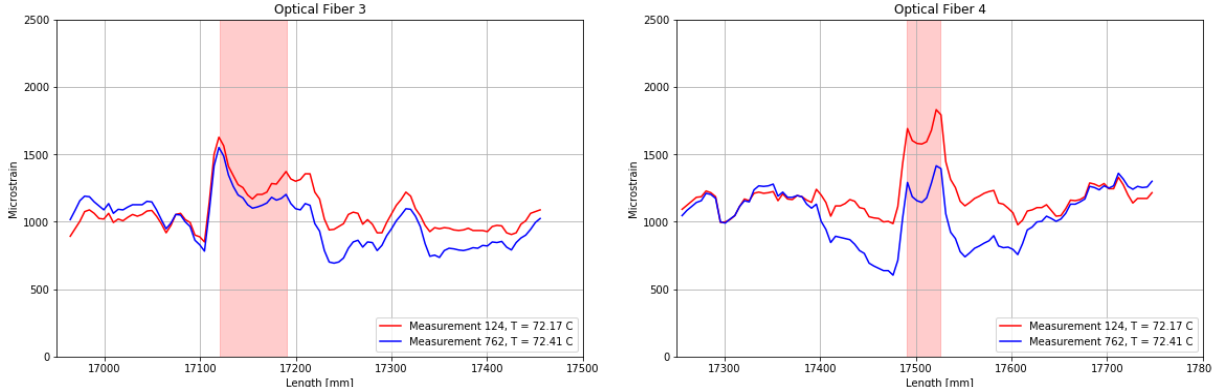
Figure 16 – Development of the debonding failures detected by OF3 and OF4.

During the main test period, the debonding failures is observed not to grow. Growth of the debonding is recognized by a larger distance between the two peaks, which cannot be found in Figure 16. However, on optical fiber 3, the debonding failure appears larger than the size of the Teflon film, which may suggest that the debonding failure developed during the trial cycles. As shown in Appendix F the predefined failure could be seen after measurement 147, and the elongation of the debonding characteristic can be seen after measurement 161 of the trial cycles. This elongation is not necessarily growth but may be inconsistent adhesion between the glass fiber composite and the steel riser around the predefined failure that occurred in the production process. Throughout the test execution, the debonding characteristic becomes more prominent but does not seem to grow.

On the basis of Figure 16 and Appendix G, no conclusion of an increasing peak strain in the debonding failure can be drawn. Although the temperature is approximately the same, measurement 124 has a higher peak strain than measurement 762. The peak strain is more dependent on the temperature than the total cycle exposure time.

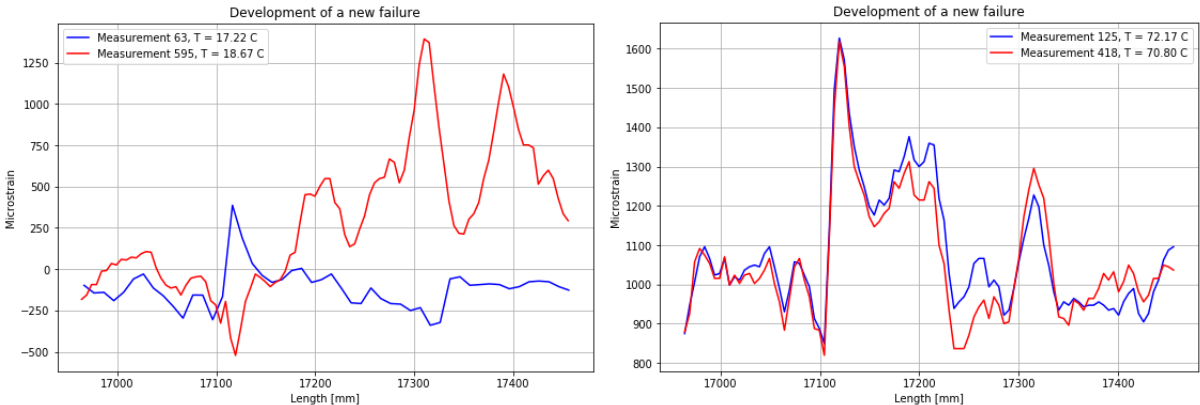
Figure 17 – Development of a new failure.

In the strain data obtained from optical fiber 3, two peaks appear at the location ~17300 and ~17400 mm of the length of the optical fiber, as shown in Figure 17. The former is prominent at high and low temperatures, while the latter is only prominent at lower temperatures. There are several possibilities of why such peaks appear in the measurements. When the optical fiber is applied to the surface of the pipe section it may contain small bends. An increased temperature causes the optical fiber to expand and this bend will fade, while when the

temperature decreases the optical fiber can buckle which will show up as a peak in the measurements. When a peak is more prominent at lower temperatures, the optical fiber buckling is more likely than failures in the glass fiber composite. It is possible that the peak at ~17300 mm, which is present at high and low temperatures, is a delamination failure similar to what was found by Díaz-Maroto et al. in [30]. However, irregularities on the riser surface will also cause peaks in the strain response.

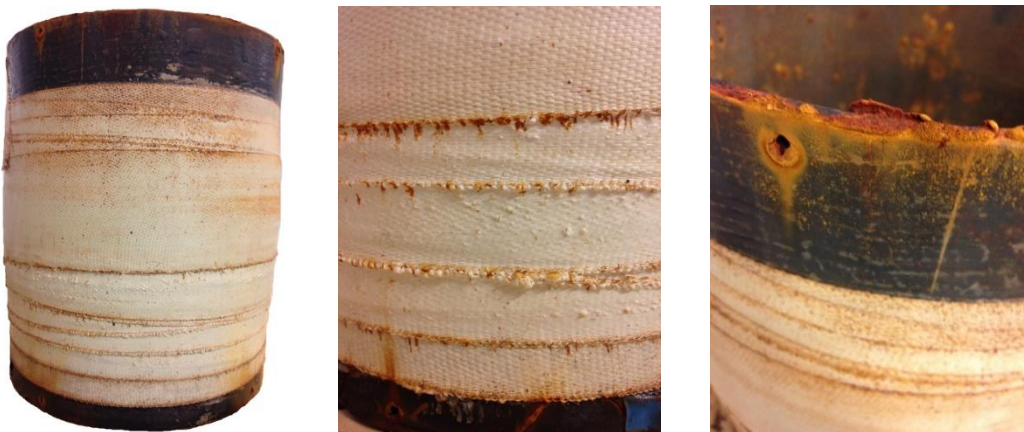
Figure 18 – Appearance of the repair after the execution of the test.

Figure 18 shows the repair after the execution of the test. The surface of the repair appeared unaffected by the temperature variations, and the documented debonding was not discovered by visual inspection. Some lumps of polyurethane were progressing along an edge of the glass fiber composite band. The glass fiber composite may not have been saturated enough with water during the application of the repair or the cure time was not satisfactory. Clearly, corrosion occurred where the corrosion resistive coating was not applied, i.e. in holes and along the top edge, as revealed in Figure 18.

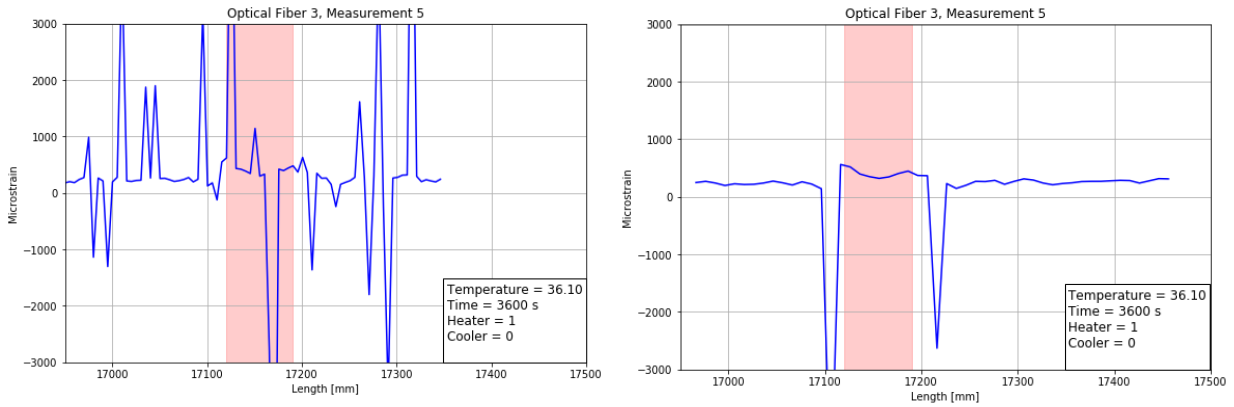
Figure 19 – Strain curves from measurement 5. The strain curve on the left is shorter because a different mid-point was used for the calculation.

Re-calculating the measurements with a larger gauge length and sensor spacing decreased the noise content significantly. In Figure 19, two strain curves are obtained from the same

measurement, i.e. the same OBR file. The strain curve containing the most noise was calculated using a gauge length of 5 mm and a sensor spacing of 5 mm, which was the same that was used for most of the other strain calculations. Due to the large noise content, the strain data was recalculated using a gauge length of 10 mm and a sensor spacing of 10 mm, resulting in a significant decrease of noise. Here, there are only two points that are considered noise, which can be removed using simple interpolation.

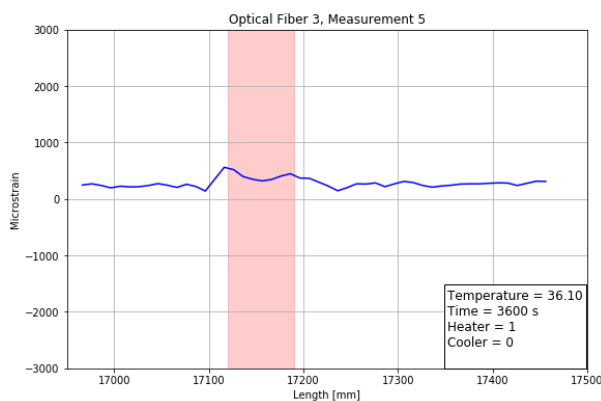
Figure 20 – Strain curve from measurement 5 without noise.
