EVALUATION OF THE STRAIN FIELD IN A COMPOSITE – METAL ADHESIVE JOINT WITH AN OPTICAL BACKSCATTER REFLECTOMETER

J. H. L. Grave¹, M. L. Håheim¹, A. T. Echtermeyer^{1*}

Keywords: Composite, Adhesive, Joint, OBR

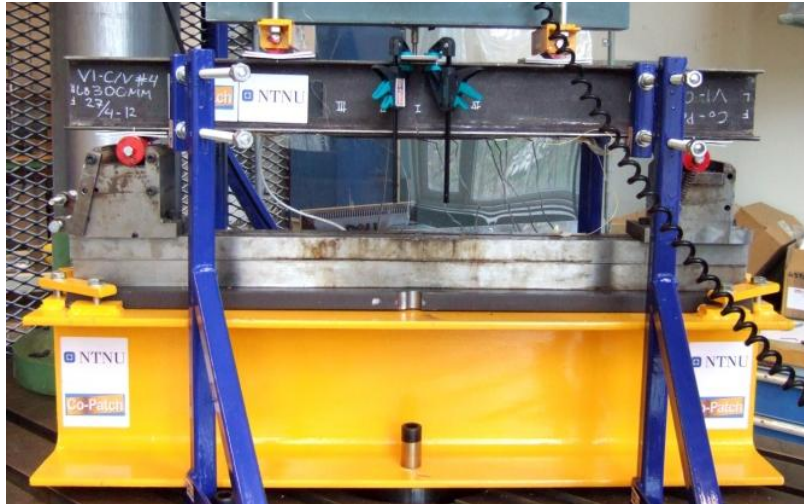
Figure 3. Experimental setup at NTNU Fatigue lab of the patched IPE100 beam.

The fiber optic cable was embedded between the carbon laminate and the galvanic protection layer, and it was attached to the surface of the patch. In addition, four electrical strain gauges were attached to the surface of the patch to compare the strain at these positions with the strain measured by the fiber optic cable.

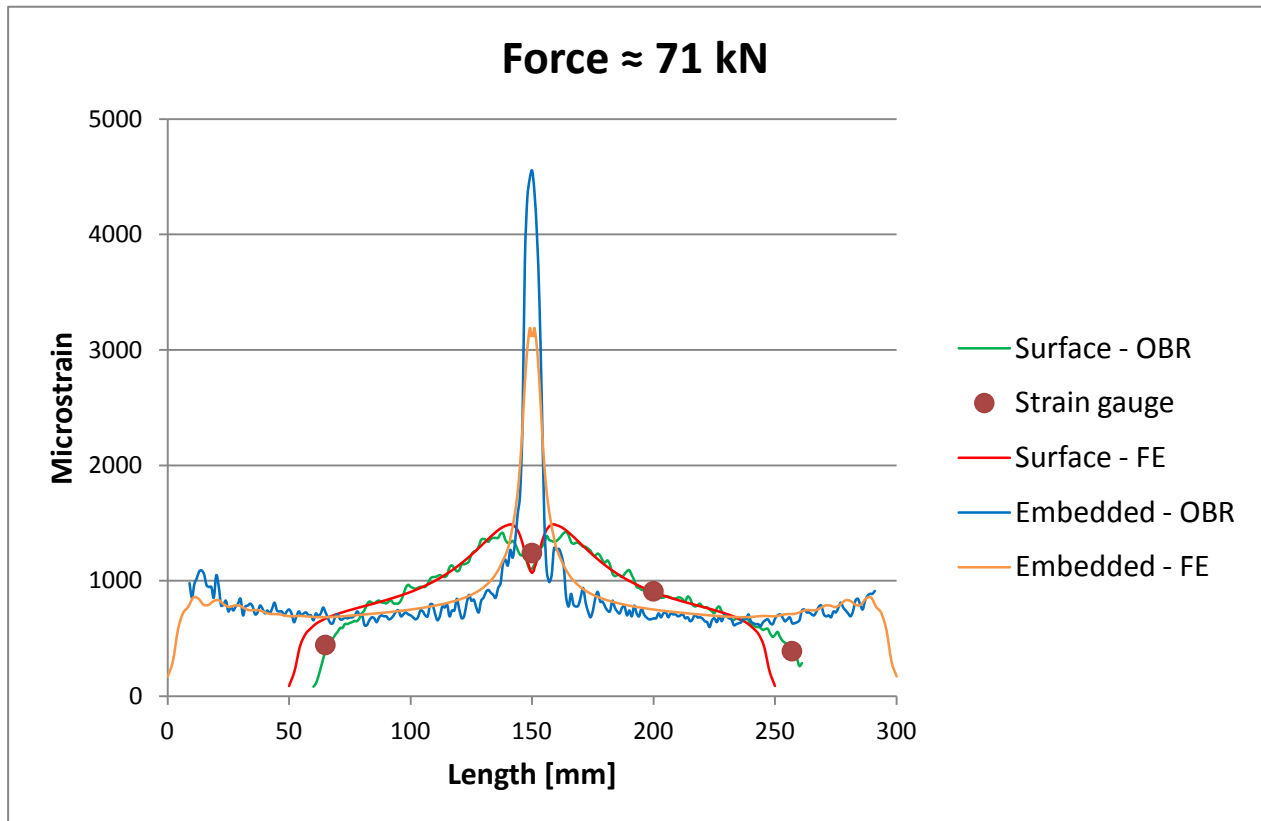
Figure 5. Strain in the patch at 71 kN.

The strain measurements from the optical fibre on the surface of the patch coincide well with both the FE-analysis and the electrical strain gauge readings. The strain gauge value at the crack is slightly higher than both the FE-analysis and the optical fibre. A reason for this is the 5mm gauge length of the strain gauge, which reads the average value over the length, compared to the 1mm “gauge length” achieved with the OBR. The top surface of the patch was displaced by 5 - 10 mm, hence the measurement with the optical fibre has an offset compared to the symmetrical FE-analysis. The positions of the strain gauge values are according to the placement on the patch surface measured from the center of the crack. The embedded optical fiber corresponds well with the FE-analysis, except directly over the metal crack.

High strain gradients are a measurement challenge for the OBR. Too big changes will cause the cross-correlating algorithms for the spectral shift to fail. The result of this is sometimes an unrealistic value, seen as noise, but also entails uncertainty in the accuracy of the absolute value of the measurements at high stress concentrations. Improvements are achieved by post processing, but for the purpose of this comparison it is more interesting to evaluate the strain gradient leading up to the crack.

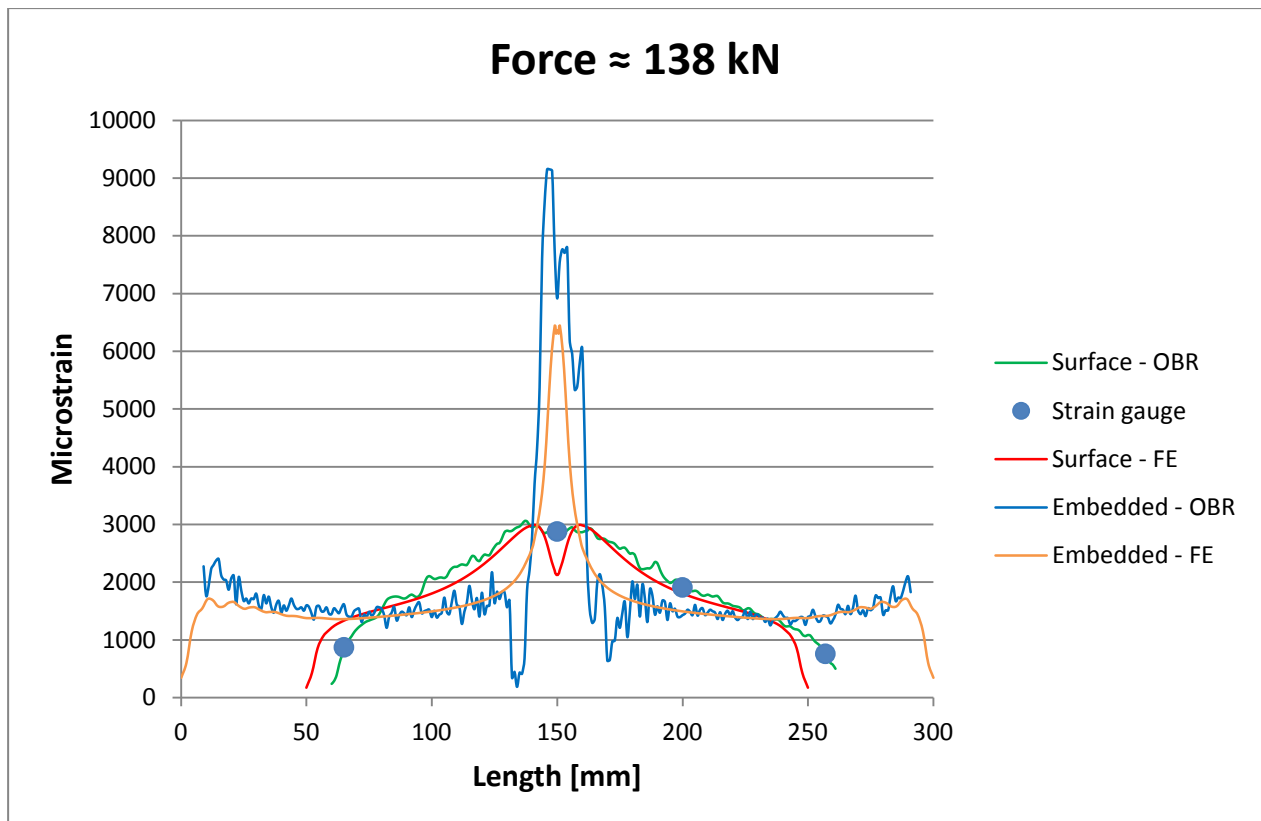
Figure 6. Strain in the patch at 138 kN.

The strain measurements of the optical fibre on the surface of the patch agree also here well with the strain gauge readings. However the FE-analysis deviates from the measured strain on the surface. The FE-analysis did not take into the account the possible degradation or cracking of the patch at the metal crack which is expected to happen at this high load. The spatial misalignment between the FE-analysis and the measurement by the fiber optic cable and the electrical strain gauges is probably due to a displacement of the patch, where the patch center is to the right of the crack.

The strain field of the embedded optical fibre is wider than the FE-analysis. This is due the effects of damage appearing at the crack tip, which has not been a part of the FE-analysis.
