Description of failure mechanism in placed riprap on steep slope with unsupported toe using smartstone probes

Ganesh H.R. Ravindra^{a,*}, Oliver Gronz^b, J. Bastian Dost^b, Fjóla G. Sigtryggisdóttir^a

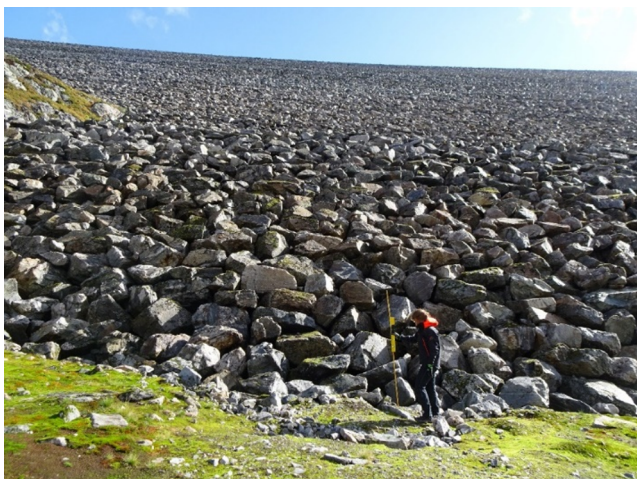
Fig. 1. Placed riprap constructed on Dam Oddatjørn, Suldal, Norway.

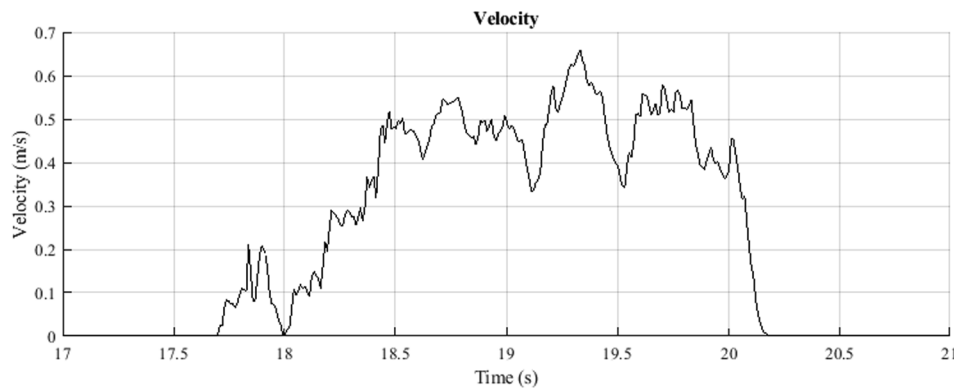
Fig. 8. Smartstone probe derived velocity for Smartstone (SS₀) from Test P05.

The acceleration and the gyroscope measurements were subjected to further analysis to derive displacement velocities of the Smartstone during riprap failure. The initial position and the gyroscope data were used to account for stone rotations within the acceleration data. Using integration of the acceleration values, a velocity time series was obtained. The resulting velocity plot is shown in Fig. 7. The probe-equipped stone is seen to be gradually accelerated, reaching velocities of up to 0.66 m s^{-1} at $t = 19.7 \text{ s}$. When the stone reaches the pile formed on the horizontal platform, rapid decelerations can be observed.
