# **On the role of the pre-exposure time in the stress-corrosion cracking of magnesium alloys**

Keywords: Mg alloys; stress corrosion cracking; pre-exposure embrittlement; gas-analysis; slow-strain rate tensile testing; quantitative fractography

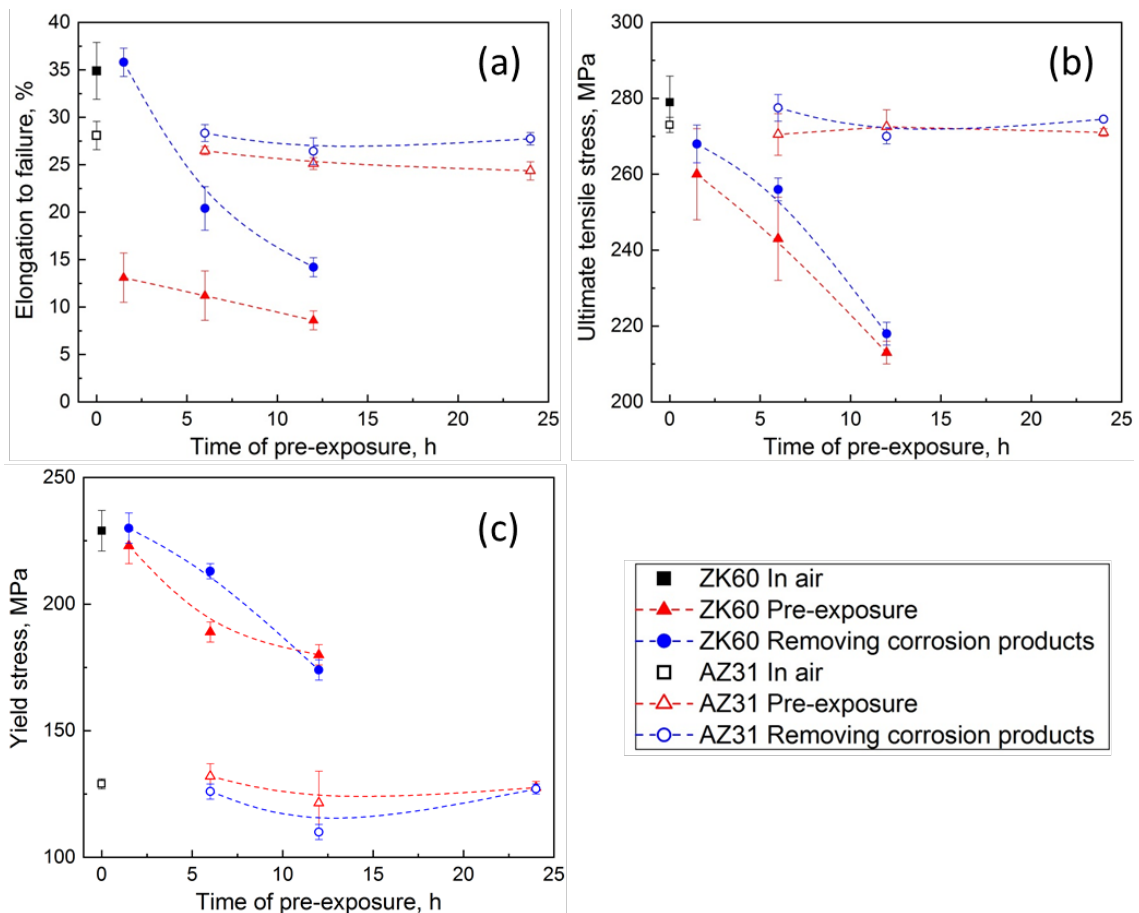
The results of SSRT testing showed that the pre-exposure to corrosive media leads to the significant deterioration of mechanical properties of the alloy ZK60, c.f. Fig. 1 and 2. The elongation to failure (EF) of this alloy dropped after 1.5 h pre-exposure, and, then, it gradually decreased further with increasing pre-exposure time up to 12 h, c.f. Fig. 1a. Thus, one has to note that the loss of ductility observed after the first 1.5 h pre-exposure is much more severe than that in the subsequent 10 h. As can be seen from Fig. 2a, the decrease of elongation occurs mainly due to the reduction of the necking part of the stress-strain diagram, although the uniform strain is also compromised. Both the ultimate tensile strength (UTS) and the yield stress (YS) are also significantly reduced with increasing pre-exposure time, c.f. Fig. 1b and 2a. However, the observed reduction of strength occurs more uniformly in comparison with the ductility: the decrease in UTS after 1.5 h pre-exposure is much less pronounced than that in EF.

Compared to ZK60, the alloy AZ31 is notably less susceptible to SCC induced by pre-exposure to 4% NaCl+4% K<sub>2</sub>Cr<sub>2</sub>O<sub>7</sub>, c. f. Fig. 1 and Fig. 2c. Although EF of this alloy slightly decreases with increasing pre-exposure time, the ductility loss is much lesser than for ZK60 at all pre-exposure times. UTS and YS values of the AZ31 alloy are virtually not affected by the pre-exposure regardless of its duration. The slight decrease in UTS, which is seen after 6 h pre-exposure, can be likely attributed to the regular experimental scatter.

As it follows from Fig. 1 and 2b, d, the removal of corrosion products from the specimens results in recovery of mechanical properties of both alloys. The ductility of AZ31 specimens can be fully restored by the removal of corrosion products in the whole range of pre-exposure time from 6 to 24 hours, while the strength was not compromised at all. For the alloy ZK60, the rate of the recovery strongly depends on pre-exposure time. In congruence with the results of our recent study [22], the ductility of the ZK60 specimens pre-exposed to corrosive media for 1.5 h fully recovers or even increases slightly after removal of corrosion products. However, if the specimens were pre-exposed to the corrosive media for longer times, the removal of corrosion products did not result in the complete recovery of ductility anymore. Moreover, the healing effect produced by removing corrosion products is reduced strongly when pre-exposure time extends, Fig. 1a. The increase in UTS and YS associated with the removal of corrosion products is much less significant in comparison to that in EF and is almost independent of pre-exposure time.

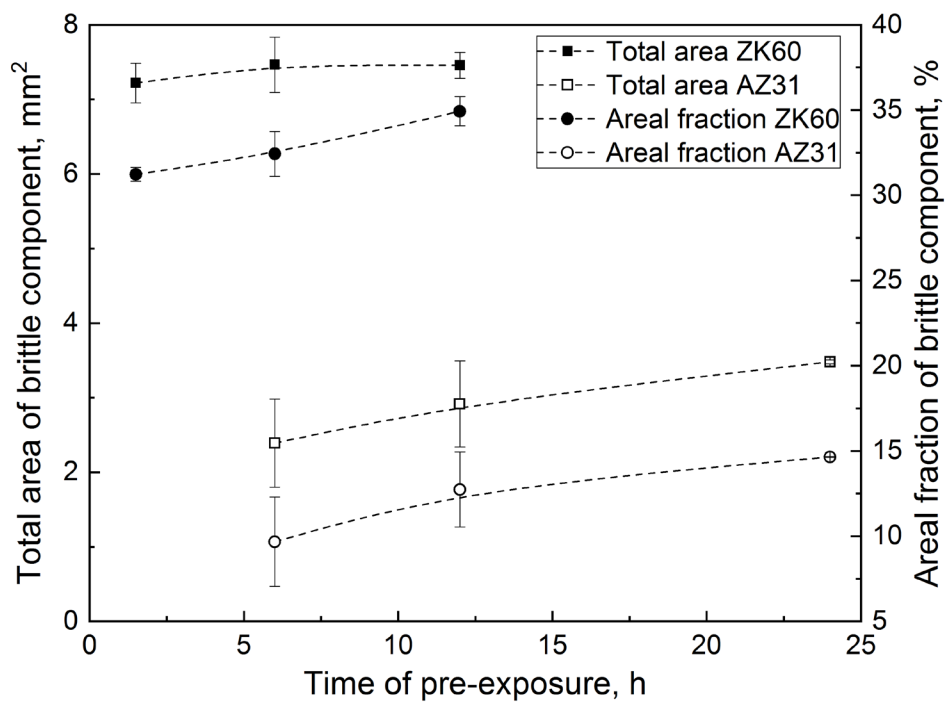
Fig. 11 – The effect of pre-exposure time on the total area and areal fraction of the brittle fracture features with respect to the entire fracture surface for the ZK60 and AZ31 specimens SSRT tested in air after pre-exposure.

with pre-exposure time increasing from 1.5 to 6 h, while the following 12 h of pre-exposure do not affect this property significantly, Fig. 11. On the other hand, the areal fraction of the brittle component grows continuously from 31 to 35 % as pre-exposure time increases from 1.5 up to 12 h.

It is shown in the present study that the area of brittle features on the fracture surface of the ZK60 specimens increases slightly with the immersion time increasing from 1.5 to 6 h, while the further prolongation of pre-exposure does not result in any notable growth of the brittle zone, Fig. 11. This observation implies that the mechanism responsible for brittle cracking in the alloy ZK60 is insignificantly affected by pre-exposure time. Therefore, the decrease in mechanical properties of this alloy with increasing pre-exposure time is likely attributed to the irreversible corrosion damage, rather than to brittle cracking. While the total area of the brittle features on the fracture surface is almost unchanged, the cross-section and the total area of the entire fracture surface of the ZK60 specimens decreases with increasing pre-exposure time due to corrosion. This gives rise to the increasing areal fraction of the brittle fracture, which, in turn, results in the reduction of ductility. Indeed, the perfect inverse linear relationship between EF and the areal fraction of brittle zone is established for both alloys as can be seen in Fig. 20. In contrast to ZK60, the AZ31 alloy demonstrated an appreciable increase in the total area of brittle features with pre-exposure time, while the only insignificant reduction in the cross-section has been documented for this alloy due to corrosion damage. Thus, the increase of the areal fraction of brittle fracture in this alloy should be attributed to the enhanced activity of the brittle cracking mechanism, rather than to the extent of corrosion damage (unlike ZK60). Nevertheless, as follows from Fig. 20, the ductility of both alloys is determined by the areal fraction of the brittle zone regardless of the underlying mechanisms, which are responsible for the formation of the resulting fracture surface.

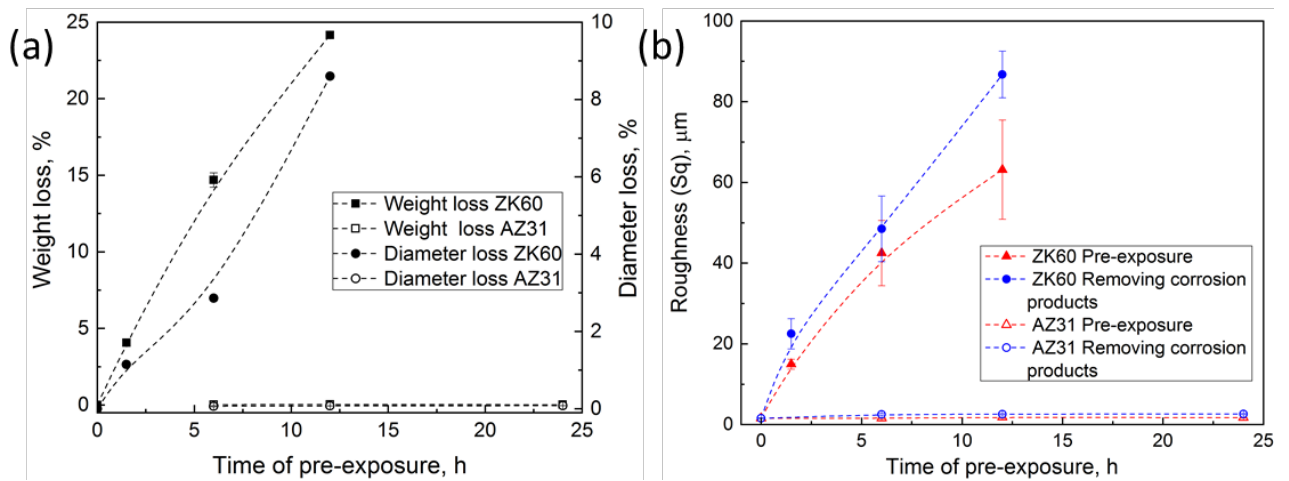
Fig. 15 – The effect of pre-exposure time on the weight and diameter loss – (a) and on the root mean square (Sq) areal roughness of the side surface – (b) of the ZK60 and AZ31 cylindrical samples.

The considerable corrosion damage of ZK60 specimens, which was evident even from epy superficial side surface observations, c.f. Fig. 3-8, was also quantified by the immersion tests. It can be seen in Fig. 15a that the weight and diameter loss of the ZK60 samples remarkably increases with pre-exposure time. The severity of the corrosion damage can also be assessed by the surface roughness of the samples with the removed corrosion products. These specimens do not contain corrosion products, which can mask the topological features, thus, affecting the apparent roughness of the bare metal. Hence, the undulations of the surface of such samples can be associated with corrosion damage. Indeed, it follows from the Fig. 15b that the roughness of the samples with removed corrosion products is notably higher than that of their counterparts covered by corrosion products. Alike the weight and diameter loss, the surface roughness of the ZK60 samples increases significantly with pre-exposure time due to the progress of corrosion damage. The corrosion damage of the AZ31 alloy is substantially lower than that of ZK60 as is evidenced by the negligible change in weight, diameter and roughness of AZ31 after pre-exposure at any pre-exposure time, c.f. Fig. 15.

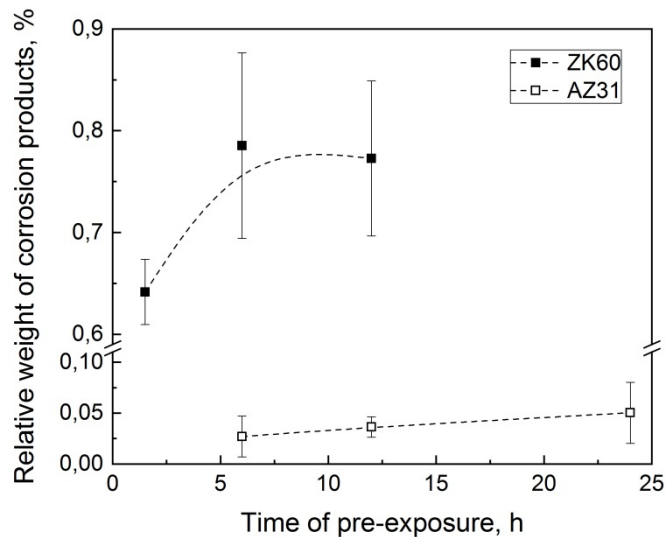
Fig. 16 – The effect of pre-exposure time on the relative weight of corrosion products on the surface of the ZK60 and AZ31 samples.

In consistence with the results of the side surface observations it is found that the relative weight of corrosion products removed from the ZK60 samples is about one to two orders of magnitude higher than that for the AZ31 samples at the same pre-exposure time, Fig. 16. However, it is worth recalling that the corrosion products were less effectively removed from the AZ31 samples than from ZK60. Hence, the weight of corrosion products for the AZ31 samples is believed to be underestimated. It is found that the increase of pre-exposure time from 1.5 to 6 h

results in the concomitant increase of the relative weight of corrosion products on the ZK60 samples, while further prolongation of pre-exposure time up to 12 h does not affect the weight of corrosion products anymore. The weight of corrosion products deposited on the surface of AZ31 gradually increases with increasing pre-exposure time from 6 to 24 h.

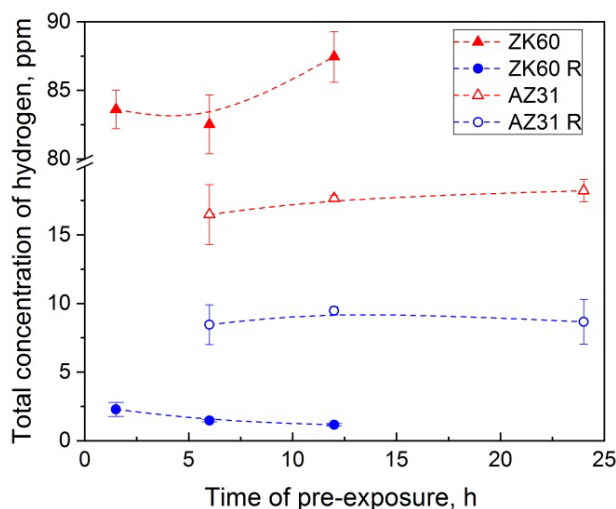
Fig. 18 – The effect of pre-exposure time on total concentration of hydrogen in the samples of ZK60 and AZ31 alloys pre-exposed to corrosive media. The letter “R” in the legend denotes the samples with removed corrosion products.

before the removal of corrosion products, the 5-6 times higher concentration of hydrogen corresponds to the ZK60 samples, which, right after pre-exposure, contain a remarkably higher amount of corrosion products on the surface than the AZ31 samples. Generally, the effect of pre-exposure time on the total concentration of hydrogen in both alloys is found rather weak. The hydrogen concentration of the AZ31 alloy slightly increases with increasing pre-exposure time and correlates with the weight of corrosion products on the surface of these samples. However, for the ZK60 samples, the dependence of the hydrogen concentration on pre-exposure time as well as on the corrosion products weight is less unambiguous.

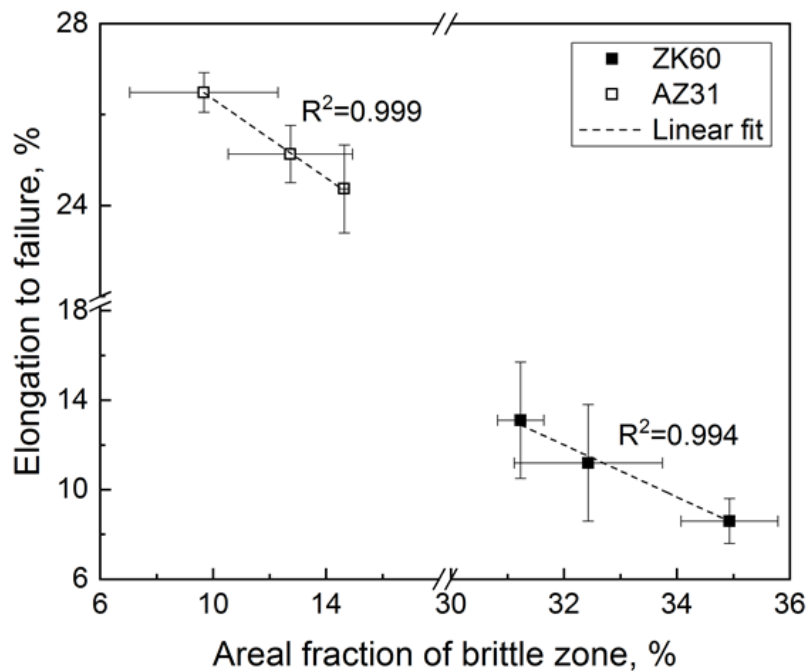
Fig. 20 – The relationship between the elongation to failure and the areal fraction of the brittle zone on the fracture surface of the ZK60 and AZ31 specimens, which were SSRT tested after pre-exposure to corrosive media for different times.

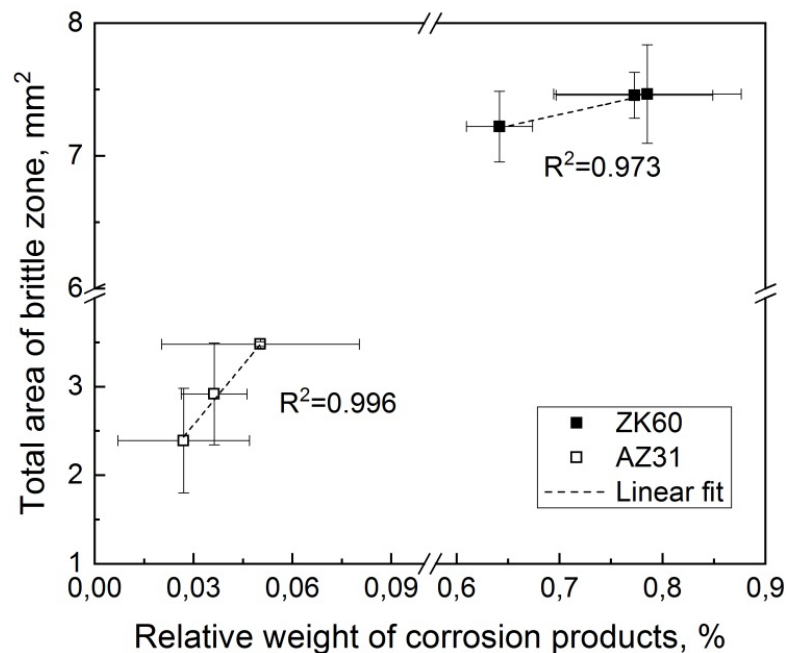
Fig. 21 – The relationship between the relative weight of corrosion products deposited on the specimens of ZK60 and AZ31 alloys after pre-exposure to corrosive media for different times and the total area of the brittle zone on the fracture surface of these specimens.

and hiding power of the corrosion products film. This conclusion is strongly corroborated by the results of the present study. Specifically, the side surface examination and the gravimetric analysis show that the significantly greater amount of corrosion products, Figs. 3, 4 and 16, and, concurrently, the substantially higher degree of pre-exposure embrittlement are observed in the alloy ZK60 if compared to AZ31. Furthermore, it was shown that both the relative weight of corrosion products and the areal fraction of brittle fracture were just slightly changed in the ZK60 specimens and increased in AZ31, Figs. 11 and 16. Indeed, as can be seen in Fig. 21 the relative weight of corrosion products deposited on the ZK60 and AZ31 specimens pre-exposed to corrosive media for different times correlates linearly with the areal fraction of the brittle features on the fracture surfaces of these specimens. The exact reason for the insignificant growth of the corrosion products layer on the ZK60 specimens with pre-exposure time is unclear as yet. The detailed study of the corrosion behaviour in both alloys in the present corrosive solution is needed to address this issue. However, it was beyond the scope of the present paper.
