An experimental study on the deformation and fracture modes of steel projectiles during impact

K.G. Rakvåg^{a,*}, T. Børvik^{a,b}, I. Westermann^{a,c} and O.S. Hopperstad^a

^a *Structural Impact Laboratory (SIMLab), Centre for Research-based Innovation (CRI) and Department of Structural Engineering, Norwegian University of Science and Technology, NO-7491 Trondheim, Norway*

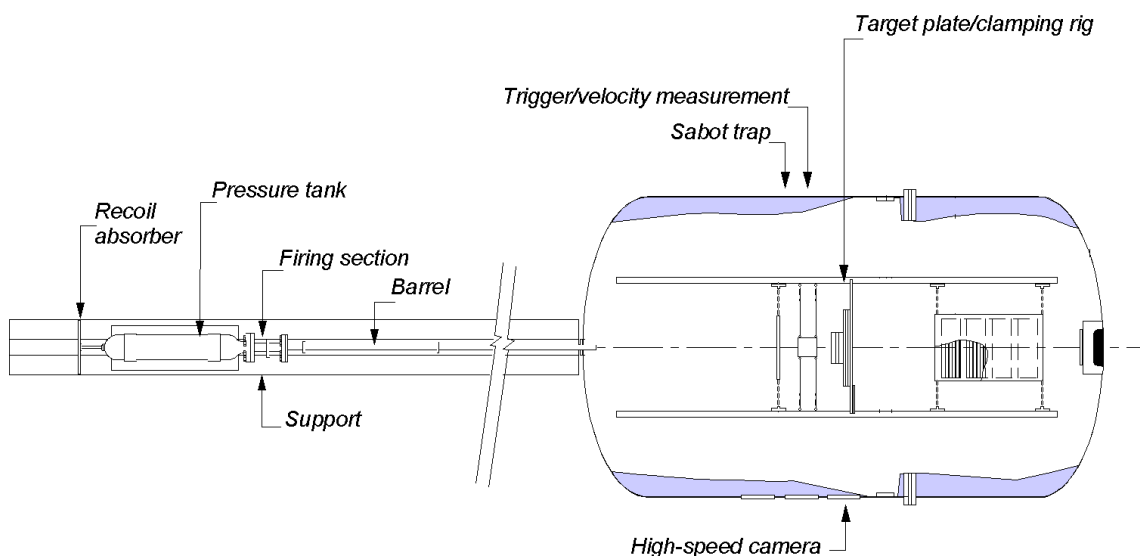
Figure 2: Sketch of the compressed gas gun used in the Taylor bar impact tests.

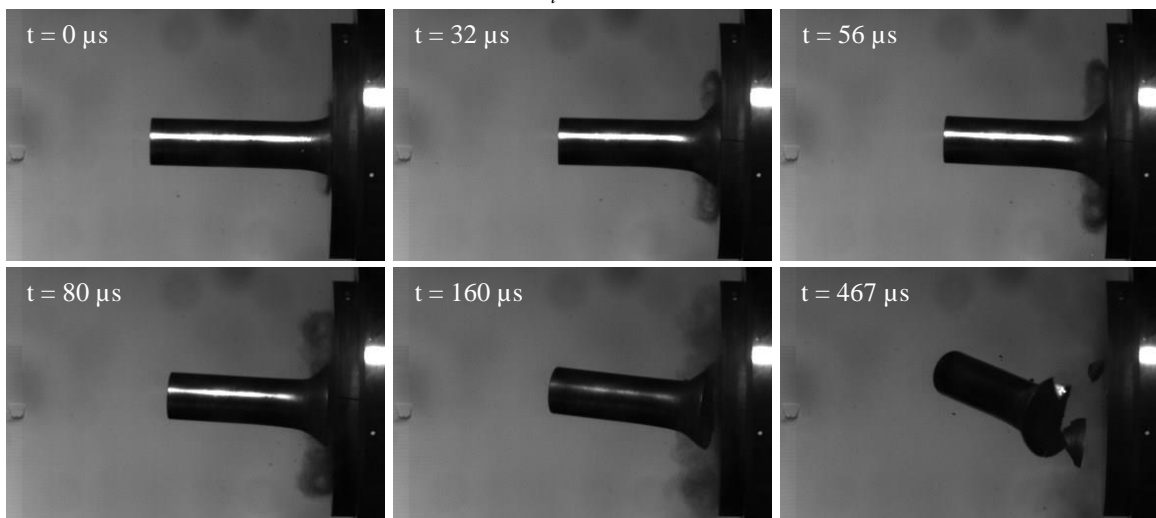
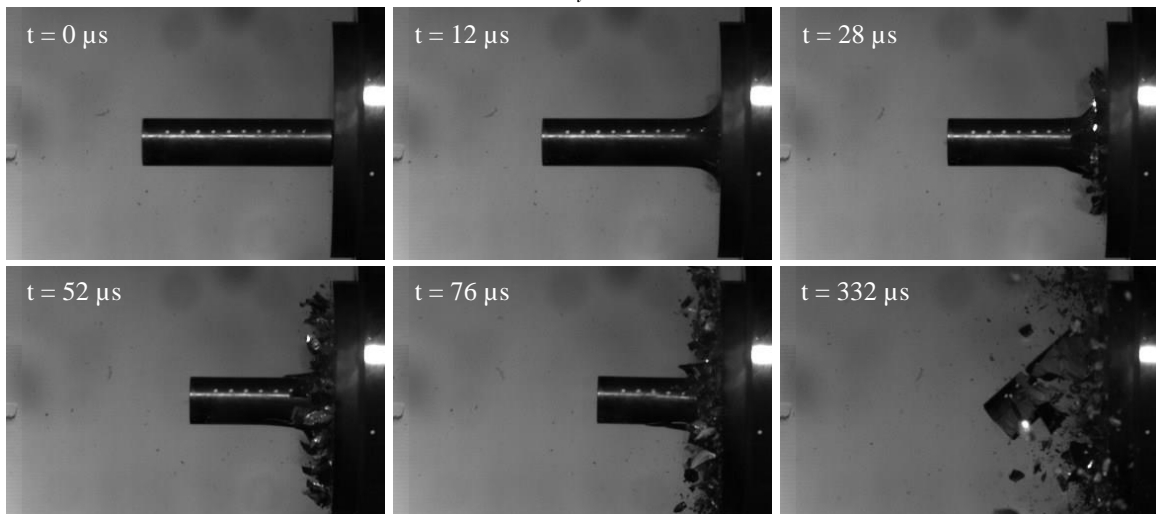
(a) UH - $v_i = 297.2$ m/s

(b) HRC 40 - $v_i = 297.7$ m/s

(c) HRC 52 - $v_i = 296.9$ m/s

Figure 3: Typical high-speed video images from Taylor bar impact tests with projectiles having different hardness at an impact velocity of $v_i \approx 300$ m/s.

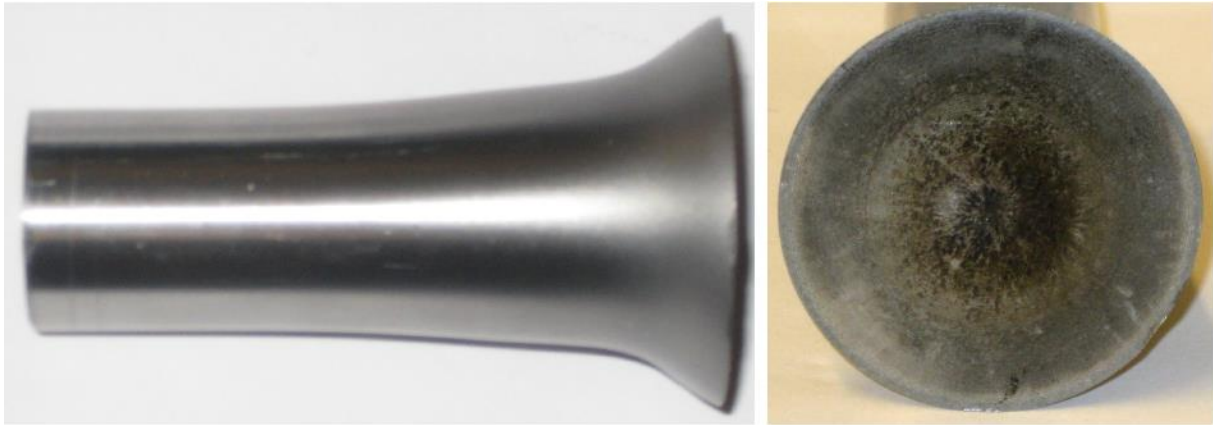
Figure 4: Unhardened projectile after impact at 297.2 m/s.

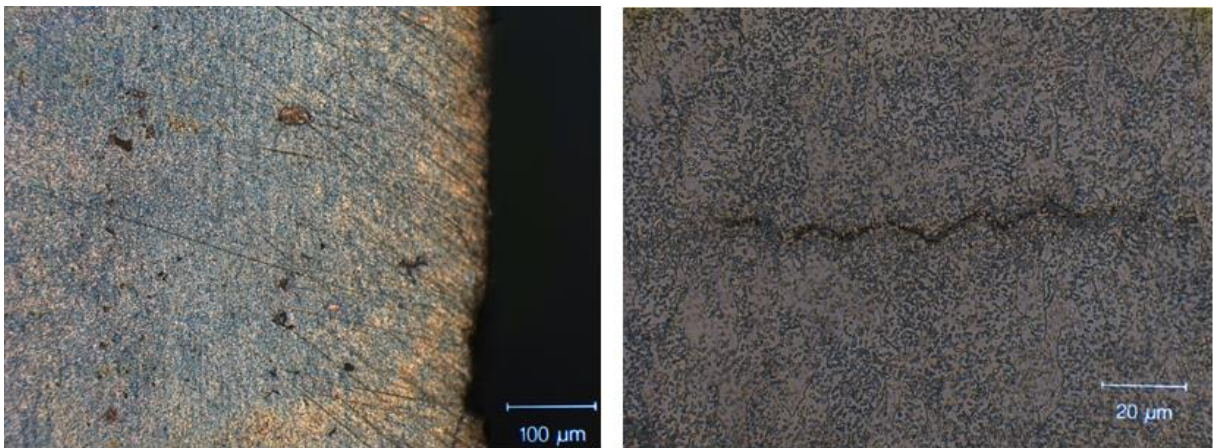
Figure 5: Microscopic images of the unhardened projectile after impact at 297.2 m/s. (a) The projectile has been sliced in the longitudinal direction, showing no sign of void growth in the central part. (b) Evidence of a deformed sulphide that has partly dissolved from the etching process during preparation.

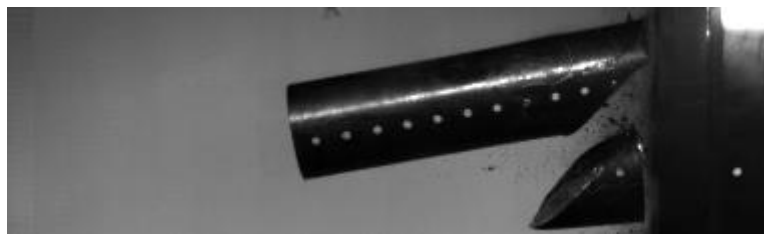
Figure 6: HRC 52 projectile impacting at 132.9 m/s captured by the high-speed video camera. The fracture mode is principal shear fracture.

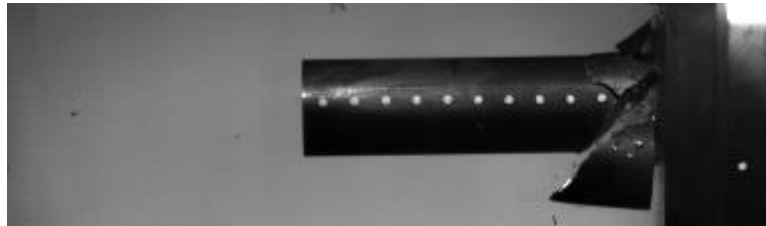
Figure 7: HRC 52 projectile impacting at 134.7 m/s captured by the high-speed video camera. Two shear fractures are evident.

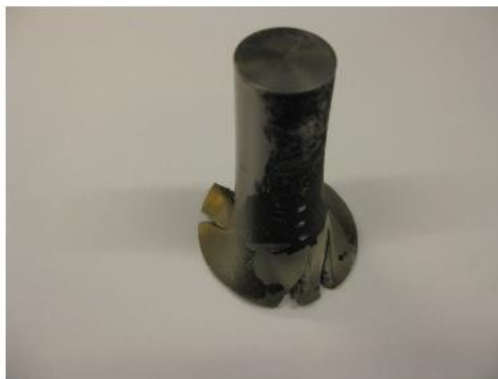
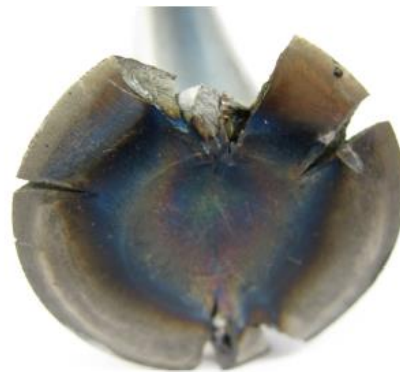
Figure 8: Unhardened projectile after impact at 341.4 m/s. A combination of spiral shear cracks and tensile splitting is visible.

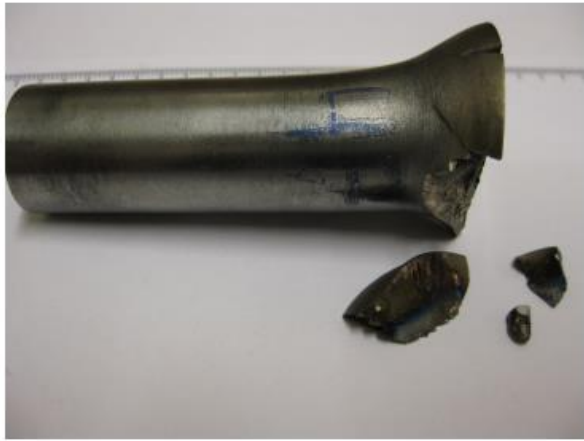
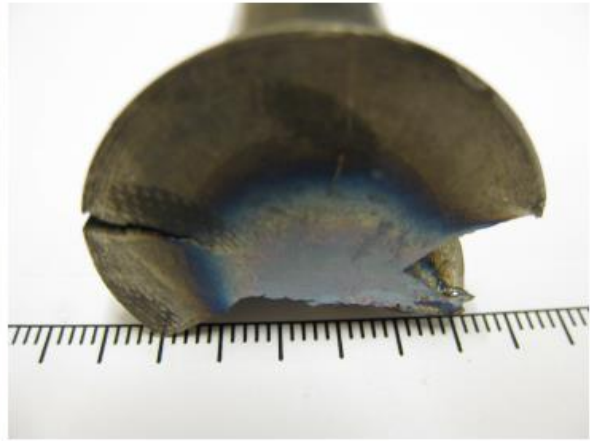
Figure 9: HRC 40 projectile after impact at 297.1 m/s. A combination of spiral shear cracks and tensile splitting is visible.

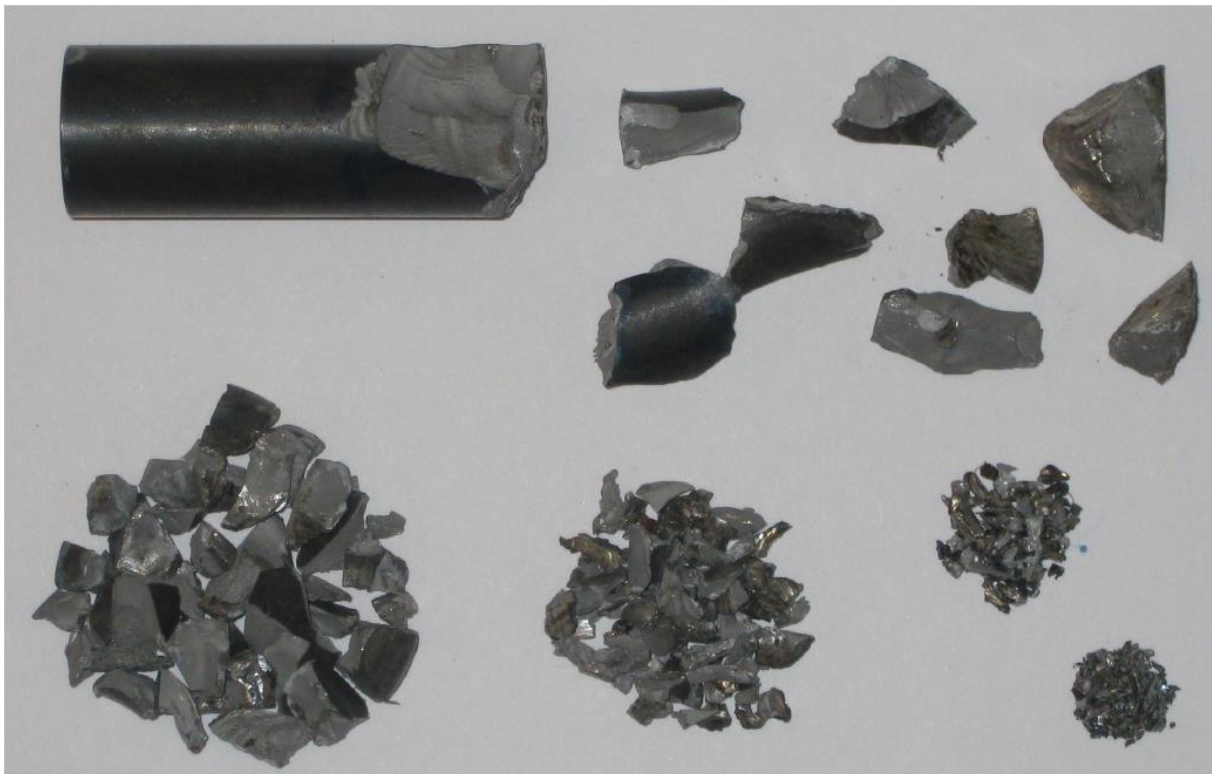
Figure 10: HRC 52 projectile after impact at 250.5 m/s. The fragments are sorted according to their size.

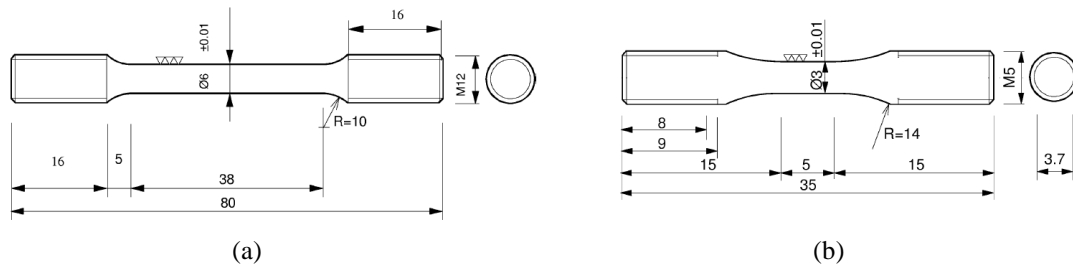
Figure 11: Test geometries of (a) specimens used in the quasi-static tests, and (b) specimens used in the dynamic tests.

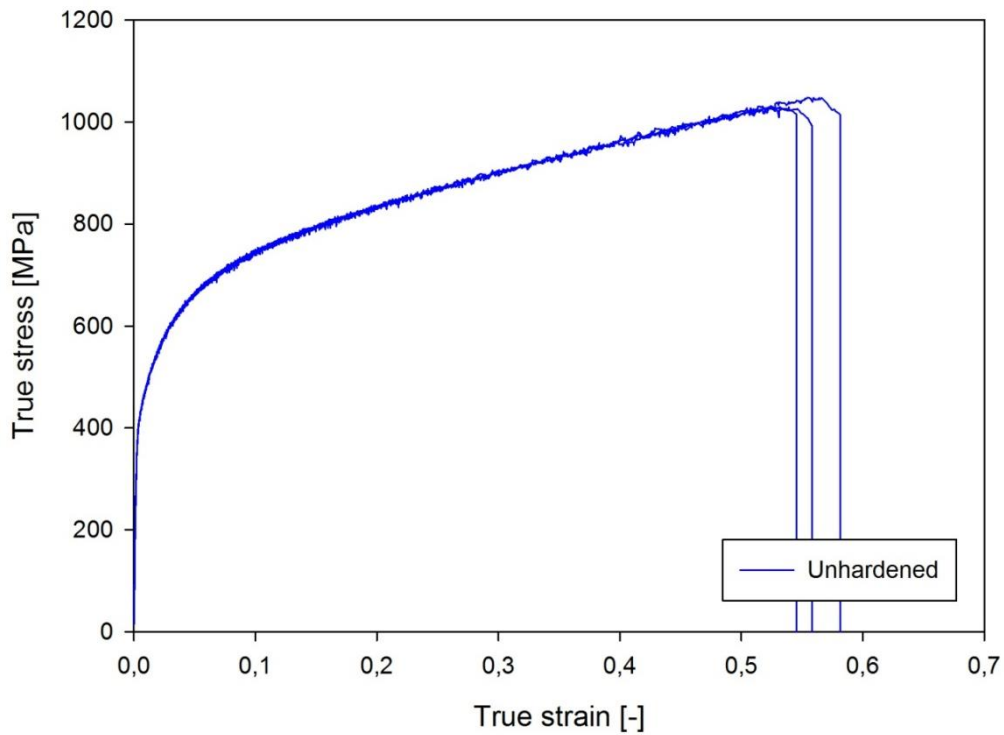
Figure 12: True stress versus true strain curves from quasi-static tensile tests on specimens from unhardened material.

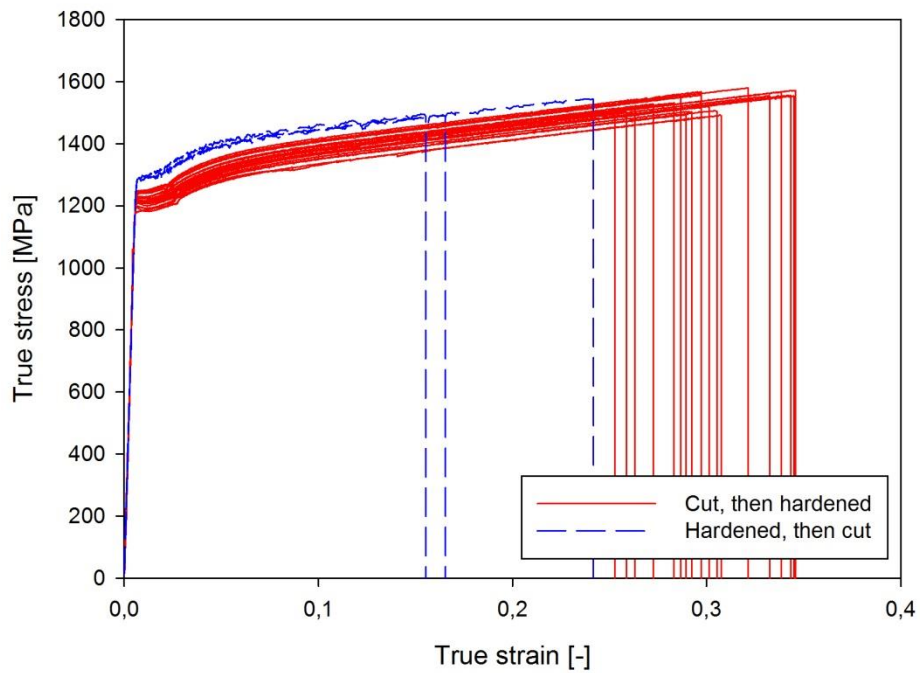
Figure 13: True stress versus true strain curves from quasi-static tensile tests on specimens from material hardened to HRC 40.

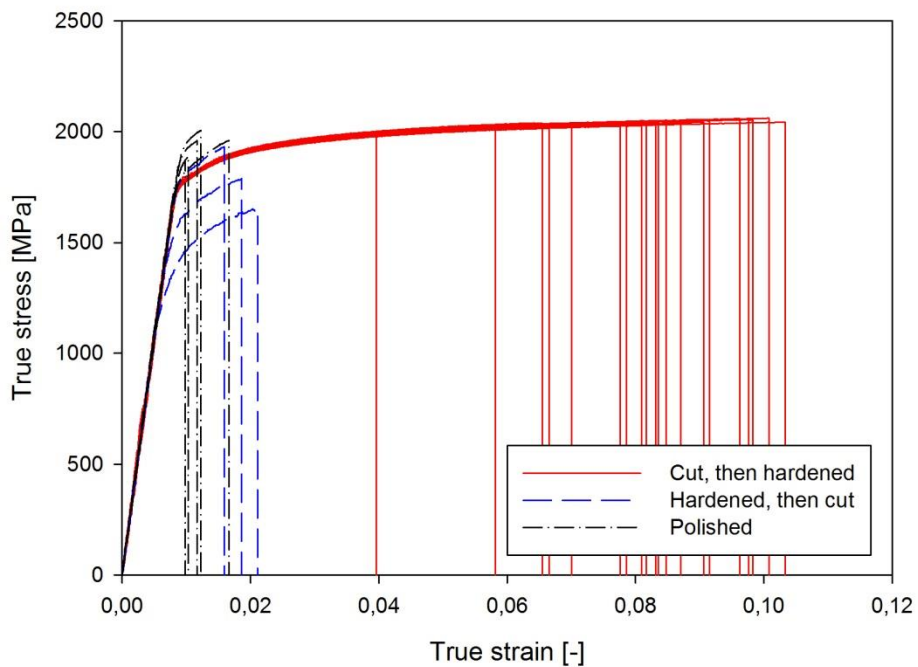
Figure 14: True stress versus true strain curves from quasi-static tensile tests on specimens from material hardened to HRC 52.

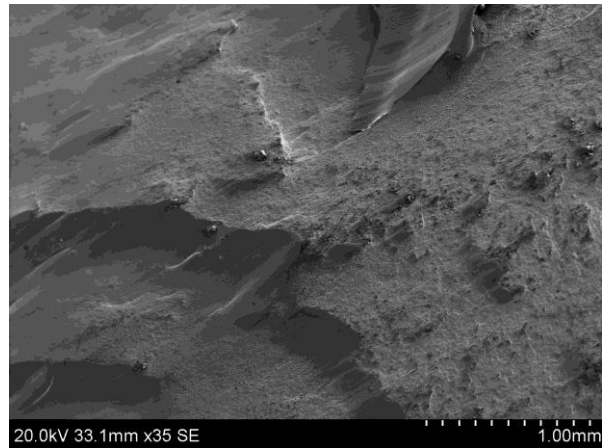
(a) Dimples

(b) Flat surface with cleavage-like patterns

Figure 19: SEM images of fracture surfaces of HRC 40 projectile that impacted at 297.1 m/s.

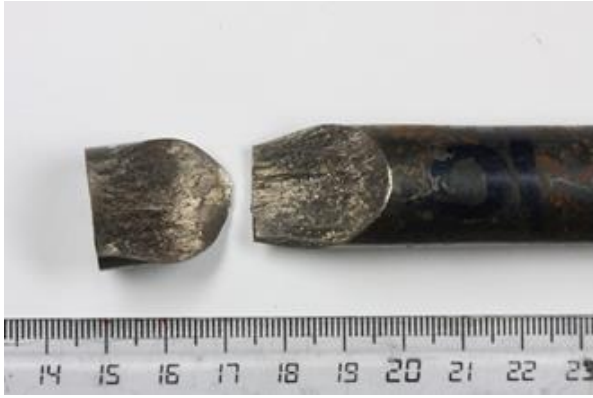
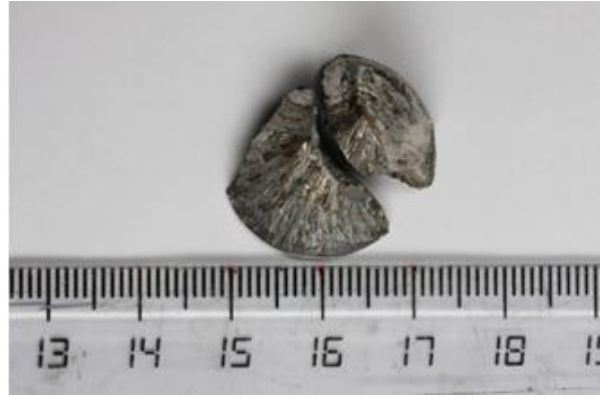
(a) Impacted at 132.9 m/s

(b) Impacted at 201.8 m/s

Figure 20: Glassy surfaces observed in HRC 52 projectiles. (a) The projectile that fractured with a principal shear fracture. (b) The projectile that fragmented.

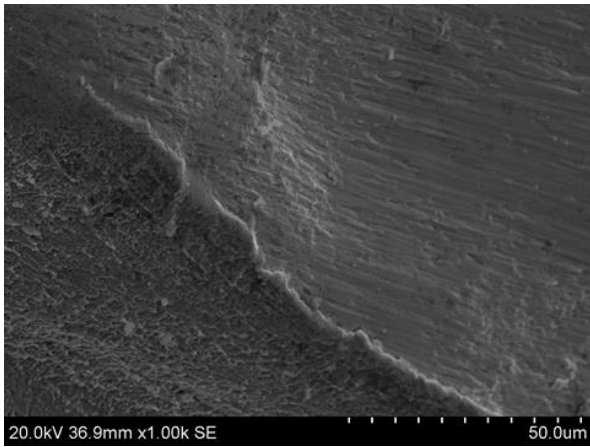
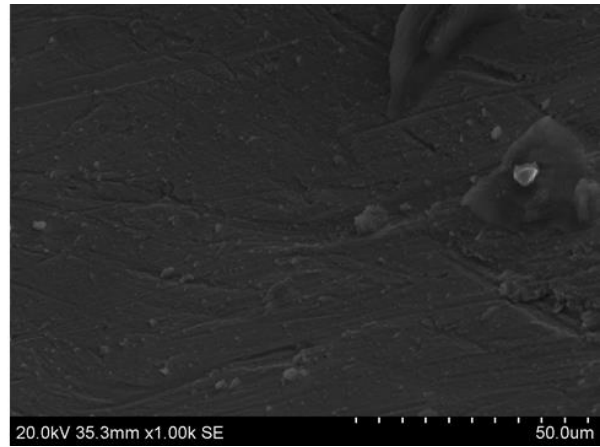
Figure 21: SEM images of the glassy fracture surfaces of the HRC 52 projectile that impacted at 201.8 m/s.

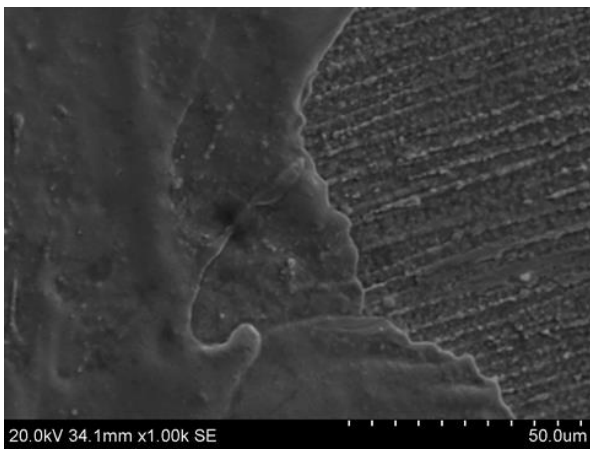
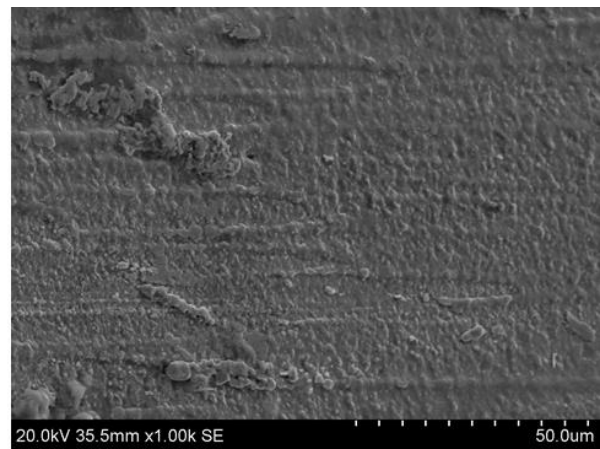
Figure 22: SEM images of a fracture surface of the HRC 52 projectile that impacted at 201.8 m/s showing melted and solidified material.

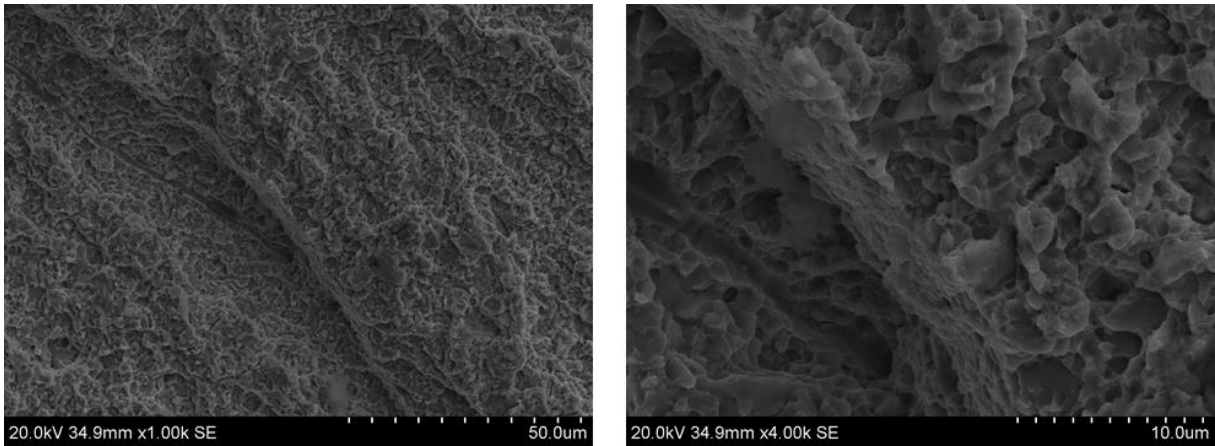
Figure 23: SEM images of fracture surfaces in a fragment of the HRC 52 projectile that impacted at 201.8 m/s some distance from the impacting end displaying quasi-cleavage.

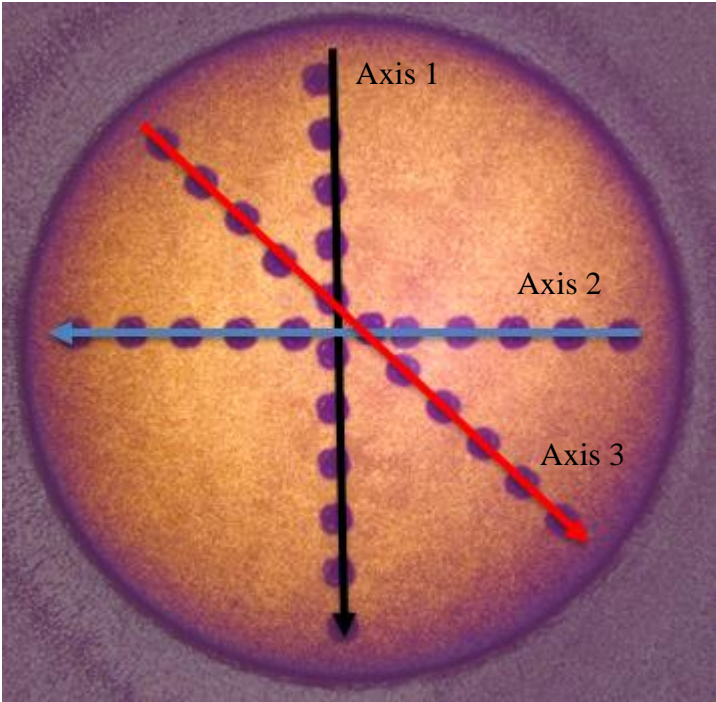
Figure 24: Position of measured profiles over the cross-section

their positions are shown in Figure 24. The hardness was measured in a Reicherter Brivisor KL2 using the HV10 Vickers scale and the measured variations of the hardness along these profiles are displayed in Figure 25. From the results, one observes that the hardness is higher in the projectiles than in the tensile test specimens with the same nominal hardness. This confirms the significant role on the mechanical properties of the material the cooling rate of the specimens after hardening may play.

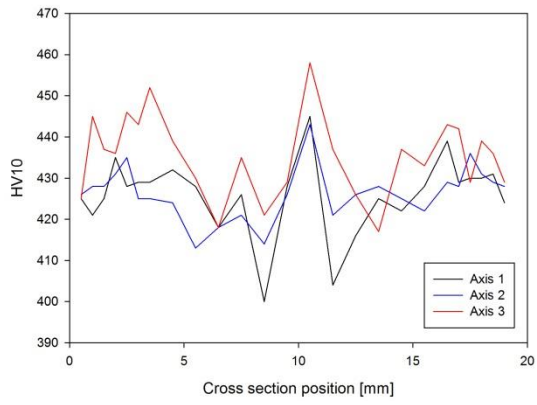
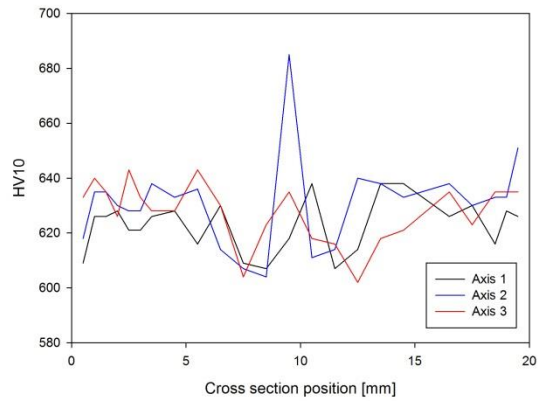
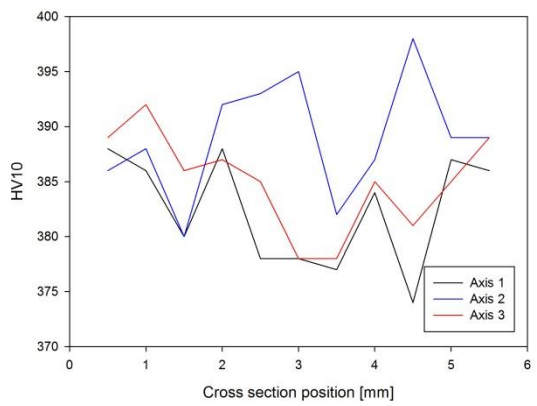
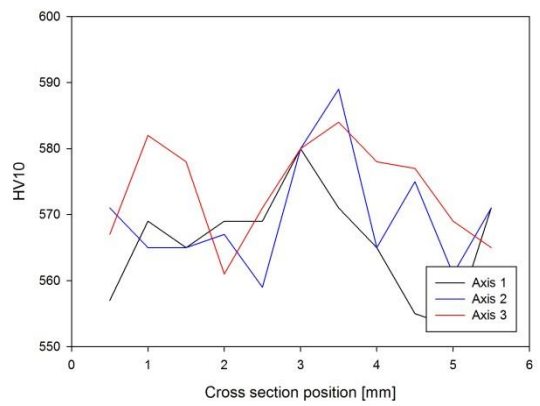
Figure 25: Measured hardness over the cross-sections of a) HRC 40 projectiles, b) HRC 52 projectiles, c) HRC 40 tensile specimens and d) HRC 52 tensile specimens.
