Fume Events in Aircraft Cabins

Tonje Trulssen Hildre
June Krutå Jensen

Safety, Health and Environment

Submission date: June 2015

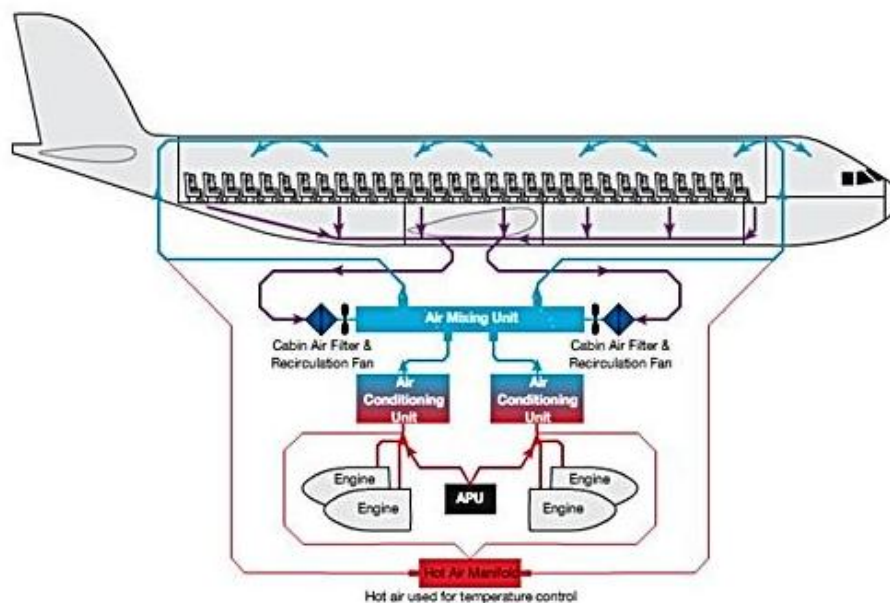
Figure 8: Schematic overview of the ventilation system on an aircraft. Outside air passes through the engine and is heated as a result of pressure changes. The air continues to the air conditioning unit to get a suitable temperature. From the air condition unit it enters the air mixing unit. Here, the bleed air is mixed with filtered and recirculated air from the cabin. The mixed air finally enters the cabin and then either passes back to the air mixing unit, or is discharged to the atmosphere (Pall, 2014, Michaelis and Loraine, 2005).

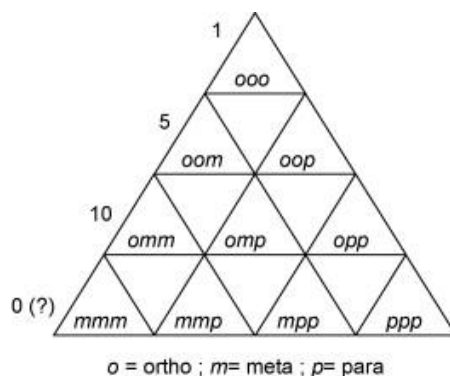
Figure 20: Triangular view of the ten different TCP isomers. MOCP is considered to be ten times more toxic than TOCP, while DOCP is presumed to be five times more toxic than TOCP (De Nola et al., 2008).

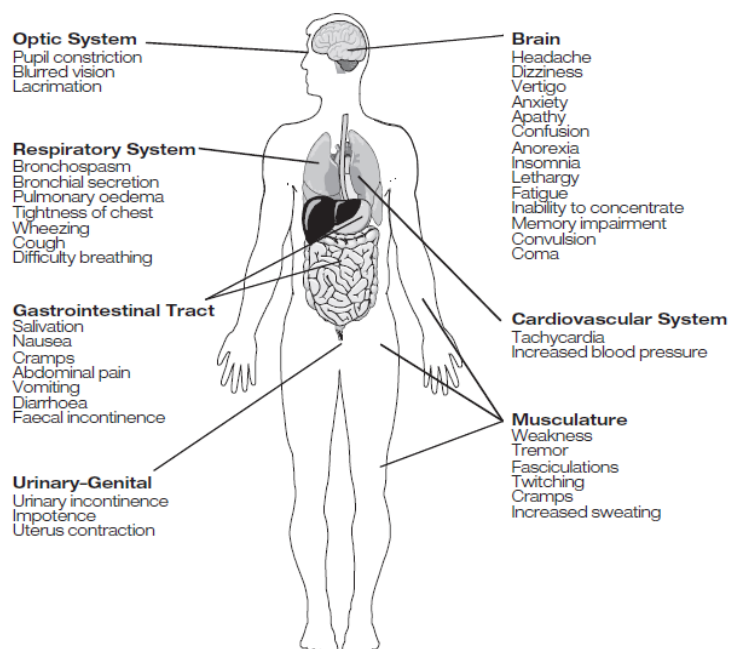
Figure 26: Overview of possible reactions in the body from organophosphate poisoning. Signs of intoxication by organophosphates may include headache, concentration difficulty, confusion, tremors, diarrhoea, vertigo, increased sweating, muscular twitching and various central nervous system effects (Klaasen and Watkins, 2010, p 312, Winder and Michaelis, 2005, Abou-Donia, 2005).

Exposure to organophosphorus compounds in single or short-term exposures, single large toxic dose, or long-term low level repeated exposure, may lead to the development of neurotoxicity (Winder and Michaelis, 2005). According to Abou-Donia (2003), there are three distinct neurotoxic actions associated with organophosphorus compounds: cholinergic neurotoxicity of organophosphorus compounds, organophosphorus ester-induced delayed neurotoxicity (OPIDN) and organophosphorus ester-induced chronic neurotoxicity (OPICN). Neurotoxic effects in humans have also been divided into four categories; cholinergic syndrome, intermediate syndrome, organophosphate-induced delayed polyneuropathy (OPIDP/OPIDN) and chronic organophosphate-induced neuropsychiatric disorder (COPIND/OPICN) (Jokanović and Kosanović, 2010). Here, the classification by Abou-Donia (2003) will be looked further into. Figure 26 shows an overview of different influences from organophosphate poisoning in humans.
