# Impact against X65 steel pipes – an experimental investigation

## Abstract

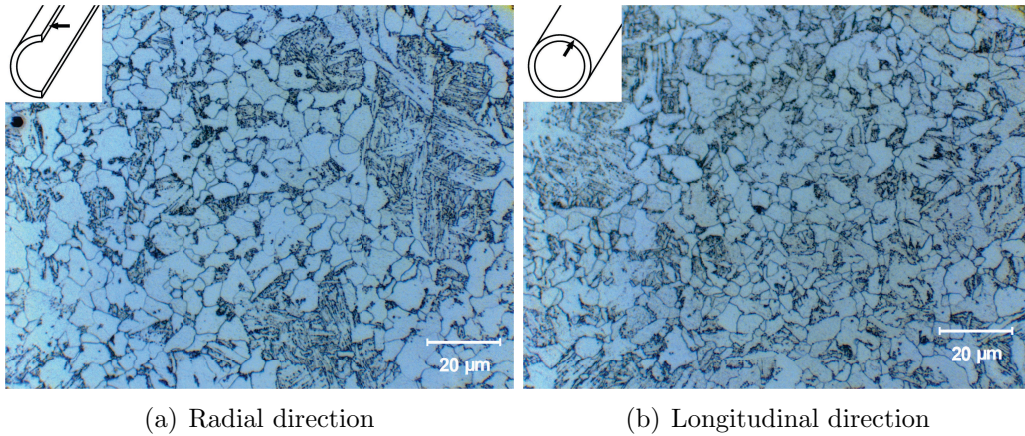
Figure 2: The microstructure of the material in undeformed condition taken from the pipeline, at  $\times 100$  magnification.

Tensile tests were carried out at quasi-static strain rate and room temperature on smooth axisymmetric specimens, whose geometry can be seen in Fig. 3(b). The chosen geometry should, based on the images in Fig. 2 from the light optical microscope, be large enough to sample a representative portion of the material. A displacement controlled Zwick testing machine was used with a constant deformation rate of 0.3 mm/min. This corresponds to an initial strain rate of  $\dot{\epsilon} = 10^{-3} \text{ s}^{-1}$  using a gauge length of 5 mm. Two tests from each of the positions across the cross-sections (north, south, etc.) and two from each of the directions ( $0^\circ$ ,  $45^\circ$  and  $90^\circ$ ) were performed.

deformation is therefore decreased in the samples exposed to compression first. Both samples' microstructures at failure are shown in Fig. 23, while the undeformed microstructure can be seen in Fig. 2. Defects like voids and particles of size 5-40  $\mu\text{m}$  were observed in the specimen exposed to tension only, while the one compressed to 40% before tension showed such defects ranging from 5 to about 90  $\mu\text{m}$ . Both cases are shown in Fig. 23, but be aware that this is a 2D representation of a 3D material, so the darker areas seen might as well be distorted areas in the vicinity of the calcium aluminate particles.

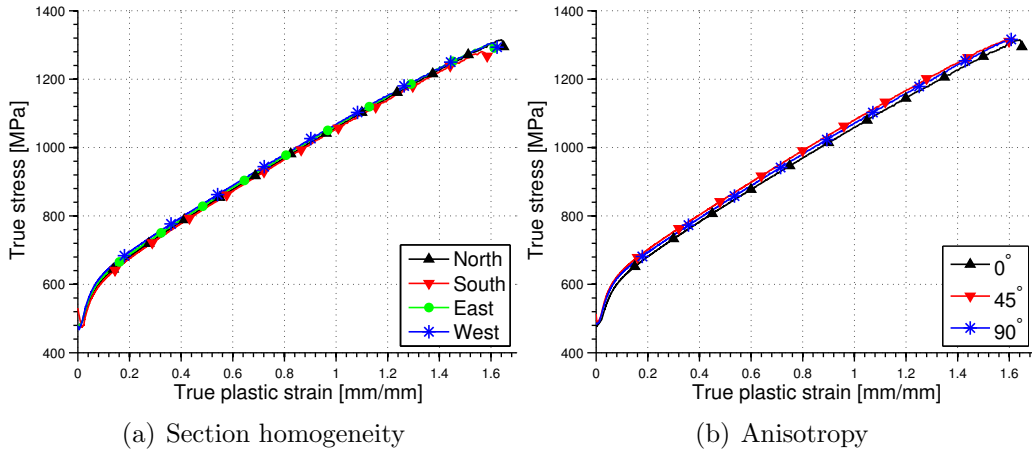
Figure 4: Data from quasi-static tensile tests on uniaxial specimens.

Results from the section homogeneity tests (one from each of the positions) are presented in Fig. 4(a), plotted as true stress vs. true strain. These curves are similar to those for the X65 steel used by Hyde et al. (2007) in their study of longitudinal indentation of unpressurised pipes. The scatter between

True stress-true strain relations from the tests at different directions (one from each direction) are displayed in Fig. 4(b), showing the same tendencies; yielding at almost 500 MPa and a peak true stress of about 1300 MPa. The fracture strain was also of the same magnitude, approximately 1.6. Again the data is quite conclusive; no anisotropy appears to be present, as the circular fracture surfaces in Fig. 5(e)-(f) also indicate. Based on these results, the material will henceforth be treated as isotropic and homogenous, in contrast to the quite anisotropic appearance of the X65 steel used by Manes et al. (2012).

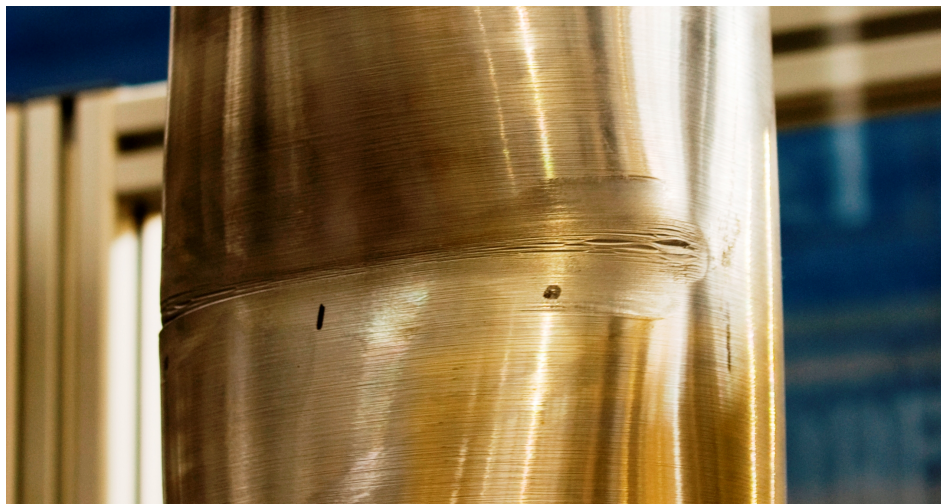
(a) Overview of pipe B

(b) Through-thickness crack in pipe B

(c) Surface cracks in pipe A

Figure 12: Photographs of (a) impact zone in pipe B with an arrow signifying the impact direction and location, (b) close-up of through-thickness crack in pipe B and (c) surface crack in pipe A. All images are taken after impact and stretching.

at very different load levels, ranging from a maximum value of 274 kN to just after stretching was initiated (about 10 kN judged by visual inspection during stretching) for the most deformed pipe. Due to the large differences in deformation, different cross-head velocities were used during stretching, but was always kept in the quasi-static regime. During stretching, pipe B ( $v_0 = 5.13$  m/s) ruptured through the entire thickness of the pipe wall (shown in Fig. 12(a) and (b)). A visual inspection of pipe A ( $v_0 = 3.24$  m/s) revealed only surface cracks and not through-thickness failure (Fig. 12(c)). The through-thickness crack has three distinct zones as indicated by the numbers on the picture in Fig. 12(b):

- Zone 1: The impact side of the pipe
- Zone 2: The side opposite to the impact side
- Zone 3: The transition zone between the two first zones

Looking at Fig. 12(c), traces of the pipe being milled down are visible and fracture appears to initiate at the bottom of these traces. An uneven surface may lead to stress and strain concentrations, thereby initiating cracks at specific locations, but as will be shown this is believed to be of minor

Firstly, the fracture surfaces from the pipes impacted and straightened were investigated to see what kind of fracture mechanisms that were present after the entire loading sequence described in Section 3. Visible fracture surfaces from the pipes were inspected, so the samples were taken from the pipes' most deformed area. Two main types of macroscopic cracks were present after impact and stretching; through-thickness cracks (Fig. 12(b)) and cracks on the pipe's surface (Fig. 12(c)). The through-thickness cracks had three different zones as mentioned above.

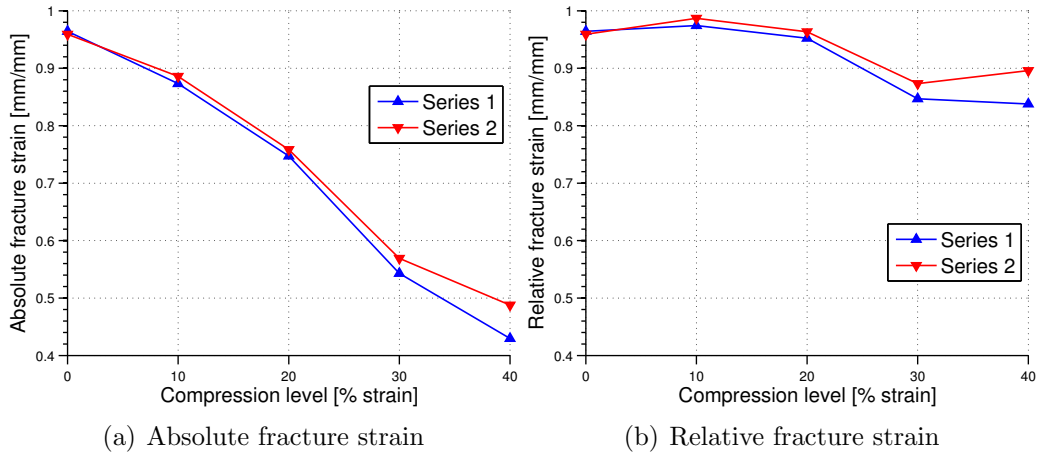
Figure 19: Absolute (a) and relative (b) fracture strain vs. compression level from compression-tension tests on specimen shapes from Fig. 18(a).

True stress-true strain curves are presented in Fig. 18(b). The scatter between the two parallel test series from 0% to 40% compression was negligible. In tension only, the true stress-true plastic strain curve has a clear concave shape. This is not true for the specimens compressed first, which exhibit a slight decrease in work hardening rate before approaching their respective asymptotes. The transient Bauschinger effect is observed through the early onset of re-yielding for the reversed load. Towards the end of the tensile phase, all the curves tend to become almost parallel including the specimens loaded in tension only. Circular and ductile cup-and-cone fracture surfaces were observed for all specimens. The area  $A_f$  of the fracture surfaces increased with increasing compression, causing the “absolute” fracture strain  $\varepsilon_f = \ln(A_0/A_f)$  to decrease as seen in Fig. 19(a). The “relative” fracture strain  $\varepsilon_r$ , obtained by using the area at load reversal  $A_r$  as reference rather than the initial area, also exhibits a drop with increasing compression. From Fig. 19(b) it is seen that the effect on the relative fracture strain is smaller.

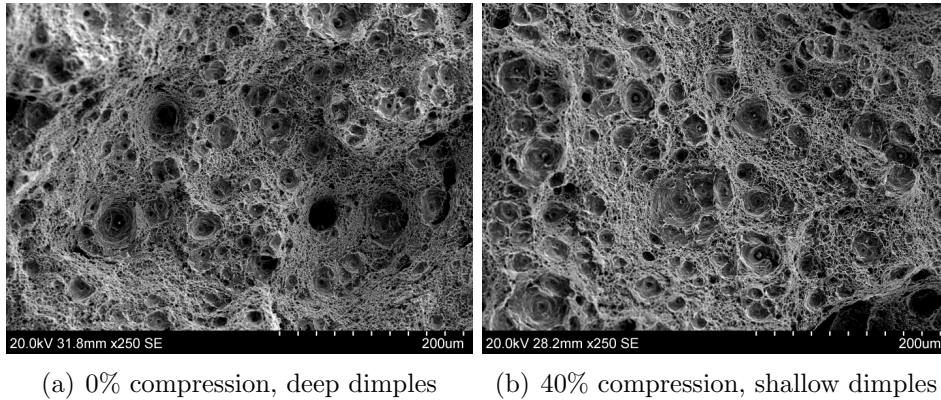
Figure 20: SEM images of fracture surfaces of notched compression-tension specimens at  $\times 250$  magnification.

the calcium aluminate particles are clearly seen in the large dimples, suggesting once again that voids initiate around these particles in compression (Sabih and Nemes, 2009). After compression, the stress level is considerably higher and the hardening similarly lower. This could lead to earlier void nucleation and accelerated void growth and coalescence by interligament necking at an early stage.

The fracture surfaces of the notched compression-tension specimens were examined using scanning electron and optical light microscopes. Using the SEM, a mixture of large and small dimples was found in the centre. Further, shear lips were present in the region near the outer surface in accordance with the cup-and-cone fracture. At 250 times magnification, the larger dimples appear to be deeper in the uncompressed specimen than those in the ones loaded in compression first (see Fig. 20), indicating that voids can grow to larger extents with less compression – a signal that ductility is being reduced (Ghajar et al., 2013). In specimens compressed to 20%, 30% and 40%

True stress-true strain curves from the second series of tests are plotted in Fig. 24(b). Herein lies a very interesting feature: where tendencies to ductility reduction was observed in the previous tests, it is now even more evident. Compressing the specimen to 90% appears to decrease the ductility to a significant extent, also when looking at the relative deformation from load reversal to failure in tension. The mode was also altered to a  $45^\circ$  shear fracture, which can be seen in Fig. 25. Again the surface area at fracture tends to increase with increasing compression. Both the absolute and relative fracture strains showed the same tendencies as in Fig. 19, with the 90% specimen standing out. The SEM images revealed a ductile fracture for the 40% specimen, very similar to the surface shown in Fig. 20(b). Both the 60% and 80% specimens did show signs of cleavage fracture along the edges,
