# **FPSO Cidade de São Mateus gas explosion – lessons learned**

by Jan Erik Vinnem

Department of Marine Technology, Norwegian University of Science and Technology (NTNU), NO 7491 Trondheim, Norway

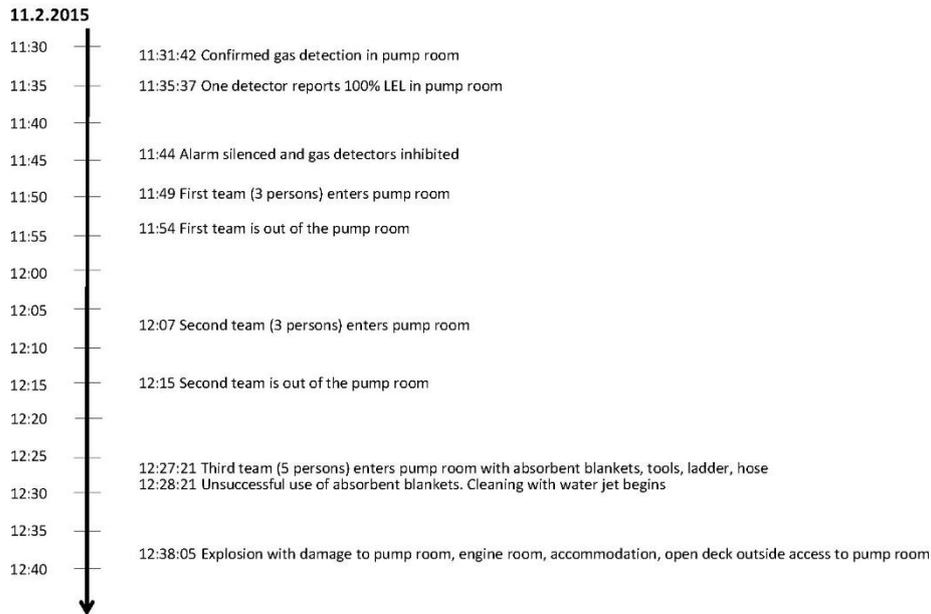
**Figure 1 Overview of immediate causes of leaks (>0.1 kg/s), NCS, 2008–2015 (n=88)**

The timeline of the accident is shown in Figure 1, which covers the period, just over an hour long, from the occurrence of the condensate leak until the explosion.

Several of the mitigation actions failed in this incidence. First of all, actions to protect personnel from escalation of the unignited condensate leak into an explosion or fire were inadequate. Figure 1 shows how three different crews were sent into the pump room survey and control the situation. The investigation report shows that actions to protect personnel were significantly inadequate, see Attachment 1, Causal factors No 6 and 7, with the following deficiencies:

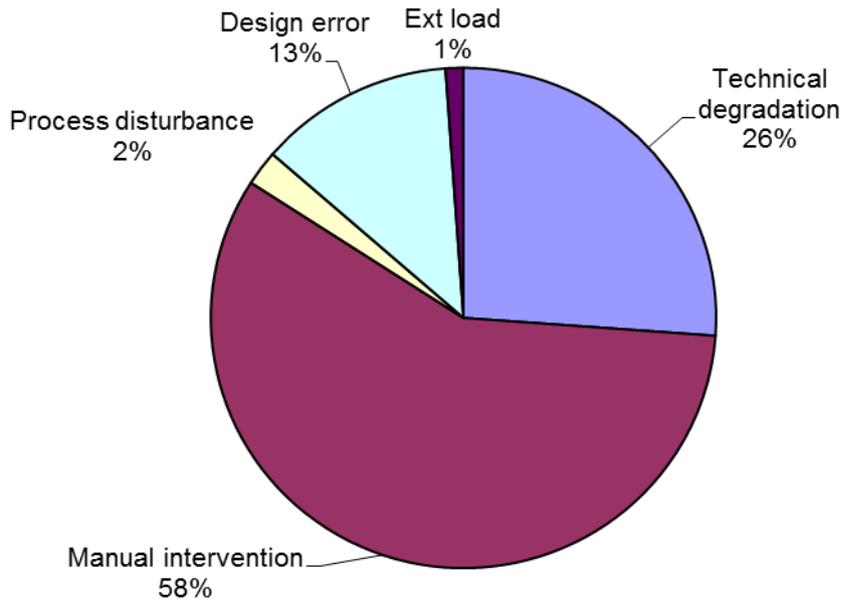
Figure 2 shows an overview of the immediate circumstances of all leaks on the NCS with initial HC leak rate of at least 0.1 kg/s.

**Figure 2 Overview of immediate causes of leaks (>0.1 kg/s), NCS, 2008–2015 (n=88)**

More than 50% of the leaks were associated with manual intervention in normally pressurized systems. This percentage has been stable at between 50% and 60% for more than 15 years, and suggests that HC leaks associated with manual intervention in process systems are one of the most significant hazards on offshore oil and gas installations. Based on the description given in Section 2.1, the accident on board CDSM would fall into the same category as about 58% of the leaks on the NCS during the last eight years. Further details of HC leaks in the Norwegian sector may be found in Vinnem and Røed (2015).

One of the relevant incidents during this period is the large gas leak that occurred on 25<sup>th</sup> May 2012 on the Heimdal steel jacket production installation in the Norwegian sector (PSA, 2012). This leak is representative of leaks associated with manual intervention (see Figure 2) and occurred in connection with the testing of two emergency shutdown valves (ESDVs). Before the test, the relevant sections of the production plant were shut down and depressurized for maintenance.
