On the dynamic response of laminated glass exposed to impact before blast loading

In this study, the effect of fragment or bullet impact before blast loading on laminated glass is studied experimentally. First, laminated windows consisting of two 3.8 mm thick annealed float glass plates and a 1.52 mm thick PVB interlayer were blast loaded in a shock tube with various pressures as a reference. In these tests, the blast loading was successively increased until fracture occurred not only in the glass plates but also in the PVB interlayer. Second, a diamond drill was used to make a 5 mm diameter centrally placed hole in some windows before they were blast loaded with the same pressures as those used for the undamaged windows. Third, windows were impacted by 7.62 mm AP bullets, both with and without the brass jacket, before they were blast loaded. Such bullets may have similar mass and velocity to typical primary fragments from an explosive detonation. The results are finally compared with each other and discussed with respect to the blast protection offered. It is found that the capacity is significantly reduced if the laminated glass is perforated by a fragment or a bullet before it

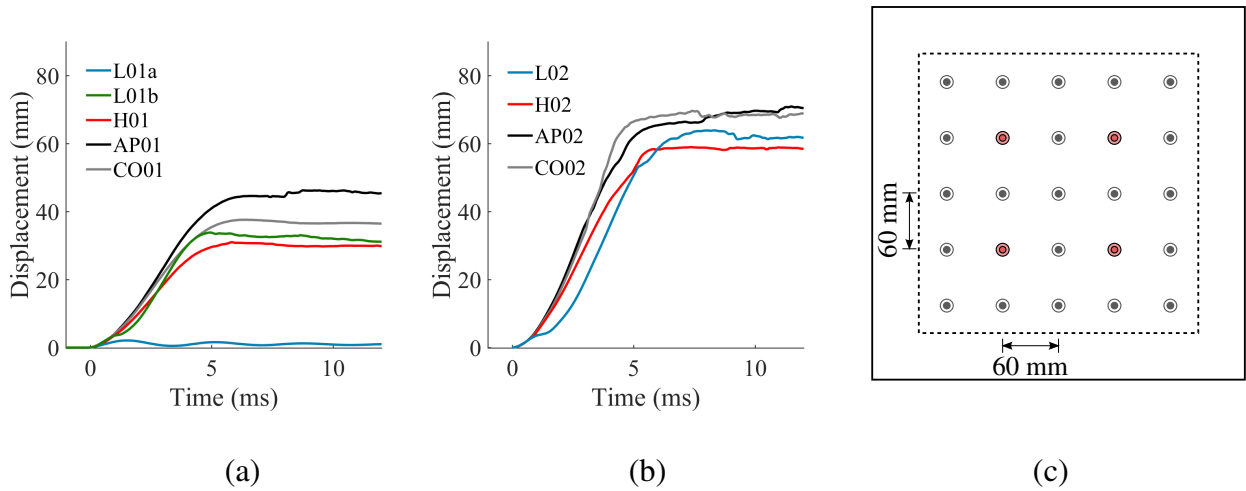
Figure 13: Average out-of-plane displacement of four optical targets from tests with P_d equal to (a) 860 kPa and (b) 1000 kPa, while (c) shows the position of the four optical targets (marked in red) on the glass surface used in the measurements.

Finally, Figure 13 presents average out-of-plane displacements versus time for four optical
 325 targets (shown in Figure 13c) during blast loading. These results are obtained by using the point-
 tracking procedure described in Section 3.4. The central optical target could not be tracked due to
 the pre-damage. As seen, when the glass plates do not fail (i.e., Test L01a), the displacements are
 negligible. However, when they do fail, the displacements become significant, and the blast load-
 ing is carried by membrane stretching of the ductile interlayer. Furthermore, when the laminated
 330 glass was pre-damaged, the displacement seemed to increase with the degree of initial damage, as
 the displacements of the glass plates pre-damaged by bullets were higher than those for the glass
 plates pre-damaged by a drilled hole. The displacement of the initially undamaged laminated glass
 plates that failed falls between those of the plates with pre-drilled holes and the plates pre-damaged
