On the hydrogen embrittlement behavior of nickel-based alloys: Alloys 718 and 725

To appear in: *Materials Science & Engineering A*

Nickel-based superalloys have attracted immense attention in the oil and gas industry due to their outstanding combination of mechanical properties and corrosion resistance. In corrosive service environment, hydrogen embrittlement is a severe issue. In the present work, the susceptibility of two precipitation-hardened nickel-based alloys, *i.e.*, Alloy 718 and Alloy 725, to hydrogen embrittlement was studied using slow strain-rate tensile test and advanced characterization techniques. The mechanical properties and fracture behavior of these two alloys were compared in both hydrogen-free and hydrogen-charged conditions. In the presence of hydrogen, Alloy 718 failed prevalently through a combination of transgranular and intergranular cracking behavior, while Alloy 725 failed primarily through intergranular failure with a considerably lower resistance to hydrogen embrittlement. This distinction was attributed to their different microstructures and different types of precipitates along grain boundaries. Specifically, in Alloy 725, the decoration of (Cr,

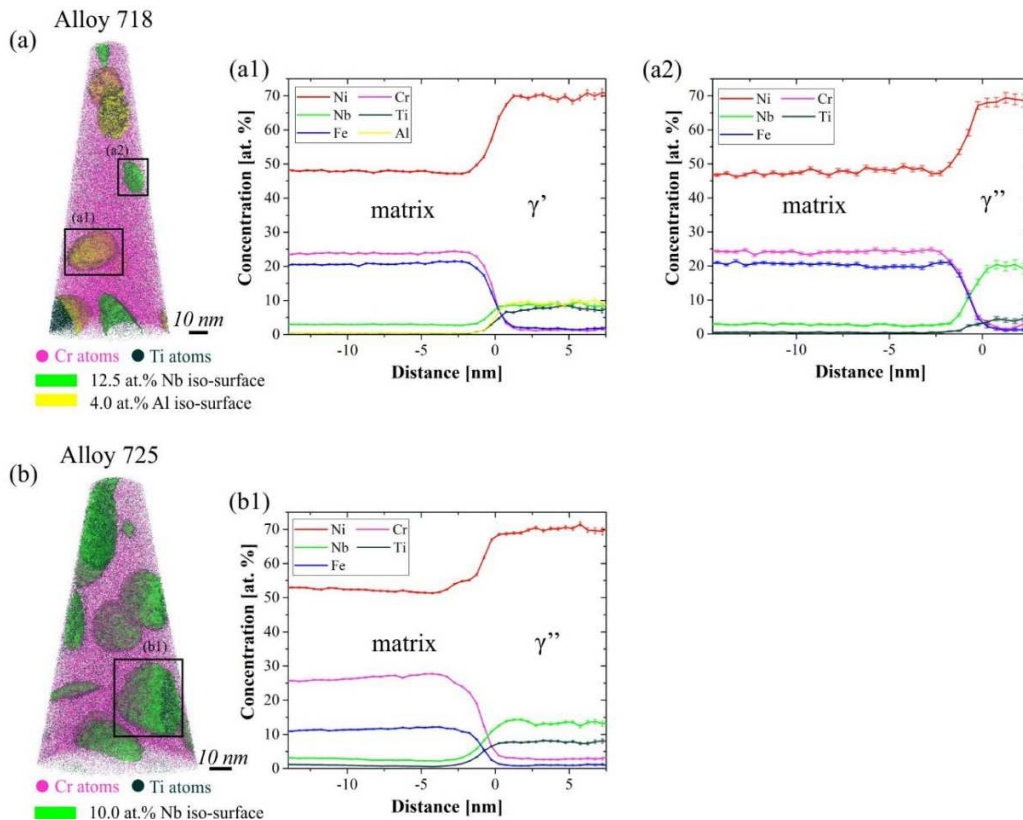
**Fig. 3.** Atom probe tomography analysis: (a) 3D atom map of Alloy 718; 1D concentration profiles of the selected (a1)  $\gamma'$  precipitate and (a2)  $\gamma''$  precipitate marked in (a). (b) 3D atom map of Alloy 725; (b1) 1D concentration profile of the selected  $\gamma''$  precipitate marked in (b).

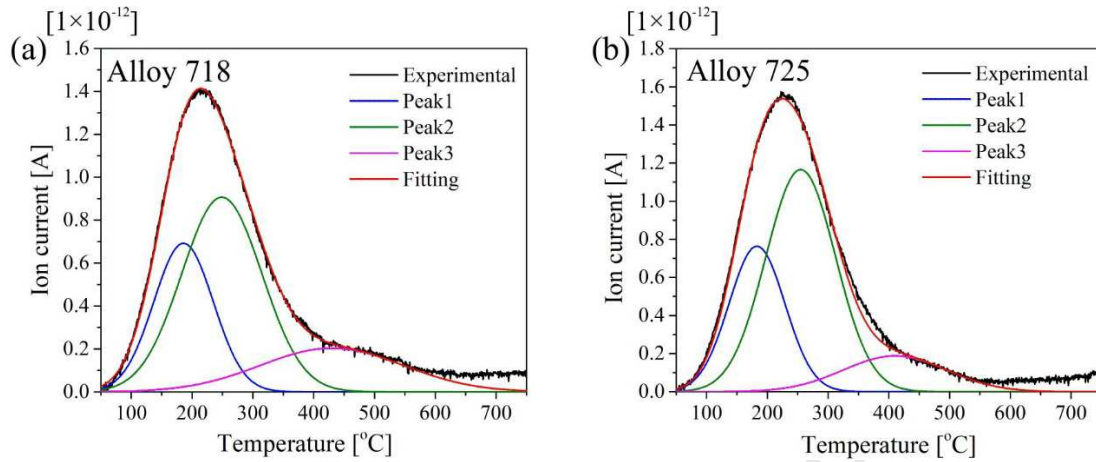
**Fig. 5.** Hydrogen desorption spectra of (a) Alloy 718 and (b) Alloy 725 obtained in thermal desorption analysis experiments including the deconvoluted peaks and the cumulative fitting curve.

Fig. 5 shows the hydrogen desorption spectra for both alloys after electrochemical charging. The total detrapped hydrogen content was 27.20 and 25.47 wppm for Alloys 718 and 725, respectively. After deconvolution of the obtained spectra, three desorption peaks were observed for each curve (Fig. 5).

The first peak corresponds to the diffusible hydrogen with a relatively low binding energy to hydrogen, the second peak to the reversibly trapped hydrogen, *i.e.*, hydrogen trapped at  $\gamma'$ ,  $\gamma''$ , GBs,  $\delta$  phases, *etc.* [35, 36], and the third peak to the irreversibly trapped hydrogen with a high activation energy for detrapping, *i.e.*, hydrogen primarily trapped at carbides [36]. The amount of hydrogen in different trapping sites can be determined by integrating each peak. Given that tested samples have different weights, only the relative hydrogen fraction of each peak was compared to study the hydrogen trapping ability in the two alloys. The relative hydrogen fraction of each peak and the corresponding peak temperature are summarized in Table 2. The results suggested that Alloy 718 contained a comparable amount of diffusible hydrogen, less reversibly trapped hydrogen, and more irreversibly trapped hydrogen than Alloy 725. Moreover, a slight variation was observed in the peak temperatures for both alloys.

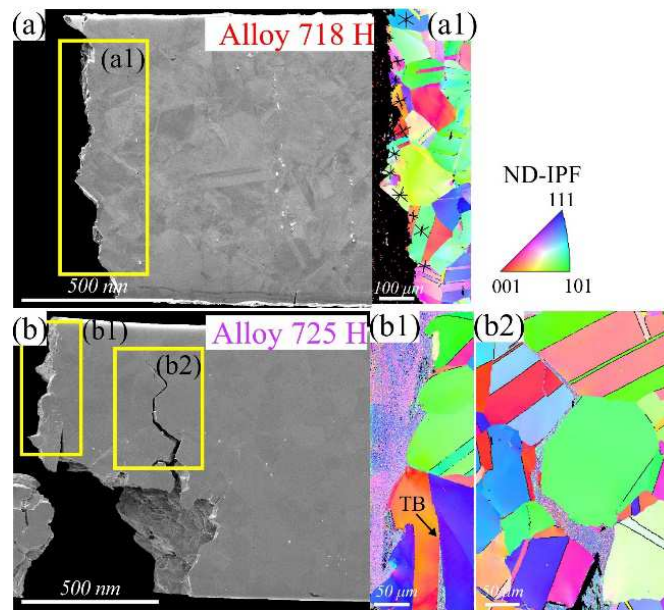
**Fig. 9.** Scanning electron micrographs of surface cracks of (a) Alloy 718 and (b) Alloy 725 after loading to fracture in hydrogen-charged condition and the corresponding inverse pole figures (IPFs) of the selected areas in the yellow frames for (a1) Alloy 718 and (b1)–(b2) Alloy 725. (ND: normal direction; TB: twin boundary.)

To further investigate hydrogen effect on damage behavior, the post-mortem characterization of surface and subsurface cracks was carried out for Alloys 718 and 725 under hydrogen-charged condition, as shown in Figs. 9-11. Consistent with the fractography results (Fig. 8(b)), Alloy 718 primarily fractured by transgranular cracking (Fig. 9(a)). As demonstrated by the inverse pole figure map in Fig. 9(a1), cracking paths

followed  $\{111\}$  slip traces (marked in black). In comparison, both primary and secondary cracks in Alloy 725 exhibited intergranular dominant cracking behavior (Fig. 9(b1) and (b2)). The EBSD results implied that the misorientation between adjacent grains along the crack path ranged from  $15^\circ$  to  $55^\circ$ . Additionally, several cracks propagated along twin boundaries and one example is shown in Fig. 9(b1).

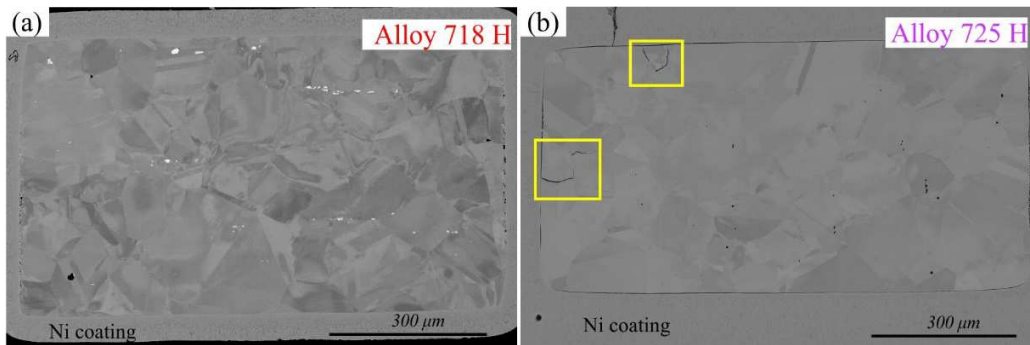
**Fig. 10.** Cross-section microstructures of hydrogen-charged (a) Alloy 718 and (b) Alloy 725 samples after loading to fracture.

On the cross-section near the fracture surface, no noticeable intergranular or transgranular cracks were found in Alloy 718 (Fig. 10(a)). The contrast variation in the matrix (Fig. 10(a)) was caused by plastic deformation. A large amount of plastic deformation was observed at local high stress concentration regions such as GBs and triple junctions, as well as areas around the small grains. In Alloy 725, several subsurface cracks were observed, as indicated by the yellow boxes in Fig. 10(b). The corresponding EBSD measurements indicated that all these cracks were initiated and propagated along GBs (Fig. 11(a1) and (b1)). Particularly, the curved GBs were more susceptible to cracking (Fig. 11). It can be seen that triple junctions and GBs with complex morphologies readily initiated cracks, as

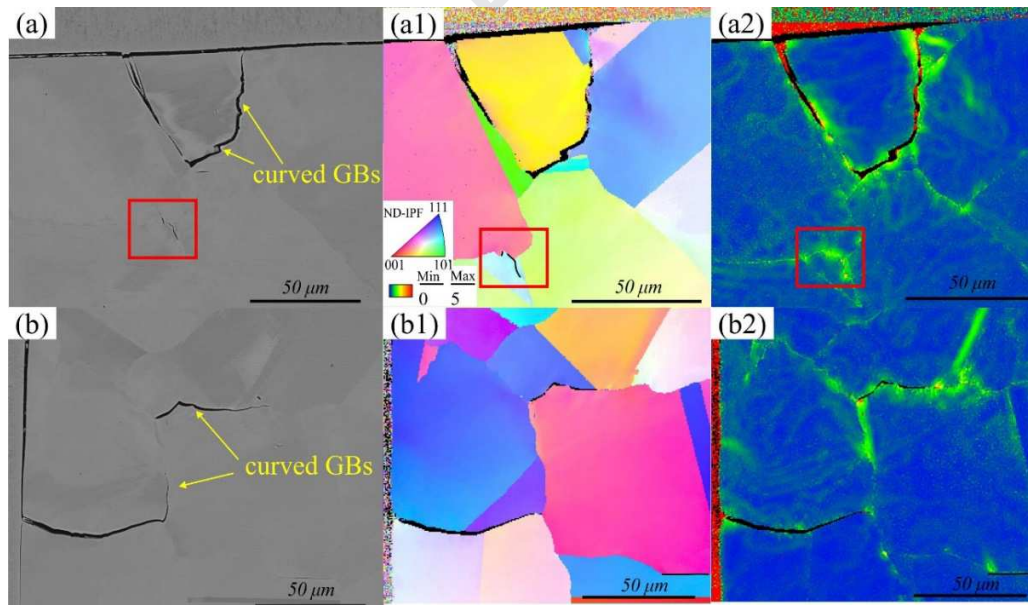
**Fig. 11.** (a) and (b) Backscattered electron micrographs of the cross-section cracks of Alloy 725; (a1) and (b1) corresponding inverse pole figures; (a2) and (b2) corresponding kernel average misorientation maps. (GBs: grain boundaries.)

illustrated in red boxes in Fig. 11(a). The high kernel average misorientation values at the cracked GBs and triple junctions involved with small grains indicated localized plasticity in these regions. Such localized deformation could be caused by intensive dislocation interactions.
