# **Effect of Fracture Mode on Acoustic Emission Behavior in the Hydrogen Embrittled Low-Alloy Steel**

## **Abstract**

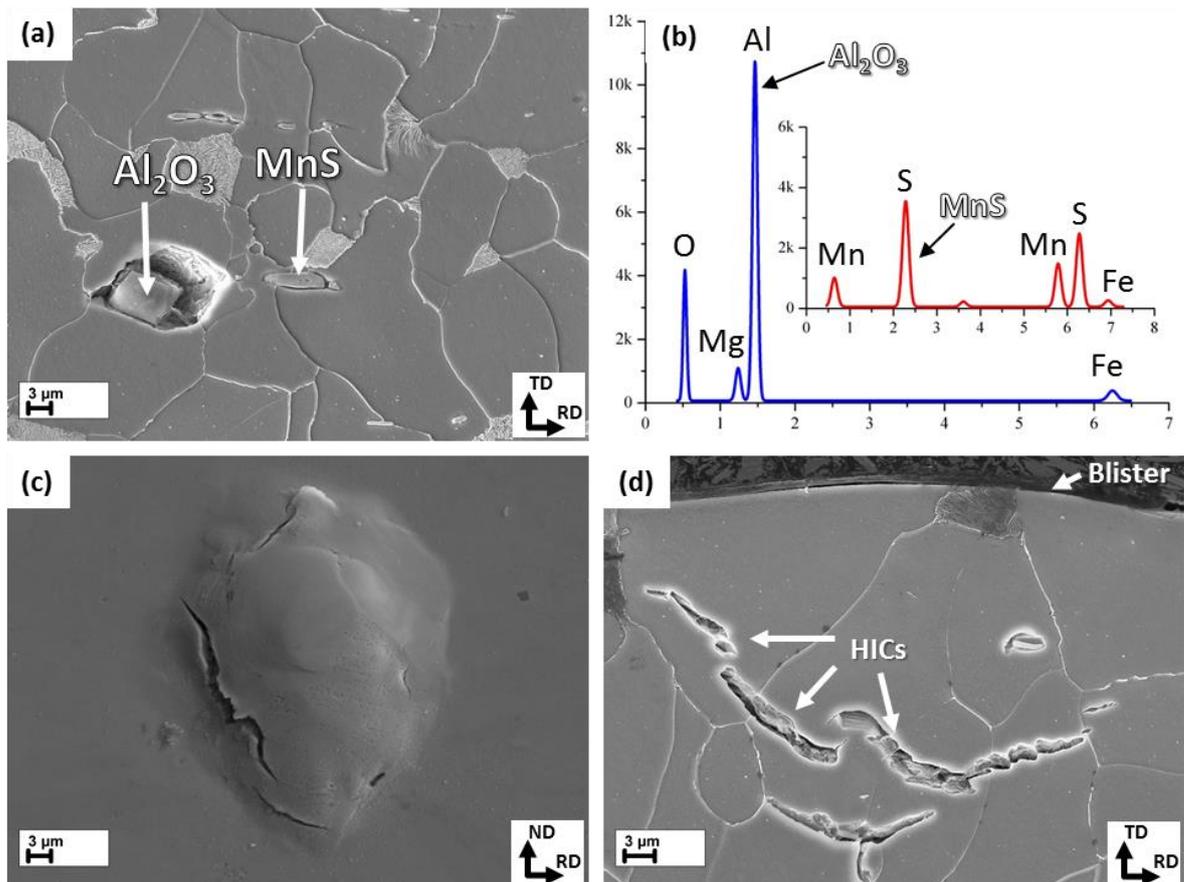
Fig. 1 – Microstructure – (a), Energy Dispersion X-ray (EDX) spectra – (b) for the non-metallic inclusions seen in (a), hydrogen-induced blisters on the surface – (c) and hydrogen-induced cracks in the microstructure – (d) of the as-received steel.

As-received specimens have a typical ferrite-perlite microstructure with coarse equiaxial ferritic grains of 10  $\mu\text{m}$  average diameter, as can be seen in Fig. 1a. The wide assortment of non-metallic inclusions such as  $\text{Al}_2\text{O}_3$  or elongated sulfides  $\text{MnS}$  is abundantly present in the microstructure, c.f. Fig. 2a, b.

After hydrogen charging, the surface of the as-received specimens contains blisters, Fig. 2c, which are the regions of the inflated metal surface with underlying HICs, see white arrows in Fig. 2d. The HICs are oriented primarily along the rolling direction of steel. They probably originate at non-metallic inclusions/matrix interfaces or grain boundaries but once nucleated they grow transgranularly across the ferritic grains, as clearly shown in Fig. 2d.

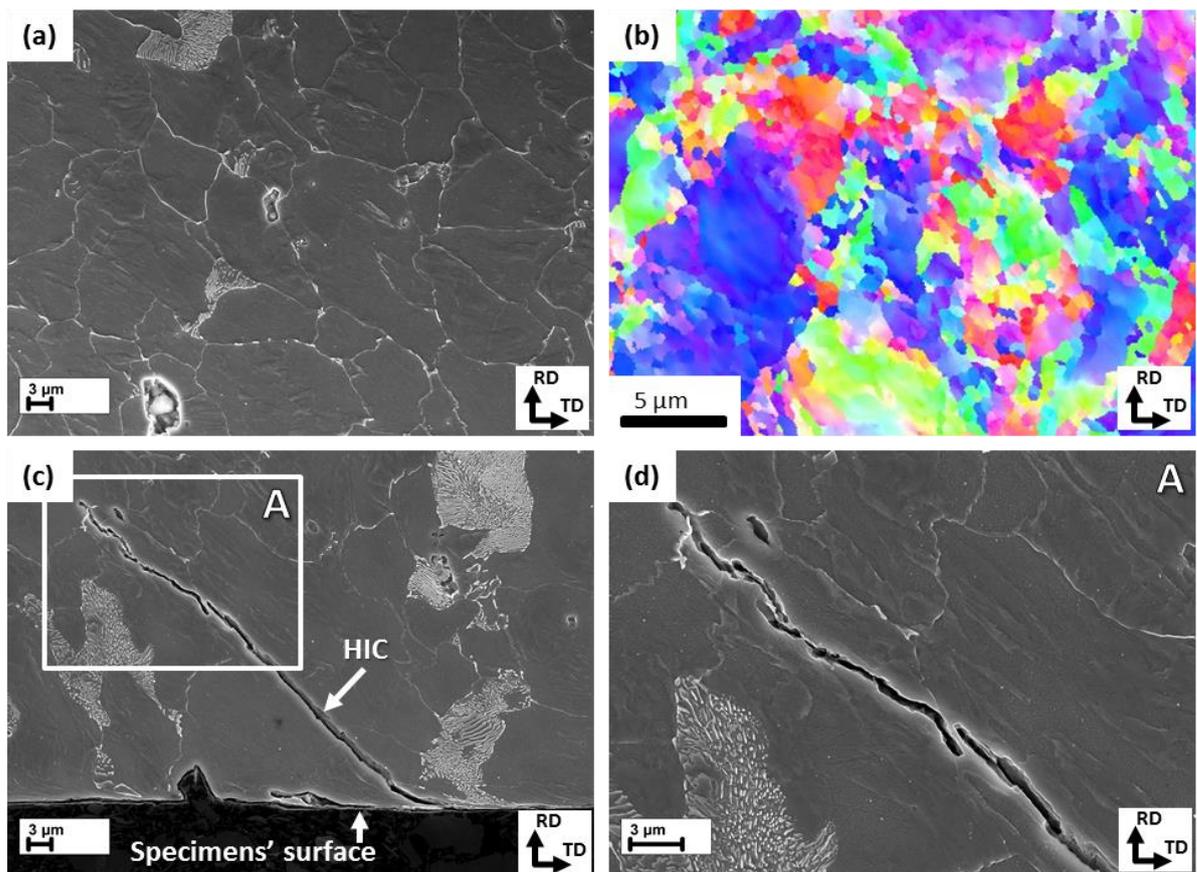
Fig. 3 – Microstructure – (a, b) and hydrogen-induced cracks (e, f) of the ECAPed steel grade 09G2S. (a, c, d) – SEM, (b) – Inverse Pole Figure (IPF) colored orientation map obtained by the EBSD method. A magnified view of the region labeled by A is shown in (d).

When examined by conventional SEM, the etched polished surface of the ECAPed steel demonstrates a distorted ferrite-pearlite microstructure with slightly smaller ferritic grain size in comparison with that in as-received steel, Fig. 2a. Grains are elongated in the direction of  $\sim 45^\circ$  to the extrusion direction, which is a common feature of many ECAPed microstructures. Nevertheless, the orientation map obtained by the EBSD technique and inked in inverse pole figure (IPF) colors shows that during ECAP the steel undergoes severe plastic deformation resulting in substantial grain refinement, Fig. 2b. The microstructure exhibiting a pronounced macroscopic texture is composed of small grains or sub-grains with the average diameter of  $0.6 \mu\text{m}$ . Dislocation-based low-angle grain boundaries are clearly seen in the original grains where transformation of the microstructure into the ultra-fine grained one has not been completed.

The thin near-surface HICs (but no blisters) have been observed in the hydrogen-charged ECAPed specimens, Fig. 2c, d. All of them are primarily transgranular and are oriented at approximately  $45^\circ$  to the extrusion direction of the steel. Thus, they are aligned with the primary direction of grains elongation which occurs in the shear plane of the last pressing operation.

a subject of future research. However, it can be plausibly supposed that these cracks grow along the dislocation sub-structure (cell) boundaries which are abundantly present in the microstructure of the ECAPed steel as was shown in Fig. 2b. The cells (or sub-grains), as well as cracks, are stretched along the shear direction of the ECAP. It has been well understood that dislocations and low-angle dislocation boundaries are strong traps of hydrogen. A particularly high local hydrogen concentration can be achieved at these traps giving rise to the high average hydrogen concentration in a whole specimen as well, c.f. Table 2. Hence, trapped hydrogen can weaken the dislocation sub-boundaries, making them susceptible to easy crack nucleation and growth.

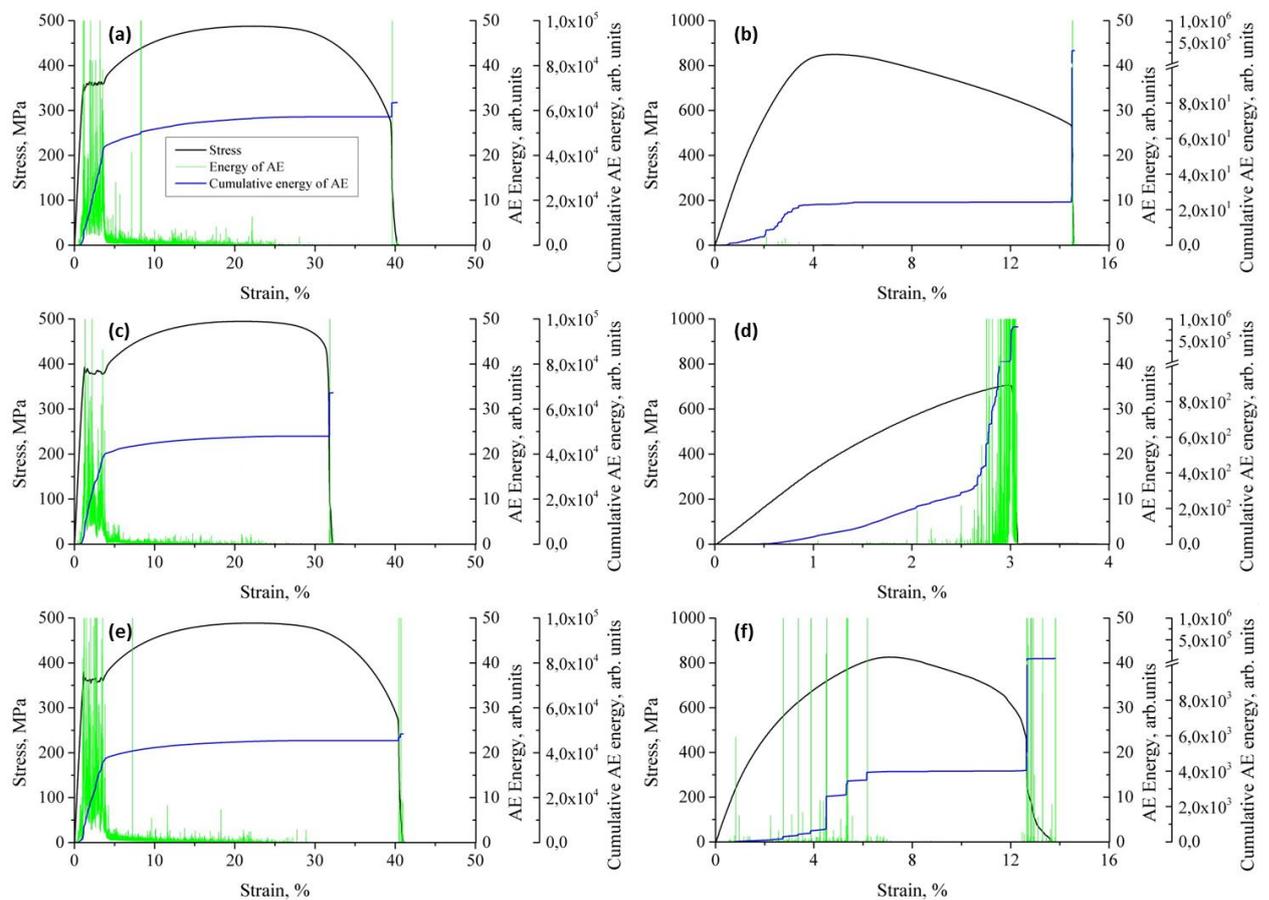
Fig. 3 – Stress-strain diagrams and concomitant AE behavior - AE energy values and AE energy accumulation curves - for the as-received - (a, c, e) and ECAPed - (b, d, f) specimens tensile tested before - (a, b) and after hydrogen charging (c, d) and after hydrogen charging and degassing at 200 °C for 15 minutes - (e, f).

As follows from Table 2 the hydrogen charging of the as-received specimens results in the decrease of their elongation, which is compromised mainly due to shortening of the necking stage, Fig. 3c. Nevertheless, the fracture of the as-received specimens is always preceded by appreciable localized deformation in the neck. Removing of diffusible hydrogen from the as-received steel before tensile testing results in the complete recovery of mechanical properties and the shape of the stress-strain diagram, c.f. Table 2 and Fig. 3e.

The ECAP results in the substantial increase of the steel strength but the elongation is compromised, Table 2. The stress-strain behavior is also changed, so that the yield plateau vanishes completely, and both the strain hardening stage and the necking stage shorten, Fig. 3b.

After hydrogen charging the fracture of the ECAPed specimens occurs suddenly in the region of quasi-elastic deformation or at the very beginning of the strain-hardening stage, so that the strain at fracture does not exceed 1 %, Fig. 3d. Degassing at 200 °C for 30 minutes followed by 5 minutes additional annealing at 300 °C completely recovers the mechanical properties of the hydrogen-charged ECAPed steel, c.f. Table 2. The shorter degassing at a lower temperature is less effective. It also remarkably reduces the harmful effect of hydrogen charging on ECAPed steel properties, Fig. 3f.

The AE behavior during tensile tests of the not charged as-received specimens is typical for low-carbon steels, see Fig. 3a. The highest rate of AE energy accumulation is observed during the yielding stage. After sharp peaking, the AE activity reduces during the strain hardening stage until fracture that is accompanied by strong AE transients as illustrated in Fig. 3a. Throughout the test AE appears as a mixture of continuous noise-like and discrete burst type signals. It has been well established that continuous AE in such steels is produced by cooperative dislocation movement while the burst-type AE is often associated with fracture of non-metallic inclusions or cementite lamellas [35].

It is interesting that hydrogen charging of the as-received specimens does not result in any notable change in the AE behavior, see Fig. 3c, despite the fact that HE has occurred and manifested itself through mechanical properties, and many alternations in the microstructure and fracture surface (see discussions above and below in the text). As follows from Table 2, before and after hydrogen charging the total AE energies accumulated during plastic deformation before fracture,  $\Sigma E_{AE}^F$ , and during the whole test of the as-received specimens,  $\Sigma E_{AE}$ , are approximately the same within the regular scatter. The degassing procedure also does not result in any notable change in the AE behavior, as can be seen in Fig. 3e and Table 2.

Negligible AE has been detected during tensile testing of the fine grained ECAPed specimens before hydrogen charging except the final fracture stage when strong AE impulses emerge, see Fig. 3b and Table 2. Obviously the lack of AE is explained by severe cold working of the steel caused by ECAP so that plastic deformation processes are limited and do not produce measurable AE in a severely hardened ECAPed material [36] in good agreement with the Kaiser effect.

The hydrogen charging of ECAPed specimens results in the appearance of high-energy transient AE signals, Fig. 3d. The AE activity in this case starts shortly after the onset of loading during the quasi-elastic deformation. It then dramatically increases shortly before final fracture which is accompanied by the large AE energy release. The total AE energy accumulated before the onset of fracture is found by four orders of magnitude higher than that before hydrogen charging and about 20 times higher than that in the as-received specimens, Table 2.

The degassing process leads to decrease of the AE intensity which becomes most pronounced just before necking and during fracture, see Fig. 3f. The  $\Sigma E_{AE}$  and  $\Sigma E_{AE}^F$  values are substantially lower than in the initial non-degassed specimens, Table 2. Nevertheless the intensity of AE in the degassed ECAPed specimens is still much higher than in the not charged ones. Besides, it depends on the effectiveness of degassing. As follows from Table 2, the degassing at higher temperature and longer time results in better recovery of mechanical properties concomitant with the lower total AE energy accumulated before fracture.

As follows from the AE behavior in Fig. 3d and f the intensive cracking starts at very low stress almost immediately after onset of loading of the specimens. Hence the fracture of the hydrogen embrittled ECAPed specimens begins at the stress well below yield point and occurs by the sub-critical growth of the multiple side surface cracks producing the regions with tearing-only morphology on the periphery part of the fracture surface. When the size of such cracks becomes essentially big, the local criteria of brittle fracture are met, and unstable critical crack growth occurs. It is in some measure evidenced by the metallographic examination which showed that no secondary cracks beneath the fracture surface are found in the bulk part of the specimen. Another good illustration of proposed scenario is provided in Fig. 8c where it can be seen that many brittle terraces having mixed tearing/cleavage relief originate at the boundary of the near-side surface region with the dominated tearing morphology. Thus the critical crack growth in the hydrogen-charged ECAPed specimens is accompanied by the formation of the fracture surface featuring the mixed cleavage/tearing morphology. According to many previous studies the cleavage fracture is recognized as a strong source of AE. In a good agreement with that, the total energy of AE in the hydrogen-charged specimens is about 2-3 orders of magnitude higher in comparison with the degassed ones which fracture surface does not contain cleavage facets. Therefore, in the case of hydrogen charged ECAPed specimens the total AE energy accumulated during the whole test,  $\Sigma E_{AE}$ , includes the energy of AE from: (i) the sub-critical crack growth characterized by the tearing fracture mode and by the gradual increase of AE energy at the onset of loading, c.f. Fig. 3d; (ii) the critical crack growth exhibiting the mixed tearing/cleavage fracture morphology and accompanying by the dramatic increase in the AE energy just before fracture; (iii) final ductile rupture of the walls of metal between the brittle terraces at the break.

Figure 3f illustrates that the degassed specimens show no substantial increase of the AE intensity just before fracture; the AE disappears almost completely before necking sets in. On the other hand, no cleavage fracture has been observed in these specimens. Thus, the brittle critical crack growth does not occur in the degassed specimens, and only sub-critical cracking and ductile rupture contribute to the  $\Sigma E_{AE}$  value. It was shown that at a higher degassing temperature and, consequently, at lower diffusible hydrogen concentration in the steel, the torn regions have a smaller size. This suggests that the rate of the sub-critical crack growth depends on the concentration of diffusible hydrogen in the ECAPed steel. Considering a relatively short time of tensile testing, the side cracks do not have enough time to grow up to the critical size in the degassed specimens having the quite low concentration of diffusible hydrogen. Hence, they blunt by plastic deformation as illustrated in Fig. 10c, d. Indeed, Figures 10b and 8c show that the diameter of the largest torn region on the fracture surface of the specimen degassed at 200 °C is about three times smaller than the critical one in the not degassed specimen, Figs. 8c. As follows from AE data in Fig. 3f, the growth of the cracks producing tearing morphology stops at the necking point and only blunting occurs during further straining in the neck.

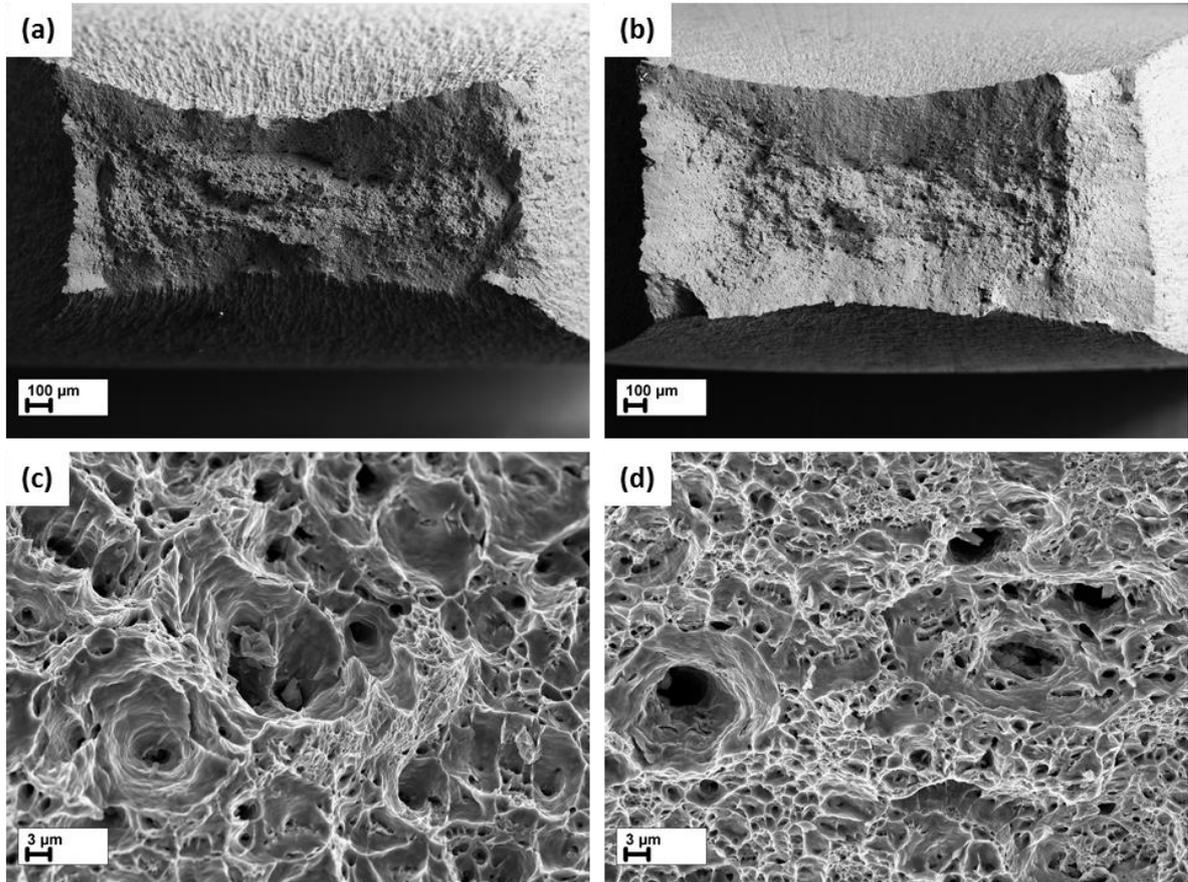
Fig. 4 – Fracture surfaces of the as-received (a, c) and ECAPed (b, d) specimens tensile tested before hydrogen charging: full-scale views (a, b) and magnified fragments (c, d).

All tensile tested specimens, which were not charged with hydrogen, exhibit entirely ductile fracture with the dimpled fracture surface, c.f. Fig. 4. Dimples are preferably nucleated around nonmetallic inclusions, as can be seen in Fig. 4c, d.

non-metallic inclusions and propagate in a transgranular manner as evidenced by Fig. 6d. Neither such cracks nor the fisheyes were found in the hydrogen-charged as-received specimens, which were degassed before tensile testing. In fact, the fracture surface of the degassed as-received specimens is completely ductile and is the same as that before hydrogen charging, see Fig. 4a, c.

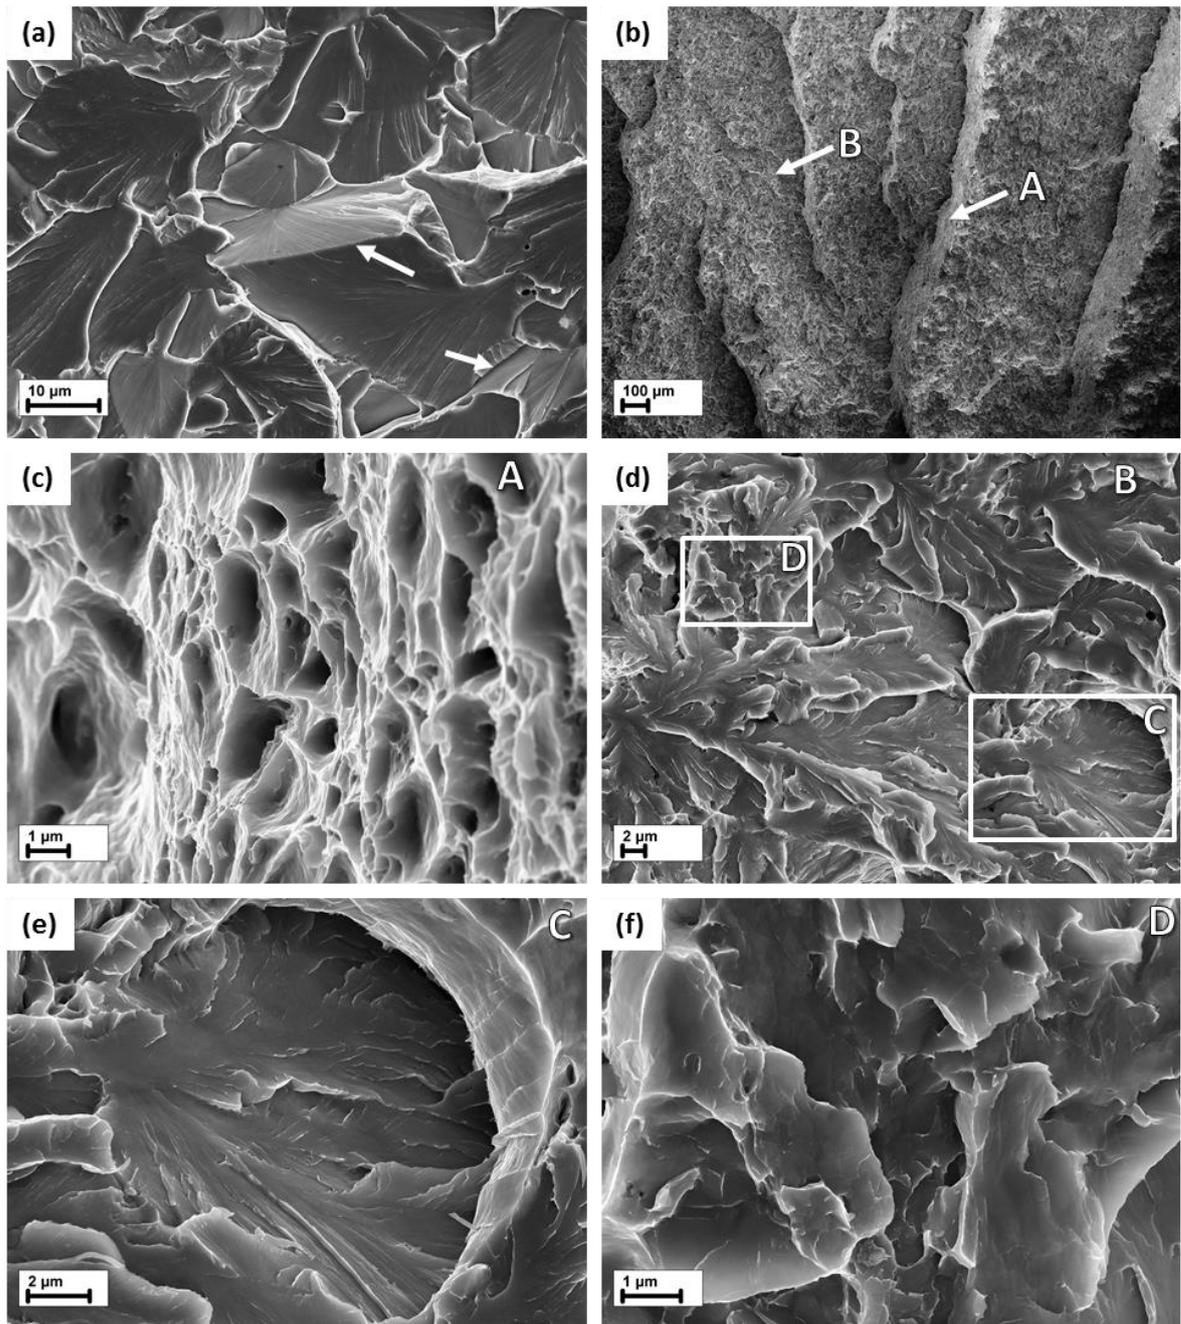
Fig. 5 – Fracture surfaces of the not charged as-received (a) and ECAPed (b-f) specimens after impact testing in liquid nitrogen: (a) – cleavage facets; (b) – terraced relief in the middle part of the fracture surface; (c) – the magnified image of dimpled morphology from the ductile terrace region indicated by arrow “A” in (b); (d) – the magnified image of mixed cleavage/tearing morphology from the brittle terrace region indicated by arrow “B” in (b); (e) and (f) – the magnified images of the cleavage and tearing morphologies from the outlined regions marked as “C” and “D” in (d), respectively.

Both type specimens impact tested in liquid nitrogen demonstrate brittle fracture surfaces, c.f. Fig. 5. The fracture surface of the as-received specimens exhibits the regular transgranular cleavage facets with typical river patterns and pronounced boundaries, Fig. 5a. In the case of ECAPed steel, the fracture surface is composed of brittle terraces, Fig. 5b, which are linked by the walls having a ductile dimpled relief, Fig. 5c. The morphology of the brittle terraces primarily consists of cleavage facets. These facets appear highly distorted. However, they still exhibit clear cleavage features such as river lines originating at the facets boundaries, Fig. 5d, e. The minor part of the brittle relief is presented by smoothly curved regions with tear ridges, Fig. 5d, f. The larger areas having a similar morphology have been found close to the periphery of the

fracture surface. The surface of this kind will be further referred to as “tearing” morphology and its probable origin will be discussed below.

Three kinds of morphologies have been observed on the fracture surface of the hydrogen-charged ECAPed steel: 1) the ductile dimpled relief, Fig. 5c, 2) the cleavage facets, Fig. 5e, and 3) the smooth curved surfaces with tear ridges referred here to as “tearing” morphology, Fig. 5f.

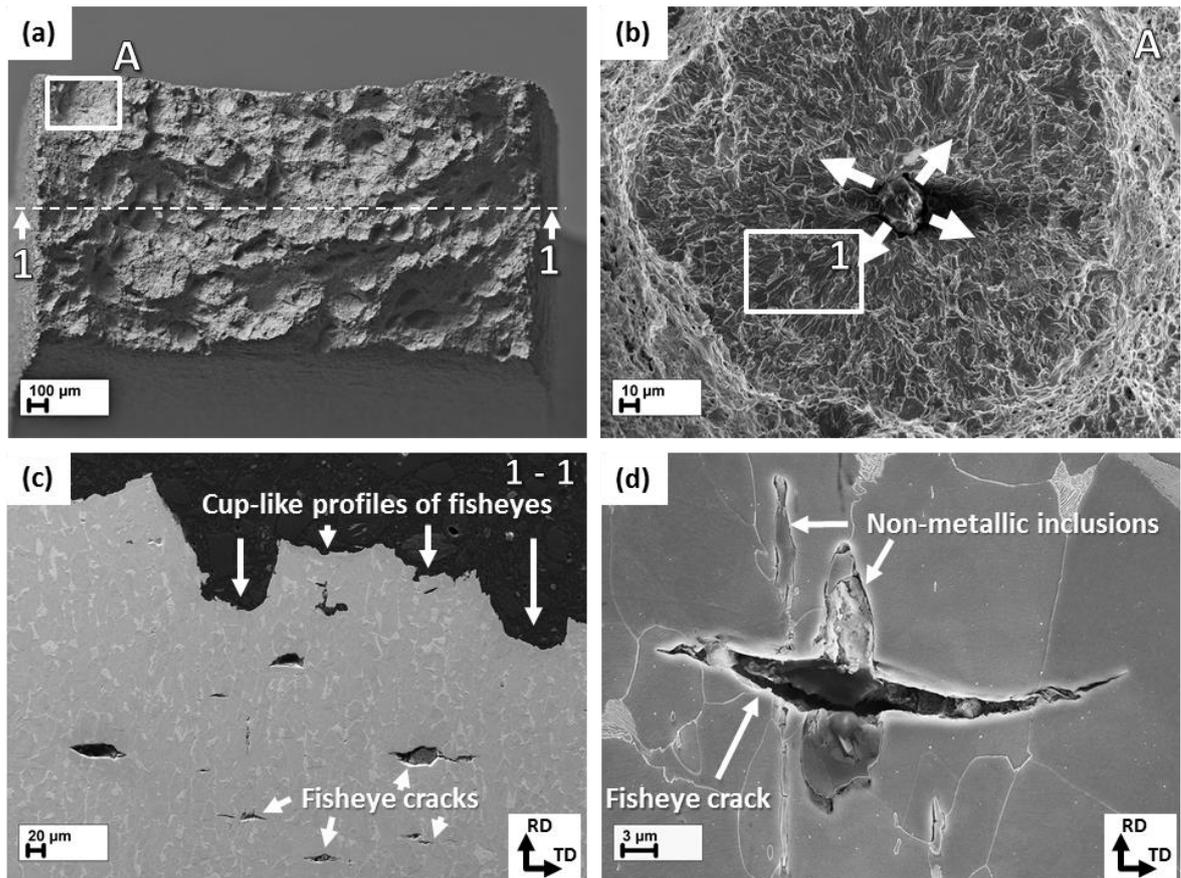
Fig. 6 – Fracture features of the tensile tested hydrogen charged as-received specimen: (a) – full-scale view of the fracture surface; (b) – the magnified image of the fisheye defect from the outlined region marked as “A” in (a); (c) – the cups-like profile of the fracture surface and underlying fisheye cracks on the cross-section taken approximately along the dashed line “1-1” in (a); (d) – the cross-sectional image of the fisheye crack originating at non-metallic inclusion.

Hydrogen charging changes the fracture surface appearance dramatically for both the as-received and ECAPed tensile tested specimens. About 50% of the fracture surface area of the hydrogen-charged as-received specimens consists of numerous fisheye defects, Fig. 6a, which are the round-shape regions having the faceted quasi-cleavage morphology and nonmetallic inclusions in their centers, c.f. Fig. 6b and Fig.7. As follows from the primary orientation of river-markings on the facets, the growth of fisheyes occurred in the radial direction from nonmetallic inclusions serving as initiation sites, c.f. arrows in Fig. 6b.

The metallographic examination of the fracture surface cross-sections shows that fisheyes have the cup-like profile and are formed by growth and coalescence of the cracks which are readily found beneath the fracture surface, c.f. Fig. 6c. These cracks are approximately parallel to the fracture surface and, in contrast with HICs, are oriented perpendicular to the rolling direction and the tensile axis of the specimens, Fig. 6c, d. It is clear that these cracks originate at

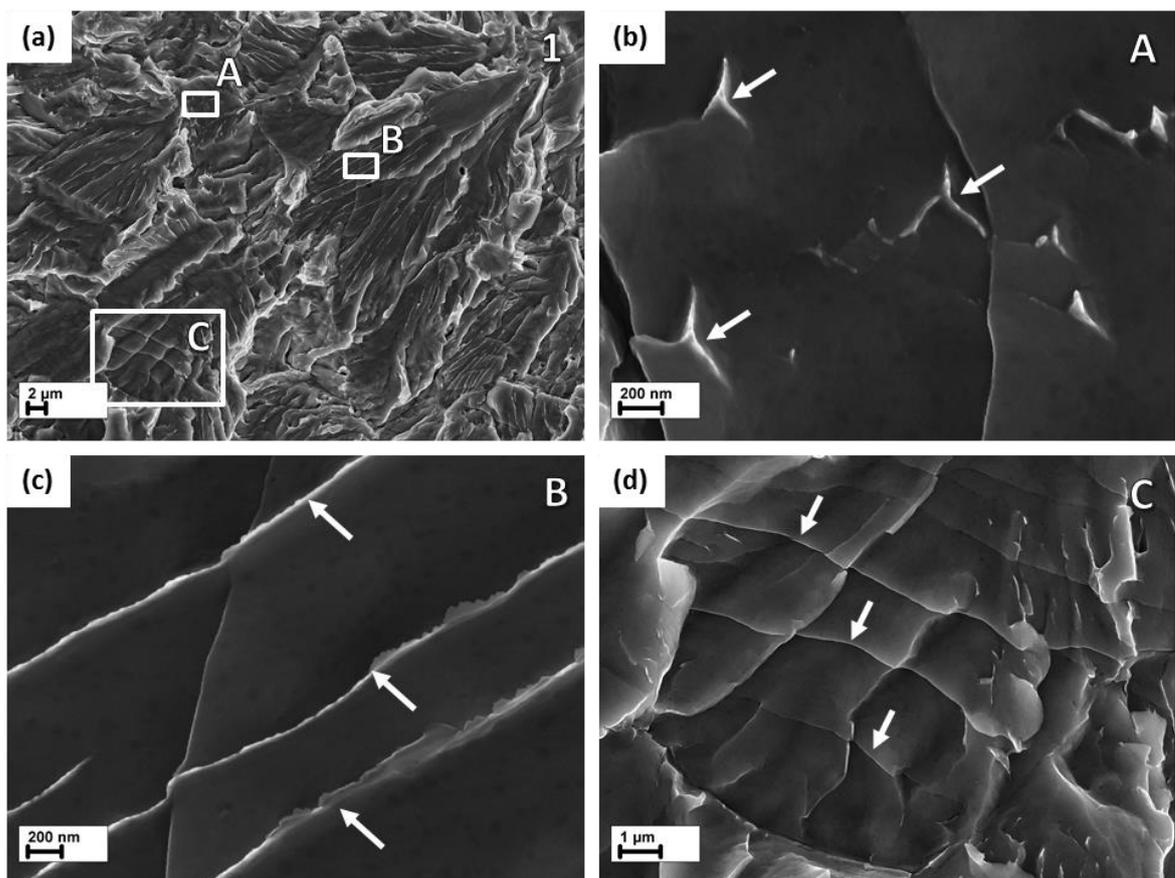
Fig. 7 – Fractographic features of the quasi-cleavage morphology in the hydrogen-charged as-received steel: (a) – the magnified image of the quasi-cleavage facets from the outlined region marked as “1” in Fig. 6b; (b-d) – magnified images representing nearly-flat terraces with Y-shaped (b) and straight (c) tear ridges, and thin bands perpendicular to the river markings (d)

from the outlined regions marked as A, B, and C in (a), respectively. The features of interest are indicated by arrows in each corresponding image.

The quasi-cleavage facets on the fisheyes surface have a complex morphology, c. f. Fig. 7. It composed of nearly-flat step-wise terraces with river markings, Fig. 7b-d, presented by straight and Y-shaped tear ridges showed by arrows in Fig. 7b and c, respectively. Besides, there are thin bands or striations approximately perpendicular to the river markings, as indicated by arrows in Fig. 7f. It should be underlined that this morphology is completely different from the cleavage in the as-received and ECAPed specimens tested in liquid nitrogen, Fig. 5a. For example, the facets of fisheyes never have straight boundaries such as those indicated by arrows in Fig. 5a. In common, the differences between cleavage and quasi-cleavage of fisheyes in steel 09G2S are the same as in low-carbon steel S235JR as was described in detail in [37].

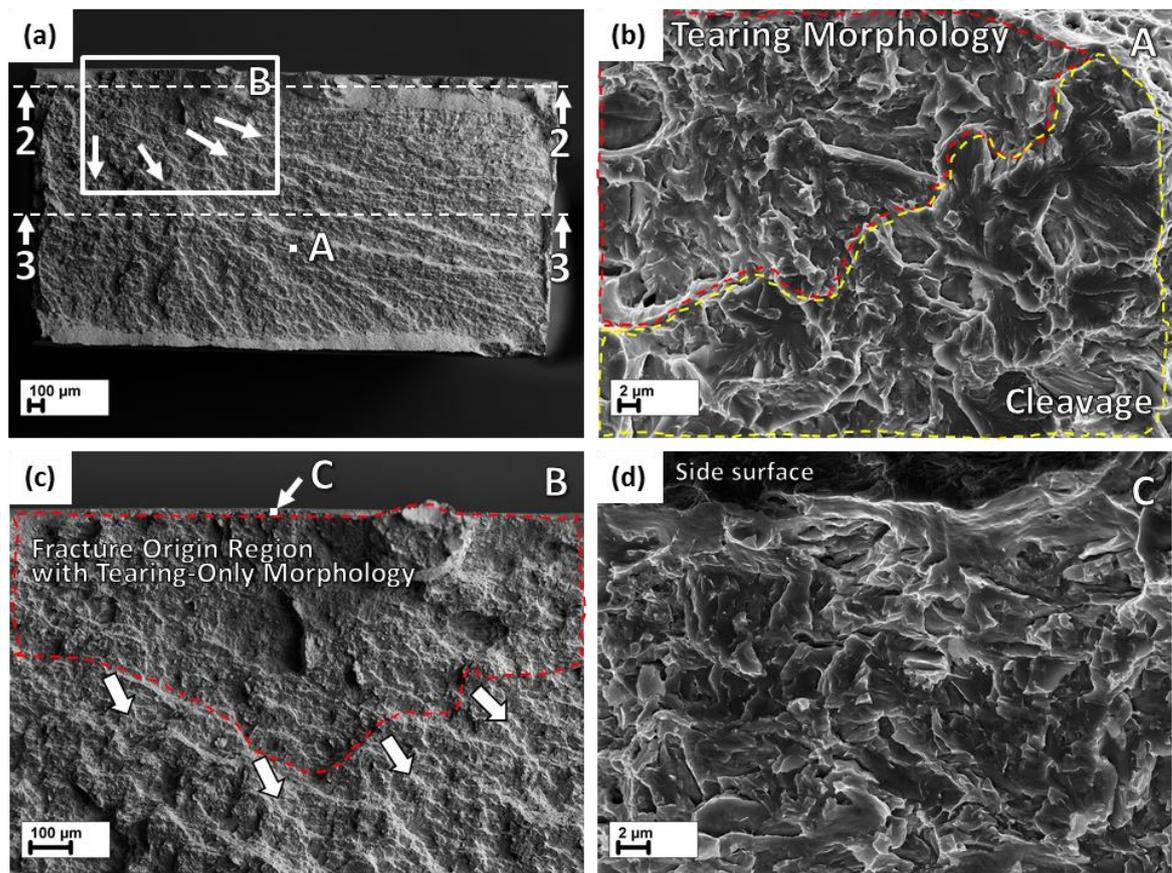
Fig. 8 – The fracture surface of the hydrogen charged ECAPed specimen after tensile testing: (a) – full-scale view; (b) – mixed cleavage/tearing morphology of the brittle terraces from the region marked as “A” in (a); (c) - the magnified image of the fracture origin from the

outlined region marked as “B” in (a); (d) - the magnified image of the tearing-only morphology from the outlined region marked as “C” in (c).

Similar to the ECAPed specimens tested in liquid nitrogen, the fracture surface of the hydrogen-charged ECAPed specimens is mainly characterized by the brittle terraces having the mixed cleavage/tearing morphology, c. f. Fig. 8a, b, and ductile walls between them, the same as those in Fig. 5b, c. However, in the case of hydrogen embrittled specimens, the amount of cleavage facets is smaller while the portion of torn surfaces is larger in comparison with the low-temperature embrittled ones, Fig. 8b. Besides, the areas with the tearing-only morphology with no cleavage facets are found on the periphery of the fracture surfaces in the hydrogen-charged ECAPed specimens, Fig. 8c, d. Obviously, one of such regions marked as “B” in Fig. 8a and outlined by the dashed line in the Fig. 8c, was the place where fracture initiated as pointed out by the terraces emanating from this region, see arrows in Fig. 8a and c. The diameter of this region is about 1 mm.

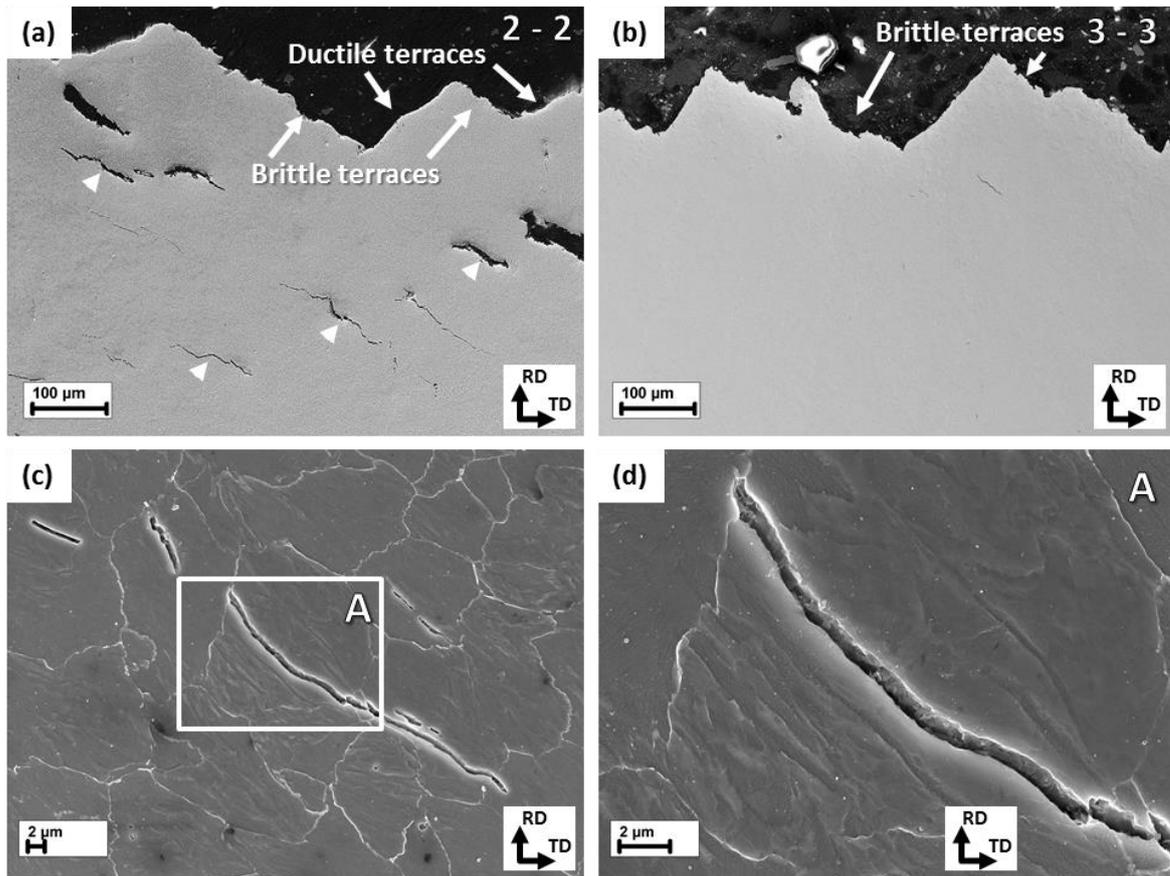
Fig. 9 – Terraced profiles and underlying cracks of the fracture surface of the hydrogen-charged ECAPed specimen: not-etched (a) – near side-surface and (b) – middle part cross-sections of the fracture surface taken approximately along the “2-2” and “3-3” dashed lines in the Fig. 8a, respectively; (c, d) – one of the cracks beneath the fracture surface on the etched “2-2” cross-section at different magnifications.

Two cross-sections were prepared from the fracture surface of the hydrogen-charged ECAPed specimen. The first was close to the side surface and the second was cut in the middle part of the specimen as shown schematically by “2-2” and “3-3” dashed lines in Fig. 8a. Both cross-sections demonstrate the fracture surface profile with the mixture of brittle and ductile terraces which are approximately perpendicular to each other and are inclined to the tensile axis of the specimen at about  $45^\circ$ , Fig. 9a, b. Numerous sharp cracks parallel to the brittle terraces can be seen under the fracture surface on the “2-2” cross-section close to the side surface, see arrowheads in Fig. 9a, while on the cross-section “3-3” close to the center they are almost absent, Fig. 9b. This observation indicates that multiple cracking started from the side surface and then one or few of such cracks provoked final fracture occurring by the critical growth of the one major crack in the central part of the specimen. Figure 9a shows that the cracks under the fracture surface are not linked to each other. Thus, it implies that their ductile coalescence occurred at the final fracture stage. The appearance of these cracks shown in Fig. 9c, d is similar to HICs which were found in the hydrogen-charged ECAPed specimens before tensile testing. They are also inclined at  $\sim 45^\circ$  to the specimen surface and are transgranular with respect to the initial ferritic grains of the steel.

the fracture process because the brittle cracks beneath the fracture surface are mainly not linked with each other, Fig. 9a. Thus, the influence of ductile rapture on the AE signal recorded before the final break of the specimen should be negligible.

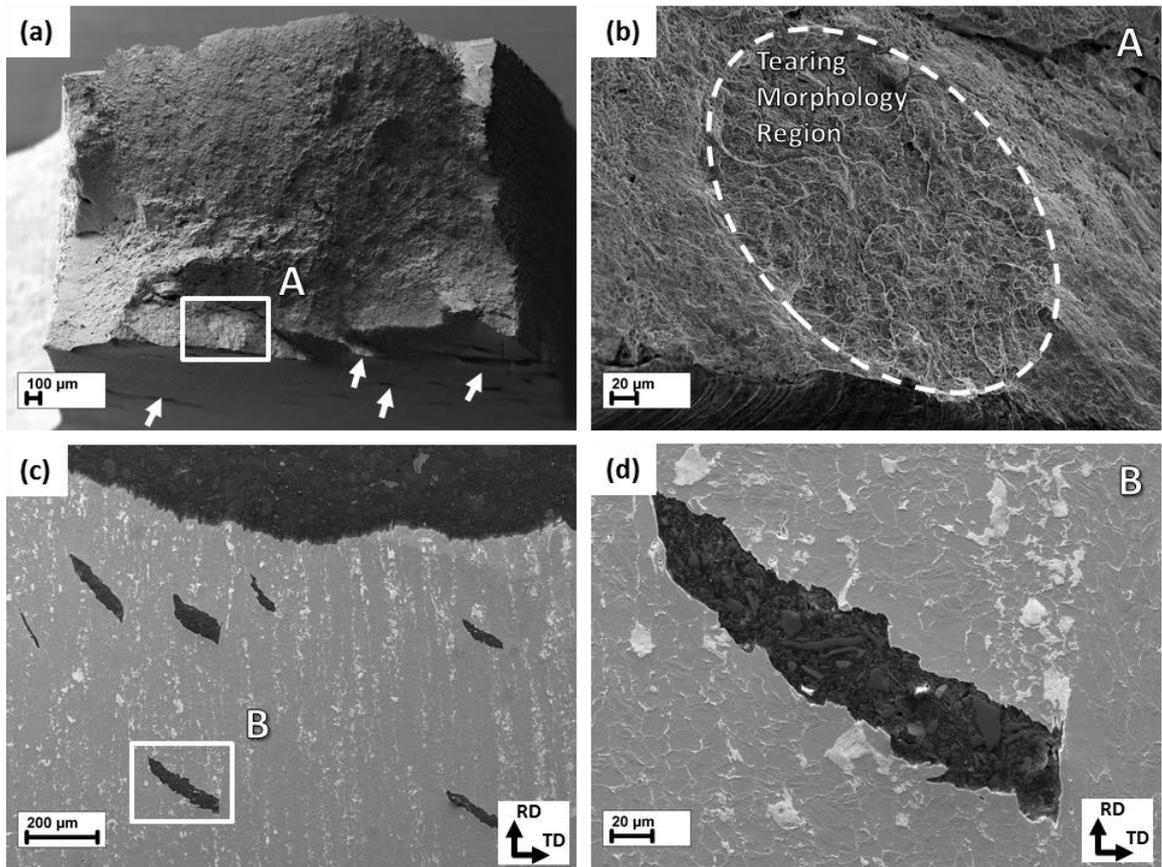
Fig. 10 – Fracture features of the hydrogen-charged ECAPed specimen degassed at 200 °C: (a) – full-scale view of the fracture surface and side surface cracks indicated by arrows; (b) – the magnified image of the torn region marked as “A” in (a) and highlighted by an ellipse; (c) – blunted cracks beneath the fracture surface on the near-side surface cross-section; (d) – the magnified image of the blunted crack from the region marked as “C” in (e).

The specimens subjected to degassing at 200 °C (15 min) prior to testing exhibited the mostly ductile fracture surface. However, several round shaped regions with the “tearing” morphology could be found on the periphery. The diameter of these regions is not higher than 320 μm. One of them is shown at higher magnification in Fig. 10b. This region is located on the terrace which is the part of one of many cracks existing on the side surface of the specimen, see arrows in Fig. 10a. Examination of the side surface showed that these cracks are inclined at ~45° to the tensile axis of the specimen, and their surface is also characterized by the tearing-only morphology. The same cracks are found in the near-side surface cross-section prepared from the fracture surface of the preliminary degassed specimen, c. f. Fig. 10c, d. As can be seen, most of the cracks beneath the fracture surface are wide open and well blunted.

The regions of the tearing-only morphology have been found in the degassed specimens, Fig. 10 and 11. It was established that these regions are produced by the growth of the side surface cracks. Since the cleavage was not found in the degassed specimens, obviously *the propagation of the cracks resulting in the formation of tearing regions is the main source of the burst AE during the deformation of the degassed ECAPed specimens until the final fracture*, Fig. 3f. This conclusion is confirmed by the lower value of the total AE energy accumulated before fracture in the ECAPed specimen which was degassed at 300 °C, Table 2. The much lower amount of tearing morphology has been found in this specimen in comparison with the one degassed at 200 °C.

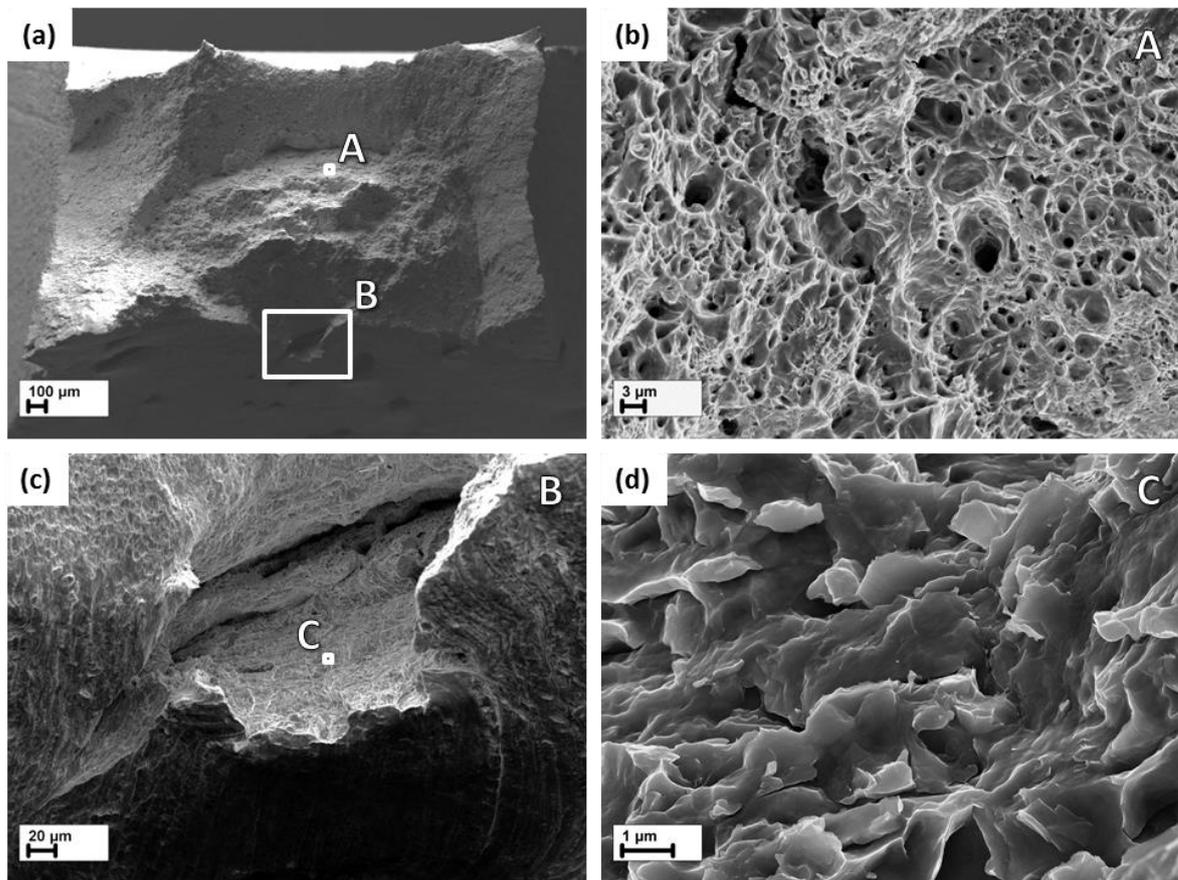
Fig. 11 – Fracture features of the hydrogen-charged ECAPed specimen degassed at 300 °C: (a) – full-scale view of the fracture surface; (b) – the magnified image of the dimpled morphology from the region marked as “A” in (a). (c) – the magnified image of the side surface crack from the region marked as “B” in (a); (d) – the magnified image of the tearing-only morphology from the region marked as “C” in (c);

Degassing at a higher temperature and longer time prior to mechanical testing results in the almost complete vanishing of the tearing morphology on the fracture surface, Fig. 11a, b, although many side surface cracks still demonstrate this kind of relief. The very rare example (actually the only one) of the torn region with 130 μm diameter is shown in Fig. 11c.
