The fundamental difference between cleavage and hydrogen-assisted quasi-cleavage in ferritic materials revealed by multiscale quantitative fractographic and side surface characterization

Keywords: quasi-cleavage, hydrogen-assisted cracking, confocal laser scanning microscopy, hydrogen embrittlement, iron, fractography

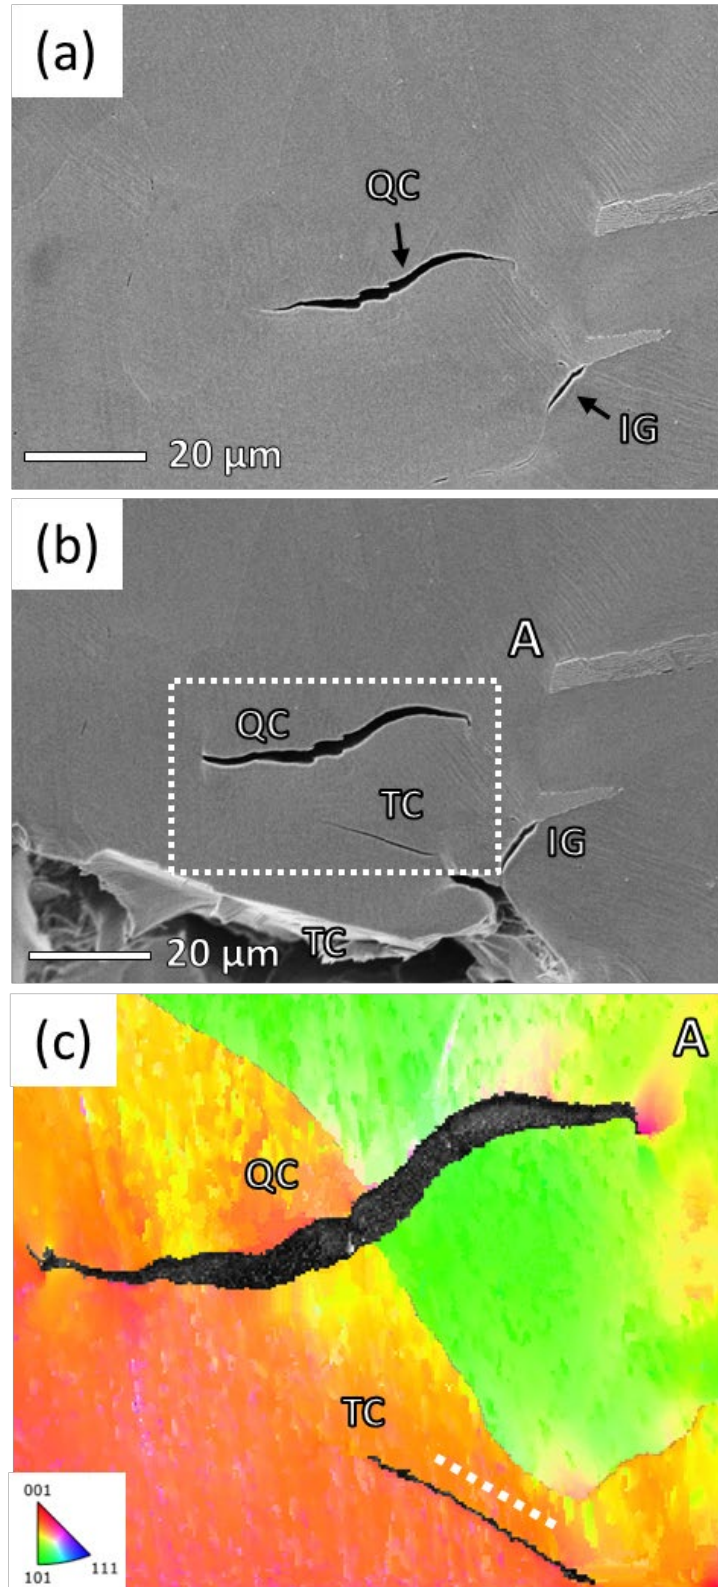
Fig. 5 – SEM images – (a, b) and EBSD IPF colour-coded map – (c) demonstrating the specific region of the side surface of the low-carbon steel S235JR specimen after the first- – (a) and second-step loadings – (b, c). The region represented in (c) is the magnified area outlined by “A” - labelled frame in (b). The white dotted line in (c) indicates the trace of the {100} crystallographic planes.

Figures 5a and b demonstrate the side surface region of the steel specimen, which was observed during the intermediate and post-mortem SEM examinations, respectively. As follows

from Fig. 5a, this region contains one IG and one TG QC secondary cracks after the first step-loading. The new secondary TG crack and the fracture surface corresponding to the primary TC crack have appeared after the second step-loading, as one can see in the bottom of the image, Fig. 5b. In contrast to the QC crack having a characteristic curved shape, the new secondary crack exhibits an obviously sharper, thinner and straighter geometry, which is typical of TC cracks. According to the EBSD inverse pole figure (IPF) coloured map of the same region, Fig. 5c, both the QC and TC secondary cracks correspond to the same grain, demonstrating the uniform crystallographic orientation insignificantly distorted by plastic deformation. As has been already stated above, the TC cracking in bcc iron and steels occurs primarily along the $\{100\}$ crystallographic planes. The cracks aligned with the crystallographic planes of this family must be either parallel or perpendicular to each other within an individual crystal. In harmony with this rule, the secondary and primary TC cracks shown in Fig. 5b are parallel to each other as well as to the traces of the $\{100\}$ planes, which are indicated by the white dashed line in Fig. 5c. In contrast, the QC crack is misoriented with the TC cracks as well as with the $\{100\}$ traces by about 18 degrees. The angle of misorientation between the QC and TC cracks far from 90 and 0° suggests their different crystallographic orientations, though it is generally questionable whether the strongly curved QC crack can be considered crystallographic at all.

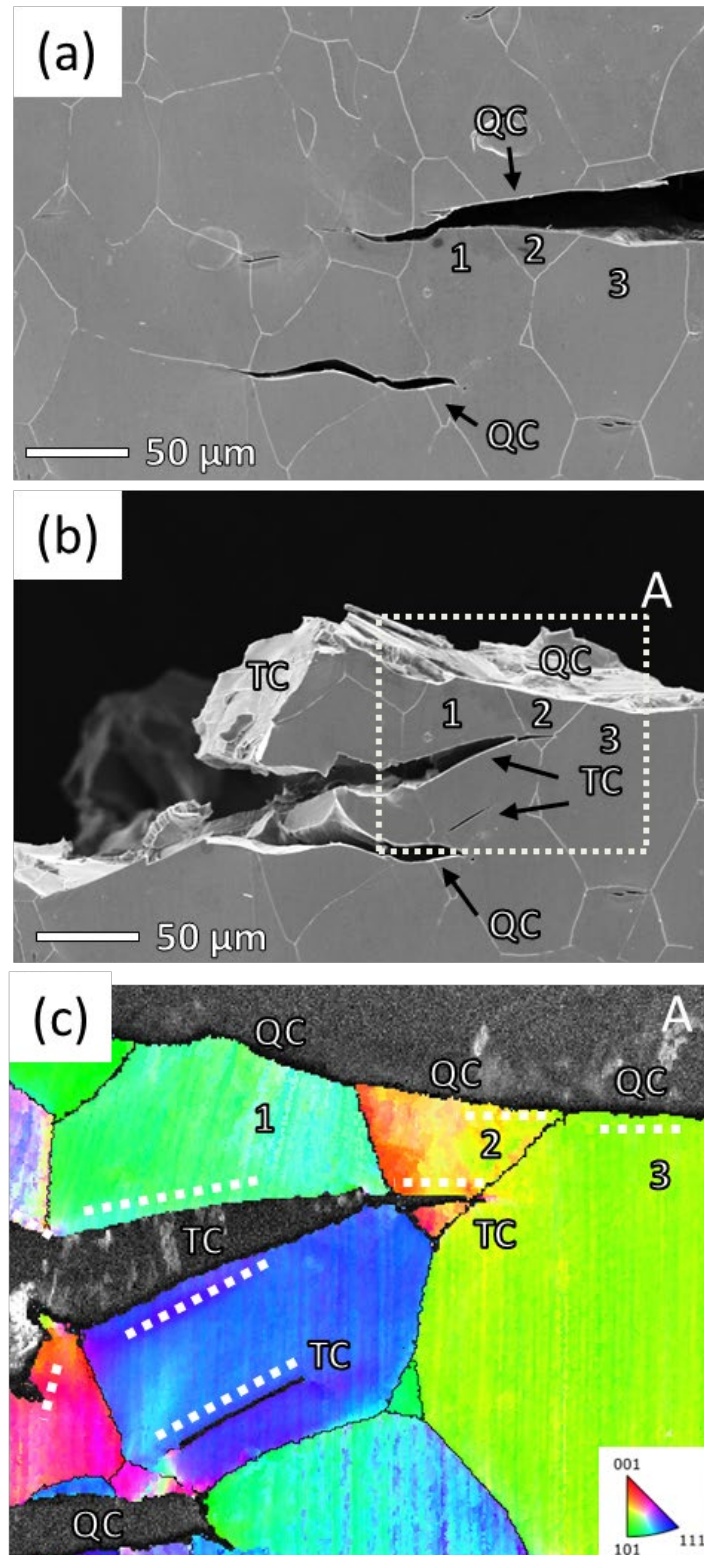
Fig. 6 – SEM images – (a, b) and EBSD IPF coloured-coded map – (c) demonstrating the specific region of the side surface of the Fe-2.5%Si alloy specimen after the first- – (a) and second-step loadings – (b, c). The region represented in (c) is the magnified area outlined by “A” - labelled frame in (b). The white dotted lines in (c) indicate the trace of $\{100\}$ crystallographic planes.

Interestingly, the evidence for the different crystallographic orientations of the QC and TC cracks has also been obtained using the Fe-Si alloy, despite the frequently reported intrinsic propensity of this alloy to $\{100\}$ cracking [13,14,16]. Figure 6 illustrates the evolution of the side surface region of the Fe-Si specimen during the two-steps mechanical testing. After the first-step loading, this region contained a few QC cracks, including the primary one, which are marked by the correspondingly labelled arrows in Fig. 6a. As can be seen in Fig. 6b, after the second-step loading, the extending of the primary QC crack by the TC mechanism resulted in the formation of the unified fracture surface. Besides, two new mutually parallel secondary TC cracks were introduced into the grain labelled by 1 in Fig. 6. This grain was also fractured by the primary QC crack during the first-step loading, c.f. Fig. 6a. As follows from the EBSD IPF map, acquired from this region and represented in Fig. 6c, the orientation of these TC cracks expectedly coincides with the traces of $\{100\}$ crystallographic planes. As opposed to that, the orientation of the QC primary crack within the same grain mismatches with that of both the TC cracks and $\{100\}$ planes by the approximately 30° degrees angle. Thus, the TC and QC cracks in grain 1 should have different crystallographic orientations. It is worth noting that, besides the cases considered above, the orientation of QC cracks occasionally coincides with that of TC cracks and planes. For example, in Fig. 6c, one can see that the edge of the primary QC crack is

nearly parallel to the traces of $\{100\}$ planes in grains 2 and 3. Moreover, in grain 2, it is also parallel to the underlying TC crack. Thereby, the obtained results confirm the literature data in that the crystallographic orientation of QC HAC may or may not match that of TC.

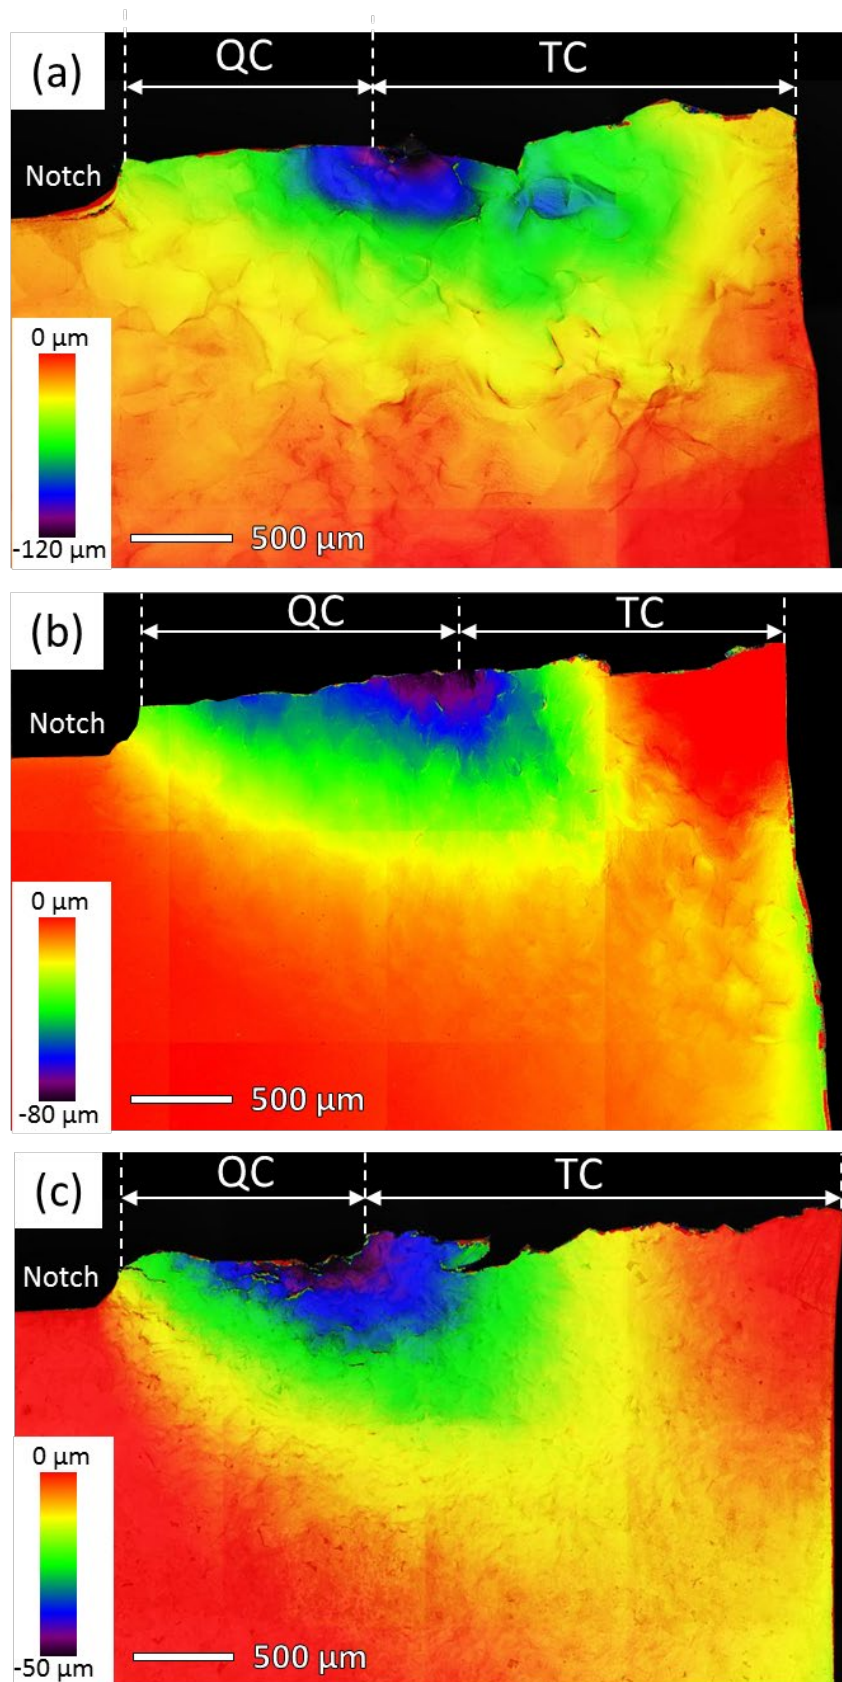
Fig. 7 – The height maps obtained by CLSM from the side surfaces of the technically pure iron – (a), Fe-2.5%Si alloy – (b) and low-carbon steel S235JR – (c) specimens.

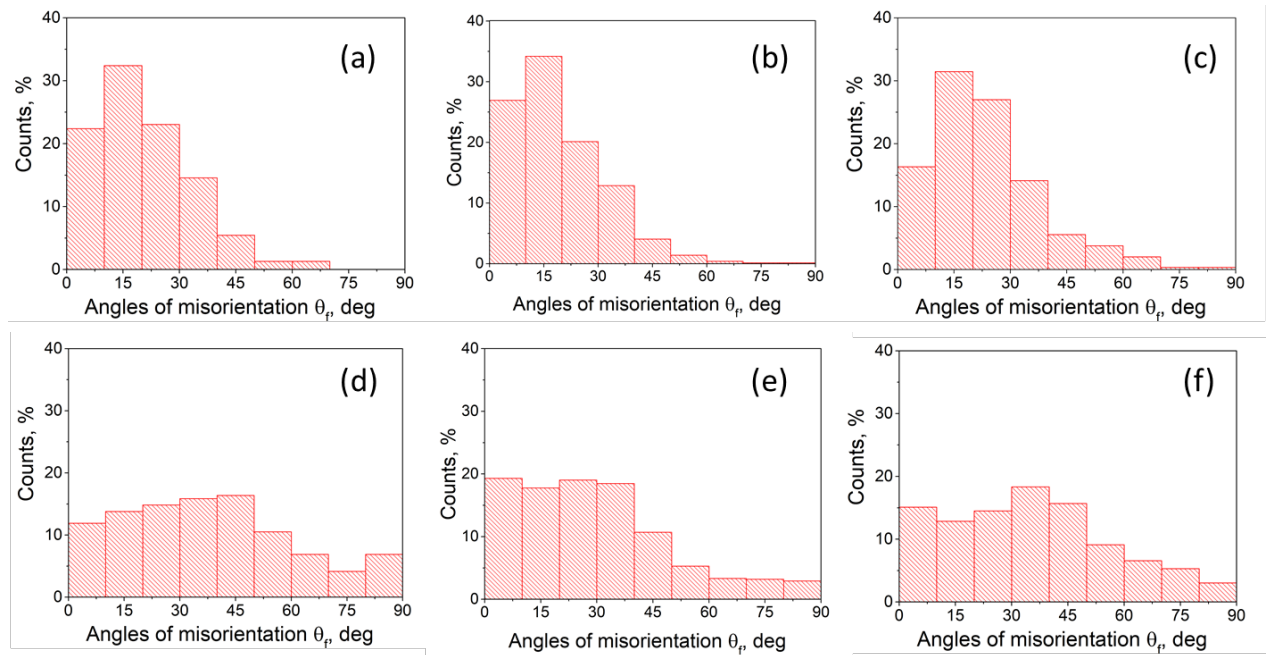
Fig. 12 – The distributions of the angles of misorientation between adjacent QC – (a-c) and TC – (d-f) facets on the fracture surfaces of the technically pure iron – (a,d), Fe-2.5%Si alloy – (b, e) and low-carbon steel S235JR – (c, f) specimens.

It is established that the roughness of the QC and TC surfaces is largely attributed to the misorientation of the facets. The quantitative analysis showed that depending on the material, the average AMs of the QC and TC facets are in the ranges of 18.9-23.3° and 29.5-38.1° respectively, see Table 2. Thus, on average, the AM of the QC facets are 1.5-2 times lower than that of the TC ones. Besides, it is found that the distributions of the angles of misorientation (DAM) corresponding to the two kinds of facets have completely different features, c.f. Fig. 12. It is found that for all materials studied, the DAMs of QC facets exhibit characteristic lognormal shape with one distinct peak at around 15°, Fig. 12a-c. The AMs of QC facets generally do not exceed 70-75°. In contrast, the AMs between the TC facets are ranged from 0 to 90°, c.f. Fig. 12d-f, while the dominating peak in the DAMs appears at 29-39.5°, depending on the material. Two other modes can be distinguished in the low- and high-angle domains of the DAMs of TC facets. The high-angle mode is observed approximately in the 70-90 degrees range and is much lower by magnitude in comparison with two other modes. Presumably, this mode can be attributed to the facets belonging to the same grain. The cleavage crack, which must turn along the equal {100} crystallographic plane within the same grain, should result in the formation of two TC facets orientated at 90° angle to each other. The TC facets of this kind have been frequently observed in the present and previous studies, c.f. Fig. 10d. In particular, the most pronounced high-angle mode on the DAM was observed in the iron specimen, which has the largest average grain size among the investigated materials. Indeed, in the large grain, the probability of the formation of several TC facets is reasonably anticipated to be higher. The magnitude of the low-angle mode is comparable with that of the dominating one. The notable prevalence of the TC facets with AMs of 0-45° in all investigated materials is evident from the DAMs shown. The exact nature of the low-angle mode is still unknown. However, we suppose that it can be related to the cleavage fracture along the sub-grains with low-angle boundaries, which are likely produced by plastic deformation. It is obvious from Fig. 7 that the TC crack propagated through the specimen, which had been already considerably deformed plastically during the first-step loading. The fragmentation of ferritic grains by the process of plastic deformation is well expected. In our previous study [41], the low-carbon steel (the same as that used in the present work) was fractured in liquid nitrogen with no preliminary straining. In that case, the DAMs of TC facets featured by the significantly lesser fraction of low AMs than in the
